FATIGUE IN NEW AND AGEING AIRCRAFT

AGING AIRCRAFT - USAF EXPERIENCE AND ACTIONS

John W. Lincoln*

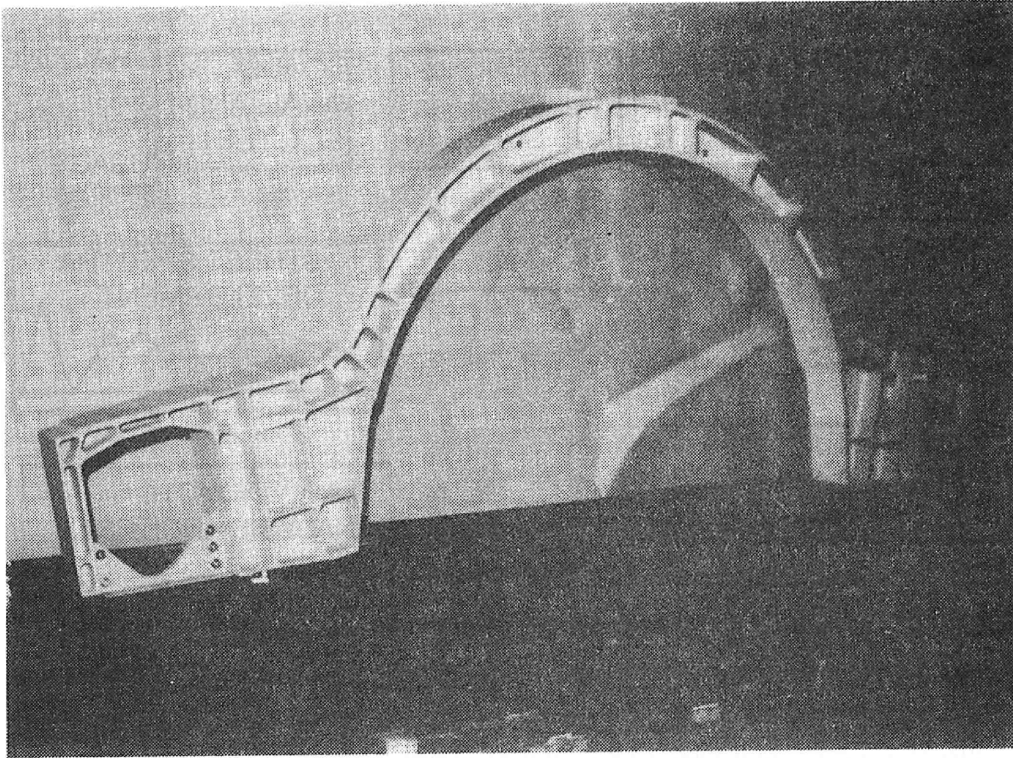
Figure 3 F16 Fuselage Station 479 bulkhead

In 1995 the USAF chartered an independent review team to assess the cracking found in the Fuselage Station 479 bulkhead. This team was to provide the

At this meeting the review team learned that three bulkheads located approximately at Fuselage Stations 446, 462, and at 479 support the vertical tail. The USAF identified in-service cracking in the Fuselage Station 479 bulkhead in 1993. They used local machining to modify the stress concentration and inspected them with eddy current on a recurring basis. This modification was not as successful as hoped since the USAF found cracks within approximately 300 hours from the time of modification. The USAF accomplished this modification on approximately 800 pre-Block 40 aircraft. The USAF believed there is a potential for cracks in the additional 1200 pre-Block 40 aircraft (474 USAF) that have not been subject to an inspection. In March of 1989, an F-16 operating out of McConnell Air Force Base suffered a partial failure of the 479 bulkhead. The aircraft returned safely, but part of the fin and the rudder were missing. The USAF has been unable to explain the reason for these missing portions of the structure. The fracture surfaces do not show evidence of a midair collision and the tail failure direction was wrong for a wake turbulence induced load. Further, for a given sideslip angle, the strength of the upper portion of the tail at the failure location is approximately four times larger than it is at the root. Also, they found no significant change in the calculated flutter speed as a result of the change in stiffness of the partially failed vertical tail support.

As indicated above, inspections have revealed significant cracking in the vertical tail to Fuselage Station 479 bulkhead attachment pads for the majority of pre-block 40 airplanes. The Ogden Air Logistics Center has considerable experience in the eddy current inspection for these cracks and has established appropriate guidelines for the disposition of cracks found in operational aircraft. As indicated above, the root cause of this cracking is the stress concentration inherent in the design compounded by increased usage severity and mass increases in the aircraft without compensating structural modifications. The stresses at the point where the cracks emanated are undesirably high although they do decrease with increasing crack depth. Figure (6) is the elastic stress distribution through the bulkhead starting from the point of initial cracking.

Normally, the USAF would not fly these airplanes with known cracking. In this situation the USAF concluded the structure had adequate fail-safe capability in the event of a first member failure. The contractor has analytically shown the vertical tail structure has fail-safety in the event of a failure of the Fuselage Station 479 bulkhead. The USAF, however, has not demonstrated this by laboratory testing. This would be difficult because of the complexity of simulating the failure and fracture surfaces as they may be in an operational aircraft. Therefore, USAF developed the recovery program with the goal of preventing another in-service failure. One of the concerns about too much reliance on fail-safety is there may be cracking in the adjacent bulkheads that would degrade the fail-safe capability. Even though the USAF placed emphasis on preventing the first member failure, they must ensure the integrity of the adjacent bulkheads through inspections. This is an example of potential WFD with a single crack in the fail-safe load path.

At the request of the review team, Lockheed Martin showed the aluminum lithium bulkhead had successfully met the five element technology transition guidelines (3). Therefore, the review team recommended this material be used for the Fuselage Station 479 bulkhead replacement. There is a lingering concern about the cost of these bulkheads because of the potential for a high rejection rate resulting from failure to meet the processing requirements. Therefore, it may turn out more economical to use conventional aluminum if the USAF can not control the aluminum lithium cost to an acceptable level. The USAF placed emphasis on replacing the existing cracked bulkheads with new bulkheads to maintain a low risk of failure of the Fuselage Station 479 bulkhead. The replacement program, based on the Lockheed Martin crack growth predictions, should be able to define a replacement program that maintains an acceptable risk of bulkhead failure. The review team recommended the fail-safe test not be conducted based on the assumption the replacement program was logistically viable.

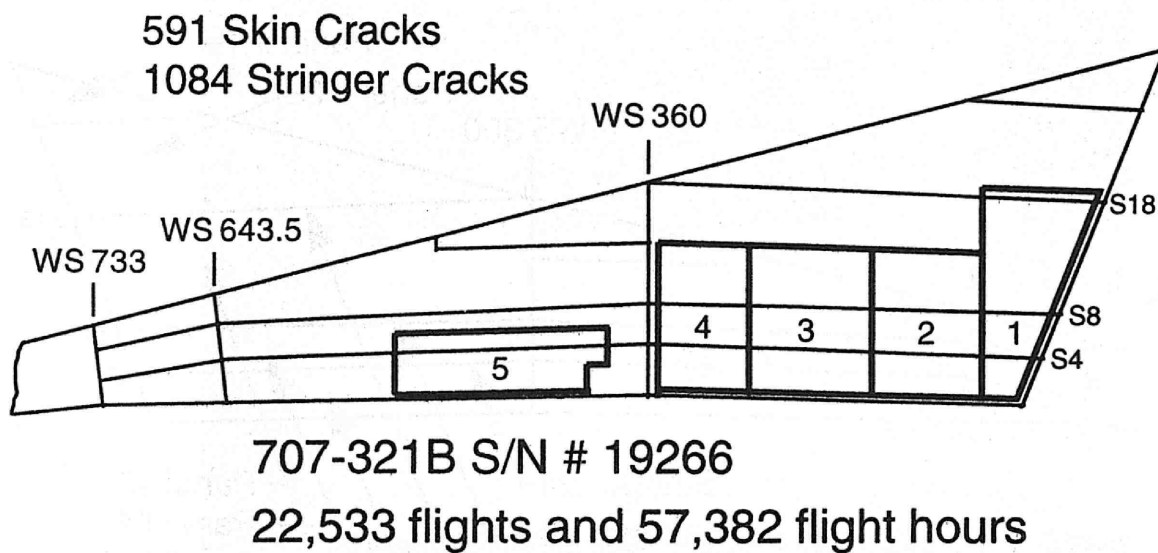
Figure 10 Sections of wing removed for teardown inspection

Boeing found that cracking in the aircraft in the area of the steel fasteners was quite extensive. In the 300 series aircraft there was a total 1915 cracks found in the five sections removed from the aircraft shown in Figure (10). They found the 100 series aircraft also extensively cracked. However, the cracking found in the 300 series aircraft was sufficiently extensive to perform an assessment of the risk of failure. Most of the cracks found in the 300 series aircraft were small. However, they found a significant population cracked to the point of considerable concern. Figure (11) shows the cracks in the stringers in one of the sections removed from the aircraft. The circles indicate crack findings. They found that increasing the size of the holes in the splicing stringer and the large adjacent stringer would not remove all of the cracks. About twenty percent of these holes would still have stringer cracks. Further, they found significant cracking outboard of the Wing Station 360 production joint. Therefore, the problem involved most of the wing. Typically, the large adjacent stringers had more large cracks than the splicing stringers. The largest crack found in Stringer 7 was approximately 38 millimeters in length. Figure (12) shows the fracture face of this crack. It was near the point of rapid fracture. Such a crack in Stringer 7, since it is a large adjacent stringer with a thick land, would be difficult to detect with low frequency eddy current from the outside of the wing. An inspector, however, would likely detect a completely severed stringer by low frequency eddy current. It would not be readily detectable from the inside of the wing by high frequency eddy current since the crack initiated on the faying surface. There were, however, many cracks found that would have gone to failure in the planned life span of the Joint Stars aircraft. There was a concern about cracking that would degrade the capability of the structure to sustain discrete source damage. There was also a concern about the fatigue failure of the stringers and subsequent catastrophic loss of the aircraft after a skin failure. Figure (13) shows the largest skin crack found in the teardown inspection.

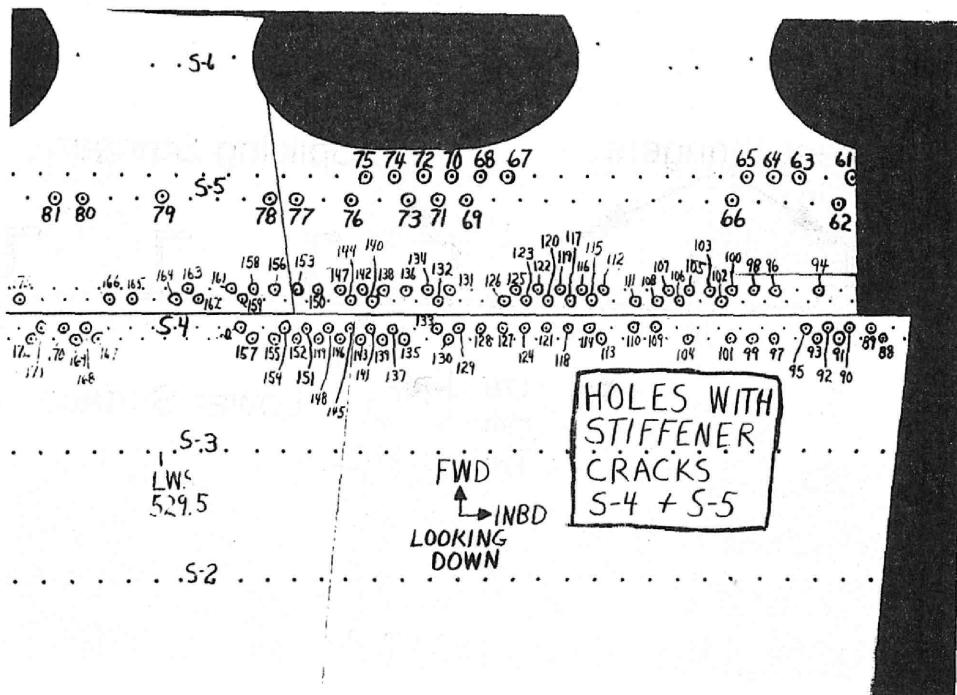
Figure 11 Stringer cracks found in teardown inspection

the cracks found. This was typically in the area of the wing skin splices and the large adjacent stringers. The large adjacent stringers rest on lands machined into the skins. The skin at the lands is typically approximately 9.5 millimeters thick and the wing skin under the splicing stringers is approximately 4.0 millimeters thick. Figure (8) shows a plan view of the 707 wing. This figure indicates the location of the production joints and splicing stringers. Figure (9) shows a cross section of the wing with the splicing stringer and the adjacent stringers. The beneficial effects of the aluminum rivets attaching the other stringers to the wing skins apparently reduced the amount of cracking there. There was, however, some cracking found in these locations.

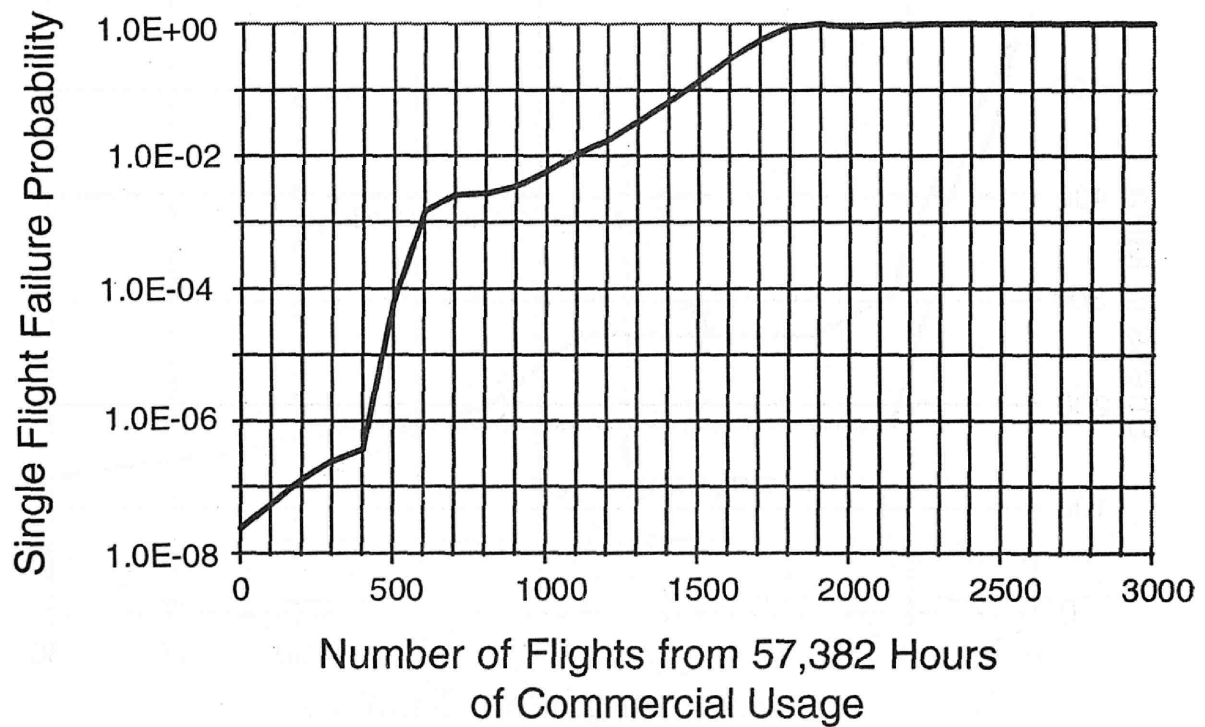
Figure 19 Risk assessment for intact structure

For the intact structure risk assessment, the more critical case was the failure from fatigue of the large adjacent stringer. Figure (19) shows the risk dependency on the number of Joint Stars usage flights from 57,382 commercial usage flight hours. This figure shows the risk is unacceptable after only a few flights of Joint Stars usage.

There are two possible approaches for solution of this problem. The first is to remove the steel fasteners in the area of concern in the lower wing surface and perform an eddy current inspection. If the inspector finds no indication of a crack or if increasing the size of the hole would remove the indication, then this hole would be cold expanded. For cracks that are too large for this remedy, the USAF could utilize a repair such as composite patching. This approach appears to be viable for aircraft with less than 45,000 commercial usage flight hours. It also may be viable for aircraft in the 45,000 to 55,000 flight hour range. A second alternative would be to replace the wing panels and stringers in the area of concern. This may be the only alternative for aircraft with more than 55,000 commercial usage flight hours.
