# A REVIEW OF AERONAUTICAL FATIGUE INVESTIGATIONS IN SWEDEN DURING THE PERIOD MAY 2007 TO APRIL 2009

EDITED by HANS ANSELL  
Saab Aerosystems  
Sweden

ICAF Doc. No. 2419

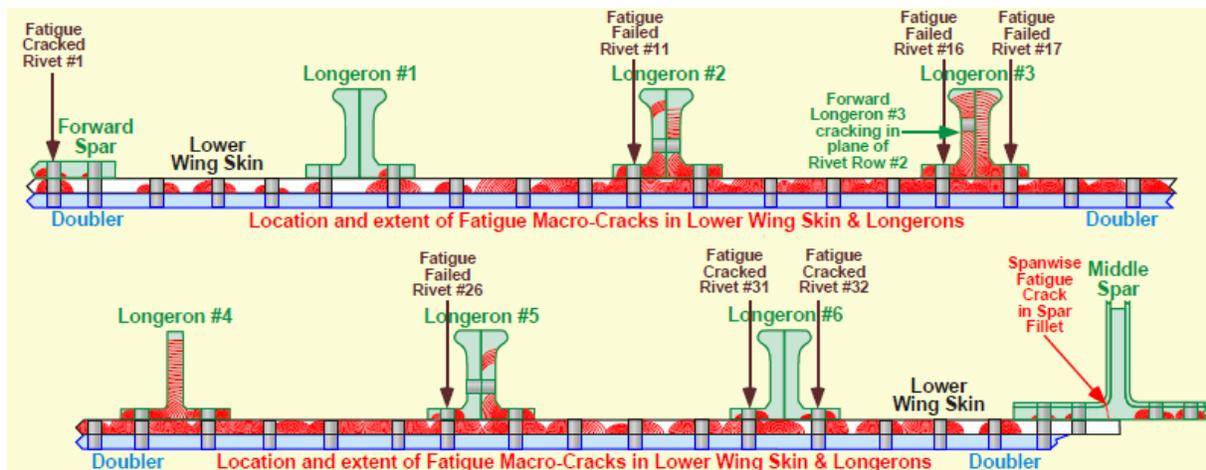
After initial examination of the evidences, cracks, suspected to be caused by fatigue, were found in the centre wing lower skin at STA Y=1030. The lower wing skin at this station has an external doubler riveted to wing skin consisting of 6 rivet rows. The cracks were confined to the first rivet row in the skin where the external doubler ends. The cracking was wide spread extending over a large portion of the wing chord, figure 2. Cracks were also found in the same area of the right hand side wing.

Figure 2. Schematic fatigue crack pattern in the left wing skin at STA Y=1030.

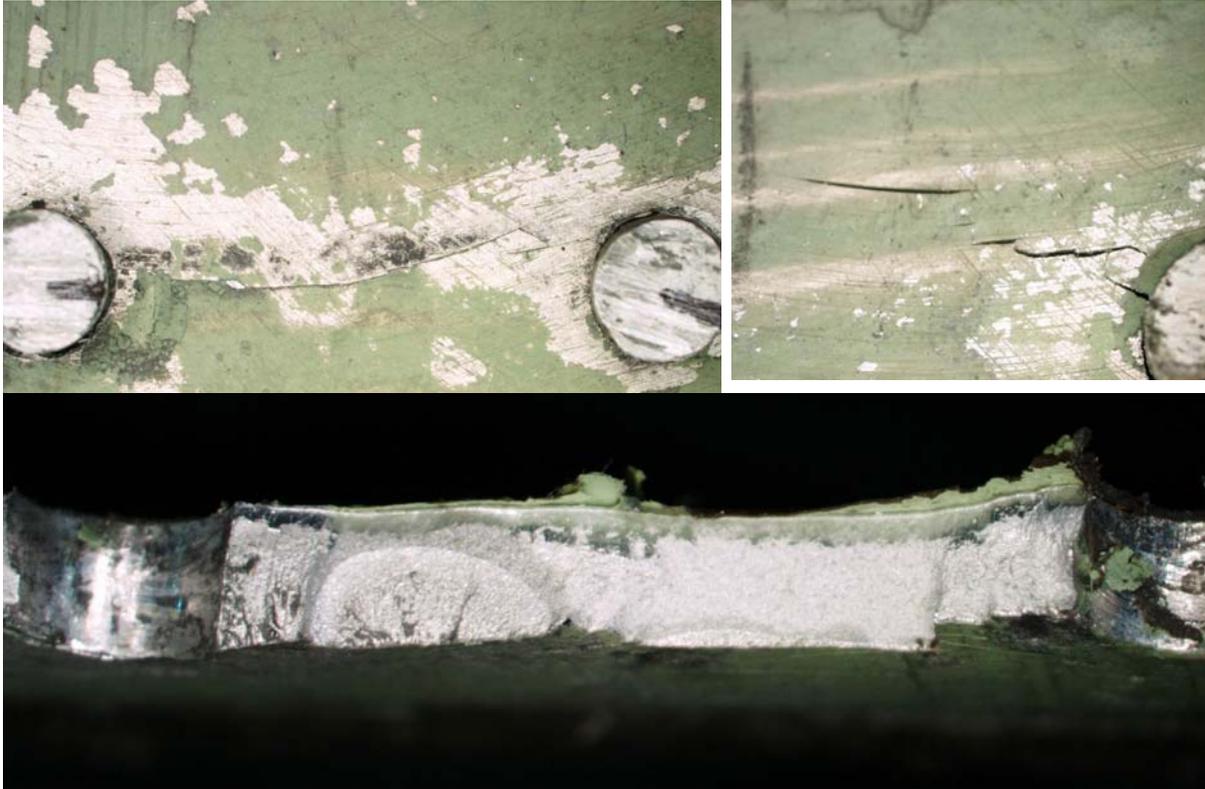
Cracks were found not only at the row of holes but also at the adjacent area following the existing grinding marks (Production standard of C-212 aircraft).

*Figure 3. Typical crack pattern, cracks following existing grinding marks.*

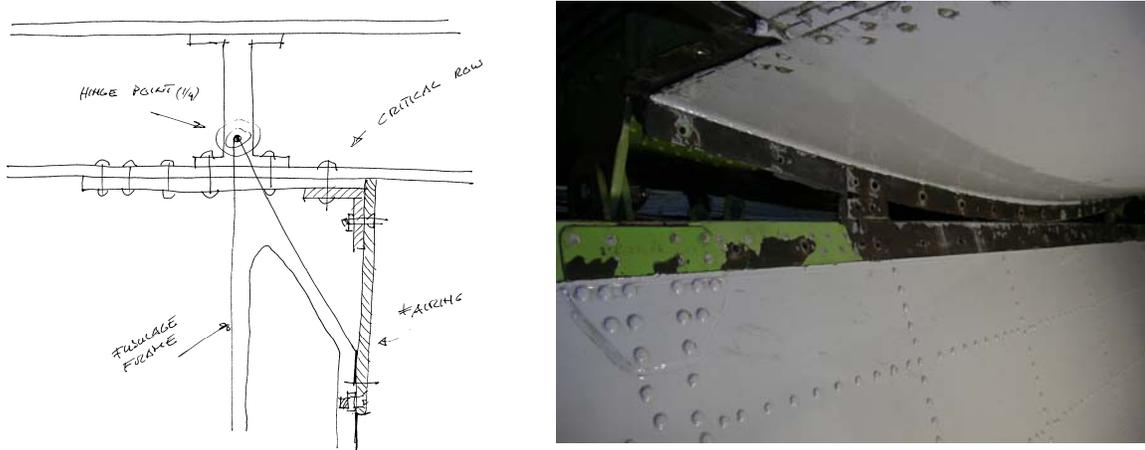
At the cracked row, there is a fairing connecting the wing to the fuselage aimed to carry thrust loads in the aircraft longitudinal direction, figure 4. The design of this fairing is however also supposed to transfer some vertical loads which partly may have contributed to the cracking by induced bending in the failed section. Fatigue cracked rivets give evidence of such an assumption.

Figure 4. Sketch showing the principle of wing to fuselage fairing and a photo showing the position.

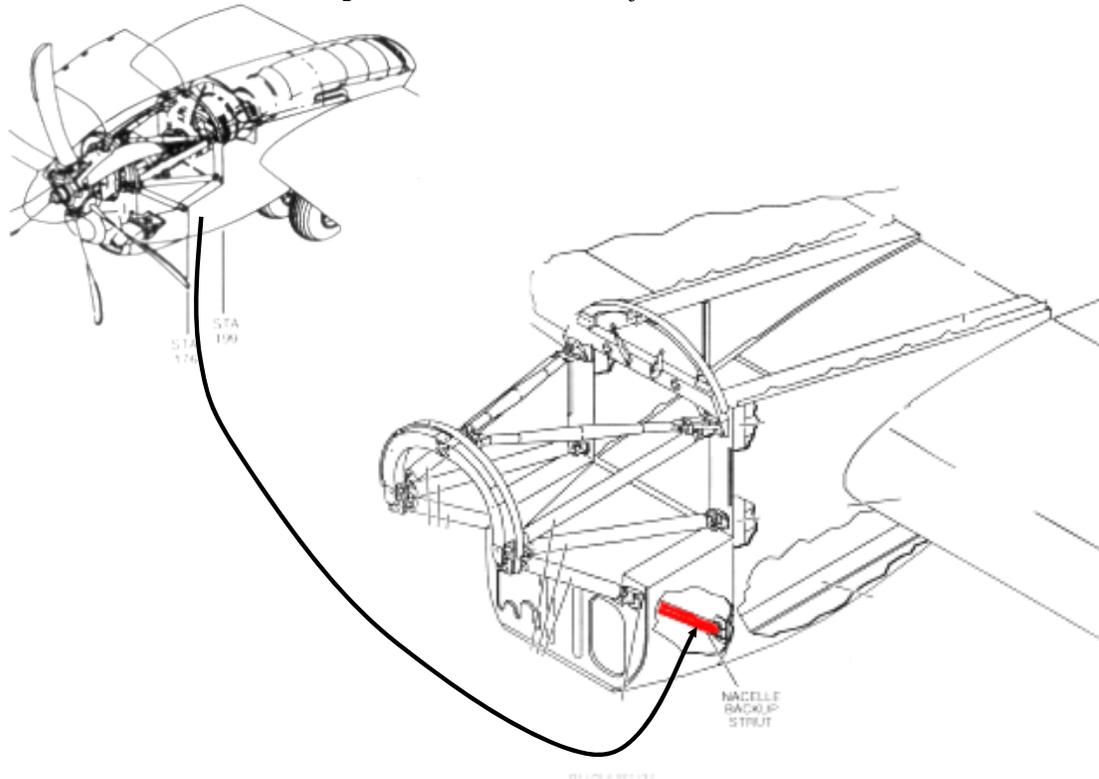
For some years ago, a primary structural element associated with the engine installation to Saab 2000 was found be cracked on aircraft in service. See figure 6 for location of the subject item.

Figure 6 Primary Structural element –Welded design

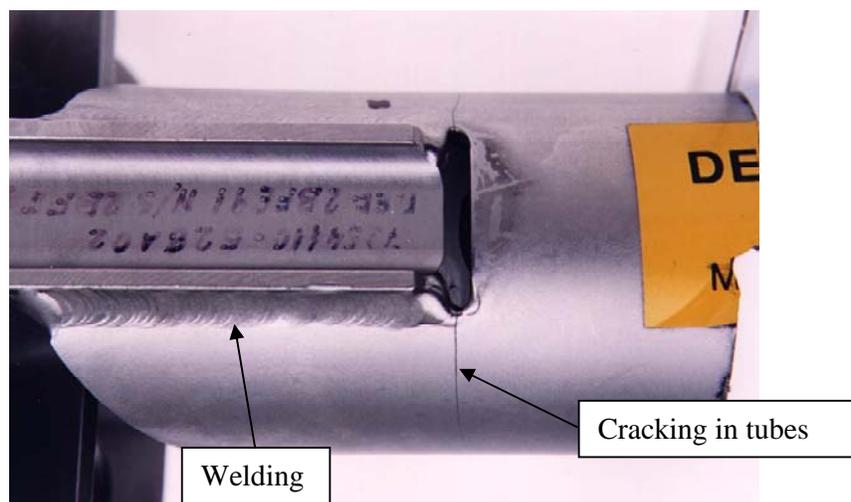
The strut is made from titanium with integrated attachments welded to the tube. The critical location from fatigue point of view is located at the ends where the welded portion interferes with the cut out for the attachment fitting. Consequently, this zone was subjected to cracking on Aircraft in service caused by loading (mass, gust and manoeuvre loads) from the engine transferred to the nacelle. Cracks started from the cut out were discovered at several strut as depicted in figure 7.

Figure 7. Welded attachment to the strut

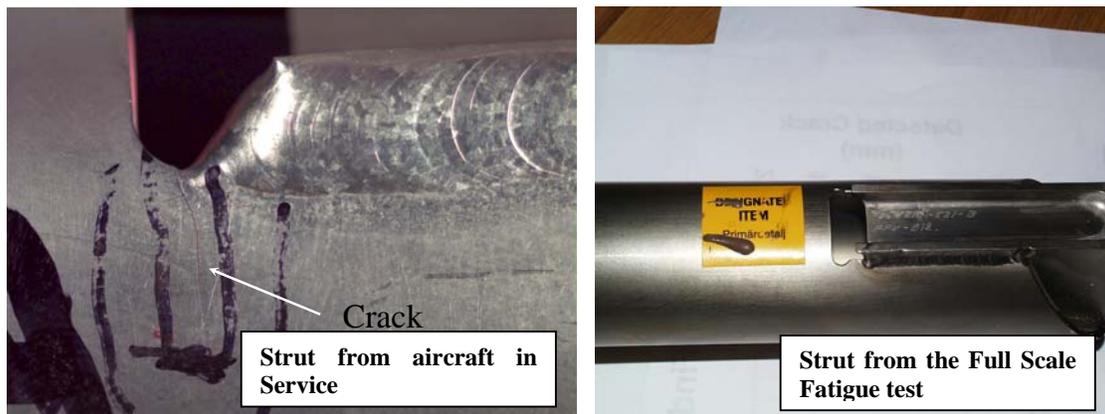
Figure 9 outlines the strut installed on the Full scale fatigue test together with a strut from an aircraft in service. The strut installed on the test specimen was not subjected to any crack growth during the complete testing, however the local design of the strut was different compared to aircraft in service. The cut out and the welded portion was not interfered to each other as on struts mounted on aircraft in service. Hence, a more propitious design was obtained leading that no cracks occurred in the test.

Figure 9 Comparison of details around the cut out

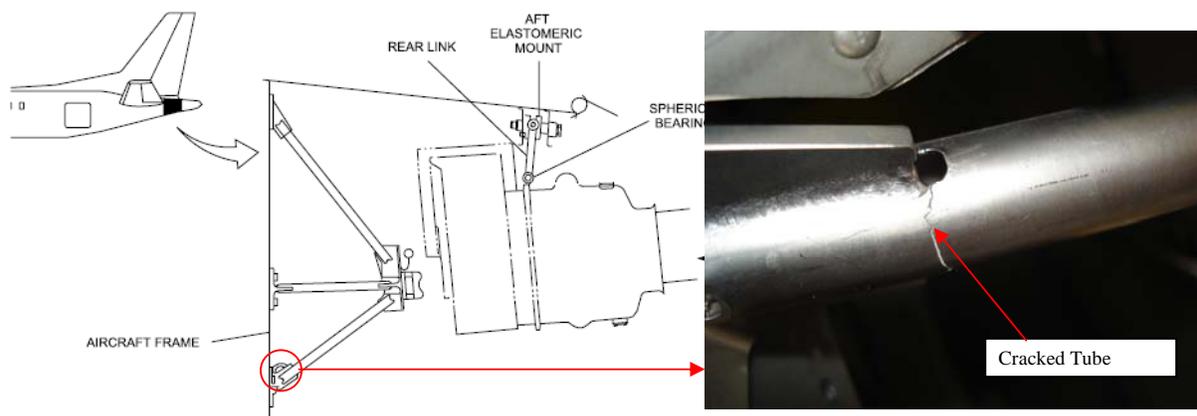
The damage tolerance testing has also revealed that welded structural elements are sensitive to fatigue and crack propagation. Experiences from fatigue/damage tolerance testing report that the structural trussgrid for attachment of the Auxiliary Power Unit was failed at a late stage of the testing. One of the strut members was discovered to be broken as outlined in figure 20. Welded designs are normally influenced by heat affected zones impairing the fatigue and damage tolerance characteristics. Adverse stress concentrations in combination with local load transfers contribute also to the failure of the welded strut.

Figure 20. Saab 2000 APU attachment failed strut due to fatigue/damage tolerance

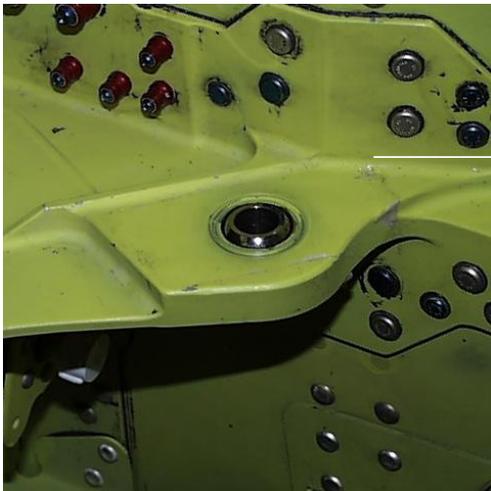
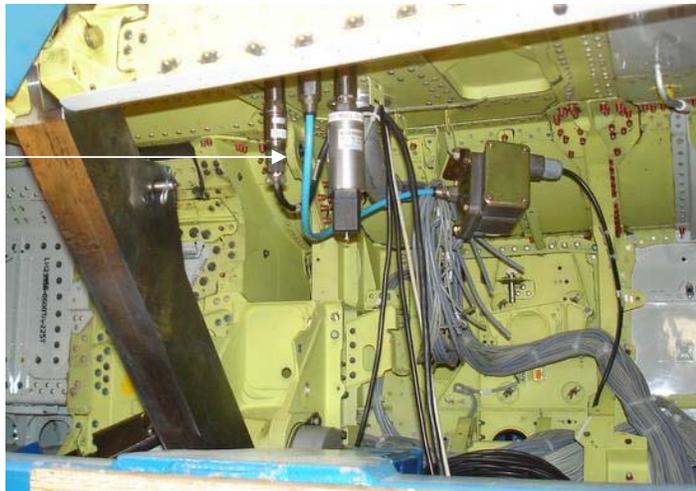
Figure 23. Cracked lug for the attachment of the actuator for the main landing gear door

Improved replacements of cracked parts have been designed.

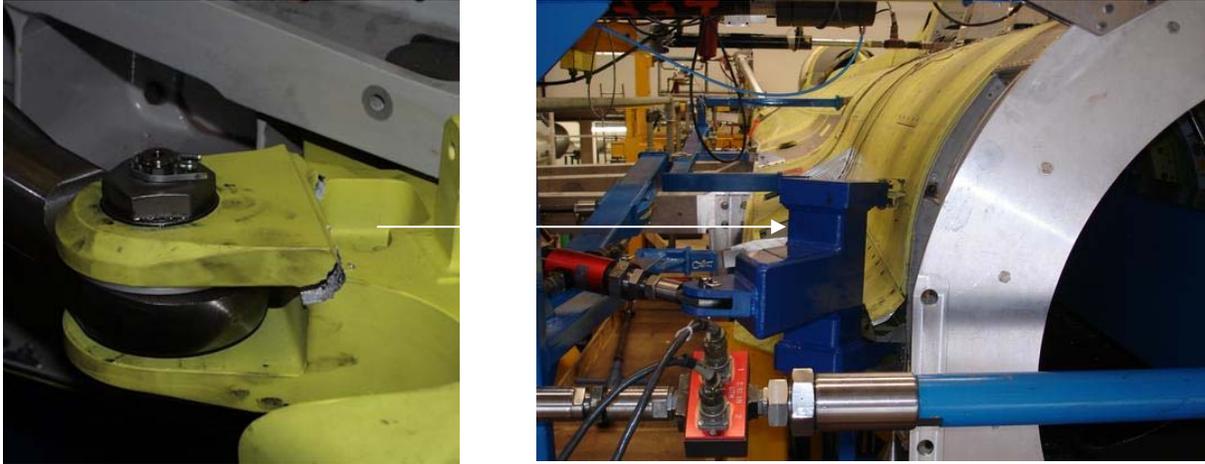
Figure 24. Cracked lug for the attachment of the actuator to the air-brake

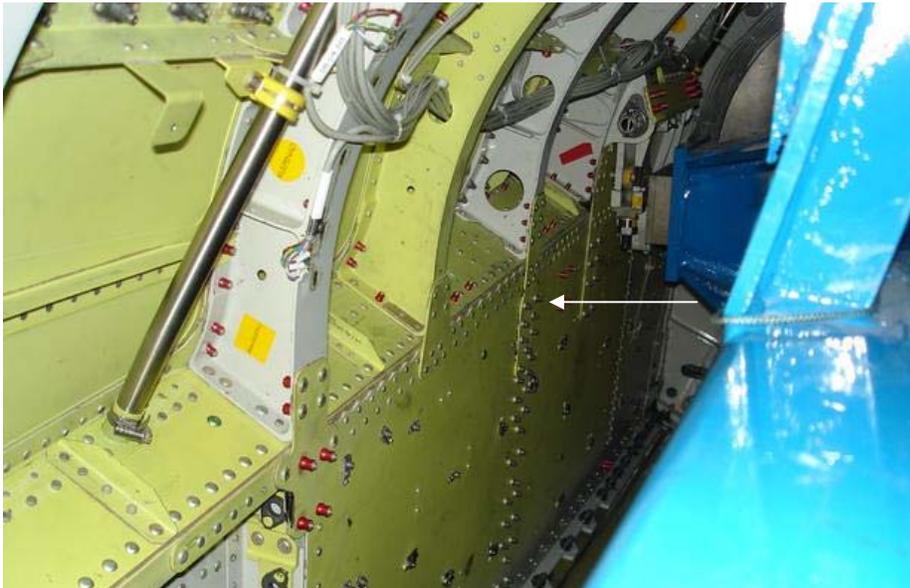
Figure 25. Cracked sheet strap connecting a frame to the engine wall in the rear fuselage.

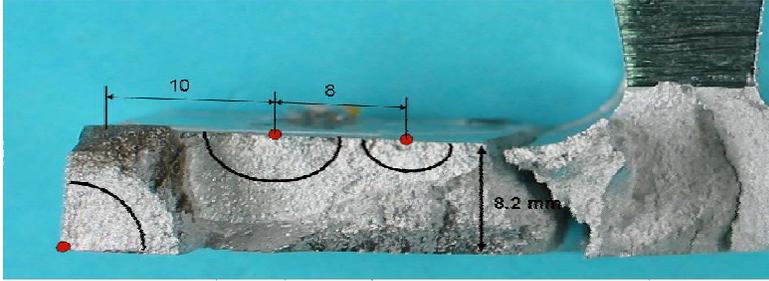
A statistical analysis that considers three initial flaws located at the observed experimental initiation points, see Figure 31, showed how such analyses can be used to improve the understanding of early crack growth behaviour. By assuming that the three initial flaw sizes are randomly distributed from one tenth of the crack length used in the previous discrete predictions, up to that very length, i.e. 0.127 mm, failure will occur after roughly the same overall number of loading blocks as for the discrete analyses. The variation in life from a 10% failure probability up to a 90% failure probability is around a factor of two, see Figure 32.

Figure 31. Fracture surface of test specimen no. 3 showing at least three nucleation sites.
