A Review of Australian and New Zealand Investigations on Aeronautical Fatigue During the Period April 2003 to March 2005

Graham Clark

DSTO-TN-0624

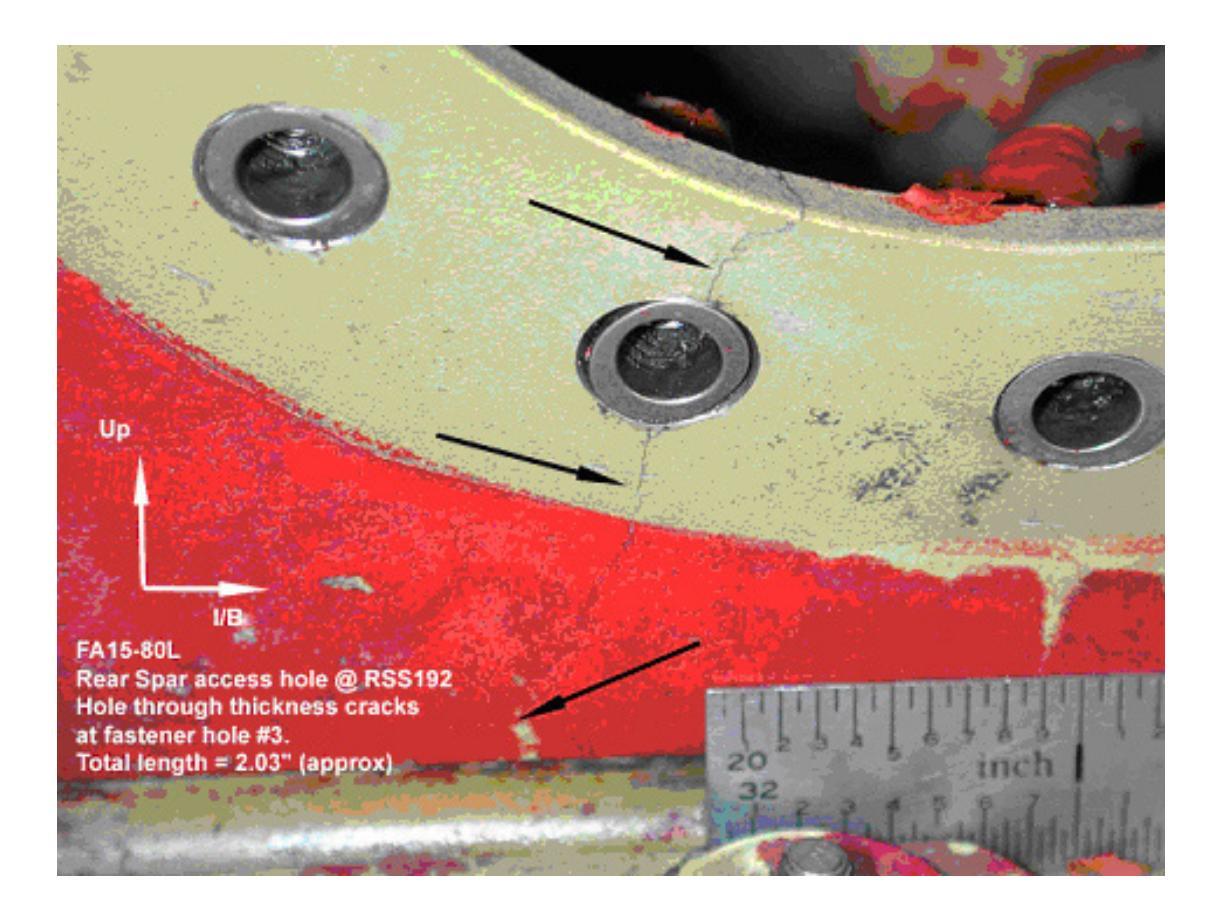
From the starting point of 4,500 Cannon AFB hours the test has progressed in a satisfactory manner although not without incident. During inspection of the test article at 5,500 flying hours a crack was detected at an inspection opening in the rear spar at a location known as Durability and Damage Tolerance (DADTA) item 73; this is a location known to crack in service. The crack had grown from an anchor nut hole (See Figure 4) across the spar web and the low spar cap. Stainless steel doublers were used to restore the spar web and to reinforce the lower wing skin to prevent further cracking of the lower spar cap as shown in Figure 5. To date this repair has performed satisfactorily with no further crack growth being evident.

Figure 4: Rear Spar Crack at DADTA Item 73

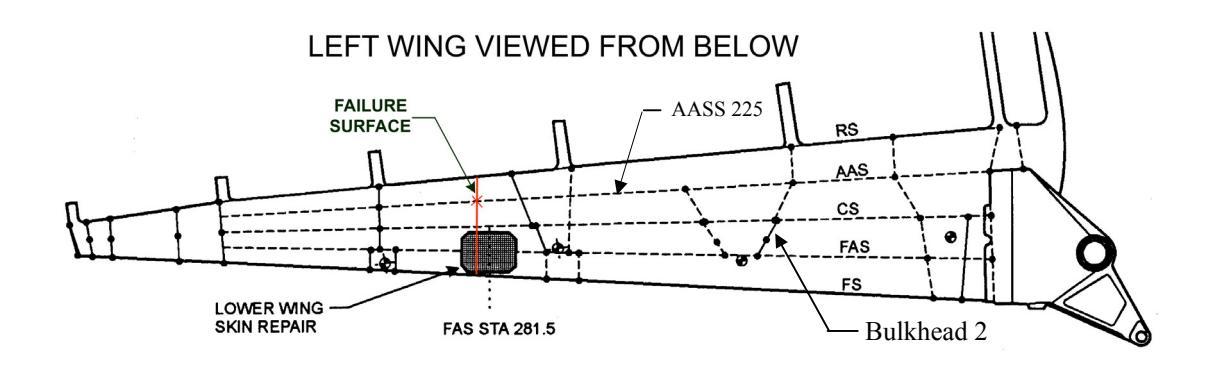
Figure 1. RAAF F-111C fatigue test wing showing failure location at Aft Auxiliary Spar Station (AASS) 277.3. The other spars are the Rear Spar (RS), Centre Spar (CS), Forward Auxiliary Spar (FAS) and the Front Spar (FS). Another significant crack location is at AASS 225.

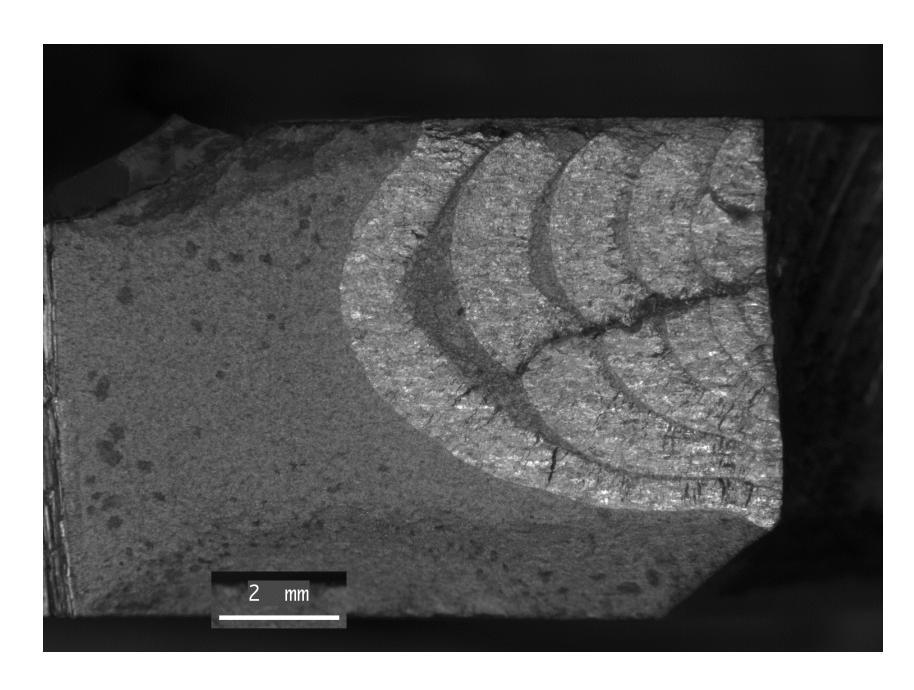
Figure 2. Fracture Surface from the forward side of the hole at AASS 225

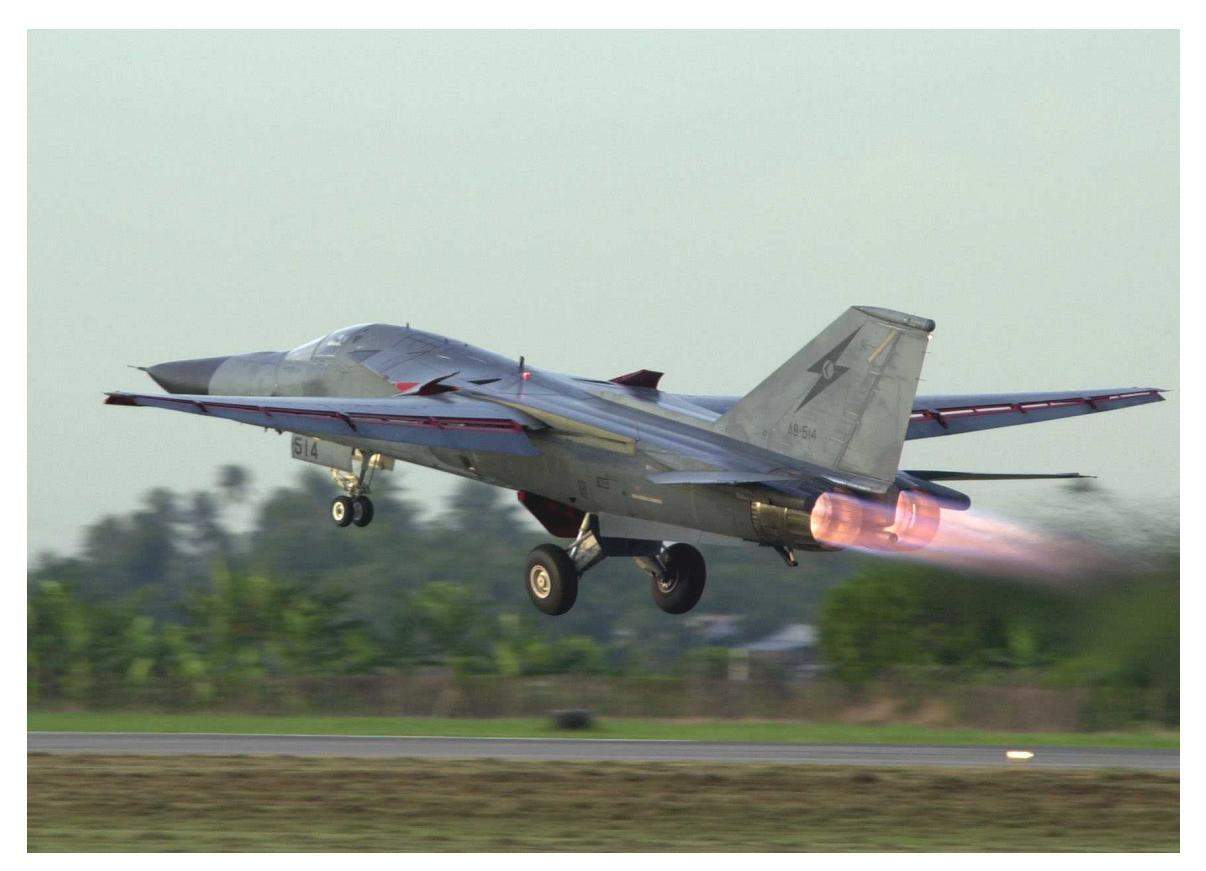
Figure 1 shows position of the strake – the fin on bottom side of rear fuselage. Figure 2 shows a failed strake next to a good one. Figure 3 shows two failures - failure occurred by fatigue of the aluminium mounting plate member, from the front working backwards. Note the similarity of the two failures about 18 inches in a total length of 24 inches was cracked, although there were smaller fatigue cracks in the "overload" region, around the side of the section. Figure 4 shows visual detail of typical fatigue region near front - fatigue cracks start on the upper radius and work there way down the length and through the section thickness. Figure 5, SEM striations on fracture surface - vibrational loading with occasional large load (i.e. high G turn). Unfortunately, there is no information on the time frame of G turns so it is difficult to obtain the rate of growth - although we can conclude that the 18 inch cracks have probably been growing since new (after an "incubation" period). Figure 6 shows a smaller fatigue crack in "overload" zone at rear.

Figure 1: Position of strake - fin on bottom side of rear fuselage

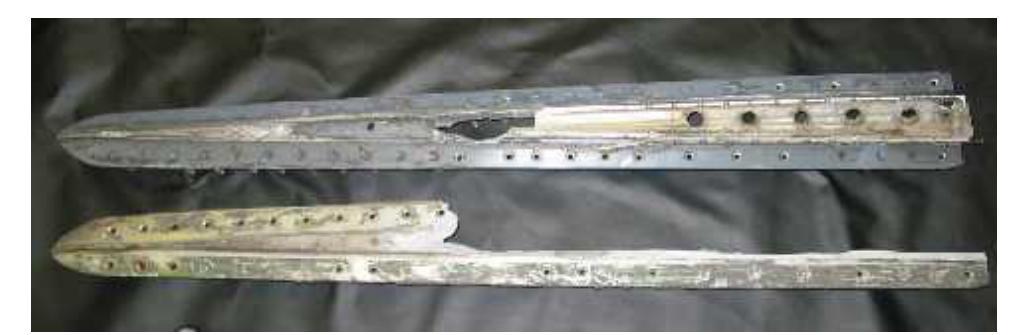
Figure 3: Two failures.

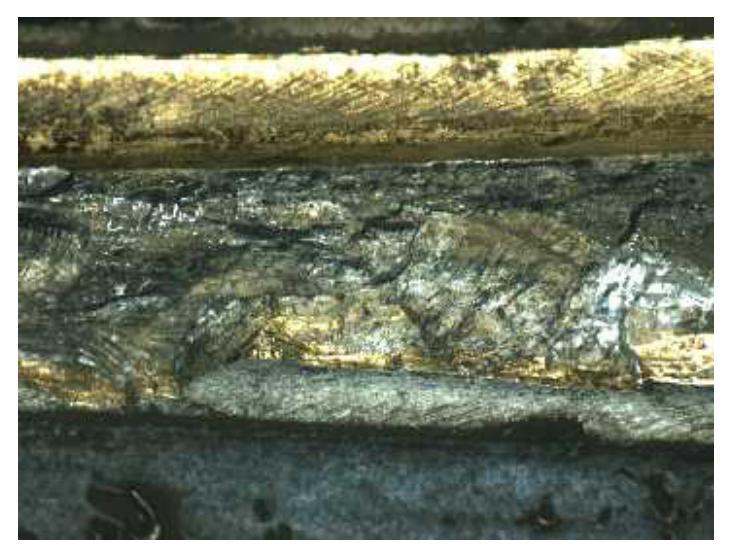
Figure 4: Detail of typical fatigue region.

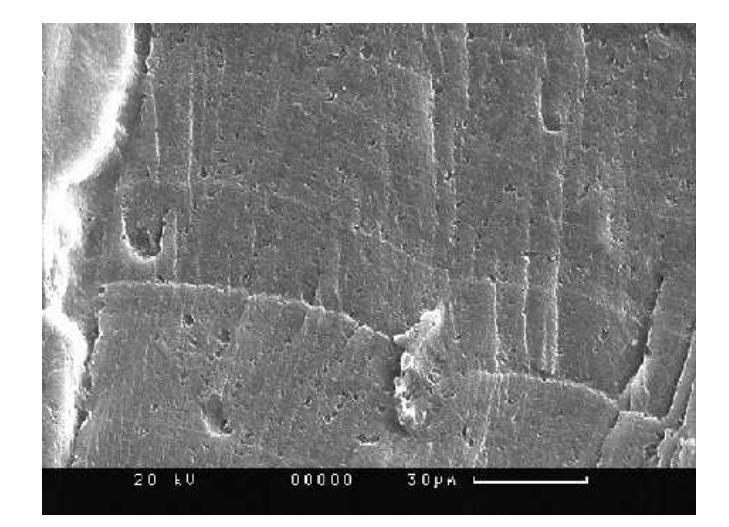
Figure 5: SEM striations on fracture surface.

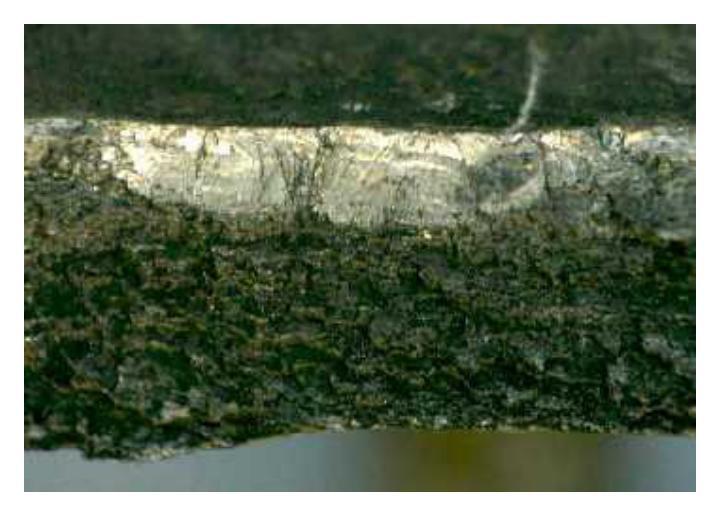
Figure 6: Fatigue crack in "overload" zone.

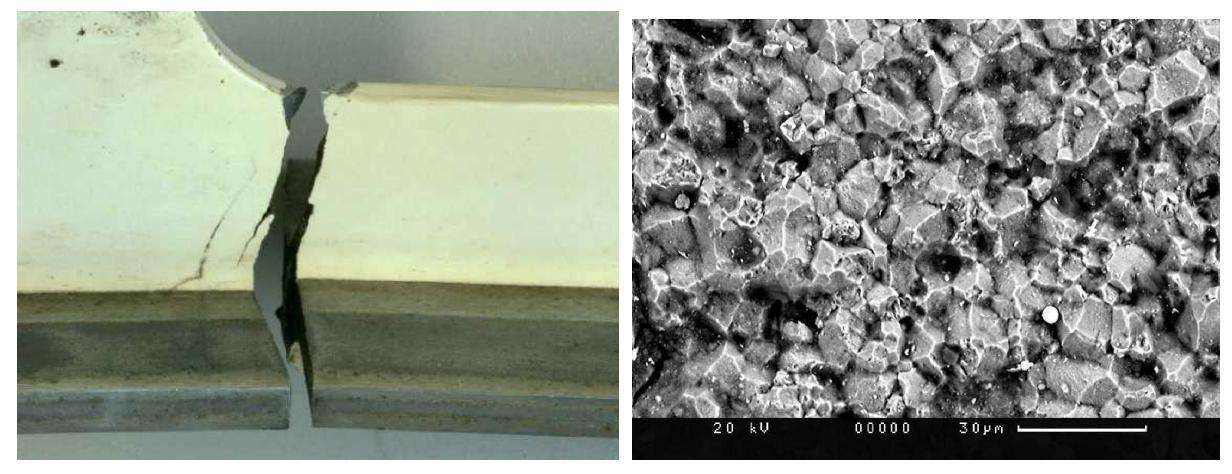
Figure 4: Optical view of fracture

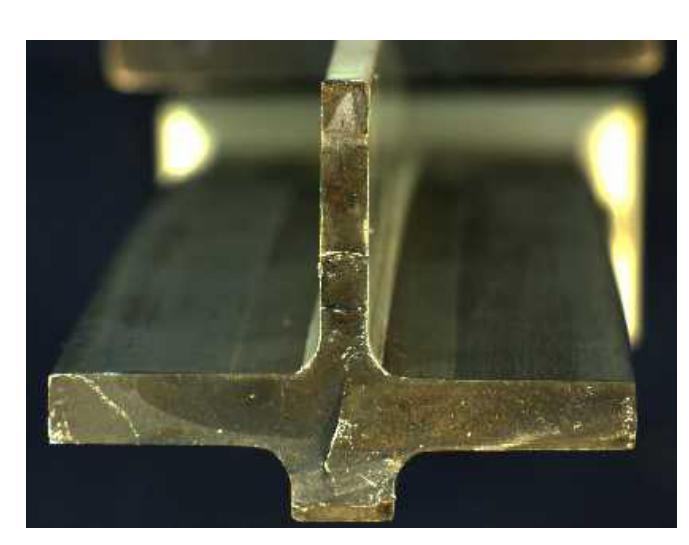
Figure 6:Fracture surface

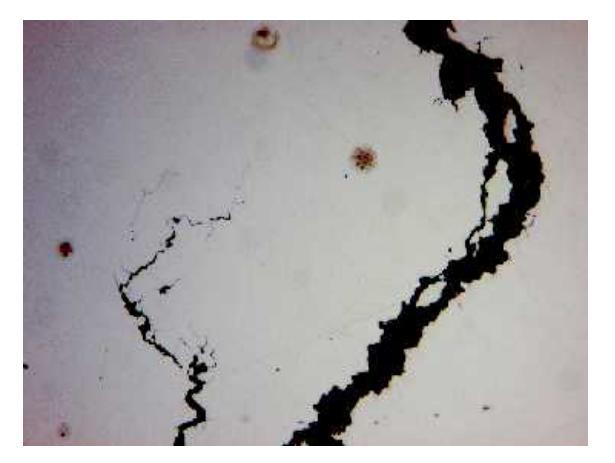
Figure 8: Metallographic section, showing SCC nature of cracking.

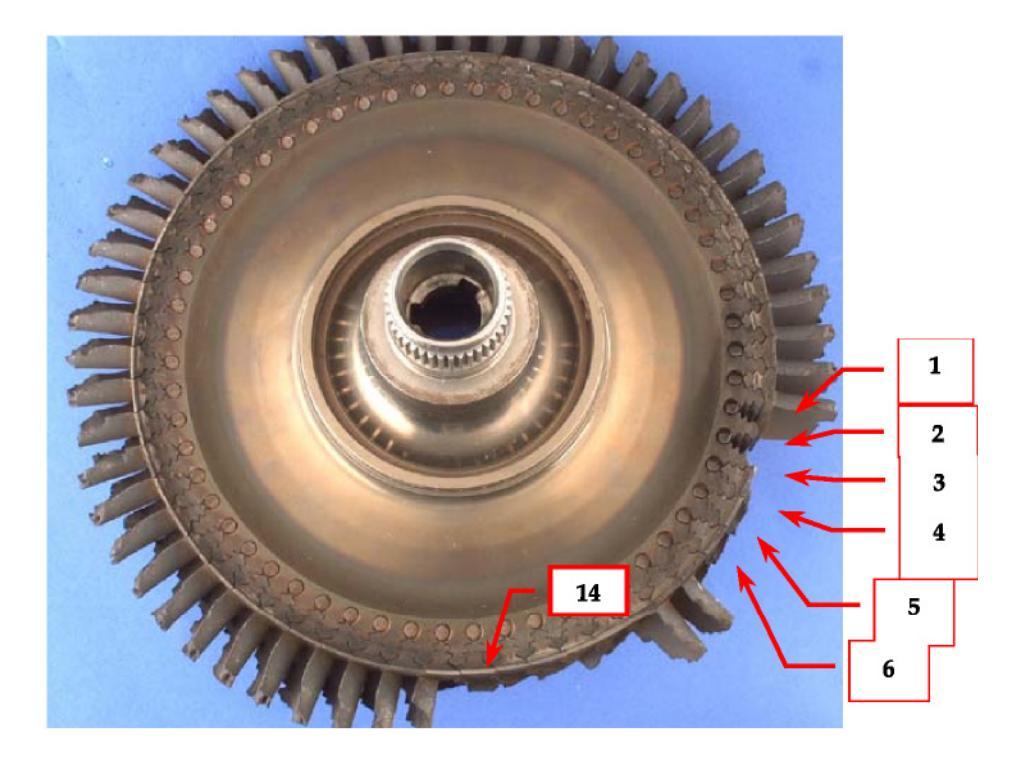
Figure 1. Photograph of the CT turbine disk assembly as received. Blade 1 (containing the primary fracture surface) and Blade 2 were removed by P&WC. DSTO labelled the blades from 1 to 59 in the clockwise direction

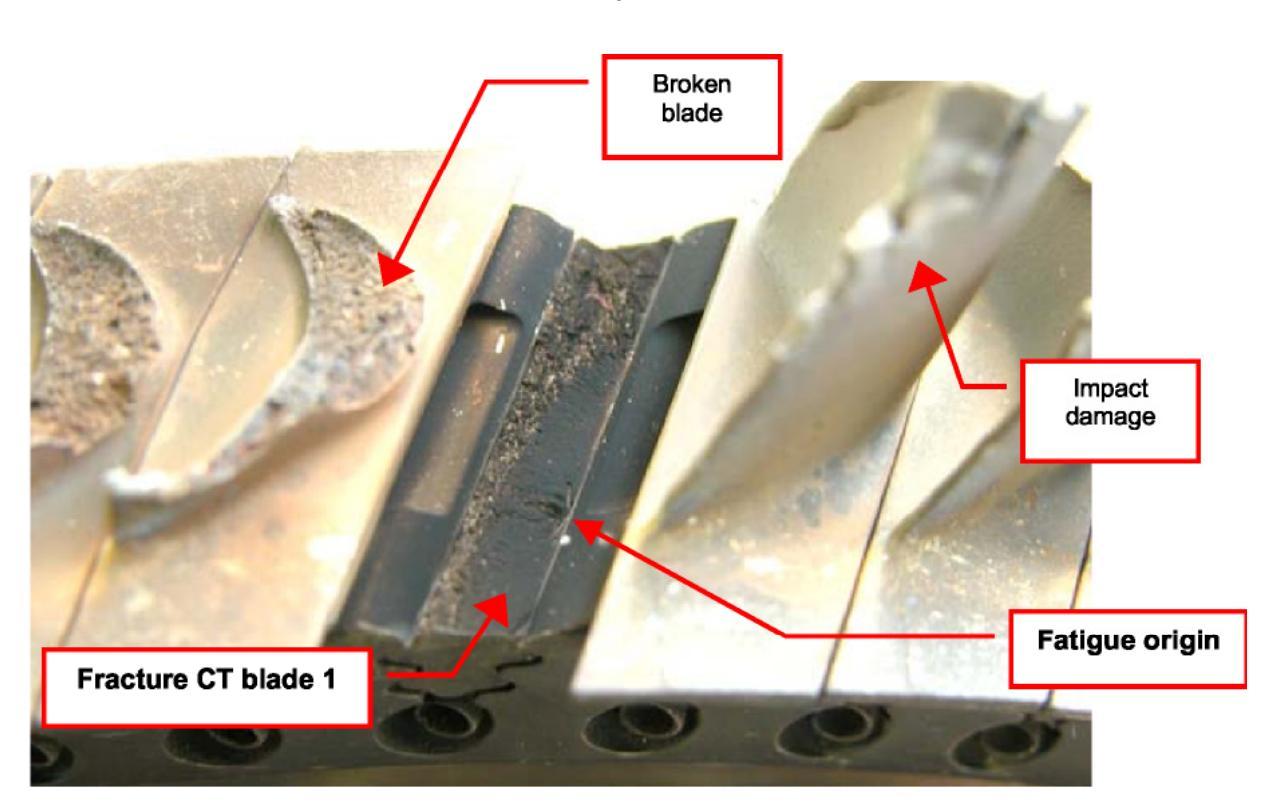
Figure 2. Photograph of the subject CT turbine blade assembly showing the fracture surface and the fatigue crack origin (Labelled) on CT blade 1. Also note that the remnant of the trailing edge of the adjacent CT blade was bent in the direction of impact (labelled).

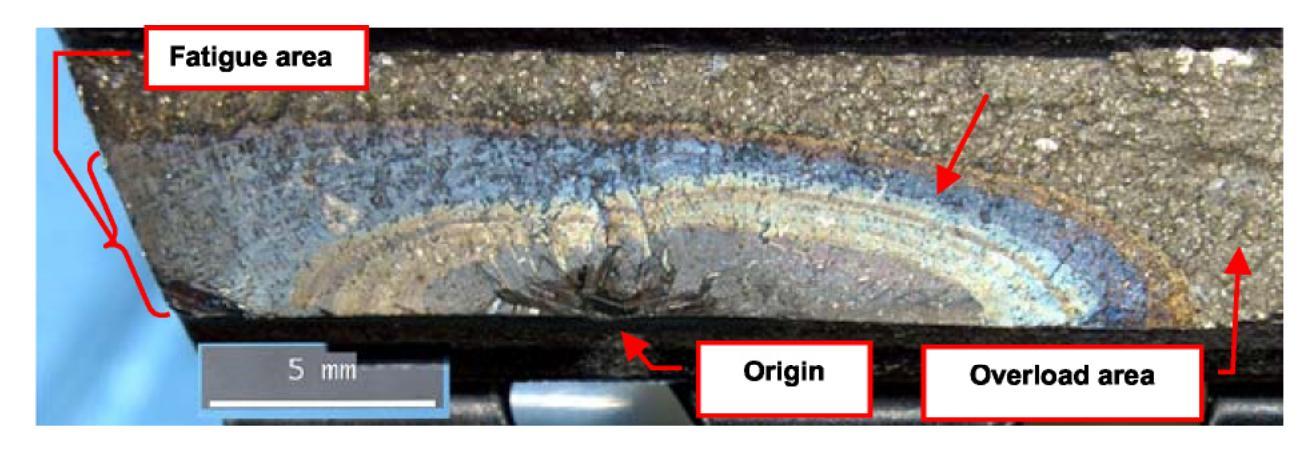
Figure 3. Photograph of the fracture surface of CT blade. Note the concentric rings produced by differing thicknesses of the oxide due to exposure time. The fatigue crack propagation is from bottom to top. Note banding of the fracture surface (example arrowed). The bands are caused by changes in the oxide layer due to variations in the service conditions and/or exposure time; this indicated that the fatigue crack propagated in numerous engine cycles

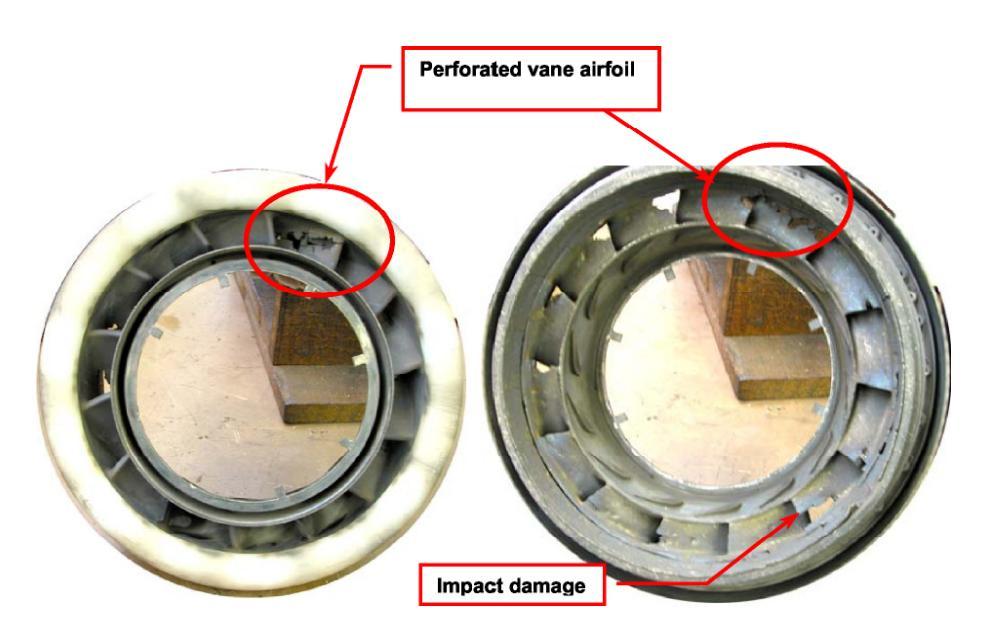
Figure 4. Photographs of the CT stator from both the leading (left) and trailing (right) sides. Severe impact and wear damage is observed at the trailing side (right). Also note the perforation of CT vane (circled). A higher magnification view of the perforated airfoil is shown in Figure 5 and 6.

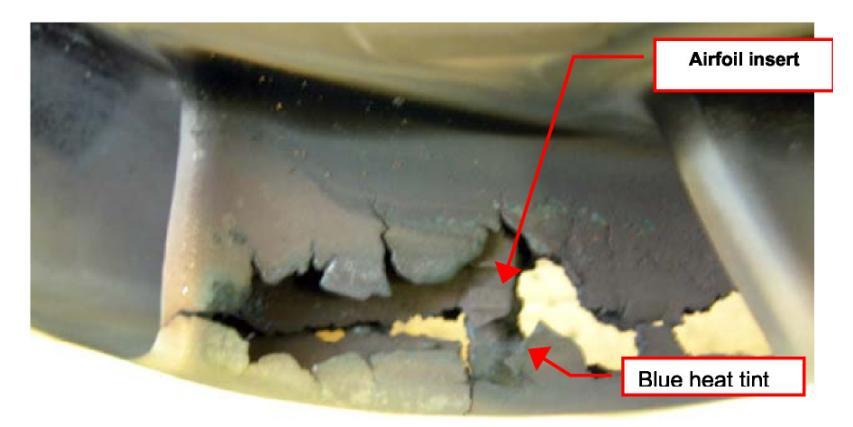
Figure 5. Photograph of the leading side of the perforated airfoil of CT vane 10 (Circled area in Figure 2). Note the rounded edges and the jagged cracking. Heat tinting of the surface is also observed (labelled).

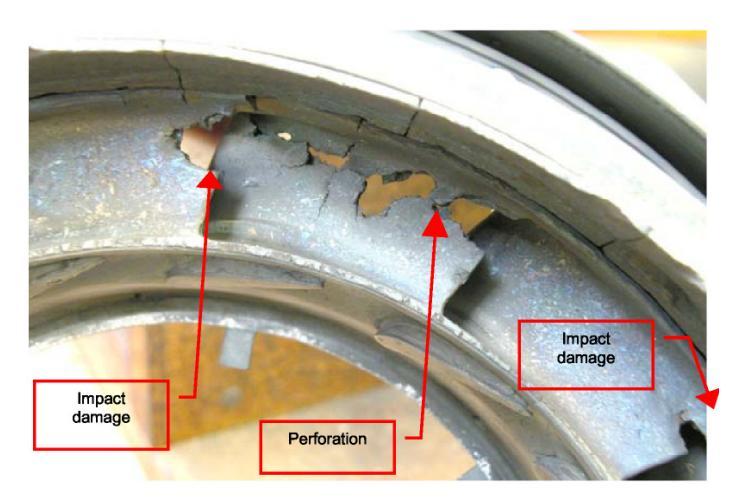
Figure 6. Photograph of the trailing side of the perforated airfoil of CT vane 10 (Circled area in Figure 4). Evident impact damage sustained on the adjacent vanes during the departure of the CT blades is also labelled.

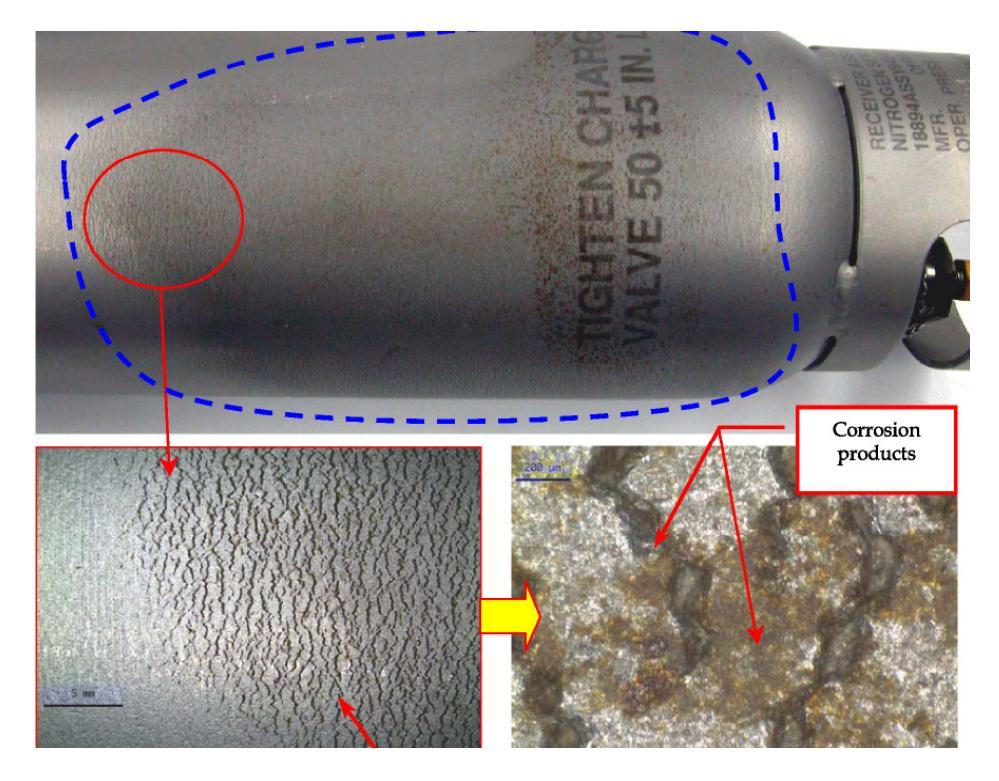
(Top) Photograph of a subject cylinder showing a large area of cracking (circled area). (Bottom left) An enlarged view of the cracking showing a network of circumferential cracks. (Bottom right) Note the corrosion products (i. e. 'rust stain') inside and in the vicinity of the cracks (arrowed).

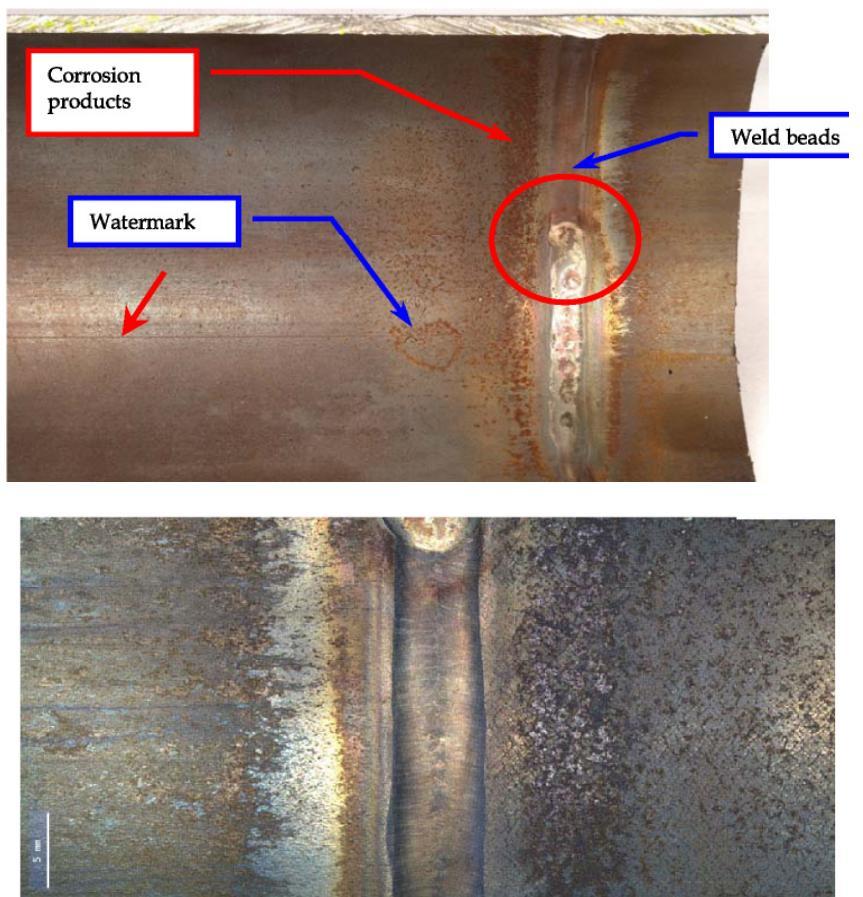
Photograph of a section of the internal surface of a subject cylinder (Top) and a higher magnification view (bottom) of the weld beads (circled). Note the large concentration of brown corrosion deposits and the dark grey colouration of the background surface. Plug scores (i.e. longitudinal score marks) are also noted (examples arrowed). Also note that the amount of surface corrosion observed on the HAZ.

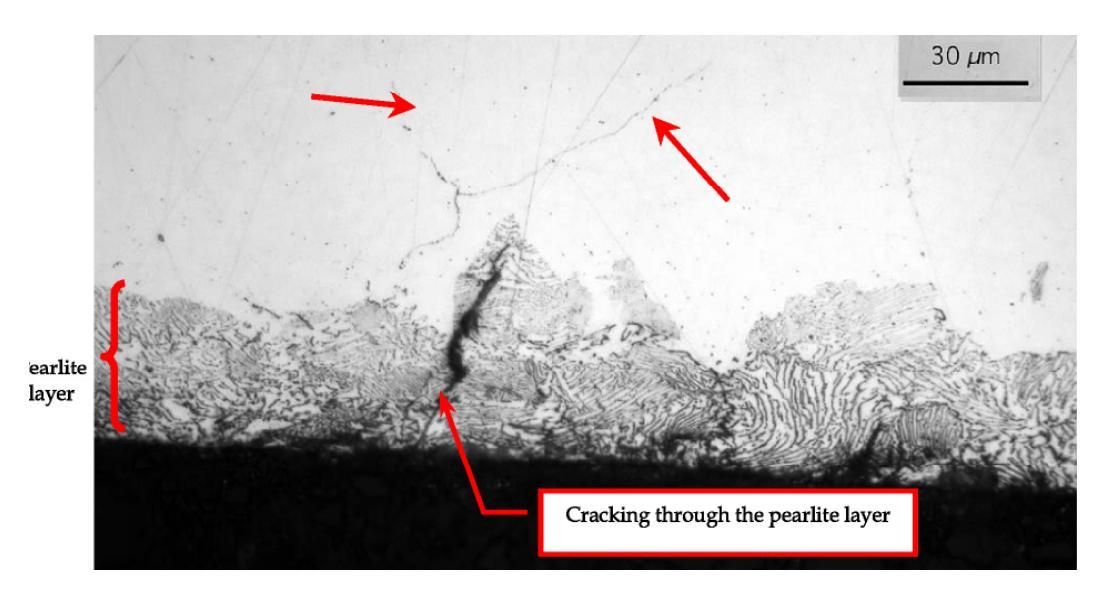
Electrolytic etching of metallographic specimens revealed the presence of a pearlite layer at the areas where corrosion and/or cracking were observed. Cracking through the pearlite layer is evident. Intergranular hairline cracking along the austenitic grains is also observed (examples arrowed).

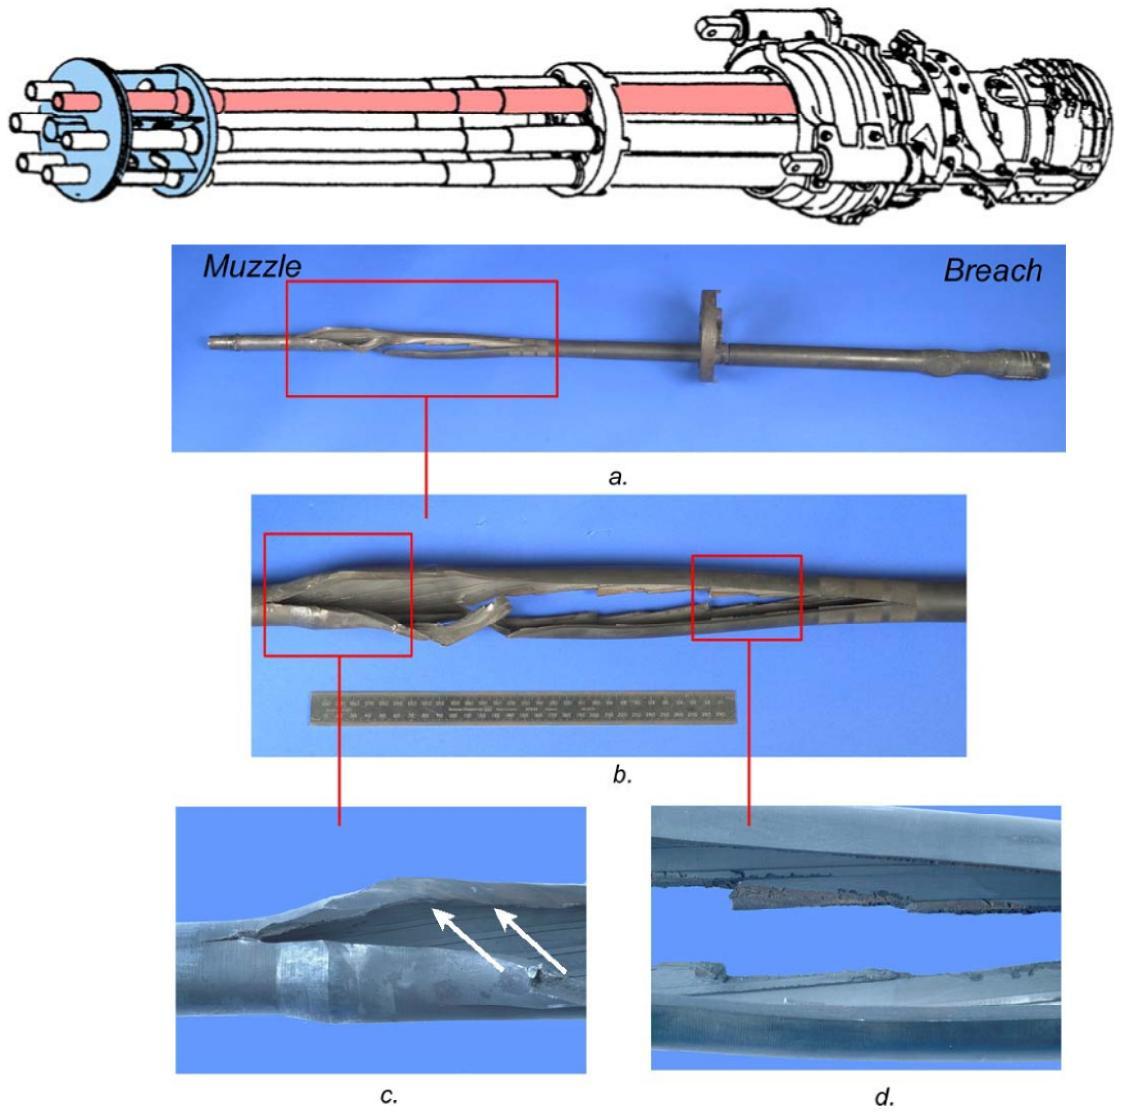
Photograph (a) shows the defective cannon barrel as received by the DSTO. Photographs (b), (c) and (d) show higher magnification images of the damaged region of the barrel and parts of the fracture surfaces. Longitudinal cracks in the barrel were located approximately 200mm aft of the muzzle, and extended for approximately a further

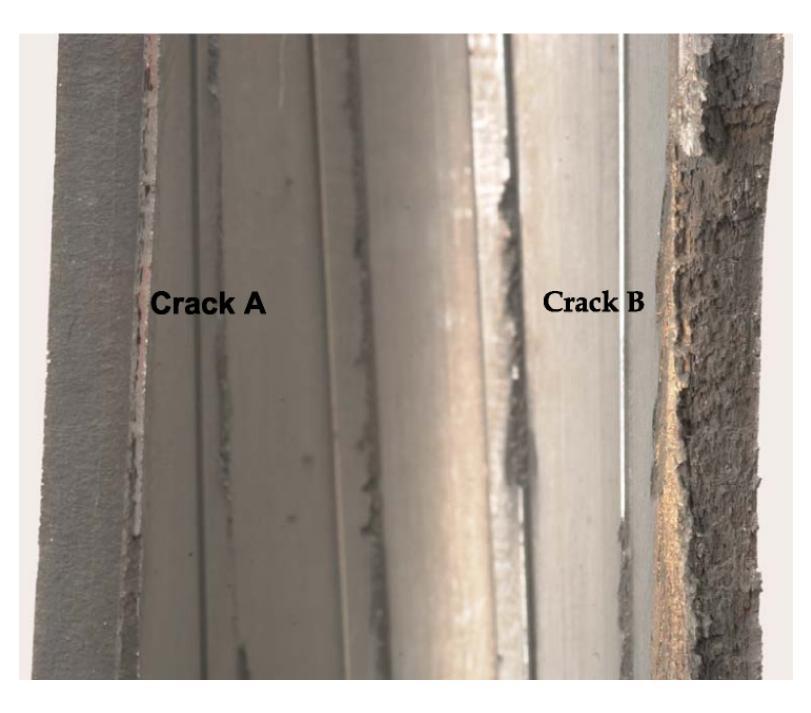
Macro-photograph of part of the fracture surface from the ruptured barrel. Two different regions of fracture associated with the failure are identified and labelled (Crack A) and (Crack B). Crack A is associated with a preexisting defect within the barrel and Cack B is associated with rapid overload.

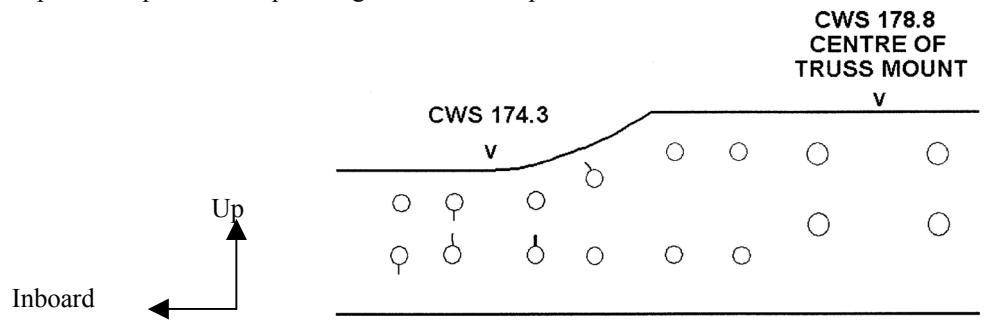
Figure 1(a) Example of cracking from Port wing of Aircraft 1

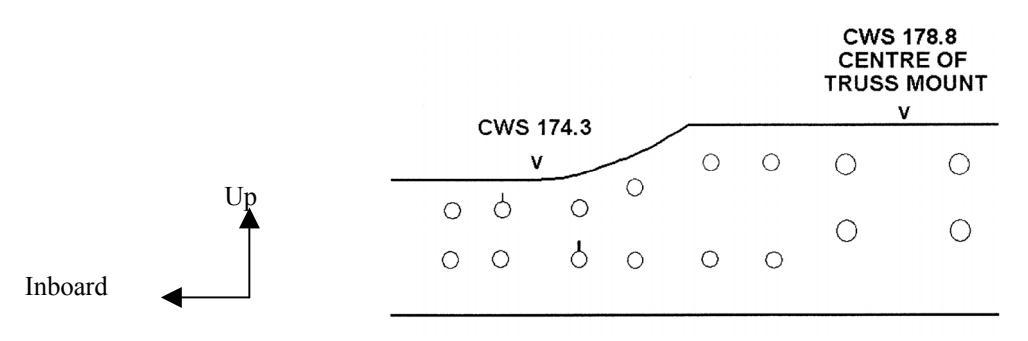
Figure 1(b) Example of cracking from Port wing of Aircraft 2

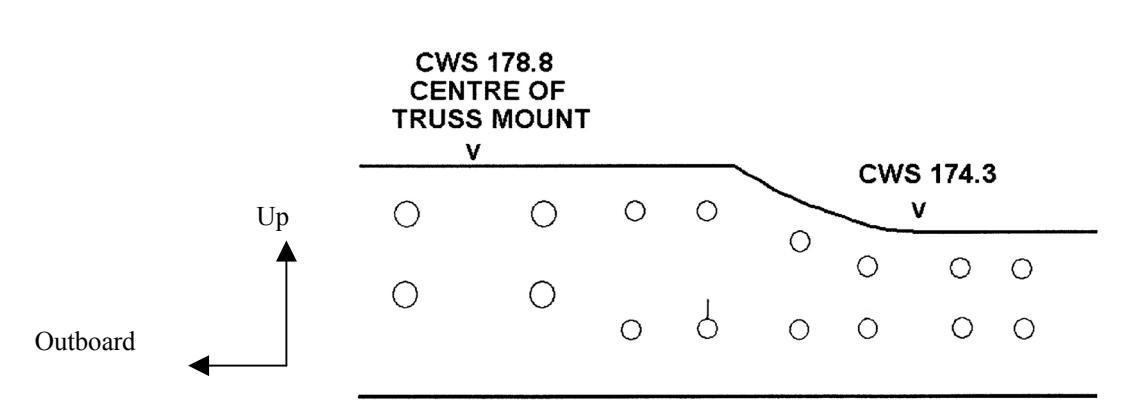
Figure 1(c) Example of cracking from Starboard wing of Aircraft 1

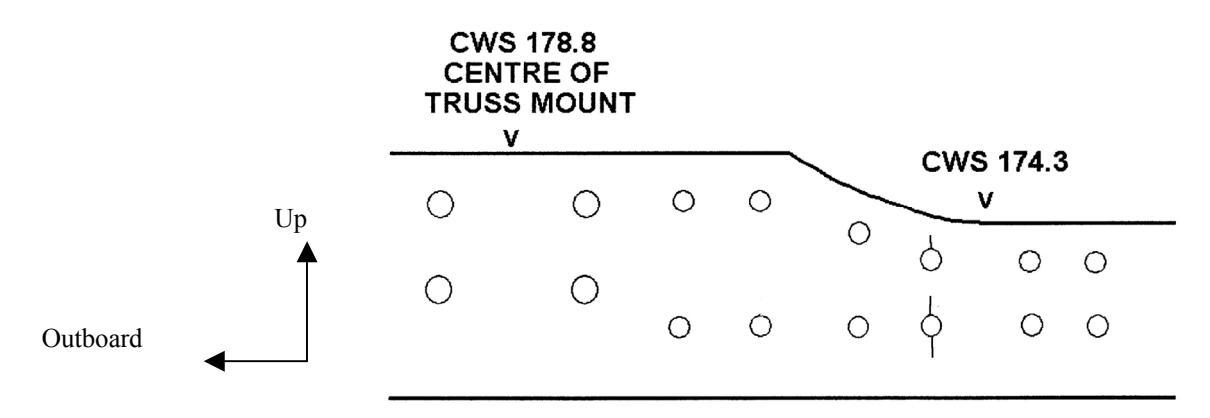
Figure 1(d) Example of cracking from Starboard wing of Aircraft 2

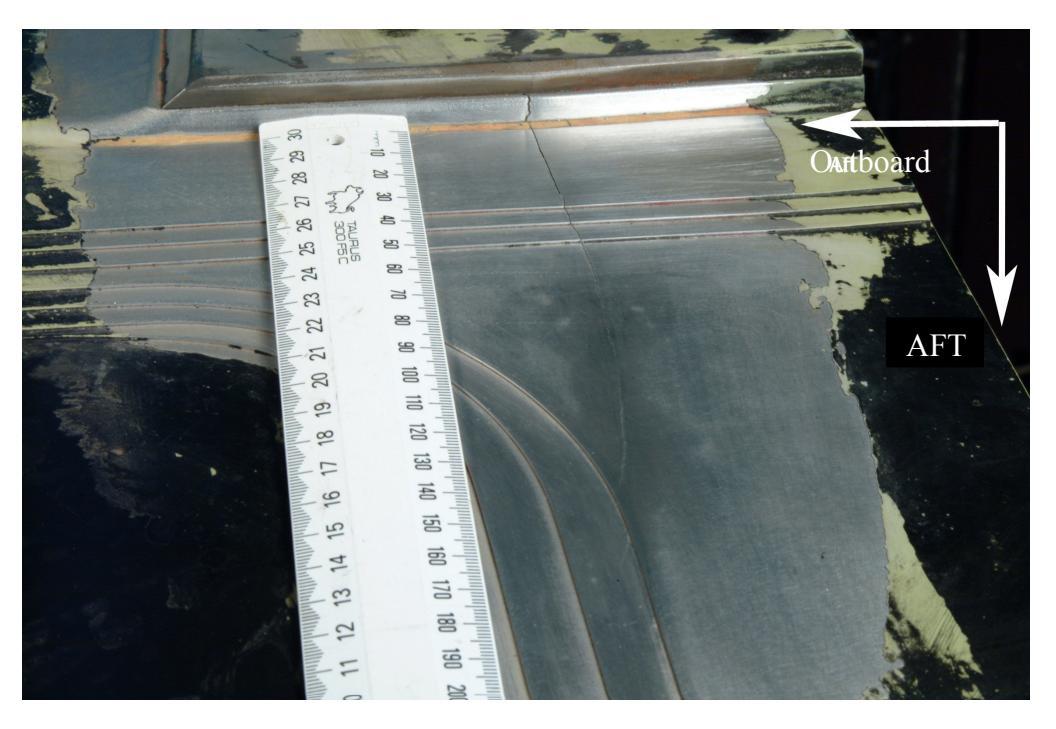
Figure 2. View of the crack propagating beyond the doubler.

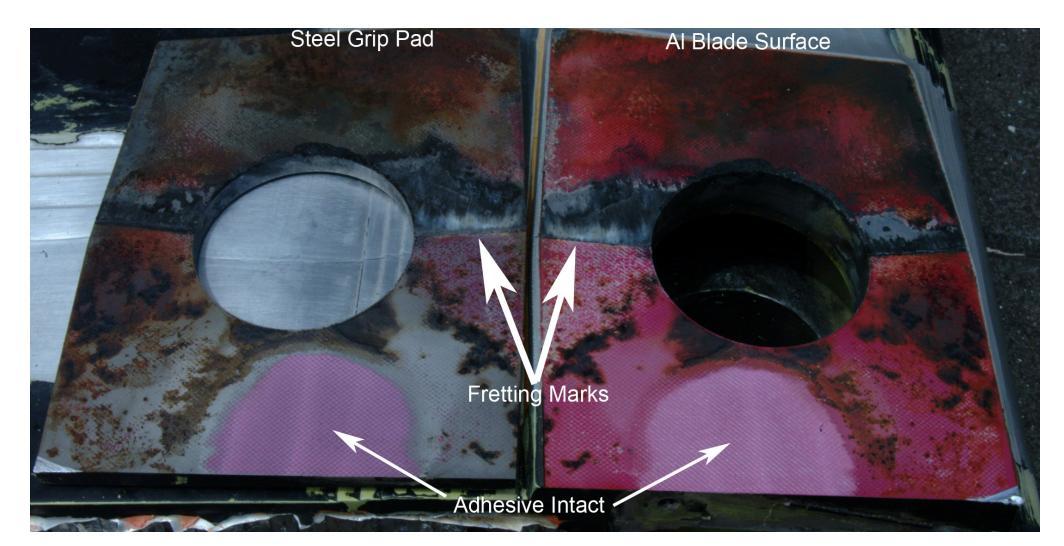
Figure 3. Adhesive surfaces after removal of the grip pad (left). The fretting marks indicate the crack opening displacement experienced in flight.

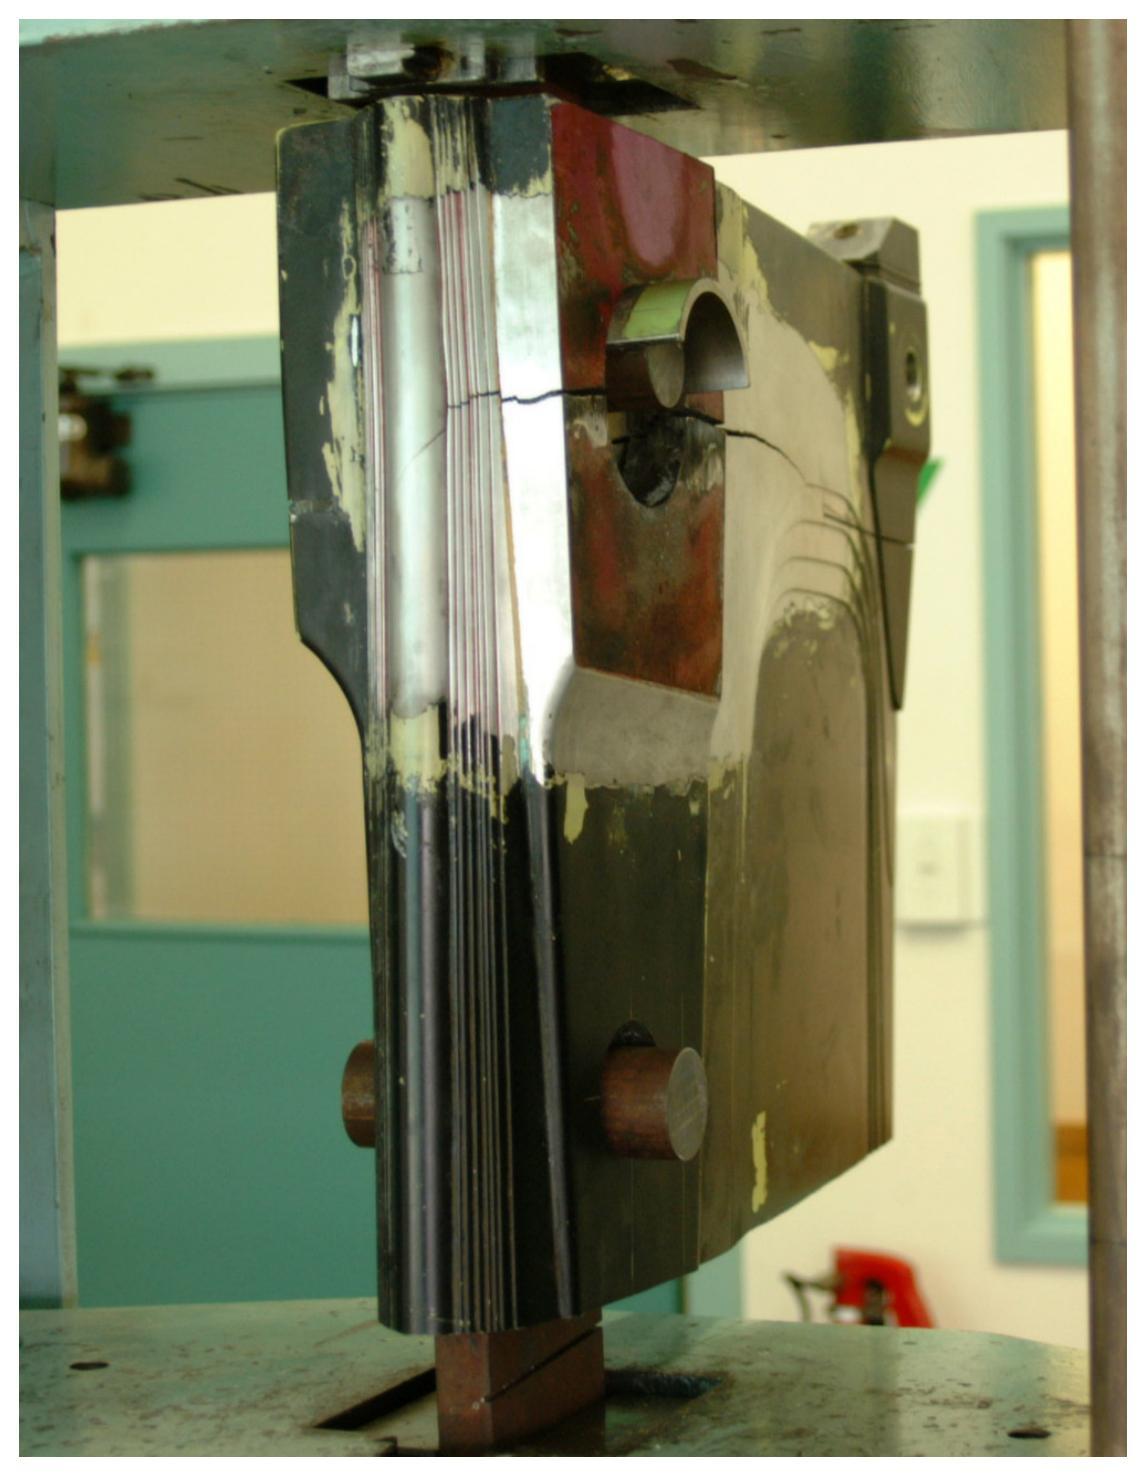
Figure 4. Application of a tensile load to simulate the crack opening displacement indicated by witness marks on the doubler. The aircraft was likely to have been flying with the crack in this configuration.
