Review of Aeronautical Fatigue Investigations in Switzerland

May 2005 – April 2007

KOR-TA2007-0165

M. Guillaume RUAG Aerospace CH- 6032 Emmen

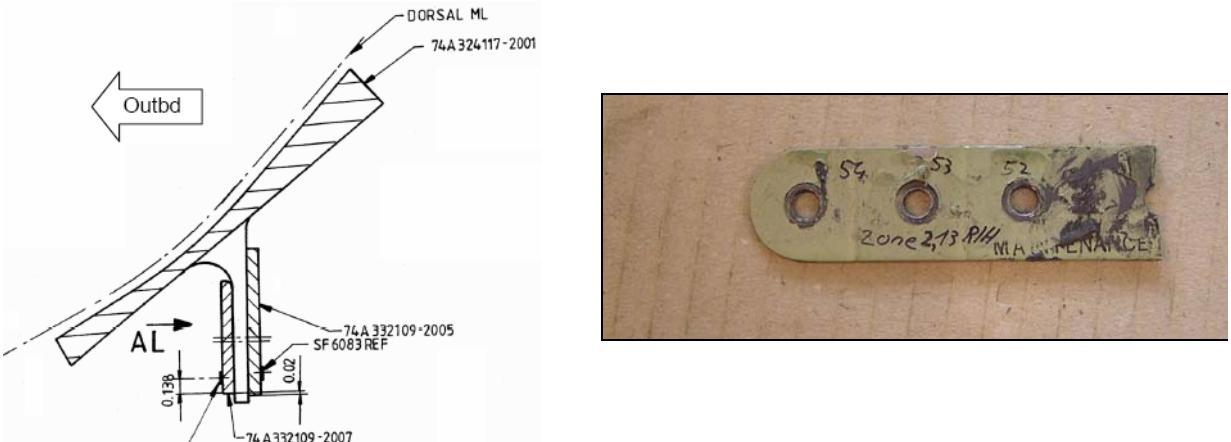
The aft fuselage section was de-spliced from the center fuselage section at the splice FS557. In the longeron between the splice and the speed brake attachment some damage was observed. The inboard plate of a twin plate splice (RH side) at the section FS574 was fully cracked, see figure 4.5.2. The outboard bracket was cracked approximately 45 % of the cross section.

Figure 4.5.2: Sketch of twin plate splice and one piece of the full cracked plate

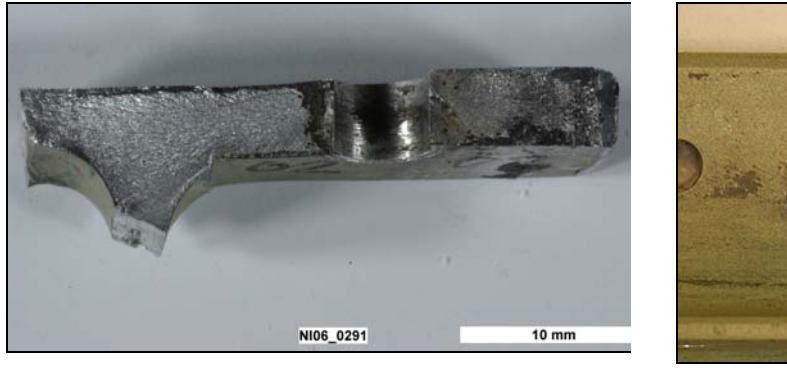
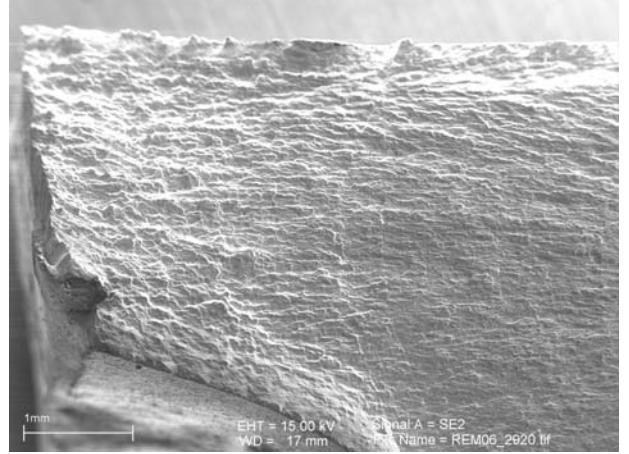
- Some more cracks were found during the tear down inspection in the upper outboard longeron. A crack was observed during fatigue cycling on LH side at 7'000 SFH at FS499. The crack was initiated at the down standing leg of the upper outboard longeron. Also on the RH side a few cracks were observed during the fatigue cycling in the section FS492.5 till FS503.2. These cracks were reported after 8'300 SFH. Some edge distances (e) were very low compared to the blueprint value of e/D = 2 (D = hole diameter). Furthermore the holes in the longeron should have Swiss interference fit fasteners which was not the case in test article. The upper outboard longeron was heavy loaded for the Swiss loads in the test section. One reason was surely due to the stiffness changes for reinforced center fuselage (titanium upper longeron and titanium bulkheads with beef up of structural elements). Up to now the much higher shear loads in center section for the Swiss compared to the US Navy could never be understood.

Figure 4.5.3: Longeron R/H, cracks started from hole, REM picture hole L/H side

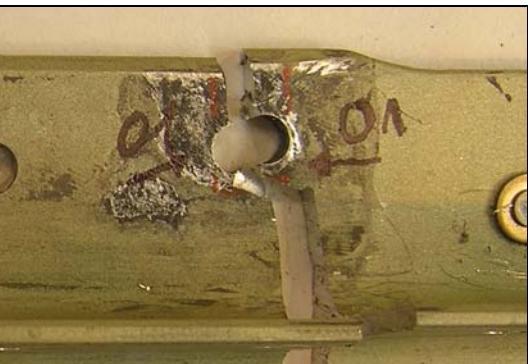
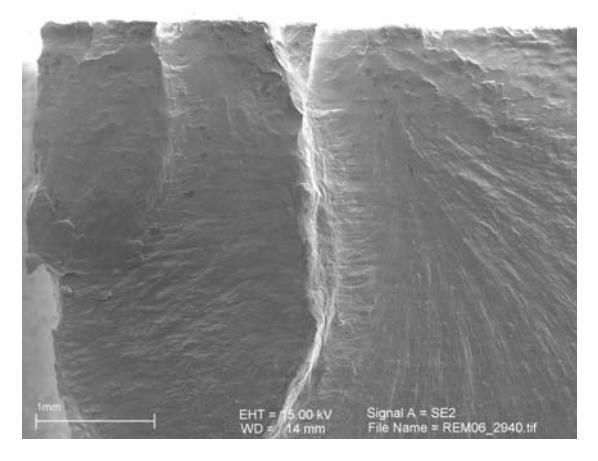
Longeron L/H (lower side), short edge distance, crack started between hole and edge; REM picture upper side

A detailed FEM analysis on the outboard longeron showed a high stress at the edge of FS489. During tear down inspection a crack was found there but the Fraktographie (figure 4.5.3) showed that the crack initiation occurred not at the predicted highest stress area by finite element analysis, see figure 4.5.9. The material (7149-

T76 Extrusion) of longeron seems also have some internal residual stresses which may lead to early cracks. The cracks in the outboard longeron may be initiated at approximately 5'000 SFH.

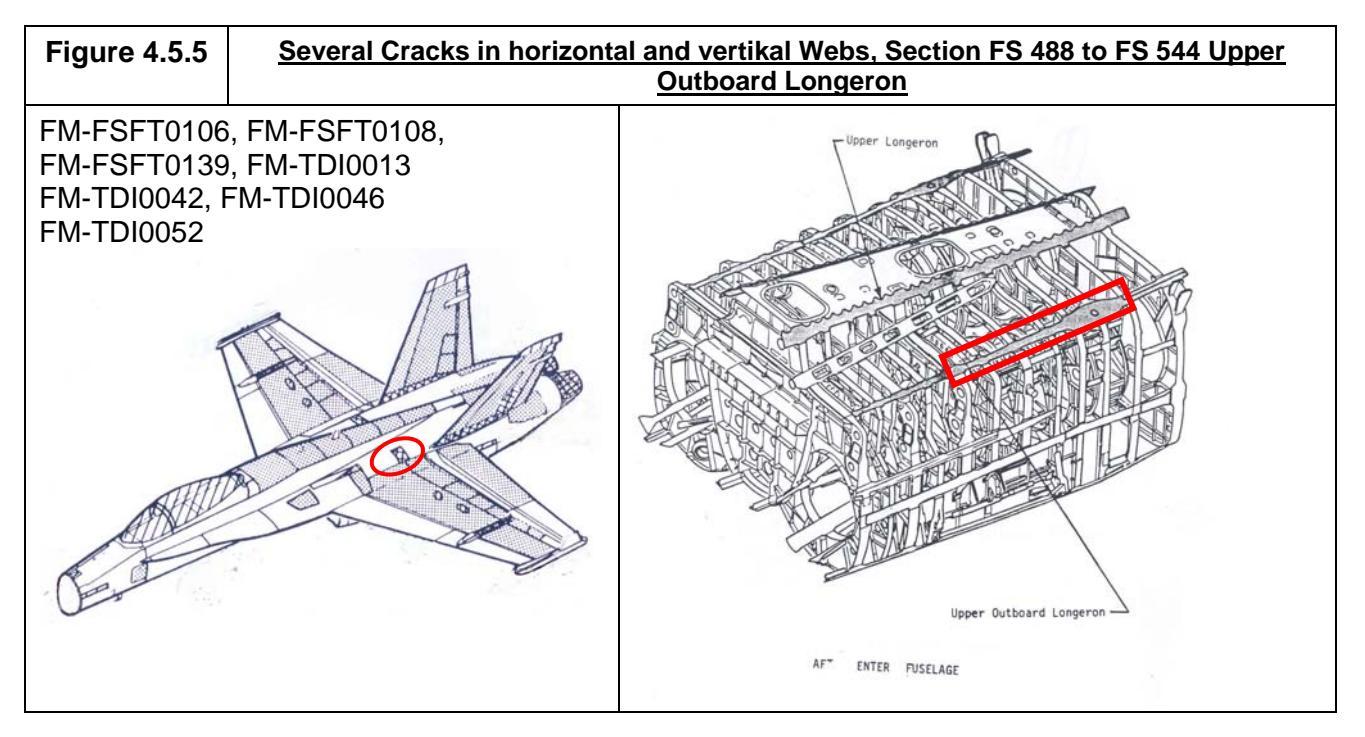
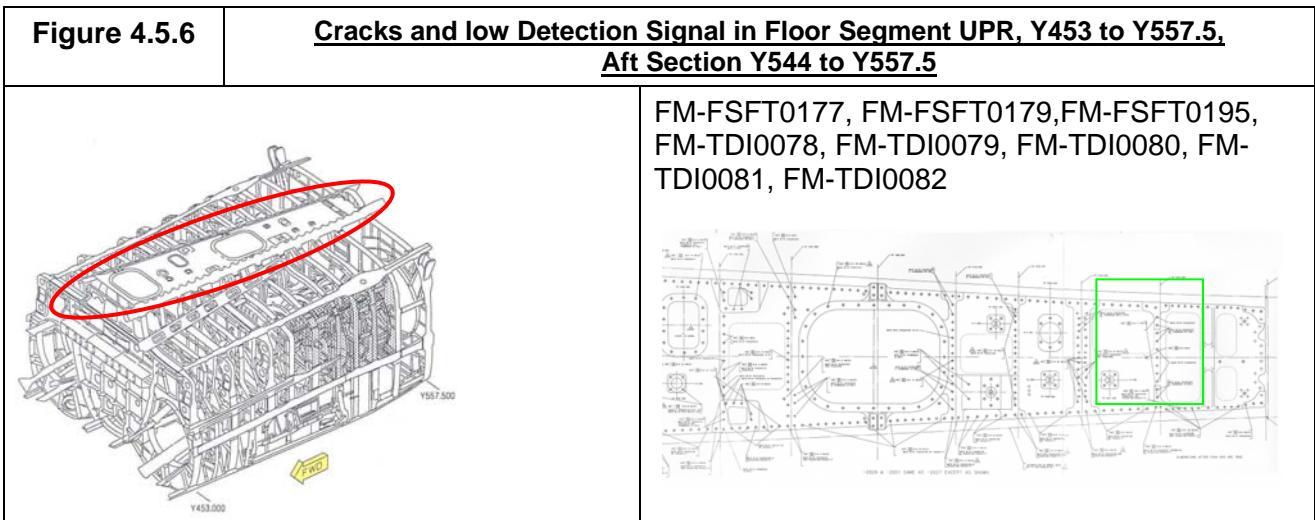
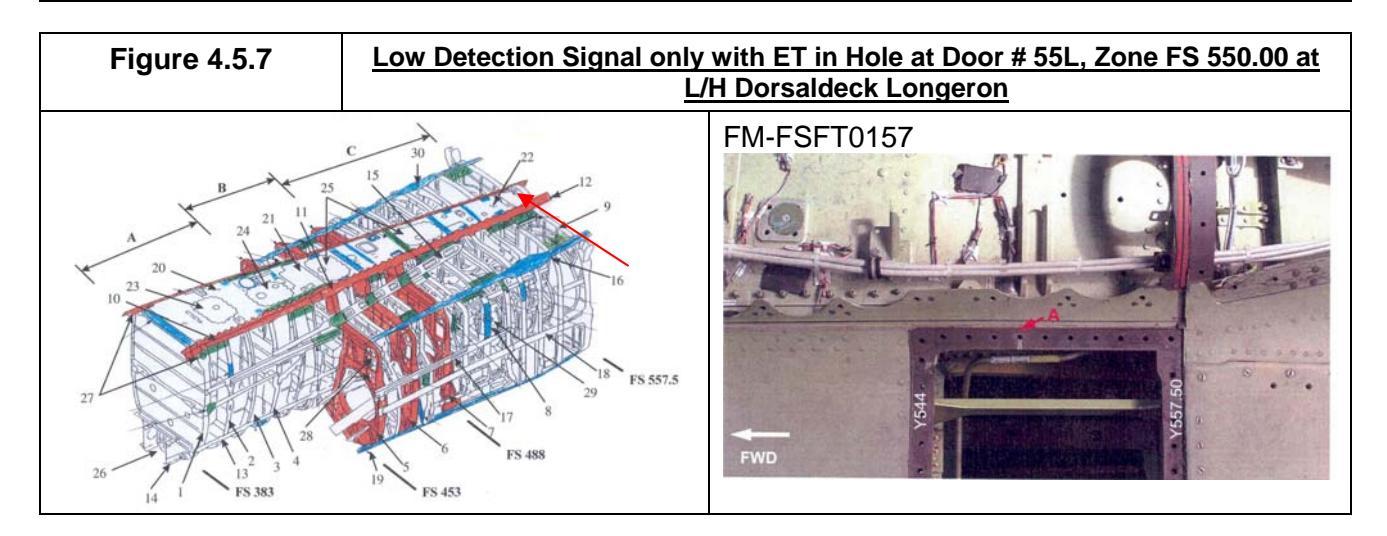
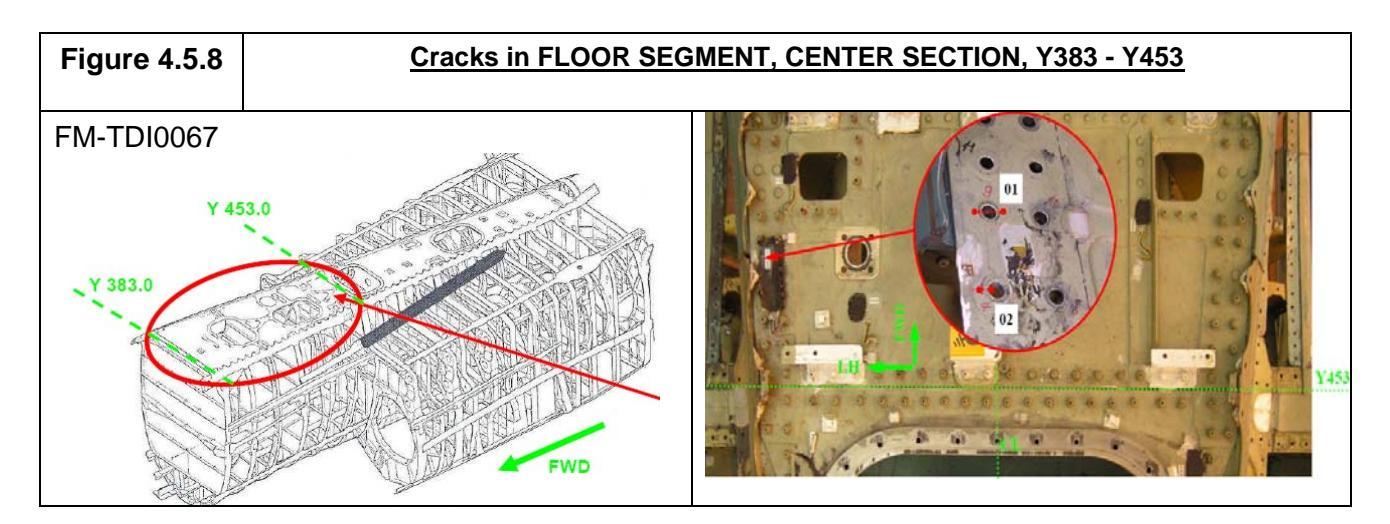
The following maintenance critical (MC) parts showed cracks in the test:

- Upper outboard longeron on both sides (LH & RH), see figure 4.5.5
- Floor segment upper section FS453 to 557.5 only LH side, see figure 4.5.6
- Titanium upper longeron only on the LH side, see figure 4.5.7
- Floor fuselage center section between FS383 and FS453 only LH side, see figure 4.5.8

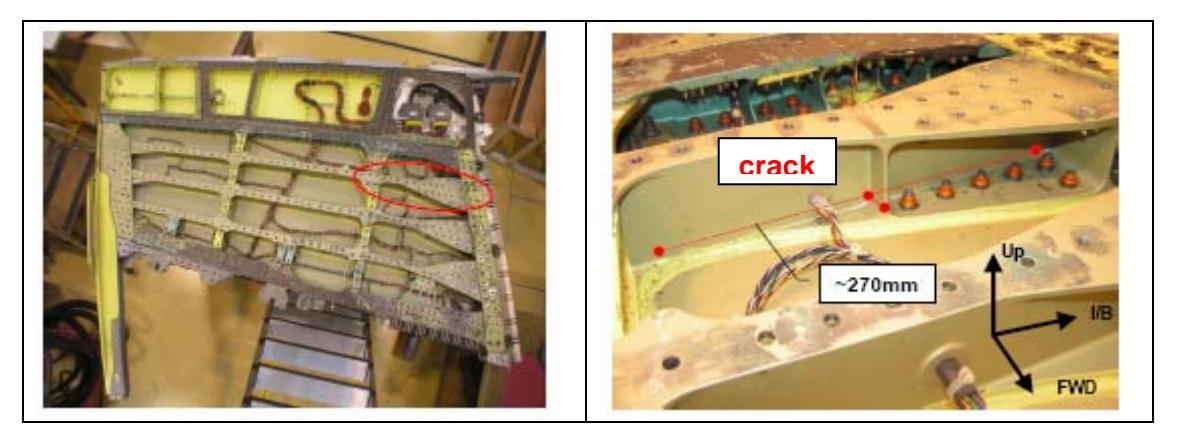
The tear down inspection on the wings started in March 2007. First the upper composite wing skin was removed from the outer wing. As a surprise a large crack was observed running in spar direction on the third spar. The crack was only observed on the RH wing, see figure 4.5.10. This anomaly has to be investigated in more detail.

Figure 4.5.10: Observed crack anomaly at the RH side of Swiss FSFT (outer wing)

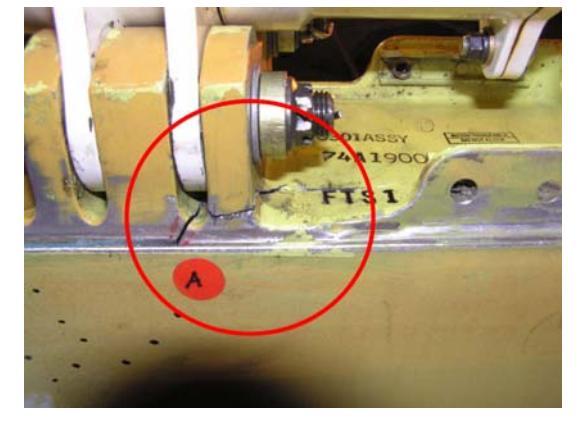
During the Swiss F/A-18 Full Scale Fatigue Test (FSFT), cracks of considerable size have been detected in both the left and right ILEF after only 3000 Design Spectrum flight hours. Such early cracking was not expected, as this location was improved by Swiss-specific modifications. Although the ILEF was primarily used as a load introduction component for the Inner Wing during the FSFT, and the loads were not intended to fully represent expected usage loads, the FSFT results are representative enough to consider the damages as fleet relevant. In addition, similar ILEF damages have been found in other fatigue tests (i.e. FT01/ST16/FT93), as well as in fleet aircraft of other users. Based on these findings, the cracks in the ILEF spar were rated as a Major Structural Issue for the Swiss F/A-18 fleet.

Figure 4.6.2: Cracked FSFT ILEF

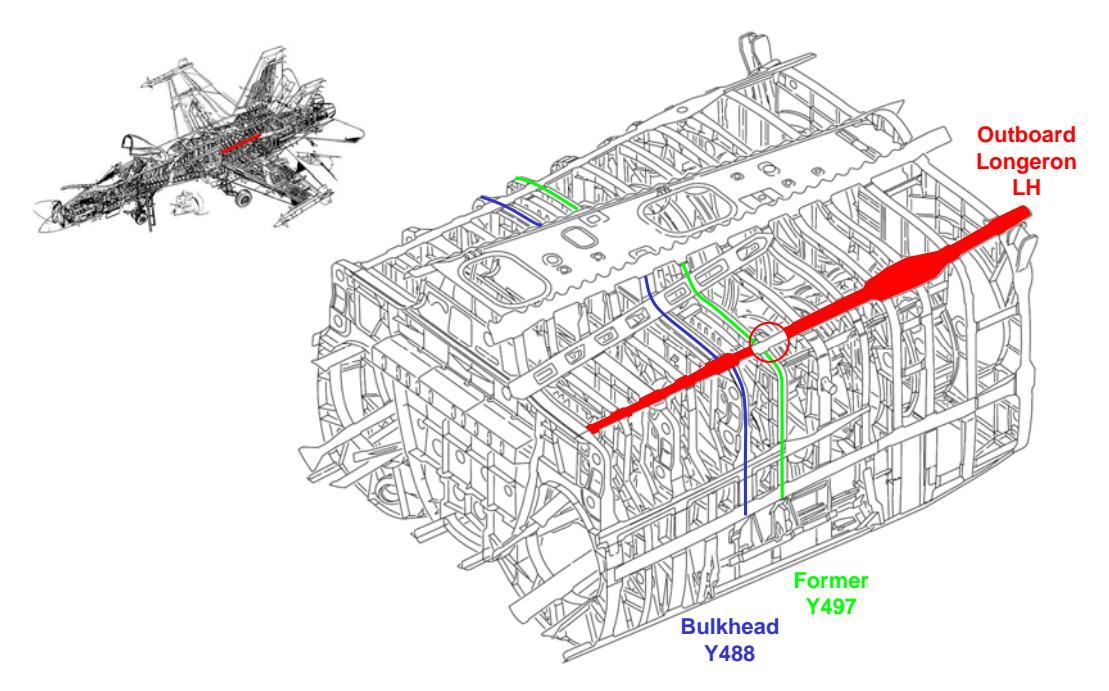
The urgency is mainly driven by the UOL for which fatigue lives of less than 1000 flight hours have been predicted based on crack initiation analysis. As of the end of 2006, the fleet leader accumulated more than 1400 flight hours. The production of a prototype is planned for 2008, the fleet refurbishment for the period of 2009 to 2011.

Figure 4.8.1: Upper Outboard Longeron

For the UOL and the FBW, the application of doublers is envisaged. The currently installed FCF made of chemically milled aluminum sheets will be replaced by titanium sheets. For all components, local life improvements such as cold working of holes are considered in order to further enhance the fatigue behavior and to compensate for increased bearing loads at fasteners transferring load into doublers and stiffened structures.

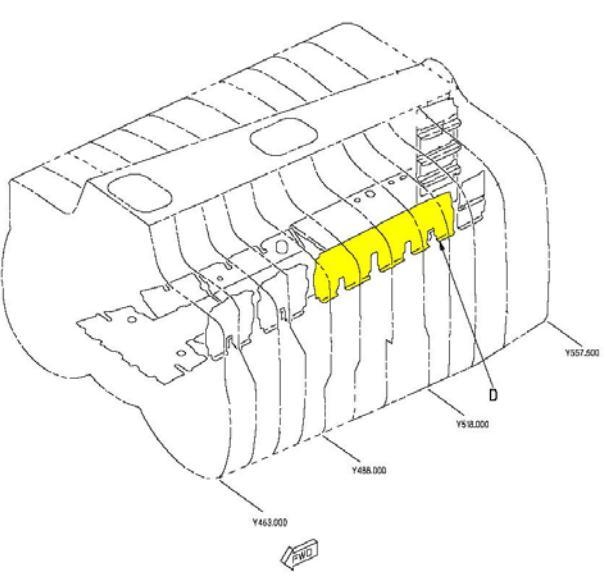
Figure 4.8.3: Fuel Barrier Web

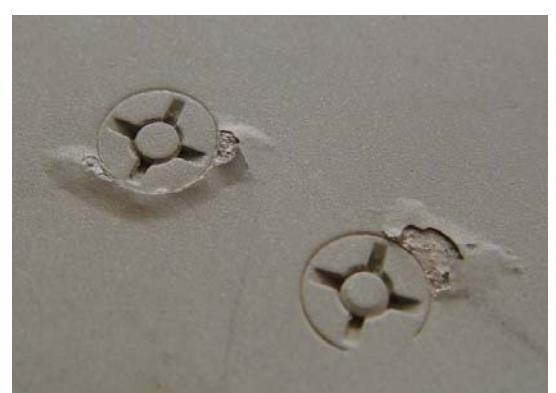
Exfoliation corrosion is commonly found in wing upper skins around fastener holes where it originates at the exposed grains in the countersink. To date, found corrosion has to be removed by local blending of the affected areas due to lack of alternative repair methods and lack of accurate methodologies to assess structural integrity taking into account the presence of corrosion. In case of the relatively large wing skin/panel affected by wide spread corrosion, the blending process is rather labor intensive. Consequently, the repair of a wing may no longer be economic.

Figure 4.11.1: Natural Exfoliation corrosion around fastener heads in aluminum wing skin
