**REVIEW OF AERONAUTICAL FATIGUE
INVESTIGATIONS IN JAPAN
DURING THE PERIOD JUNE 2009 TO MAY 2011**

For Presentation at the 32nd Conference of
the International Committee on Aeronautical Fatigue

Montreal, Canada, 29-31 May 2011

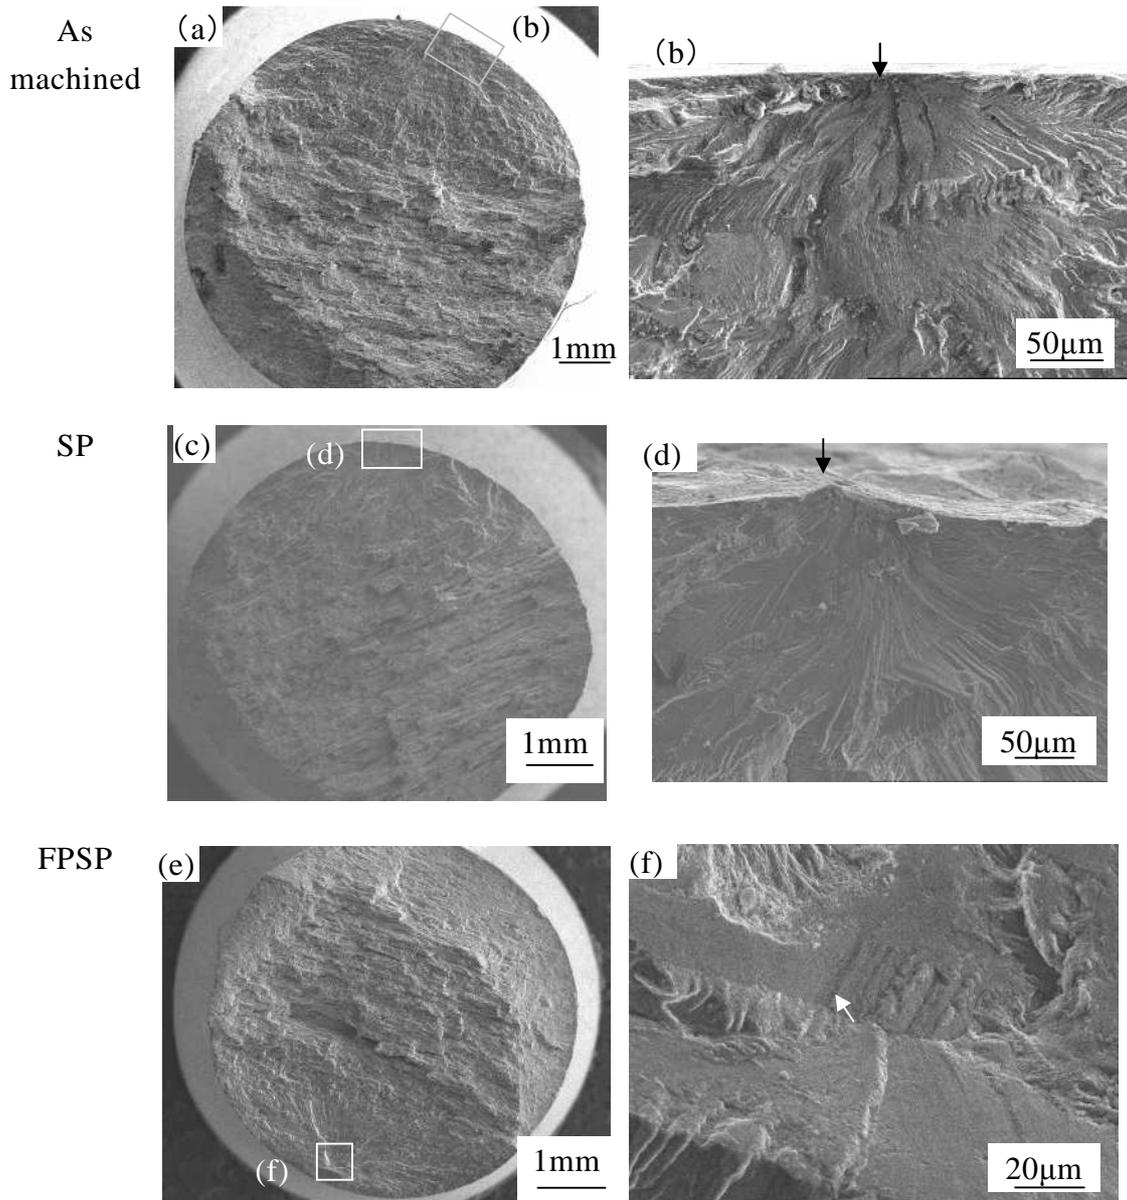
SEM images of fractured surfaces are shown in Fig. 7. The fatigue crack initiation sites in a conventional shot peened specimen, or in a virgin specimen, are located on the specimen surface as shown in Fig. 7(b) and (d), while an arrow in Fig. 7(f) indicates that the fatigue crack in the FPSP specimen initiated at the subsurface layer inside of the specimen.

Fig. 7 SEM images of fatigue fractured surfaces

As machined specimen in (a) is magnified in (b). Shot peened specimen in (c) is magnified in (d) and FPSP specimen in (e) is magnified in (f). Arrows in (b) and (d) indicate the crack initiation site on the surface, while an arrow in (f) indicates subsurface crack initiation site. Maximum stress of fatigue testing is 344MPa.

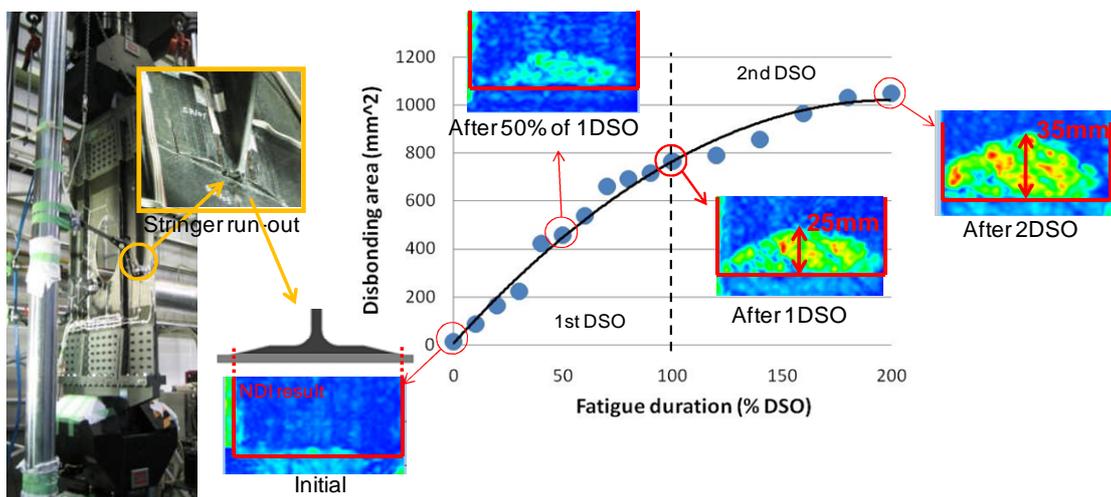
Fig. 41 Sub-component test and slow growth of stringer run-out disbonding

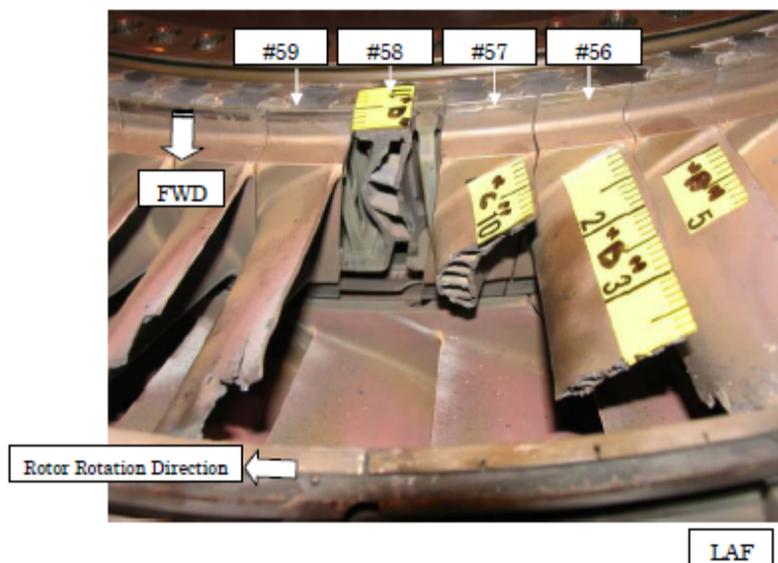
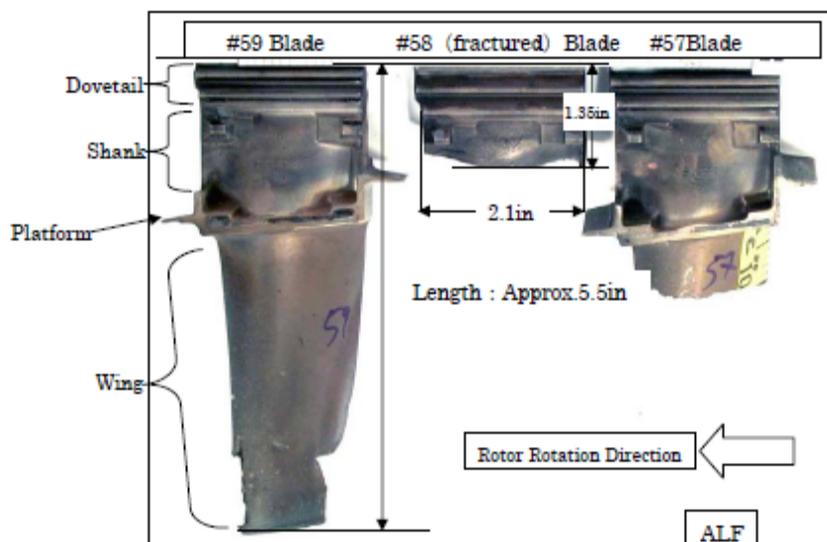
Fig. 44 Stage 2 HPT shank separation and adjacent blade damage

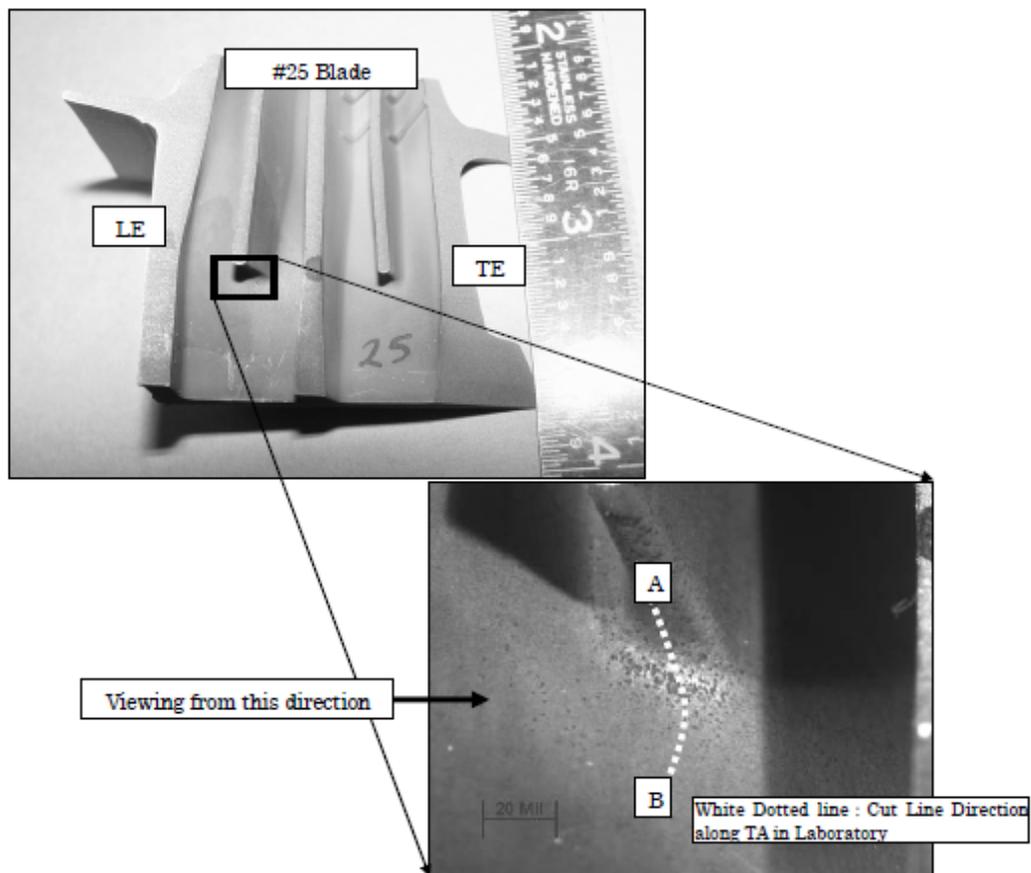
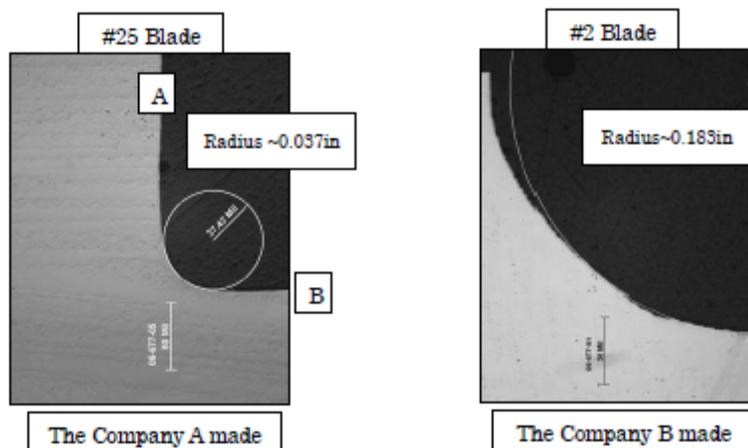
Fig. 45 Differences of turnaround radius features

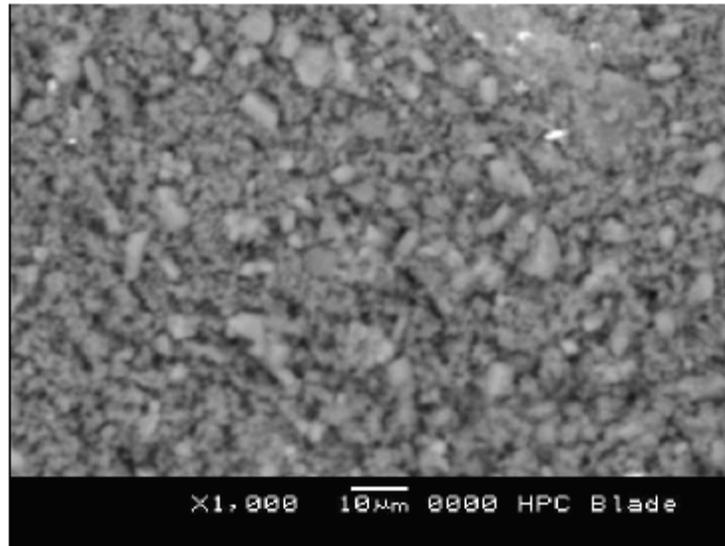
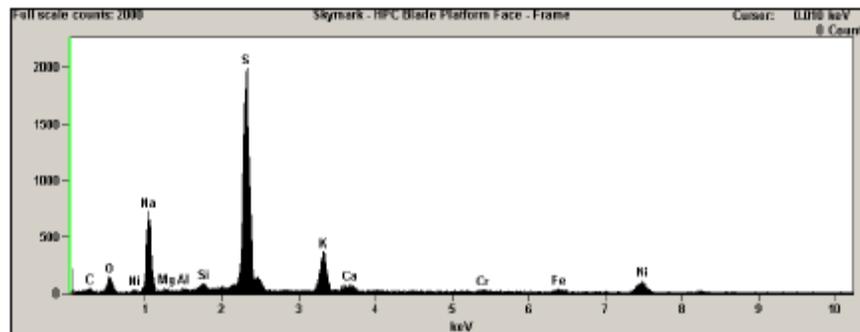
White Debris Exhibited Elevated Sulfur(S), Sodium(Na)
and Potassium(K) along with Oxygen(O)

Fig. 46 Debris from Stage 10 HPC blades

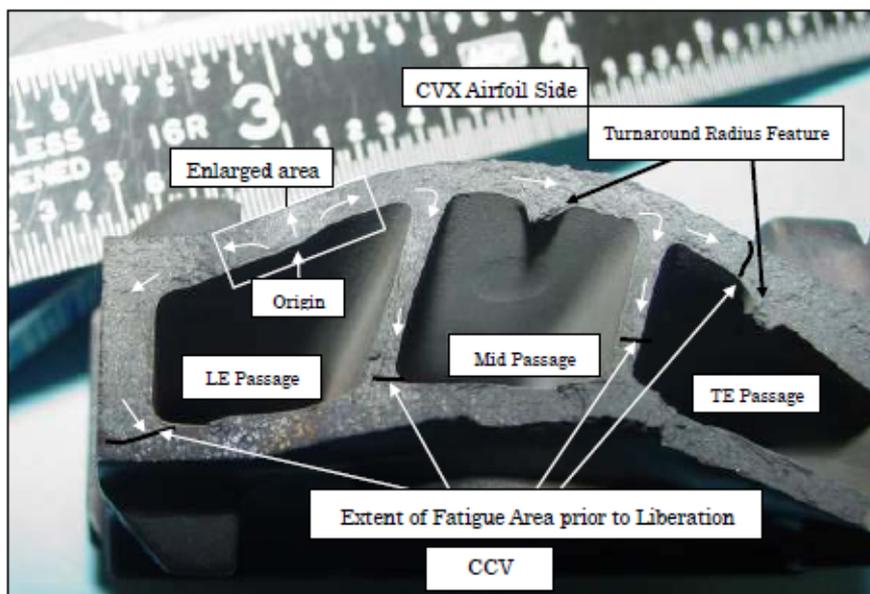
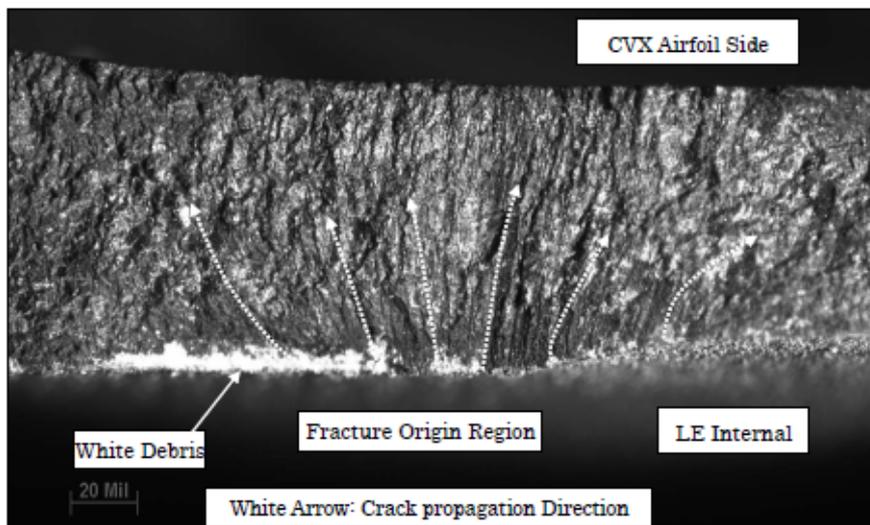
Fracture Origin Region (Enlarged Area)

Fig. 47 Fracture origin of #58 blade and internal cooling air passage
