# **Review of Aeronautical Fatigue and Structural Integrity Work in Canada (2017 - 2019)**

**Report No.:** LTR-SMM-2019-0063

**Date:** April 2019

NATIONAL RESEARCH COUNCIL CANADA (NRC)

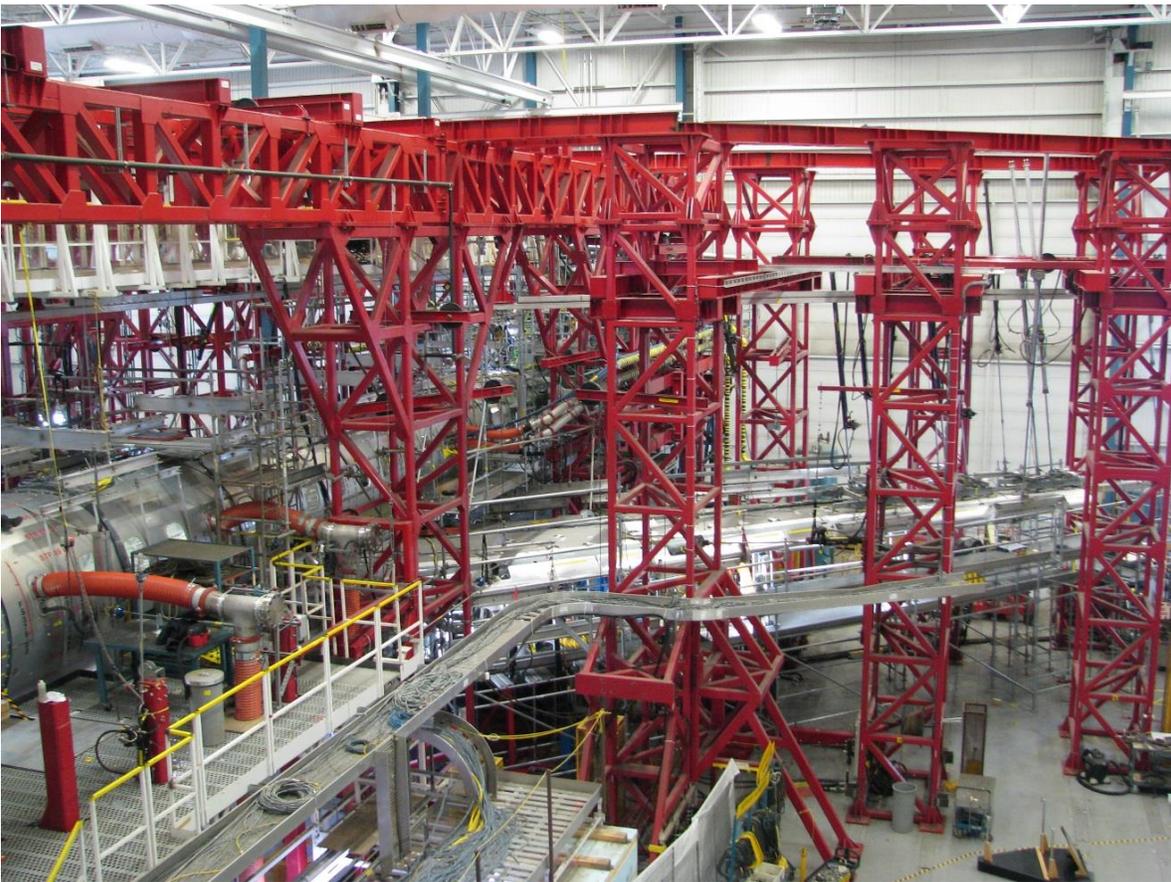
**Figure 1 Global 7500 durability and damage tolerance tests in Montreal, Canada  
(Note: Bombardier Aerospace has changed the name of the Global 7000 ultra-long range aircraft to the Global 7500 thanks to performance improvements that continue to surpass expectations)**

The Global 7500 Complete Aircraft Durability and Damage Tolerance (DADT) Test started in November 2017 at BAEX (Bombardier Aerospace Experimental Department) in Montreal, Canada, shown in Figure 1.

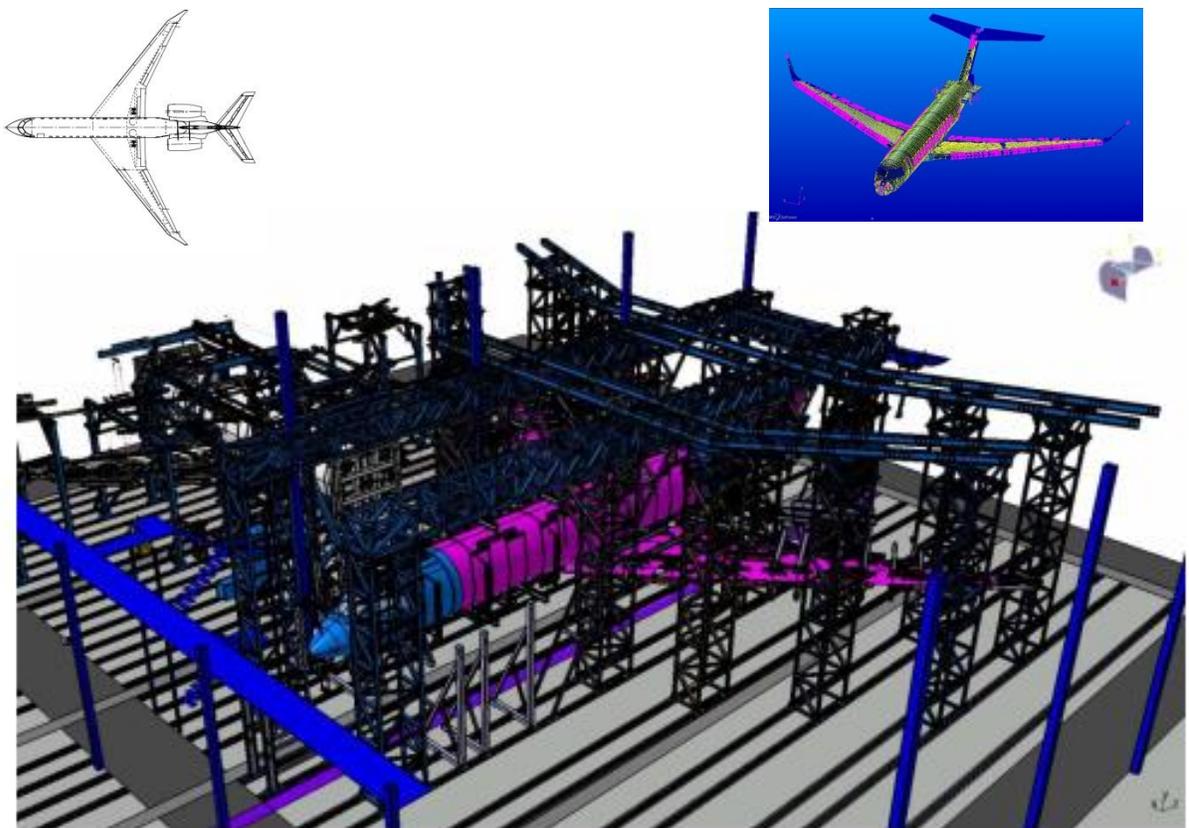
**Figure 2 Overall setup of the Global 7500 complete aircraft DADT test**

The main components covered by the Complete Aircraft DADT Test: complete fuselage, wing, engine mounts, vertical stabilizer and metallic parts of the horizontal stabilizer. It also covers all doors, landing gear interfaces, as well as the control surface and high lift device attachments and backup structures within the wing box and empennage boxes, as shown in Figure 2.

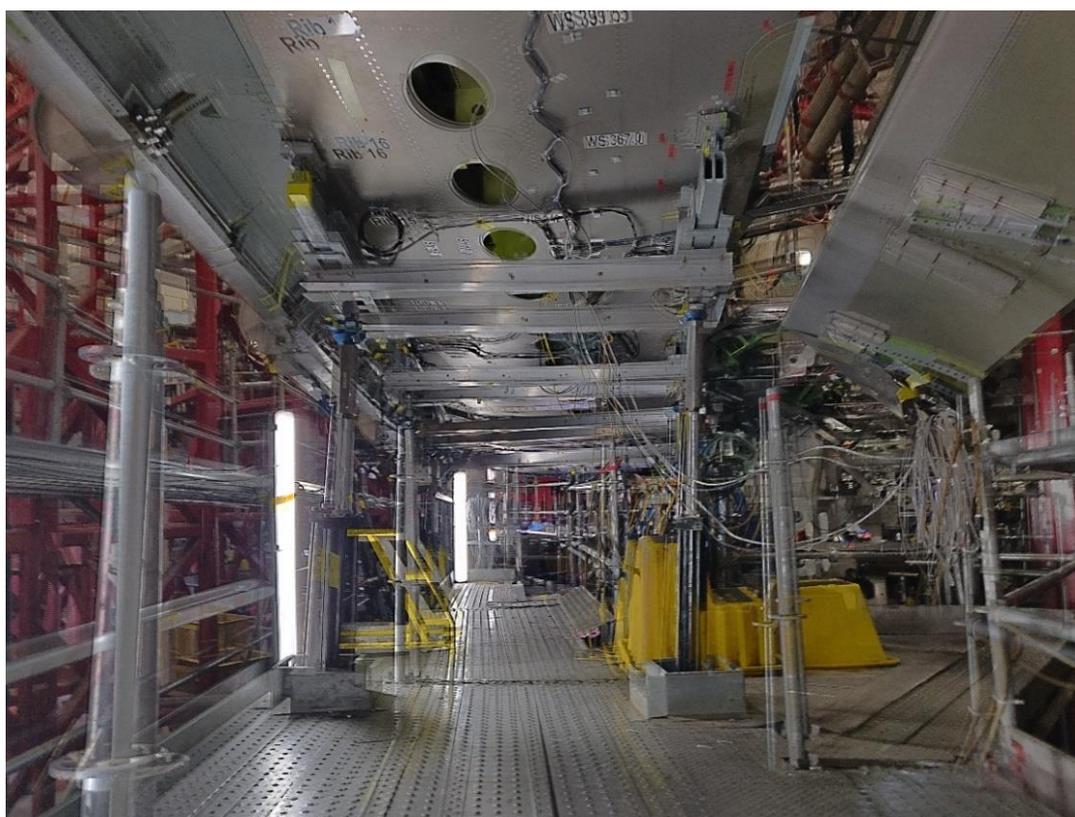
**Figure 3 Close-up of wing test setup**

Close-ups of the wing and fuselage tests are shown in Figure 3 and Figure 4 respectively.

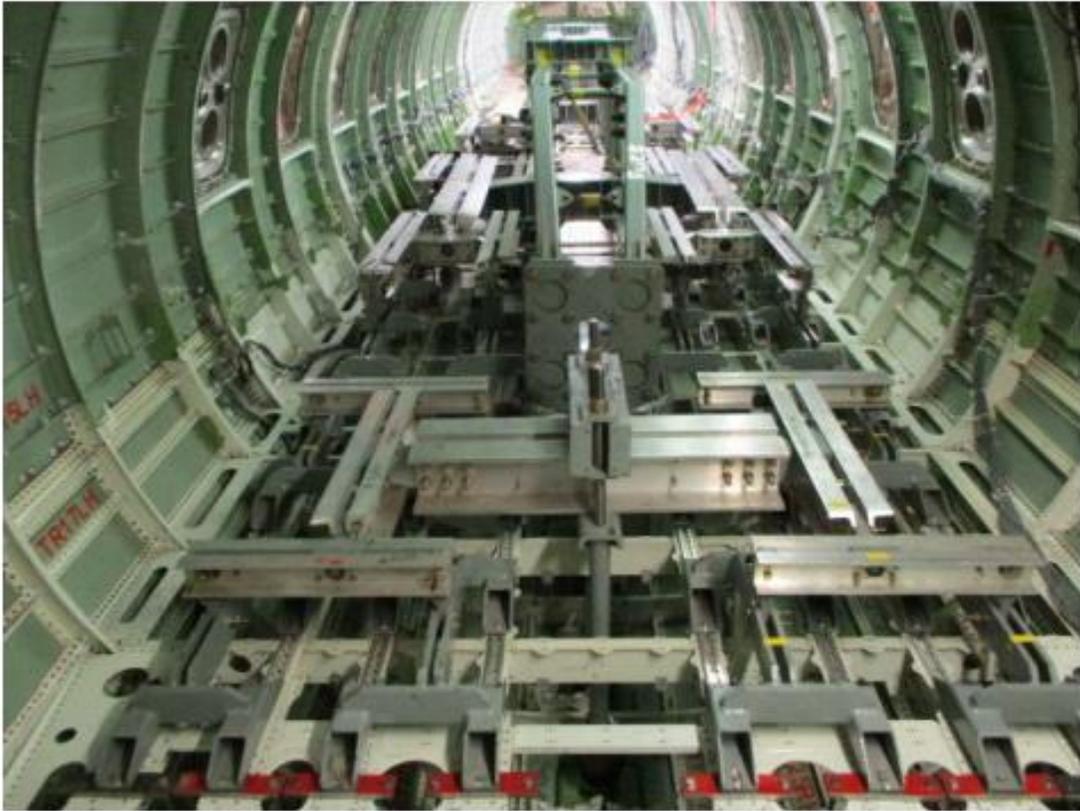
**Figure 4 Close-up of fuselage test setup**

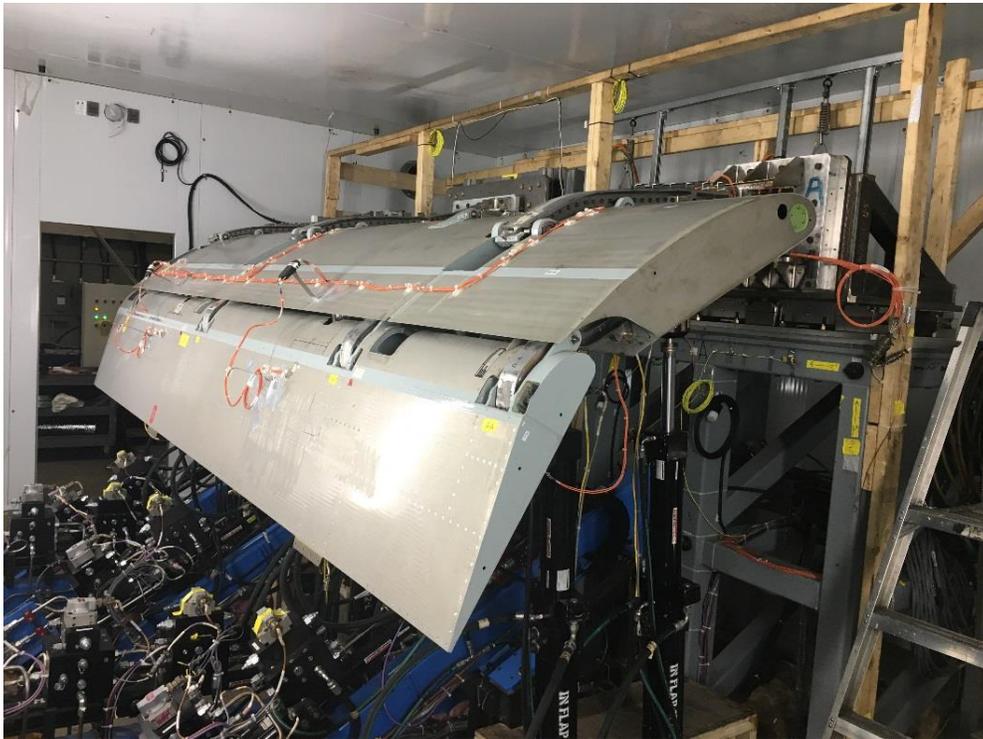
**Figure 5 Inboard flap test rig**

Both Inboard and Outboard flap Durability and Damage Tolerance Tests are performed at BAEX in Montreal, Canada, shown in Figure 5 and Figure 6. Both flaps are moving to various deployment angles during flight-by-flight spectrum to more accurately match interface loads.

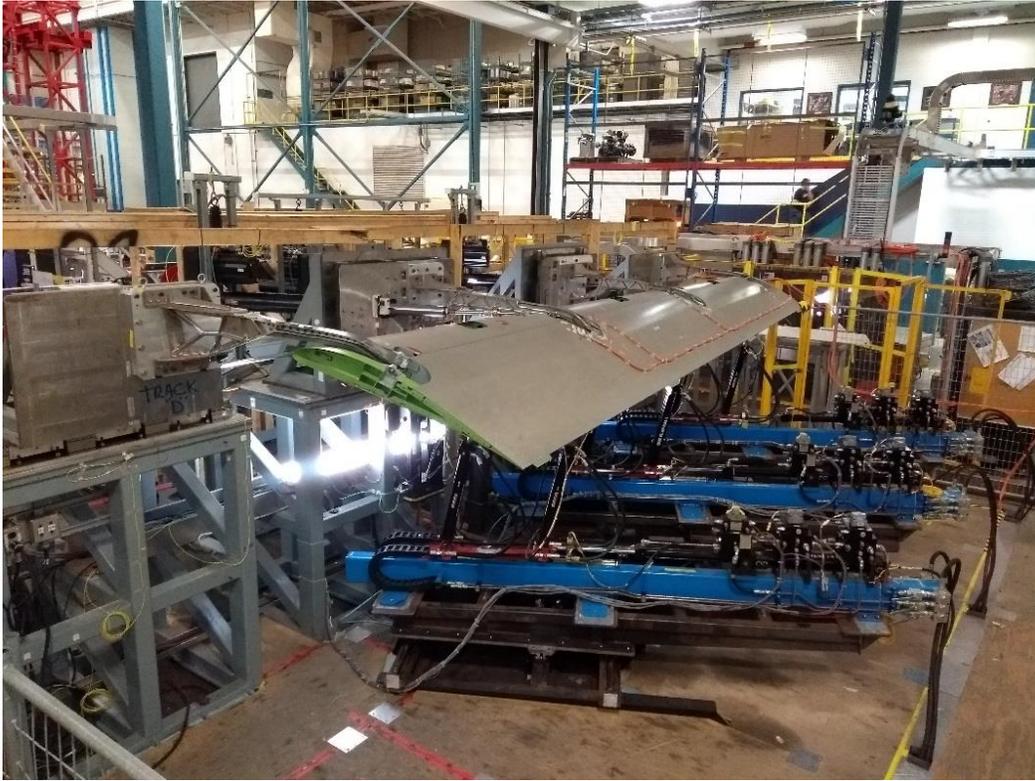
**Figure 6 Outboard flap test rig**

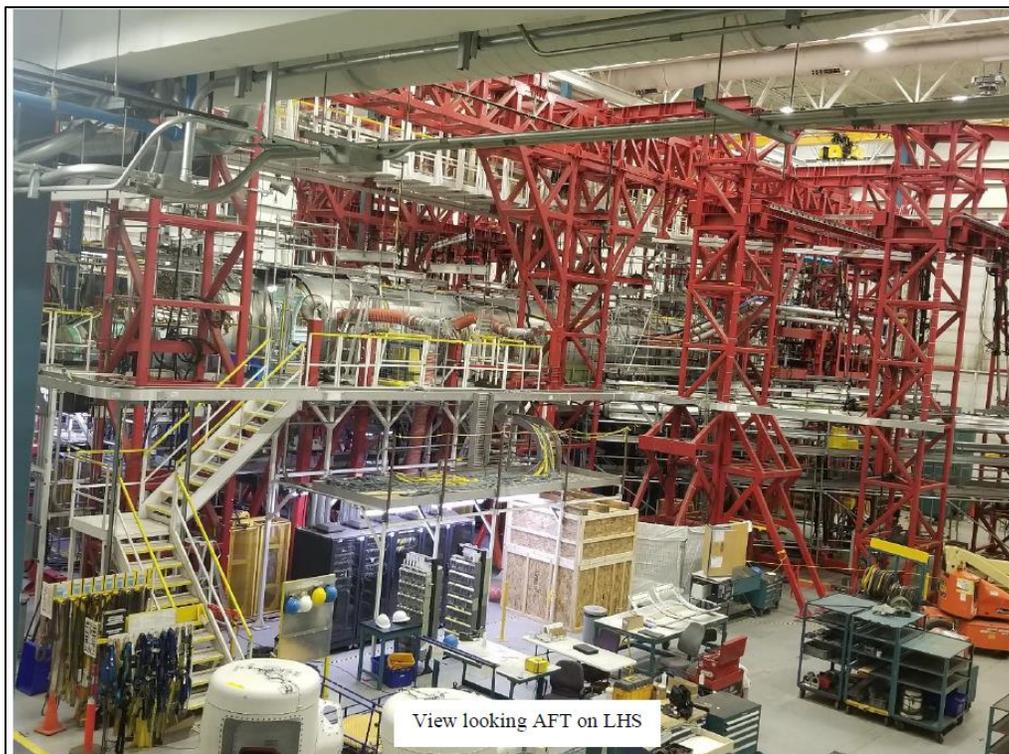
**Figure 8 Global 7500 DADTT test setup (view AFT on LHS)**

These techniques included: judicious data-informed hydraulic and pneumatic hardware selections; informed design choices to minimize mass and actuator count; hydraulic and load controller training and procedure generation on a dedicated independent test platform; extensive hardware-in-the-loop tuning to maximize performance; and using the global finite element model (GFEM) of the test article, coupled with a simple pneumatic model to better estimate test load transition times. An image of the test setup is shown in Figure 8.

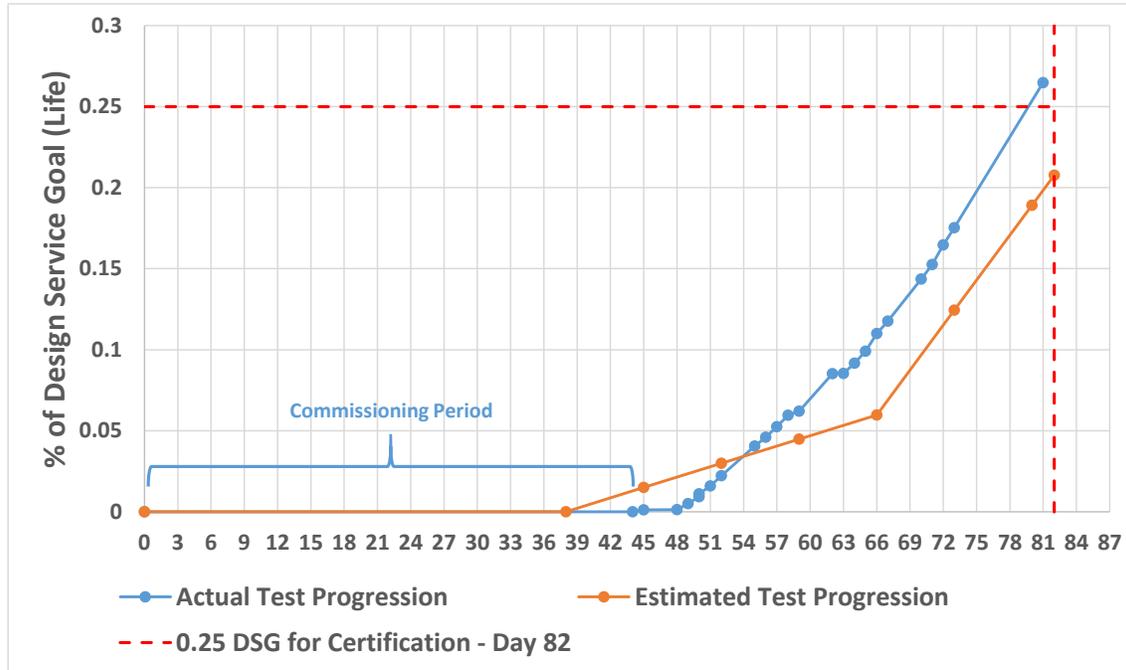
Figure 9 Global 7500 test schedule to certification milestone

These techniques were successfully employed to meet the required certification target schedule, and surpassed the original estimate, as shown in Figure 9. A more fulsome explanation of these techniques is included in a paper in the ICAF2019 conference proceedings [1].

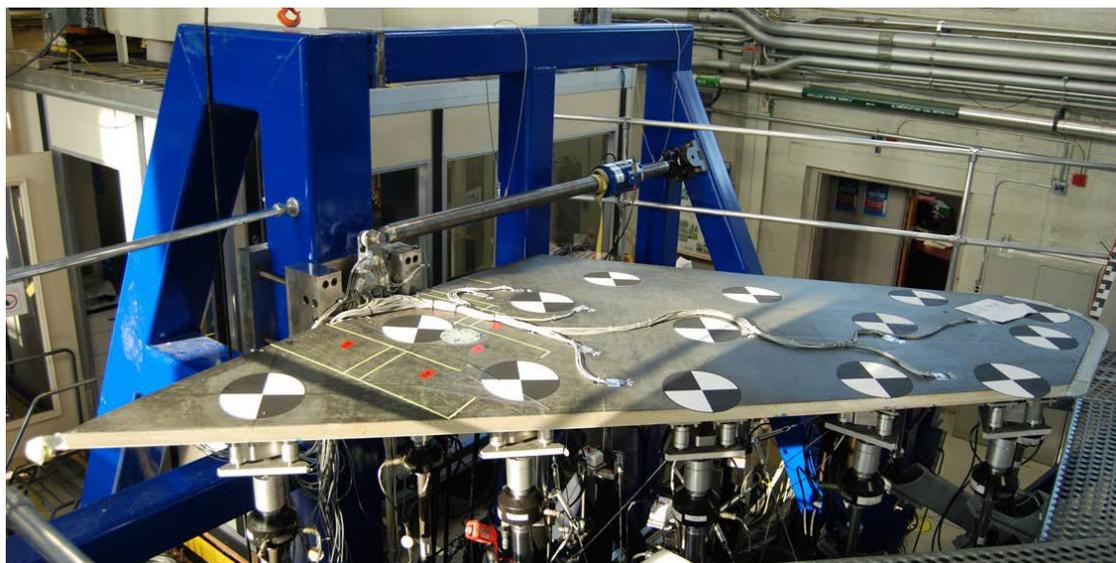
**Figure 10 FTS2 test article with optical marker tracking at actuator locations**

The NRC Aerospace Research Centre used the same test rig that was used to test the Royal Canadian Air Force (RCAF) H-stab, designated FT905, to fatigue test the armasuisse test article to extend its original certified life. The test setup is shown in Figure 10.

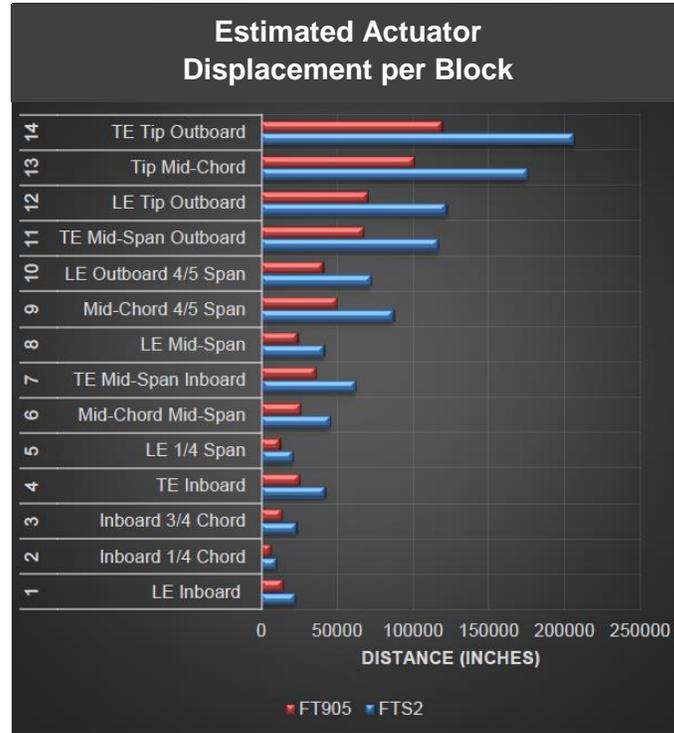
**Figure 11 Fatigue testing actuator travel displacement, a comparison between FT905 (RCAF) and FTS2 (SAF)**

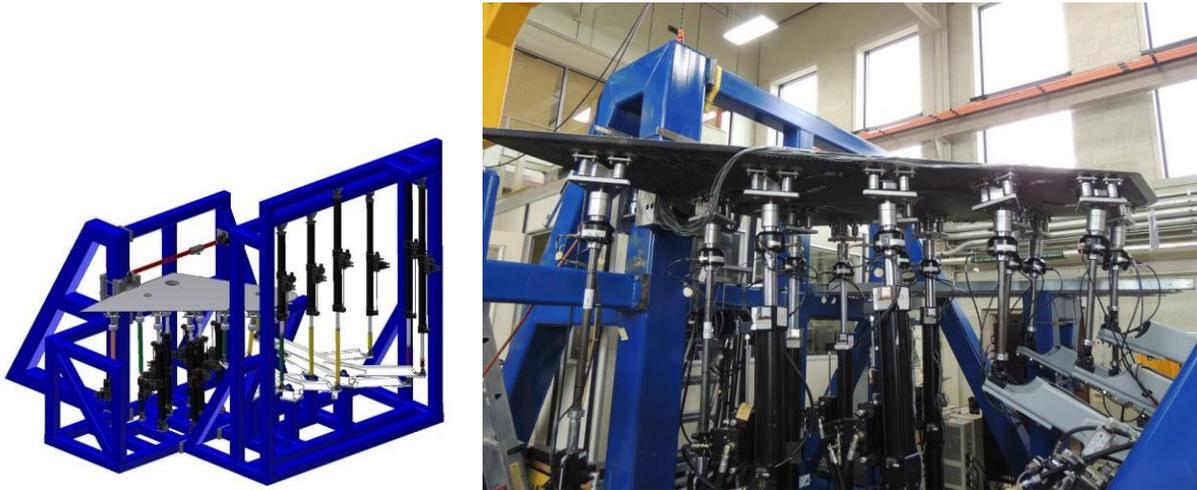
**Figure 12 Fatigue testing FTS2 test configuration**

For the FTS2 test, the loading was introduced using 14 hydraulic actuators, all attached at the bottom surface of a left hand side (LHS) H-stab, as shown in Figure 12. All actuators were at the same locations and whiffle tree configurations as the RCAF test. The test involved a strain survey pre-test and the application of a total of six lifetimes of armasuisse fatigue/durability cycling on the H-stab. All loads were applied on the in-service component to prove that existing component damages and armasuisse magnitude loads will not compromise the required H-stab performance during its desired service life.

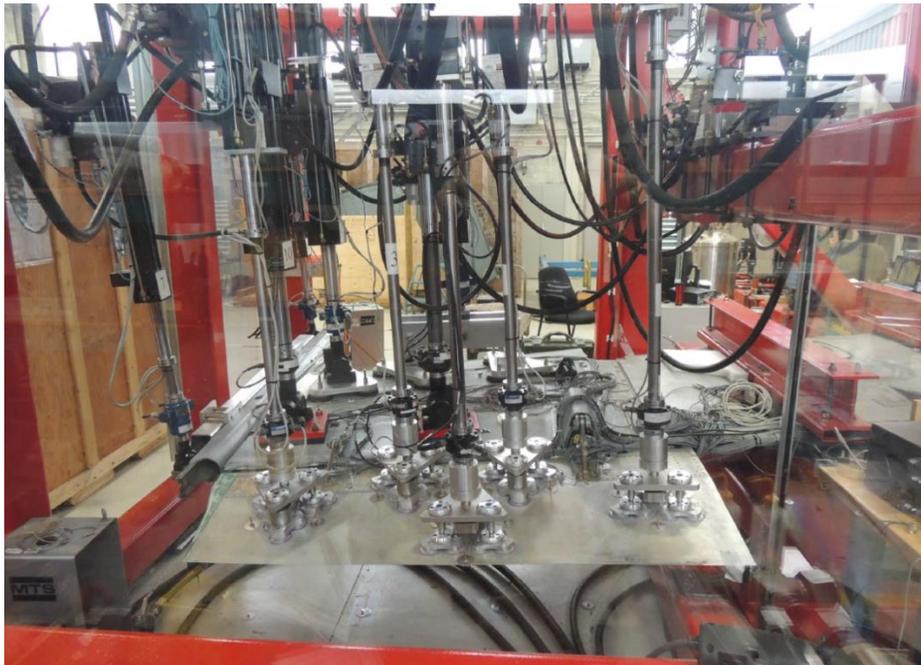
**Figure 13 Aileron test (FT370) article and test rig**

NRC had an existing F/A-18 wing test rig that contained a test article that was used to evaluate structural health monitoring techniques. Since this test article had existing damages the wing was replaced and the rig was modified to accommodate the installation of an aileron with additional actuators. This specifically designed and built test rig was used to apply loads normal to the aileron and outer wing using 11 hydraulic actuators, all attached to the bottom surface of a right hand side (RHS) aileron, wing, outboard leading edge flap and dummy wing tip missile through a missile launcher. A picture of the test article in the test rig is shown in Figure 13.

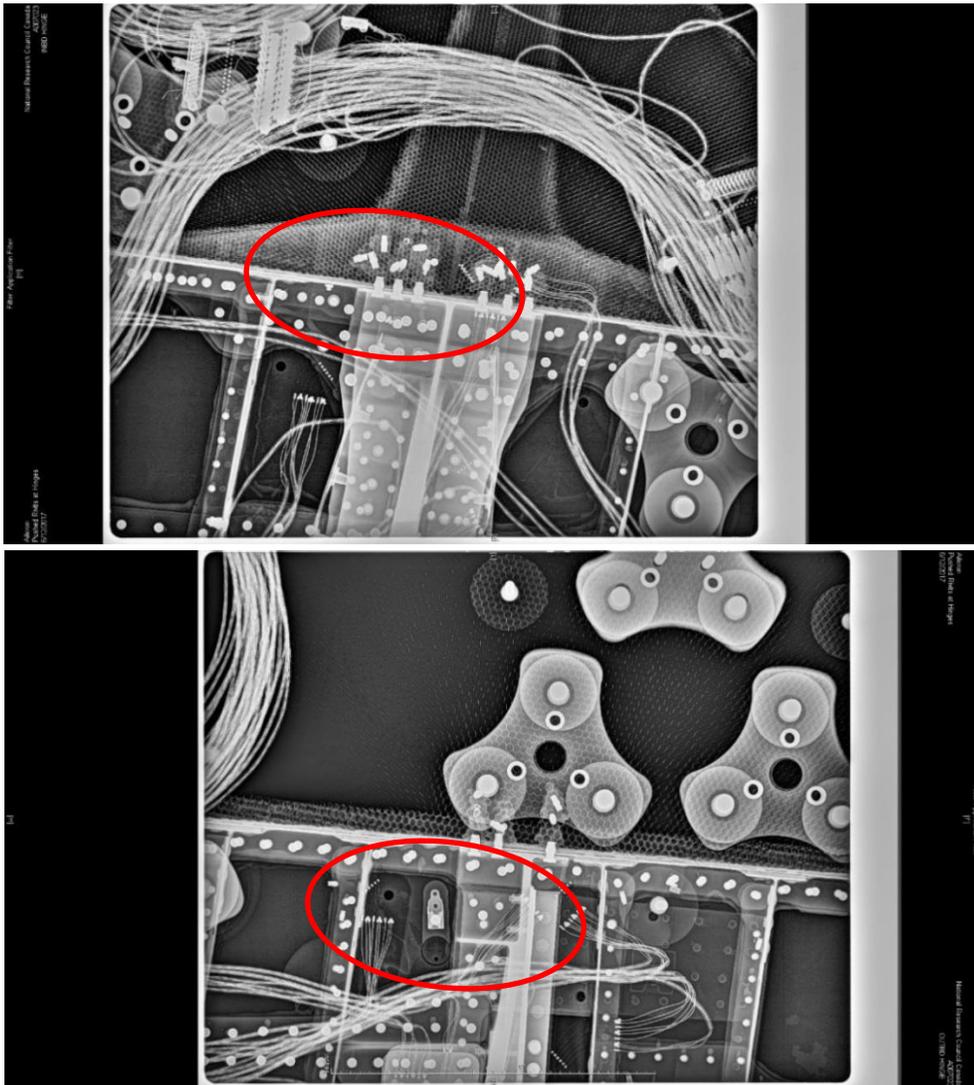
Figure 14 Aileron test (FT370) X-ray inspection showing pushed fastener locations

The testing work included: a strain survey pre-test; and the application of five (5) lifetimes of fatigue cycling on the aileron. Note that the test article had 90% of its original fatigue life expended prior to test start. Testing on the in-service component was intended to prove that existing component configuration and damages will not develop to failure and that these damages can be found with the current maintenance procedures. During testing, NRC monitored the entire structure and carried out inspections. Periodic X-ray inspections were carried out at the pushed fastener locations that were created when the hinges were modified. An example of an X-ray inspection is shown in Figure 14.

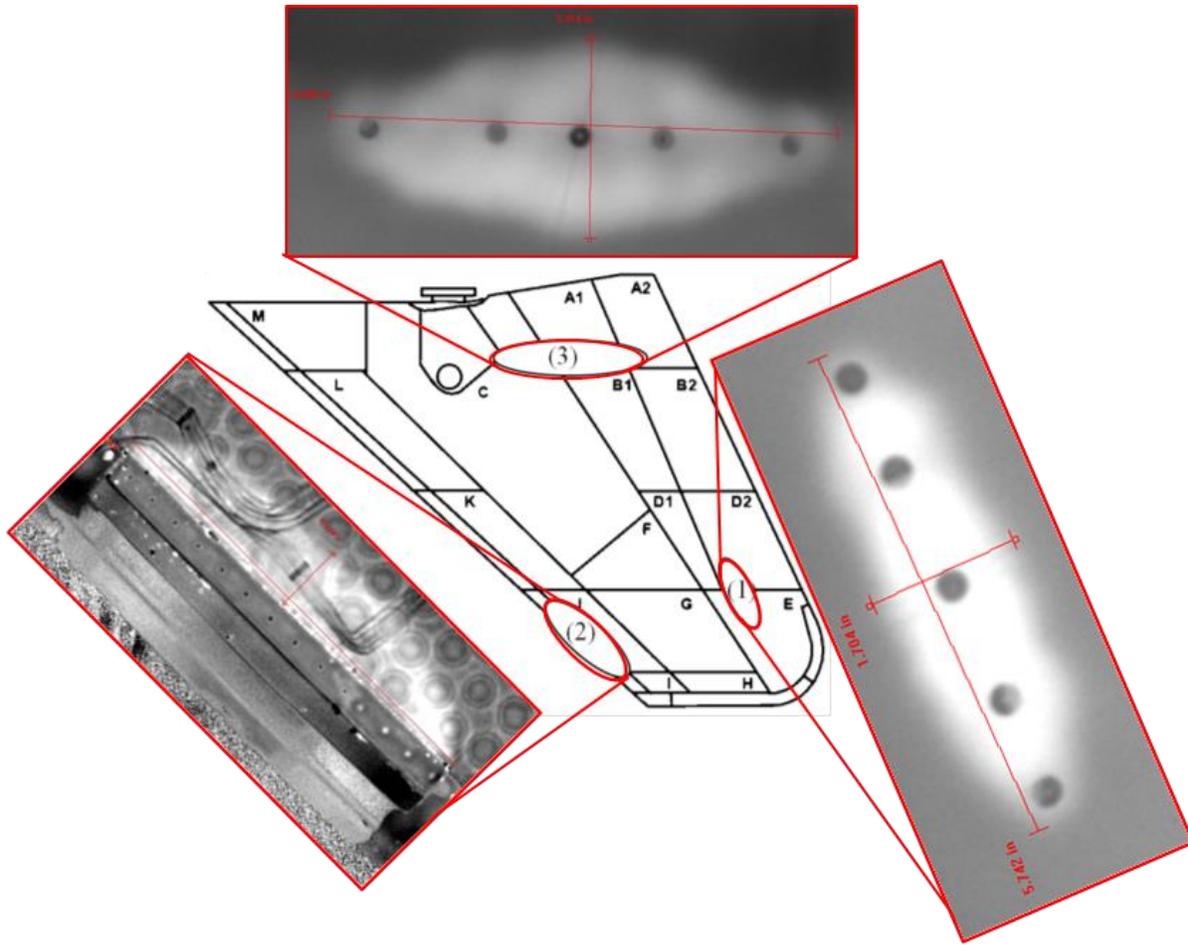
**Figure 15 CF-188 FT905 H-Stab Induced Damages taken by Pulse Flash Thermography**

In 2015, the Royal Canadian Air Force (RCAF) contracted the National Research Council Canada (NRC) to conduct a life extension test of the CF-188 horizontal stabilator (H-stab) to support the extension of the Canadian CF-188 Estimated Life Expectancy (ELE). This test, referred to as FT905, was conducted in order to avoid costly and time consuming procurement of additional parts. The F/A-18 horizontal stabilator is composed of graphite / epoxy composite skins enclosing an aluminium honeycomb core. Test objectives included determining the durability of the aluminium core in the presence of substantial damage, investigating suitable inspection techniques for this type of damage, and determining suitable inspection intervals if required. The test consisted of five (5) lifetimes of durability cycling, followed by damage introduction, five lifetimes of damage tolerance testing, and then residual strength testing (RST), with the residual strength loads incorporating an environmental load factor to account for the service environment (for more details please refer to ICAF 2017 Proceedings, F-18 Flight Control Surface Life Extension Testing - CF-188 Horizontal Stabilator, C.A. Beltempo et al). Pulse flash thermography was found to be effective in characterizing honeycomb core damage, as shown in Figure 15, where induced damages in three (3) critical areas are presented.

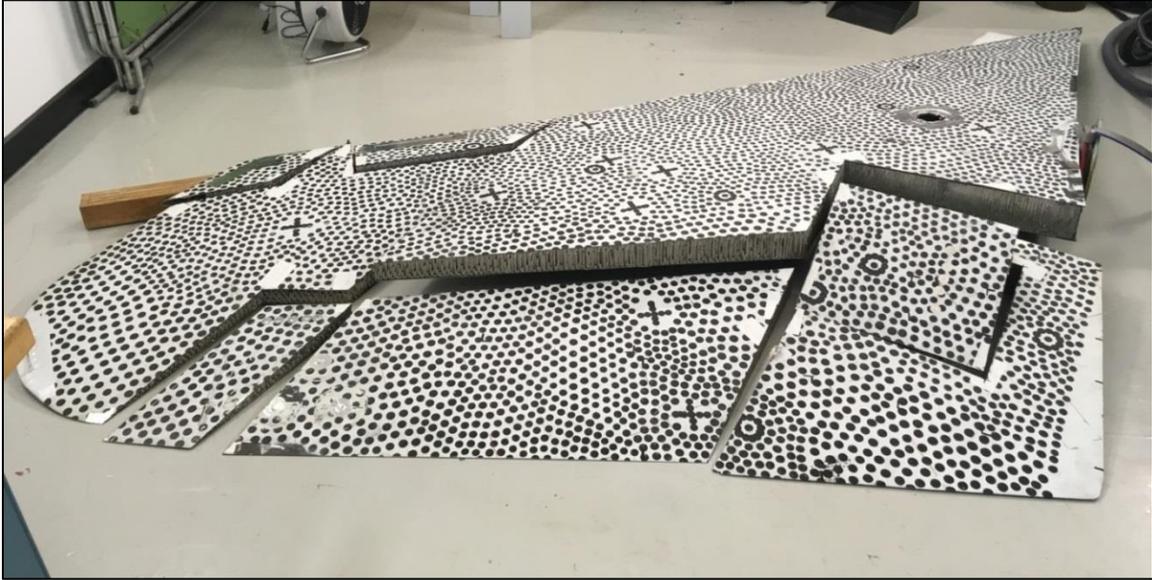
**Figure 16 CF-188 FT905 H-Stab following initial sectioning for tear-down inspection**

During the test, periodic X-ray, through transmission ultrasonic C-scan, and pulse flash thermography inspections were carried out, but revealed no damage growth. The test was completed successfully in 2017, and the test article was sectioned in 2018 for post-test non-destructive inspection (NDI). The post-test NDI also did not reveal any damage growth of the induced damages, nor any indications that were not caused by loading system failures or were not already present in the test article. As a result of the NDI null findings during the test, the tear-down sectioning was primarily focused on the three (3) induced damage areas and a fourth area of concern near the tip, to determine whether the induced damages had grown via fatigue cycling. The initial sectioning of the part is shown in Figure 16.

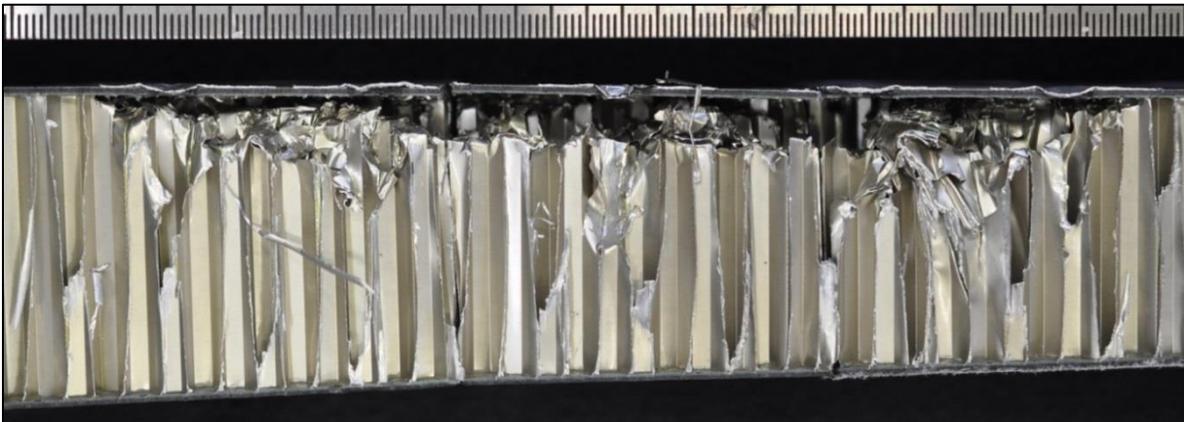
**Figure 17 CF-188 FT905 H-Stab lengthwise section cut showing induced damage with no growth at edges**

The teardown inspection confirmed the NDI findings and also validated pulse flash thermography as an acceptable inspection technique for honeycomb core subsurface damage. The large damages introduced to the honeycomb core had not grown during the damage tolerance cycling of the FT905 test, nor had they changed during residual strength test (RST) load applications. A sample of a final section cut in the aft area is shown in Figure 17. As a result of the teardown inspection, the CF-188 H-stab was certified a life extension of 1.5 times the original certification, with a single comprehensive inspection at 2/3 of the new baseline lifetime usage.

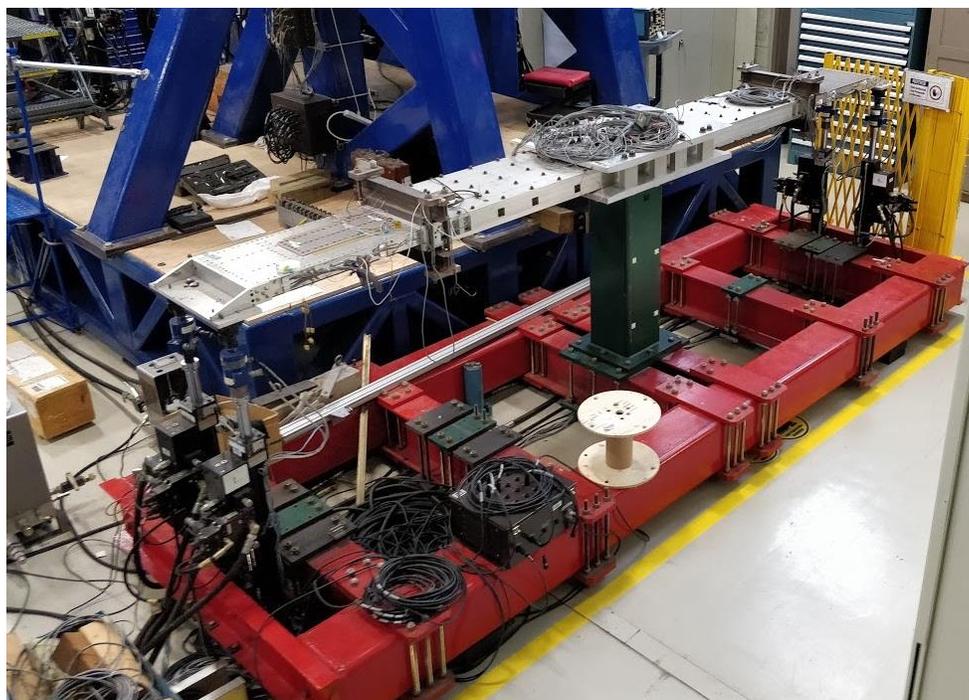
**Figure 18 Test rig setup for FASTER structural fatigue testing research**

The Structural Integrity group at NRC-SMPL had a test rig setup for experimental purposes, shown in Figure 18. This test set up was based on a need to apply bending and torsion loading to a structure for previous Structural Health Monitoring (SHM) sensor and algorithm development. The set up consisted of two (2) identical cantilevered beams on which two (2) actuators were mounted at each end, in order to apply bending and torsion loads to the testing structure in the middle (Figure 18). NRC has recently engaged in a research project in collaboration with McGill University to conduct a variety of control system trials in order to better understand the control problem. The project centered around various activities, including methods for proportional-integral (PI) gain estimation, investigating System Identification approaches to accurately predict plant (complete system) dynamics, developing both single-input single-output (SISO) and multiple-input multiple-output (MIMO) dynamic feedforward (DFF) controllers based on identified plant models, and finally implementing H-infinity controller synthesis methods to assess their performance for force-controlled fatigue test. Although these methods require substantial additional knowledge, preliminary results indicate the application of DFF or H-infinity methods, or a combination of the two, yield lower errors and potential increases in test cycling rate. The preliminary results were also submitted to the proceedings of the 21st International Federation of Automatic Control (IFAC) Symposium on Automatic Control in Aerospace, (ACA 2019) [2]

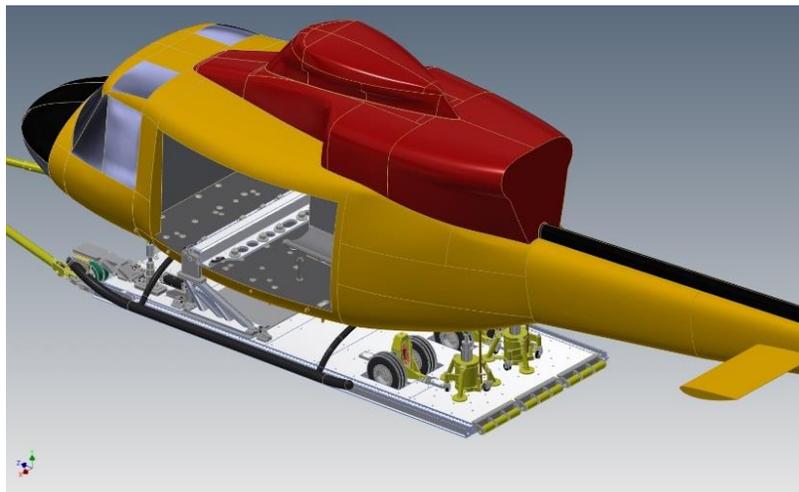
**Figure 19 A prototype of the PG-ATK system**

As the key component of the PG-ATK system, the pallet support structure assembly must meet all the strength, stiffness and weight requirements, while ensuring the structural integrity of the entire aircraft system. Therefore, a detailed structural analysis is mandatory. Based on the NASTRAN linear elastic finite element (FE) analyses of two preliminary designs, the current analysis is being conducted using ABAQUS/Standard to continually support the on-going design improvement (a prototype of the design is shown in Figure 19). The latest analysis includes elastic-plastic material properties and comprehensive part interactions (see Table 3) to present precisely the load paths and achieve sufficiently accurate stress solutions at all critical locations. A finite element mesh of the pallet support structure assembly is shown in Figure 20. In addition, the fastener related strengths were examined, which are the crucial considerations for the design configuration. Based on the analysis results, a refined design is being carried out.

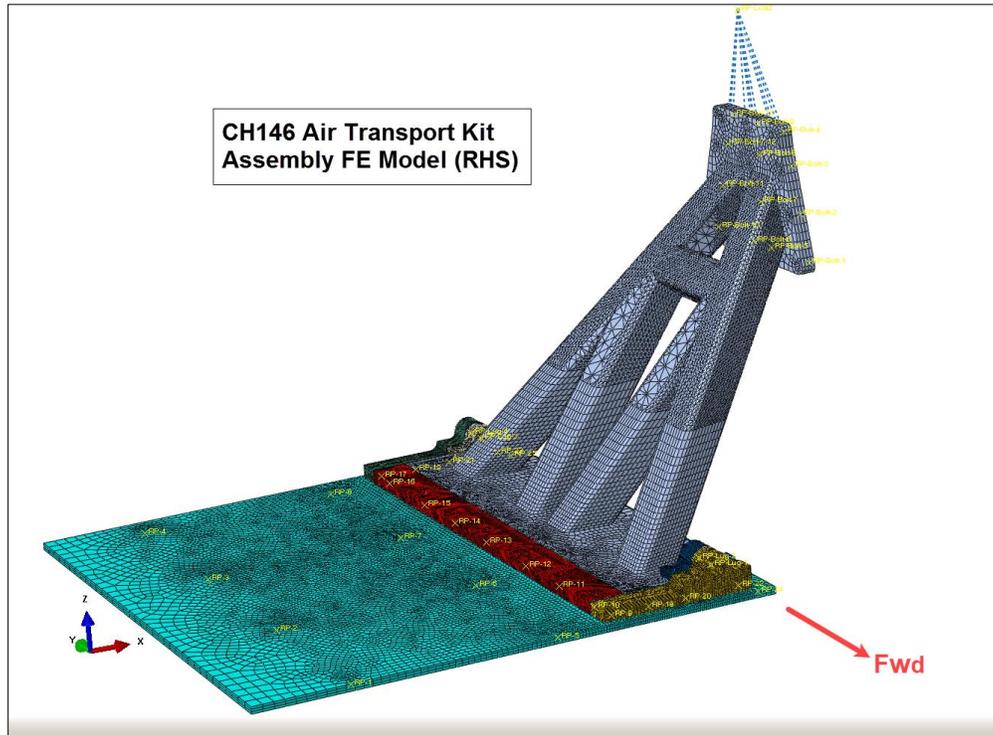
**Figure 20 A finite element mesh of the pallet support structure assembly, right hand side (RHS)**

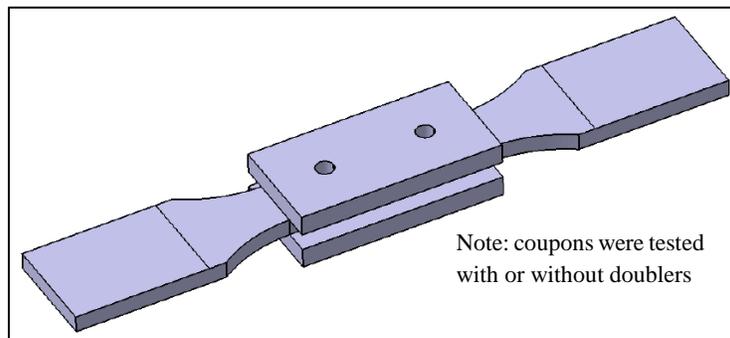
**Figure 22 Geometry of fastener test coupons (with doublers).**

Twelve mandatory and two conditional series of seven coupons were defined to cover baseline cases (open holes) and fastener configurations with and without load transfer. Moreover, each coupon allowed life determination from two identical holes. The geometry of the fastener test coupons is illustrated in Figure 22.

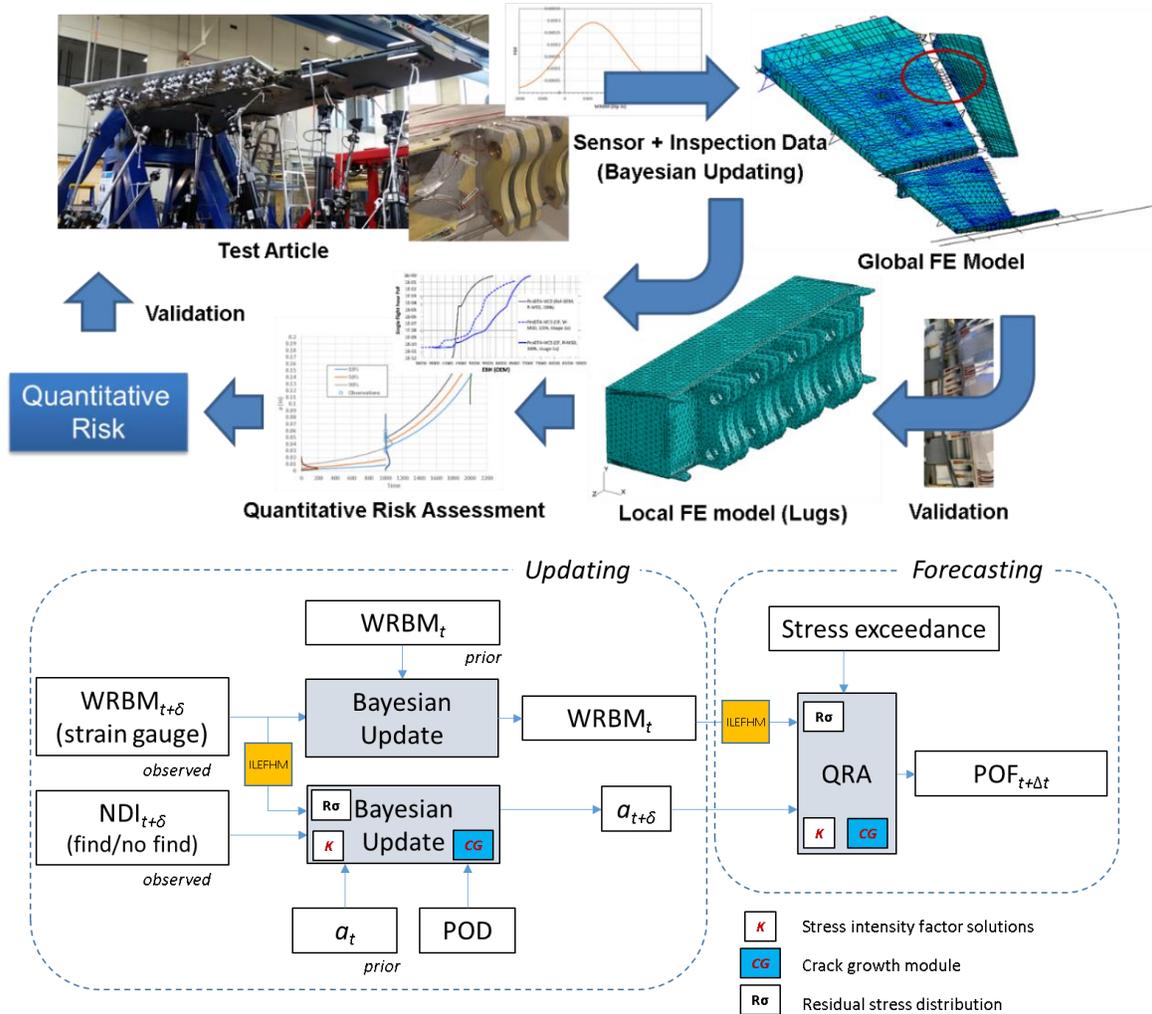
Figure 26 ADT framework demonstration using the CF-188 ILEF component test

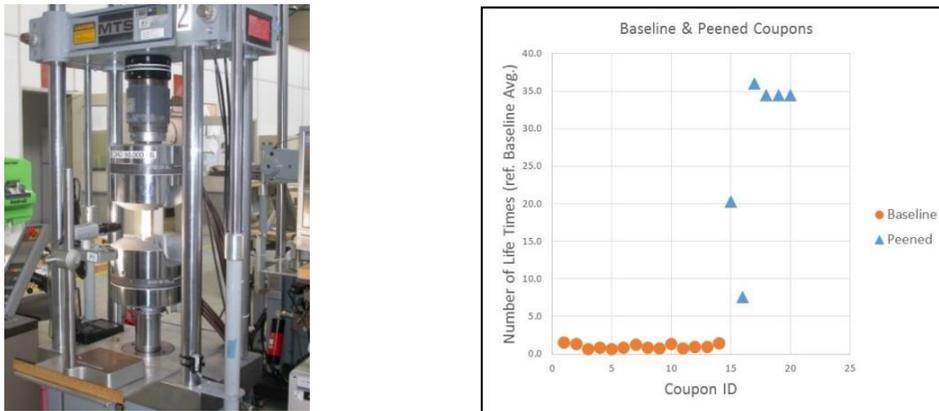
Figure 27 Recent test program at NRC on shot peening

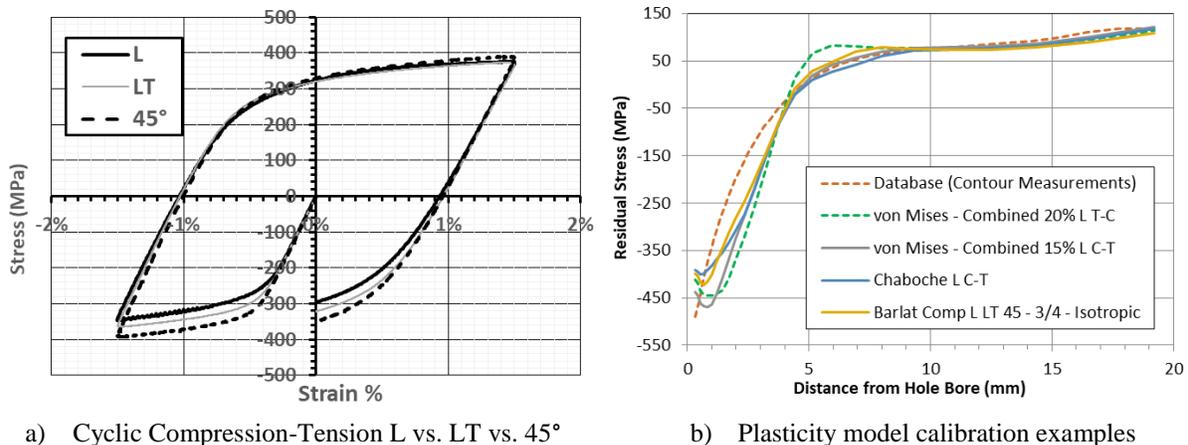
Figure 28 Hole cold expansion process modelling from material characterization

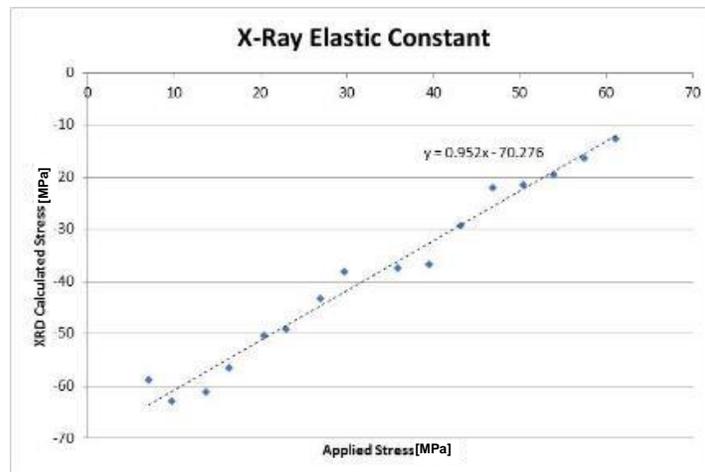
Figure 29 X-ray elastic constant determination

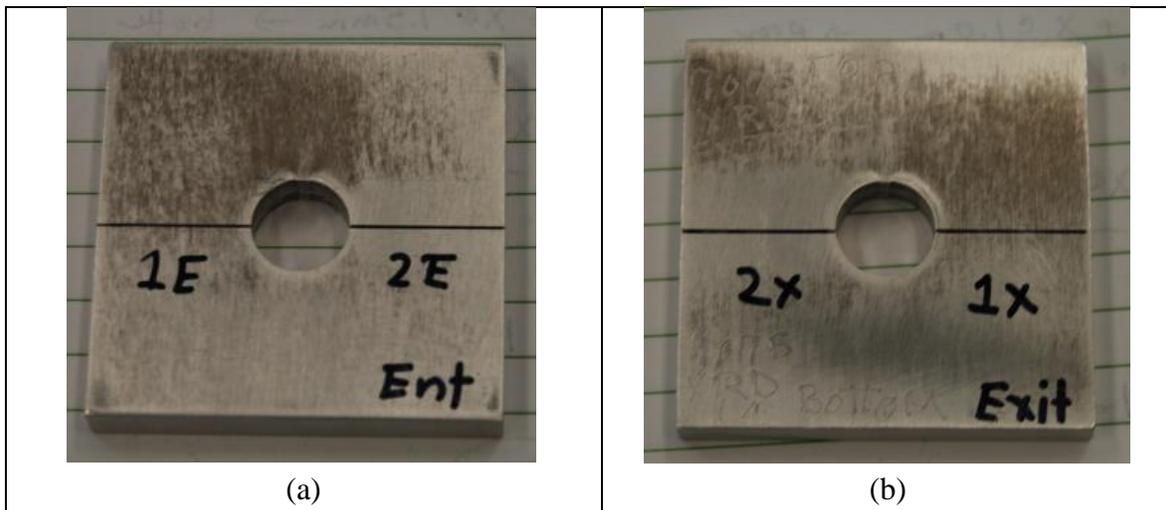
**Figure 30 (a) Coupon H1 Entry face (b) Coupon L1 Exit face**

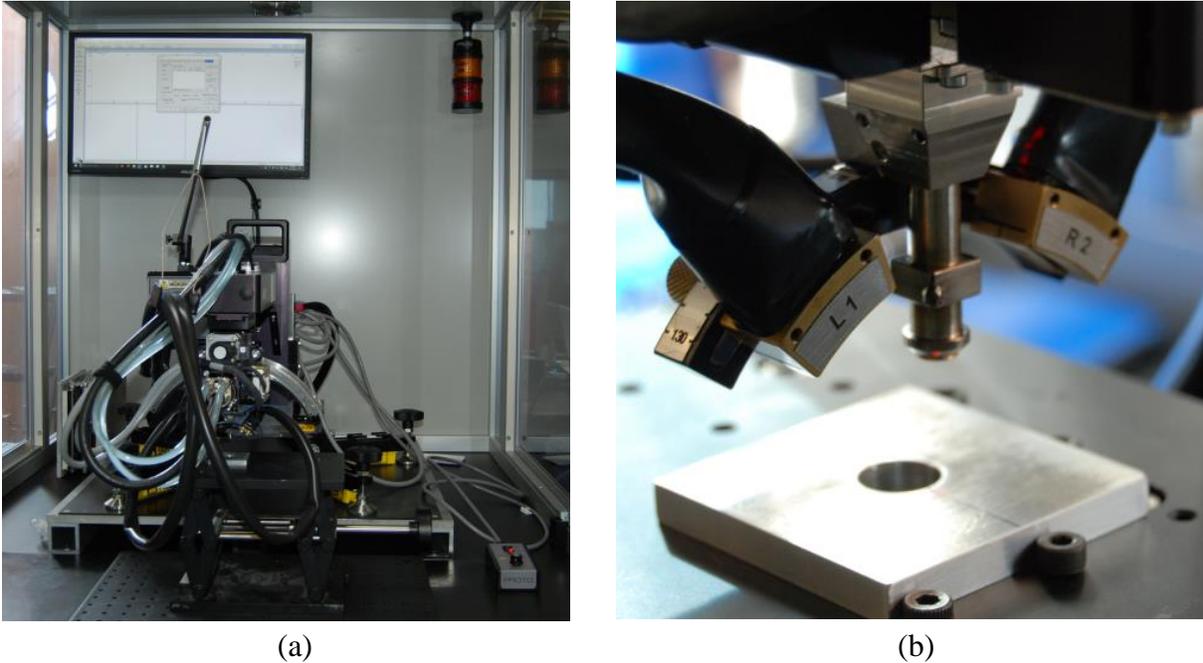
**Figure 31 (a) Overall view of XRD machine (b) Detail view of XRD aperture, left and right detector and coupon**

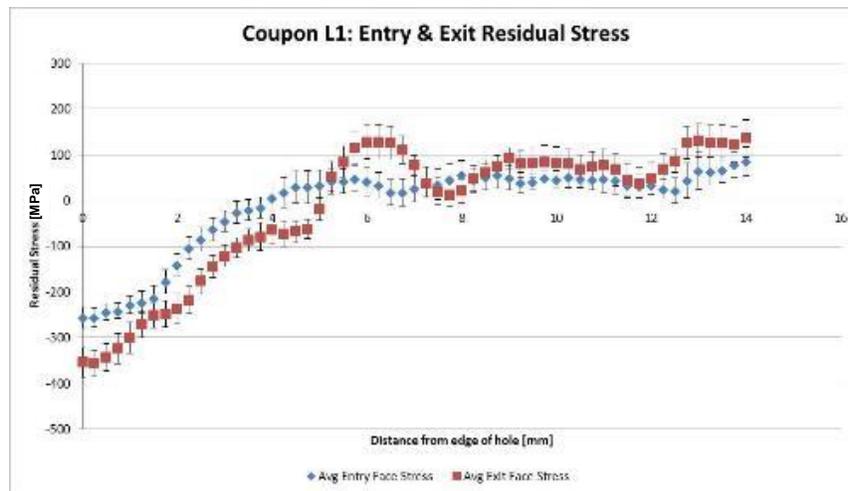
**Figure 32 Entry and exit face residual stress results for coupon L1**

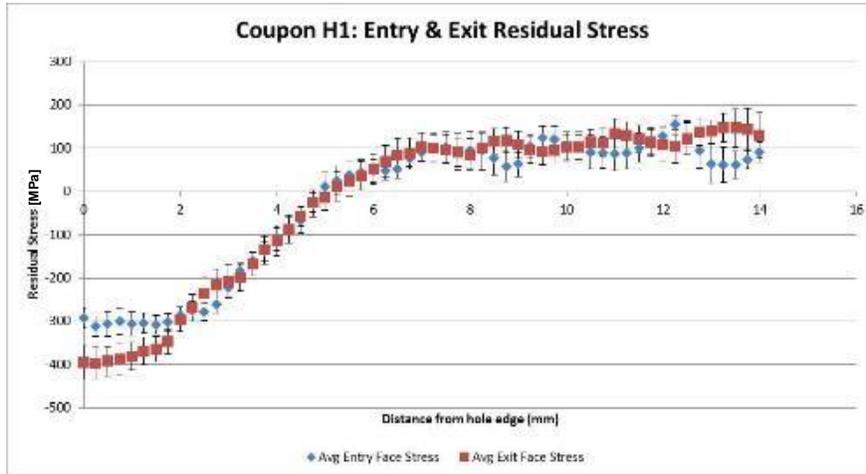
**Figure 33 Entry and exit face residual stress results for coupon H1**

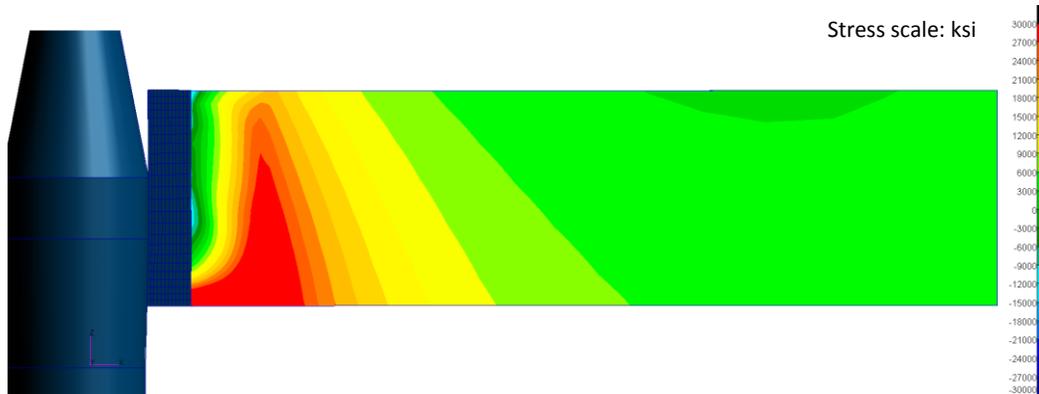
**Figure 34 Calculation of the residual stresses resulting from the finite element simulation of the installation of a ForceMate bushing**
