# **Review of Aeronautical Fatigue and Structural Integrity Work in Canada (2017 - 2019)**

**Report No.:** LTR-SMM-2019-0063

**Date:** April 2019

NATIONAL RESEARCH COUNCIL CANADA (NRC)

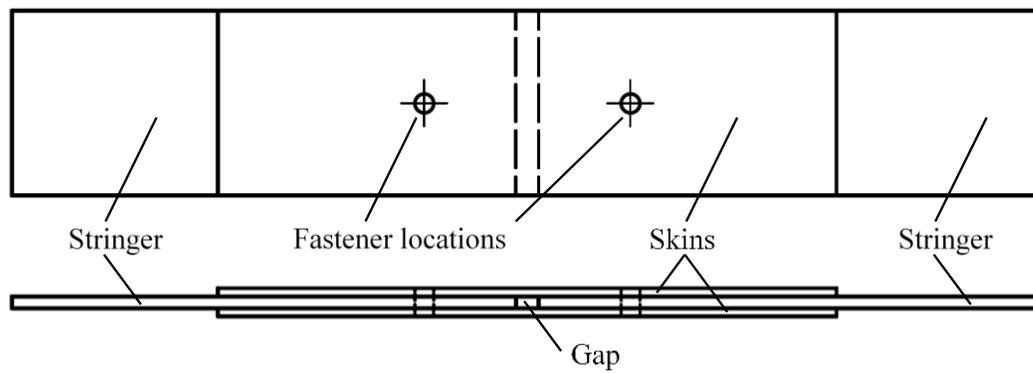
**Figure 35 Double lap shear specimen design**

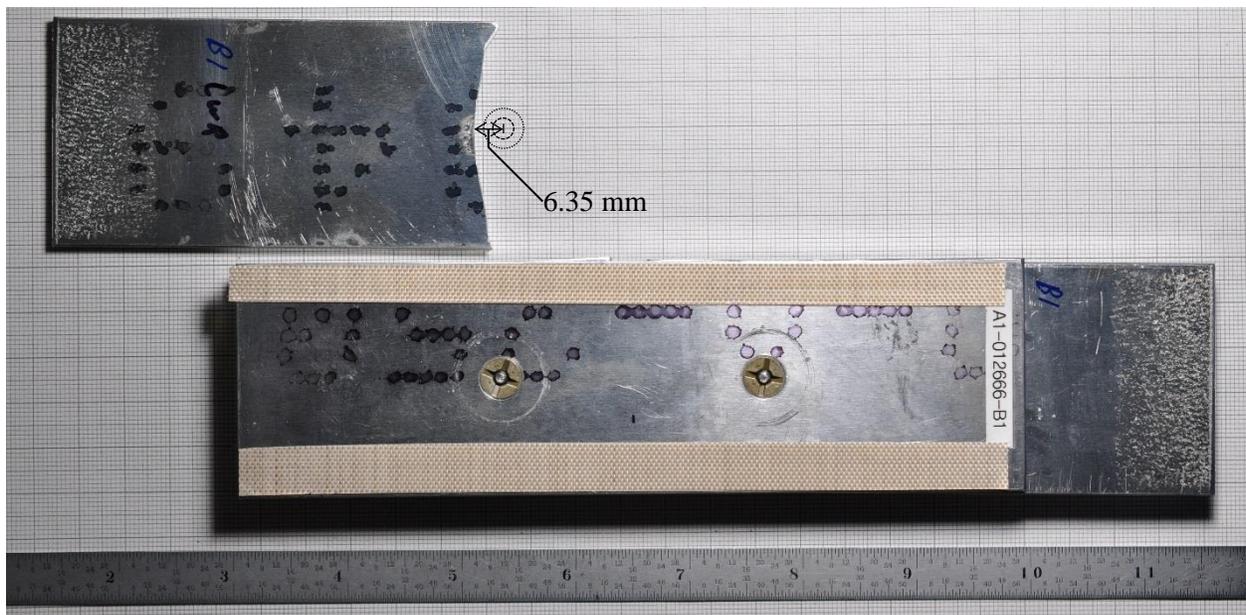
**Figure 36 Typical failure at a NAS1670 blind bolt**

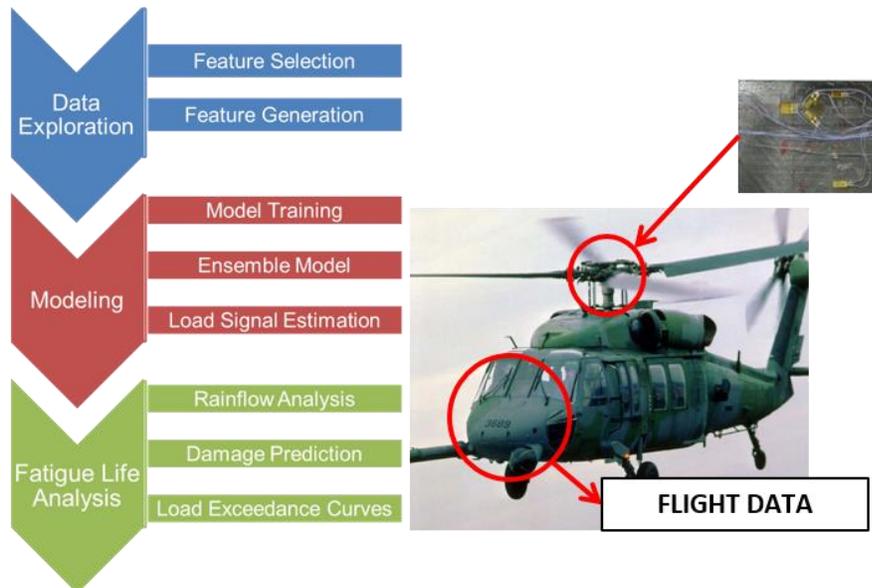
**Figure 37 Illustration of load estimation approach**

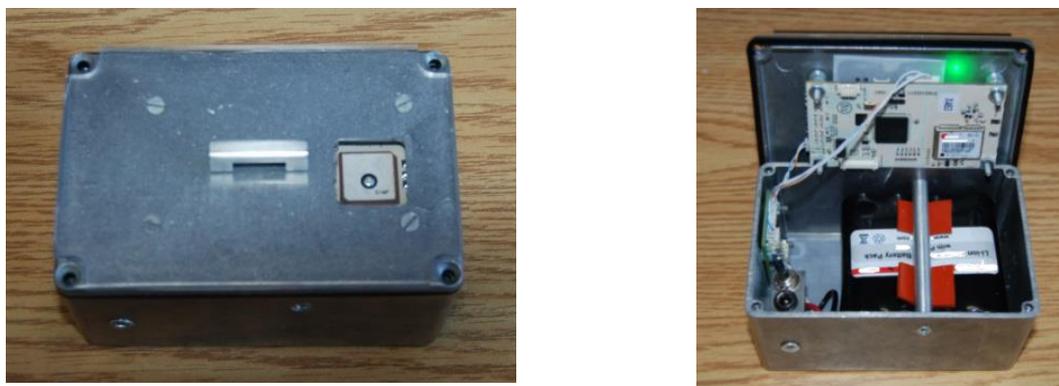
**Figure 38 MEMS-IMU system for helicopter usage monitoring**

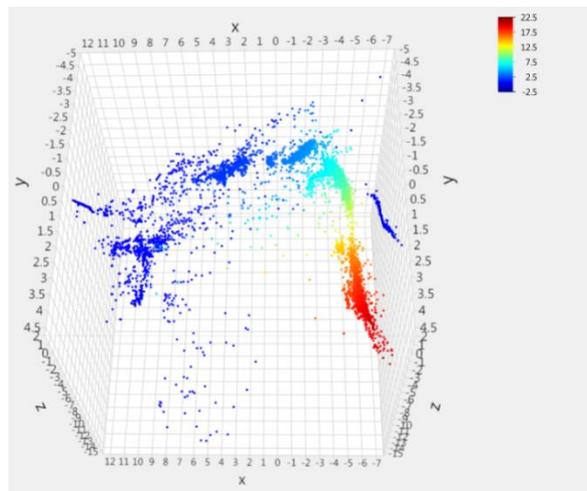
**Figure 39 Turbo A speed sensor value [kRPM] overlay onto Isomap transformation**

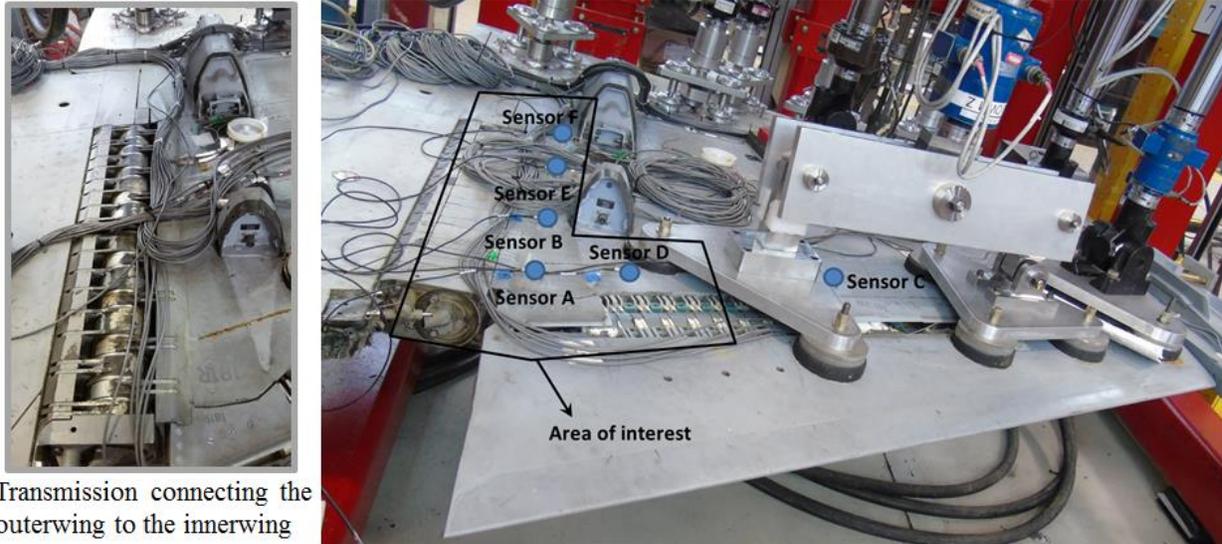
Transmission connecting the outerwing to the innerwing

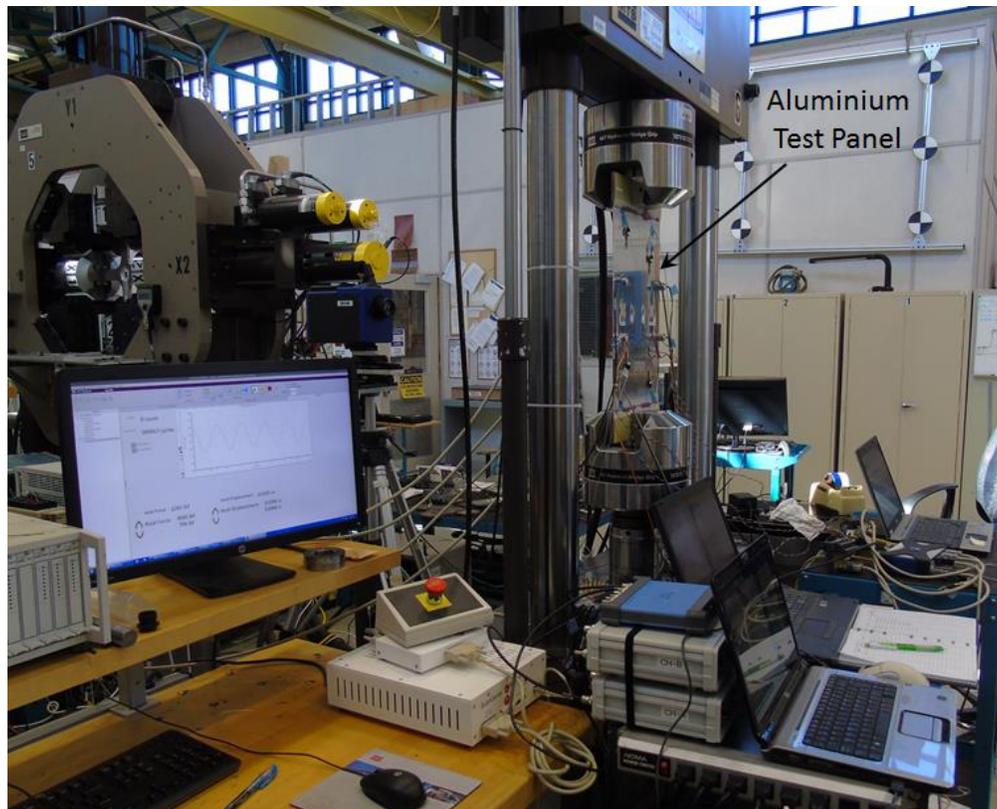
**Figure 41** Experimental setup for a repeatability study of SHM sensors

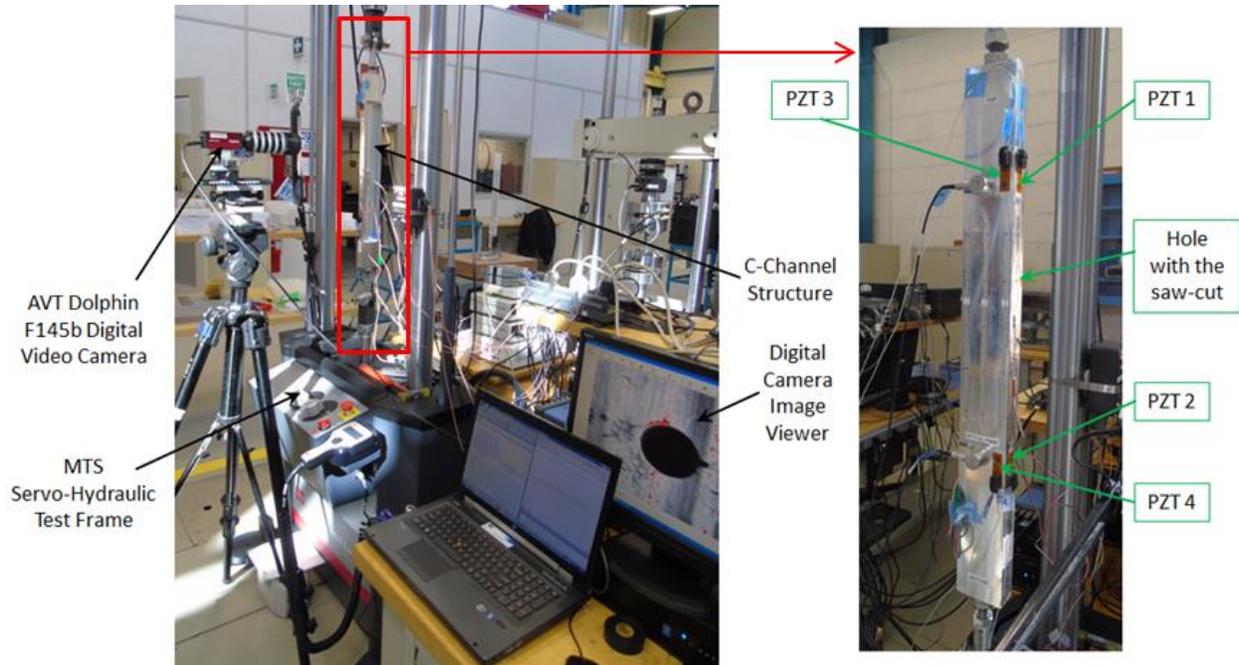
**Figure 42** Experimental setup to grow fatigue crack in C-Channel structure

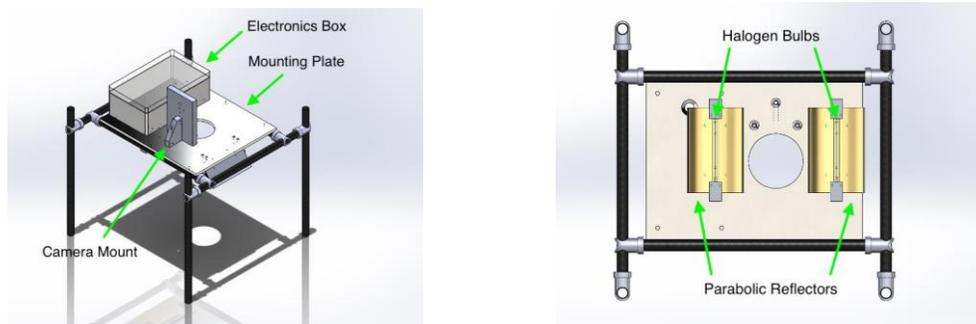
**Figure 43 Infrared thermography apparatus for heating the sample and recording a sequence of images of the surface temperature**

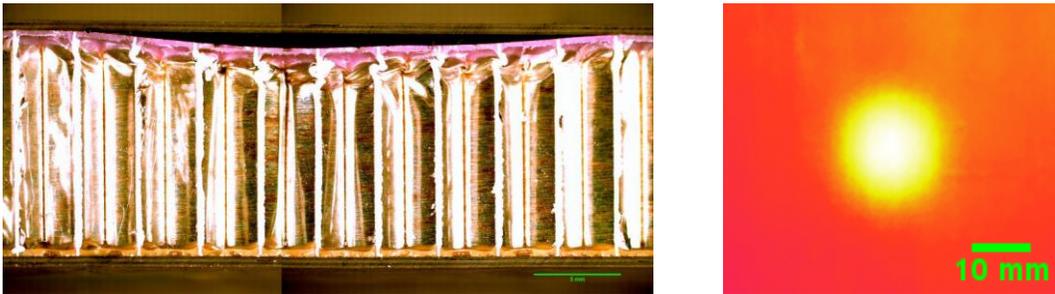
**Figure 44 a) Cross-section of an impact location with an adhesive disbond, b) thermographic image of the surface of the impact region**

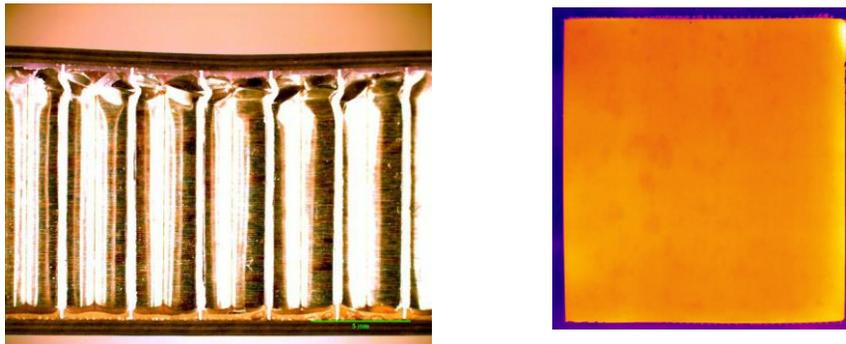
**Figure 45 a) Cross-section of an impact location with an intact adhesive bond, b) thermographic image of the surface of the impact region**

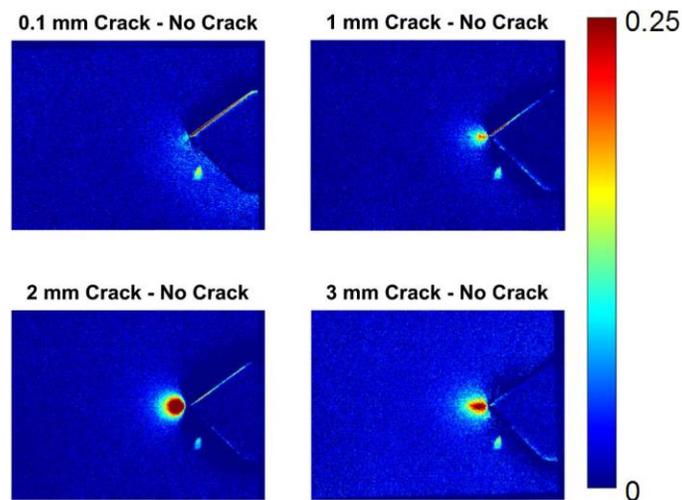
**Figure 46 Temperature difference from the reference sample with the 50A current at time 100 ms heating time**

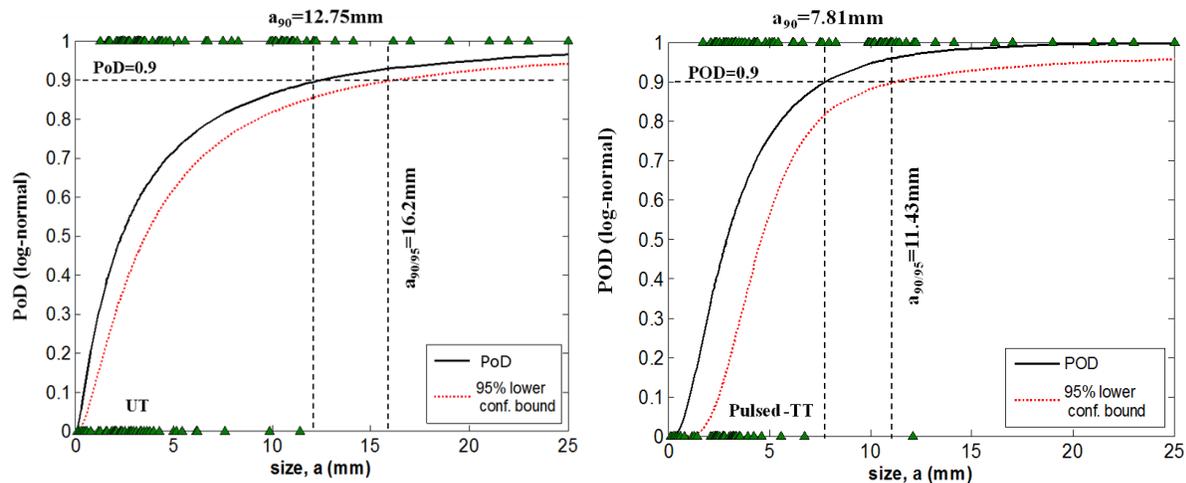
**Figure 47 Log-normal PoD curve and the corresponding 95% lower confidence bound for UT (left) and pulsed thermography (right) [17]**

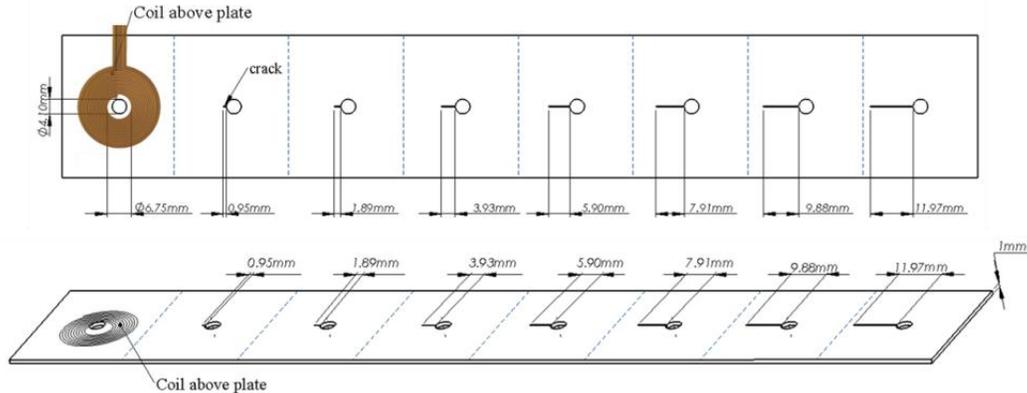
**Figure 48 Spiral coil centred around a fastener hole, on the back side of a mock-up specimen**

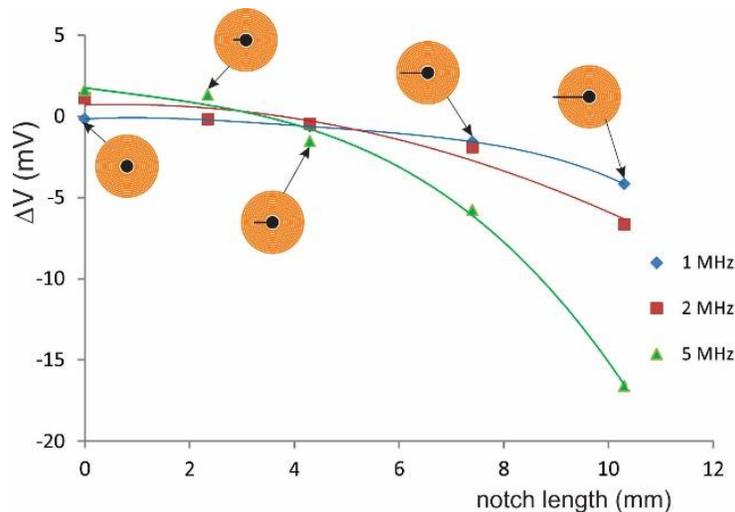
**Figure 49 High frequency application: voltage variation with respect to the notch length when the coil is used in absolute mode**

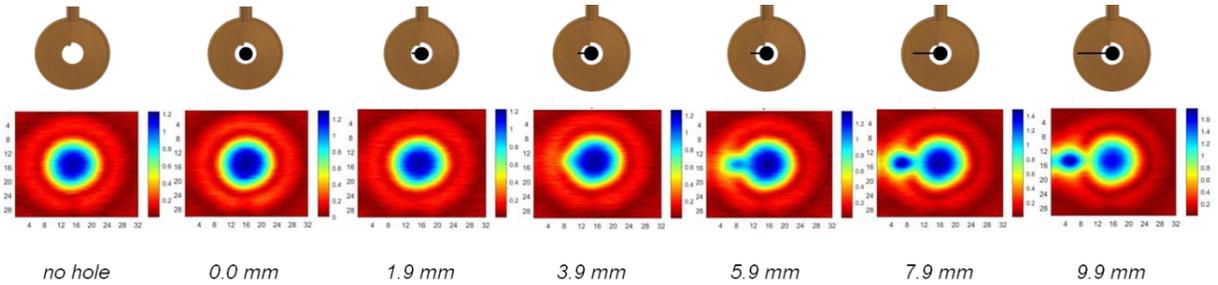
**Figure 50 Low frequency application: area scan with a Hall sensor, when the coil is used as a driver in a transmit/receive mode**

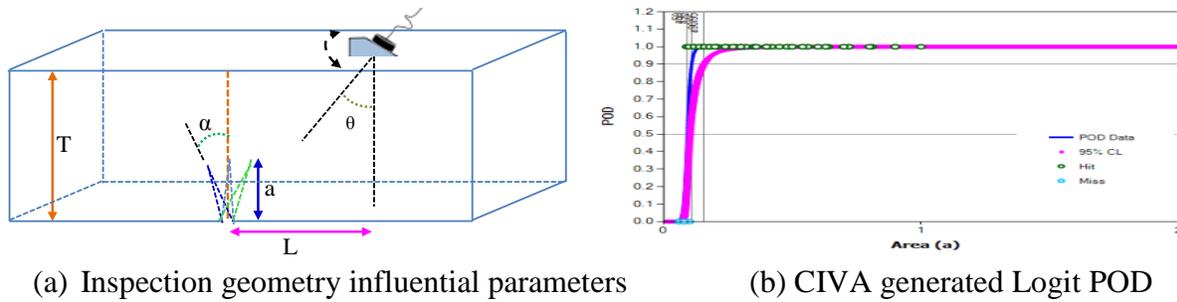
**Figure 51 Inspection geometry and simulation**

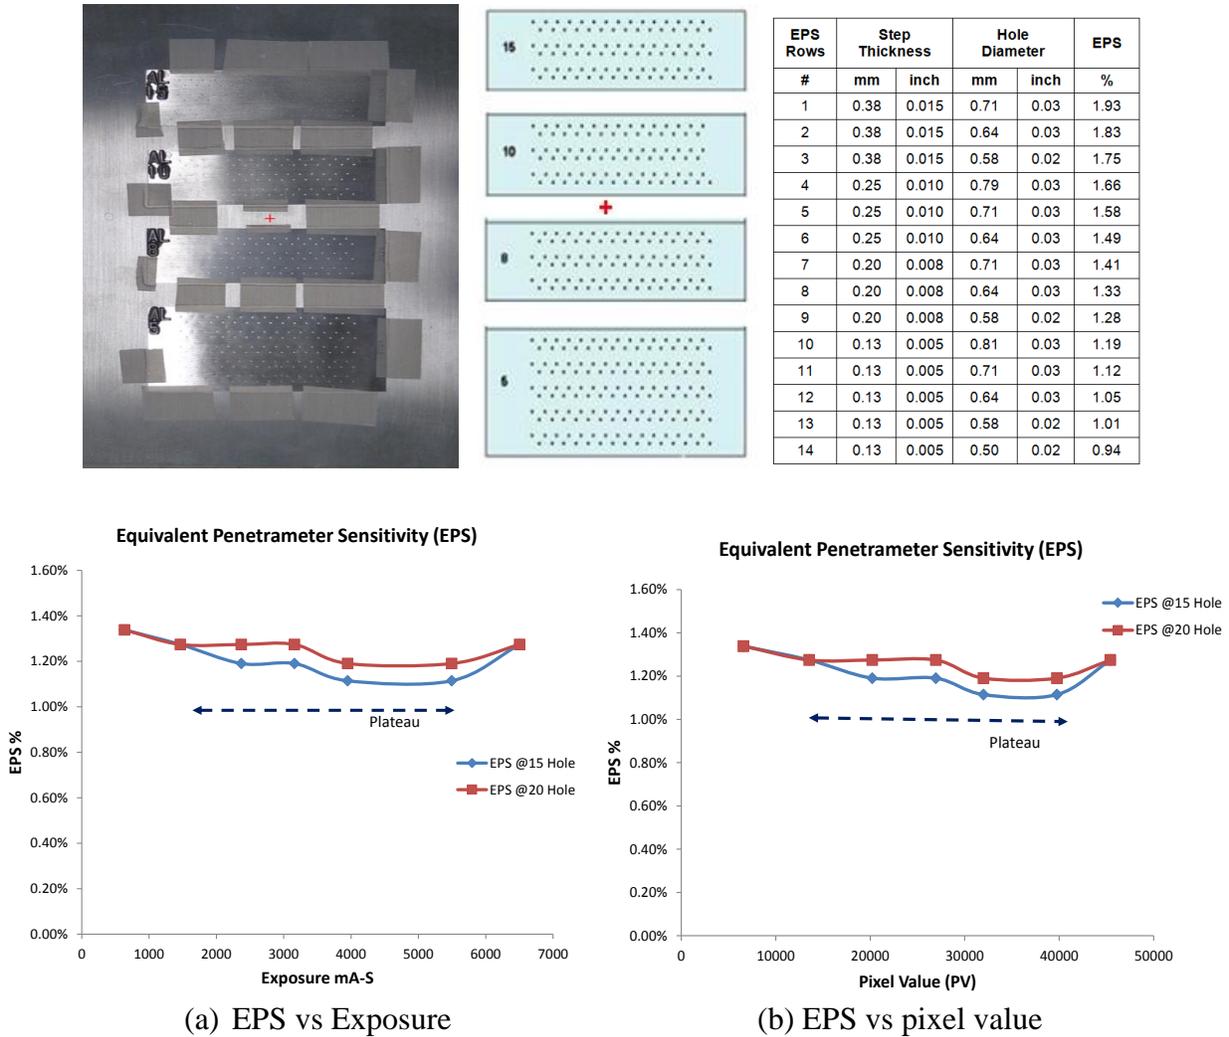
Figure 52 EPS and aluminium (Al) absorber plate setup and EPS curve

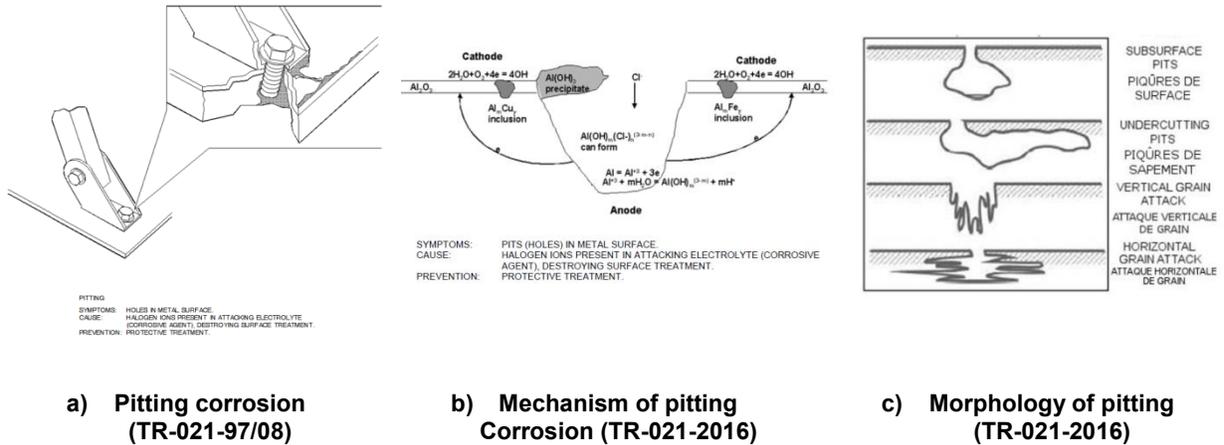
Figure 53 Pitting corrosion sketch and updates in DND C-12-010-040-TR-021

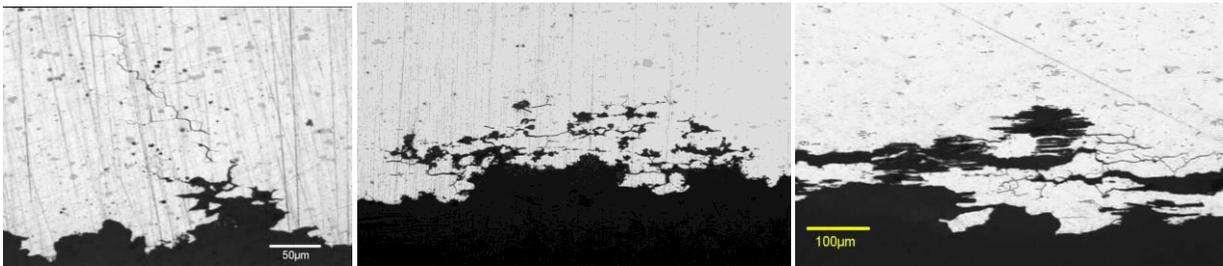
Figure 54 Optical micrographs showing additional damage at base of pits found on the faying surface of a 2024-T3 fuselage lap joint

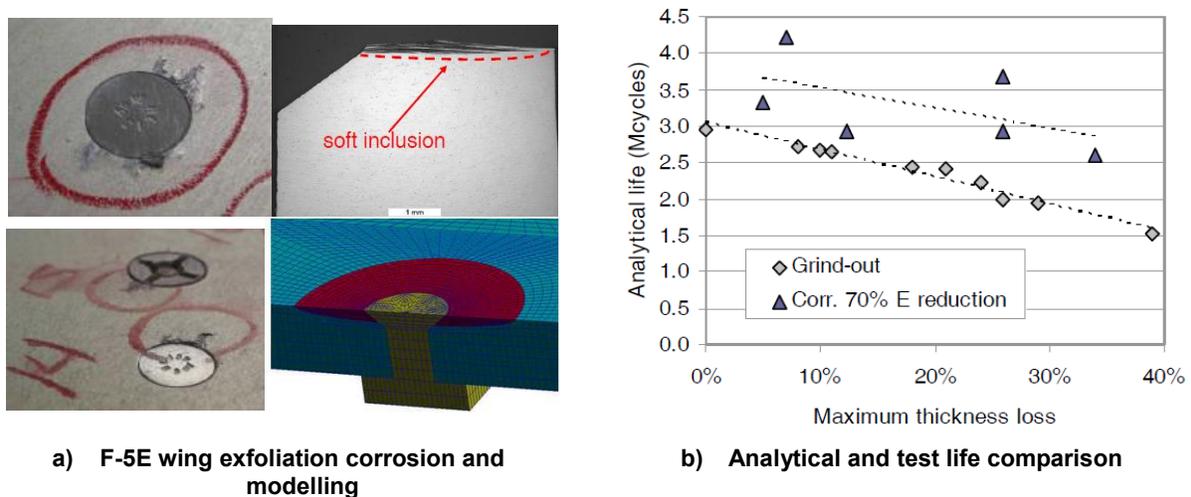
Figure 55 Modelling of exfoliation corrosion effect on F-5E upper wing (7075) structural integrity

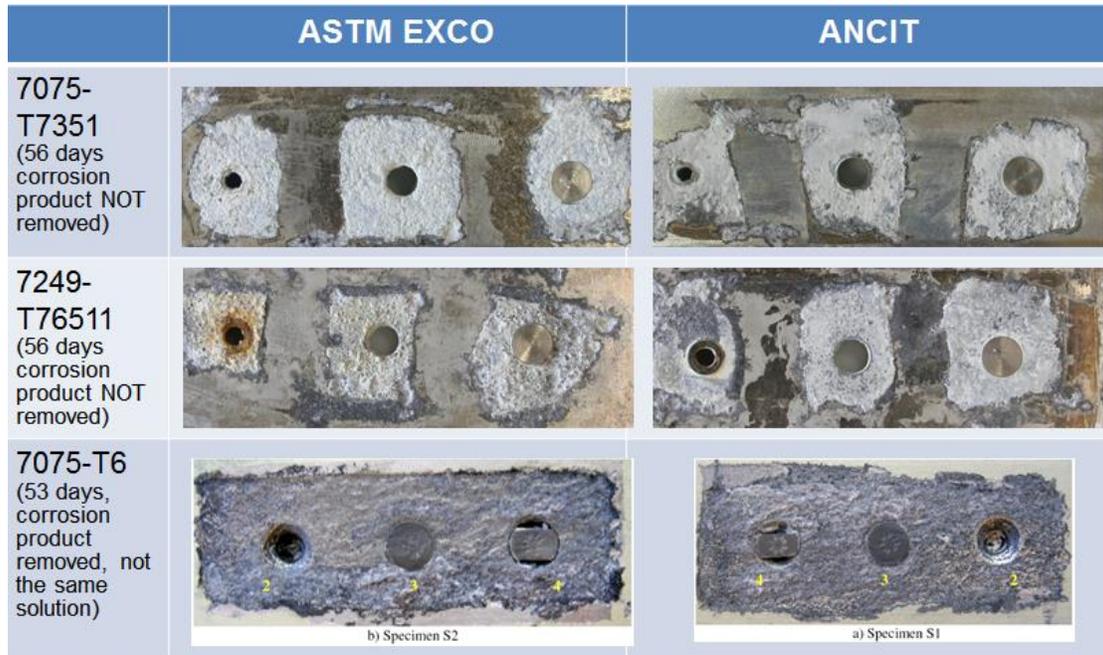
**Figure 56 Accelerated corrosion tests for aluminum alloys, 7075-T7351, 7249-T76511, and 7075-T6**

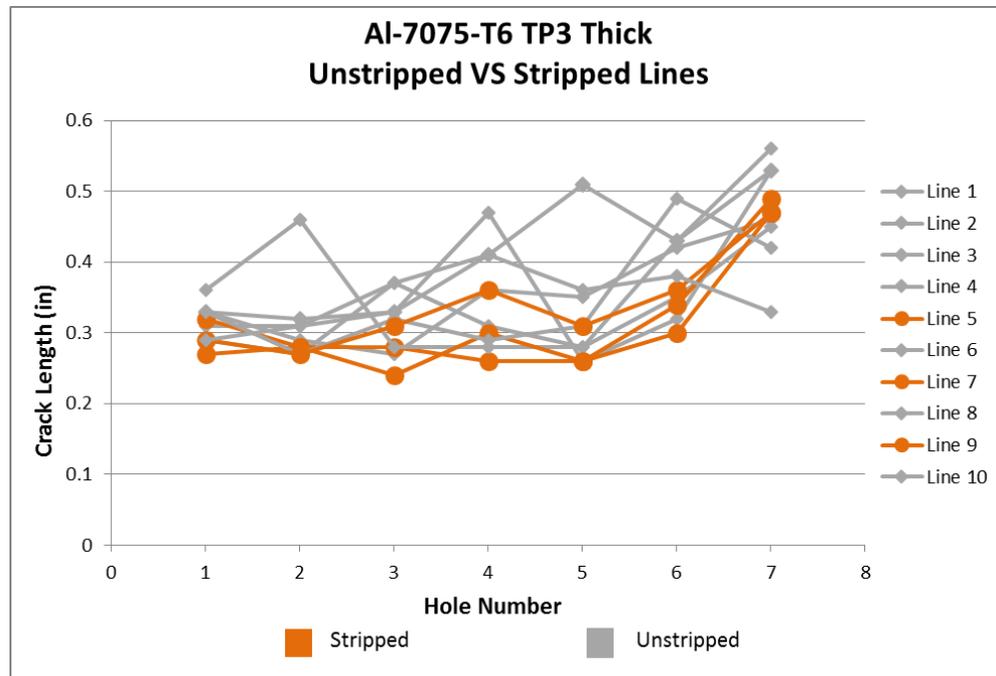
**Figure 57 Al-7075-T6 TP3 full crack length results and comparison between all lines on the test panel**

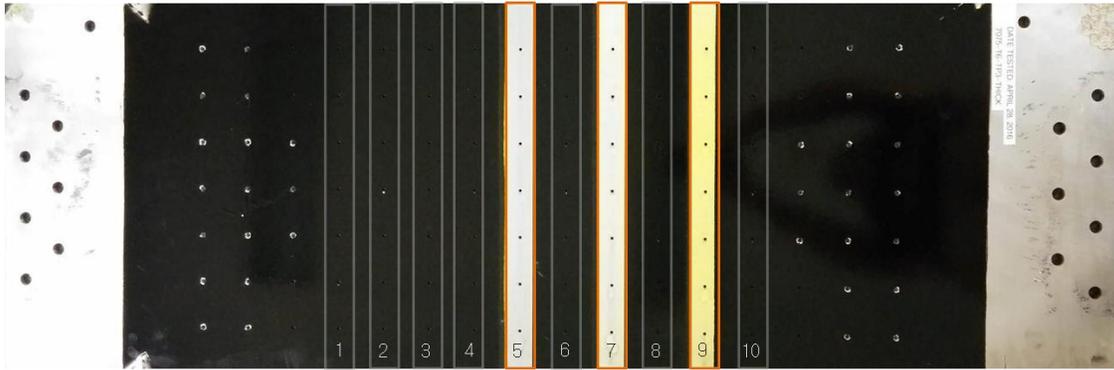
**Figure 58 Panel layout showing stripped and non-stripped lines in Figure 57.**

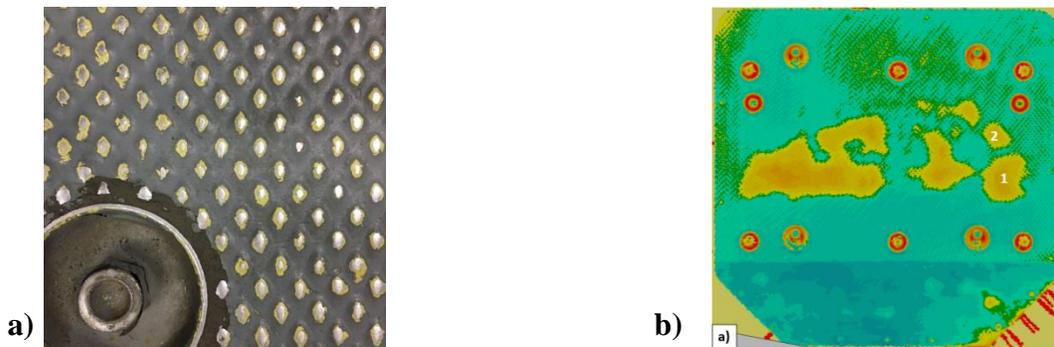
**Figure 59 a) Close-up of the textured tread pattern on the floor panel, b) preliminary deviation analysis of the entire floor panel with the dented regions shown in yellow**

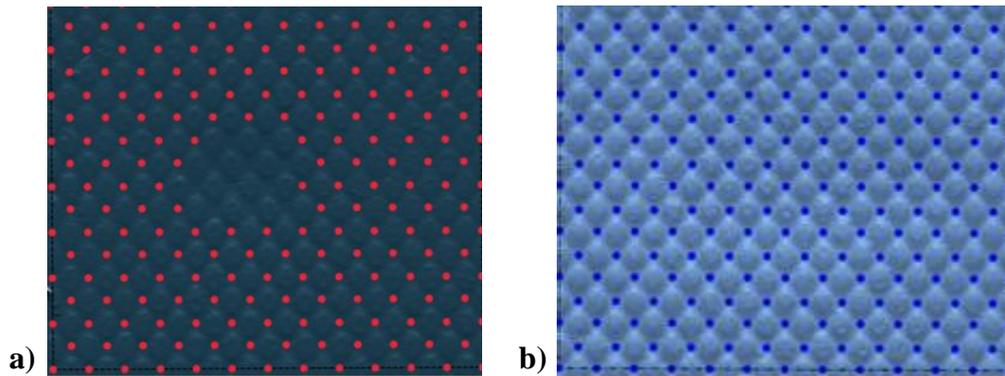
**Figure 60 a) Control regions defined for the undamaged surface fit surrounding an individual dent, b) control regions defined for the damaged surface fit surrounding an individual dent**

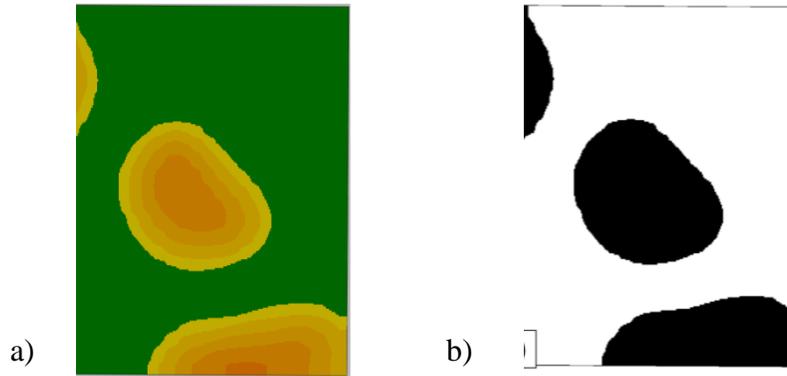
**Figure 61 a) Deviation analysis results showing the deepest part of the dent in orange, b) black and white image used for extracting the dent area and diameter**

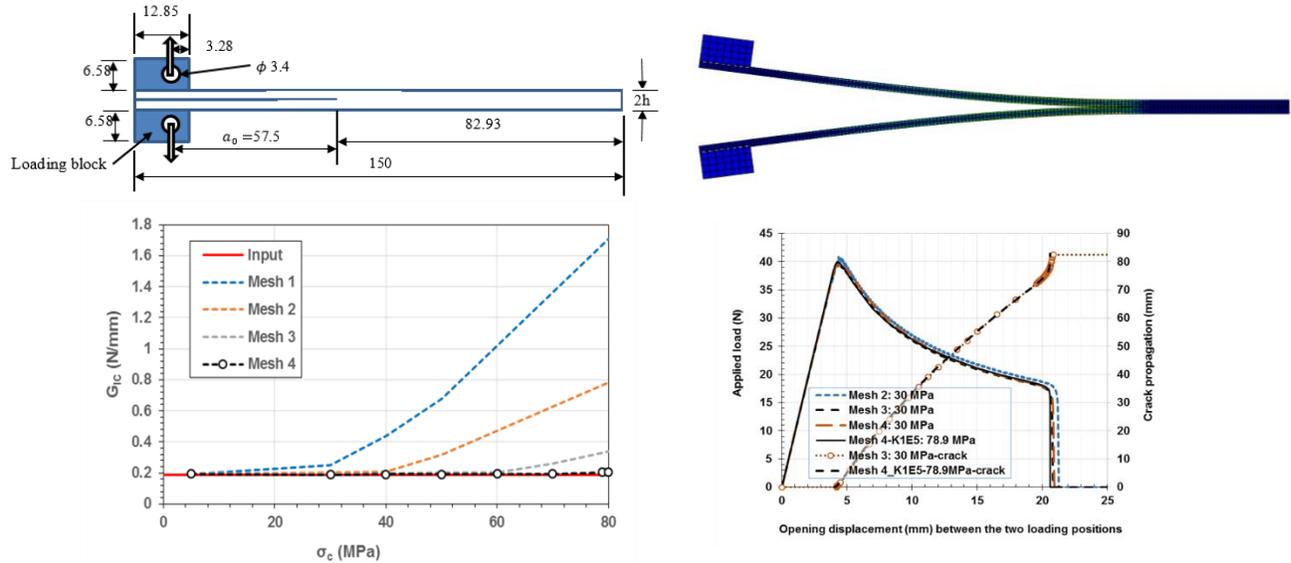
**Figure 62 A quasi-static CFRP DCB test and cohesive zone modeling of progressive failure**

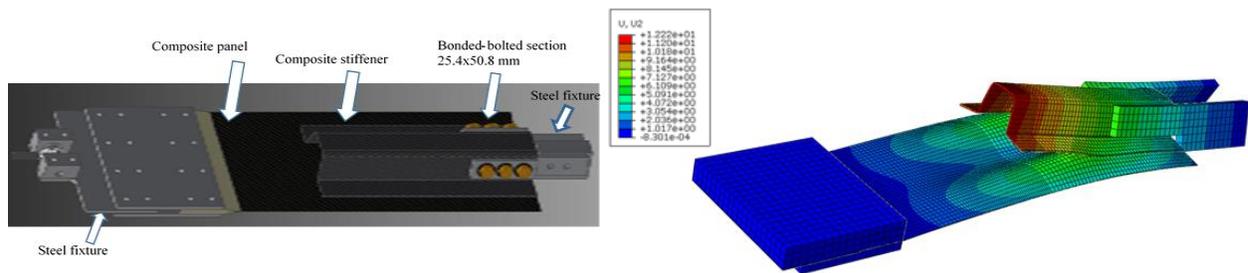
**Figure 63 Failure strength prediction of a bonded composite structure**

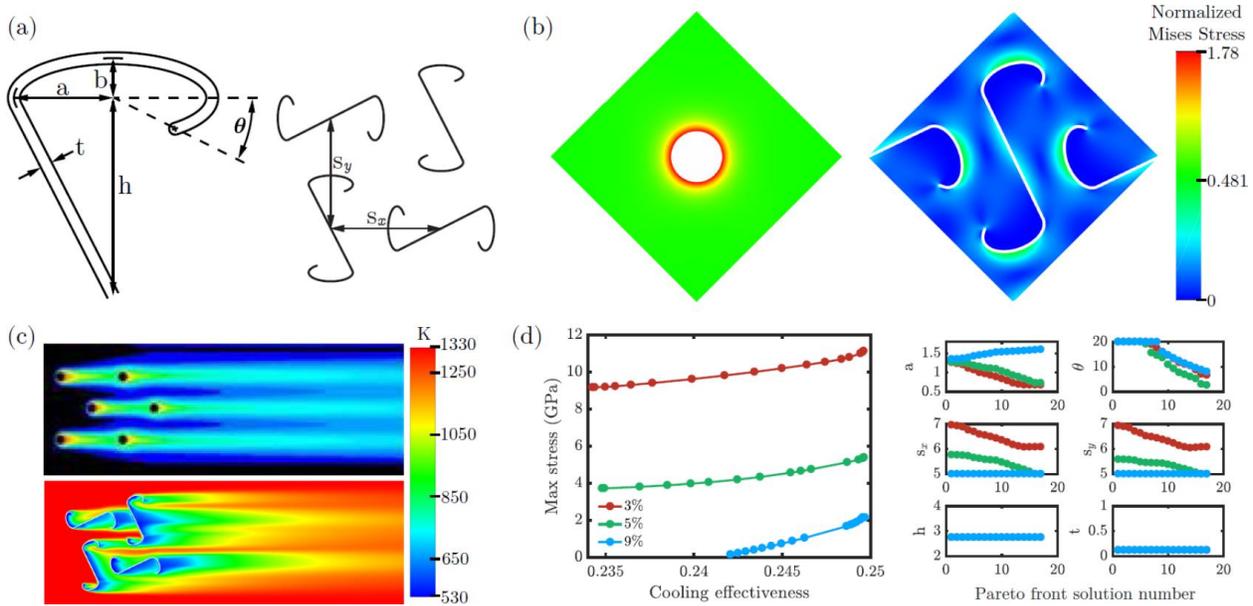
**Figure 64 (a) The six geometric parameters that define the S-slot metamaterial. During optimization, the parameter  $b$  is held constant. (b) One of the mechanical simulations from the optimization of S-slot geometry compared to the conventional design of circular holes.**

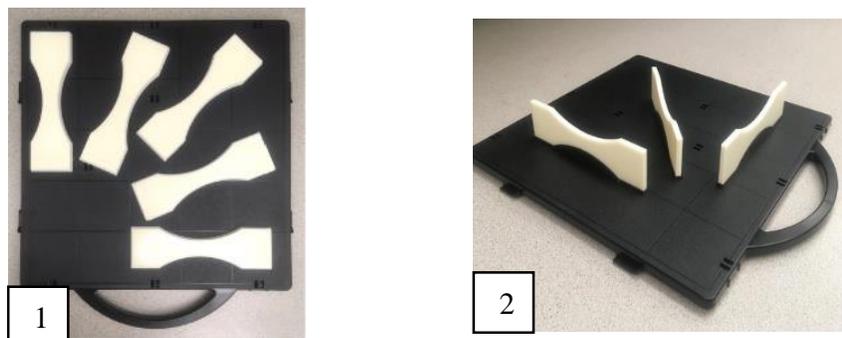
Figure 65 Fatigue coupon: 1. Flat specimen, 2. On-edge specimen

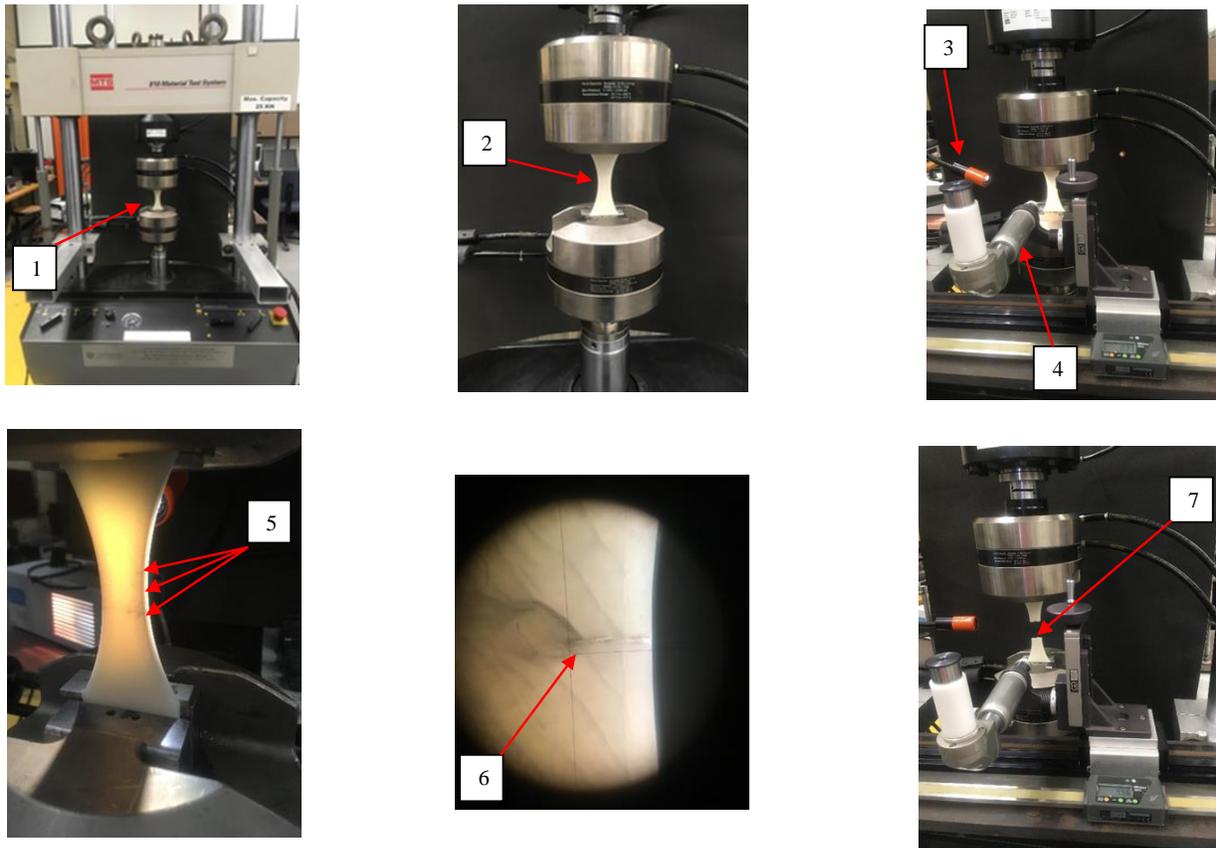
**Figure 66 Fatigue Testing: 1. Specimen mounted at 25 kN MTS load frame, 2. Close-up of specimen in fatigue testing, 3. Light source 4. Travelling microscope, 5. Multiple crack sites, 6. Single crack length measurements, 7. Specimen at failure.**

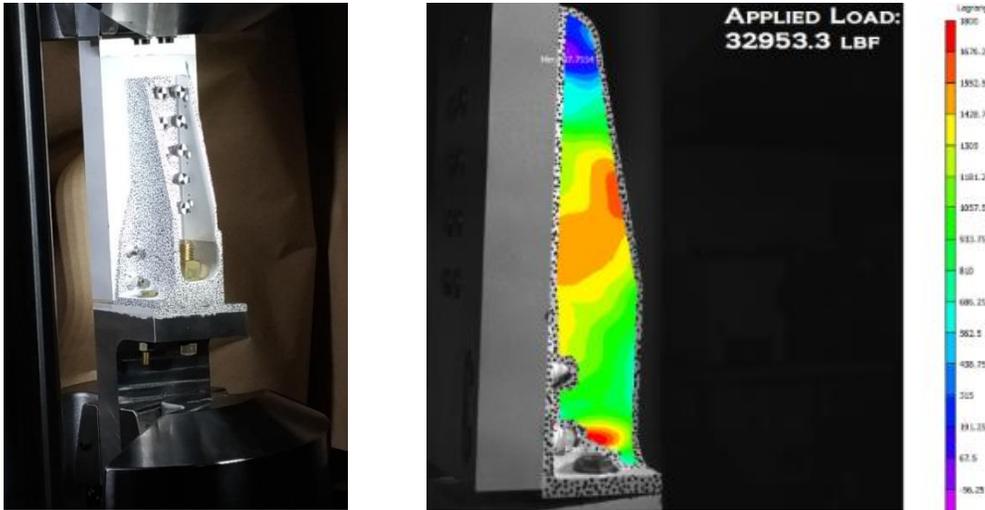
**Figure 67** Static test of an additively manufactured aircraft structural corner fitting, using digital image correlation technique
