## **REVIEW OF CANADIAN AERONAUTICAL FATIGUE WORK 1999-2001**

**Jerzy P. Komorowski  
INSTITUTE FOR AEROSPACE RESEARCH  
NATIONAL RESEARCH COUNCIL OF CANADA**

This paper provides a review of Canadian work associated with fatigue of aeronautical structures during the period 1999 - 2001. All aspects of structural technology are covered including full-scale tests, loads monitoring, fracture mechanics, composite materials and engine fatigue.

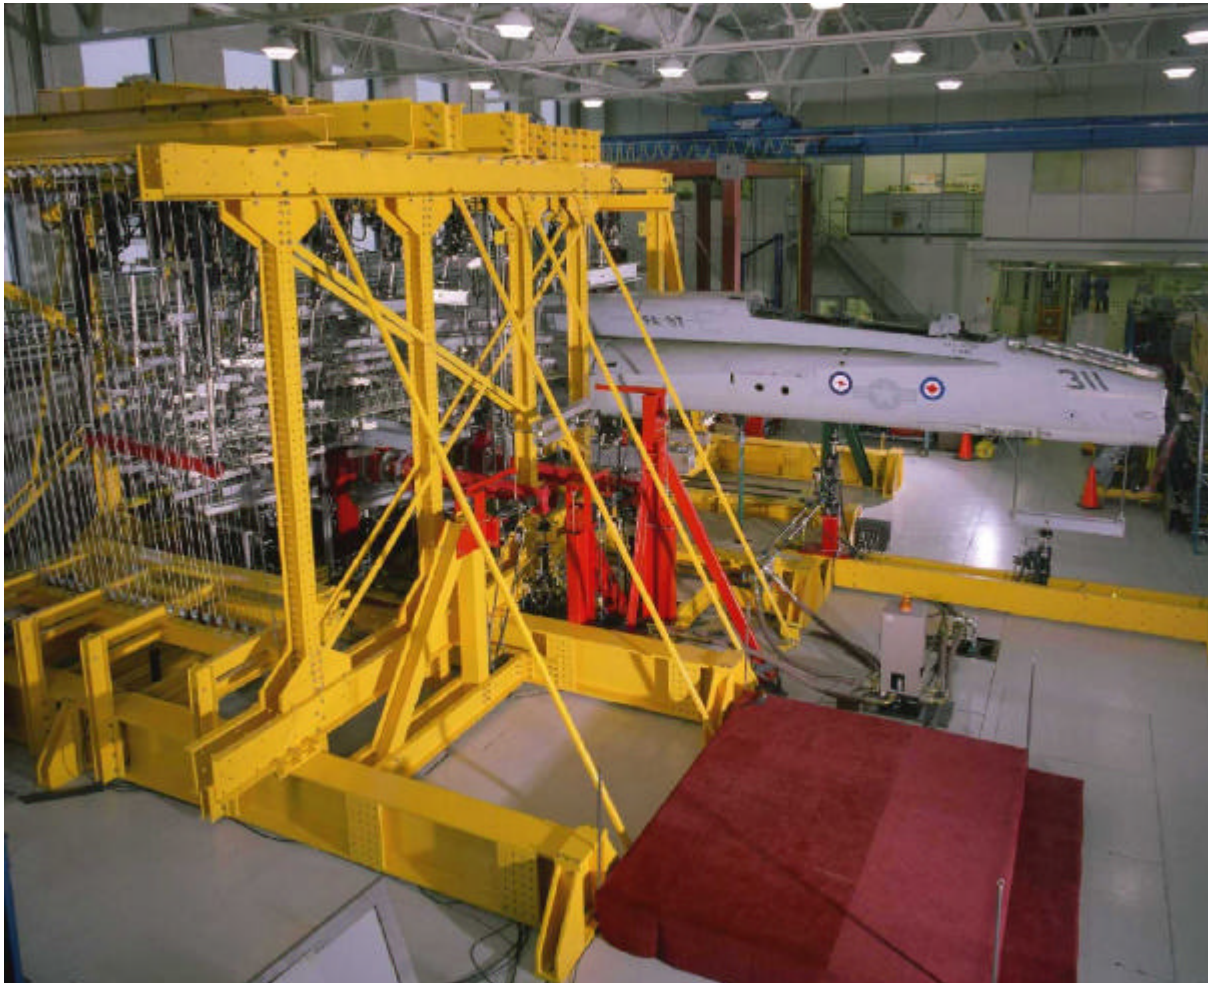
**Figure 1. Overall View of FT-245 Wing Fatigue Test.**

As of May 31, 2001, the test has accumulated 1467 flight hours. The test is shown in Figure 1.

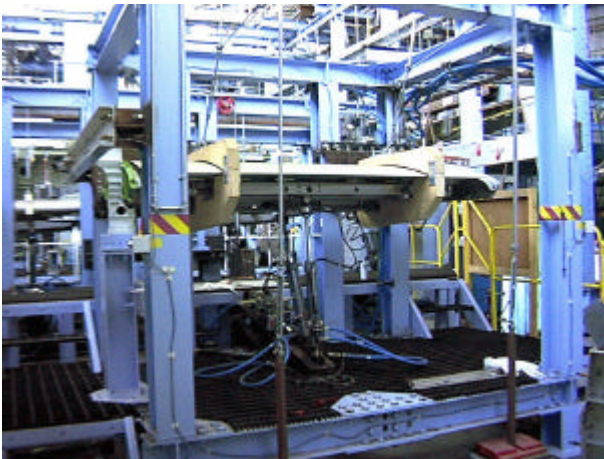
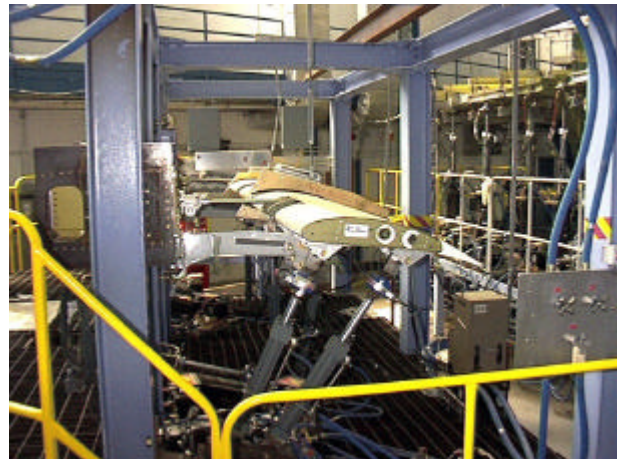
Figure 4. Dash 8-400 flap inboard (a) and outboard (b) fatigue tests.

Over the past two years, fatigue and damage tolerance work at Toronto site has largely consisted of certification analysis and fatigue tests for the recently introduced DHC-8 Series 400 aircraft. Although it is a derivative of the earlier Series 100 and 300 aircraft, certain changes in design and local increases in loads have made this a challenging task. On the other hand, it has been possible to use essentially the same analysis methods as those used on the earlier Dash 8 models. Component fatigue tests have either been completed or are being conducted on the nacelle, (Figure 2), horizontal stabilizer (Figure 3), and the inboard and outboard flaps (Figure 4). A complete aircraft fatigue test is also under way (Figure 5). Detail tests for various smaller components, for which analytical damage tolerance methods are considered to be inadequate, are under way or have been completed. A component fatigue test of the horizontal stabilizer of the Series 700 Canadair Regional Jet is being conducted at the Toronto site in support the Montreal site's certification program for that aircraft (Figure 6).

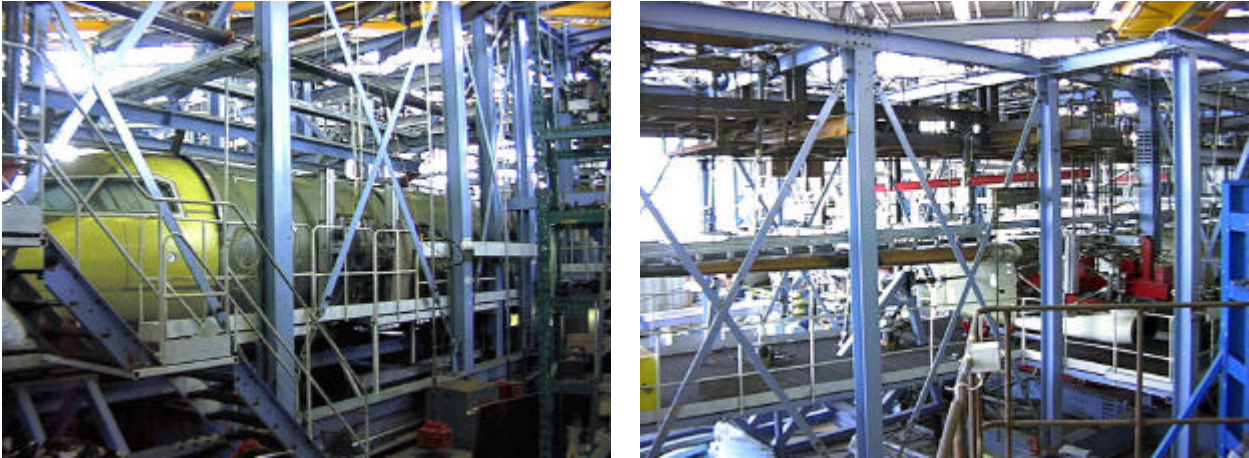
**Figure 5. Dash 8-400 full-scale fatigue test.**

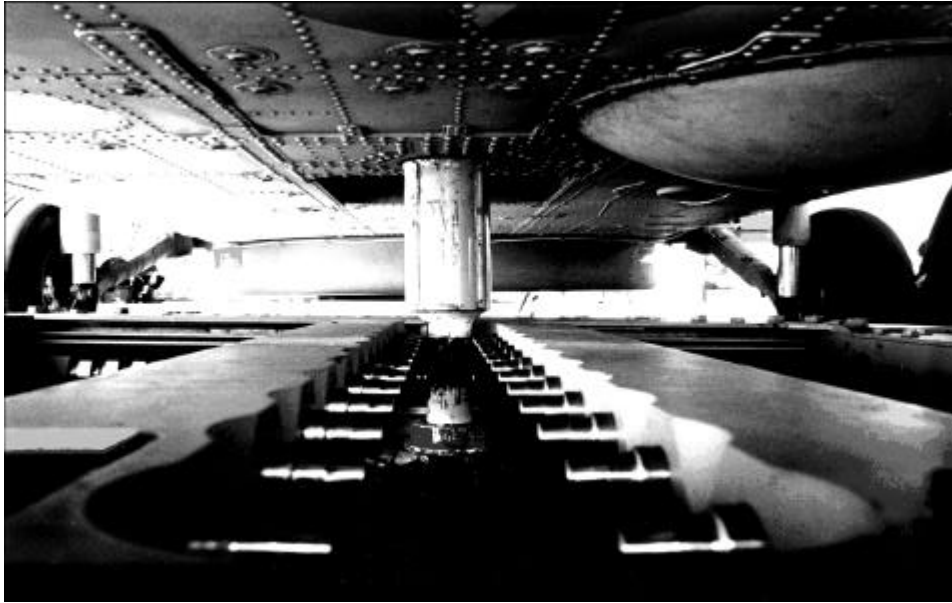
**Figure 11: ITI RAST RSD and a typical probe.**

The analysis was conducted in three distinct parts. The first involved computer-simulation-based dynamic interface analysis of typical probe securing forces for the SH-2G(A) embarked on the ANZAC Frigate. This was performed

using ITI's proprietary *Dynaface* simulation software. The results quantified the load spectrum expected to be applied to the in-service probe. The second portion of the analysis used a block loading approach to conduct a full-scale fatigue test to failure of the complete probe system. The test results indicated that the mode of the failure was fatigue of the aluminium upper flange. The loads to failure data were used to calibrate a generalised component S-N curve for the probe system. In the third and final portion of the analysis, the in-service load spectrum, which resulted from the dynamic interface analysis, was combined with the safe-life curve, which resulted from the fatigue test to perform Palmgren-Minor cumulative damage analysis on the probe. The results revealed that fatigue damage on the probe during its life is minimal and that fatigue failure of the probe system, based on the data available at the time of analysis, will not occur during the 30 years design life of the probe. The report contains all necessary data such that the probe estimated fatigue life could be updated should the aircraft's in-service operating profile change. [14].

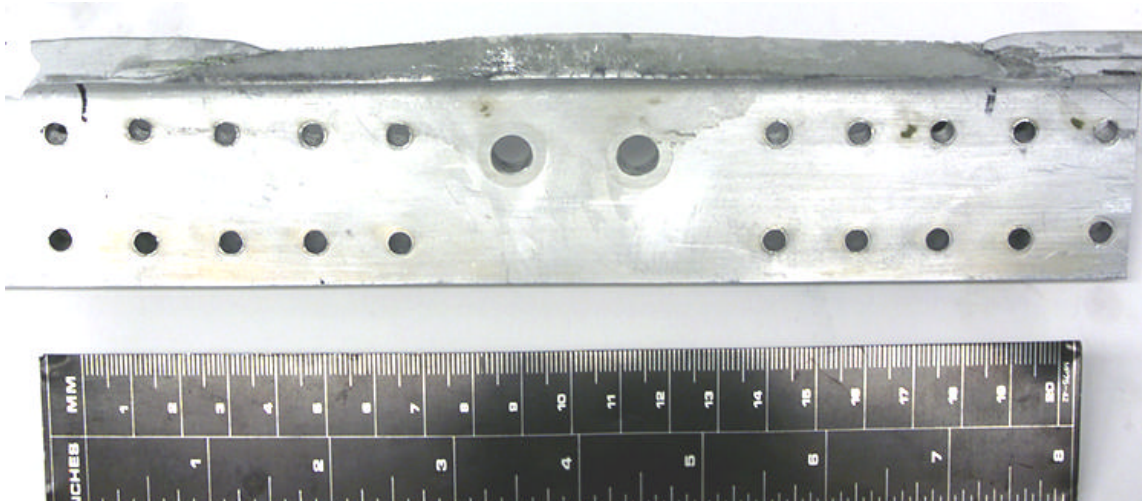
**Figure 18. Overall view of the surface of the 7.5 in. long crack at F.S. 497 on the horizontal member of the CC130307 drag angle. With the part as shown, the aft end of the drag angle is towards the left.**

The 7.5 in. long crack at F.S. 497 was clearly visible. Eddy current inspection of the radius along the length of the drag angle confirmed the presence of cracking at F.S. 537 over a length of 1.0 in. Eddy current inspection also indicated the presence of a 0.7 in. long crack and two smaller ones on a slightly different plane at F.S. 577.

The 7.5 in. long crack was opened up (Figure 18). Its surfaces were covered with paint and sealant residue and had to be extensively cleaned prior to visual and scanning electron microscope (SEM) examination. Macroscopic examination revealed the presence of adjacent small fatigue cracks which joined up to form a shallow nearly semi-elliptical fatigue crack, 1.625 in. long and 0.084 in. deep (Figure 19). However, detailed SEM examination of the fatigue cracks revealed that the initial crack propagation was intergranular, up to a depth of about 0.017 in., indicating that the early

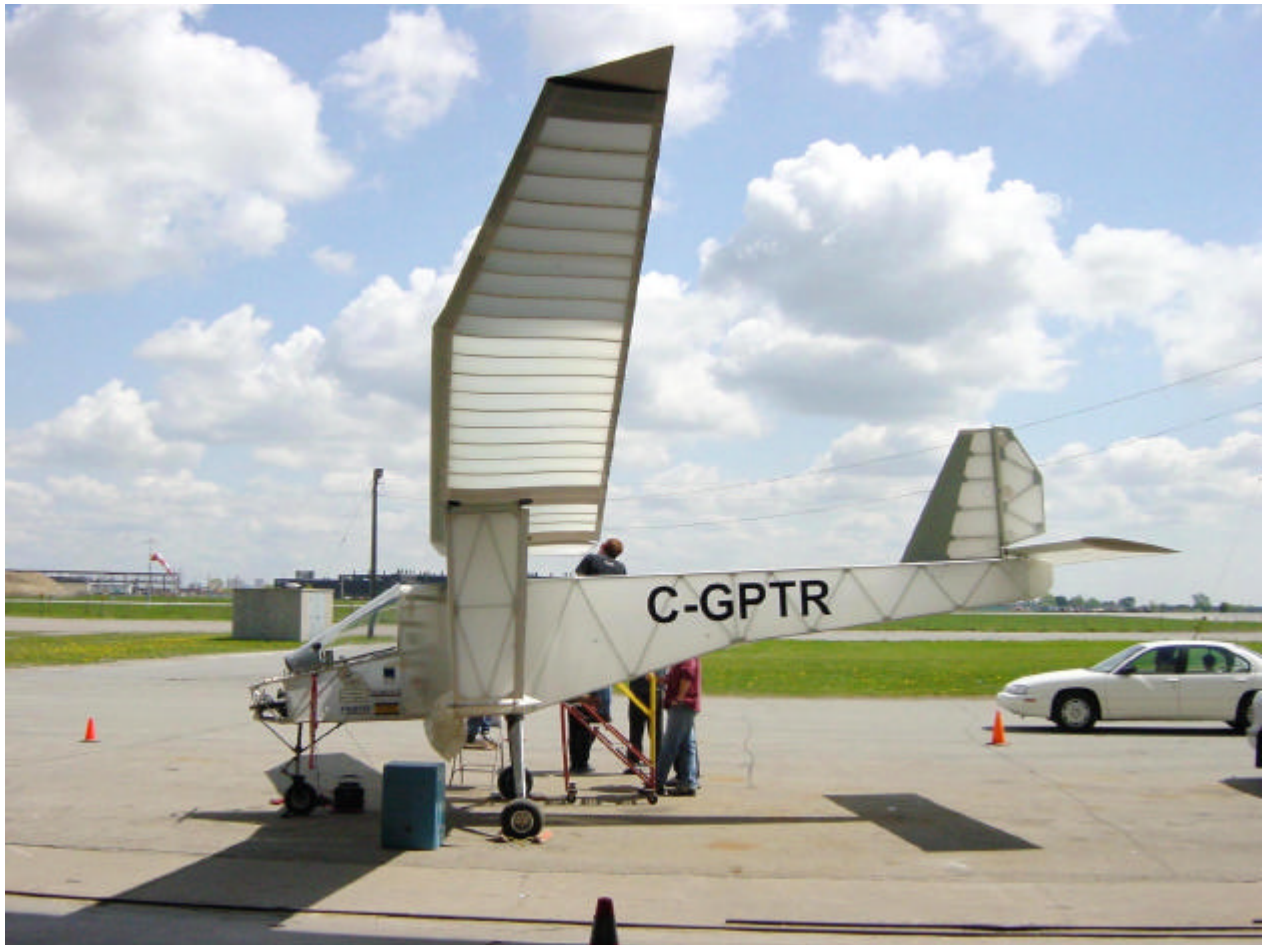
**Figure 42. Repaired Ornithopter spring 2001.**

Since the accident the aircraft has been repaired and in some areas design changes were incorporated. The flapping wing aircraft is currently being readied for flight (Figure 42).
