A REVIEW OF AERONAUTICAL FATIGUE INVESTIGATIONS IN ISRAEL

APRIL 2001 – MARCH 2003

**Compiled by:
Abraham Brot
Engineering Division
Israel Aircraft Industries
Ben-Gurion Airport, Israel**

**Presented at the 28th ICAF Conference
Lucerne, Switzerland
6 May 2003**

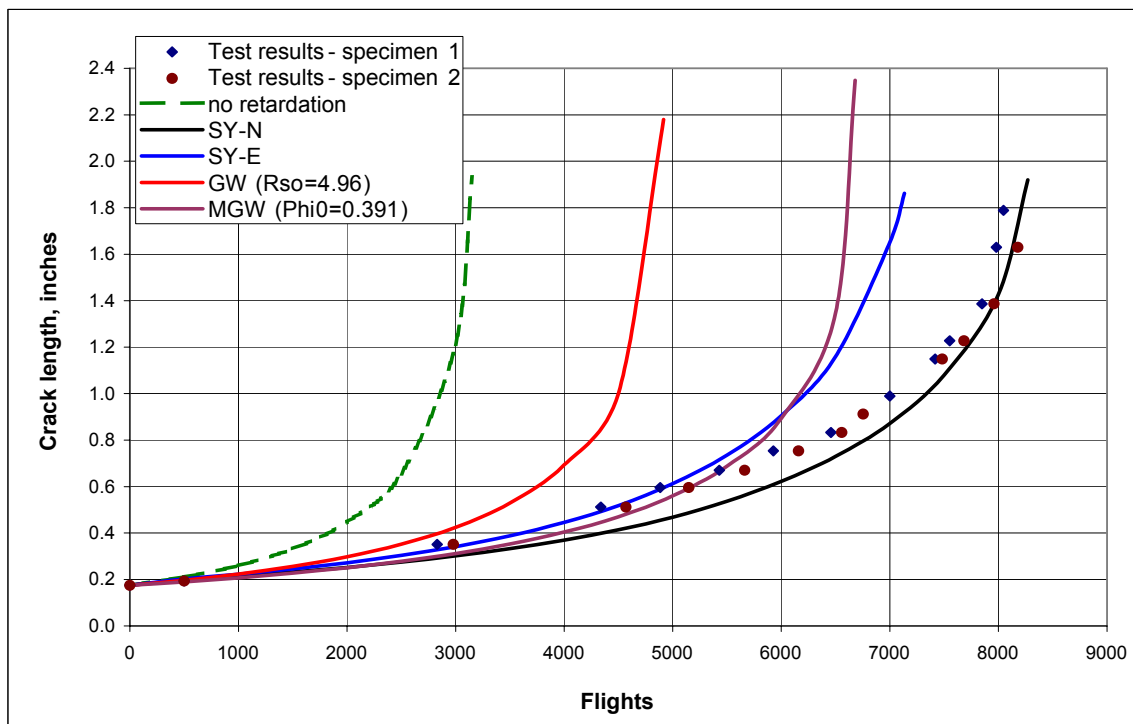
Figure 1: Crack Growth of 2024-T351 CCT Coupons Under the “Fighter Aircraft Maneuver Spectrum”

Predictions of the four retardation models gave large variations compared to crack growth measurements, over the entire range of tests. Figure 1 shows typical test results compared to unretarded calculations and retardation predictions using the four models that were studied. The challenge was to examine all the results and to attempt to find the patterns of the behavior.

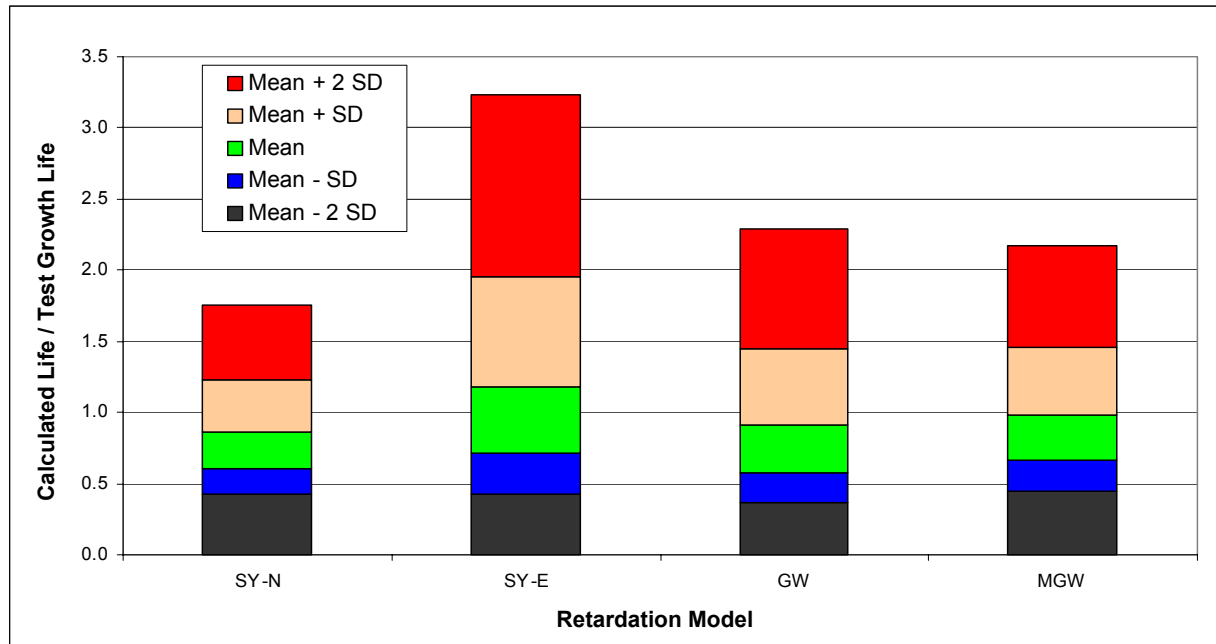
Figure 2: Retardation Model Performance Comparison

All the predicted crack growth lives were compared to the measured results, for each of the four retardation models that were studied. Statistical analyses of the results were performed and showed that all the retardation models, on the average, correlated reasonably well with the range of test data. However, the “Strip-Yield Model” (NASA) gave the least variation, as is shown in Figure 2.

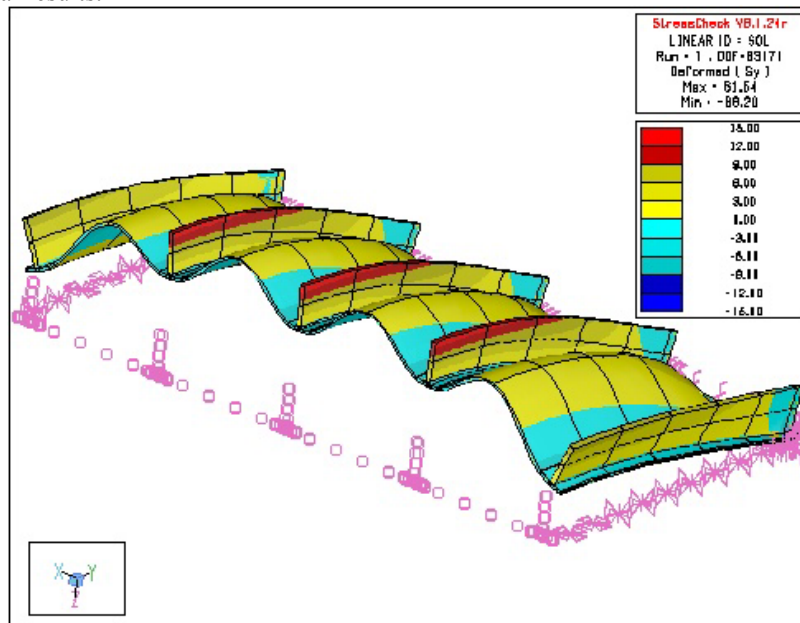
Figure 3: Finite-Element Model (p-version) of a Cracked Integral Structure

IAI has begun a study into the crack-arrest capability of integrally machined structures. Among the configurations to be studied is a bulkhead having integral ribs subjected to pressure loading. A finite-element model was built using StressCheck p-version software. A crack is introduced into one of the stiffening ribs and the crack is progressively lengthened. Stress-intensities and stress levels on the adjacent ribs are calculated by the software as the cracking is progressively lengthened. Figure 3 shows a typical result of the p-version FEM. It should be noted that sophisticated nature of the elements (up to 8th order polynomial) allows the use of relatively few elements without compromising accuracy of the solution.

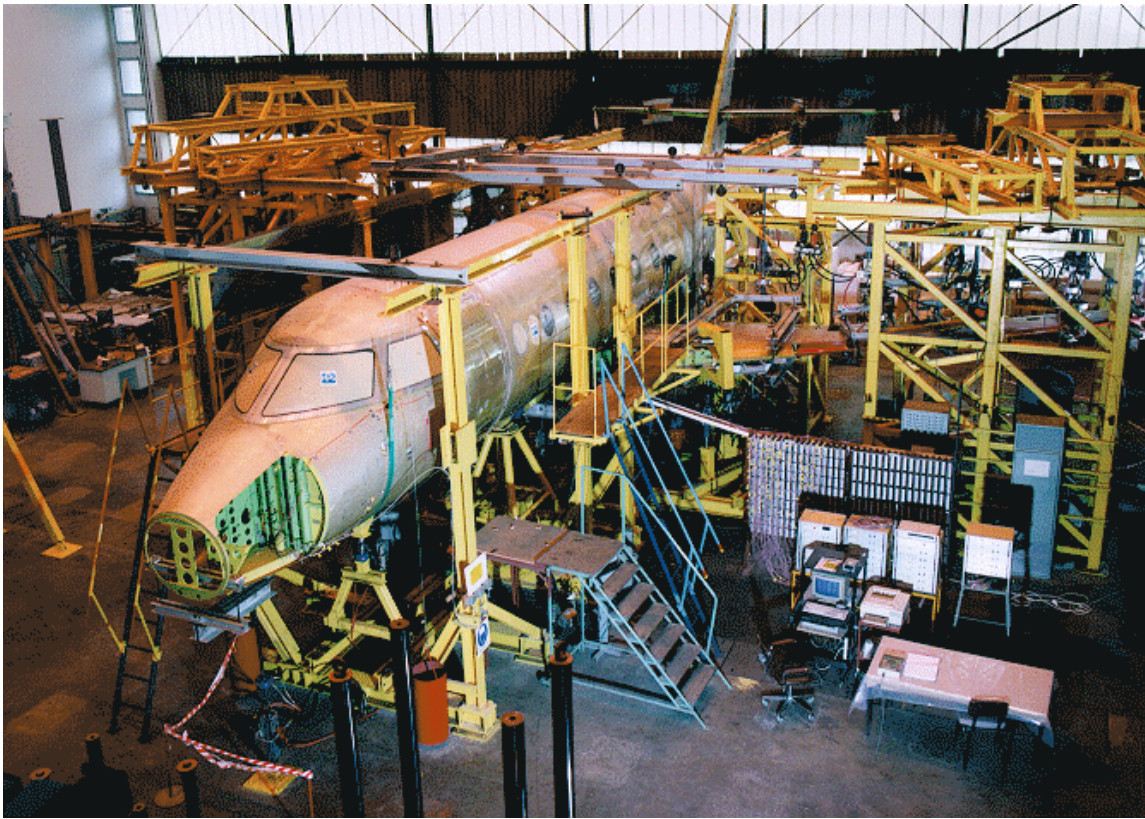
Figure 4: G200 Full-Scale Fatigue Test Aircraft

The test-article for the full-scale fatigue test consists of all the structural members of the fuselage and both wings. The empennage is being fatigue tested separately. The test aircraft was mounted to the test fixture at the nose landing gear attachment and at the engine mount fittings. Figure 4 is a photo of the G200 aircraft mounted in its loading fixture.

The test-article was divided into 29 loading zones, each of which is independently loaded during each event of the spectrum, using 42 servo-hydraulic actuators. In addition, the passenger cabin and baggage compartment is pressurized, using compressed-air during the airborne events of the spectrum. The zone loading for each event was determined using a “constrained least-square error method” which minimized deviations in loading of the important structural parameters. Approximately 1500 strain-gages have been bonded to the test-article, mainly to monitor the onset of cracking.

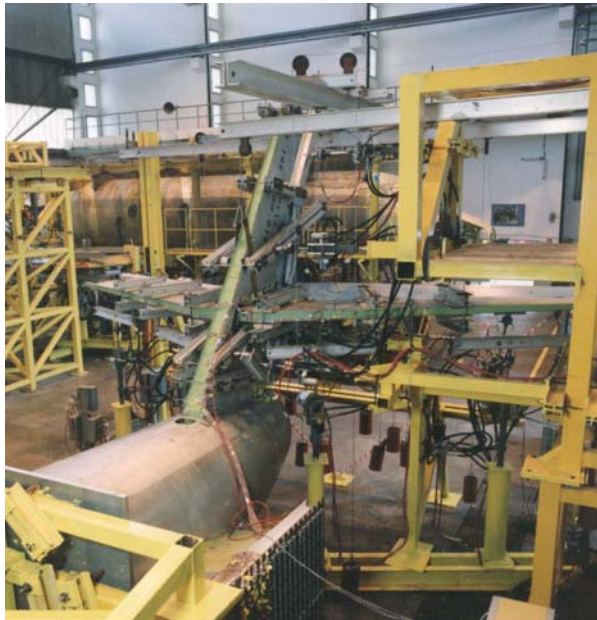
Figure 5: G200 Empennage – Fatigue and Damage-Tolerance Test

The entire empennage assembly has been mounted to an aft fuselage structure for fatigue testing, as is shown in Figure 5. The test includes the elevator and rudder, which have been manufactured from composite materials. The loading spectrum includes vertical and lateral loading resulting from gust and maneuvers as well as measured buffeting loads arising from thrust reverser deployment. The horizontal and vertical tails were divided into ten loading zones, each of which is independently loaded during each event of the spectrum, using servo-hydraulic actuators. Approximately 200 strain-gages were bonded to the structure for strain monitoring, which is performed every 1000 flights. The test-article is inspected for cracks at 5000 flight intervals.

The G200 Empennage fatigue test started in December 1998. The aim of the test is to follow a two-lifetime (40,000 flight) fatigue test by one lifetime of damage-tolerance testing (total of 60,000 flights). Following the completion of two lifetimes, 30 flaws were introduced at specific locations on the empennage metallic and composite structures; testing has reached 43,000 flights. These flaws are monitored for crack growth on the metallic structure and delaminations on the composite structures.

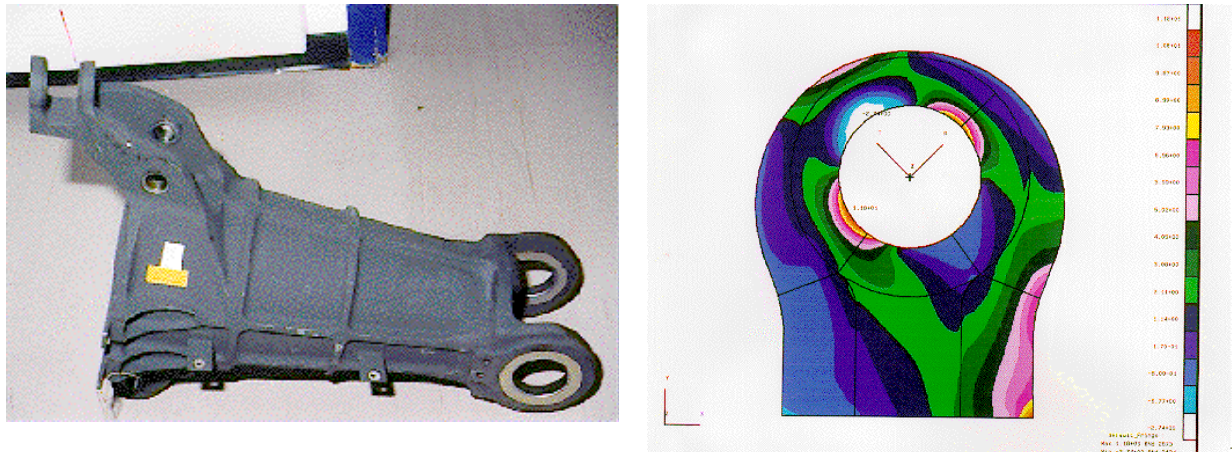
Figure 7: IAF AH-64A Apache Helicopter Pitch-Housing Component and Stress Distribution in Lug

The pitch-housing component in the IAF AH-64A Apache helicopter (Figure 7) is currently replaced by the IAF at specific intervals, based on the "safe life" replacement policy recommended by the manufacturer. This policy was thought to be unnecessarily conservative and costly. An investigation to extend the service life of the 7049-T73 aluminum pitch-housing by using an "on-condition" replacement procedure was performed. Up to now, no pitch housing removed from IAF aircraft has exhibited fatigue cracks.

Spectrum evaluation and crack growth analysis of the pitch-housing lug was performed in order to determine whether the component has the potential to be used safely for additional flight hours by inspecting periodically for cracks, as was described in the 2001 Israel National Review [1].

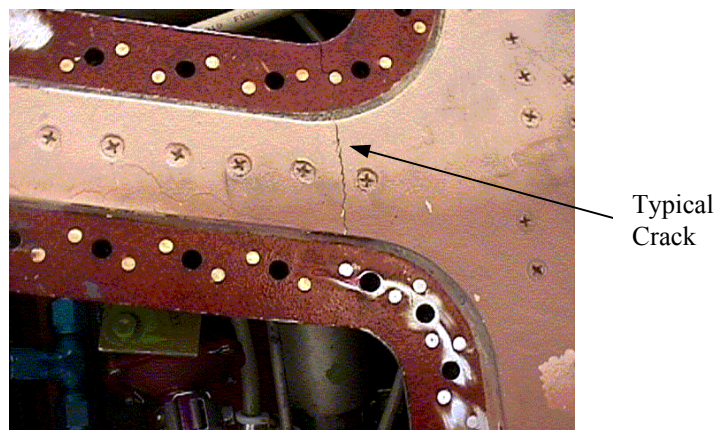
Figure 8: F-16 Fuselage Upper Skin at Station 341.8

The F-16 upper fuselage skin suffers from fatigue cracks, initiated from fastener holes and access panels corners, as is shown in Figure 8. The Israeli Air Force (IAF) has also experienced numerous fatigue cracks at the skin splice at fuselage station 341.8. Available repair kits are expensive, labor intensive and with long lead-time. A bonded repair concept was selected as a temporary repair in order to avoid drilling in the original structure and allowing the possibility of removing the repair to accommodate a standard permanent repair.

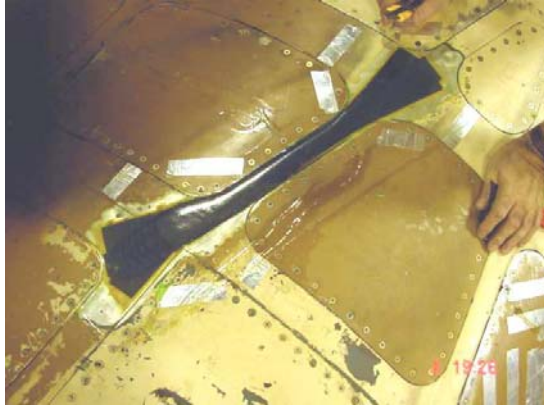
Figure 9: F-16 Boron-Epoxy Patch Repair

The major challenge in designing a repair for this location is the limited area available for bonding. The ligament between the access panels is only 40mm wide. In order to get the required stiffness, a 4mm Boron-Epoxy co-cured patch was designed. The Boron-Epoxy tape was selected as the repair system because of its high strength and stiffness. The use of Boron, as compared to Carbon, also reduces the residual thermal stresses induced during the cure cycle due to the difference in the thermal expansion coefficient between the basic aluminum aircraft structure and the composite repair. Special effort in the design phase was dedicated to the drop-off area of the patch because of the limited area available. Figure 9 shows the repair on the F-16 aircraft.

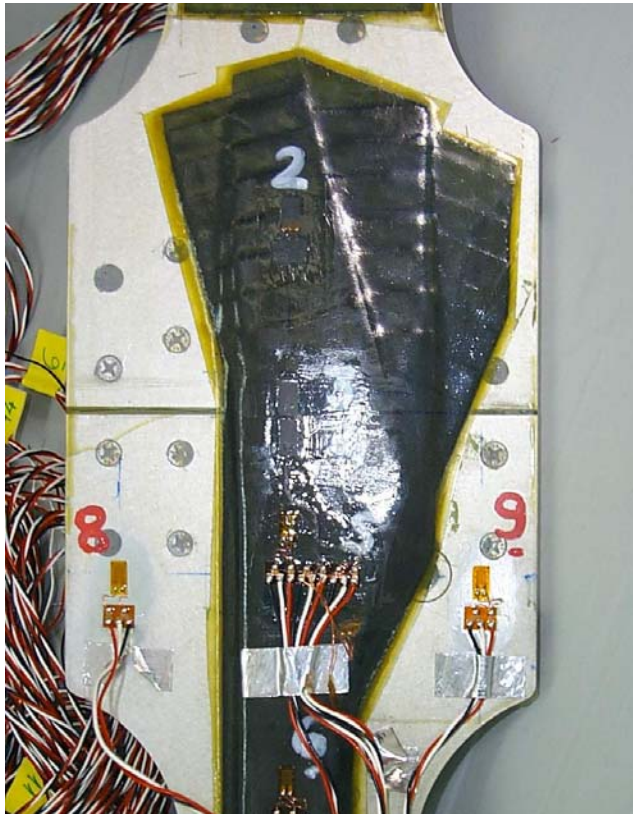
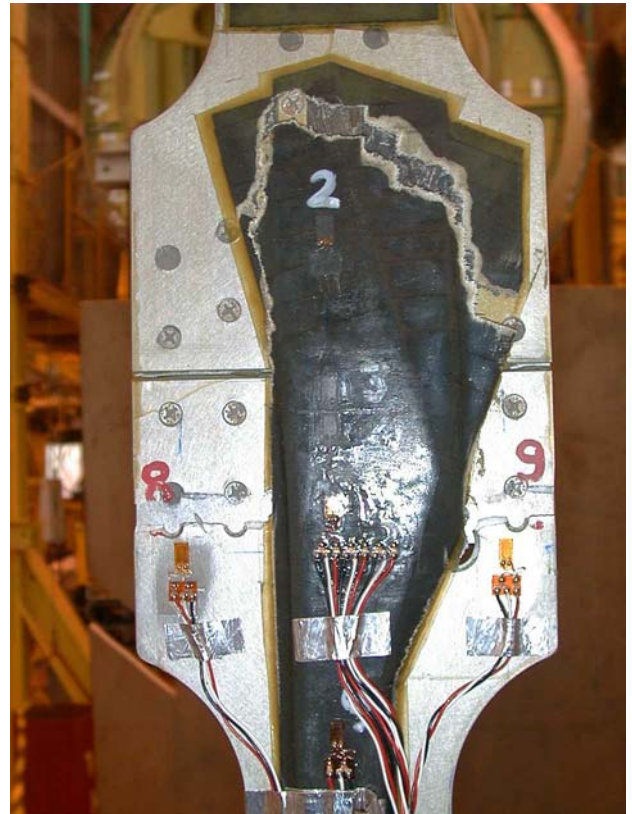
Figure 10: Static test specimen before and after failure

A test specimen, representing the repair and original structure at STA 341, was designed. A total of 4 static and fatigue tests were performed. One specimen was statically tested up to failure and all others were tested in fatigue. No indications of damage were found in the patch after ultimate loads were applied. The static test specimen failed slightly above 150% Limit load. The failure mode can be seen in Figure 10. The fatigue test with initial crack at a fastener hole demonstrated very low crack growth rate (1mm for 1000 flight hours).

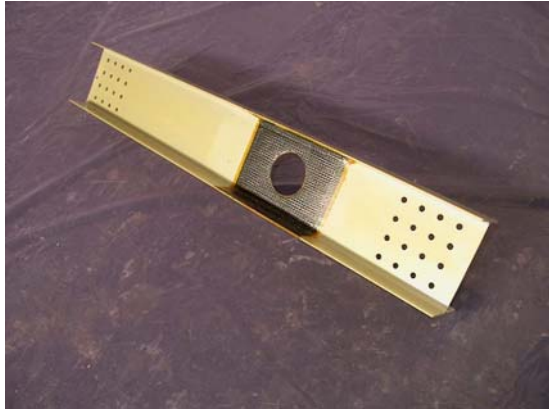
Figure 11: Typical Bonded Composite Repair that was Experimentally Evaluated

The results of this study will be presented in a paper to be given at the 22nd ICAF Symposium [13]. The purpose of the paper is to present the results, technical progress and lessons learned during the *COMPRES* project and to emphasize the innovative aspects that have the most relevance to the fatigue community. Figure 11 shows a typical bonded composite repair that was experimentally evaluated. Figure 12 contains measured crack growth behavior of a repaired aluminum structure compared to analytical predictions.

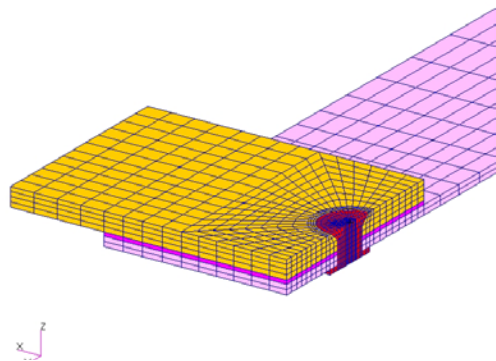
Figure 14: FEM Used in the Study

In the present work full 3D Finite Element Analysis of a rivet joint connection was conducted by means of widely used commercial code MSC.NASTRAN. To model the rivet-hole interaction, slide line type of boundary conditions were used. This type of boundary condition allows simulating contact between deformable bodies.

Both the rivet and details were modeled by CHEXA 3D elements. The other boundary conditions (loads and constraints), applied to the local model, were obtained from the global model.

3D models (including contact between rivet and attached plates) provide more realistic stress distribution around the hole. Figure 14 shows the finite-element model that was used for this study. Figure 15 describes the three-dimensional stress distribution around the hole, displacements and contact under loading. The data obtained from this study were used for the life expectancy prediction of riveted connections.

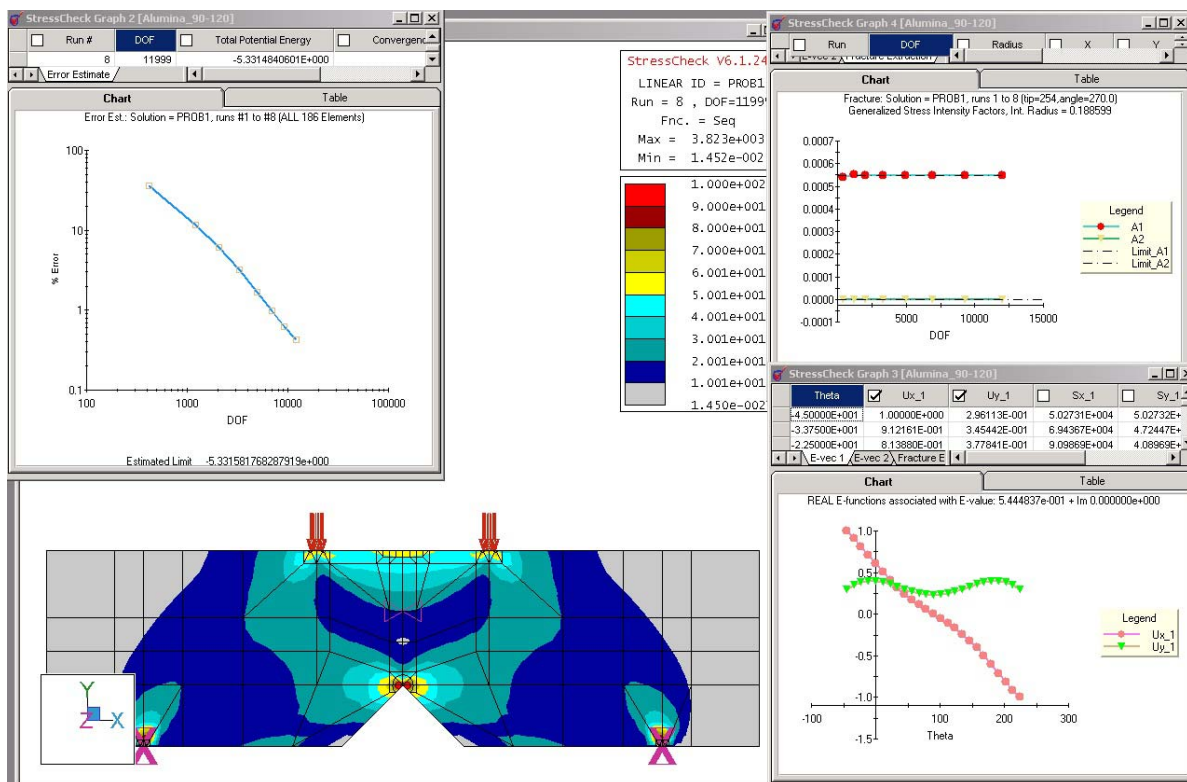
Figure 16: Typical Finite-Element Model of a Composite Ceramic Specimen

A sample of the many p-version finite-element models simulating the Al_2O_3 -7% ZrO_2 tested specimens together with the extracted eigen-pairs and generalized stress intensity factors [17] is shown in Figure 16, and the prediction (by Novoshilov-Seweryn and Leguillon's criteria) vs. the experimental generalized stress-intensity factor, as a function of the V-notch opening angle [17] is shown in Figure 17.

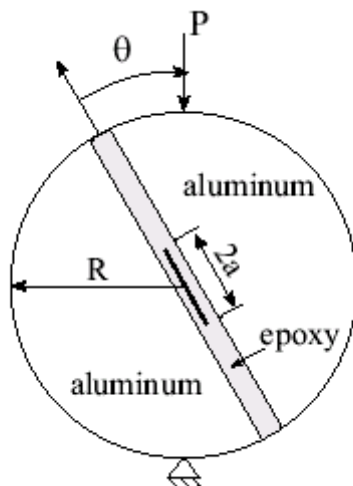
The purpose of these investigations was to measure the fracture toughness of a crack within an adhesive joint and consider its crack path. Sandwich Brazilian disk specimens (Figure 18) made of two aluminum substrates joined by a thin layer of epoxy were employed in the testing. A paraffin notch was located within the adhesive layer. The advantage of this specimen type is that it provides a wide range of mode mixity.

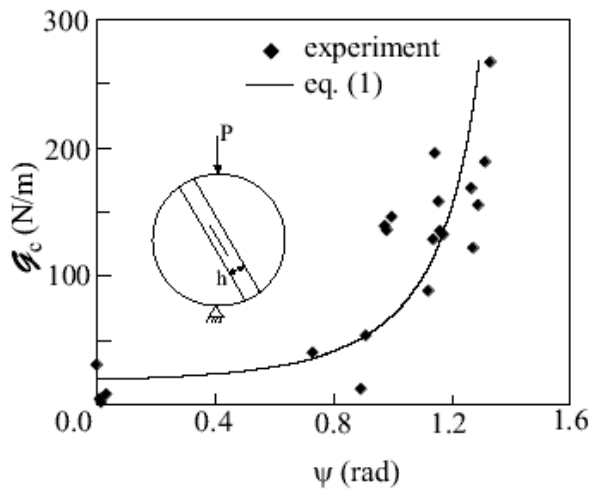
Figure 19: Critical Energy Release Rate as a Function of Phase Angle

N/m. For the sandwich specimens a G_{IC} value of 19.9 N/m was obtained. This value is approximately 40% that of the bulk epoxy. Measurements showed the critical energy release rate of the bulk epoxy to be somewhat higher than that for the in-layer path in the sandwich structure. Other investigators found G_{IC} of the bulk epoxy to be lower than that in the sandwich specimen even when the crack propagated within the epoxy. Perhaps the low critical energy release rate values obtained from the sandwich specimens for small values of the loading angle θ are a result of the crack propagating into the interface; this would be similar to the phenomenon observed in the literature.
