# **Review of Aeronautical Fatigue Investigations in Switzerland**

**May 2003 – April 2005**

**KOR-TA2005-0252**

**M. Guillaume  
RUAG Aerospace  
CH- 6032 Emmen**

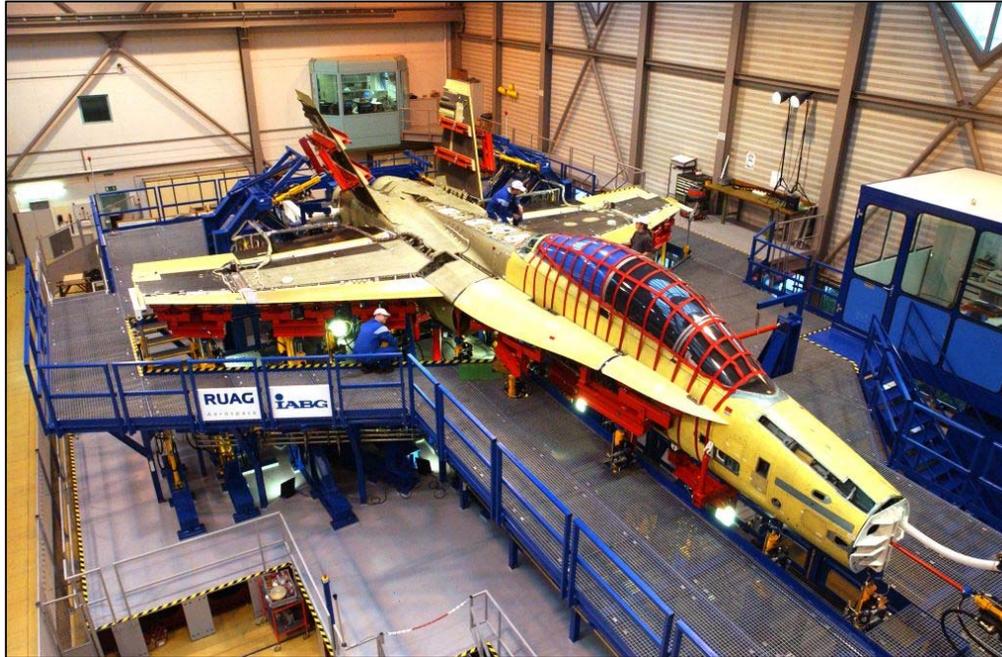
Figure 4.2-1 Test set-up of the Swiss full scale fatigue test.

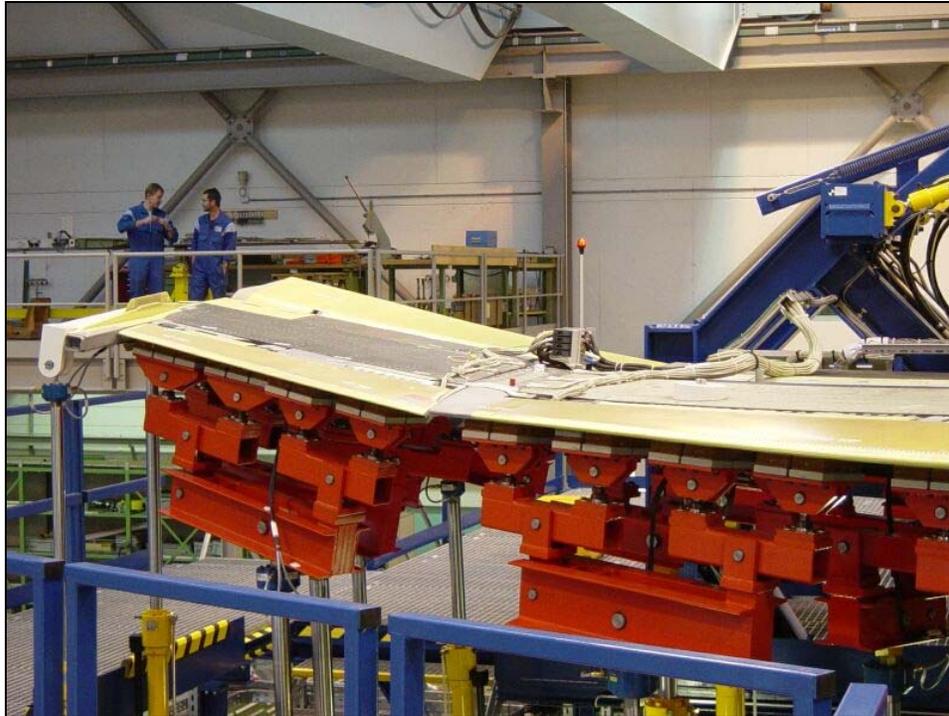
Figure 4.2-2 Wing displacement during strain survey at 70% load level of  $N_z = 8.25g$  symmetric steady state pull up maneuver.

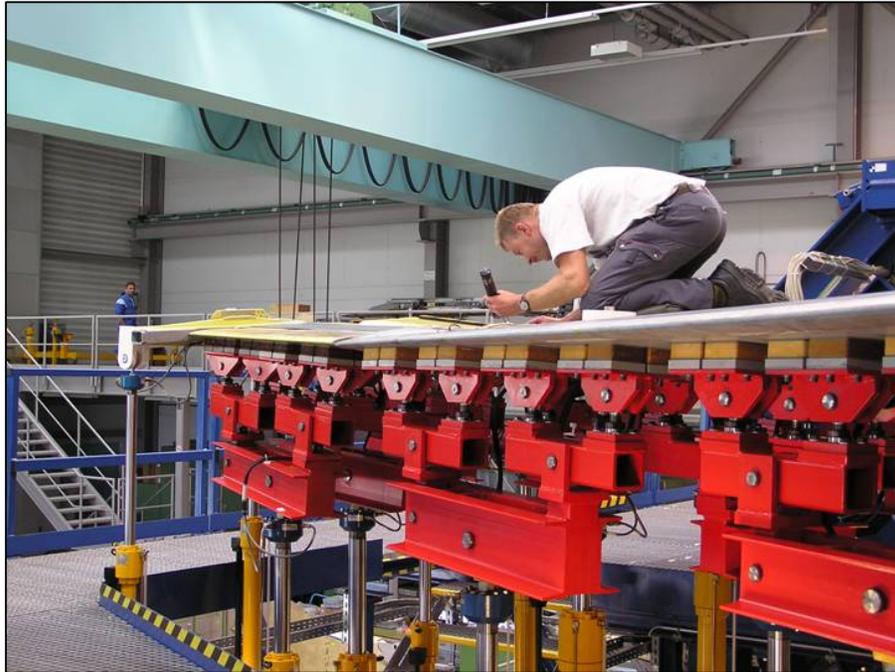
Due to the optimal accessibility the test article was inspected visually by qualified staff in daily walk-around inspections during the fatigue cycling, see Figure 4.2-3. Also the dorsal deck, the engine bay, the engine inlet, the bulkheads on the lower side were inspected for early cracks.

Figure 4.2-3 Inspection at wing fold during fatigue cycling, see deflected wing.

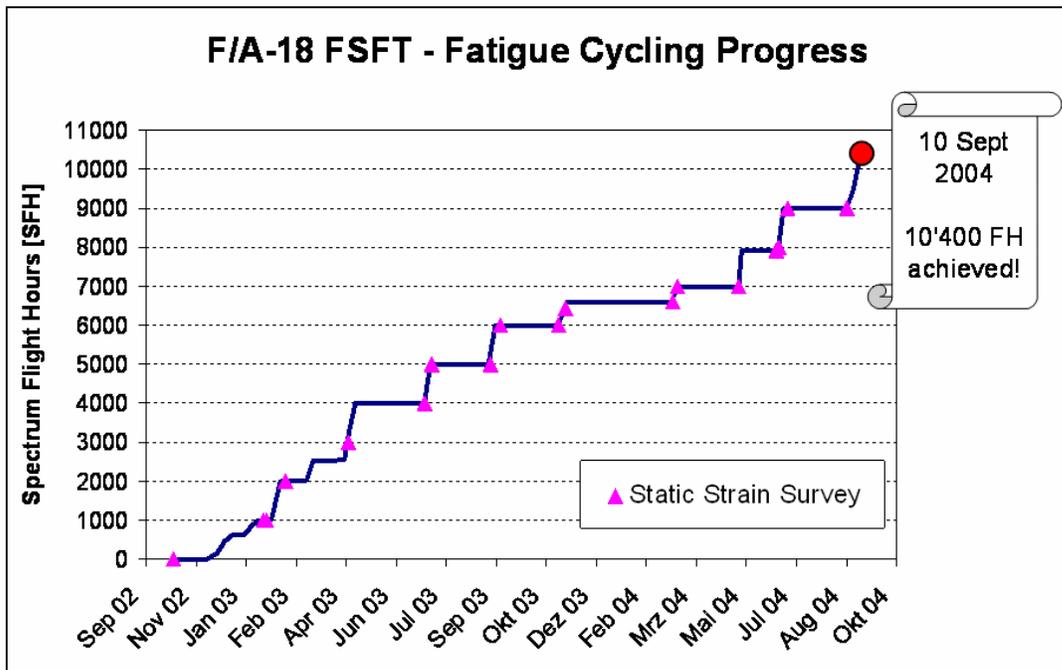
The Swiss test reached the 10'400 FH in September 2004 in less then two years, see Figure 4.2-4. The test article sustained the last strain survey which any problems. The structure was still able to carry the load of a 9g steady state limit load condition.

Figure 4.2-4 Fatigue cycling progress to reach 10'400 FH.

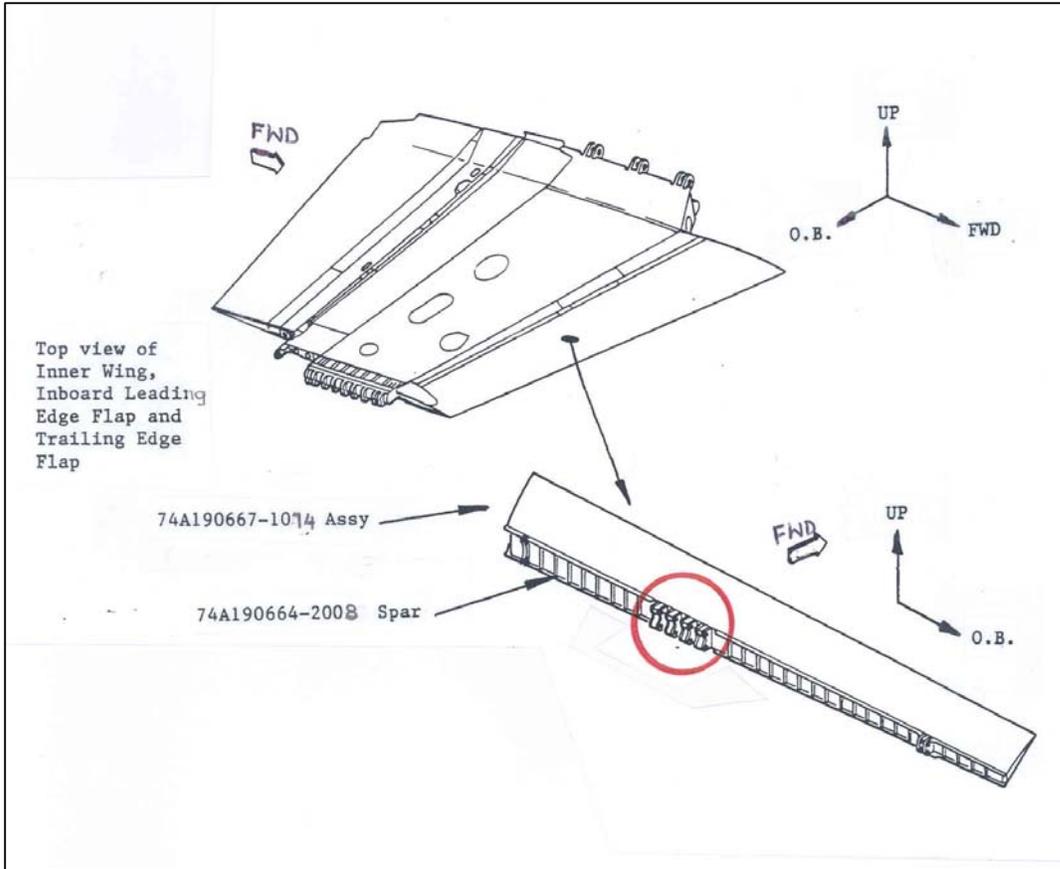
The ILEF was analyzed in the Swiss ASIP study. Due to cracks at the lower lug area in the FT93 wing test the Swiss ILEF was redesigned (Figure 4.2-5 a, b). The Swiss configuration was changed from circular fillets at the lug area to parabolic fillets. Furthermore for the forward and aft lug of the inboard lug set the thickness was increased by 50%. The spar web was moved forward compared to the US Navy design. The Swiss improvements showed by analysis a crack initiation life of 38'000 FH based on the hinge moment spectrum.

Figure 4.1-5 a Overview of the inner wing with the ILEF flap and the lug area.

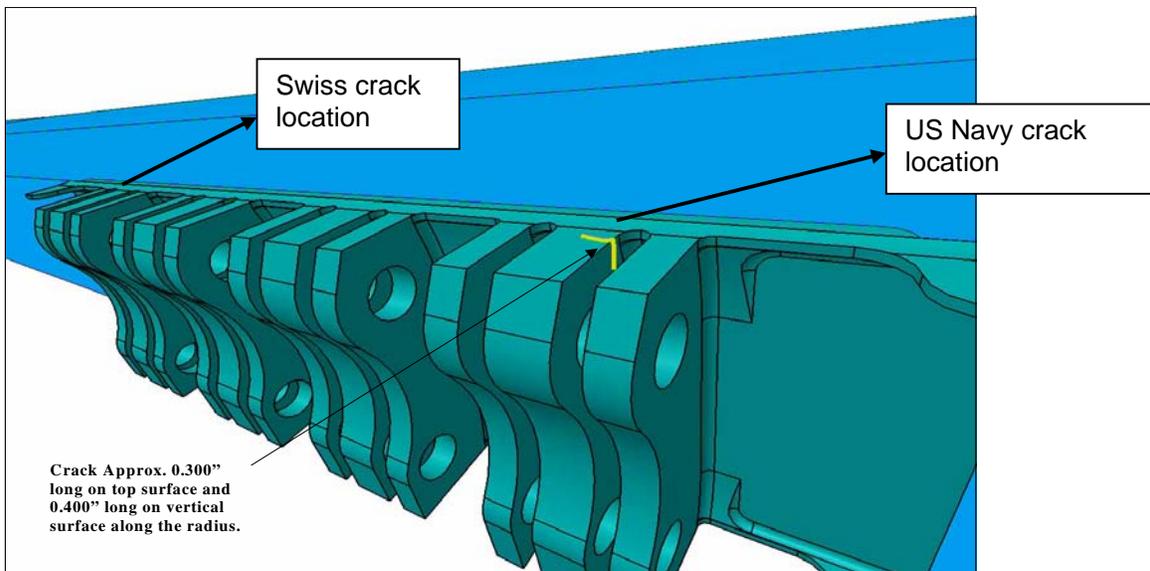
Figure 4.1-5 b Cracks observed at ILEF lower lug fillets on FT93 wing test and on Swiss test article.

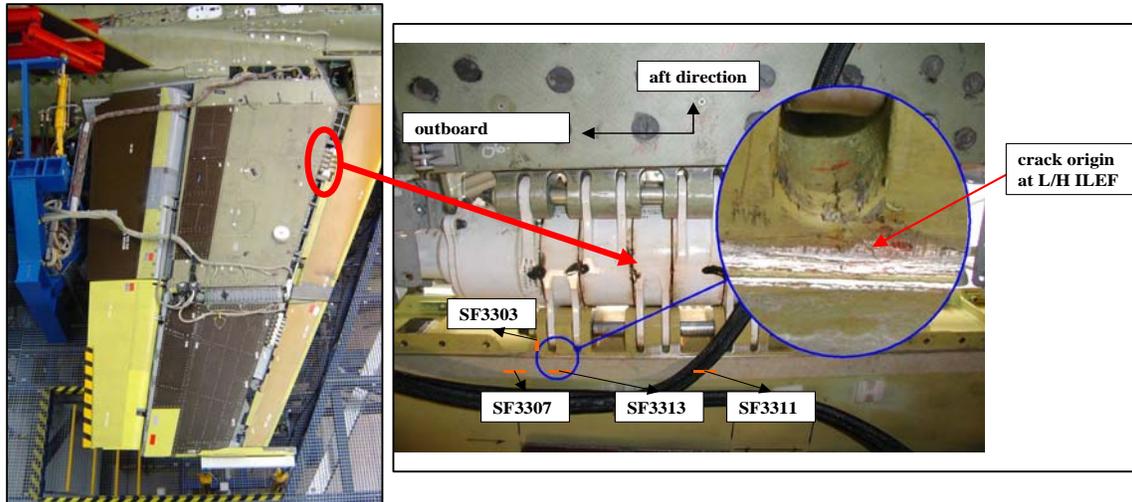
In the Swiss FSFT at 3'000 FH a crack was observed in the most outboard lug at the lower side (Figure 4.2-6). The crack was not perpendicular to the lug load as in the FT93 wing test, rather it runs  $30^\circ$  off into the spar web and the spar flange.

Figure 4.2-6 Swiss crack observed at 3'000 FH on the lower side of the ILEF lug fillet area; the strain gauge locations are labeled orange (application at 4'000 FH).

The strain survey results up to 6'000 FH showed significant changes in the area close to the crack. The strain gauges at lug set #1, #2, and #3, however, do only see minor changes due to the growing crack in the spar section.

From continuous measurements of the 16 strain gauges crack initiation curves (CI) were generated. The CI curves at the lug affected trough the crack showed a drift to lower stress levels which demonstrates the growing crack in the spar. The CI curves do not show any drift for the gauges at lug set #1, #2, and #3.

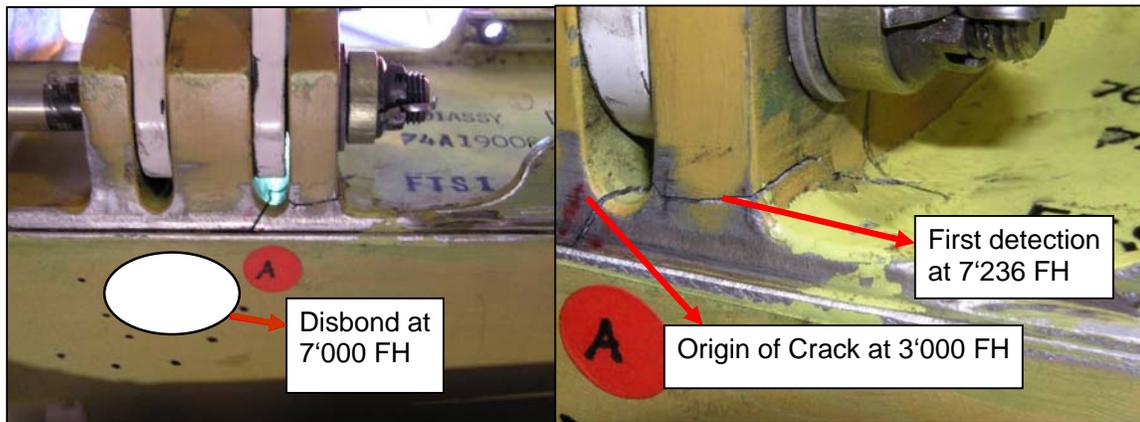
The crack grew in direction of the neutral axis and it was inspected regularly during fatigue cycling. Due to the opening of the crack the bonded skin of the ILEF started to disbond. First data of disbonding area was monitored at 7'000 FH using ultrasonic inspection. At 7'236 FH a crack was observed at the corner of the outboard lug, see Figure 4.2-7. This crack grew

further and merged with the original crack observed at 3'000 FH. The ILEF skin failed at 9'181 FH (R/H side) and at 9'461 FH (L/H side). They were replaced by Canadian scrapped ILEF (US Navy configuration) for the rest of the test.

Figure 4.2-7 Cracks at ILEF observed on Swiss test, status at 9'000 FH.

At 9'181 FH and 9'461 FH the ILEF were replaced by scrapped Canadian ILEF to continue the test. The Swiss ILEF showed a disbonding failure at the lug area due to the large cracks in the outer lug set. RUAG maintenance people were able to replace this ILEF flap within a day and to resume the test again.

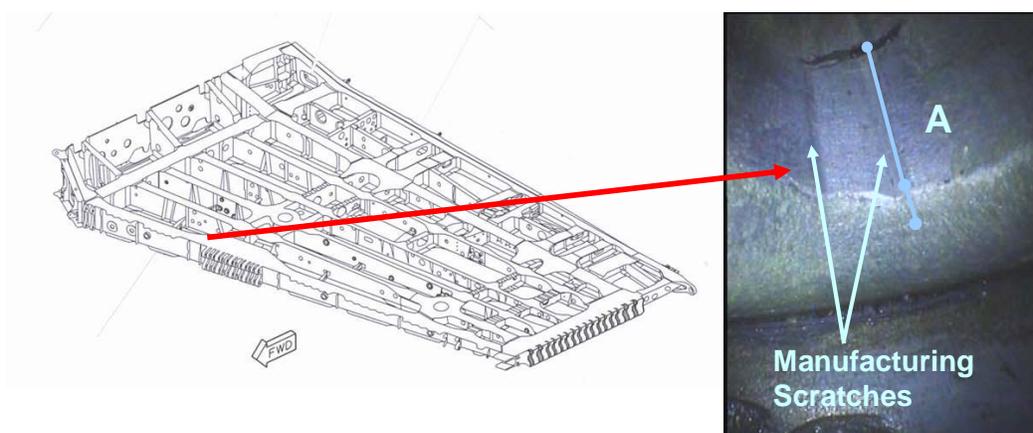
At 9'000 FH a crack was observed at the lower side of lug area of front spar in the main transmission drive area, see Figure 4.2-8. The crack was along the lug fillet direction and on the lower surface. The crack was running along a mechanical drill mark along the fillet direction. This damage was only observed on L/H side. Up to 10'400 FH the crack grew further but the crack growth rate was relatively slow. At 9'464 FH an additional crack was observed on other lug fillet. The crack runs also along a mechanical drill mark and the crack growth rate was small up to 10'400 FH. No drill marks were observed on R/H side and no damage was found up to 10'400 FH.

Drill marks and residual stresses due to machining in such areas as lug fillet may have a detrimental impact on the fatigue life of these parts.

Figure 4.2-8 Crack in the lower lug area of the inner wing front spar due to manufacturing scratches.

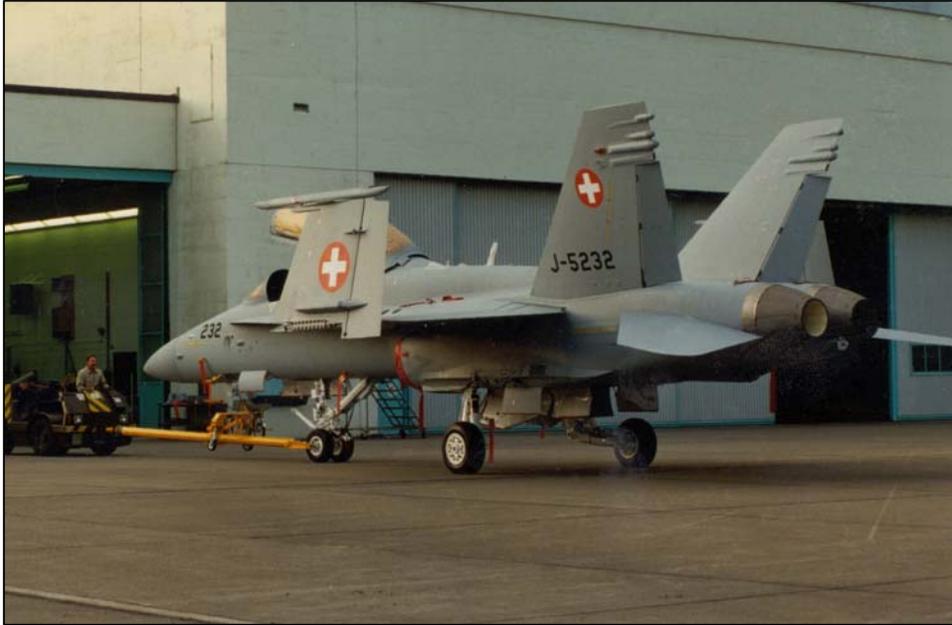
The F/A-18 is an airplane designed for the US Navy for carrier operations. Therefore the outer wing can be folded by a transmission mechanism (Figure 4.2-9). The titanium wing fold ribs at the inner and outer wing transfer the loads through the transmission. The inner and outer wing fold ribs are highly loaded and fracture critical parts.

Figure 4.2-9 Wing fold mechanism for the F/A-18.

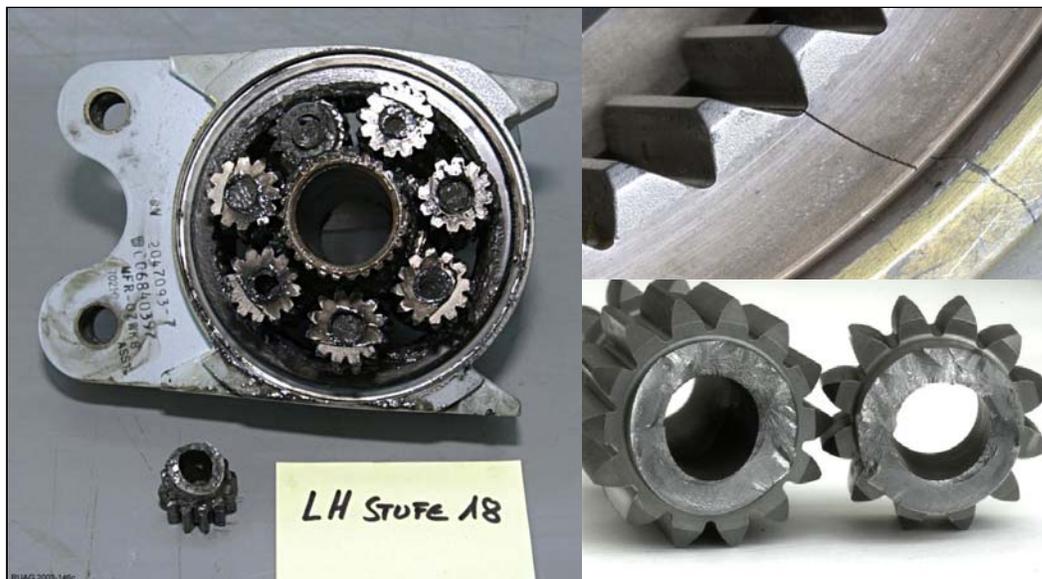
The transmission of the wing fold rib is a life limited part. Boeing has delivered three pairs of transmissions for the Swiss test due to the limited life of approximately 4'000 FH. This limit was only estimated due to the design spectrum severity between US Navy and Swiss. Indeed after 4'000 FH of cycling the first pair of transmission showed severe cracking and had to be replaced. The weakest point is gear section 18 and 19 at the aft section which is highly loaded. At 4'000 FH also the housing of the transmission was cracked. During the continuation of the test at 6'606 FH the transmission were checked by folding the outer wing. The right hand transmission could not be folded and was therefore disassembled for detailed inspection. Several gears at the critical section 18 and 19 were already cracked. The cracked gears were replaced and the transmission was tested and adjusted. This transmission was again installed for continuation of the test. At 7'929 FH a fatale failure on this transmission was observed. The transmission could only be dismantled by breaking up the housing. The Figure 4.2-10 shows the cracked gears at the gear section 18.

Figure 4.2-10 Cracks observed at wing fold transmission section 18.

The early cracking of the wing fold transmissions is not a surprise due to the severe testing of the wing fold area compared to the Swiss design. The Swiss test showed that actually the wing fold transmission seems to have more margin of safety than estimated during the ASIP study.

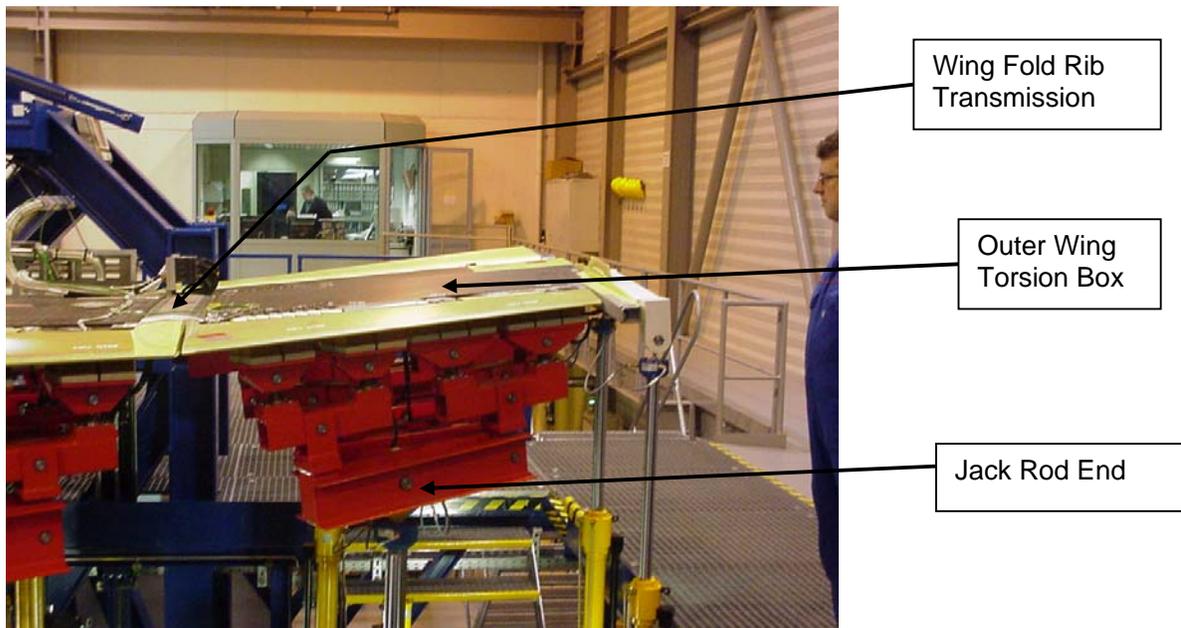
vertical motion of the jack head (rod end) a small lateral displacement was induced. This way the distance between the force vector and the load reference point of the wing fold was slightly increased and yields to an increase of the actual bending moment.

Figure 4.2-11 Displacement of rod end of the actuator at the outer wing.

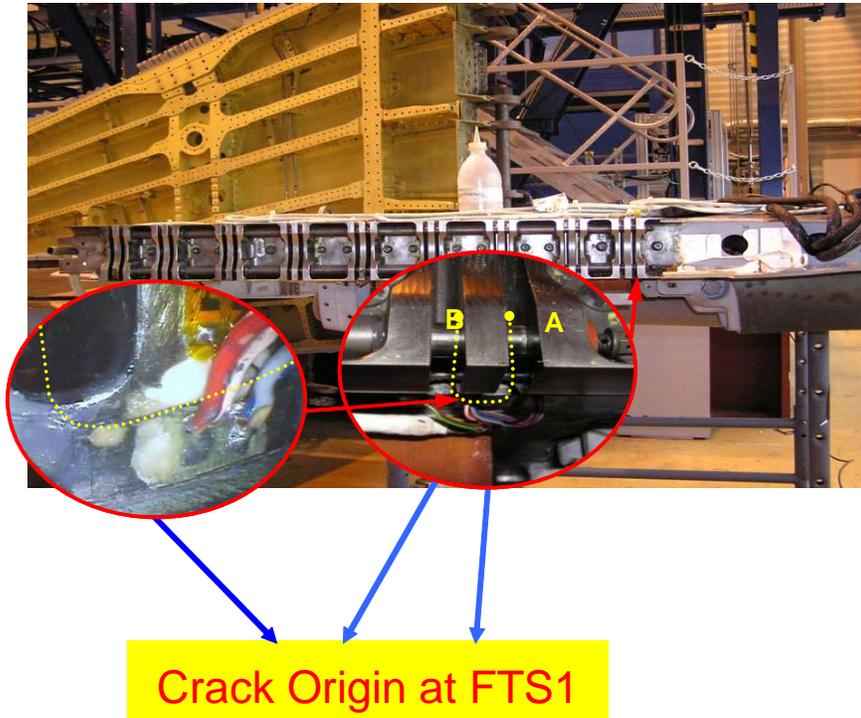
The forward and aft wing fold rib lugs of each lug set were beefed up (increase of the thickness) and the fillet was changed from circular to parabolic for the Swiss F/A-18 as for the ILEF. Only at one lug set #9 of the R/H outer wing fold rib a crack was observed at 6'606 FH. The crack showed small crack growth behavior. At 9'000 FH also a crack on L/H outer wing fold rib was observed. At 10'000 FH further cracks on the L/H side at lug set # 1, #5, and #8 were observed. No cracks were observed during the test at the inner wing fold rib. In the US Navy test FT01/ST16/FT93 severe cracking at inner and outer wing fold rib lugs were observed. Due to the severe testing in Swiss test compared to the Swiss ASIP design the wing fold rib seems to be superior. Even the early crack on R/H outer wing fold rib (Figure 4.2-12) did not reach the critical crack length until the end of the test. The Swiss test demonstrated that the redesigned structure can tolerate a much larger crack size than assumed in the Swiss ASIP study.

Figure 4.2-12 Observed crack at R/H outer wing fold rib lug fillet.

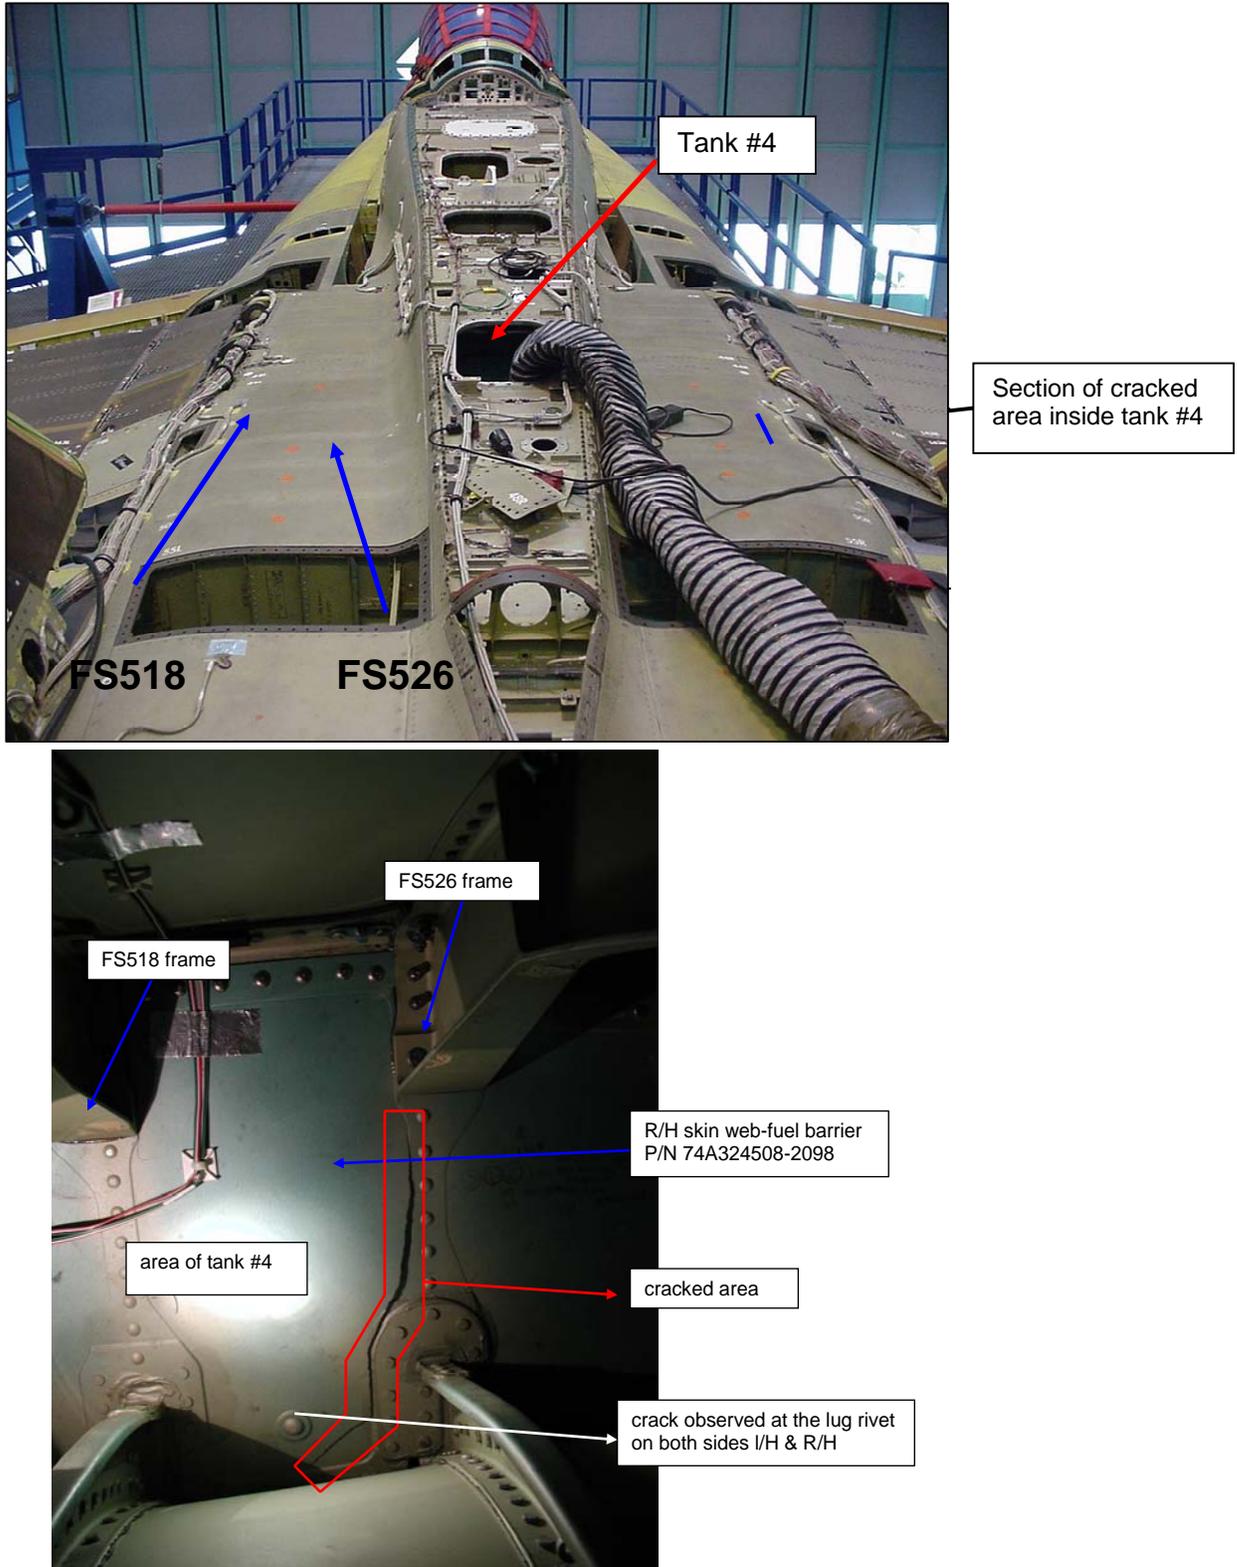
During the inspection after the first life time at 5'000 FH the tank #4 was inspected. In the fuel barrier web skin at frame station FS526 a large crack (approx. 10 inch) was observed, see Figure 4.2-13. At 6'000 FH a large doubler was installed to avoid unloading and further damage in this area. At 7'921 FH the same crack was observed at the L/H side, the same doubler was installed. The loading on the L/H and R/H side is the same, this was confirmed by the applied loads and strain gauge readings during strain survey and the fatigue cycling. The skin thickness of the fuel barrier web skin was on the R/H side on the lower tolerance and on the L/H side on the upper tolerance of the blue print value. Further cracks were observed on the fuel skin barrier web between frame station FS97 and FS44. At 9'000 FH the doubler at the R/H side was removed because further damage at web in this area was observed. A new doubler from FS08 to FS26 was installed. The heavy loading due to horizontal tail loading is the main driver of these cracks. A loads survey of the ASIP loads procedure with using Computational Fluid Dynamics showed that the ASIP loads for the horizontal tail and the balancing procedure are not fully consistent. The aft fuselage loading of a flying F/A-18 seems to be different compared to the ASIP design loads.

Figure 4.2-13 Observed cracks in fuel barrier web skin between FS518 and FS526.

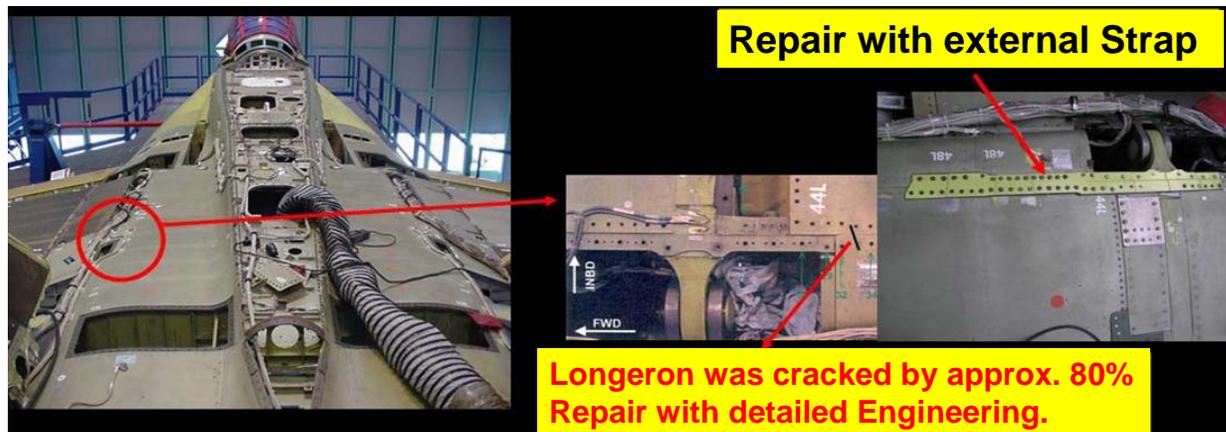
During the inspection at 7'921 FH in the fuel barrier web skin at FS499 a crack was found at the down standing leg of the upper outboard longeron. Further inspection using eddy current confirmed that the longeron was broken by 80% of the flange area. The strain gauge monitoring near the cracked location confirmed the changes of load path as well. Only the L/H side had a crack, the R/H side seemed not be cracked yet

During the Boeing FT01/ST16/FT93 tests this area was also severely damaged and had to be repaired by doublers several times. The ASIP pegging procedure could therefore not be applied for the estimation of the Swiss crack initiation life. The direct calculation of crack initiation life for the Swiss design spectrum showed a very low life. To meet the Swiss structural requirements of 10'000 FH crack initiation life Swiss interference fit fastener with LIF = 5 were recommended. The stresses at the upper outboard longeron in the test were high which would clearly lead to short initiation and crack growth life. A large stepped doubler was installed at the L/H side to ensure a by pass loading to avoid further damage, see Figure 4.2-14. During the repair all holes with removed fasteners were checked by eddy current, and more cracks were found. With this repair the test could be continued up to 10'400 FH without any further problems.

On the R/H side in the area of FS488 to FS499 up to the end of the test also some cracks were observed but none of them were very long and critical for the upper outboard longeron. Further checks and discussion showed that the LIF = 5 were not applied during the production due to impractical reasons. Therefore this longeron is highly loaded and a short life depending on the severity of the spectrum may be the case. This location must surely be analyzed more carefully for the fleet.

Figure 4.2-14 Cracked area of upper outboard longeron with strap repair.

A further stop was needed to reinforce the upper outboard longeron on the L/H side by a strap in April 2004. The longeron was severely cracked in the aft section of the center fuselage.

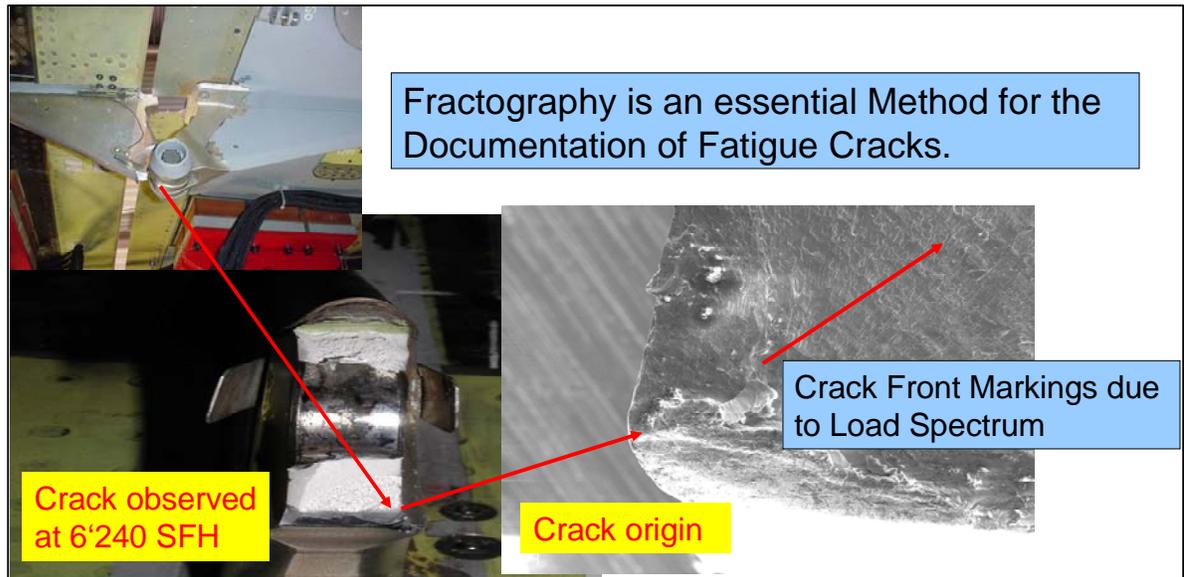
The lug of Trailing Edge Flap (TEF) hinge rib at the L/H side showed a crack at 6'240 FH at the free edge corner. This part is maintenance critical and was not redesigned for the Swiss. This hinge rib is loaded highly by buffet during flight and therefore the ECP574 will also be introduced for the whole Swiss fleet. The replacement of the aluminium hinge rib for the fleet by a modified titanium hinge rib is already ongoing. The R/H side hinge rib was instrumented with strain gauges to monitor the spectrum loads. No changes were observed during the test.

The L/H rib failed at 6'606 FH in the test, see Figure 4.2-15. To understand why the rib failed detailed fractographic investigations were done. The results showed that drill marks were the origin of the crack. Once the crack has initiated the crack growth is pretty fast, so that no damage tolerance in fleet can ensure the structural integrity due to severe buffeting. For the Swiss test both ribs were replaced by the new titanium hinge rib to get strain gauge information for the new hinge rib by the Swiss test loads for further future stress analysis.

Figure 4.2-15 Failure of TEF flap at 6'606 FH, only on L/H side.

Due to the replacement of the outboard TEF hinge rib at 6'450 FH the test has to be stopped from November 2003 till March 2004.

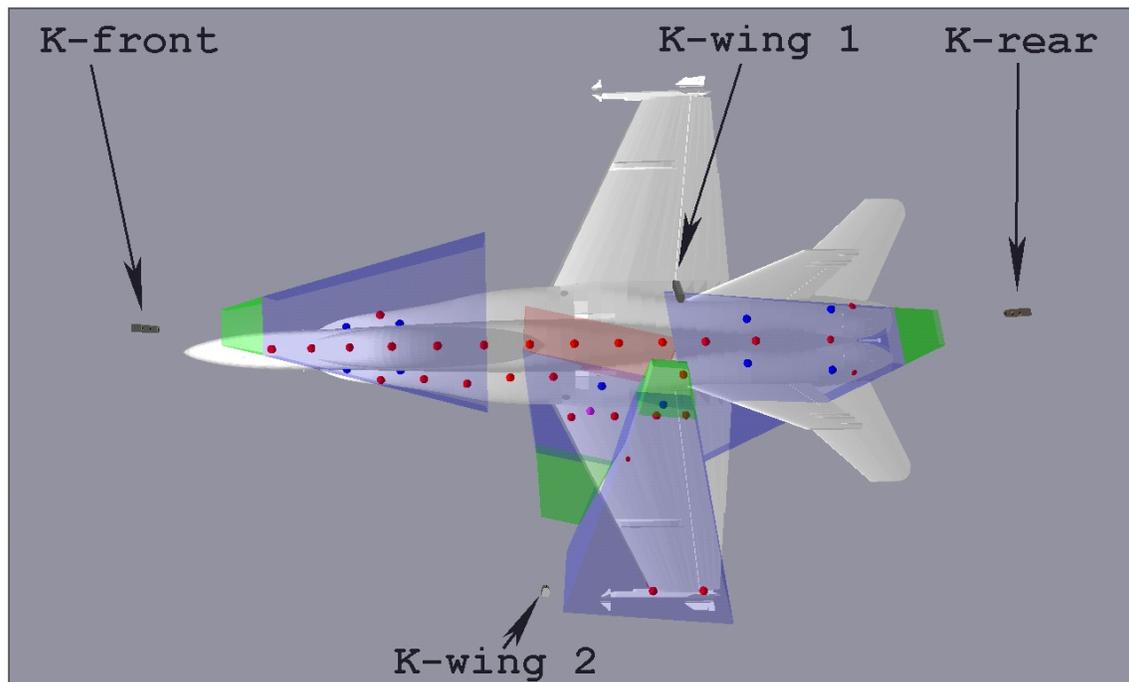
Because of the size of the measurement object and the large deflection of the wing-tip, four Krypton camera's were used. Three K600\_8000 which were calibrated to measure up to 8 m, and one K600 which is calibrated to measure up to 6 m. An optimal configuration was studied to incorporate as many requested measuring points as possible. The coordinates were expressed in the global coordinate system (GCS) of the airplane (see below). For the orientations, the Roll-Pitch-Yaw convention was used: rotation order Z-Y-X and the rotations are performed around the absolute axis. Figure 4.3-1 shows a top-view of the set-up.

Figure 4.3-1 Top-view of the set-up.

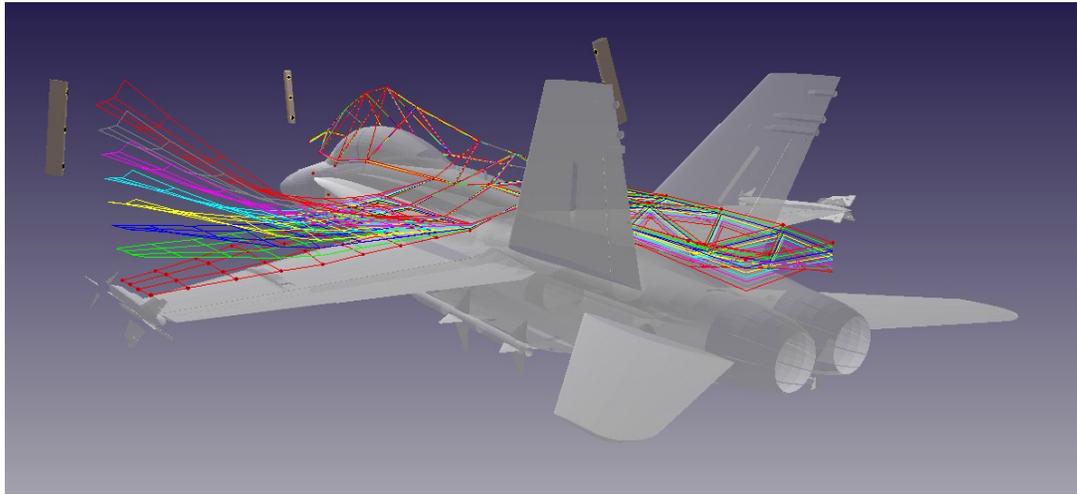
Figure 4.3-2 gives an impression of the displacement of the TLC1496 load case. The displacement of the wing (amplification factor of 5) is clearly seen as bending and torsion. The aft fuselage shows also a relative big displacement compared to the forward fuselage.

Figure 4.3-2 shows the displacement of the load case TLC1496 with the amplification factor of 5.

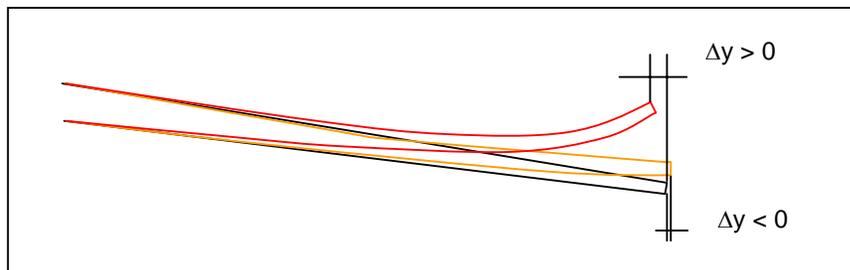
The linearity of the displacement in all three directions ( $x$ ,  $y$ ,  $z$ ) was checked for all measurement points and showed some deviations for the wing in  $y$  (side direction). The wing has a dihedral angle of  $3^\circ$  on the ground. Loading the wing by a flight condition induces a non linear  $y$  displacement which results first in a side slip outboard (at 10 to 30% load level) and afterwards inboard (at 40 to 70% load level). For detailed explanation see Figure 4.3-3.

Figure 4.3-3 shows the influence of side displacement due to positive wing loading during strain survey.

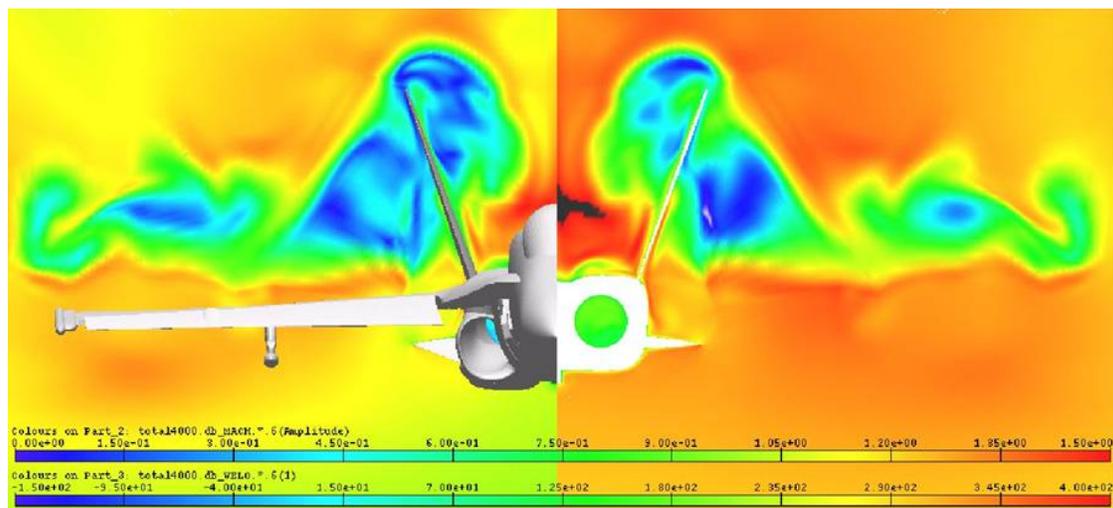
As an input for a steady state maneuver the following data is required: altitude, mach number (M), angle of attack, flap positions (leading edge flaps and trailing edge flap) and horizontal tail position. As a first step the grid mesh has to be adopted for the correct configuration. To reach a convergence about 3'000 iterations has to be done, see Figure 4.4-1.

Figure 4.4-1 Calculation for steady state maneuver  $N_z = 8.25g$  at 25'000 ft and  $M = 0.95$  with AIM9 at the wing tip and one AMRAAM under each wing.

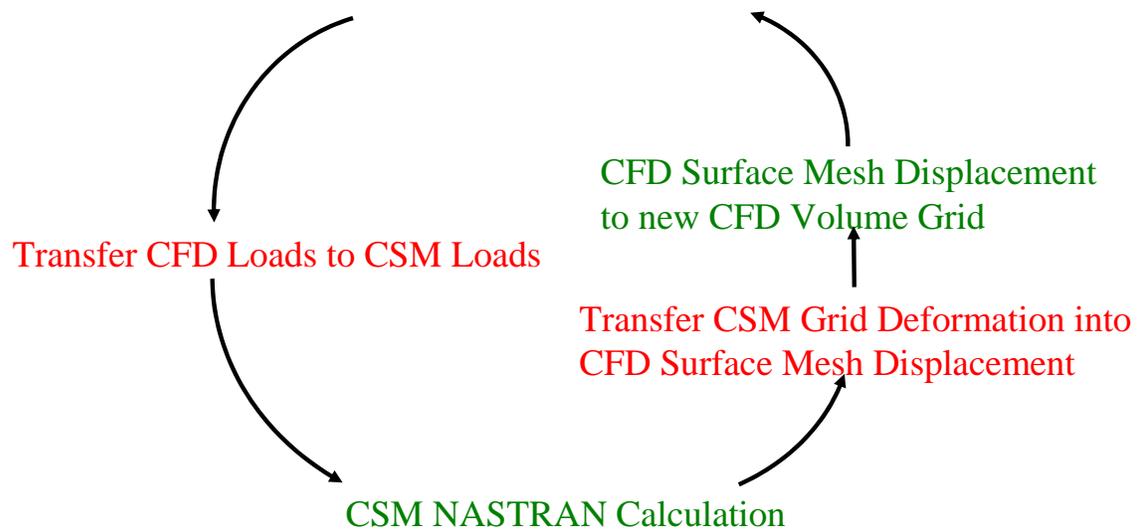
The structural deflection of the structure due to the stiffness was not considered. The deflection plays an important role for high normal  $N_z$  accelerations. Therefore a special force transfer tool was developed to transfer aerodynamic loads (CFD loads) to the grid of the structural finite element model (CSM). Then a finite element calculation was performed for the displacement of the structure (CSM). A second transfer tool has to be developed to transform the displacement of the CSM grid to the grid of the CFD model. Then the CFD mesh blocks has to be adapted to the displacement of the CFD surface grid. For details see Figure 4.4-2.

Figure 4.4-2 Iteration loop for calculation of CFD loads on flexible F/A-18 structure taking the stiffness into account.

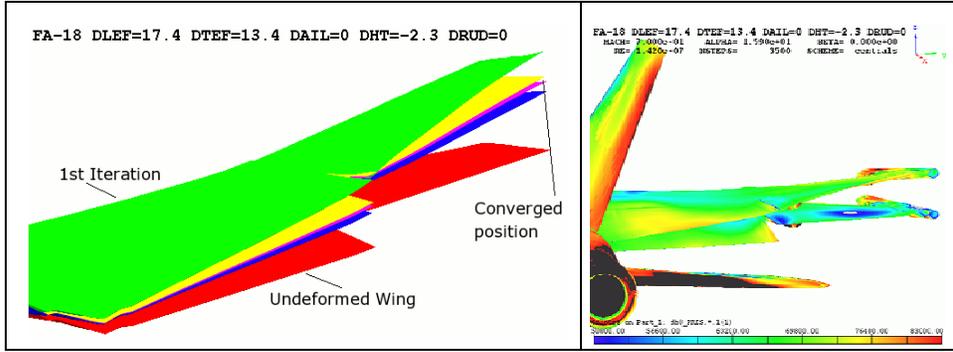
The deflection of the structural components was calculated using the original F/A-18 finite element models. For 8.25g steady state pull up maneuver it just took for iterations to reach the convergence. The loads especially on the wing were reduced compared to the undeformed CFD calculation. RUAG calculations demonstrated that for high g maneuvers the stiffness of the wing structure has to be taken into account for fatigue loads development, see Figure 4.4-3.

Figure 4.4-3 Influence of iterations on the wing displacement and final result with CFD plot.

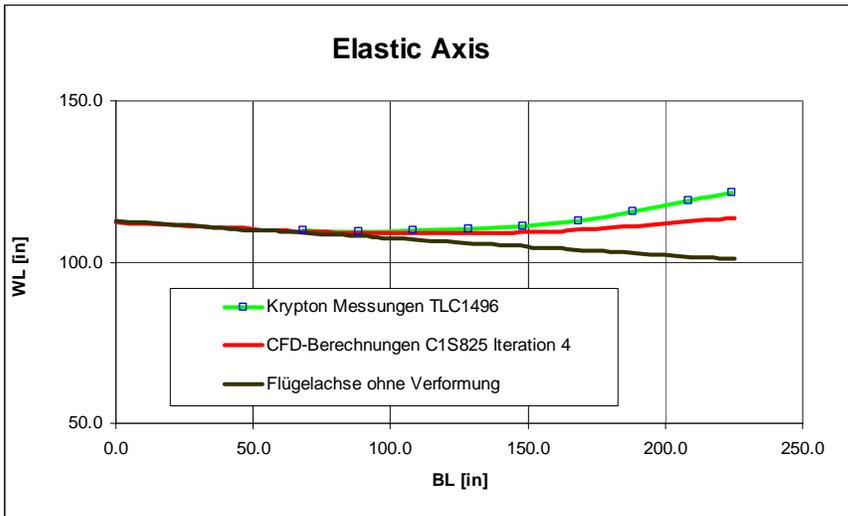
RUAG also made a comparison between the displacement along the elastic axis of the wing between the full scale fatigue test (data measured by Krypton) and the CFD calculation taking the stiffness into account. The outer wing had a much higher bending moment (+ 18%) due to the actuator rod position discussed in the full scale fatigue test chapter. It is therefore not surprising that the CFD calculation showed a smaller displacement especially on the outer wing, see Figure 4.4-4. It is strongly recommend to fully understand the loading of the structure during a full scale fatigue test. The higher loading on the wing has surely an impact on the introduced fatigue damage during cycling. As mentioned in the full scale fatigue test chapter the fatigue life will be much shorter at critical locations compared to the design life of the ASIP study. Such an overtesting gives more margin of safety for the fleet which also could be expressed in higher safety factor compared to the factor of 2 used in the Swiss test.

Figure 4.4-4 Comparison of F/A-18 wing displacement along elastic axis for test data, CFD result, and undeformed wing.

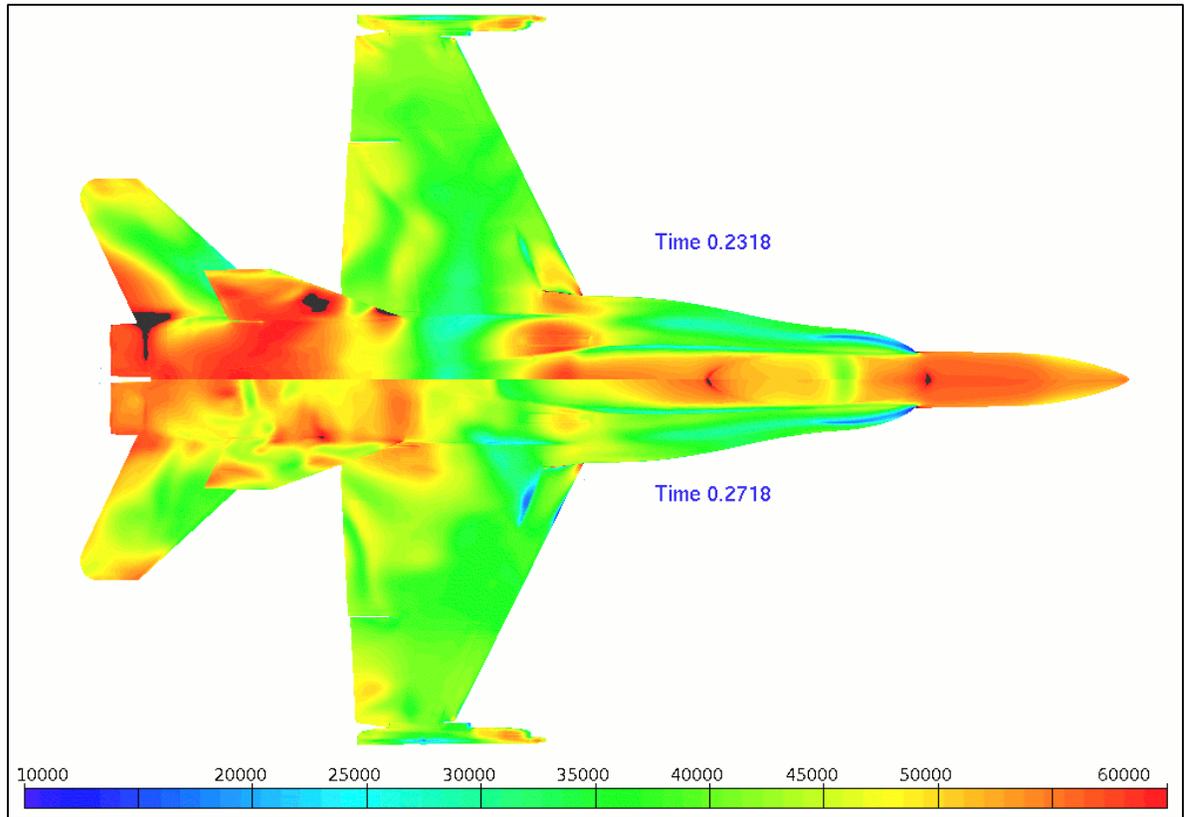
observed. For the two load cases of 8.25g with an angle of attack of  $15.9^\circ$ , respectively  $26.6^\circ$  remarkable unsteady flow was predicted. The Figure 4.4-5 demonstrates clearly the difference in time at 0.2318 and 0.2718 sec for upper and lower part of the Figure. The result of the high dynamic loading on the aft fuselage is well known for buffet problems on the F/A-18 structure.

Figure 4.4-5 Unsteady CFD calculation for two time steps on the F/A-18.

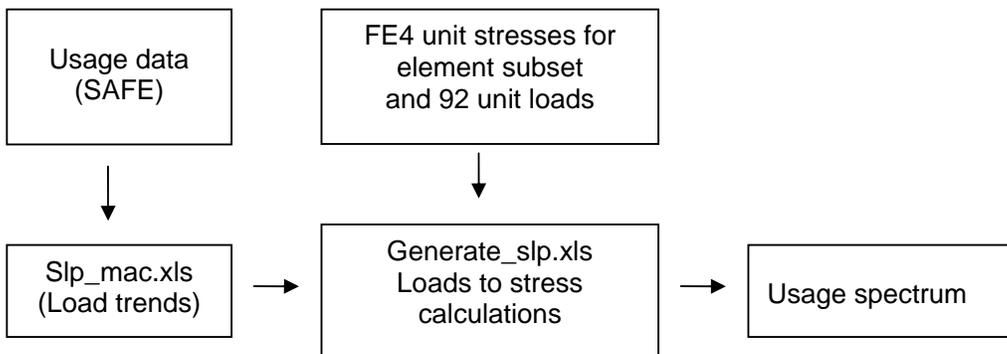
Part of the stress sequence generation with SLP (Symmetric Loads Prediction) is the translation of discrete loads to a derived fleet FE model (FE4) of the Swiss F/A-18. With the loads processing tool slp\_mac loads along the fuselage reference stations and at the interface locations are generated from flight data load trends which are generated from different load sources. Figure 4.5-1 shows the role of the loads to stress calculation in the SLP process.

Figure 4.5-1 SLP process, data and data processing.

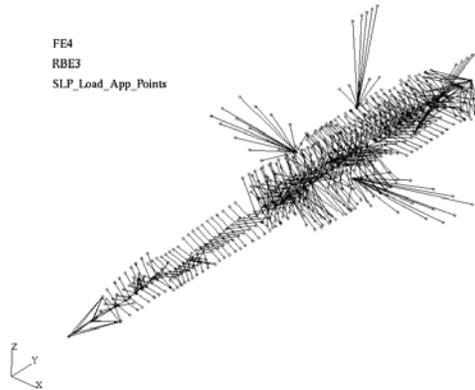
The discrete loads and moments are distributed to the structure with Nastran RBE3 elements. Those RBE3 elements don't add additional stiffness but translate a single load or moment to an equivalent load set. Loads are applied at a total of 80 grid points along the fuselage centre line and at the interface locations. Moments are applied at a total of 12 grid points to the structure at interface locations. The figure below shows the RBE3 elements which were used to spread discrete loads to the structure.

Figure 4.5-2 Nastran RBE3 elements used in FE4.

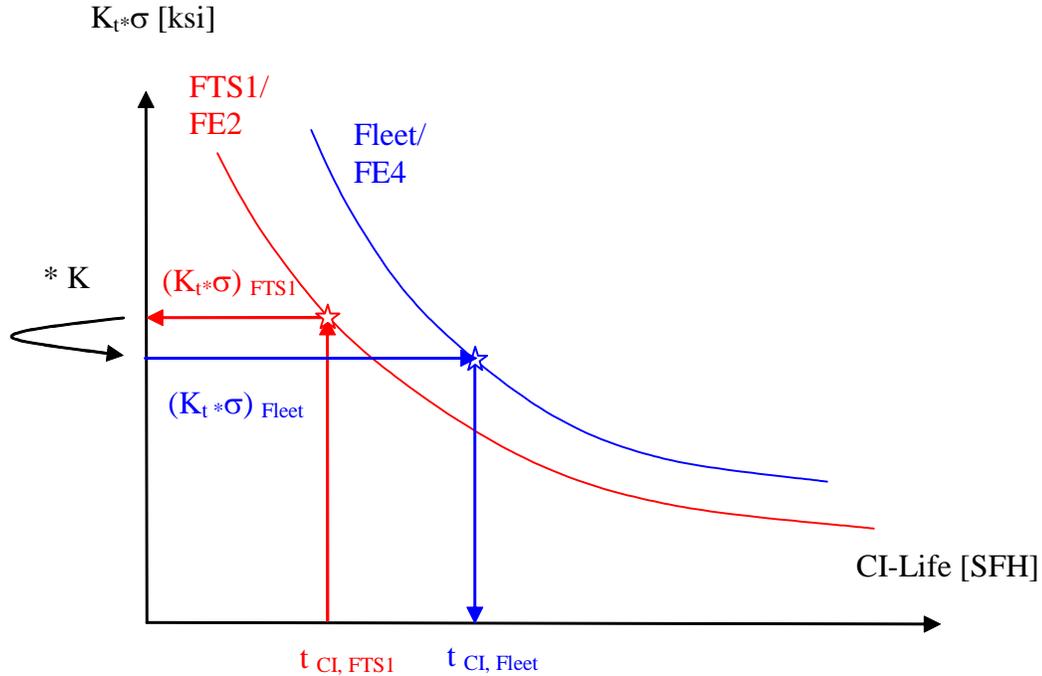
The pegging process as it was applied is shown in the figure below.

Figure 4.5-3 Prediction of crack initiation life for fleet usage
