# **Review of Aeronautical Fatigue Investigations in Switzerland**

**May 2003 – April 2005**

**KOR-TA2005-0252**

**M. Guillaume  
RUAG Aerospace  
CH- 6032 Emmen**

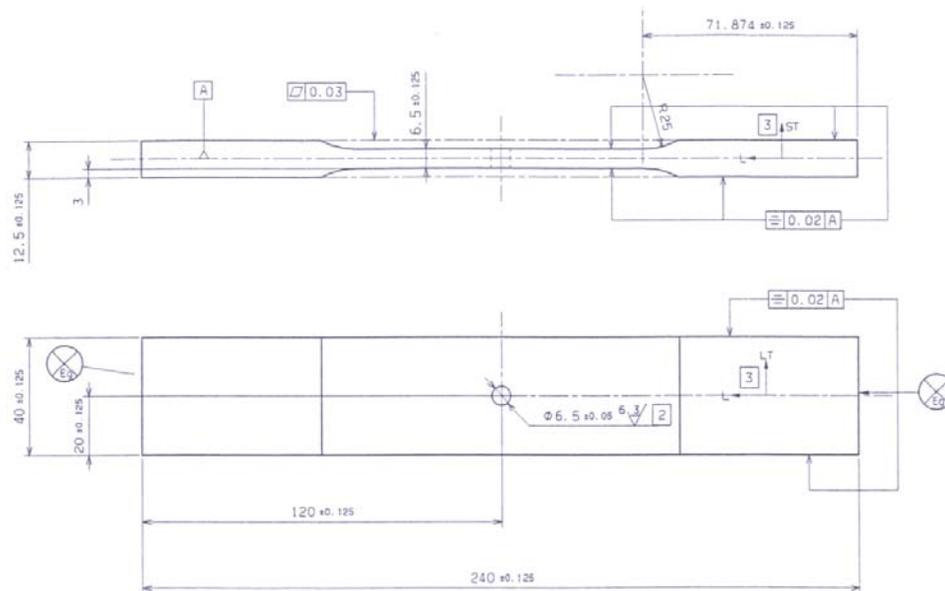
A total of 6 high  $K_t$  Coupons with a 6.5 mm centre hole were tested. The coupon is shown in the figure below.

Figure 4.5-4 High  $K_t$  coupon Al 7050-T7451

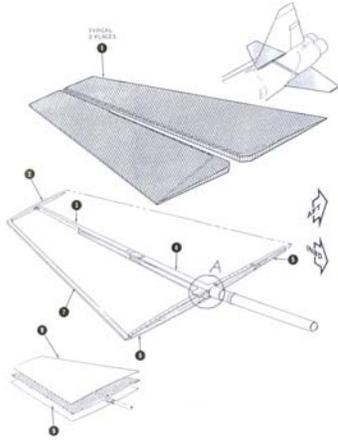
In the year 2002 loose fasteners became apparent on several horizontal stabilizers of the F-5 Tiger fighter aircraft. The horizontal stabilizers of the F-5 are of a free floating design. They consist of an aluminum spar spliced to a steel fitting, aluminum honeycomb core with aluminum skin and aluminum closing rib. The fasteners, some of which were found to be loose, connect the aluminum skin with the steel fitting in the root area of the stabilizer. Additionally to the fasteners, the skin is also bonded to the steel fitting.

Figure 4.5-5 Structure of F-5 horizontal stabilizer.

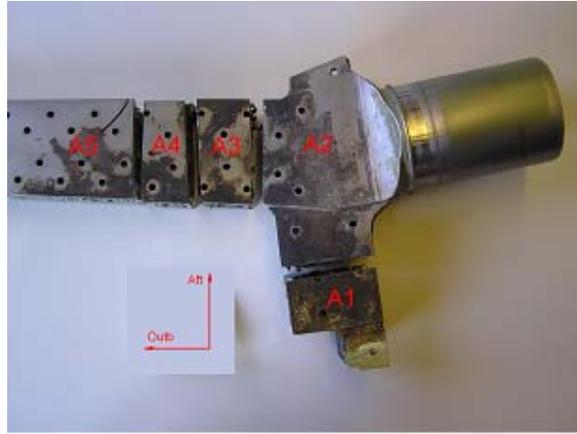
Figure 4.5-6 Corroded steel fitting, sectioned during teardown inspection.

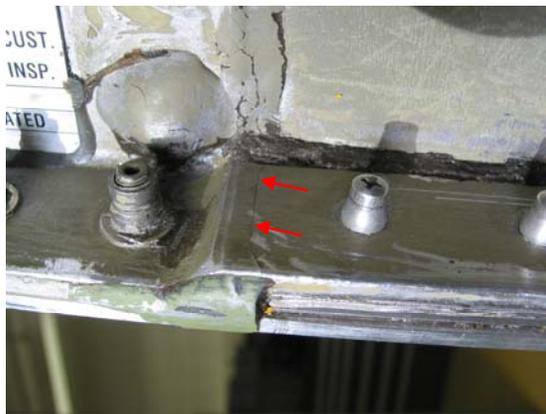
Teardown inspection on 3 stabilizers was conducted. In all 3 stabilizers extensive damage was found in the root region. The disbonds between the steel fitting and the skin were revealed to be of an adhesion failure type on the steel fitting. The steel fitting itself started to corrode, as well as the adjacent aluminum honeycomb. In some small areas the honeycomb core revealed fatigue cracking. Also 2 of the 3 stabilizers showed fatigue cracked closing ribs.

Figure 4.5-7 Cracked closing rib.

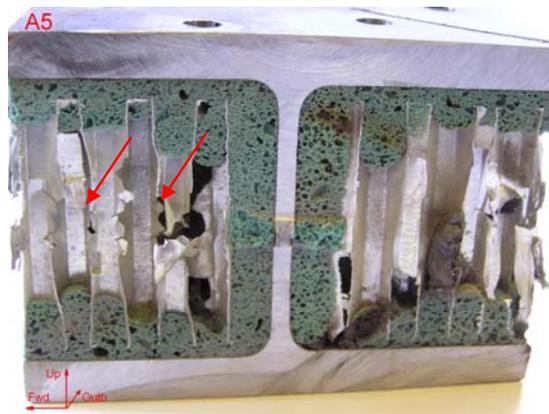
Figure 4.5-8 Corroded and cracker honeycomb core.

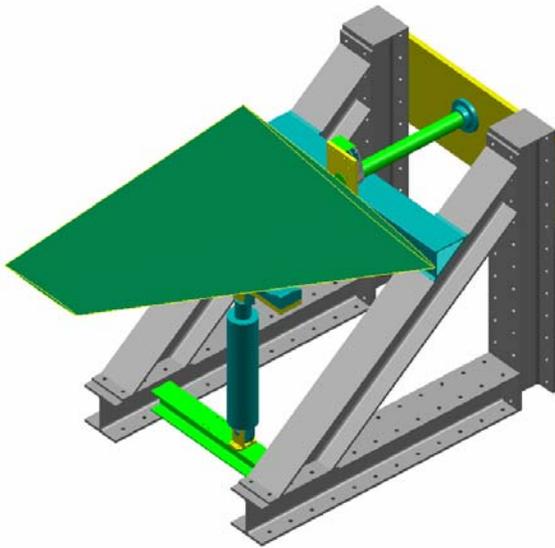
Figure 4.5-9 Layout of static residual strength test.

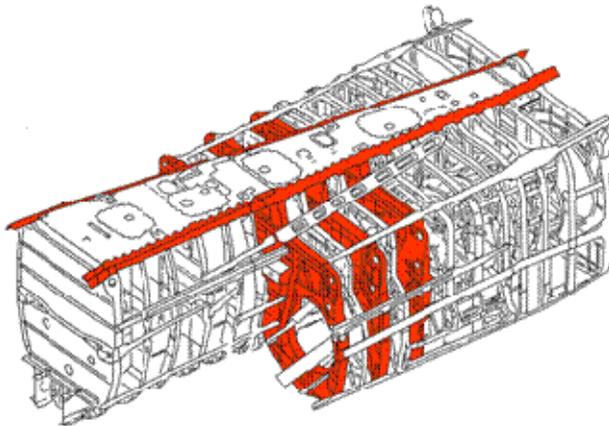
Repair by welding is not an issue for structural parts made of aluminum alloys due to their poor weldability and use in heat treated conditions. Modern lightweight structures often embody parts made of titanium alloys to ensure the fatigue life requirements, e.g. the three Carry-Through-Bulkheads and Dorsal Longerons of the Swiss F/A-18C/D model.

Figure 4.6-1 Structural Titanium parts (shown red) in the Swiss F/A-18C/D center fuselage.

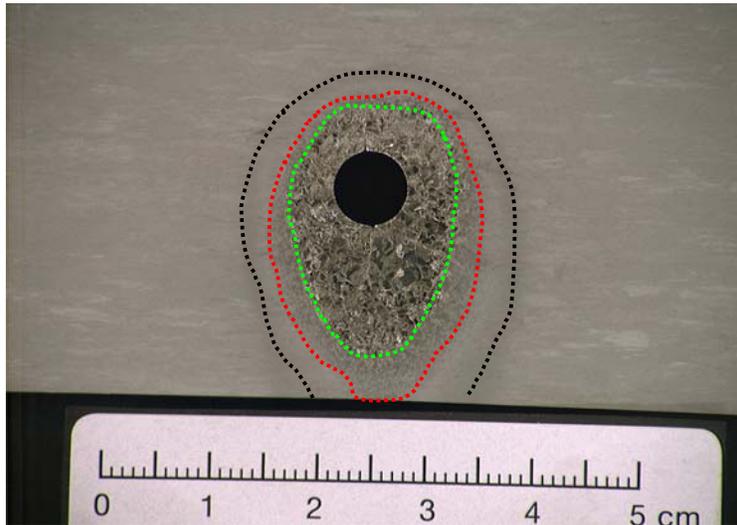
Figure 4.6-2 Typical macrostructure of a welded joint.  
Circled in green: welded material, circled in red: coarse grain zone of the HAZ, circled in black: end of the HAZ.

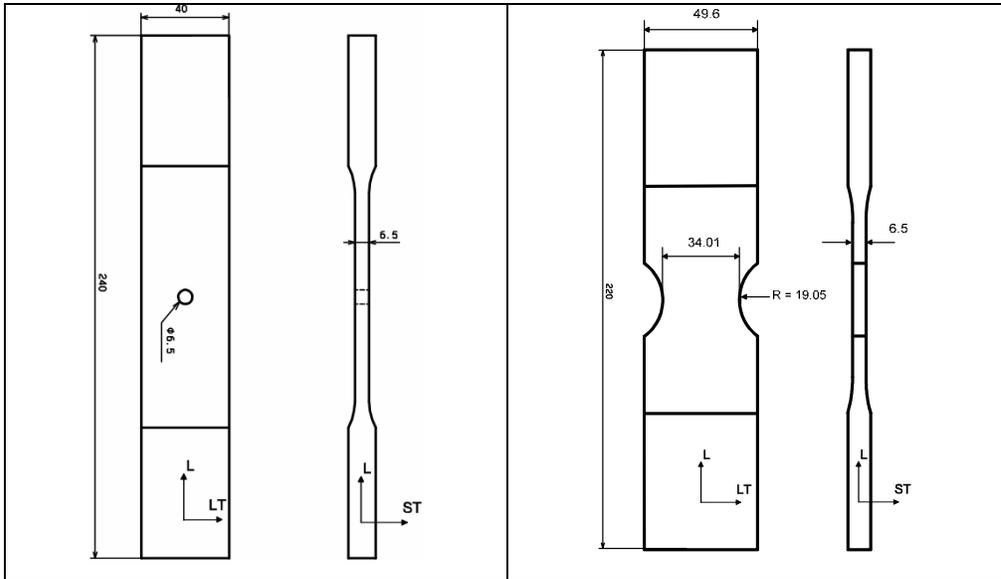
Figure 4.6-3 Coupon Geometry

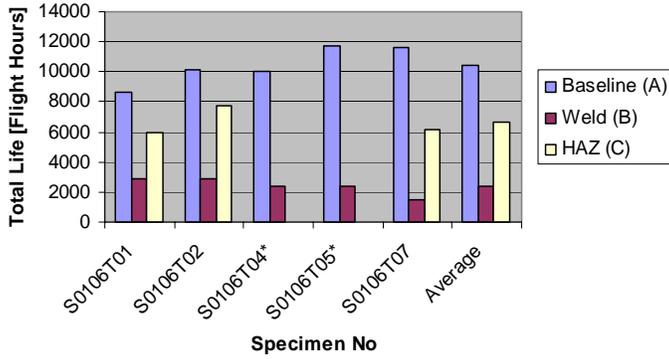
**Total Life of High Kt Sigma 5000 Tests  
(WRBM SD)**

Figure 4.6-4 Total Life Results of the High Kt Sigma 5000 Tests.

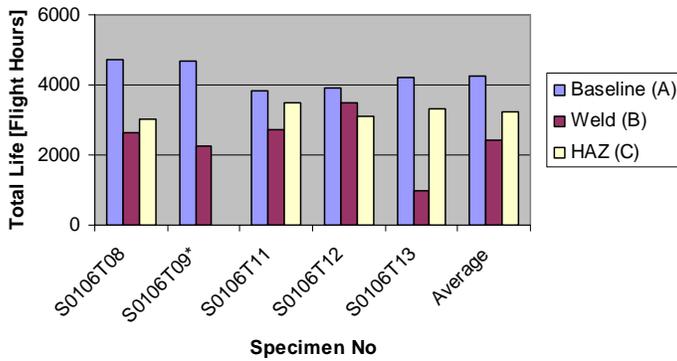
**Total Life of High Kt Sigma 2500 Tests  
(WRBM SD)**

Figure 4.6-5 Total Life Results of the High Kt Sigma 2500 Tests.

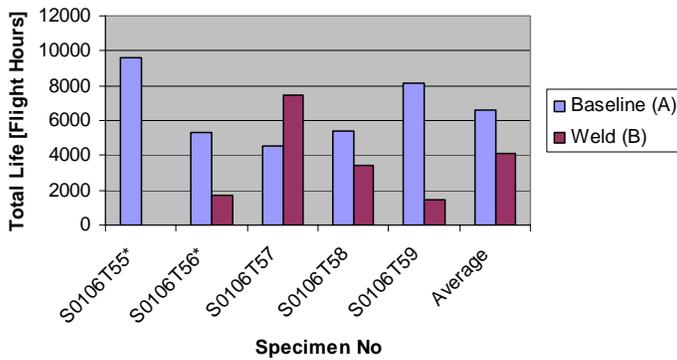
**Total Life of Low Kt Sigma 5000 Tests  
(WRBM SD)**

Figure 4.6-6 Total Life Results of the Low Kt Sigma 5000 Tests.

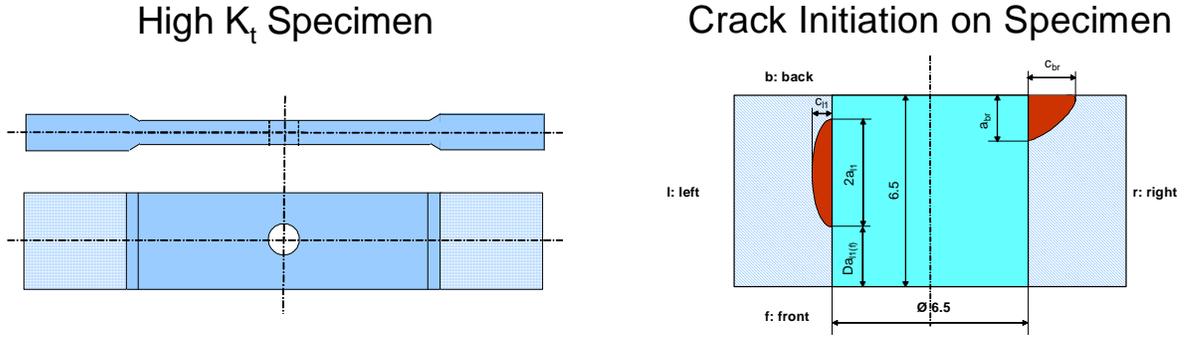
Figure 4.6-7 Typical specimen and crack description used.

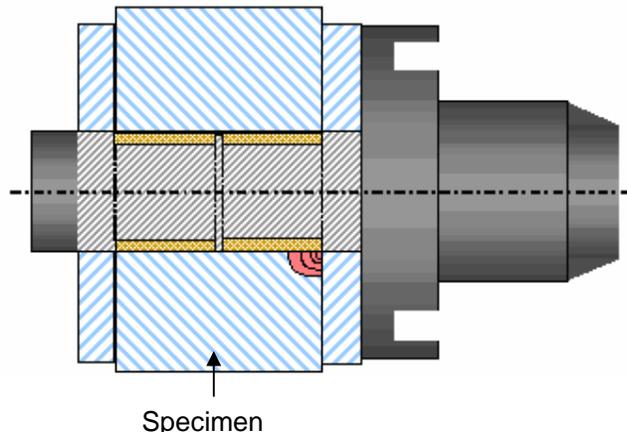
Figure 4.6-8 Eddy current signal and eddy current probe.

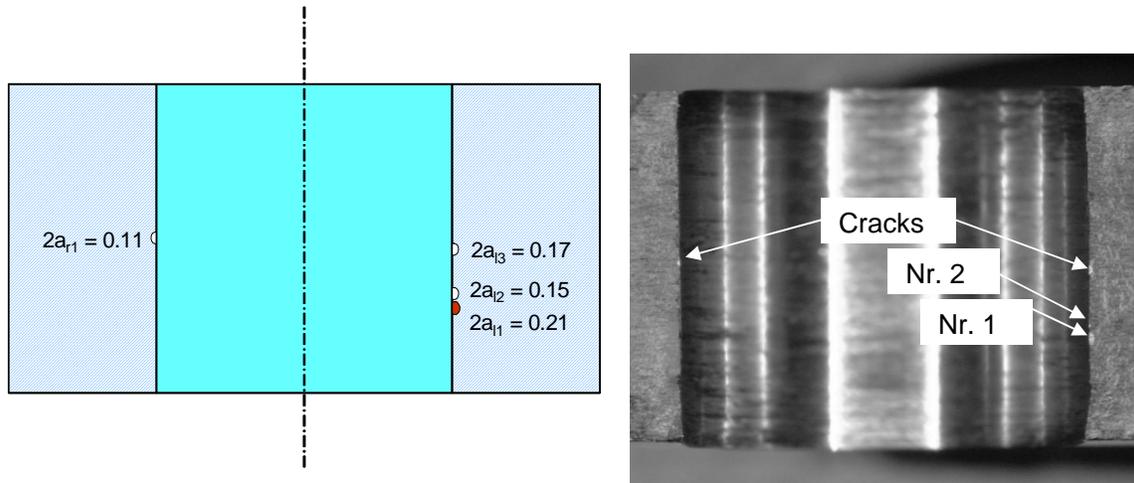
Figure 4.6-9 Force opened specimen after crack sensor exceeded critical signal level. The initiated multiple cracks were evaluated fractographically. Indicated crack lengths are by optical microscope.

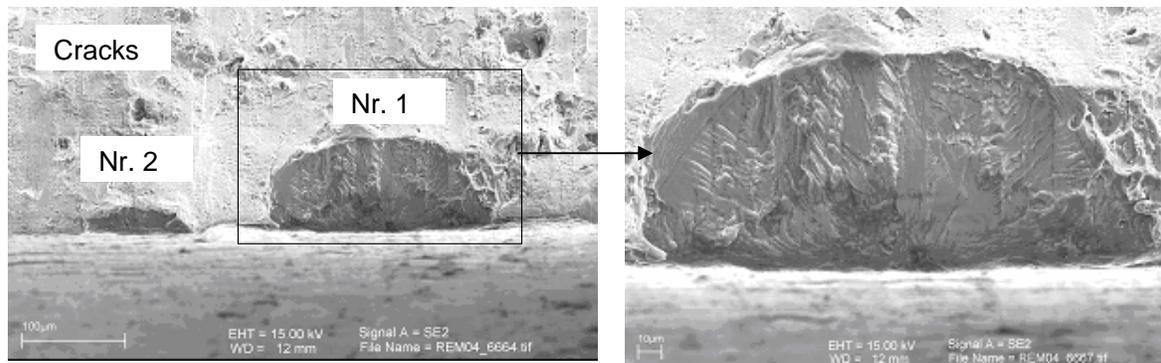
Figure 4.6-10 Pictures of initiated cracks by scanning electron microscope SEM.

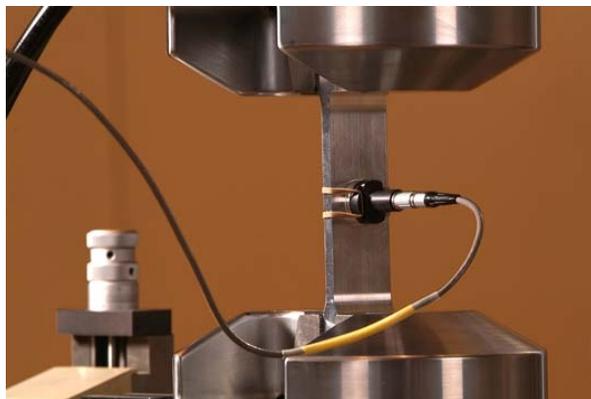
Figure 4.6-11 Crack sensor in place on test specimen.

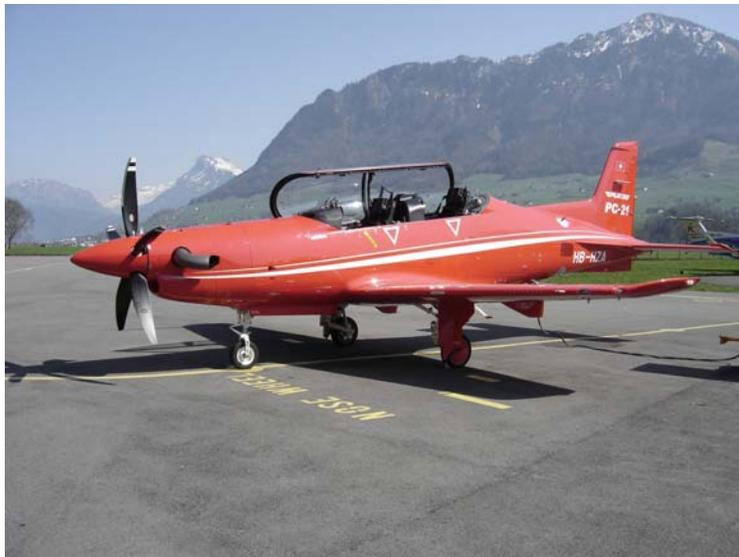
The Pilatus PC-21 trainer is a low-wing monoplane (Figure 4.7-1) with a pressurized stepped, tandem-seat cockpit. It's powered by a 1'600 HP turboprop engine. The aircraft is designed to satisfy the needs of the basic and the advanced pilot training. In addition to the high aerodynamic performance, it is equipped with a mission computer, which has more capacity than any other found in current generation training aircraft.

Figure 4.7-1 PC-21 Trainer.

The primary structure of the aircraft is made of aluminum alloy in machined and sheet form. The aircraft has to meet an operational load factor range of +8g and -4g for symmetric maneuvers. The required service life is 15'000 flight hours for the PC-21 design spectrum.

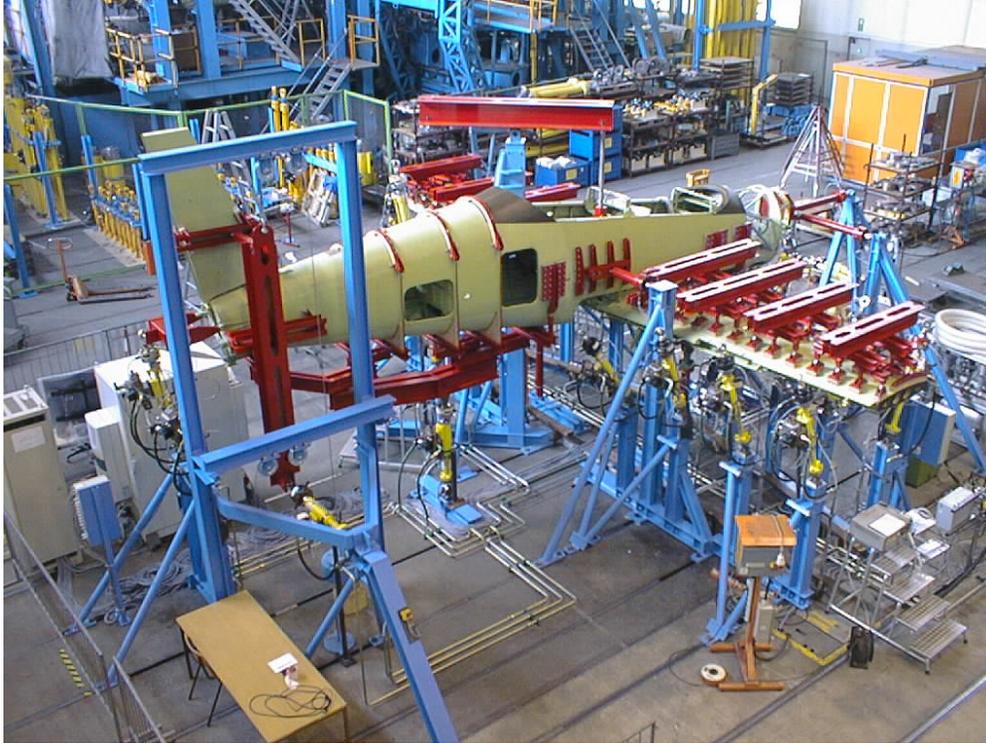
Figure 4.7-2 PC-21 Full scale fatigue test set-up at IABG Ottobrunn.
