**A REVIEW OF RESEARCH  
ON  
AERONAUTICAL FATIGUE IN THE UNITED STATES  
2003 – 2005**

Compiled by  
James L. Rudd  
Air Force Research Laboratory  
Wright-Patterson Air Force Base, Ohio, USA

FOR PRESENTATION AT THE MEETING  
OF THE  
INTERNATIONAL COMMITTEE ON AERONAUTICAL FATIGUE

6 – 10 JUNE 2005

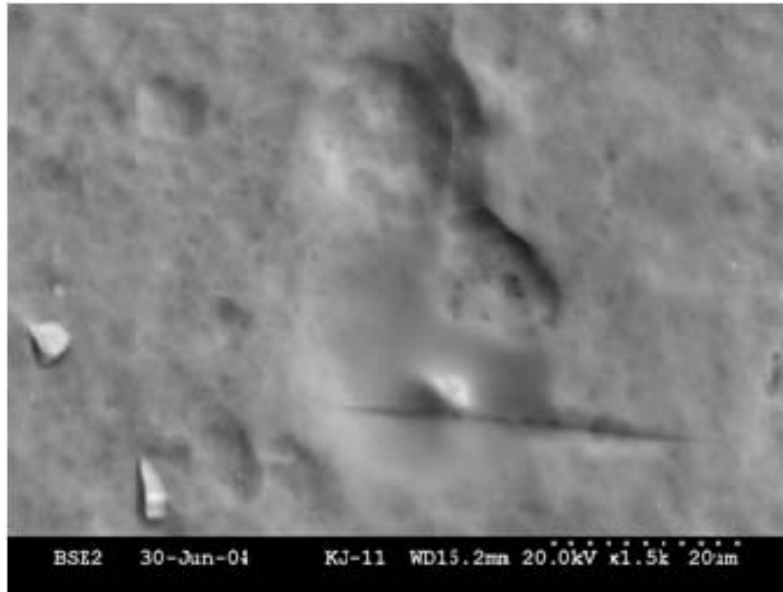
Figure 9.7-25 7075-T6-0.106" Specimen With a Constituent Particle Related Crack: Corrosion Aided in Material Removal Around the Particle, and Subsequently Crack Nucleation.
