# **REVIEW OF CANADIAN AERONAUTICAL FATIGUE WORK 2005-2007**

Jerzy P. Komorowski  
INSTITUTE FOR AEROSPACE RESEARCH  
NATIONAL RESEARCH COUNCIL OF CANADA

## **SUMMARY**

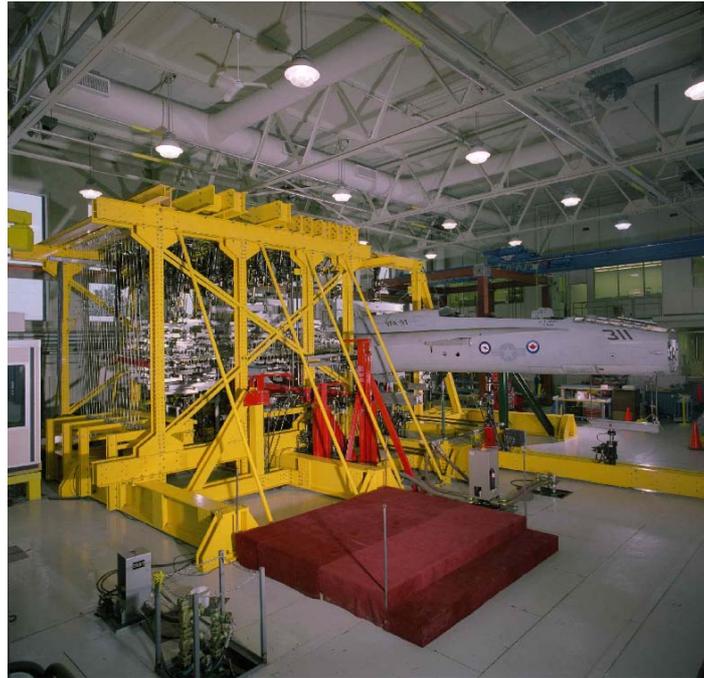
The Structures Laboratory of the NRC-IAR completed the wing fatigue test (Figure 1) to 18256 simulated flight hours by October 29th 2004. After completion of 18256 simulated flight hours of the IARPO3a spectrum, the CF18 wing in FT245 was inspected and residual strength tests were carried out and completed by October 28th 2005. The residual strength testing was required to statically test the wing specimen to load levels twenty percent higher than design limit loads. The Canadian Forces (CF) and Royal Australian Air Force (RAAF), through their airworthiness policies, have a requirement to test fatigued specimens to these levels to ensure the safe operation of the aircraft throughout the service life. To perform this additional testing the maximum loads that combine various interface loading actions, such as wing root bending moment or a combination of wing root bending and wing root torsion, were developed through a Gumble extrapolation of the IARPO3a 326 hour spectra to obtain one in 6000 hour occurrence load magnitudes throughout the envelope. The magnitude and combinations of loading that were applied in these tests were documented in the residual strength test report. Thirty-seven static tests in the test end configuration were applied following a planned end of fatigue testing inspection. Then three critical areas of the wing specimen were statically tested to 120% design limit load with induced damages. Following these load cases two ultimate load cases were applied. An ultimate wing root bending moment combined with an ultimate wing root shear case was applied as well as an ultimate aft fuselage bending moment case was applied. These additional tests were intended to aid the CF and RAAF in demonstrating the inconsequential nature of the cracked structures for airworthiness and help substantiate a fleet management approach that may employ a safety-by-inspection and replacement on condition philosophy. The RST report document provides a summary of the applied loads, measured strains, displacements and resultant data for each of the load cases. Post test examination of the structure has revealed numerous cracks. NRC Aerospace is in the process of documenting all the damages.

**Figure 1 FT-245 Wing Fatigue Test**

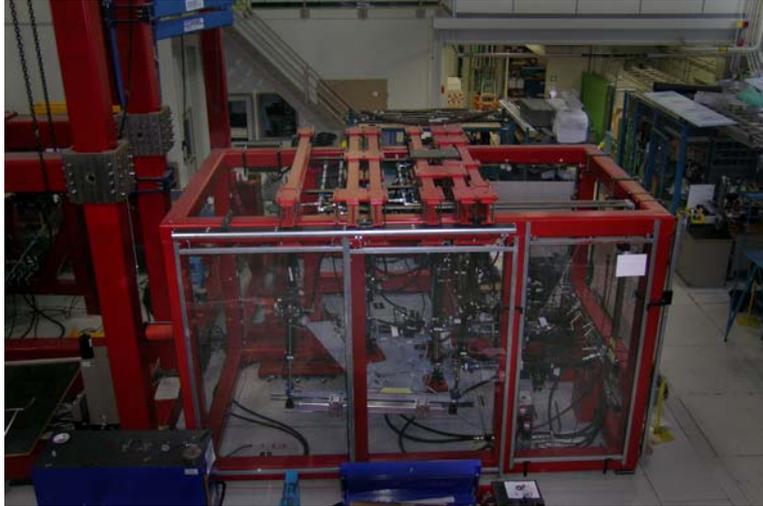
**Figure 2 FT-193 Extended Fatigue Test Set-up**

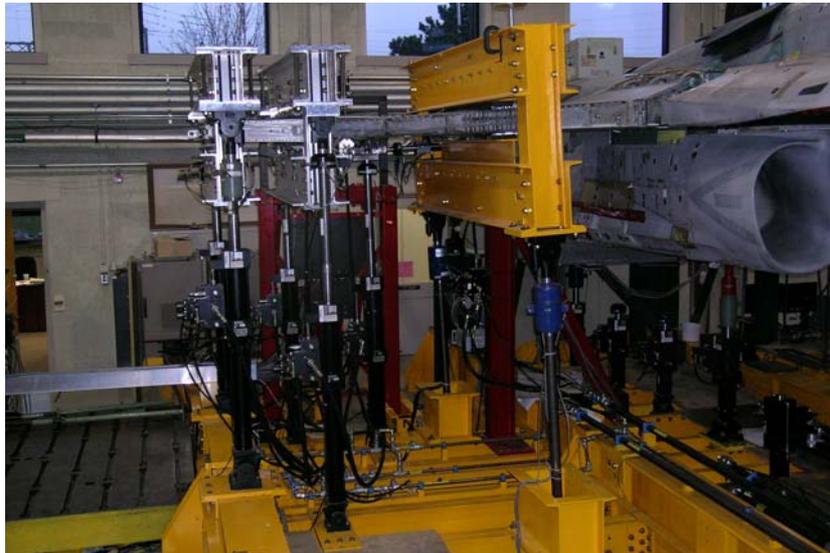
**Figure 3 FT-169 Extended Fatigue Test Set-up**

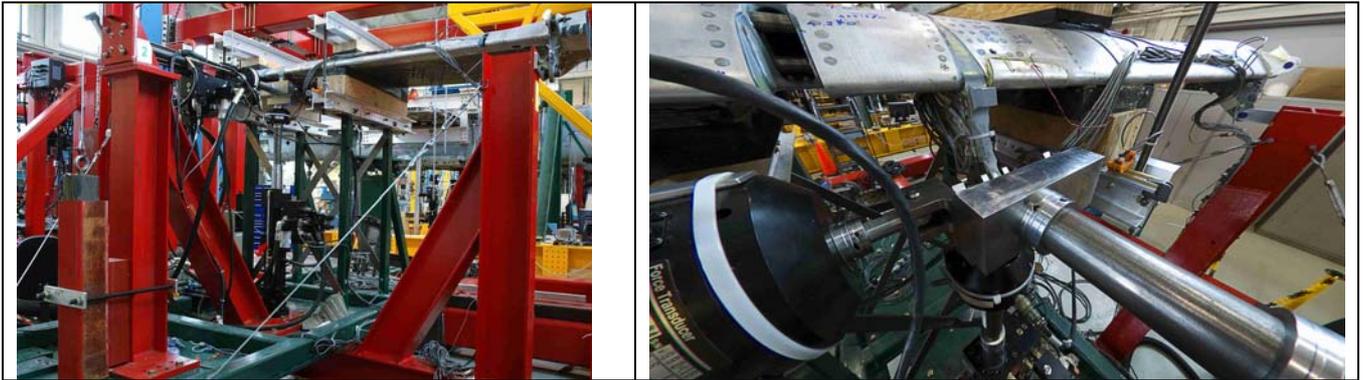
**Figure 7 F/A-18 FT333 CF-18 Trailing-edge Flap Outboard Lug Fatigue Test Set-up and Tri-Axial Lug Hinge Attachment**

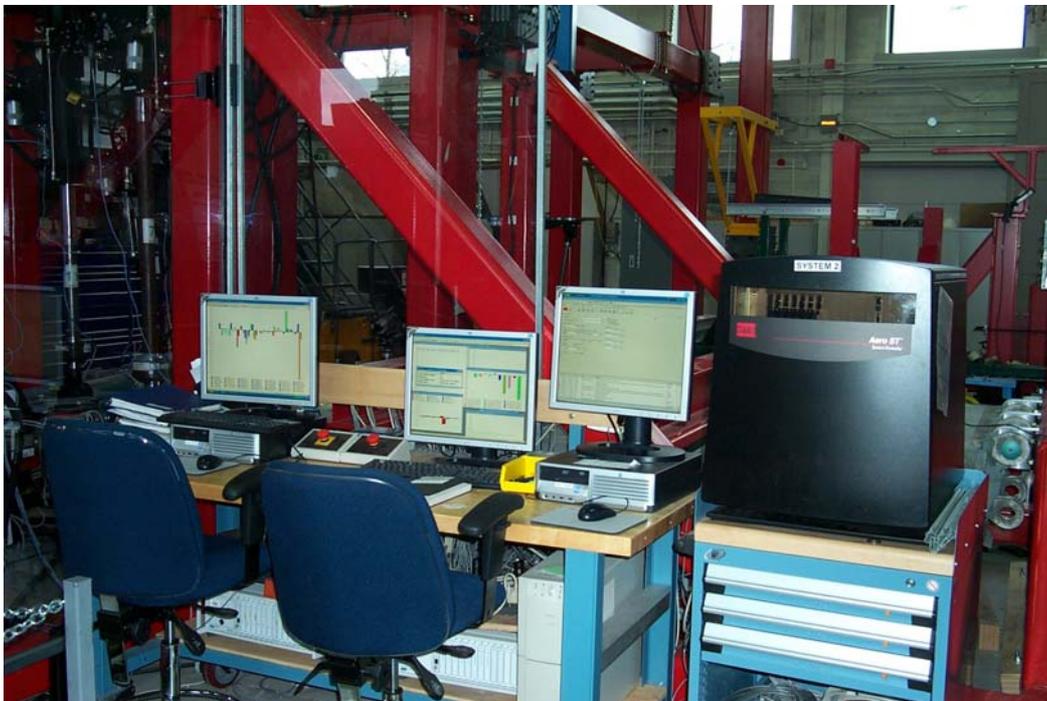
**Figure 8 F/A-18 FT193 MTS's AeroPro™ and SOFFT Control System Set-up Adjacent to the Rig**

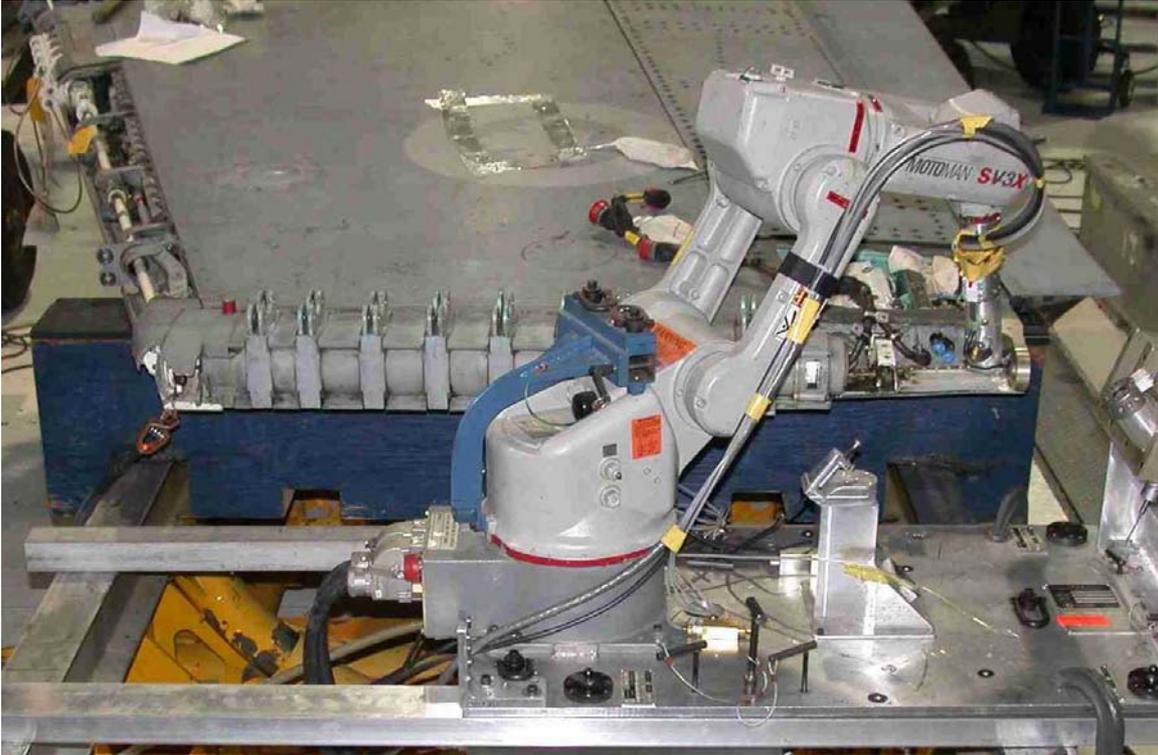
**Figure 50** Robotic Material Removal Modification on the Inner Wing

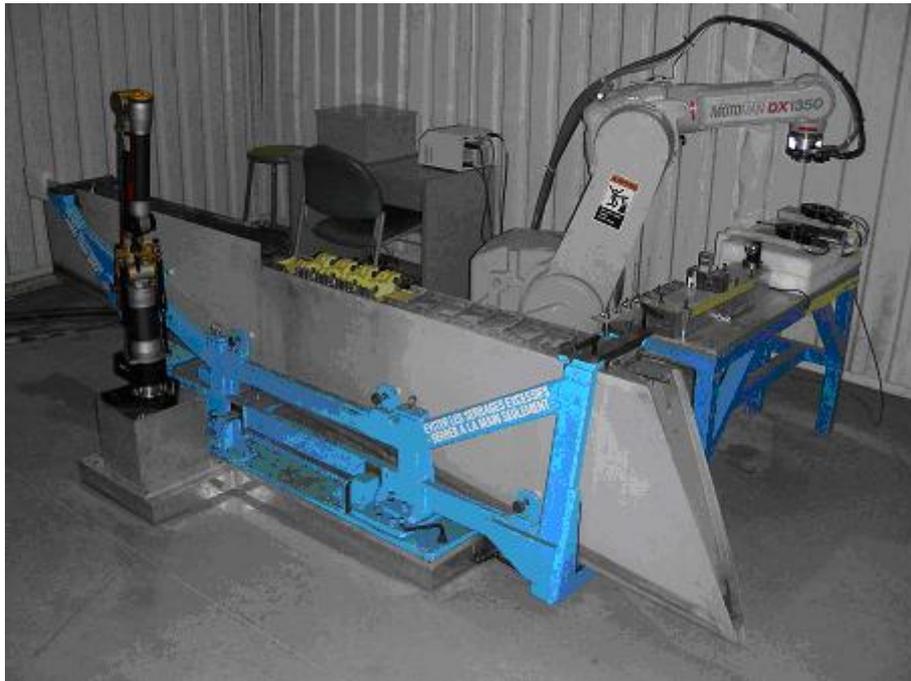
**Figure 51** Robotic Material Removal Modification on the Inboard Leading Edge Flap

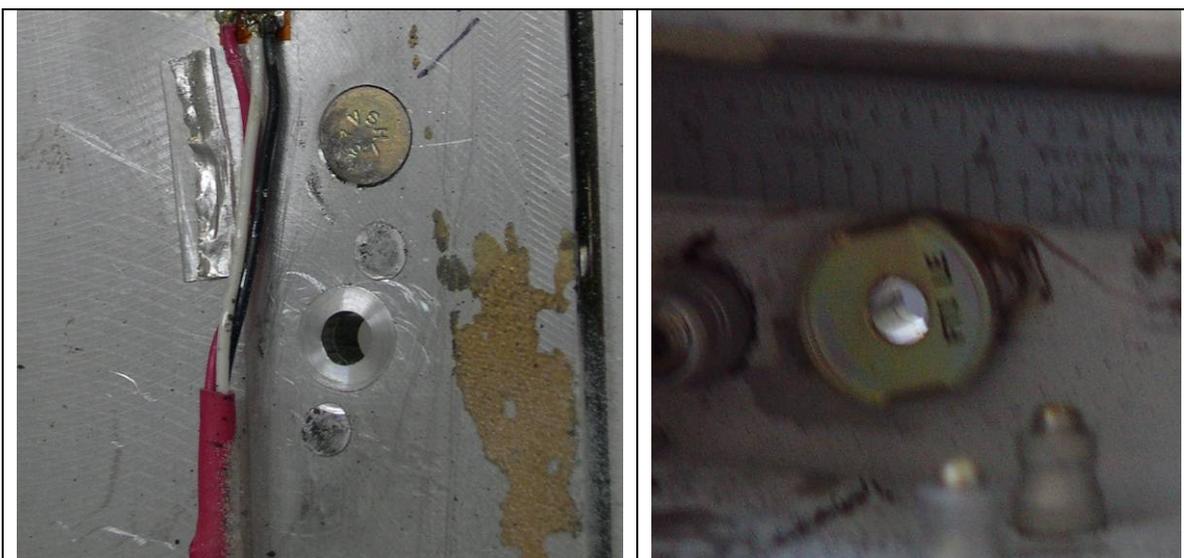
**Figure 57 Two Forcetek Rivetless Nut plates that were successfully tested in the WS167 component spectrum fatigue test.**

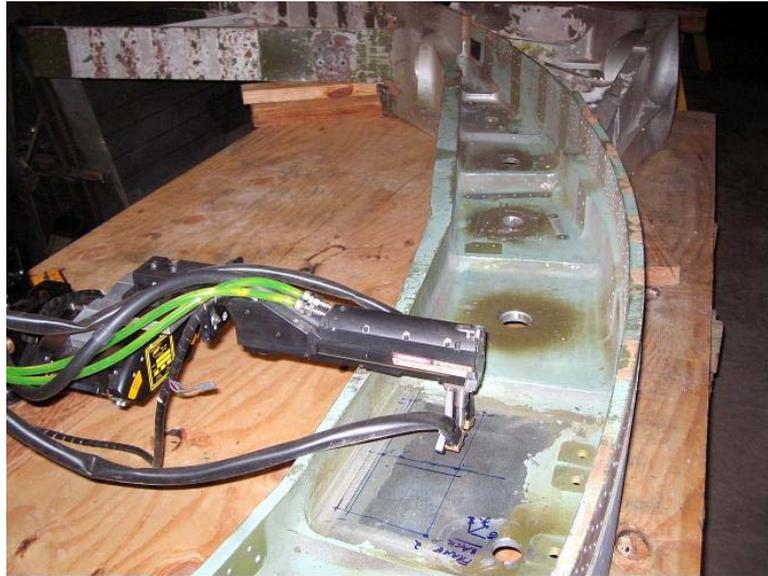
Figure 58 Measuring residual stress on a C-141 998 frame pocket with XRD.

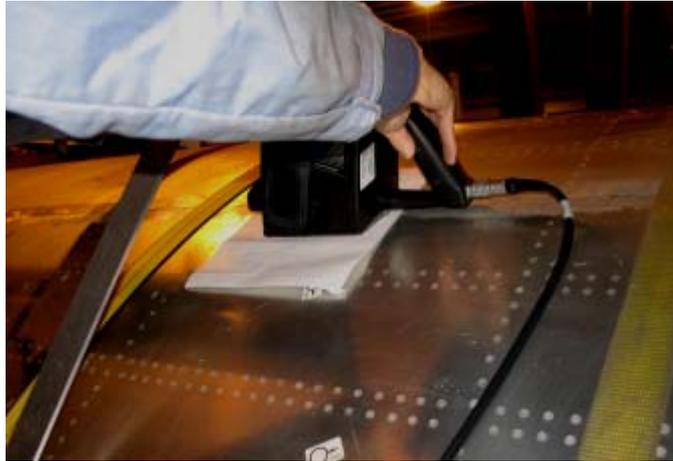
**Figure 69 Magneto-optic inspection head.**

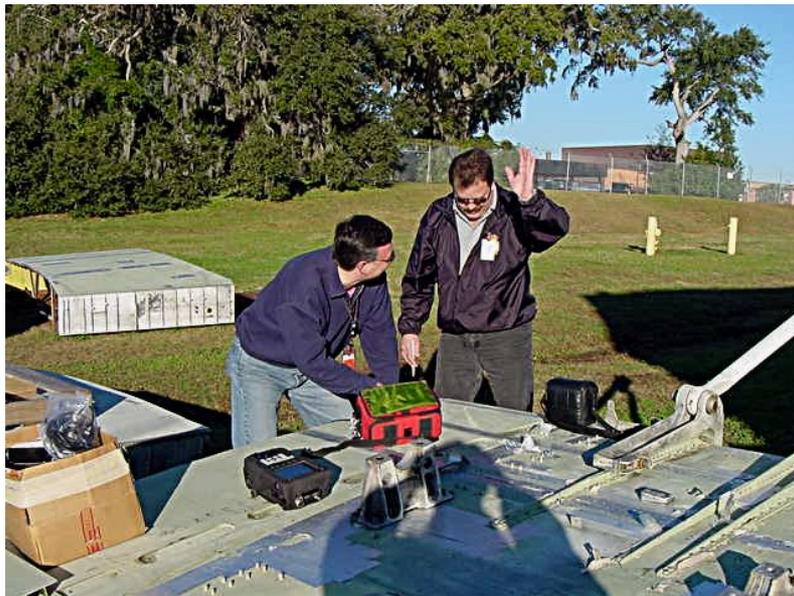
**Figure 71 Trial Inspection of P-3A Wing**
