**REVIEW OF AERONAUTICAL FATIGUE
INVESTIGATIONS IN JAPAN
DURING THE PERIOD JULY 2005 TO MAY 2007**

For Presentation at the 30th Conference of
the International Committee on Aeronautical Fatigue

Naples, Italy, 14-15 May 2007

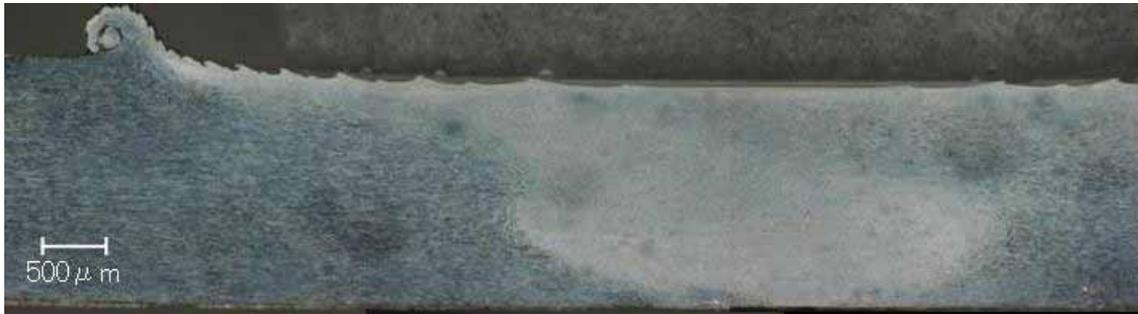
Figure 12.5 Section Perpendicular to the Welding Line

Figures 12.5 and 12.6 show the section perpendicular to the welding line and parallel to it, respectively. The feature for perpendicular section is close to that reported in other papers. The periodic feature is observed on the section parallel to the welding line. It is found that the measured pitch of the tool mark and that of the periodic feature are same as the ratio of the tool traveling speed to the tool rotation speed. This tendency is also observed other joining condition.

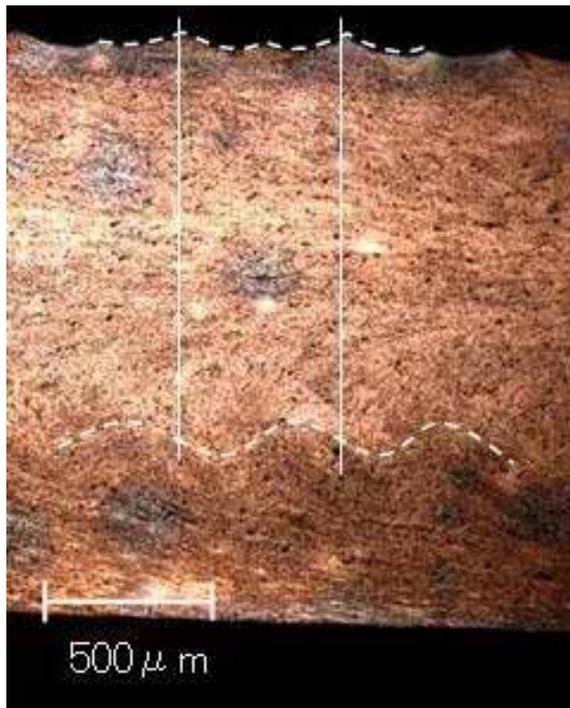
Figure 12.6 Section Parallel to the Welding Line

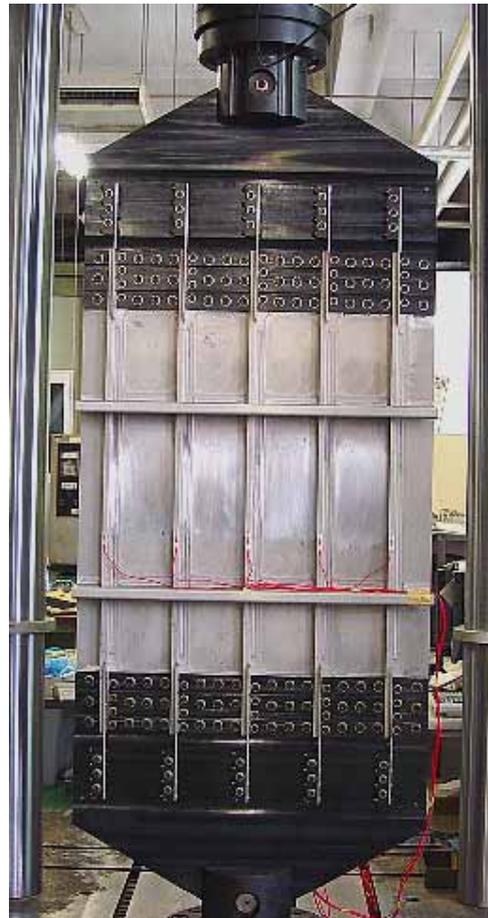
Figure 12.7 Five Stringer Panel

In this study, the crack propagation properties were evaluated by using the panel of five stringers with initial cracks, which is shown at Figure 12.7. The crack propagation properties of FSW and riveted panels are shown at Figure 12.8. The crack propagation speed of FSW panel is much faster than that of riveted panels. The crack propagation time from visible size crack (50.8mm) to critical crack length of FSW panel is 1/3 of that of the riveted panel. The crack propagation of the FSW panel is accelerated by the tensile residual stress due to FSW and the crack propagation from skin to stringers. The cracks, initiated at skin, propagated directly to the center stringer, and the center stringer was broken before the skin crack did not become so large. Then the center stringer was unable to stiffen the panel, the skin crack propagation speed became faster. So the crack propagation properties of FSW panel are inferior to those of riveted panels.

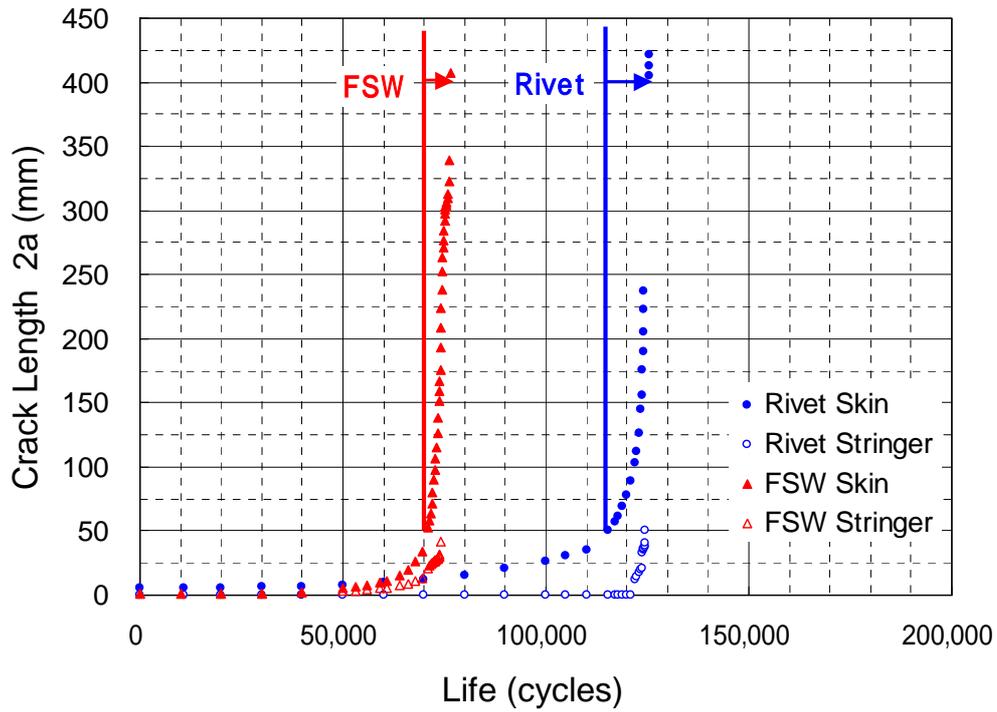
Figure 12.8 Crack Propagation Properties of FSW and Riveted Panels

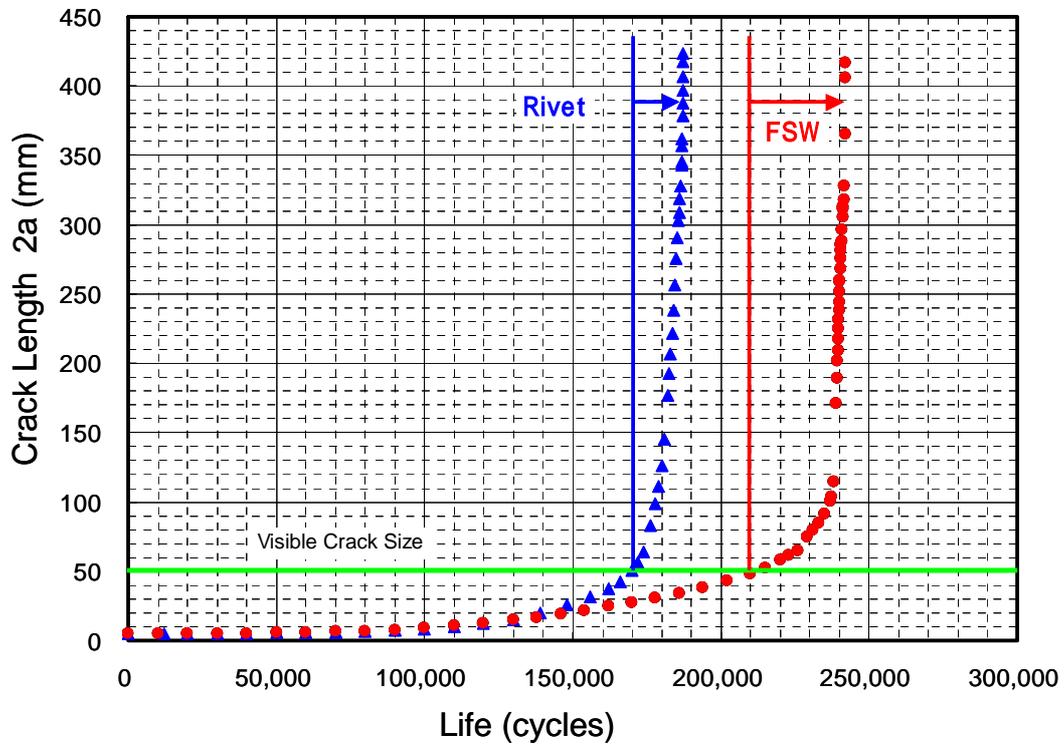
Figure 12.9 Crack Propagation Properties of Roller Burnished FSW Panels

The crack propagation properties of FSW coupon specimens after the burnishing treatments were evaluated. The crack propagation properties of those specimens depended on the burnishing conditions. In case of good burnishing condition, the crack propagation properties are better than those of riveted joints. The FSW panels with the burnishing treatment were also evaluated in this study. The test results are shown at Figure 12.9. And we have found that this method is very effective to improve the crack propagation properties of FSW panel.

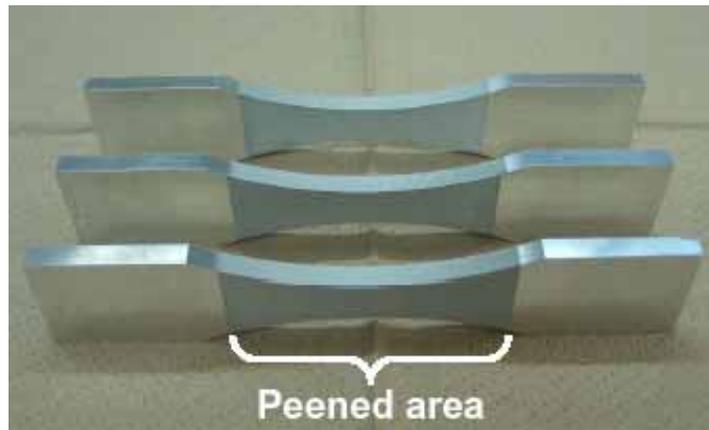
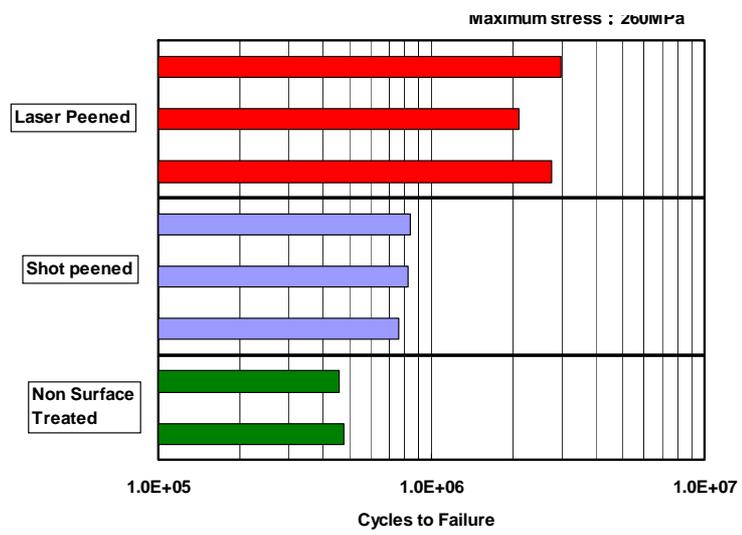
Fig. 12.10 Un-notched Coupon Test

After establishing process parameters, coupon fatigue tests for un-notched specimens and flat plate with a central circular hole specimens were conducted. Figure 12.10 shows that the fatigue life of un-notched laser peened specimens are enhanced more than three times of shot peened specimens. The flat plate with a central circular hole specimens were used for evaluating the fatigue characteristics improvement on condition of the stress concentration.

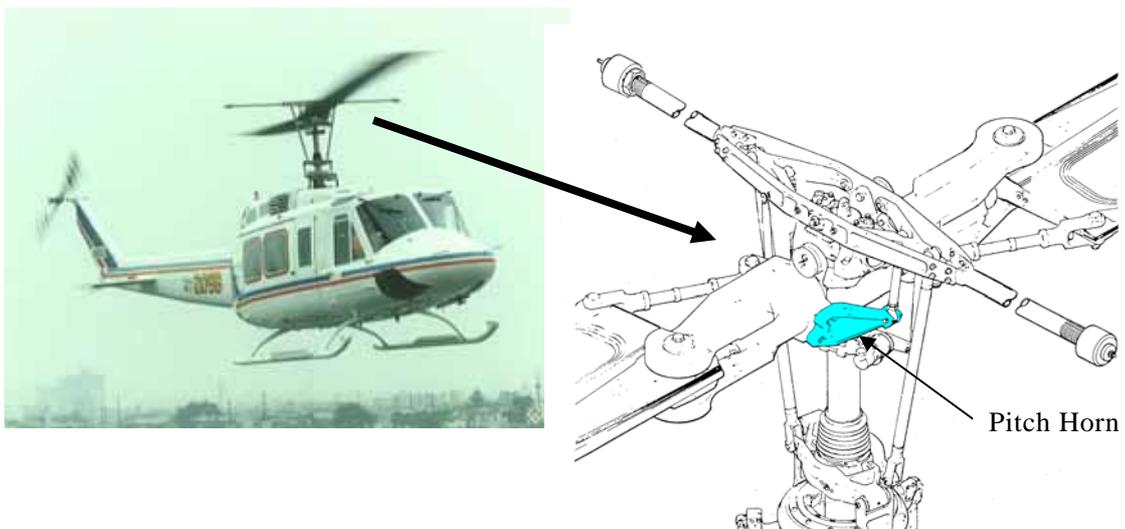
Figure 12.11 Pitch Horn of Helicopter

The actual-sized element test specimen was simulated as a pitch horn. The pitch horn is a part of flight control system for the main rotor of helicopter (see Figure 12.11). The pitch horn in actual helicopter is loaded by about 5Hz high cycle fatigue load during flight, then the retirement life is assigned to this part because of fatigue damage during operation. The actual-sized element test was conducted by applying simple sinusoidal load, as shown in Figure 12.12. The laser peened specimen showed the fatigue enhancement compared with untreated specimen.

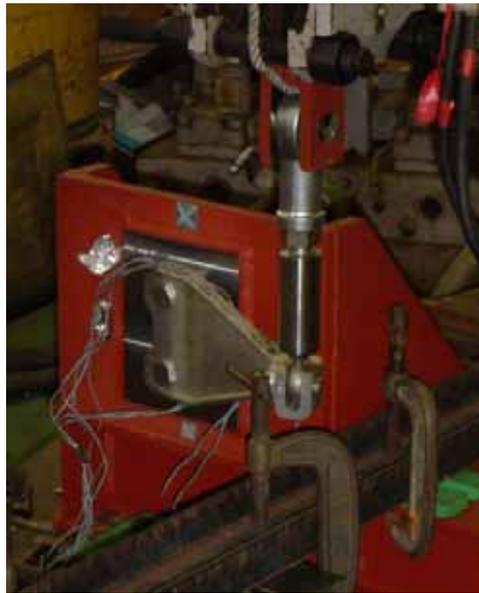
Figure 12.12 Actual-Sized Element Test (Pitch Horn)

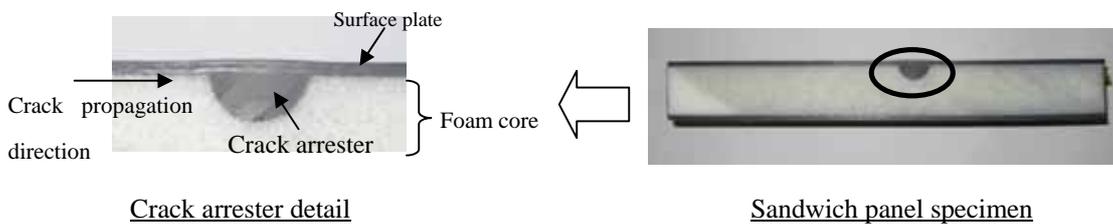
Fig. 12.13 Crack Arrester Concept

A new type of crack arrester was proposed for an interfacial crack between a facing and a core for a CFRP / foam core sandwich panel based on the behavior that the interfacial crack in the foam core sandwich panel remained between the surface skin and the foam core. It was considered that the dissimilar material with higher stiffness on the crack propagation path would suppress crack propagation. The concept of the crack arrester is shown in Figure 12.13. This report describes the analytical prediction and experimental validation of this concept in the mode I type loading condition.

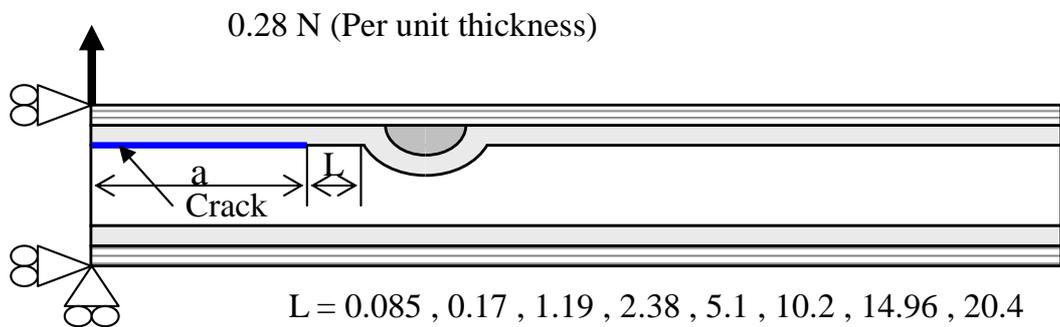
Fig. 12.14 Loading Condition of the Test Specimen

Finite element calculations were carried out to evaluate the driving force of the interfacial crack using fracture mechanics parameters. Here, the energy release rates were calculated under mode I type loading conditions with FE models of test specimen configurations. These energy release rates with and without the crack arrester were compared. Loading condition of the test specimen is shown in Figure 12.14.

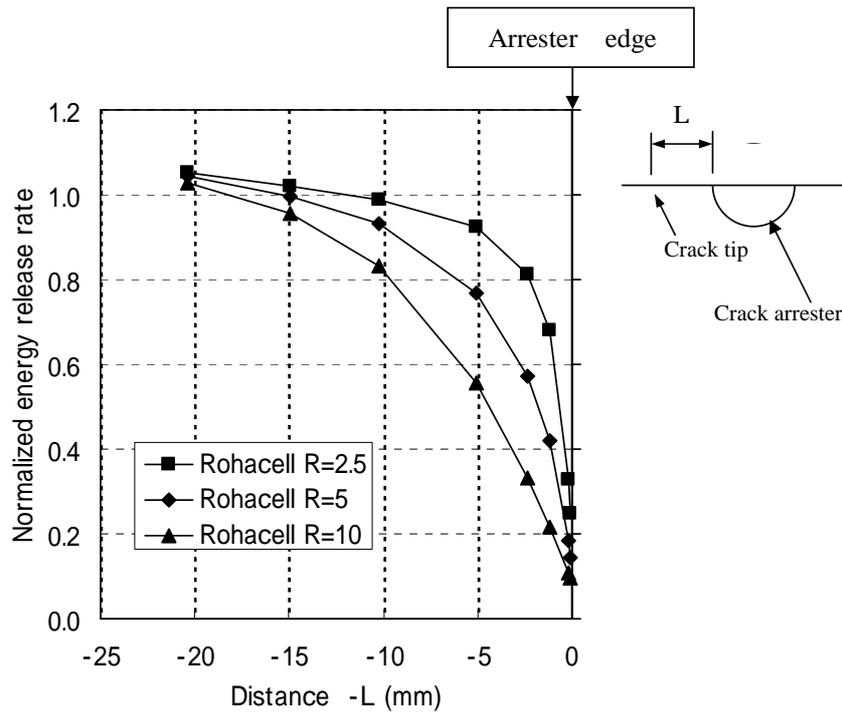
Fig. 12.15 Relation between Energy Release Rate G and Distance L for Mode I Type

the FE analyses as the crack tip approached the crack arrester. The energy release rate at the crack tip was abruptly reduced starting at a point of 15 mm from the leading edge of the crack arrester and converged to a small value close to zero near the arrester edge. The relation between normalized energy release rate and distance L is shown in Figure 12.15. In this figure, “Normalized energy release rate” is defined as a ratio between the energy release rate with a crack arrester and that without an arrester (using the same crack length). Distance L is also defined as the length between the leading edge of the crack arrester and the crack tip.

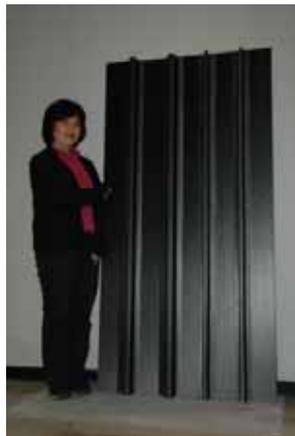
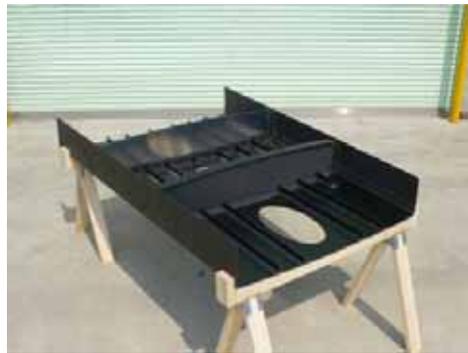
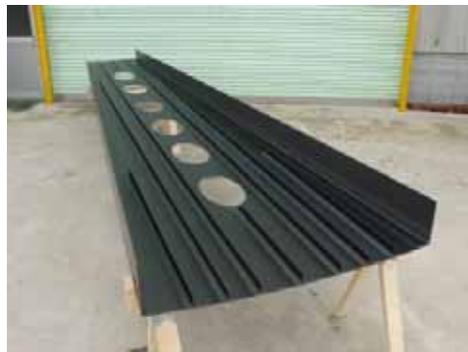
Figure 12.21 Three Types of Demonstrators Manufactured by VaRTM Process

a) 2m stiffened panel

b) 2.1m long demonstrator

c) 6m long demonstrator

The formability is evaluated by manufacturing the three types of demonstrators: (a) the 2m long stiffened panel, (b) the 2.1m long wing structure, and the third demonstrator of (c) 6m long full-scale wing structure (See Figure 12.21).

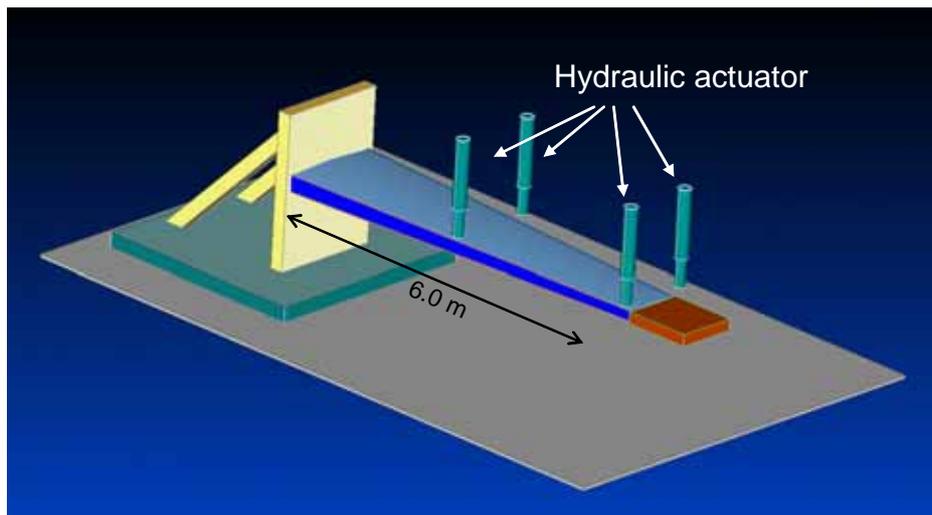
Figure 12.22 Experimental Setup of Full-scale Static Test of Wing Box

Furthermore, the full scale static test of wing box fabricated from VaRTM graphite-epoxy material is planned as the final step of this project. (See Figure 12.22) This wing box represents the load-carrying wing box of a 30-passenger commercial aircraft. The upper and lower skin panels, the front and rear spars, and ribs are fabricated from VaRTM graphite-epoxy material, minimizing the number of mechanical fasteners needed to assemble the wing box. The wing box was designed to withstand associated with two flight conditions: 2.5G upbending and -1.0G downbending. The loads are introduced through 4 hydraulic actuator/load cell assemblies. Each actuator/load cell assembly is connected to the floor and to the wing box by using swivels which would allow the actuator to rotate as the wing box deforms. The hydraulic actuator control system, Aero ST produced by MTS, is adopted to control the loading, and the high frequency data acquisition systems produced by Kyowa Electronic Instruments Co., Ltd. and VXI Technology Inc. are adopted to record data from all instrumentation. The wing box will be subjected to a 50% DLL (Design Limit Load) test for the -1.0G and 2.5G flight conditions to verify accurate function of all components and instrumentation, followed by a 100% DLL test. Finally, the wing box will be subjected to a 100% DUL (Design Ultimate Load) test for the 2.5G flight condition.

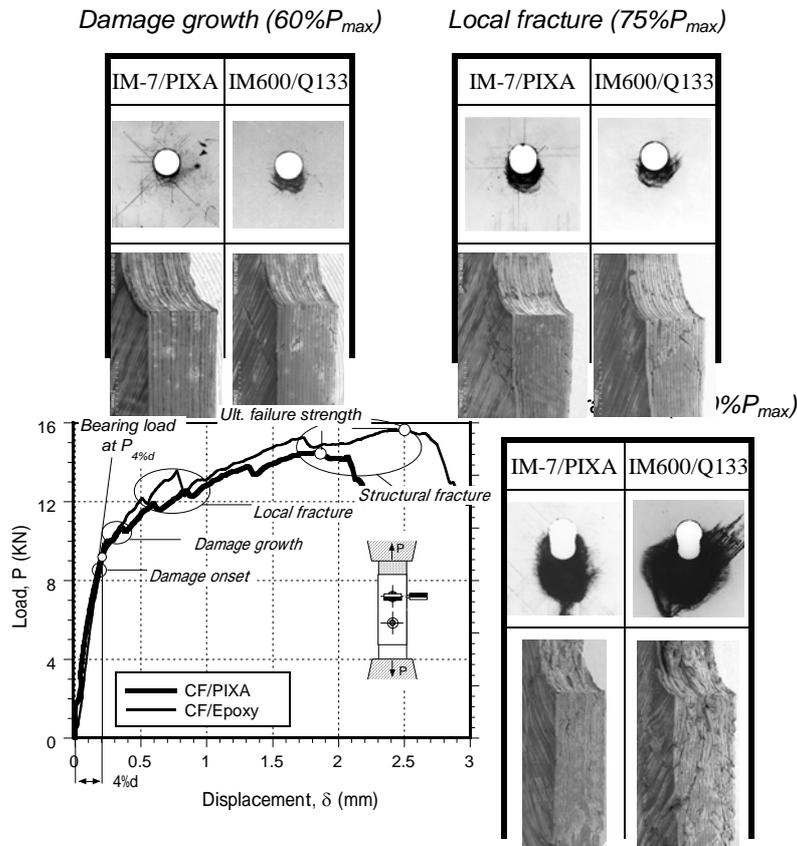
Figure 12.23 Relationship between Bearing Response and Damage Progression for IM-7/PIXA and IM600/Q133 Composite Joints.

progression behavior in bolted composite joints will be summarized as following. Figure 12.23 illustrates the strength and damage characteristics determined by this study. Bearing failure induces a compressive damage accumulation process that can be classified into four stages: damage onset, damage growth, local fracture and structural fracture. Fiber micro buckling and matrix cracking appear to be the dominant modes for the onset of damage, while the final failure stage is dominated by out-of-plane shear cracks and delamination. The lateral constraints and the matrix "toughness" based on the laminate also influence the bearing failure and damage mechanisms. Moreover, the accumulation of damage resulted from fiber micro-buckling, fiber-matrix shearing and matrix compression failure in the individual laminate layers.

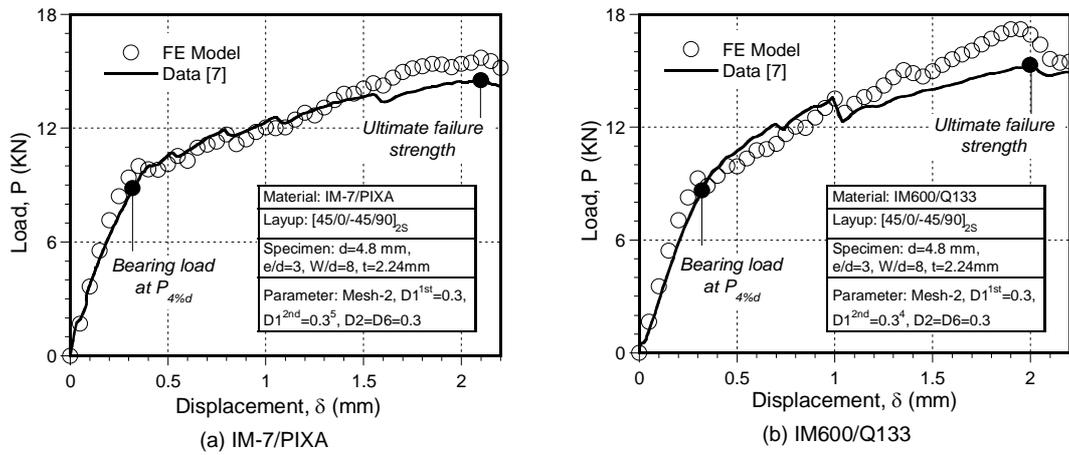
Figure 12.24 Comparison between Measured and Calculated Load-Displacement Curves for Two materials

The strength response and damage pattern simulation results were compared with experimental data. Figures 12.24 (a) and (b) display the comparison between the calculated

and experimentally determined load-displacement curves leading up to the ultimate failure. The predicted ultimate strength is within 6% of the measured strength for the IM-7/PIXA composites and within 12% for the IM600/Q133 composites. Overall, the predicted curves agree with the experimental data very well, not only in the initial damage stage, but also in the final structural failure stage for the joints for both materials. The comparison of the predicted damage growth patterns as a function of the applied load is depicted with a set of X-ray radiographs, as displayed in Fig. 12.25. The damage pattern on each layer was plotted for different damage modes, and the applied load was obtained from the reaction with the central node of the pin. The predicted damage progression qualitatively shows the similar damage growth tendencies between the numerical and experimental results.

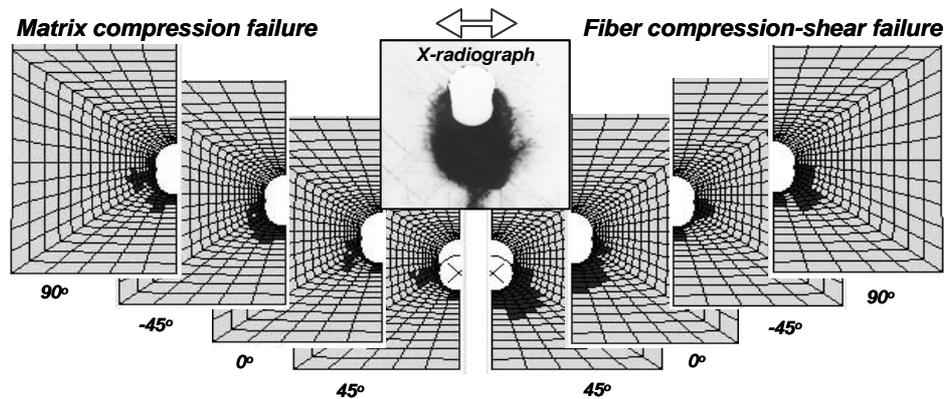
Figure 12.25 Comparison between X-ray Radiography and Numerical Damage Progression for the IM-7/PIXA [45/0/-45/90]_{2S} Laminate (a) P=10 kN, (b) P=16 kN

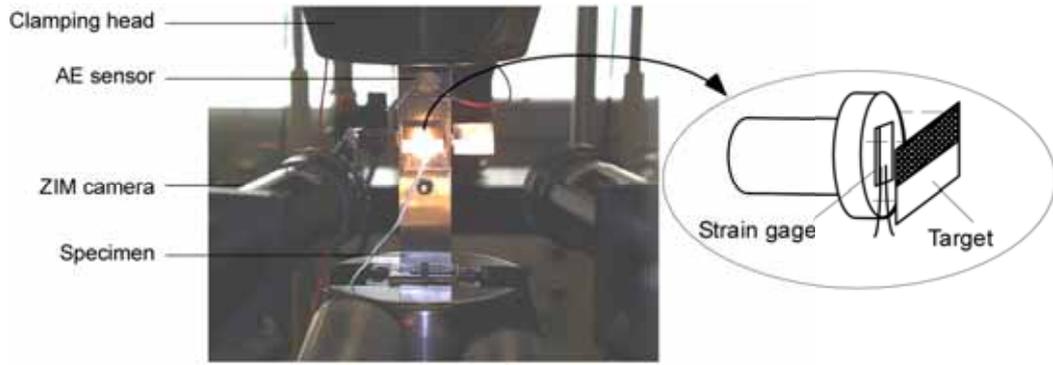
Figure 12.26 Schematic of Double Lap Joint Specimens with BG System

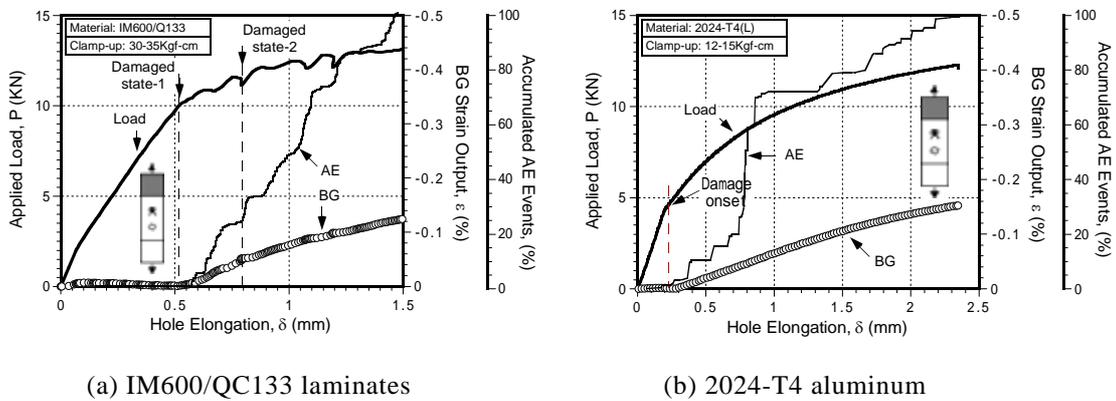
Figure 12.27 GB Responses for Different Material Systems Tested at Monotonic Tensile Loading

Figure 12.27 shows the bearing damage estimates by BG measurement obtained at the monotonic tensile tests for different material systems, called CFRP specimen and Al specimen. For any case, it can be found clearly that the response of BG output was related directly to the bearing damage and/or deformation. BG output can be obtained in a relatively stable development together with the response of bearing strength (P - δ curve) until the bearing

damage occurred, but once the bearing damage occurred, a sharp change in BG output and AE signal was observed. Simultaneously, non-linear behavior appeared in the load-displacement curve. Afterwards, the change of BG output as well as AE signal increased monotonously with hole elongation. Figure 12.28 shows the typical curves of the BG output versus the applied load for the case of CFRP specimen subjected to an initially applied torque of finger tight, 12~15, 30~35 kgf-cm, respectively. Figure 12.29 shows the BG output versus the applied load for various joint geometries, since the distinction between the failures is established largely by the joint geometry, particularly the width-to-diameter ratio, w/d or the edge-to-diameter ratio, e/d . From above, it was evident that the BG output has not been influenced by the change of the initial clamp-up levels or the joint geometry but only has been influenced at the generating time of the initial damage. Figure 12.30 shows the BG output versus the applied load for the case of CFRP specimen and Al specimen during the cyclic loading-unloading tests. The enveloping curve shows nearly unchanged in comparison with the monotonic tensile test. The unloading and reloading curves, however, show a somewhat unexpected behavior than the loading, because of the relationship of permanent strain. The results indicate that BG output did not depend on a load history, but can record the permanent strain received in the past.

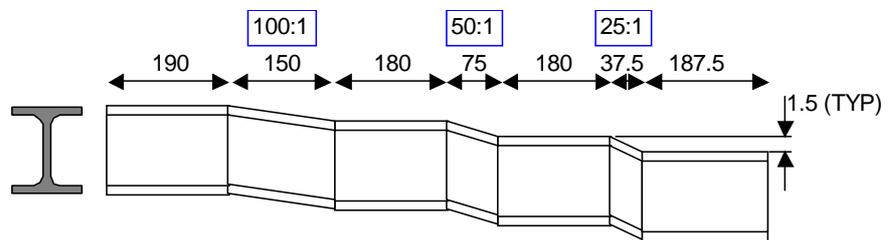
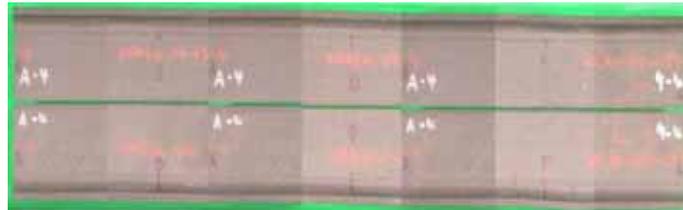
Figure 12.34. Ply Drop-off Condition

Aggressive ply-drop-off test (including the ramp ratio 100:1, 50:1 and 25:1) shows great advantage of “Dry” process of A-VaRTM compared to “pre-impregnated based” process. Fiber wrinkle is one of the most significant factors to reduce part strength and stiffness. “Pre-impregnated based” process has a limitation with the large ramp ratio due to fiber wrinkling. In A-VaRTM process, however, no fiber-wrinkle is observed even with 25:1 ramp ratio shown in Figure 12.34, based on DI and NDI results.

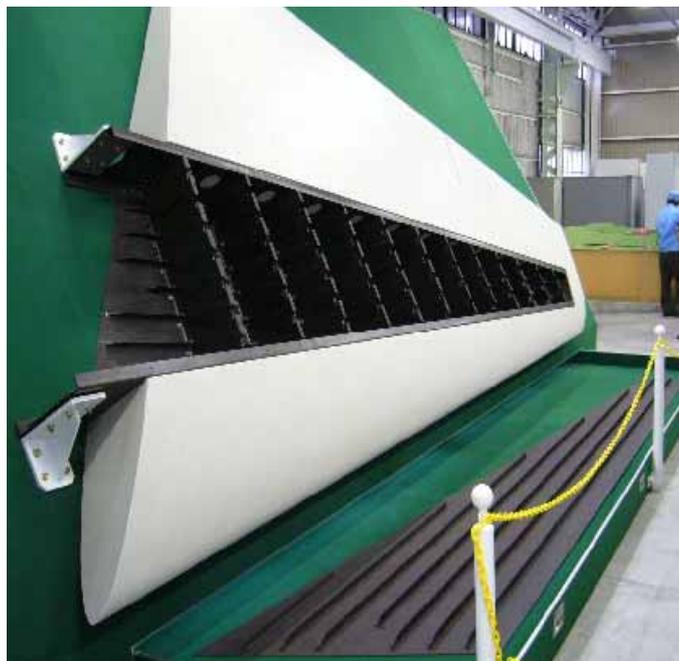
Figure 12.35 Proto-Typed Vertical Stabilizer Box Structure

A-VaRTM technology has been matured based on good characteristics in the material, fabrication process and the strength / stiffness of structural components and the design concept and we can proceed to verify A-VaRTM technology by “Proto-typed Vertical Stabilizer” shown in Figure 12.35.

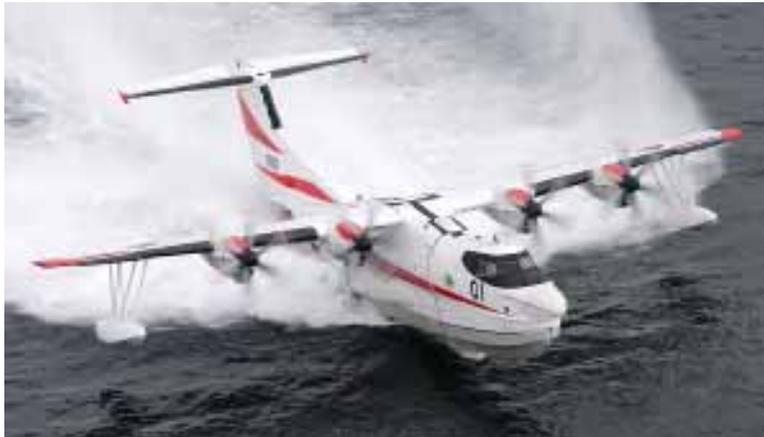
Figure 12.36 US-1A KAI

The development of the US-1A KAI, Japanese new search and rescue amphibian aircraft, was started in 1996 for Japan Maritime Self Defense Force (Figure 12.36). The aircraft is modified on the base of current aircraft US-1A, and improvements are a pressurized cabin, replacement f engines, etc. The full-scale static test finished without any critical failure in primary structures in March 2005. The full-scale fatigue test (FSFT) has started since January 2004 by the TRDI Air Systems Research Center (formerly Third research center). The durability test of two-life-time loading was completed in the late 2004 as reported in the previous ICAF national reviews, and then the damage tolerance test of another two-life-time loading and the teardown inspection were carried out in early 2006. The main feature of the FSFT is as follows:

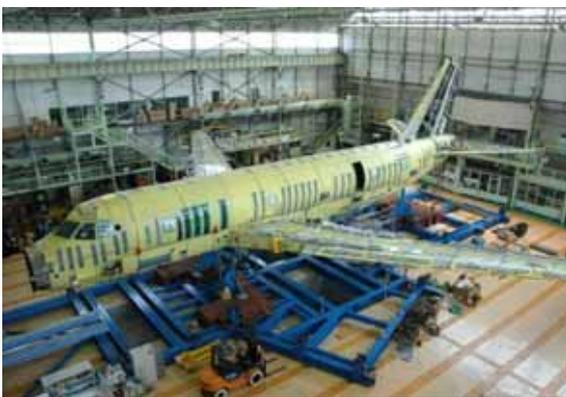
Figure 12.39 P-X FSST Test Article

The full-scale static tests (FSST) and full-scale fatigue tests (FSFT) are planned for each aircraft. Both of test articles for the FSST were delivered in the late 2006, and the FSST is now ongoing (Figures 12.39 and 12.40). On the other hand, the test articles of the full-scale fatigue tests (FSFT) are in course of manufacture now. The objective of the FSFT is to evaluate all primary structure in order to demonstrate their capabilities to achieve the design service life goal for each aircraft. In detail, the full-scale test article is required to experience

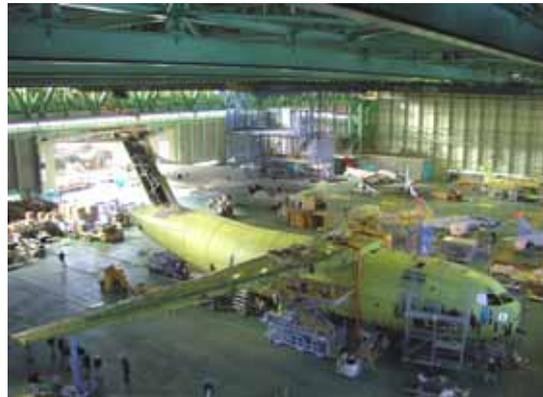
Figure 12.40 C-X FSST Test Article

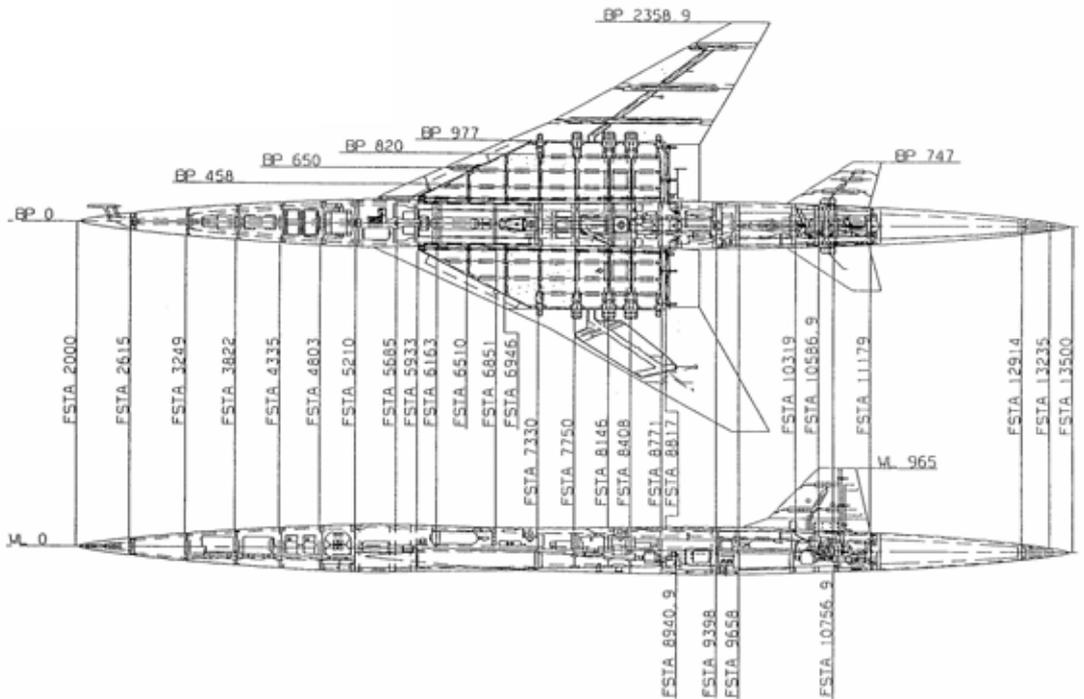
Figure 12.43 Structural Layout of the NEXST-1

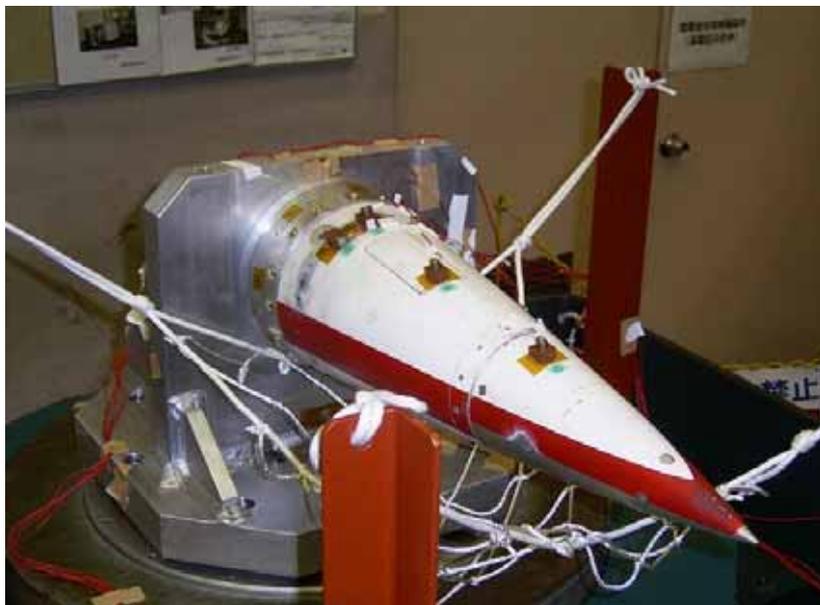
Figure 12.45 Component Fatigue Test

Static strength of the airframe was substantiated by conducting a strain survey testing and analysis based on the test results. Since only two experimental flight per vehicle were planned, fatigue evaluation was not required. On the other hand, the airplane was subjected to vibratory loads from the solid rocket booster. These vibratory loads at frequency of 73Hz for 80 seconds are generated by flow-induced acoustic resonance of rocket motor case. As the results of structural response, these vibratory loads are critical for the separation units between the pilot-chute container and main parachute container (Figure 12.44). Fatigue (safe-life) evaluation was used for the substantiation. At first, P/N curve (loads vs. cycles) was generated from the fatigue tests in the laboratory with twelve separation units and scatter factor of 4.13 was calculated from test results based on 99 % probability with 95% confidence. The reduced P/N curve, applied the scatter factor on time scale, was used to evaluate the cumulative fatigue damage with Miner's Rule and the results showed that the separation unit was able to withstand the vibratory loads. After this evaluation, component fatigue tests with the actual separation units and the pilot-chute container were conducted and showed that the units was able to withstand the maximum vibratory loads for 30 minutes and more. Therefore sufficient fatigue strength of the separation units was substantiated. (Figure 12.45)

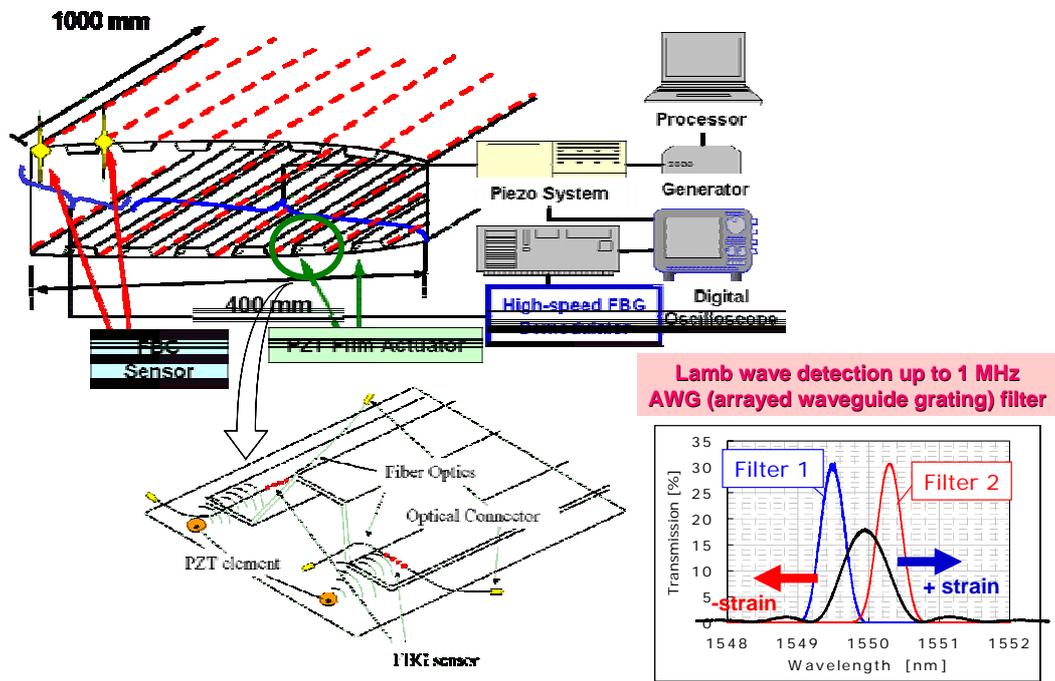
Figure 12.46 PZT-FBG Hybrid Active Damage Sensing System

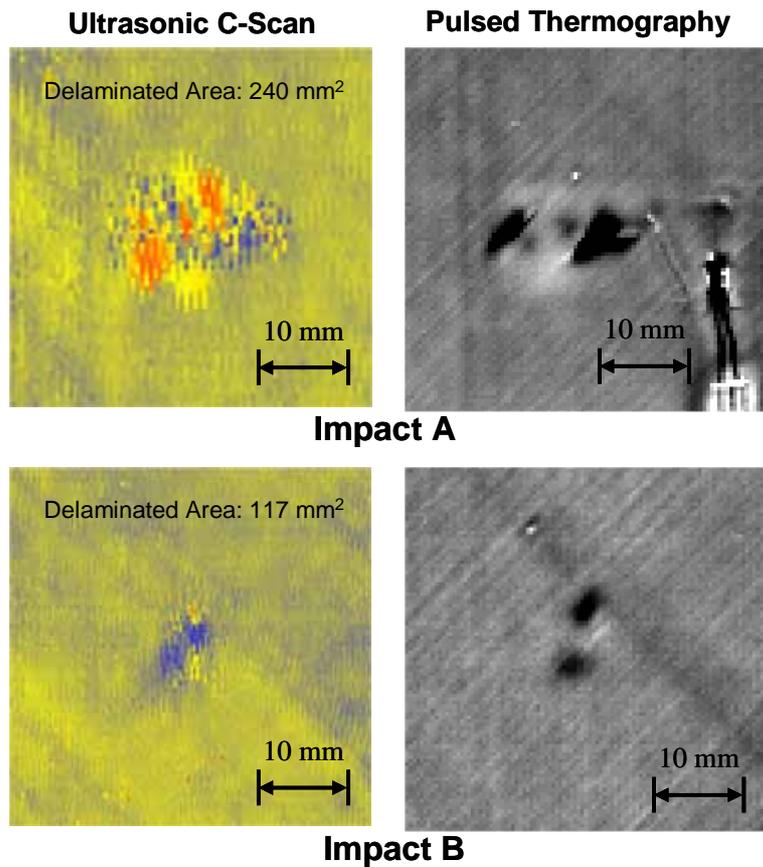
Figure 12.52 Photographs of BVID after Fatigue Tests (= 80,000 Flights)

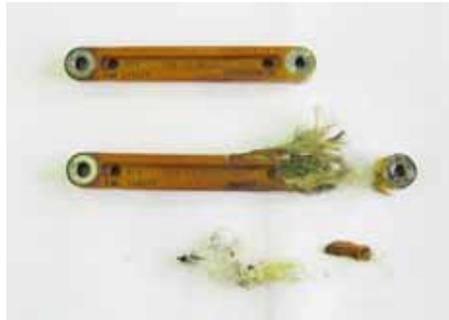
Figure 12.53 T-T Straps

A T-T strap (Figure 12.53) is a composite material which is made of Kevlar49 fibers continuously wound around two corrosion-resistant metal spools and impregnated in polyurethane. The outer surface is coated with polyurethane.
