Institute of Aviation

Review of Polish Aeronautical
Fatigue Work 2005 – 2007

Antoni Niepokólczycki
May 2007

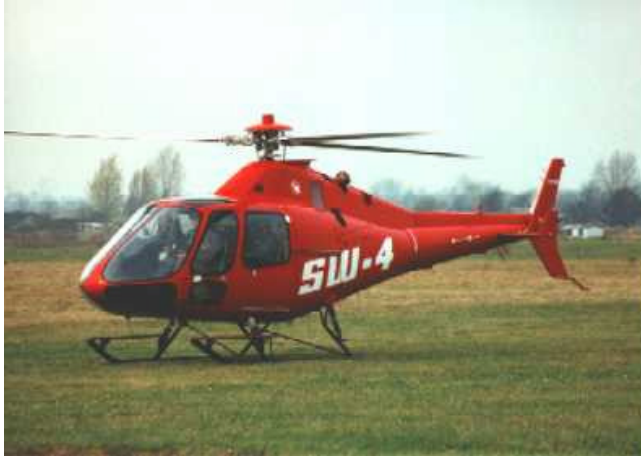
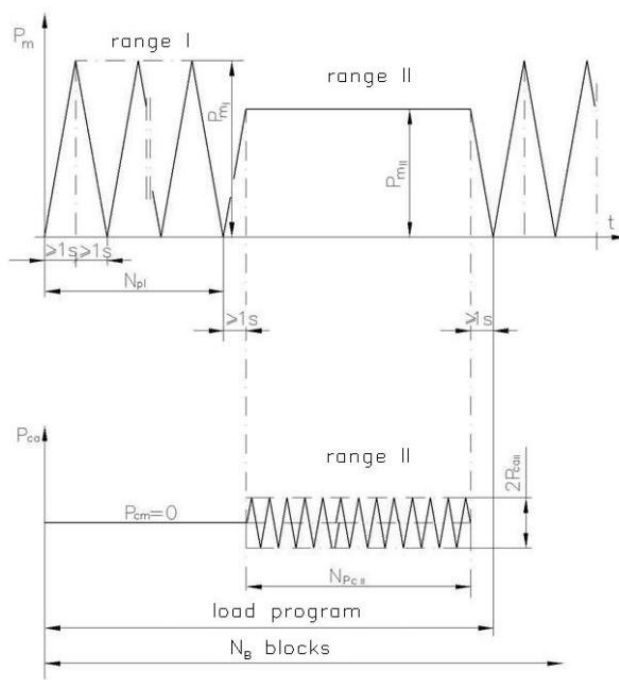
The rotor head of the PZL SW-4 helicopter was tested.

On the test stand a specimen was subjected to both the axial forces P_m applied to each arm of the hub and variable forces P_{ca} due to masses rotating at an angular velocity ω . In the thrust plane those forces generated a variable moment M_{ca} .

The magnitudes of P_{ca} resulted from a proper choice of the values of rotating masses and the angular velocity ω .

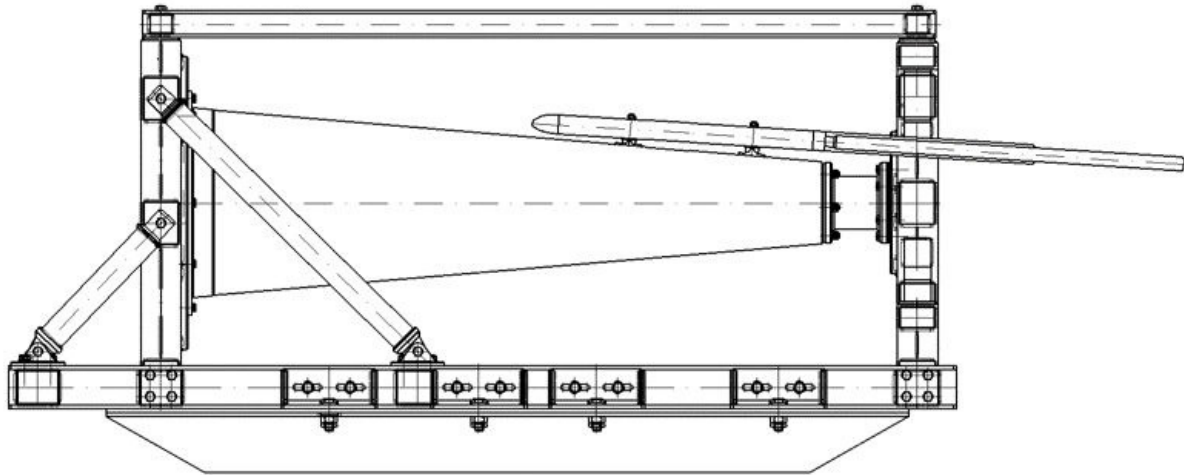
Fig. 2.2.1. Fin with a tail boom mounted on the test stand.

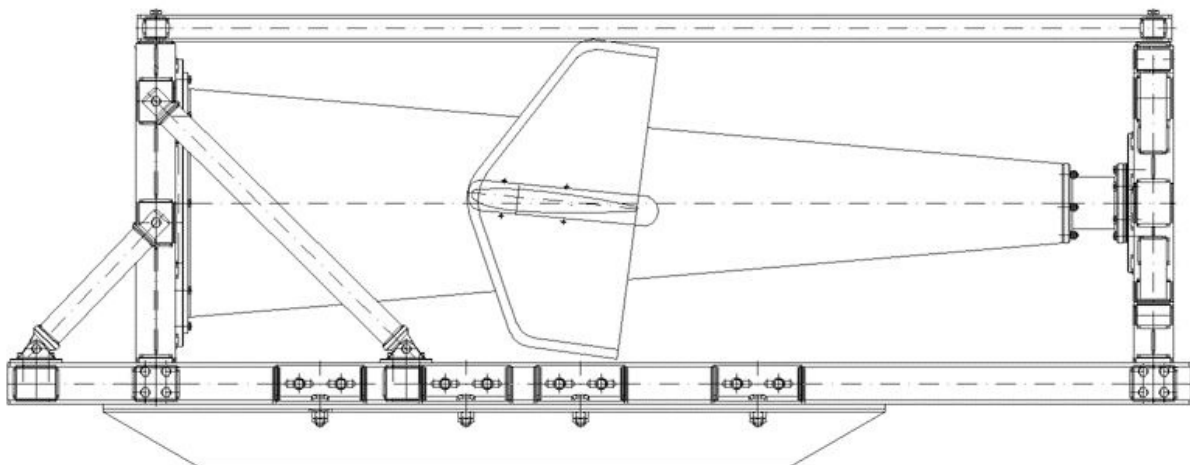
Fig. 2.2.2. Horizontal stabilizer with a tail boom mounted on the test stand.

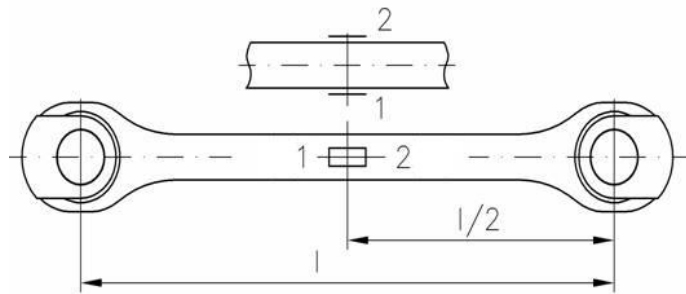
For each connector two strain gauges were used for measurement of the specimen loading.

Fig. 2.3.1.
Location of the strain gauges on the specimen.

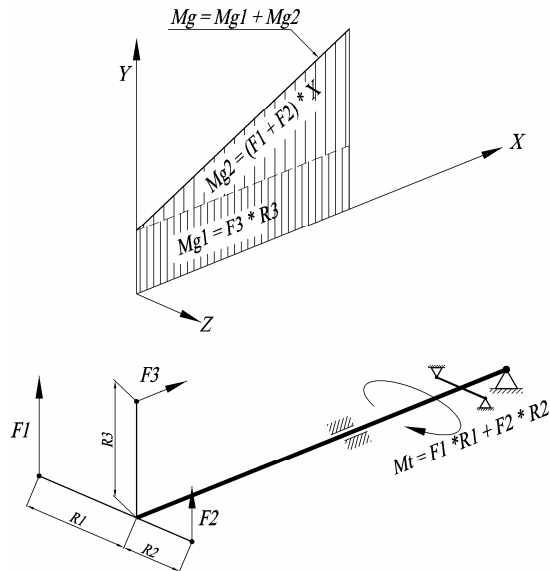
The tests were performed on the stand representing the conditions the shaft is subjected to in the helicopter (in view of geometry and kinematics).

Fig. 2.4.1. Loading scheme of the shaft.

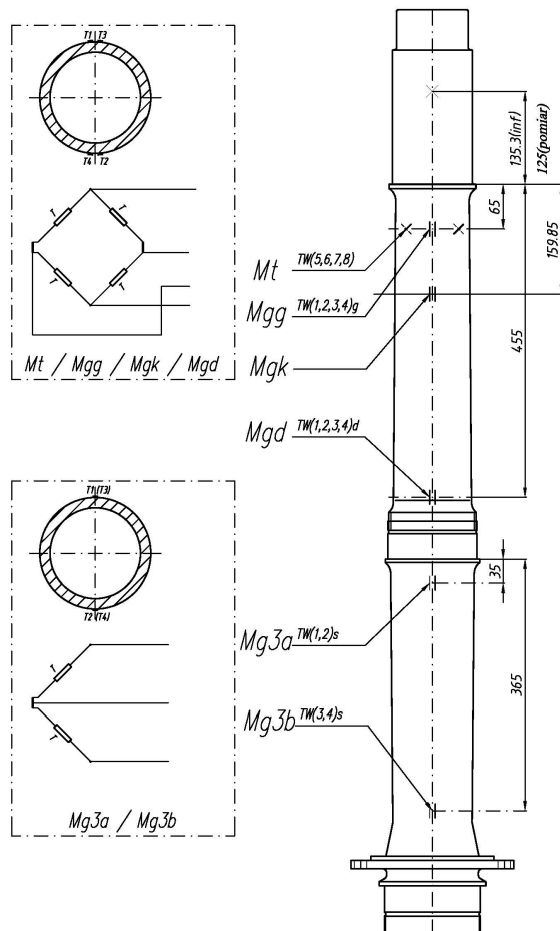
Fig. 2.4.2. Arrangement of strain gauges.

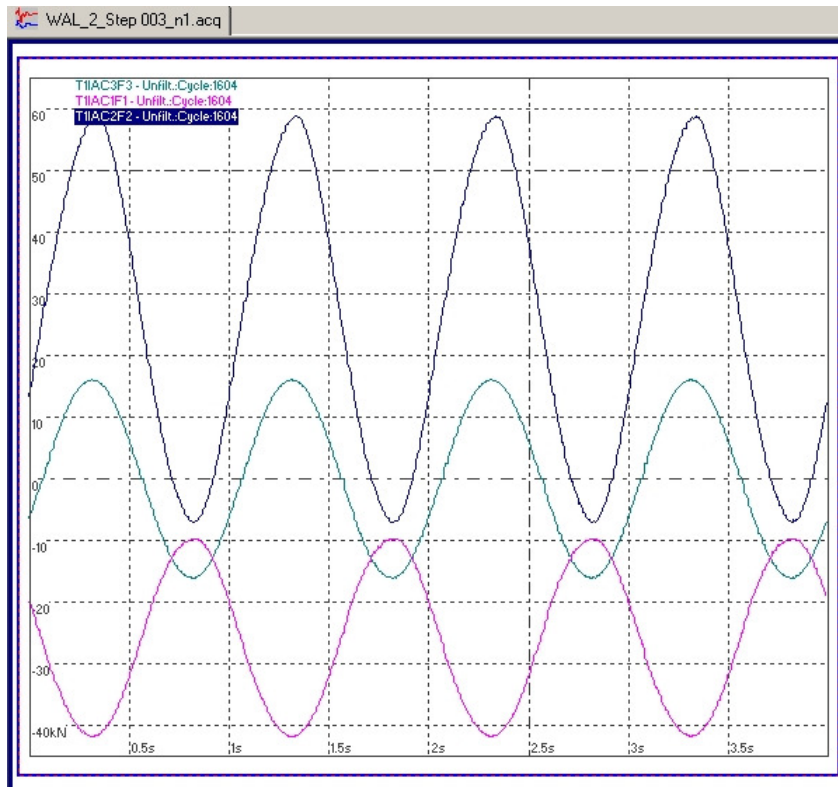
Fig. 2.4.3. Loading program.

The loading remained unchanged during the test. Both the investigated specimens failed after about 800 000 cycles.

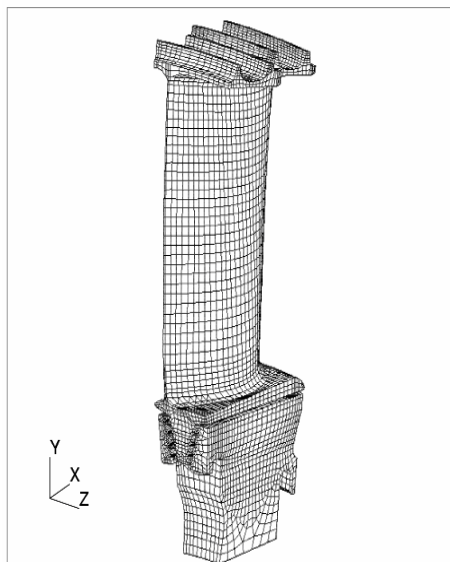
The stress analysis of turbine disc under the operational thermomechanical conditions was conducted. To this end, the finite element analysis of complex geometrical axisymmetrical model of turbine was carried out, the radial deformations resulting were then used to define boundary conditions for a 3D sub-model of the turbine segment consisting of one blade and part of disc (Fig. 2.5.1).

Fig. 2.5.1. Finite element model of the turbine segment.

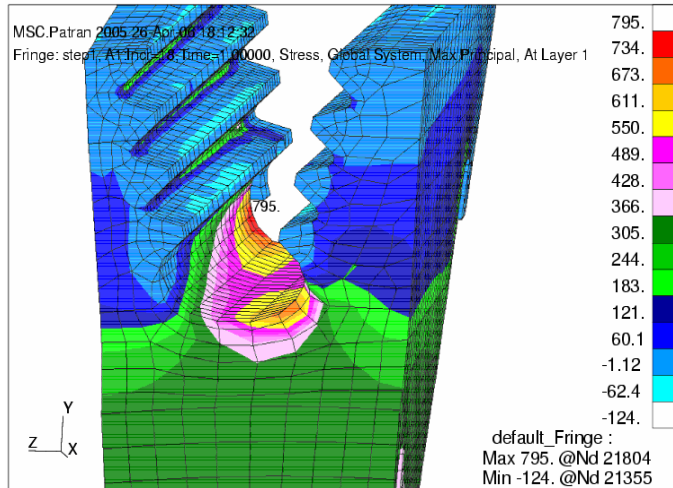
The stress contours resulted from a nonlinear static analysis performed for the turbine under operating conditions (Fig. 2.5.2). High stress zones were found at different regions of the turbine, where the initiation of fatigue cracks was expected. Critical nodes of the model (where the maximum stresses were observed) were then subjected to the fatigue analysis.

Fig. 2.5.2. Maximum stress (σ_1) distribution in the blade locking.

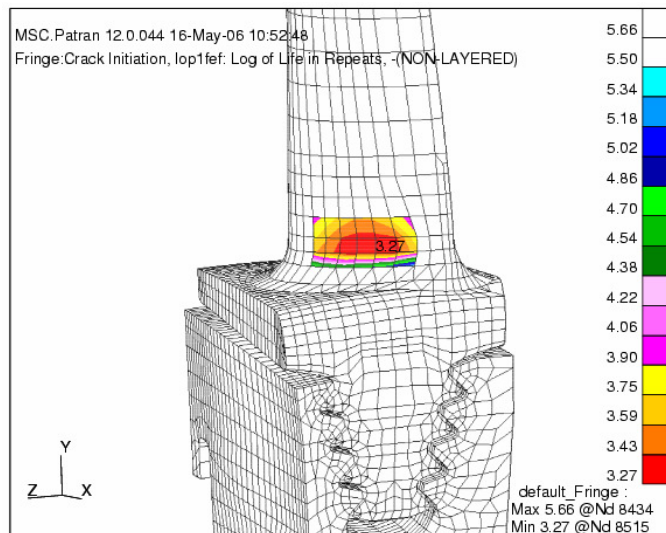
The results of numerical crack initiation (ϵ -N) analysis carried out for a simplified load history corresponding to 6-hour helicopter flight (basing on the laboratory long time fatigue test of engine) have been presented as well. The number hours of flight before the fatigue crack initiation in the critical components of turbine were estimated (Fig. 2.5.3).

Fig. 2.5.3. Results of ϵ -N analysis – number of hours to the crack initiation and location of the fatigue critical region for the blade. The time before the crack initiation in the blade is $10^{3.7032} \times 6 = 32376$ hours of engine operation.

The critical areas of turbine (in view of both the static and fatigue strength) are located on the blade lockings. In these regions both the maximum stress and the minimum fatigue life were observed (Fig. 2.5.2, Fig. 2.5.4). These zones should be subjected to a detailed visual inspection on a regular basis due to high probability of the fatigue crack initiation.

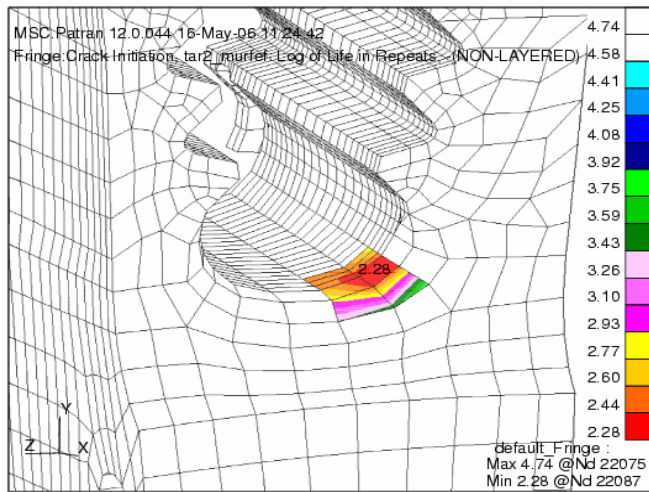
Fig. 2.5.4. Results of ϵ -N analysis for the bottom serration region of the turbine disc.

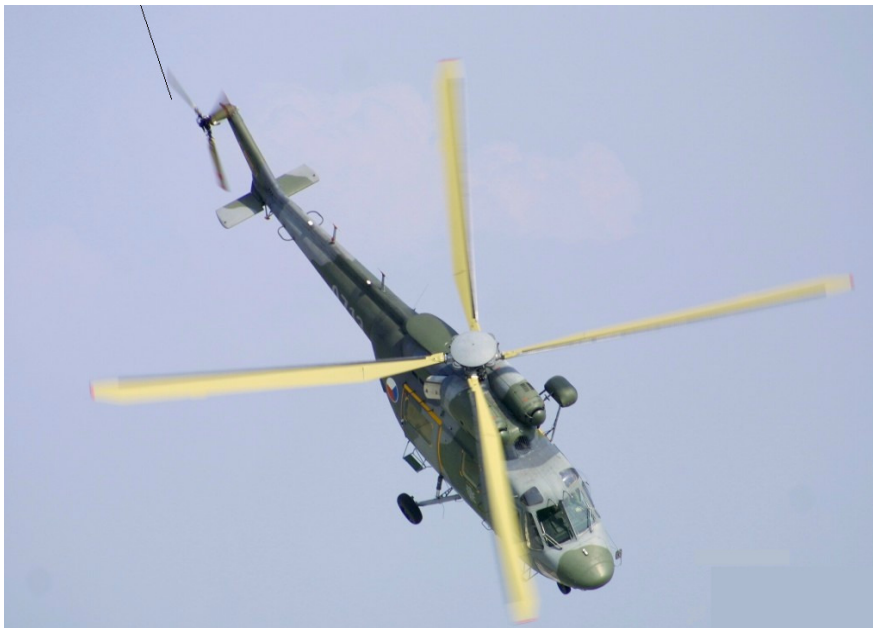
The magnitudes of load acting on a helicopter rotor depend mainly on flight parameters and the position of collective pitch control system and cyclic pitch control system.

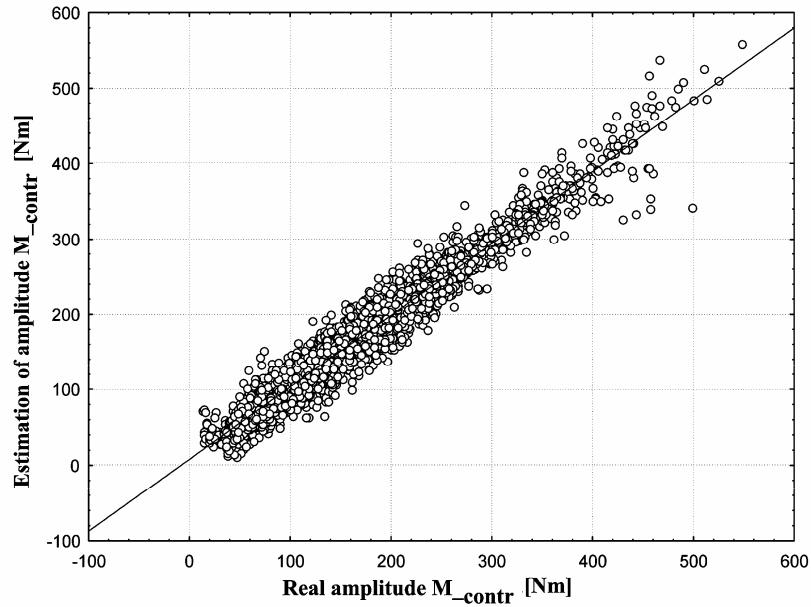
Fig. 2.6.1. Blade control moment amplitude. The scatter between the calculated results (the neural network) and the real values.

The results of calculations made using the trained neural network with the defined amplitudes and mean values of blade control moment and bending moment of the rotor hub body are presented in the figures. The scatter can be seen between the calculated results and the real values.

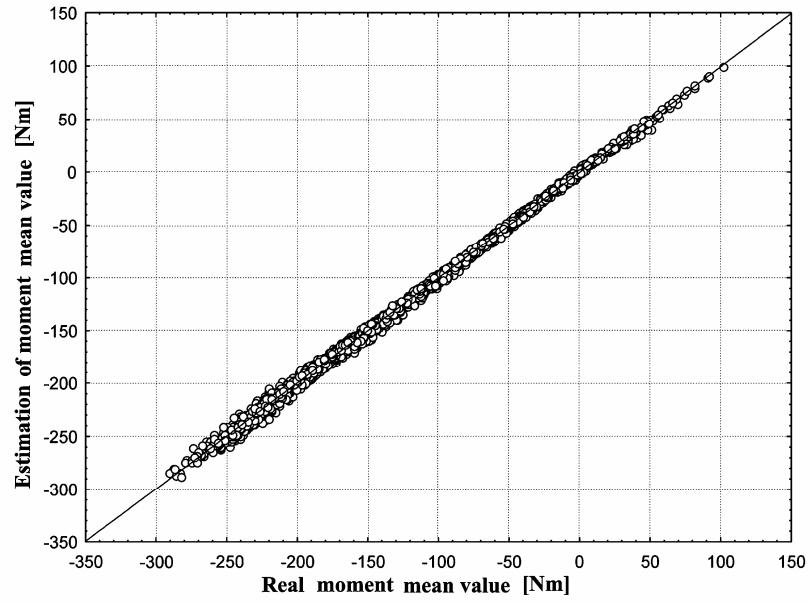
Fig. 2.6.2. Mean values of bending moment of the rotor hub body. The scatter between the calculated results (the neural network) and the real values.

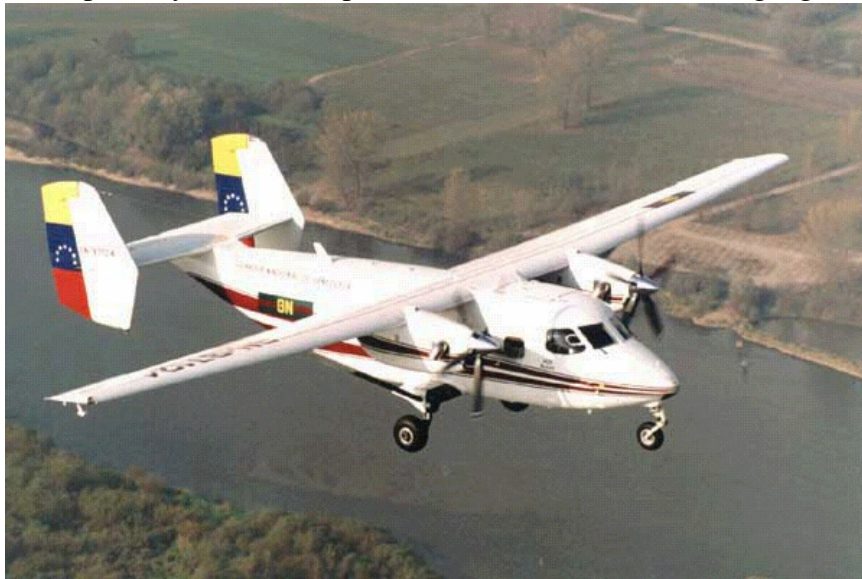
Fig. 3.1.1. The side view of a test stand with the PZL M28 empennage (with a double vertical tail) and the rear part of the fuselage.

After obtaining promising results from the previous fatigue tests made on the PZL M28 05 SKYTRUCK empennage at the Structural and Component Test Laboratory of the Institute of Aviation in Warsaw (see reports in *Review of Aeronautical Fatigue Research and Development in Poland During the Period 1999 to 2002*), in which 40000 flight hours were simulated, it was decided that the test should be continued at the Structural Tests Laboratory of Polskie Zakłady Lotnicze in Mielec. The empennage with the rear part of fuselage was transported from Warsaw to Mielec. The same test program was applied using a safe life approach. The test stand was built to ensure that the same loads were applied to the test article and the same reactions appeared (see Fig. 3.1.1). Hydraulic servo actuators were controlled by a computer system developed in Mielec. The same strain gauges were used in monitoring the

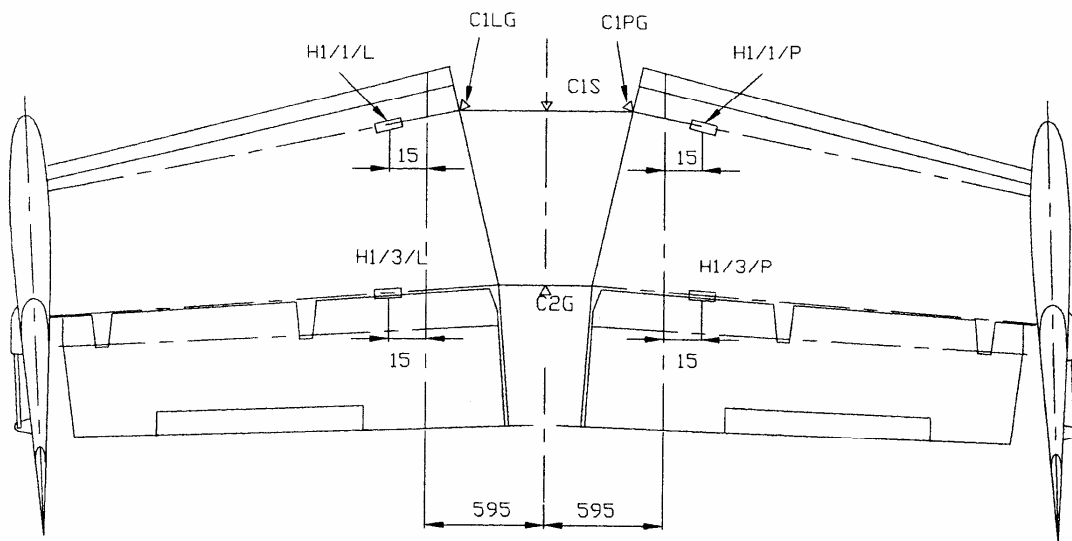
Fig. 3.1.2. The upper view of strain gauges located on a horizontal tail (stabilizer).

stress level in critical points of the structure, mainly in a stabilizer torsion box (see Figs. 3.1.2 and 3.1.3). The goal of test was to reach the service life of 16000 flight hours. With a scatter factor of 4, the total number of 64000 flight hours should have been simulated, so that 24000 flight hours were to be simulated in Mielec.

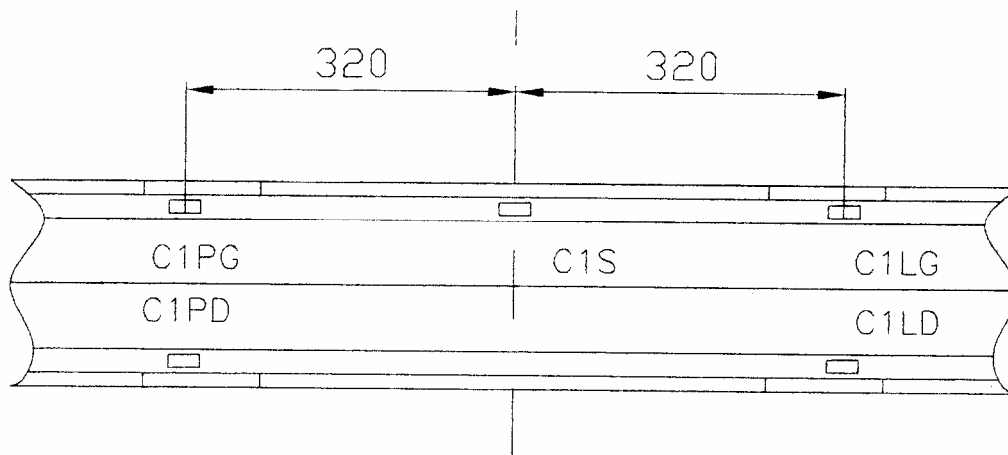
Fig. 3.1.3. The front view of the stabilizer front spar with strain gauges.

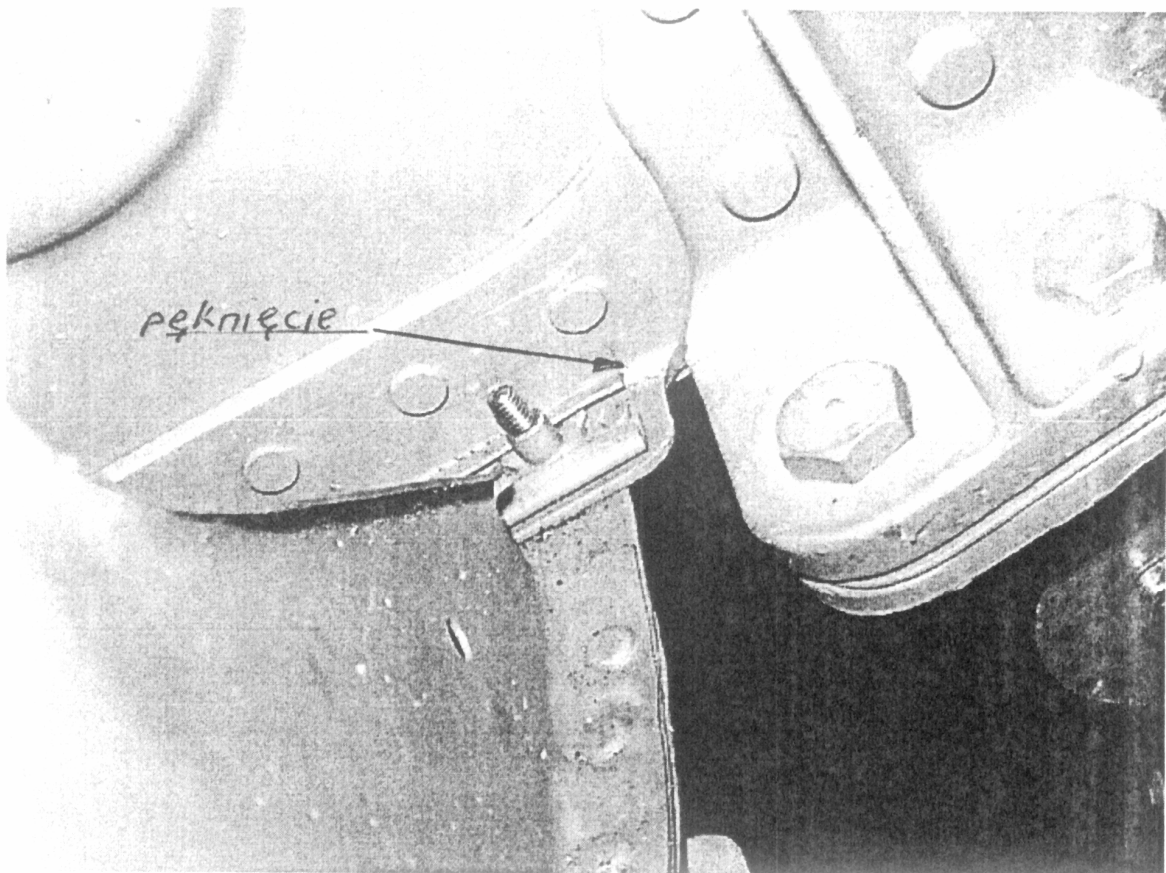
Fig. 3.1.4. The photo of the stabilizer region with a crack (indicated by an arrow) observed during the test.

The results obtained in view of both the stresses and deflections were very close to those obtained in Warsaw. After simulation of 6356 flight hours (in fact, after 46356 flight hours, including the previous test in Warsaw) a crack was observed in a stabilizer in the region of front spar lower cap, close to rib No. 1 (attachment to the fuselage, right-hand side, see Fig. 3.1.4). Despite the relatively low stress level observed, this region was predicted in previous fatigue analysis as a critical due to geometric stress concentration. The test was stopped and the damaged region was subjected to a more detailed inspection. More short cracks were found not only on the lower cap, but also on the upper one. The symmetry may be explained by the applied load spectrum, which is symmetrical since the ground loads during operation on an unpaved air strip are predominant in the fatigue damage evaluation. The material of failed spar caps was examined as well, i.e., the D16chT aluminium alloy of upgraded strength (a chemical constitution as 2024) with the following strength parameters for 2 samples: $F_{tu} = 572 \text{ MPa}$ and 559 MPa (minimum according to the standard is 470 MPa), $F_{ty} = 448 \text{ MPa}$ and 441 MPa (minimum according to the standard is 355 MPa) and $A50 = 13\%$ and 12.5% (minimum according to the standard is 8%).

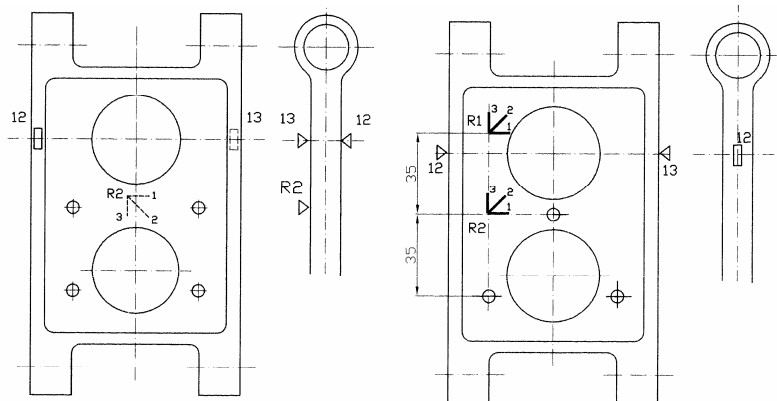
Fig. 3.2.2. Fitting that connects the lever arms with the cylinder of nose landing gear. On the right-hand side the initial design is shown. Two times during the tests a crack occurred at a

During the test a crack was observed at the fitting that connected the lever arms with the cylinder. The test was conducted further on since the landing gear was still capable of withstanding the applied loads. After 3000 simulated flight hours the test was stopped and the fitting was replaced with the another one of the same design. Once more a crack occurred, therefore the fitting was redesigned and a modified design was then tested. Both the fittings are shown in Fig. 3.2.2. The test on the new fitting was conducted up to 64000 simulated

Basing on the test results the service life of investigated nose landing gear has been determined as 16000 flight hours on condition that the modified fitting is used.

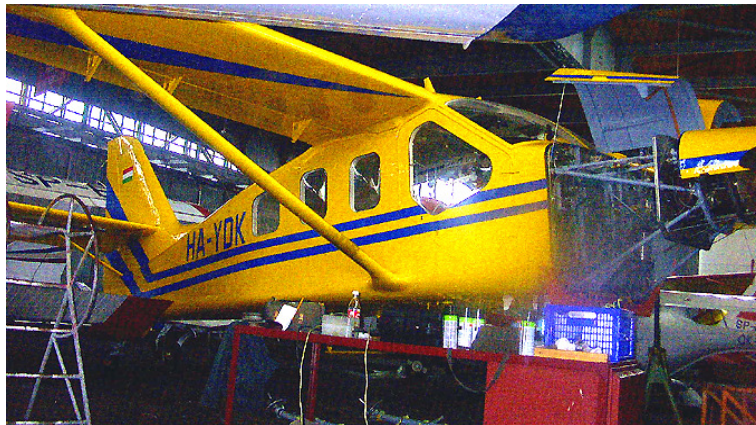
Fig. 3.3.1. Aircraft SMG – 92 TURBOFINIST.

Elements of the SMG-92 TURBOFINIST aircraft No. HA – YDK (Fig. 3.3.1) after „a hard landing” were investigated.

As a result of the “hard landing”, the undercarriage legs were permanently deformed. A non-destructive inspection was performed in order to verify that no damage had occurred in other elements of the aircraft structure.

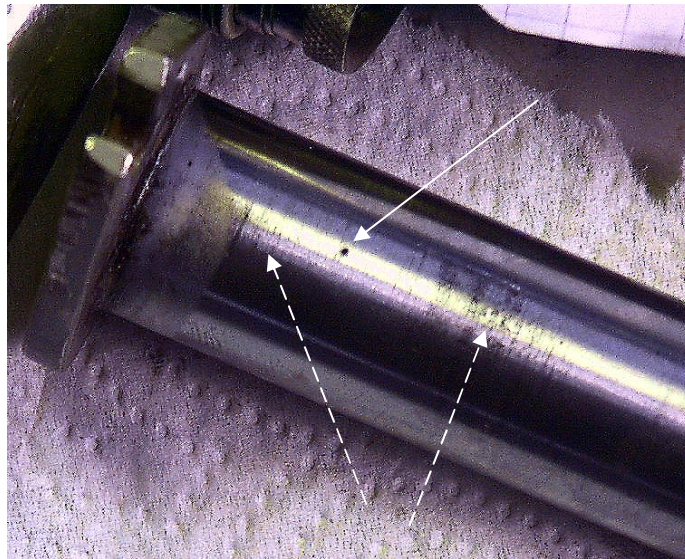
Fig. 3.3.2. Landing Gear, right leg, fuselage fitting fixing bolt.
The material defect of pinhole type – (full line);
circumferential scratches on the surface - (dotted line).

1. Replacement of the right leg fitting bolt. In the region the material defect of pinhole type was detected, which could initiate a fatigue crack. So as the scratches and the traces caused by strokes – indentations.
2. Avoiding scratching of the bolts surface, which could result in fatigue crack initiation.

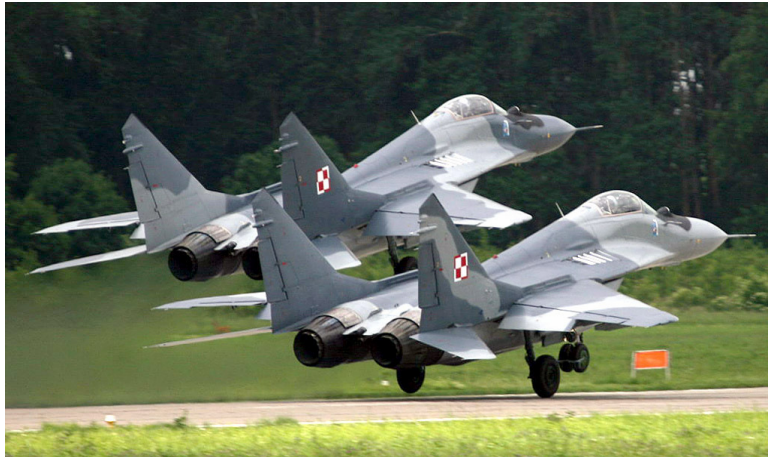
The investigations aimed at the development of load database in some selected structural elements of the MIG-29 aircraft. Measurements of loads affecting the MiG-29 structure were taken with use of the KAM-500 system.

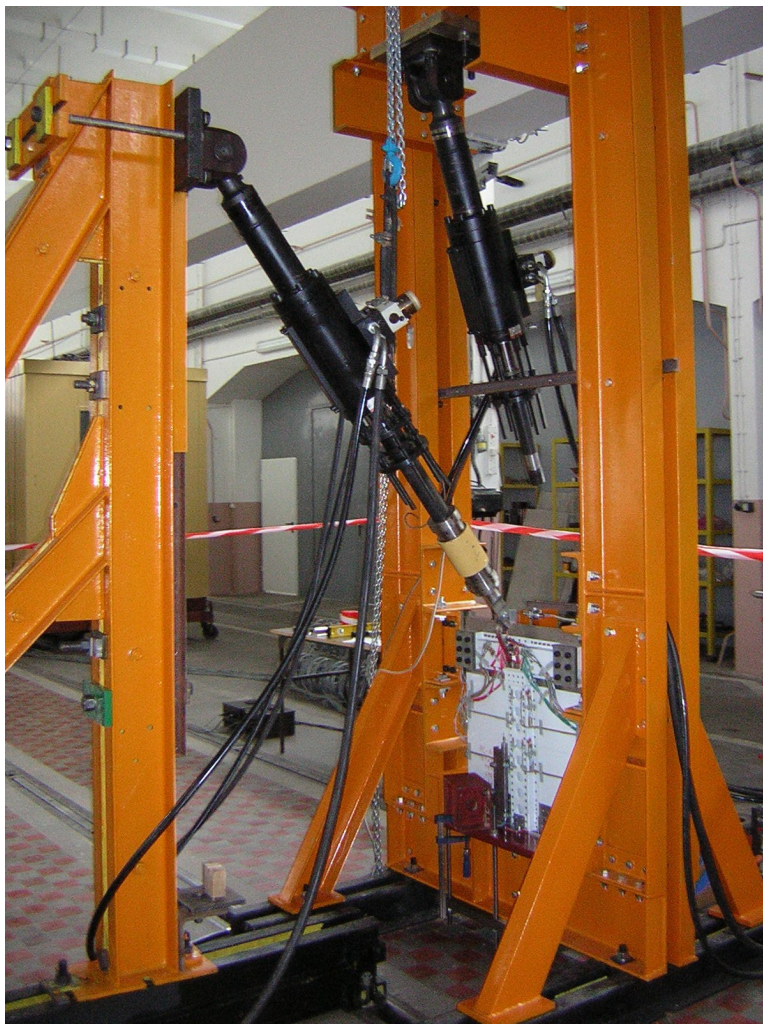
Fig. 3.5.1. Test set-up with the hinge fitting specimen.

The Institute of Aviation designed and built the test set-up and installed the hydraulic loading system, the control system and the measurement and the data acquisition system. The entire test set-up for each specimen consisted of a specimen fixing frame and a one-channel load application system. Fig. 3.5.1. shows the test set-up with the hinge fitting specimen (one of the configurations) and Fig. 3.5.2. shows the test set-up with the latch housing specimen. 137 channels for the strain gauges and 3 displacement transducers for both specimens were required to measure the specimen behaviour during both the static and fatigue tests.

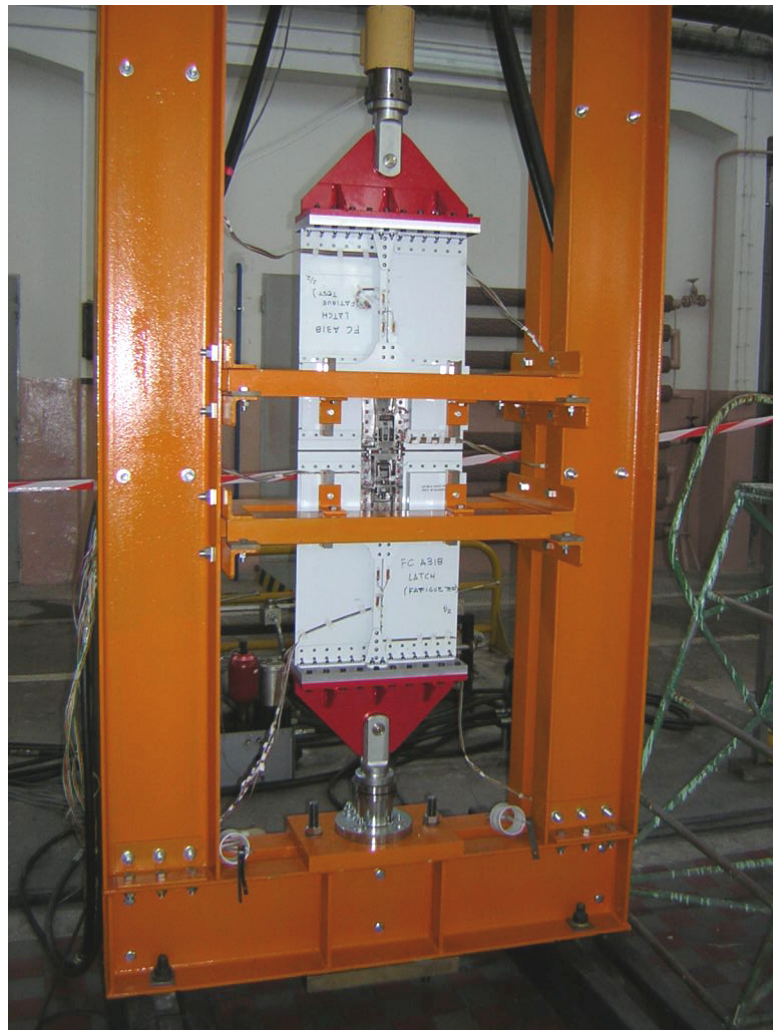
Fig. 3.5.2. Test set-up with the latch housing specimen.

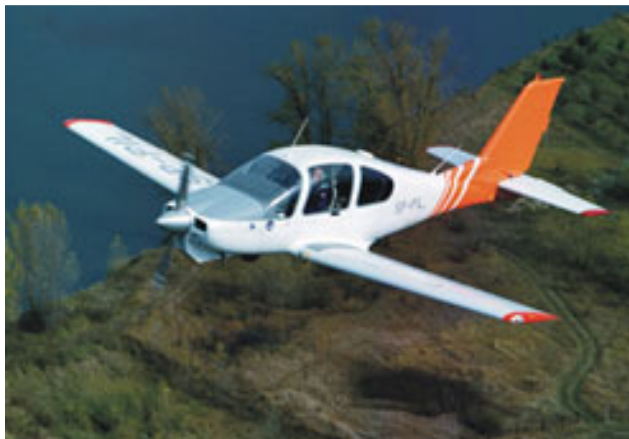
Fig. 3.6.1. I-23 Manager aircraft

The fatigue test of a composite wing spar of the I-23 *Manager* aircraft was carried out at the Institute of Aviation in Warsaw. The I-23 *Manager* (Fig. 3.6.1) is a small business aircraft with four seats developed by Institute of Aviation. The aircraft is made of glass and carbon fibre composite materials. The wing spar is made of carbon fibre reinforced plastic (CFRP) with metallic fittings for joining two halves of the spar in the symmetry plane of the aircraft, and for attaching the spar to the fuselage and for attaching the main landing gear.

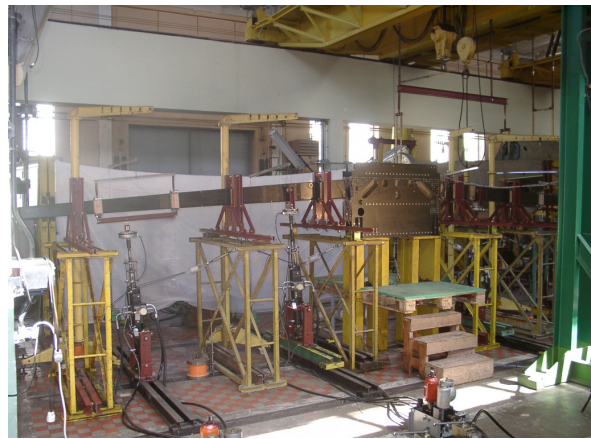
Fig. 3.6.2. Wing spar test set-up.

The test was carried out at room temperature and without moisture conditioning. Some artificial defects e.g. bonding failures were introduced into the CFRP structure. The inspection program included both visual and NDT inspections with periodical wing spar disassembly to examine the central fittings. A flight-by-flight loading spectrum was applied. 40000 flight hours (which correspond to 4 design service goals) were successfully simulated until December 2006.

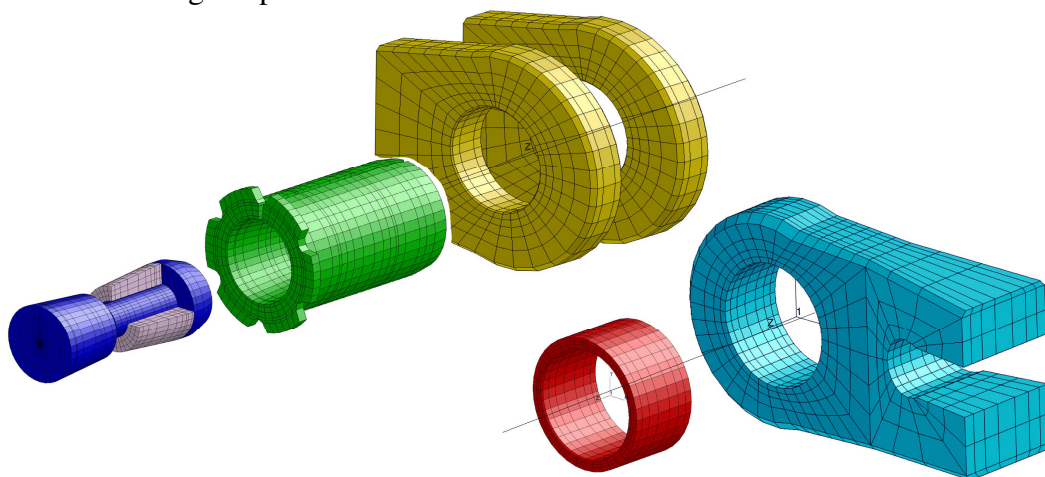
Fig. 3.7.1. Components of the numerical model of connector before assembling.

The stress contours were generated basing on the results of nonlinear static analysis conducted for both the standard and modified connectors, (Fig. 3.7.1) under operating conditions. Zones

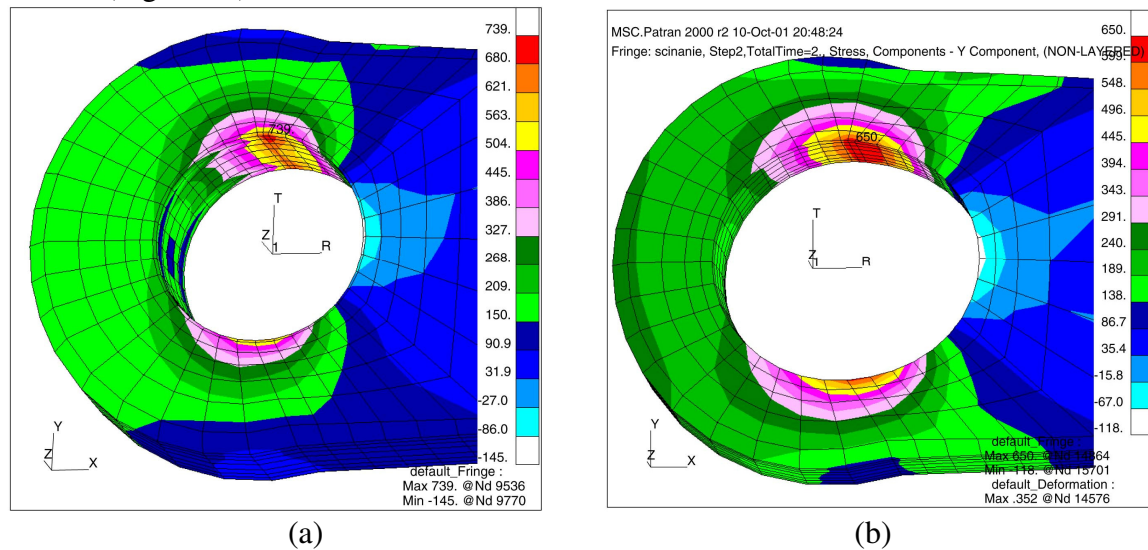
Fig. 3.7.2 Circumferential stress distributions in the original lug (a) and after modification (b).

of high stresses were found at the region of wing lug, where the cracks were detected in the aircraft (Fig. 3.7.2).

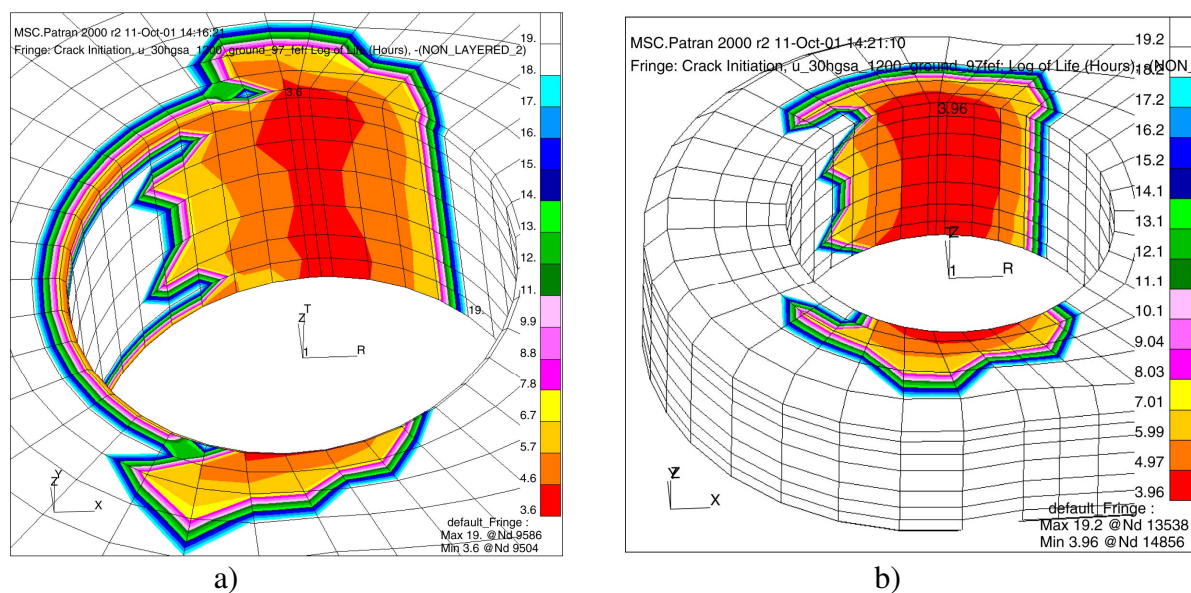
Fig. 3.7.3. Results of ϵ -N analysis – number of flight hours to first crack initiation and location of the fatigue critical region for original (a) and modified (b) wing lugs

The results of ϵ -N analysis for the original wing lug are presented in Fig. 3.7.3a. From the figure it can be seen that the minimum number of hours before the first fatigue crack (for depth of crack at about 1,5 mm), equals $10^{3,6024} = 4003$ hours of flight.

Fig. 3.7.3b presents the results of the ϵ -N analysis for the modified wing lug. From this figure it can be seen that in the modified lug the first fatigue crack can occur after $10^{3,96} = 9120$ hours of flight.

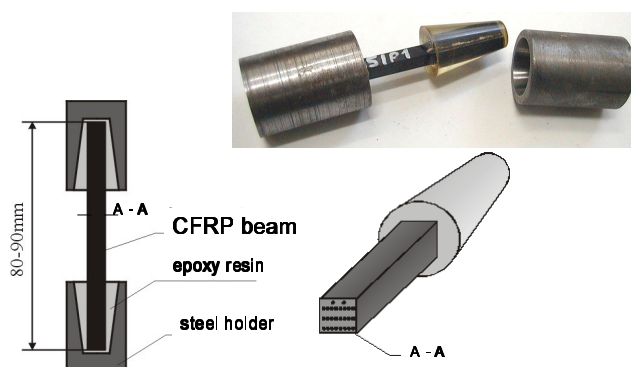
Fig. 4.1.1. Specimen used for the static and fatigue compression tests.

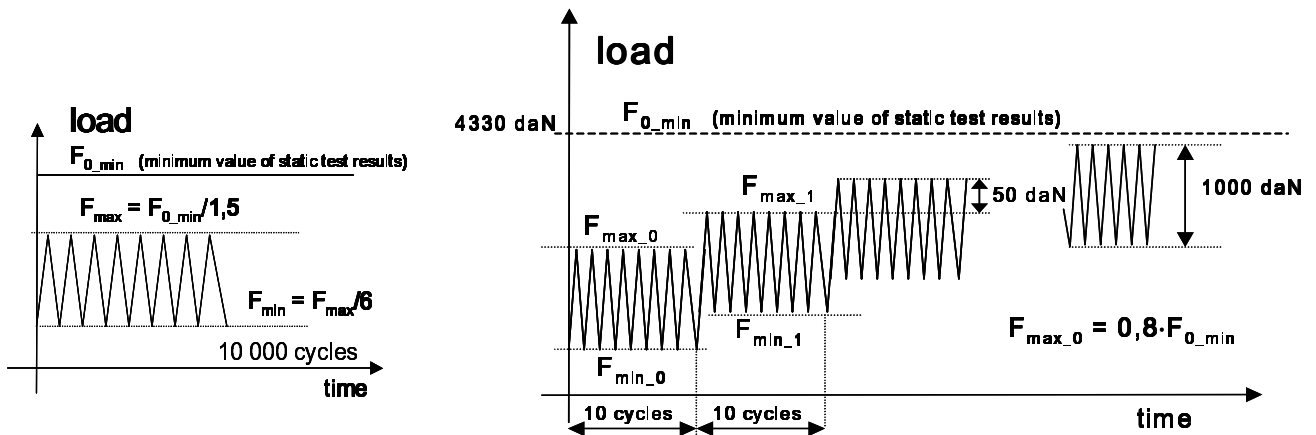
Fig. 4.1.2. Profiles of the fatigue loads in Experiment No. 1 (left) and Experiment No2 (right).

The upper magnitudes of loads (see Fig. 4.1.2) correspond to the limiting operational glider loads (G-load equal to + 6g, i.e. the magnitude appearing due to a strong vertical gust), while the lower ones correspond to the G-load equal to +1 (i.e. for a horizontal flight at smooth air). The assumed number of cycles applied was 10 000. Experiment No 2 was aimed at finding the moment of fatigue test made with increasing load levels, at which structural changes of the CFRP appear, introducing changes into the A-scans. The specimens were made of: carbon roving: Tenax 5631HTSA; epoxy resin & hardener: L285/286. The volume fraction: 0,46; thermal cycle: 24h – RT plus 15h at 60°C.

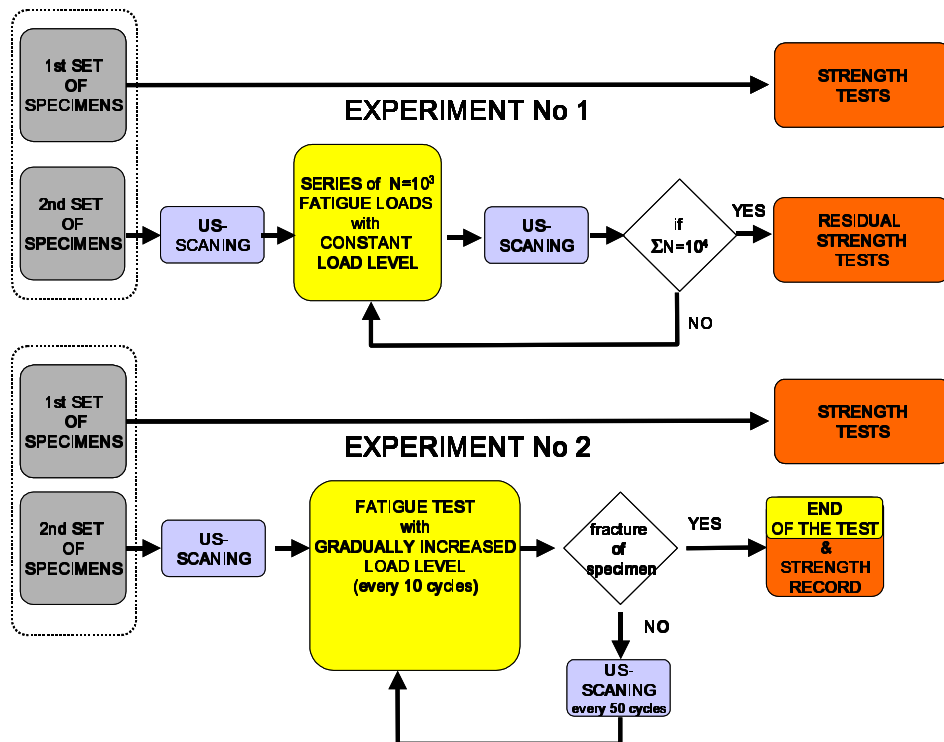
Fig. 4.1.3. Block-scheme of the low-cycle fatigue testing.

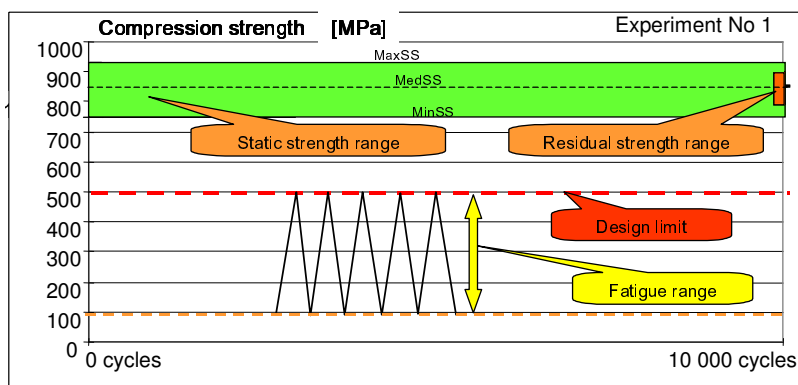
Fig. 4.1.4. Set of the static and the residual strength ranges after 10 000 cycles.

The ultrasonic investigations were conducted on the immersion stand, equipped with ultrasonic flaw detector Panametrics 9100 connected to a PC. The results of static and the residual strength tests obtained from Experiment No 1 are illustrated in Fig. 4.1.4.

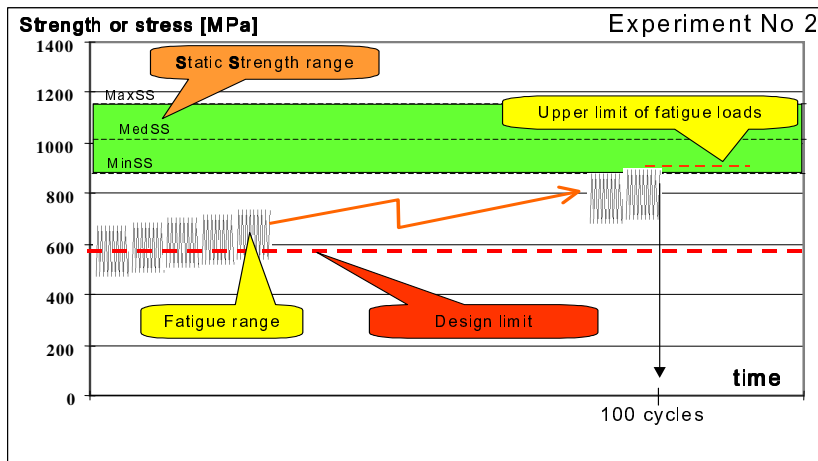
Fig. 4.1.5. Course of the low-cycle fatigue test in the range of over-limiting operational loads.

Basic results obtained from Experiment No 2 are shown in Fig. 4.1.5. The fatigue tests were made up to the lower strength limit of the static strength range. At several phases of the test the specimens were examined on the ultrasonic stand. Every scanning session was performed for several available filter-frequencies. No significant differences in the A-scans were observed.

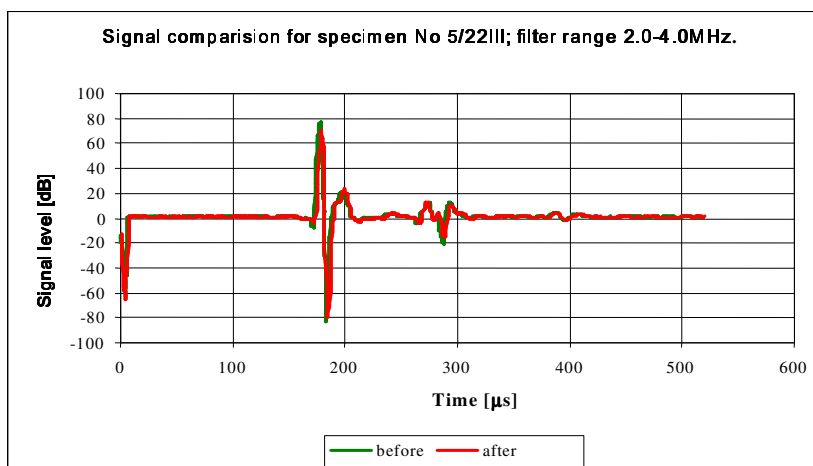
Fig. 4.1.6. Set of the A-scans for initial and final stadiums, respectively, of the fatigue tests (typical diagram for experiments No 1 & 2).

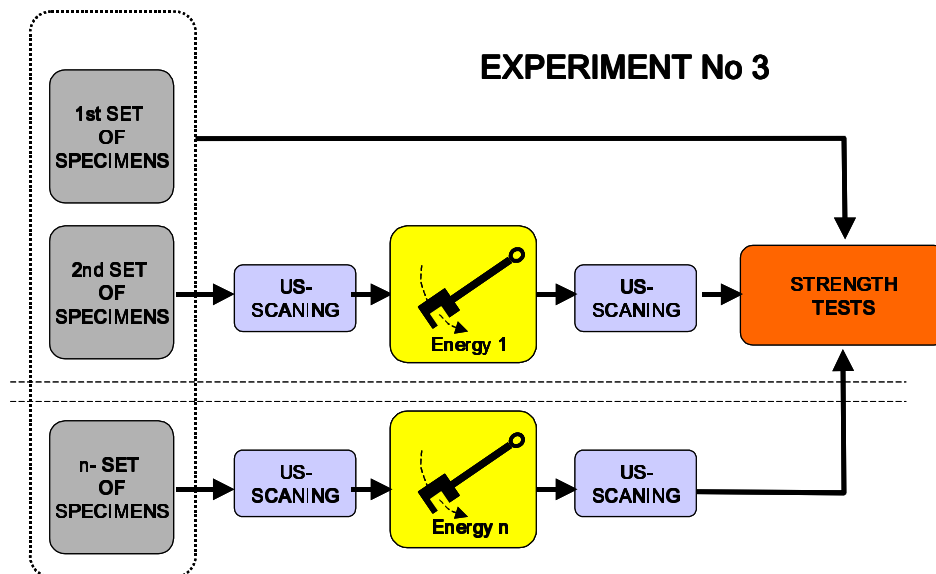
Fig. 4.1.7. Block-scheme of the impact tests.

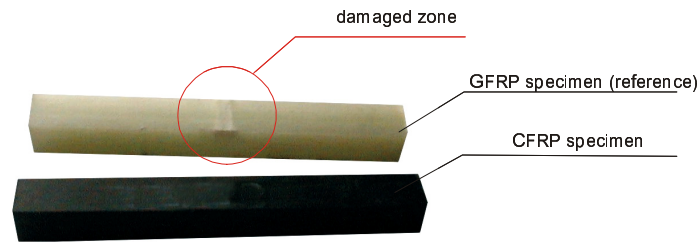
Fig. 4.1.8. Specimens used in the impact tests; (the GFRP specimen was used for better visualization of the impact effect, invisible in the CFRP specimen).

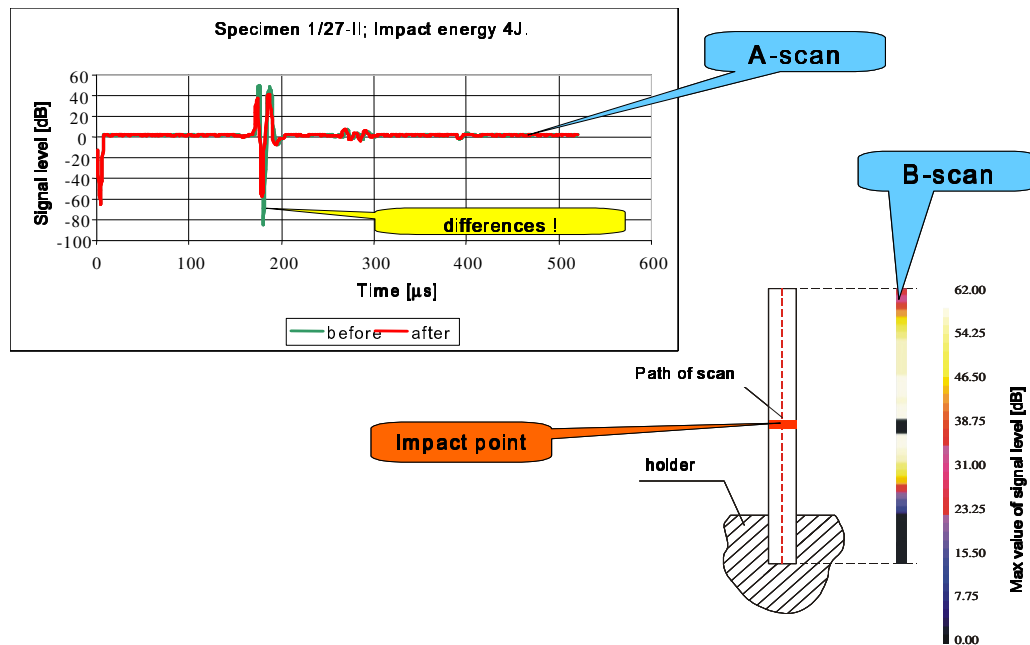
Fig. 4.1.9. A-scans and B-scan of the specimen subject to the impact of 4J energy.

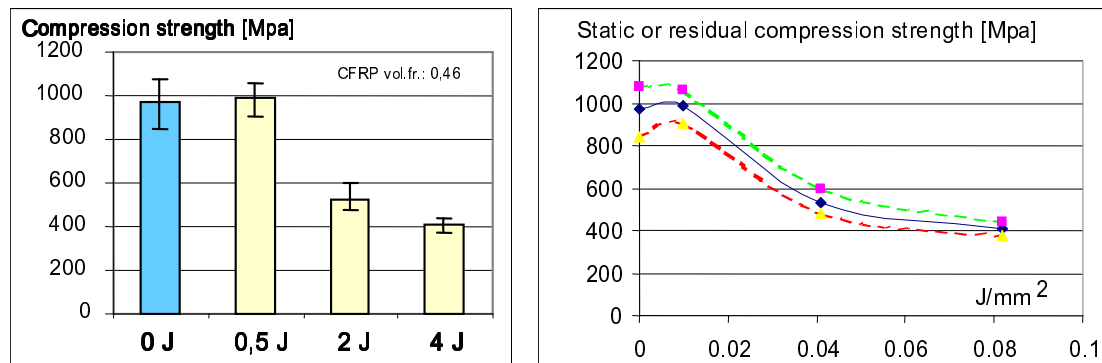
Fig. 4.1.10. Impact energy influence on the residual strength.

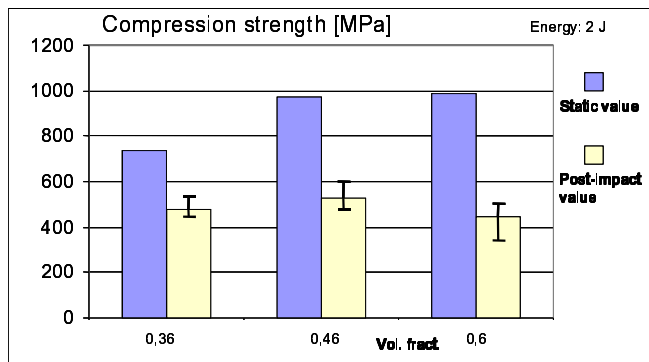
Fig. 4.1.11. Volume fracture influence on the residual strength of the specimen subject to the impact of 2J compared to the static strength at a room temperature.

The volume fracture influence on the residual strength of the specimen subjected to the impact of 2J is shown in Fig. 4.1.11. together with the strength for non-impacted specimens. From the diagram it can be seen, that the highest impact durability of the composite appears close to the volume fracture of 0,5. In the previous investigations it was found that this very value of volume fracture was optimal for the compression strength of the CFRP composites formed using the LPC method.
