Institute of Aviation

Review of Polish Aeronautical
Fatigue Work 2005 – 2007

Antoni Niepokólczycki
May 2007

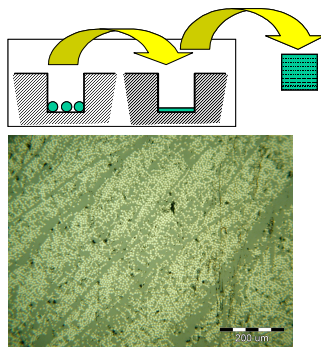
Fig. 4.1.12. Source and the microscopic image of quasi-layers.

The influence of technological aspects is illustrated in Fig. 4.1.12. and Fig. 4.1.13. The forming method was taken into account; i.e., free forming (LPC) or pressure forming (HPC). The quasi-laminar structure of the beams reinforced by the carbon roving should be emphasized, caused by the method of beam fabrication; (the strands of impregnated roving are introduced and squeezed in the mould layer by layer).

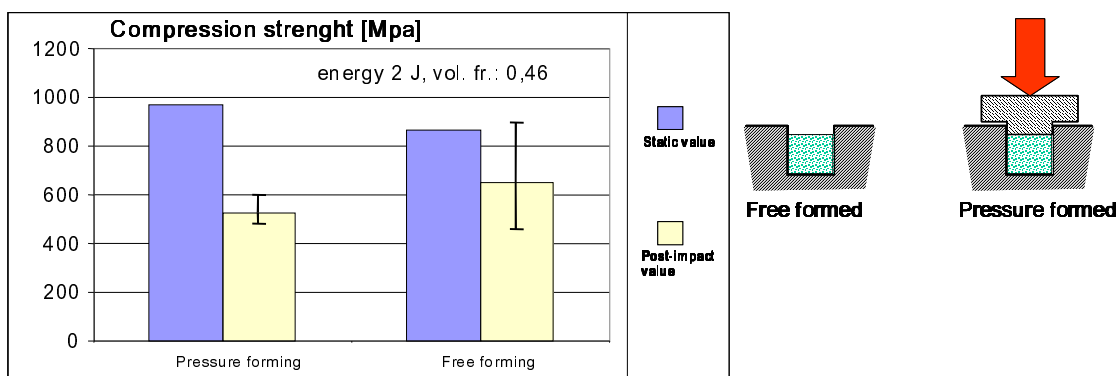
Fig. 4.1.13. Influence of pressure applied during the CFRP beam forming on the static strength and the residual post-impact strength.

From the diagram it can be seen, that the lack of pressure during the beam forming causes wide scatter of the CFRP strength, probably due to higher impact energy dissipation in the structure formed using the LPC method caused by heterogeneity of the structure.

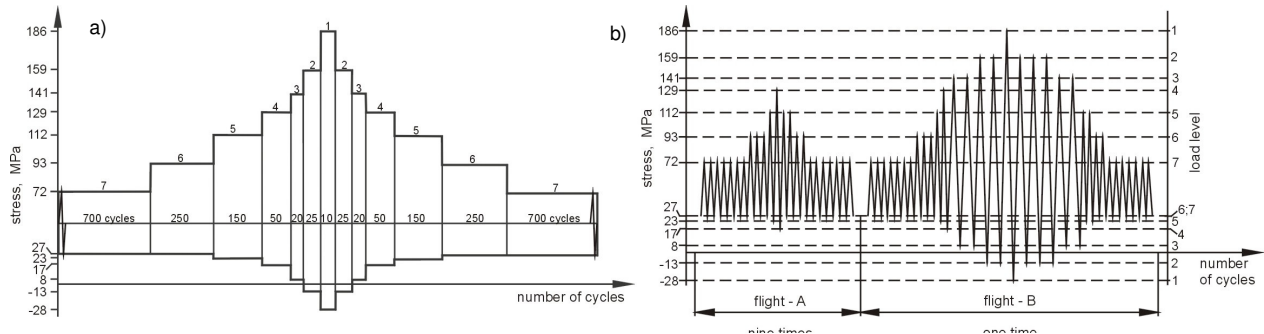
Figure 4.2.1. Schemes of LHL-100 block program (a) and Flight-by-Flight cycle sequence (b).

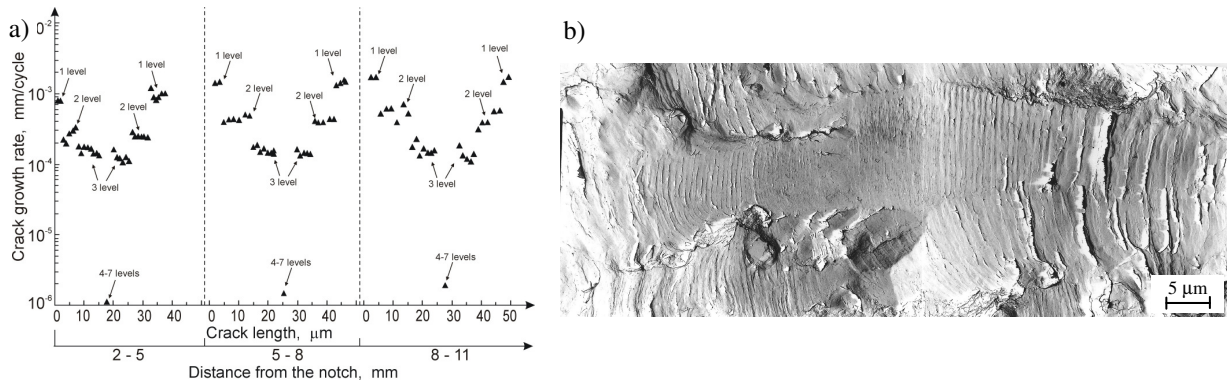
Fig. 4.2.2. Local crack growth rates versus crack length for three distances from the notch root (a) and TEM micrograph with the fatigue striation distributions (b) during the LHL load program.

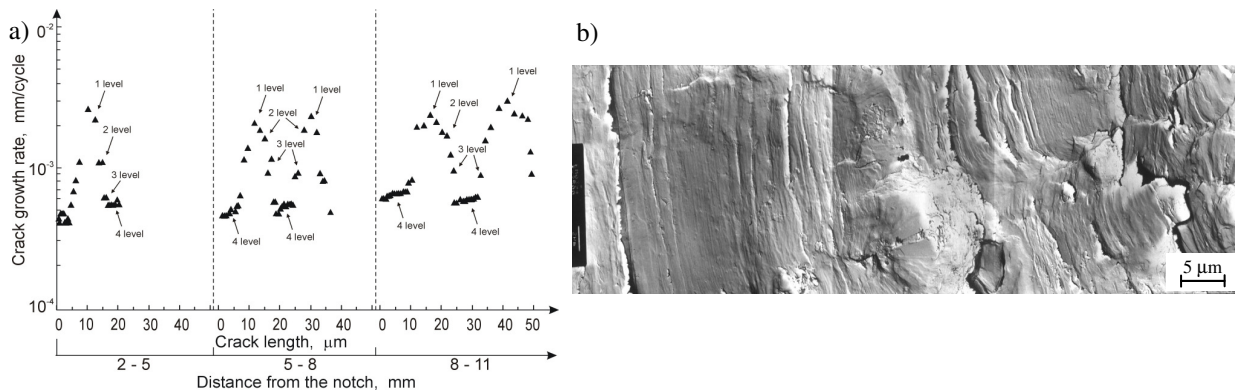
Fig. 4.2.3. Local crack growth rates versus the crack length for three distances from the notch root (a) and TEM micrograph with fatigue striation distributions (b) during the Flight-by-Flight load program

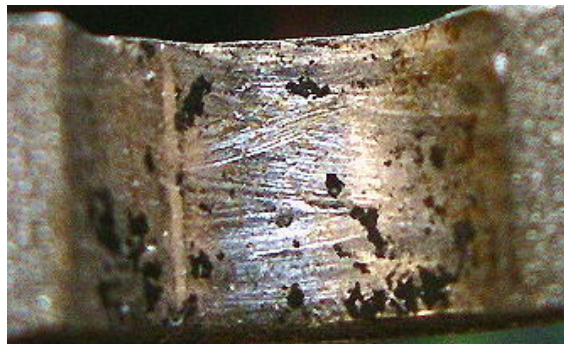
Fig. 5.1.1. Fretting wear at the rivet hole.

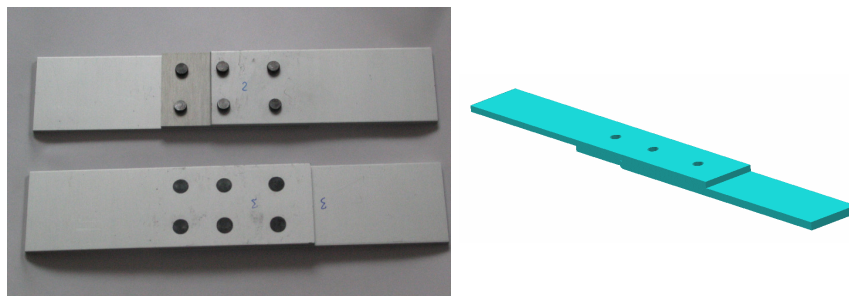
Fig. 5.1.2. Riveted specimen.

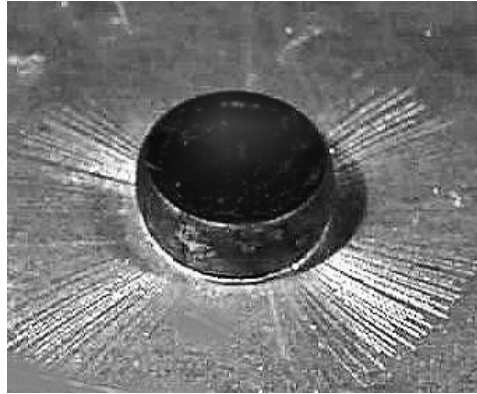
Fig. 5.1.3. Visual detections analysis.

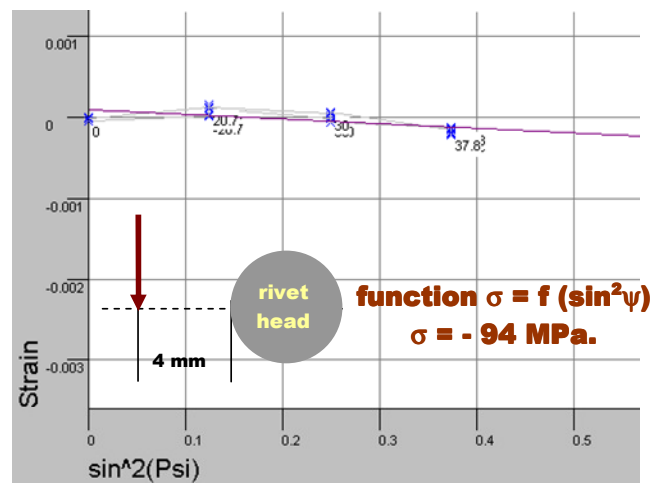
Fig. 5.1.4. X-ray diffraction measurement.

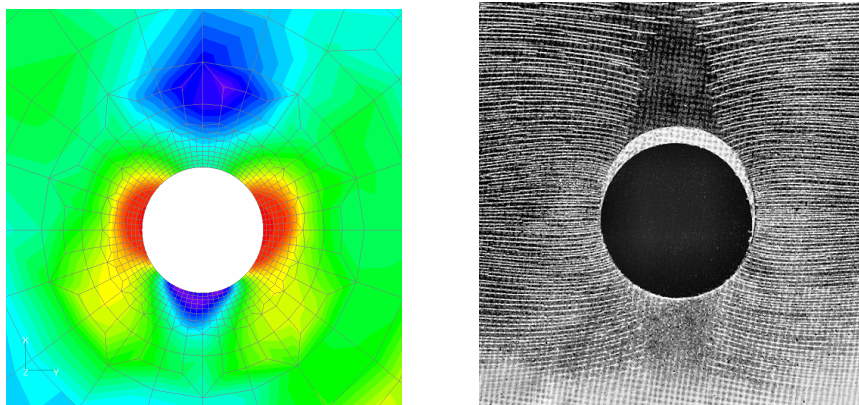
Fig. 5.1.5. Stress state around the rivet hole a) calculations b) experiment.

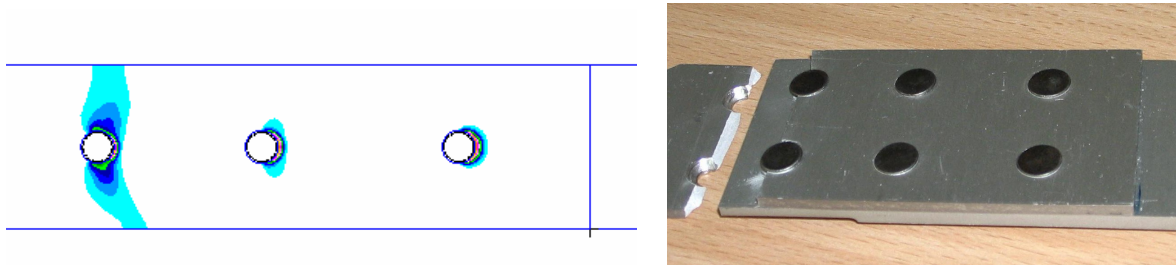
Fig. 5.1.6. Specimen after tensile loading.

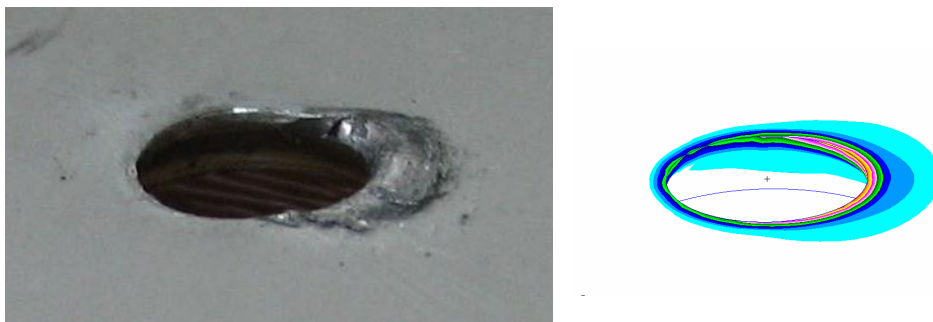
Fig. 5.1.7. Plastic strain field around the rivet hole.

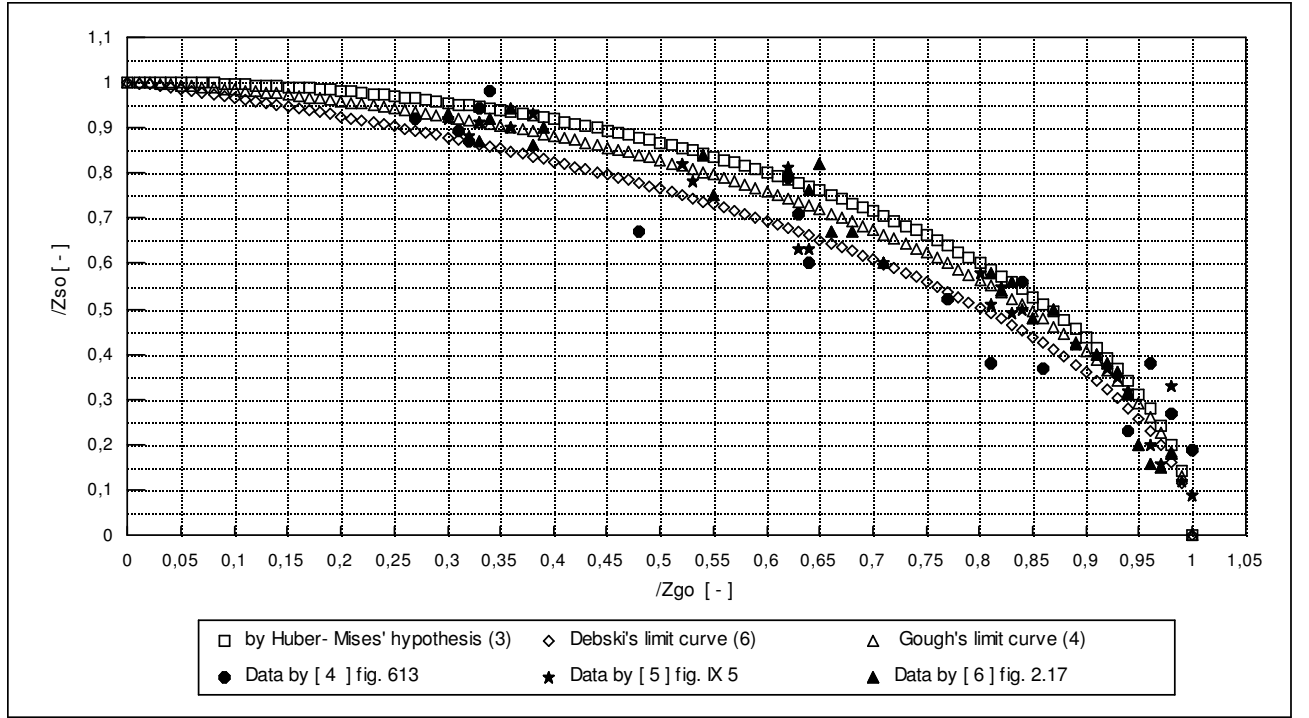
Fig. 6.1.1 Limit curves in complex stress-state.

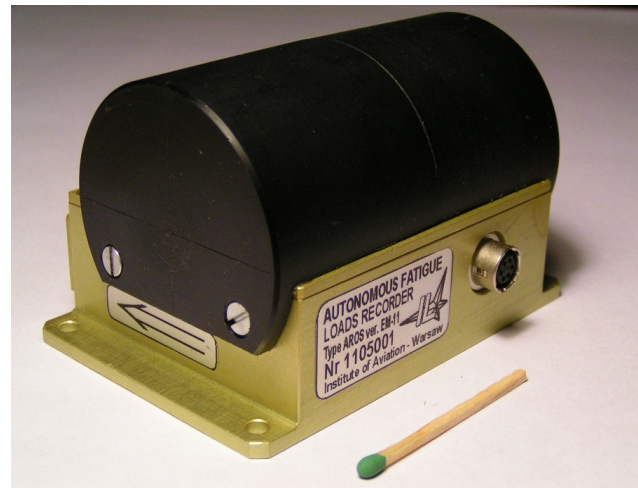
Autonomous Fatigue Recorder – AFR

Autonomous Fatigue Recorder - AFR is a kind of small computer. The processor Texas Instruments MSP-430 is the main part of the recorder. Software of AFR for signal analysis was written in C and Assembler programming languages.

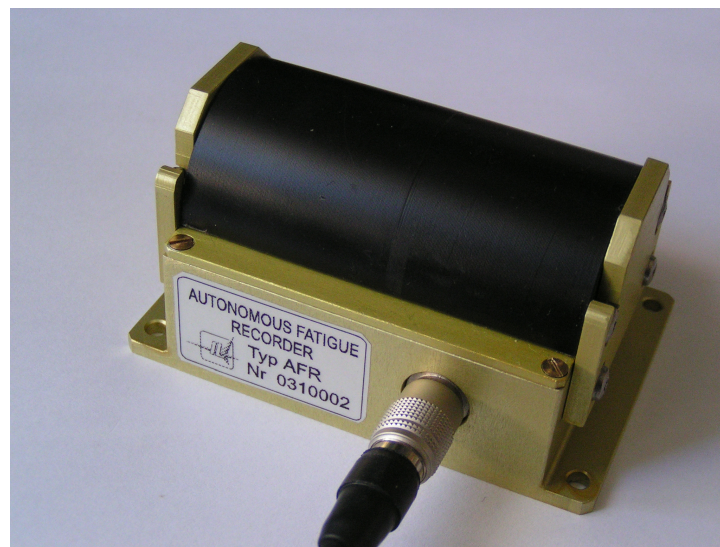
- classic method of the cycles reductions, used for estimation of the aircraft fatigue load spectrum,
- full cycles method – 3D diagram

At the first stage of measurement the AFR software registers and analyzes the fatigue load spectrums at the critical points of structures.

For the signal classification (analysis) the following methods were used:
