A REVIEW OF AERONAUTICAL FATIGUE AND STRUCTURAL INTEGRITY IN ISRAEL (2019 –2021)

A REVIEW OF AERONAUTICAL FATIGUE AND STRUCTURAL INTEGRITY IN ISRAEL

JANUARY 2019 – DECEMBER 2020

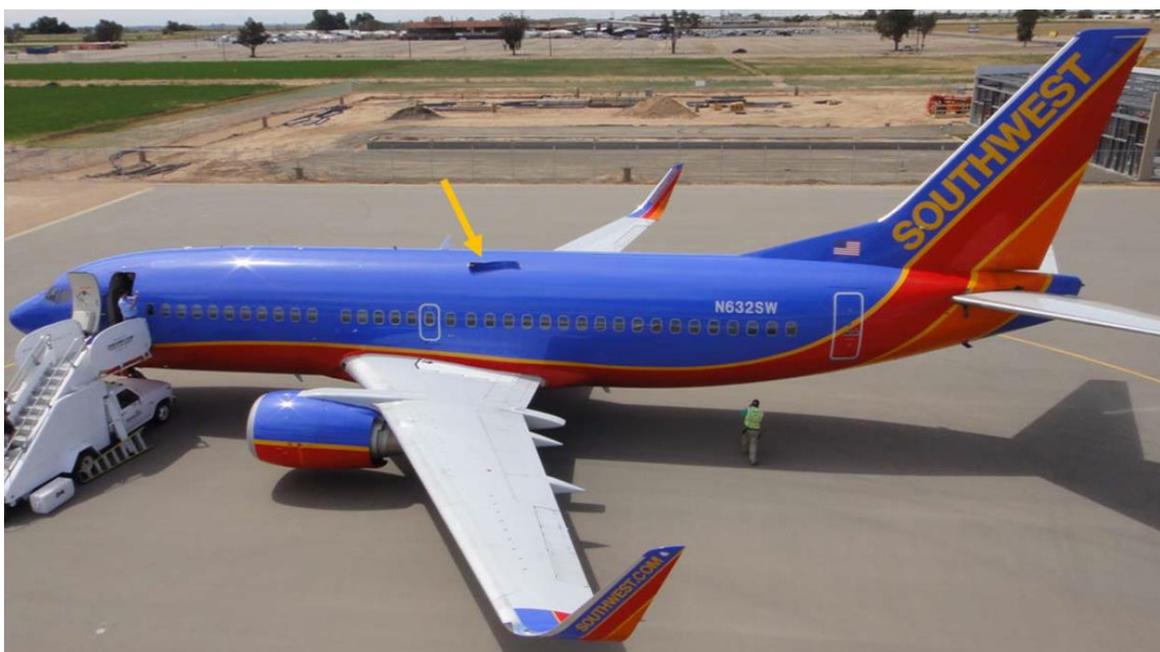
To this end, the author and his co-worker have published several papers in recent years introducing a new risk-assessment based approach for determination of inspection program to protect the structure from a WFD threat [3, 4]. This approach was implemented to investigate a very special case of the South Airlines accident in 2011. On April 1, 2011, a Boeing 737-300 airplane operated as Southwest Airlines (flight 812) experienced a rapid decompression during flight. The pilots conducted an emergency descent and diverted to Yuma International Airport in Arizona. Of the 5 crewmembers and 117 passengers on board, one crewmember and one nonrevenue off-duty airline employee passenger sustained minor injuries. The airplane sustained substantial damage; post-accident inspections revealed that a section of fuselage skin about 60 inches long by 8 inches wide had fractured and flapped open on the upper left side above the wing. At the time of the accident, the airplane has accumulated 39,786 flights, while its Limit of Validity (LOV) is 75,000 flights, and Boeing's Service Bulletin [5] calls for panel replacements at 50,000 flights (in WFD evaluation terminology this may be referred to as the lap joint SMP). Picture of the airplane on ground after landing is shown in Figure 1.

Figure 1: Photograph of Southwest Airlines flight 812 airplane on ground.

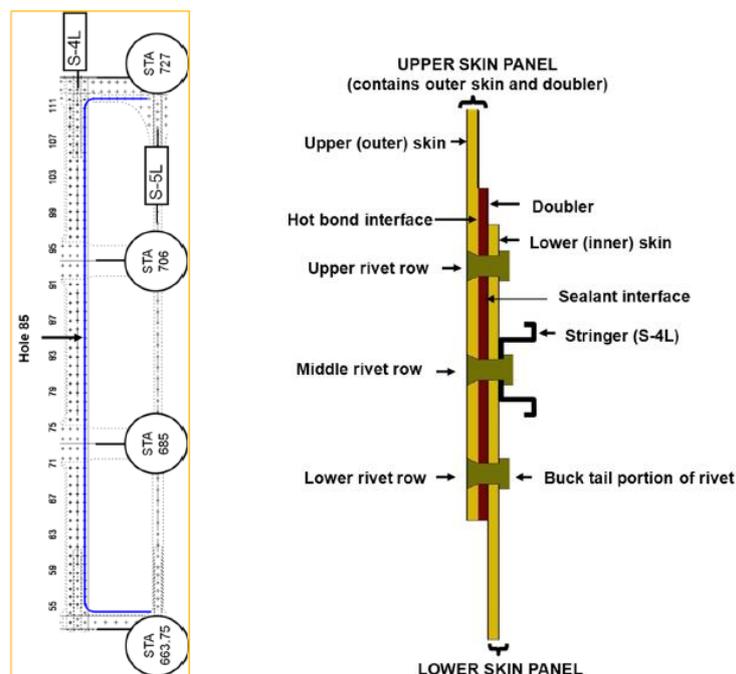
A comprehensive investigation was conducted to derive the root cause of this failure [6]. Microscopic examination of the longitudinal portion of the fracture surfaces revealed fracture features consistent with fatigue cracking that originated from 54 out of 58 rivet holes. The fatigue cracks emanated from the outer surface of the lower skin, which is not visible from the interior or exterior of the airplane. In nine adjoining rivet holes fatigue cracking occurred through 100% of the skin thickness. The two longest fatigue cracks were found on the forward and aft side of one of the holes (indicated as 'hole 85', see Figure 2), measured as 0.55 and 0.60 inches, respectively. The calculated total number of cycles for the longest fatigue crack at the critical rivet hole was 38,261 flight cycles, which was within about 1,500 cycles of the total cycles on the airplane. Illustrations of the crack pattern and the lap-joint structural detail are shown in Figure 2.

Figure 2: Typical skin longitudinal lap joint (left) and the crack pattern (right).

Examination of the rivets in the fracture area revealed numerous anomalies, including oversized rivets, variations in finish, under-driven conditions, expanded shank areas, and crank-shafting. Most of the lower-row holes in the lower skin had discrepancies including ovalized holes, double-drilled holes, gaps between the buck tail and the hole, sealant in the rivet hole, and burrs protruding from under the buck tail. Examination of the lap joint before it was separated revealed that almost all of the lower-row holes in the lower skin were offset from the holes in the upper skin and attached doubler. Based on the panel marking *it was concluded that the panel was replaced during assembly, and the evidences indicate that during drilling of the lap joint, the crown skin panel and the upper left fuselage panel were misaligned, so most of*

the lower rivet row holes were misdrilled. Many of the installed rivets did not completely fill the holes in the lower skin panel, which significantly reduced the fatigue life of the panel.

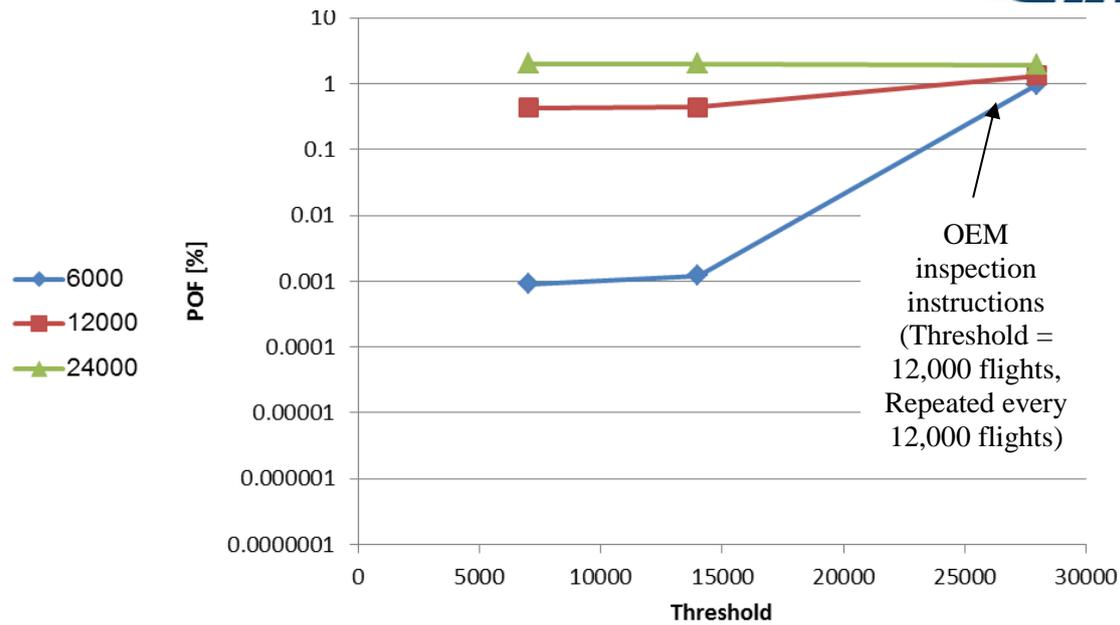
This study [2] assessed the effect of such improper manufacture on the structural integrity of the airplane in line of the damage tolerance philosophy and the WFD evaluation. The risk analysis incorporated data from the fractographic examination of the cracked panel, in which the crack initiation period was only 1,500 flights, with crack growth lifetime of 38,261 flights. The critical crack length was reported as 0.6 inches [6]. By accounting for the inspection capabilities of the concerned regions, the scheduled inspection program of this structural detail and its life limitation, the Cumulative Probability of Failure (CPOF) was obtained. Figure 3 presents an illustration of the CPOF for the concerned case with various threshold and repeated inspection periods. In this analysis, it is assumed that the SMP is 50,000 flights. Acceptable CPOF (~0.01% - 0.001%) is reached only if the threshold inspection is performed at ~15,000 flights, with recurring inspections every 6,000 flights. It may be noted that the OEM instructions for inspections are at 28,000 flights with subsequent inspections every 12,000 flights. These instructions are obviously not sufficient for the southwest accident specific case.

Figure 3: Cumulative Probability Of Failure (CPOF) for a "Southwest accident" lap joint analysis with crack initiation period of 1,500 flights, and crack growth lifetime of 38,261 flights. The effect of threshold inspection periods and repeated inspection intervals are shown.

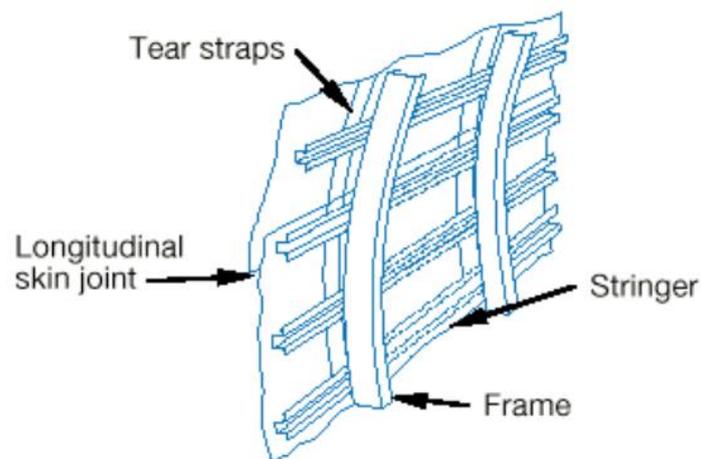
Typical fuselage structures consist of several structural details joined together by means of mechanical fasteners. Several of these structural concepts are shown in Figure 4 below. The fatigue performance of those elements, and especially the fatigue characteristics of their joints, can be a primary limitation to the endurance and safety of a traditional transport category airplane fuselage.

Figure 4: Typical fuselage structural details.

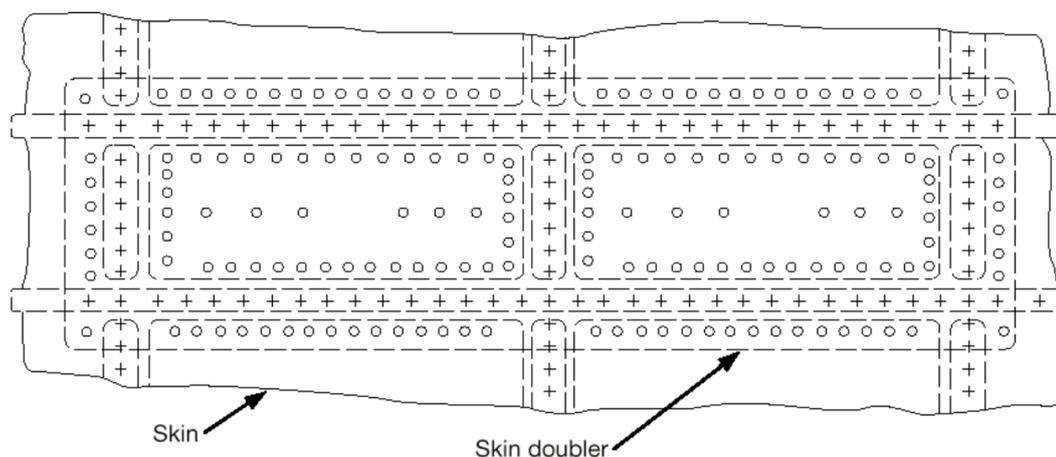
Hard-points are attachments in which the load is jointly carried by two or more members. Typical hard-points that may be found in fuselage structure are skin-doublers attachments and skin-stringers attachments. An example of an hardpoint is shown in Figure 5.

Figure 5: An example of skin-doubler attachment

Hard-point attachments, as shown in Figure 5, are considered as candidates for MSD scenarios due to the fact that almost all the fasteners in each row of fasteners attaching the doubler to the skin are subjected to very similar loads (resulting in membrane stresses) upon cabin pressurization. Thus, it is reasonable to assume that natural crack will nucleate in adjacent fasteners in the hard-point. In addition, fastened attachments as hard-points include inherent eccentric with respect to the load path, which induces out of plane deflections of the skin sheets. This is referred to as secondary bending, and it is considered as a side effect of tensile membrane loads acting on the skin.

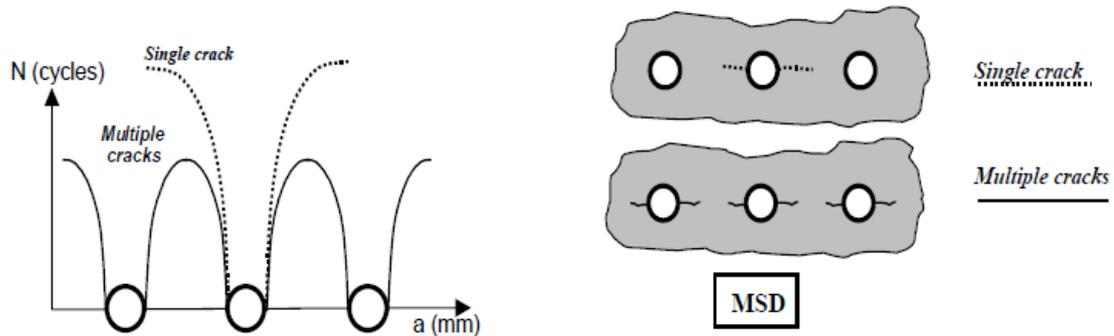
meet its required residual strength. A good example of WFD is a Multiple Site Damage (MSD), in which the damage is characterized by the simultaneous presence of fatigue cracks in the same structural element. Illustration of MSD is provided in Figure 6.

Figure 6: Multiple Site Damage (MSD) interaction effects

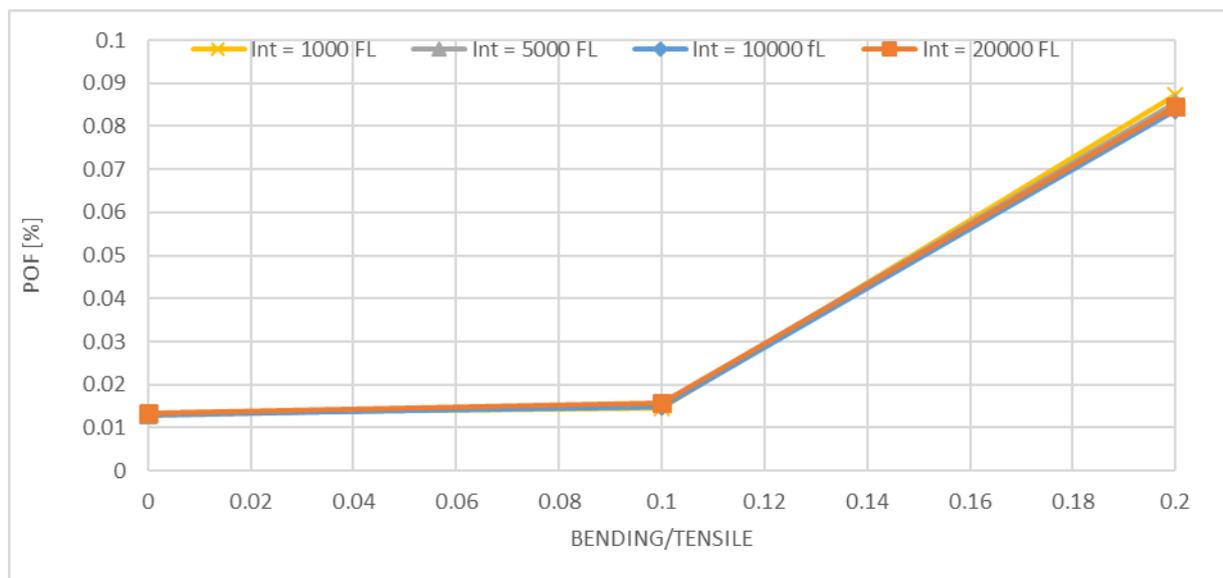
Figure 7: Effect of secondary bending on the probability of failure for a given scenario of $ISP = 60,000$ flights, $SMP = 75,000$ flights

The current study focuses on the effect of the induced secondary bending on the inspection program defined to ensure that no failure occurs during service upon MSD. To this end, a typical case of skin reinforcement by a doubler is investigated, with several combinations of skin to doubler thicknesses. The induced secondary bending for each combination is obtained, as well as the expected reduction in WFD average lifetime and the corresponding ISP, SMP and inspection intervals. Figure 7 below provides an example of the effect of the secondary bending on the required inspection intervals. $ISP = 60,000$ flights, with $SMP = 75,000$ flights, and several inspection intervals were examined. It may be easily observed that the probability of failure increases significantly with the increase of the secondary bending effect to 20% of the

membrane stresses. However, the effect of 10% bending stresses is not that significant. Similar calculation was conducted for $ISP = 20,000$ flights and $40,000$ flights, and similar conclusions were drawn. In addition, the inspection intervals have minor effect due to the fact that the ISP was set as $60,000$ flights, with SMP taken as $75,000$ flights, and due to the relatively short critical crack length for a MSD scenario.

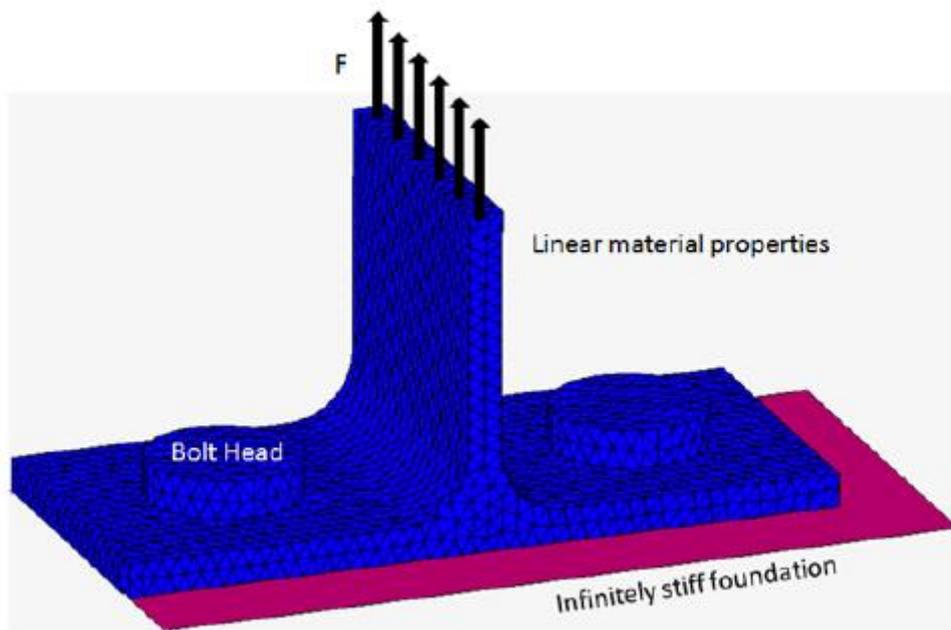
Figure 8: Finite element model used for validation of the analytical approach

To achieve this objective, a method is proposed that assumes the clip to rest on an infinitely stiff, tensionless Winkler foundation. The corner radius is modelled using Castigliano's 2nd theorem to accurately predict the shear and moment distribution throughout the clip. The fastener is modelled as both an axial and torsional spring, allowing for extension and rotation of the fastener, and to establish the point of first contact of the clip with the foundation. Fastener preload is also included in the model. Finally, the maximum applied force at which the clip initiates plastic hinges is also predicted. Predicted results for 'thin' clips match those of 1D Nastran beam models (CBARs) on CGAP elements, as well as a 3D Marc non-linear contact

model (as shown in Figure 8), closer than any other model found in the literature (Figure 9 and Figure 10).

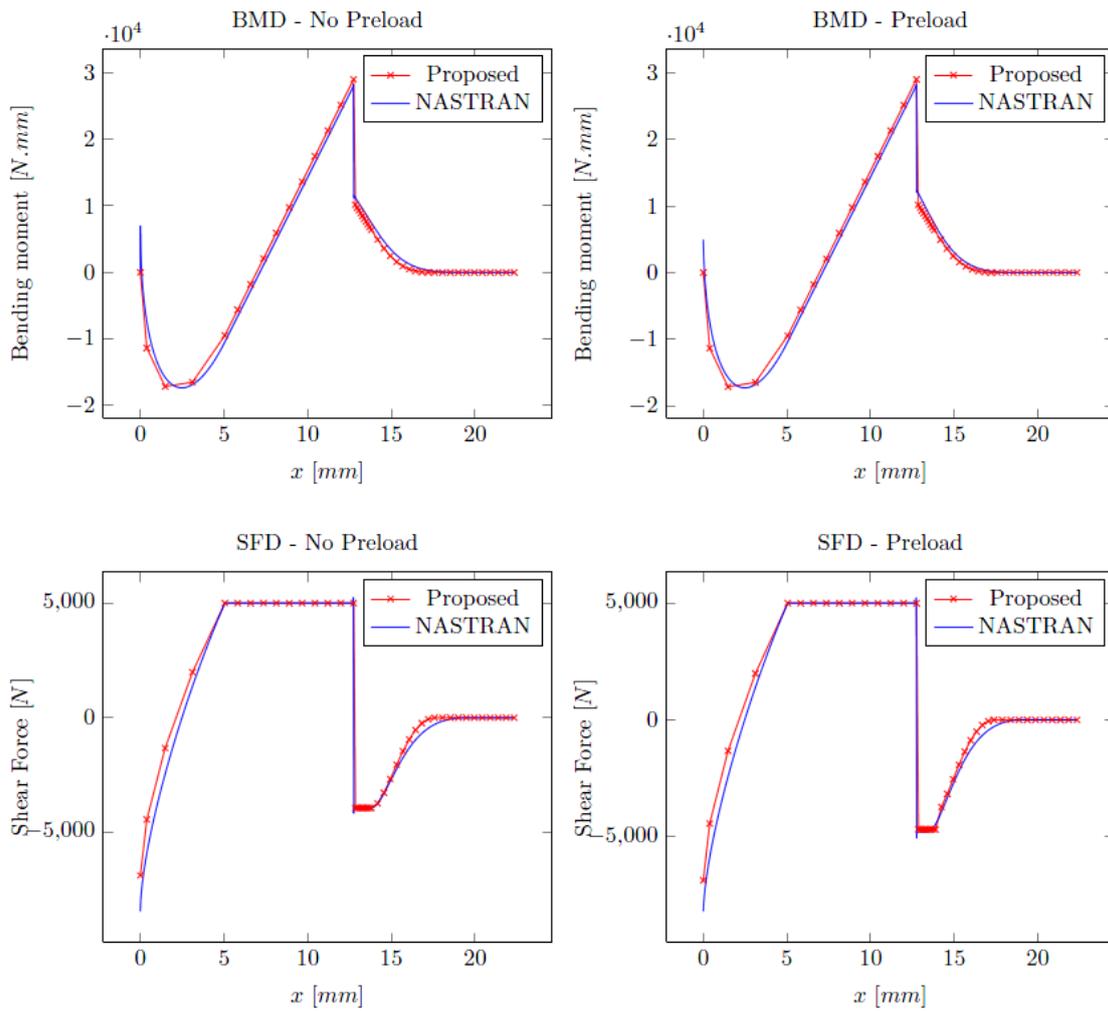
Figure 9: Comparison of results between the proposed approach and a 1-D nonlinear Nastran model

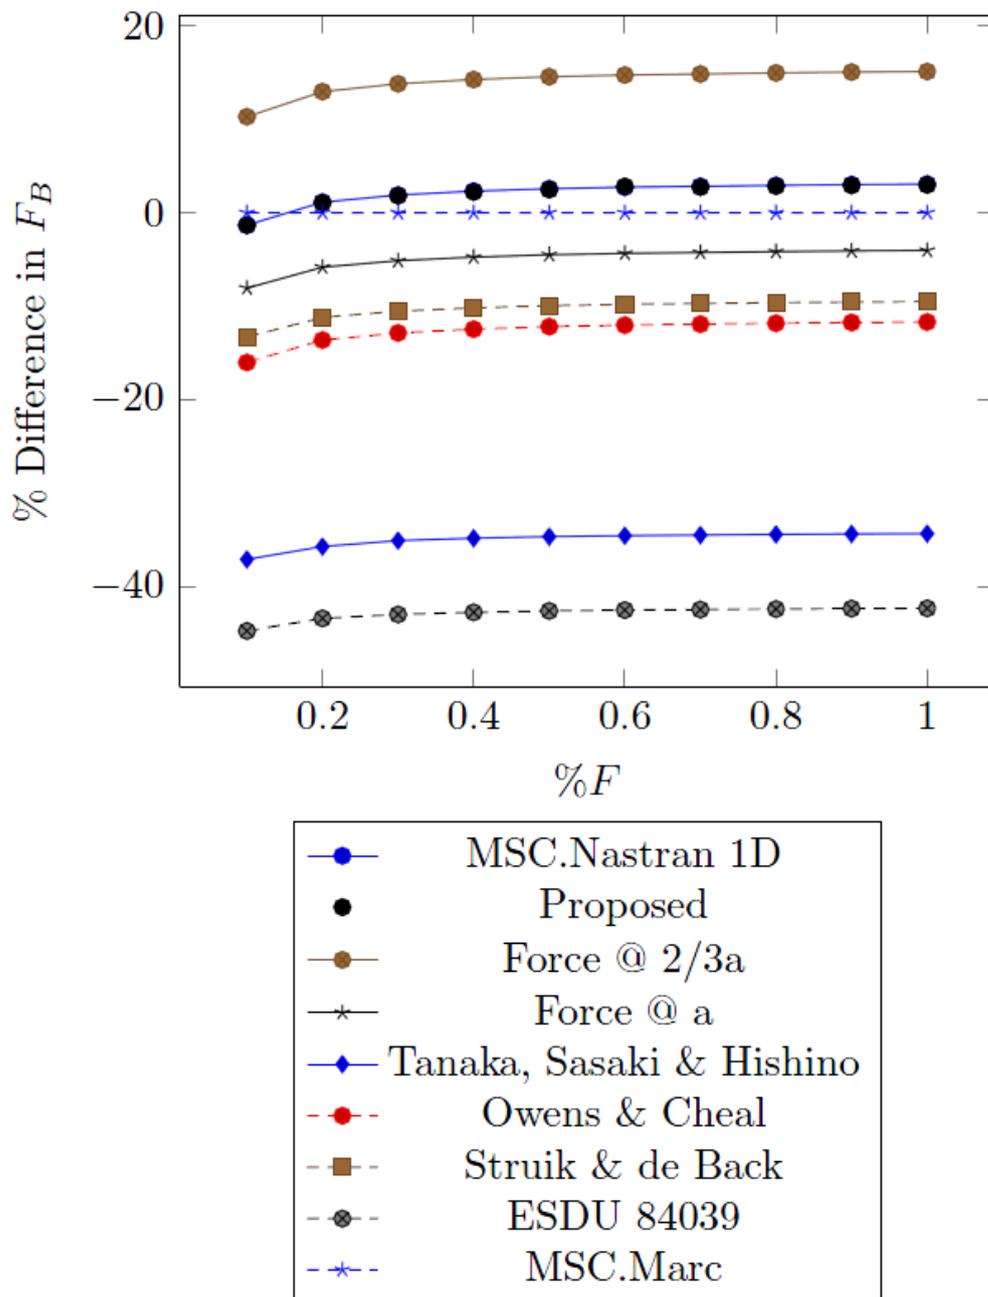
Figure 10: Percentage difference in bolt force compared to MSC.Marc model results; no preload. Similar trend is observed with preload accounted for

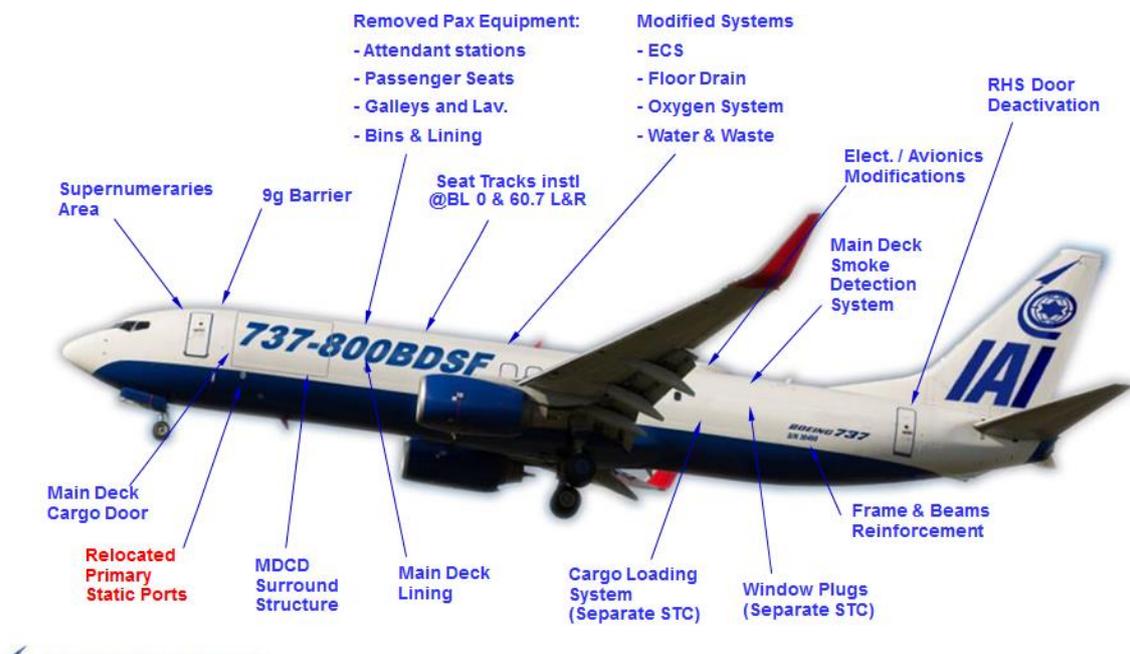
Israel Aerospace Industries has developed and certified in the past two decades converted freighter for a series of Boeing models, such as 747-200/400, 767-200/300 and 737-300/400/700. Its newest converted freighter, for Boeing 737-800 aircraft, was certified as a supplemental type certificate to the CAAI, FAA and EASA in mid 2020. The conversion includes the installation of a cargo door on the fuselage, additional structural modification to support full load capacity, and implementation of smoke and fire detection in the cargo bay. A solid 9g barrier/smoke partition is installed at aircraft forward fuselage, separating the class E compartment from the occupied area and creating a supernumeraries compartment in the area between the flight deck and the 9g barrier. Interiors, ECS, smoke detection, oxygen, lighting and other systems are modified to accommodate the freighter configuration. The converted B737-800BDSF presents a main deck cargo volume of 4,999 ft³., with lower decks bulk volume of 1,543 ft³, enabling it to carry up to 53,000 lb. An overview of the modifications in the 737-800BDSF aircraft is shown in Figure 11.

Figure 11. Modification at the 737-800BDSF aircraft

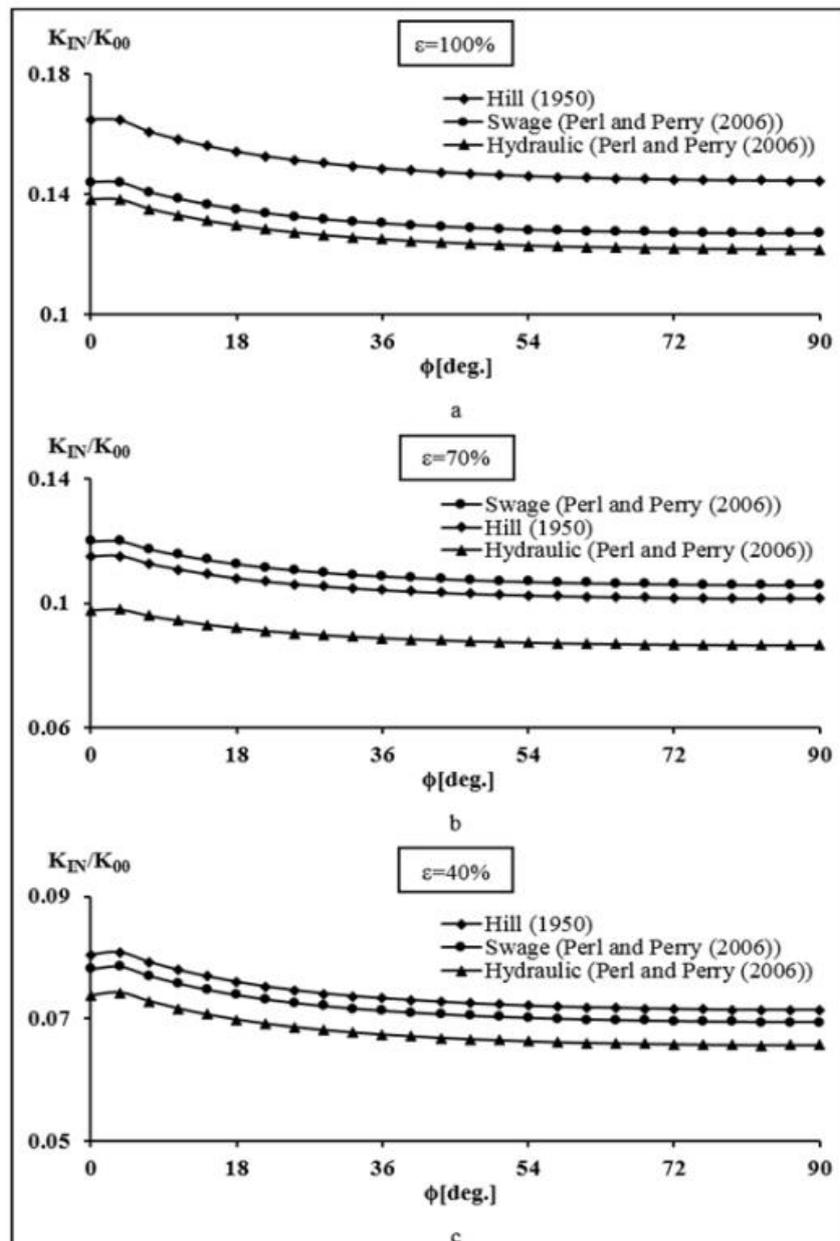
The Stress Intensity Factors (SIFs) of cracked modern tank gun barrel is investigated in Refs. [20, 21]. The combined stress intensity factor K_{IN} consists of two components: K_{IP} —the SIF caused by internal pressure; K_{IA} —the positive SIF due to the tensile residual stresses induced by autofrettage. Ref. [20] investigates the stress intensities for elliptical cracks (with $a/c = 0.2 - 1.0$) and different levels of swage, hydraulic and Hill's autofrettage. Hundreds of different 3-D cases are analyzed by means of finite element models. In Ref. [21], these stress intensities are used for evaluations of the barrel fatigue life due to external cracking. An example of stress intensity factors distributions of an external radial semi-circular of depth $a/t = 0.005$ subjected to three different levels of Hill's, swage and Hydraulic autofrettage is shown in Figure 14.

Figure 14. Stress intensity factors distributions of an external radial semi-circular of depth $a/t = 0.005$ subjected to three different levels of Hill's, swage and Hydraulic autofrettage

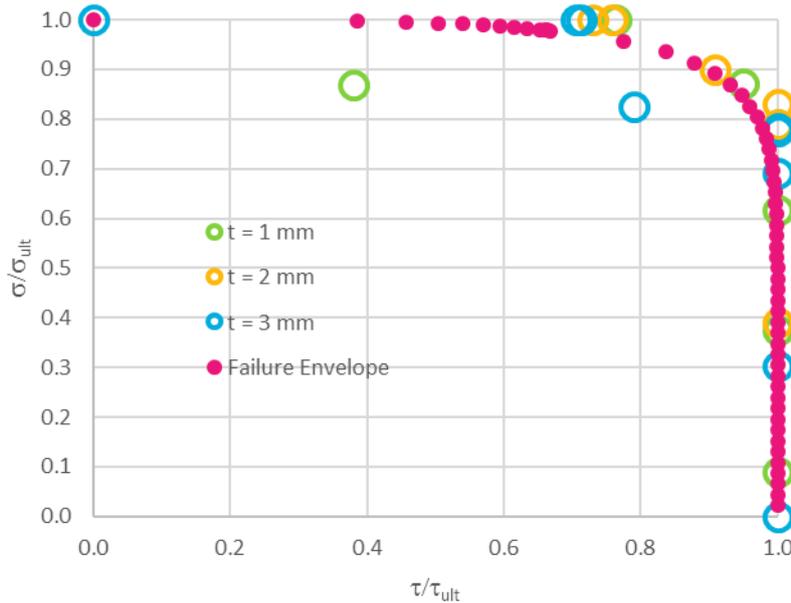
Once the failure parameters for each mode mixity and bond line thickness are in hand, curve fitting using the least squares method was executed. Four mode mixities out of the nine tested (including the pure shear and pure tensile) were used for the curve fitting: $G_{II}/G = 0.5, 0.9$ and pure shear and tension. The remainder of the mode mixities were used for validation of the failure curves, as shown in Figure 16. Very good agreement between the failure envelope and the test results is observed.

Figure 16: Failure envelope for 9394 adhesive in different thicknesses ($m = 2.4$, $n = 13.4$)

As can be seen from Figure 16, all adhesive thicknesses can be correlated to a single failure criterion. This is due to the fact that the MMB specimen induces almost no secondary bending at the bond line (note the deformed shape of the MMB specimen in Figure 15), as opposed to the classical lap shear specimen. Therefore, increased bond line thickness does not induce significant peeling stresses at the disbond tip. Such behavior is more realistic to typical structural bonding such as wing spar to skins, or fuselage frames to skin, in which secondary bending at the bond line is negligible. For structural bonding representing skins longitudinal splices, in which the secondary bending is significant, other failure criteria are recommended to be used.

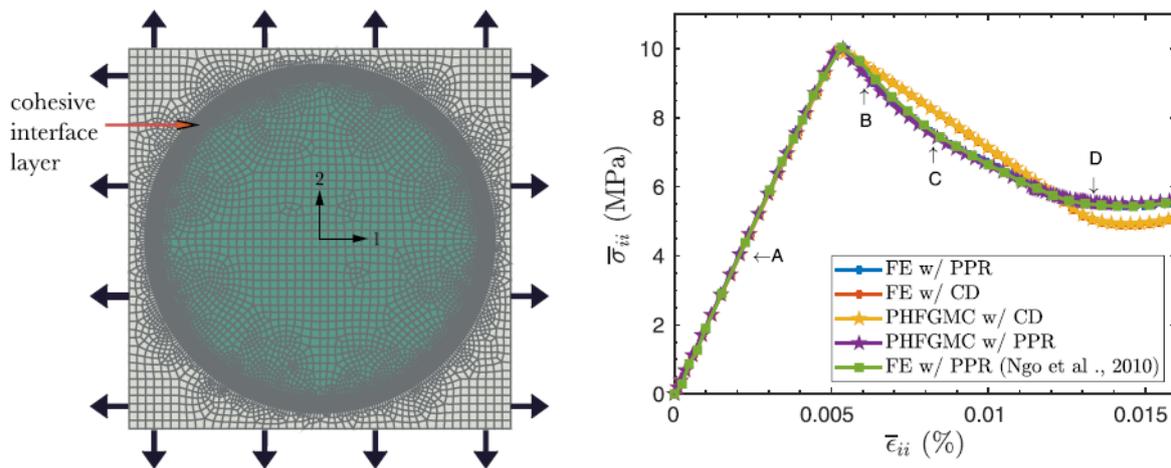
Ref. 26 presents a comprehensive study comparing the PHFGMC approach with FEM predictions. An example of the accuracy of the PHFGMC method for a case study of a double cantilever beam made of composite materials is shown in Figure 17.

Figure 17: Comparison between PHFGMC and FEM with different cohesive zone traction-separation laws (right) and an overview of a Repeated Unit Cell (RUC) used for the PHFGMC predictions (left)

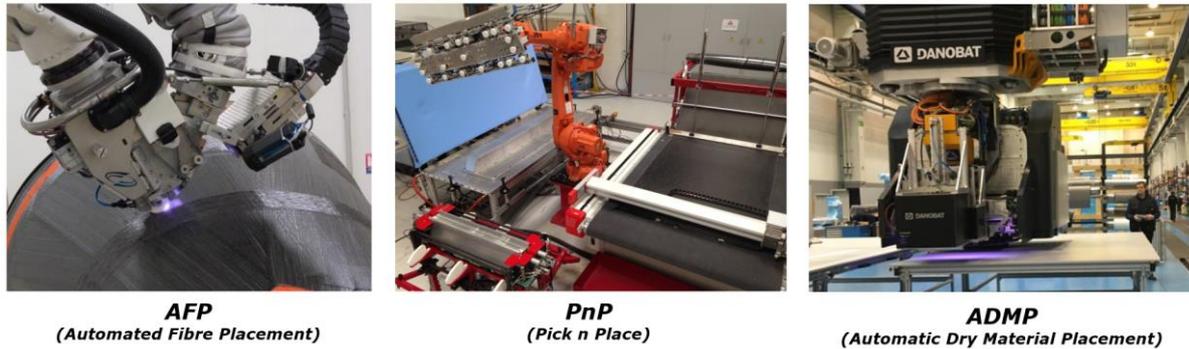
Figure 18: Automated composite manufacturing technologies being assessed in OPTICOMS

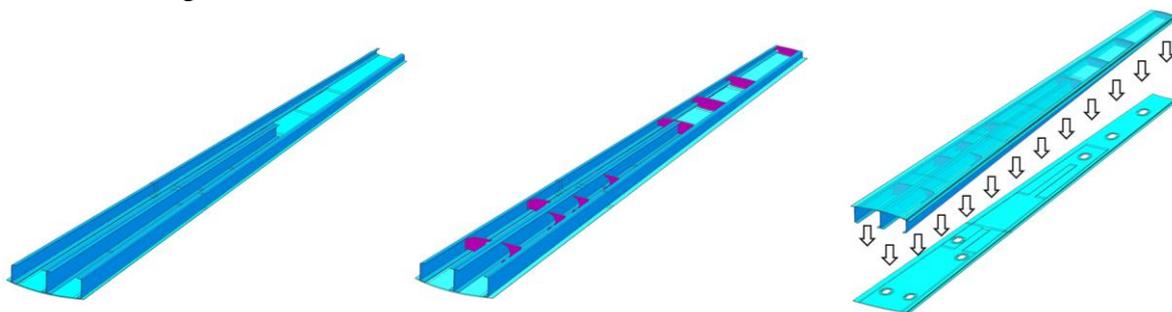
Figure 19: Major manufacturing stages (i) Co-cured skin and spars, (ii) Ribs installation, (iii) Lower skin bonding

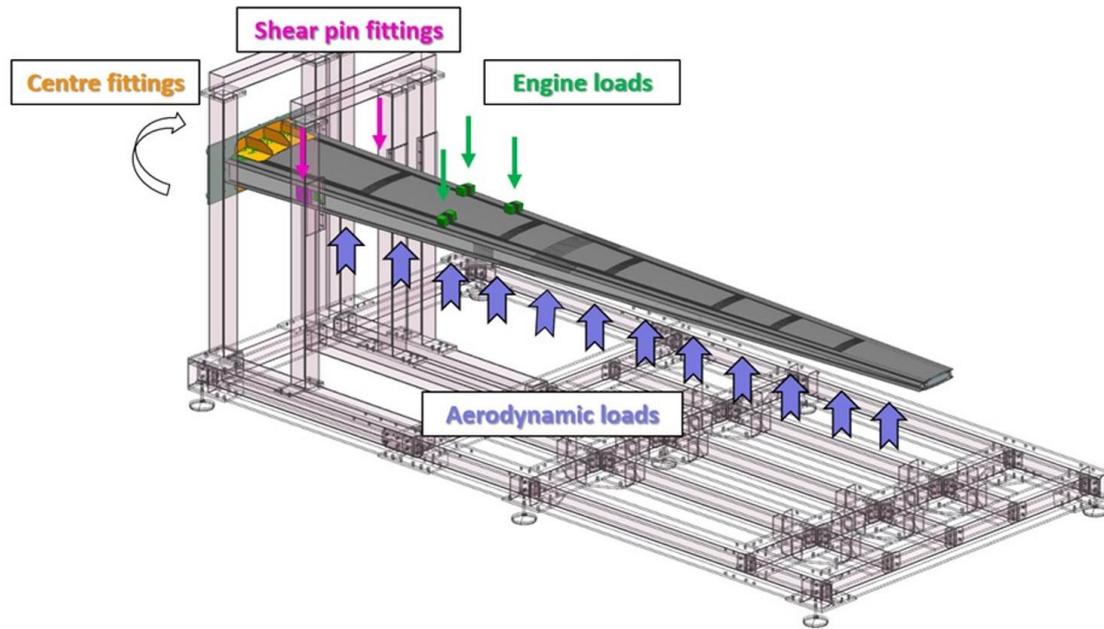
Using the metallic wing of Piaggio Aerospace's P180 Avanti as the baseline, the OPTICOMS consortium (which eventually included over 15 independent European companies) was tasked with producing and substantiating a full-scale, 7m half-wing composite demonstrator. This entire process included the definition, conceptualisation, design, manufacturing (including building block pyramid coupons to elements), finally culminating in a static ground test (as illustrated in Figure 20).

Figure 20: Final static ground test scheme

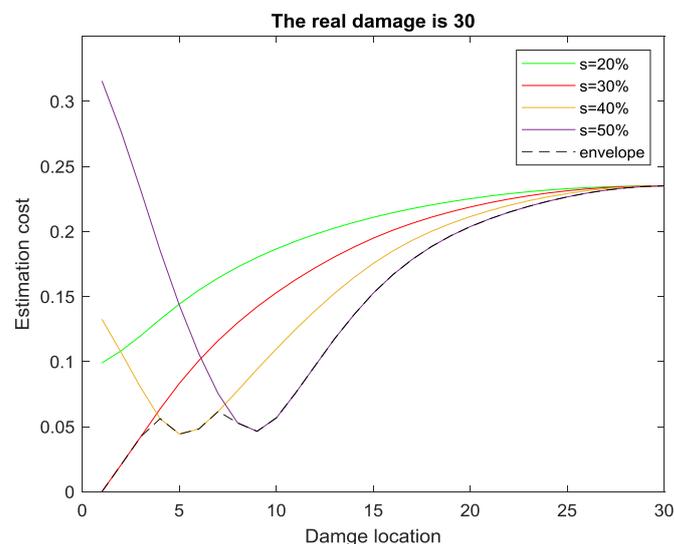
A benchmark problem is investigated in this research. The identification problem is solved by means of two approaches. First, it is assumed that the damage intensity is known, while the damage location is unknown. In the second approach, both damage intensity and its location are unknown. For the second approach, assuming 181 measurements in time, the damage location ('30' in Figure 21) is easily detected for different damage intensities.

Figure 21: Identification of damage location and size

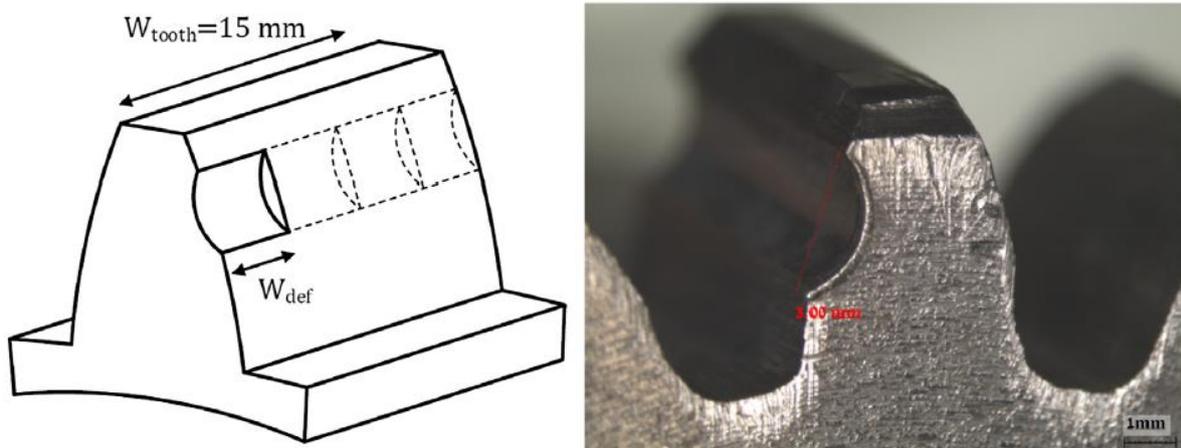
In Ref. 27, the contribution of dynamic models for the development of reliable prognostics and diagnostics algorithms is investigated. The dynamic models enable prediction of changes in dynamic behavior reflecting the fault type and severity using condition indicators and signal processing techniques. A tooth face spall like fault is investigated, as shown in Figure 22.

Figure 22: Tooth face spall like fault

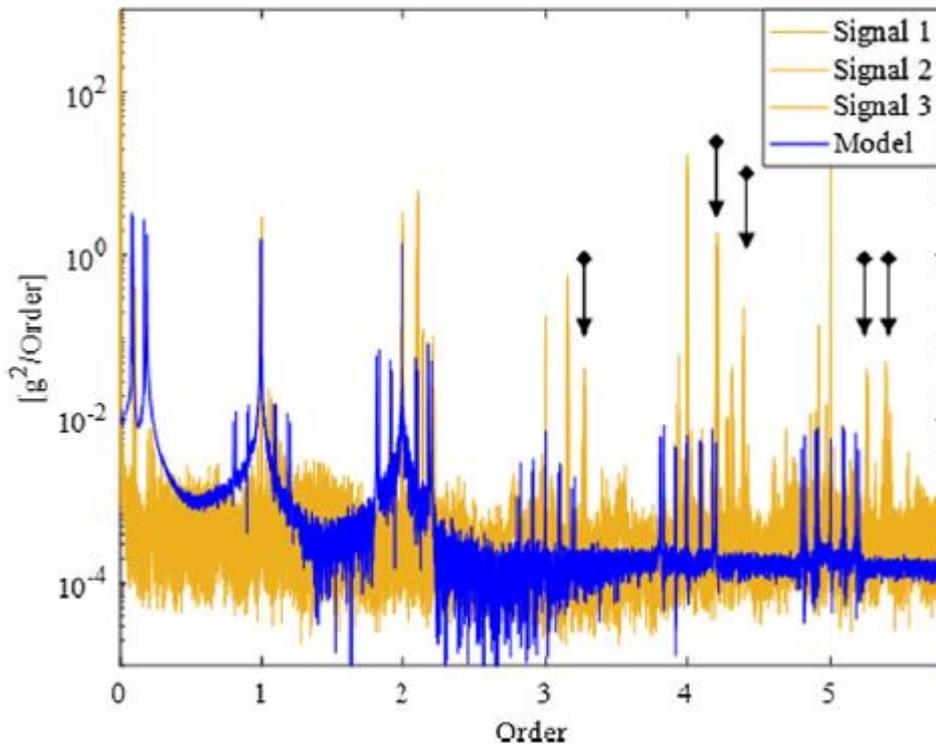
The model simulations were compared to the vibrations measured during test. Figure 23 presents the experimental and simulated results. Shaft speed harmonics (related to the support bearings) are marked by black arrows. Most of the peaks in the measured spectrum correspond to one of the test components or one of the supporting bearing tones.

Figure 23: Experimental and test results

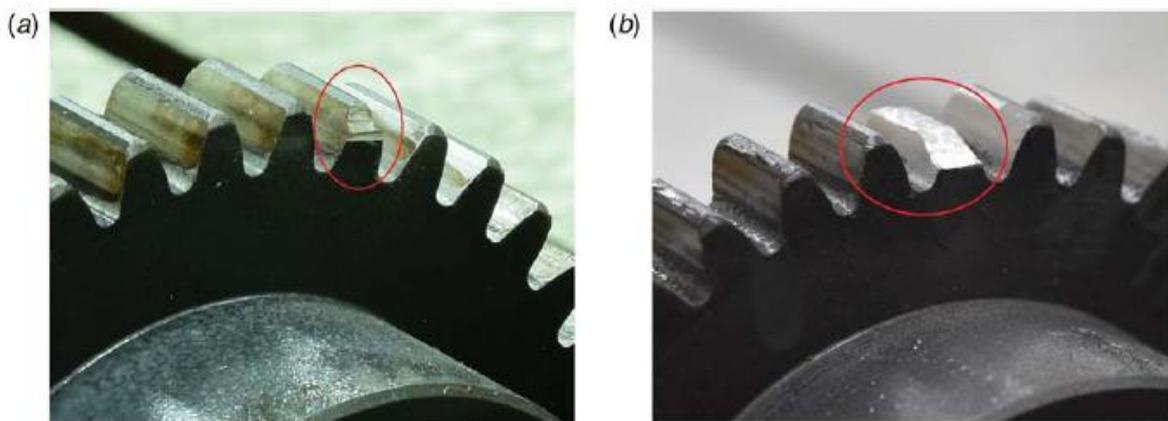
In Ref. 28, three different typical failures in gear transmissions were investigated: tooth face fault, broken tooth, and cracks at the tooth root. Example for tooth face fault is shown in Figure 22, while examples for the other faults are given in Figure 24 and Figure 25.

Figure 24: Examples of: (a) chipped tooth and (b) broken tooth

The faults were thoroughly analyzed to understand the fault manifestation in the vibration signature and to find condition indicators that are sufficiently robust and yet sensitive to the existence and severity of the fault. For each fault, the condition indicators were categorized according to their discrimination power between faulted and healthy states and the ability to rank the fault severity. It was concluded that faults that affect the involute profile throughout the tooth are easily detectable. Faults such as root cracks or chipped tooth, in which mainly the tooth stiffness is affected, are much more challenging to detect.

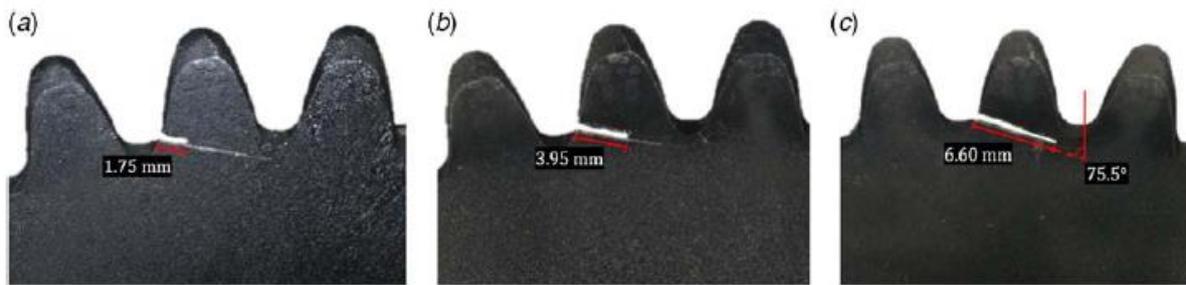
Figure 25: Examples of cracks of different lengths at the tooth root

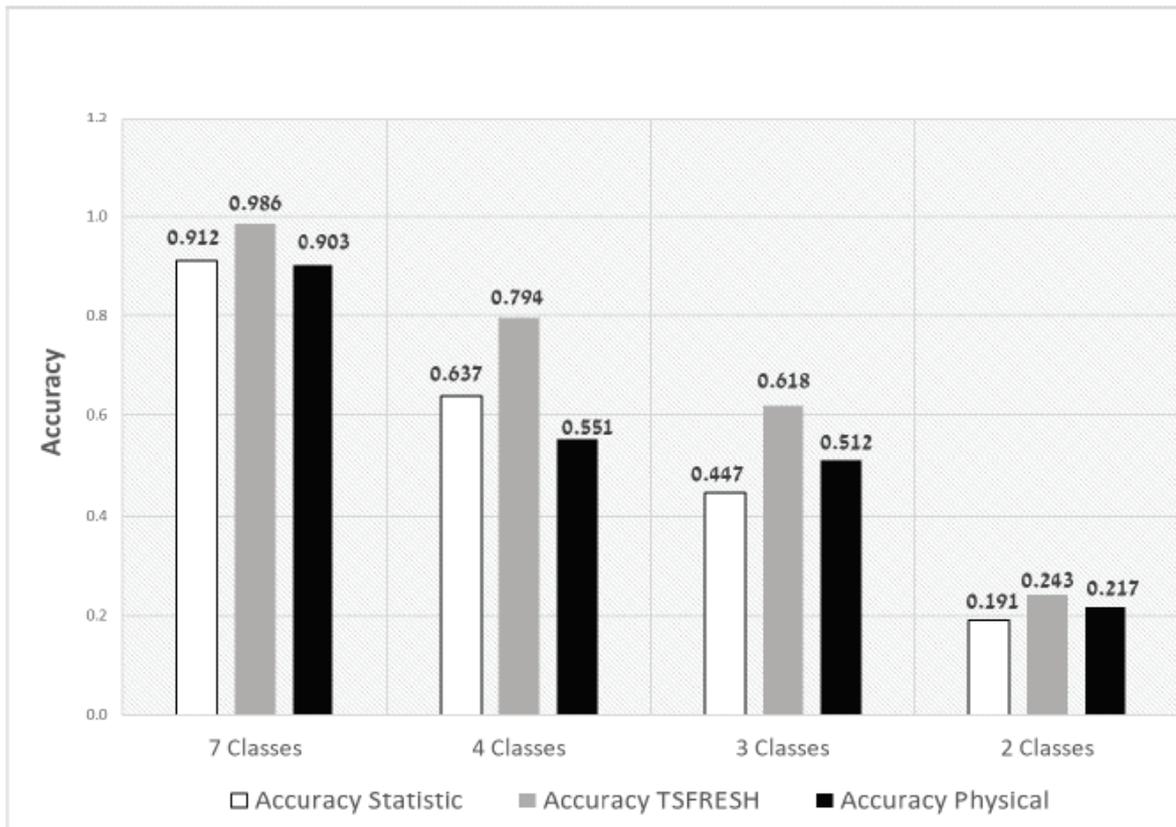
In Ref. 30, the “Probability-Based Forest” is proposed. This machine learning algorithm uses a partial physical model with the following steps: First, the behavior of some of the spall sizes is physically modeled and a simulator based on this model generates scenarios for these spall sizes in different conditions. Then, the machine-learning algorithm trains these scenarios to generate a prediction model of spall sizes even for those that have not been modeled by the physical model. Feature extraction is a key factor in the success of this approach, and it is extracted using two traditional approaches: statistical and physical, and an additional new approach: Time Series Feature Extraction based on Scalable Hypothesis tests (TSFRESH). Experimental evaluation with well-known physical model shows that the proposed approach achieves high accuracy, even in cases that have not been modeled by the physical model (see Figure 26 below). Also, it was demonstrated that the TSFRESH feature-extraction approach achieves the highest accuracy.

Figure 26: Comparison of the accuracy of the Random Forest classifier for da different number of classes used for training

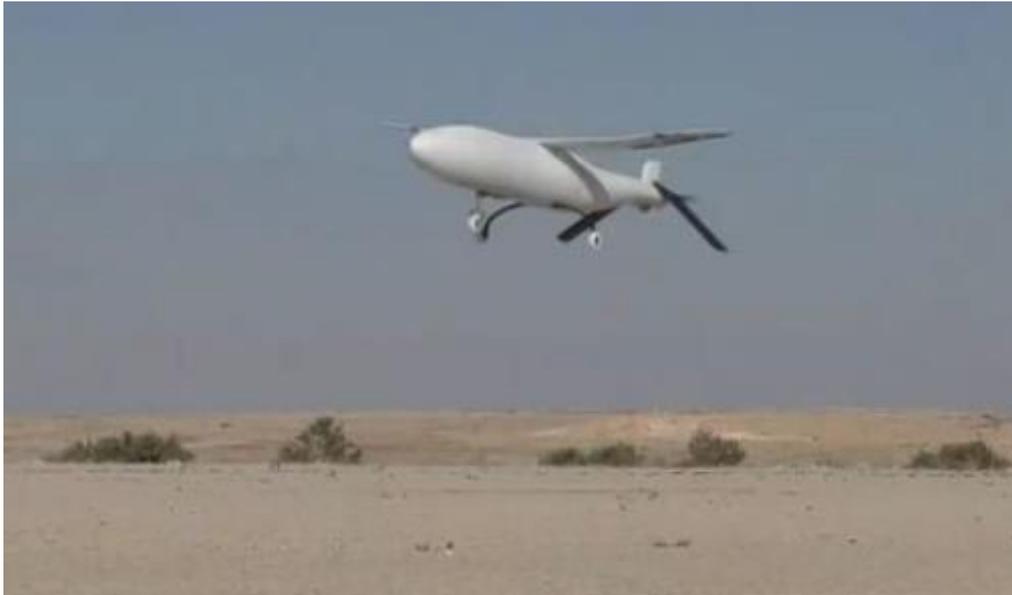
Figure 27: Skyprinter UAV after take-off

The SkysPrinter had undergone stringent flight tests, including 5G forces, and drop tests. Distributed optical-fibre sensing was used to certify the system for military requirements, with a strain signature distribution in the UAV in resolutions not seen in the past in similar products, down to the level of millimetres.

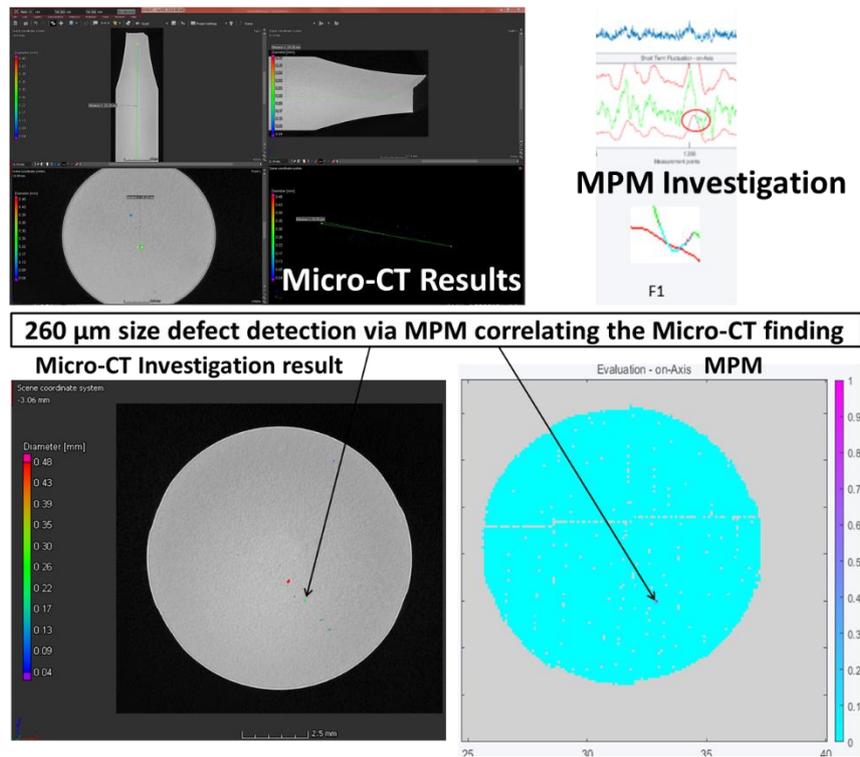
Figure 28 presents example from the Printing MPM investigation results and from the Micro-CT inspection results, and the correlation between the two.

Figure 28: Correlations between printing MPM investigation results and Micro-CT inspections
