A REVIEW OF AERONAUTICAL FATIGUE AND STRUCTURAL INTEGRITY IN ISRAEL (2019 –2021)

A REVIEW OF AERONAUTICAL FATIGUE AND STRUCTURAL INTEGRITY IN ISRAEL

JANUARY 2019 – DECEMBER 2020

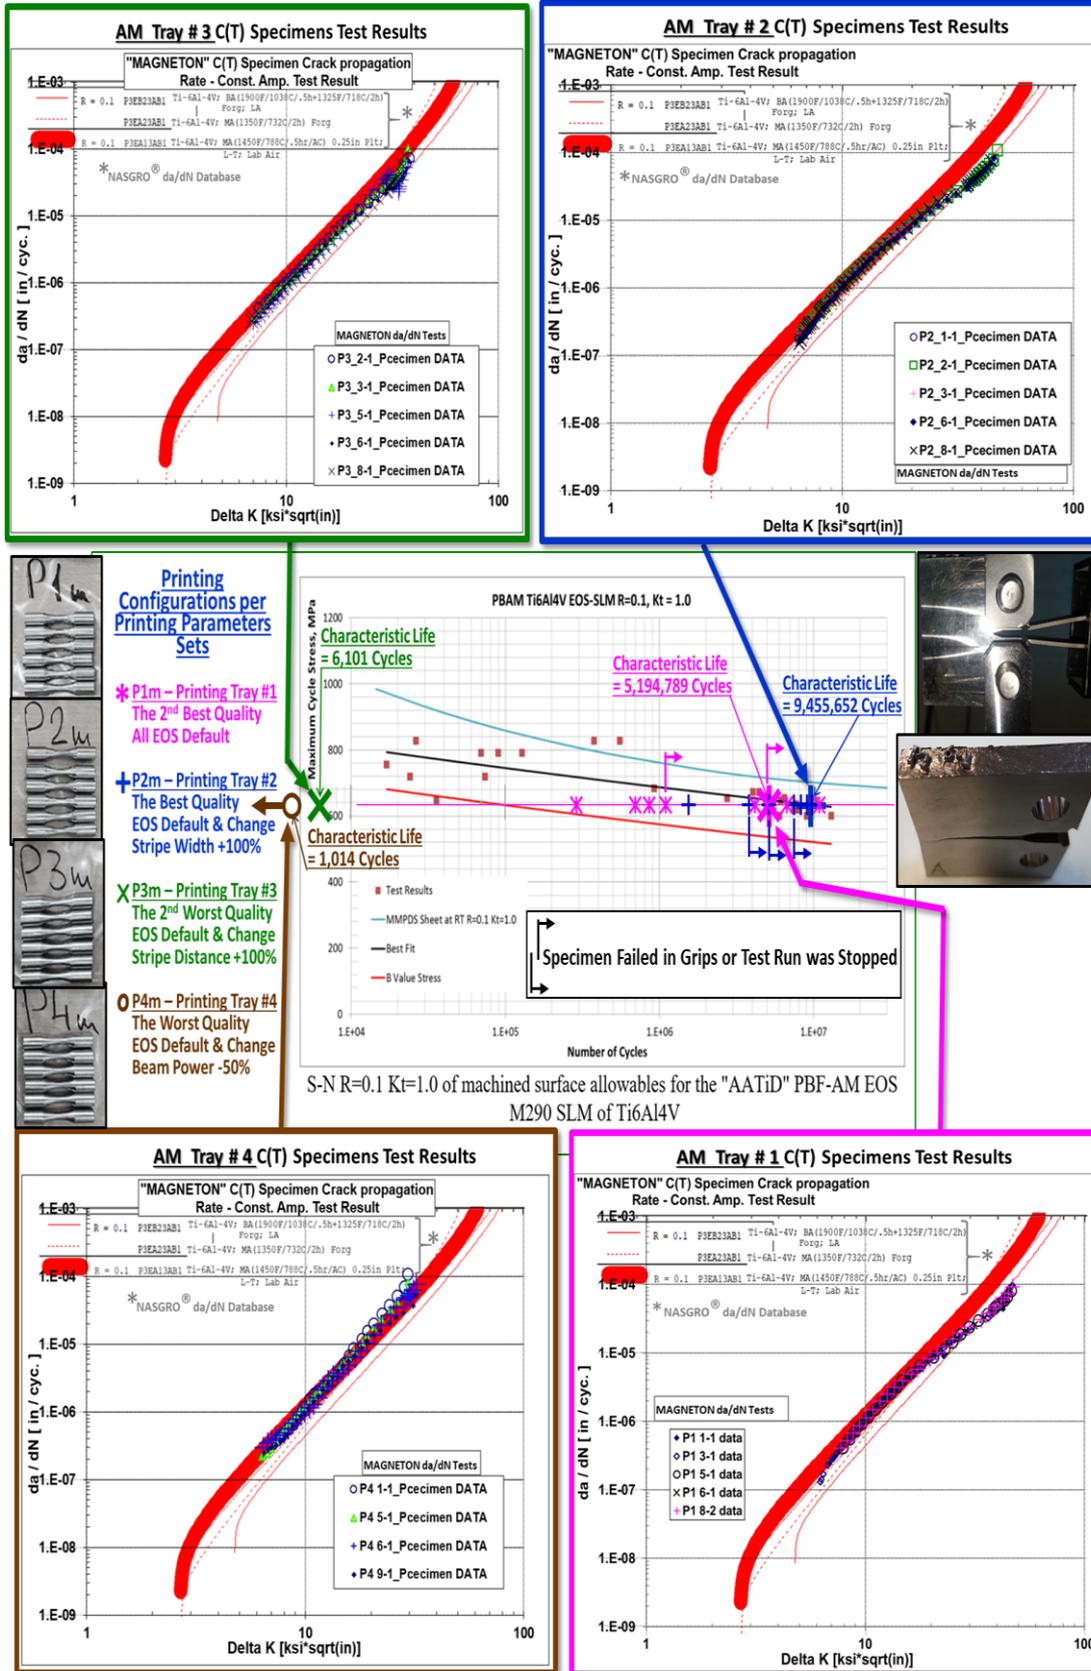
Figure 29 presents the crack-initiation and da/dN test results for the different 4 printing parameters configuration sets performed in the study. Tray #1 printing parameters are the EOS machine defaults, resulting in Weibull characteristic life of about 5,200,000 cycles. Note that all specimens did not perform HIP procedure (HIP procedure is done for next program stage). Tray #2 introduces a change in printing parameters that improved the fatigue results to Weibull characteristic life of about 9,500,000 cycles (as HIP result). Trays #3 & #4 introduce changes in printing parameters that create lots of defects and their fatigue life is very low (~6,000 & ~1,000 cycles respectively). It is interesting to notice that for all the printing parameter configurations (the “good” & the “bad”), the da/dN test results does not present much differences or variations, and are relatively close to the accepted NASGRO® da/dN data for Ti-6Al-4V alloys (Plate & Forging).

Figure 29: Crack-initiation and da-dN test results for four printing parameters configurations
