AEROSPACE – STRUCTURES AND MATERIALS PERFORMANCE (SMP)  
NATIONAL RESEARCH COUNCIL CANADA

# **Review of Canadian Aeronautical Fatigue and Structural Integrity Work 2011-2013**

Report No: LTR-SMPL-2013-0046

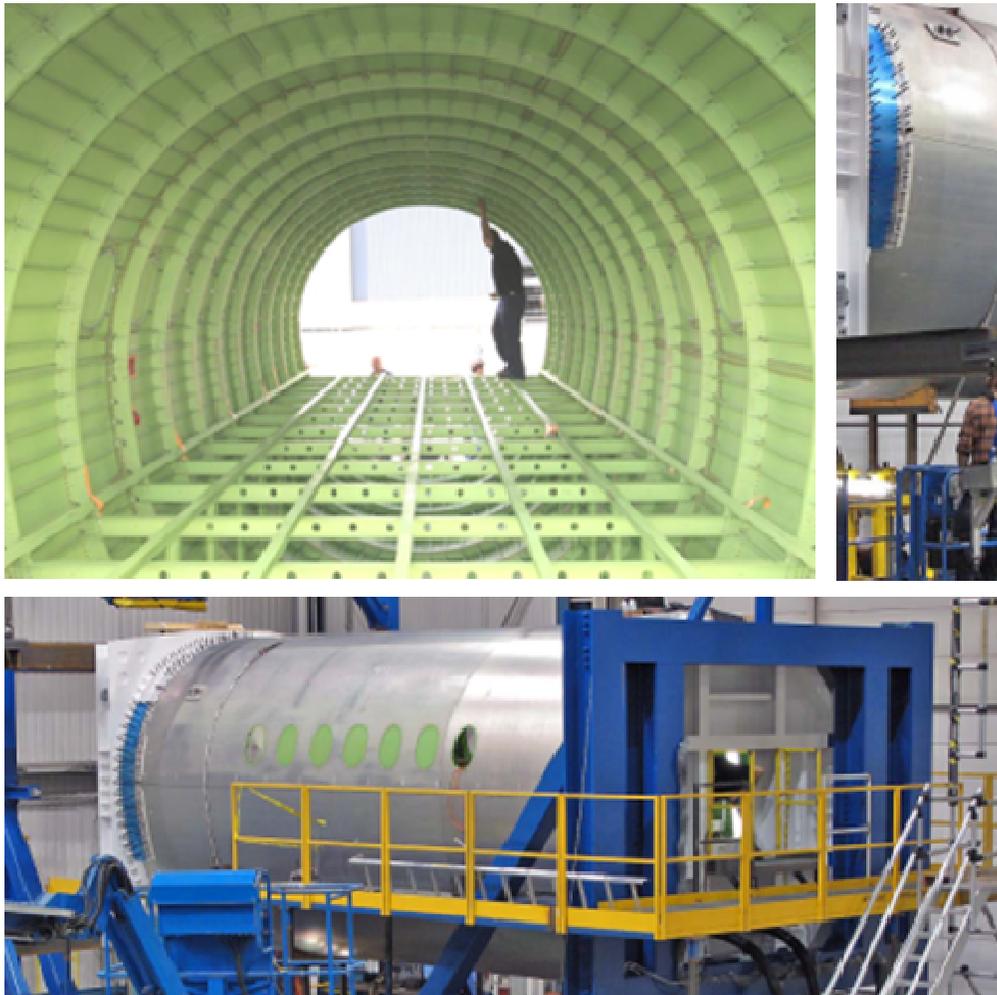
Figure 6. Pre-production fuselage barrel

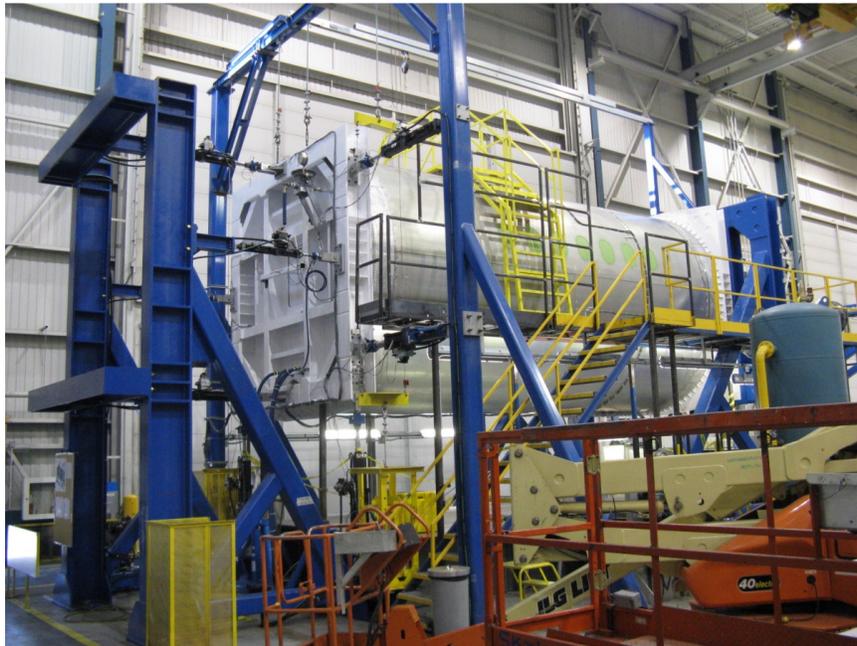
Figure 7. Fuselage barrel test

In conclusion, testing simulated three aircraft design lives through 180,000 test cycles with no major finding and all objectives were achieved.

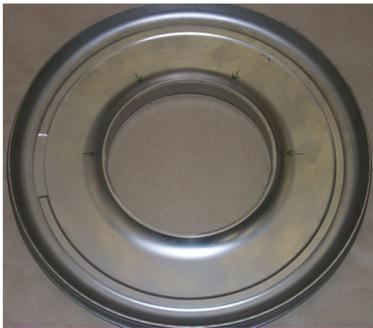
Figure 8. Turbine spacer

NRC is performing life updating and damage tolerance assessment of several components from a legacy, turboprop engine. Details of the entire program can be found in [1]–[6]. On the basis of the mission profile analyses as well as thermal and stress analyses of the entire rotor of this turboprop engine, four components were considered to be the most critical, however, both analyses and testing concentrates on the turbine spacer shown in Figure 8.

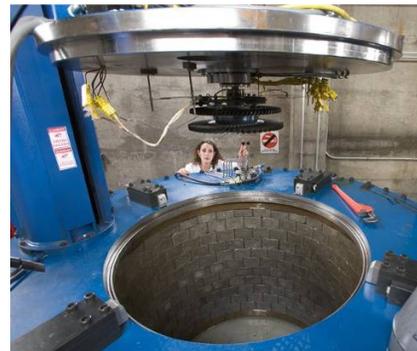
Figure 11. Spin rig facility at the NRC

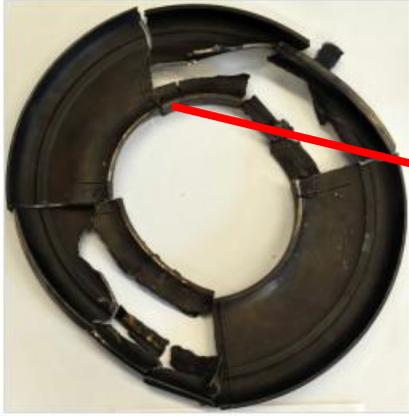
Figure 12. Remnants of the spacer after burst

During the second rig test, Test B, Spacer 3 burst. This was a planned event designed to establish the experimental safety margin for the spacers. Figure 12 shows remnants of this spacer partially arranged. Similar to Test A, Spacer 4 in Test B did not show any visible damage indications after the burst of the other spacer. Remnants of Spacer 3, Figure 13, were investigated using an SEM. Microstructure analyses confirmed that the crack nucleated from spacer aft bore corner. However it was also found that another location, the anti-rotational pin hole side also exhibited significant damage that contributed to the spacer burst pattern. In addition, Test B allowed for the very rudimentary assessment of the crack growth rate. It was found that the crack propagation rate was replicated within a factor of two when compared to the FE predictions. So far, the spin rig based experimental results have not allowed for extending the spacer life, however both analyses and tests revealed significant uncertainties in research methods.

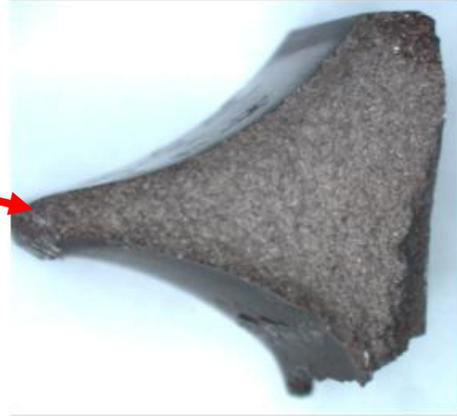
Figure 13. Microstructure analysis of the fragment of the burst spacer

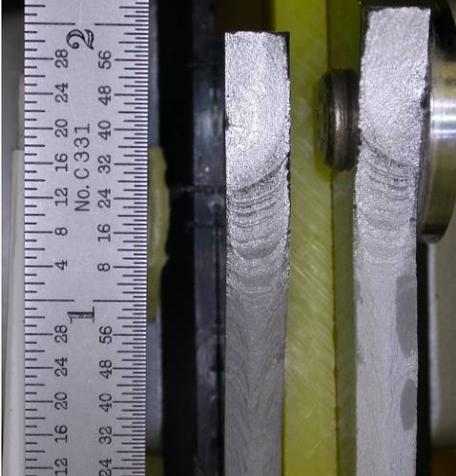
Fretting fatigue cracks nucleated on the plate surface under the disc at contact points with the plate leading to fatigue cracks that joined and grew around the hole.
NLT 3D38 C03 $e/D = 2.0$ SsCx + Hi-Lok

A fretting fatigue crack nucleated on the plate surface under the disc at the contact point with the plate leading to fatigue cracks that grew into the fastener hole and progressed on the other side of the hole in fatigue.

Figure 14. Failure surfaces of NLT coupons with  $e/D = 2.0$ , SsCx and Hi-Lok fastener

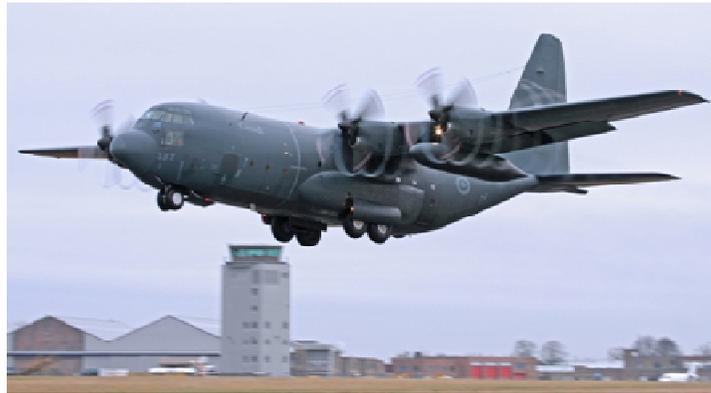
Figure 26. CC130 H-model Hercules aircraft

The Royal Canadian Air Force (RCAF) operates a fleet of CC130 H-model Hercules aircraft, Figure 26, primarily in the Search and Rescue (SAR) and Air-to-Air Refuelling roles. Until recently this fleet included older E-model aircraft and also conducted tactical operations and strategic air lift across Canada as well as abroad. The latter roles have been transferred from the retiring E-models to the recently acquired J-model fleet.

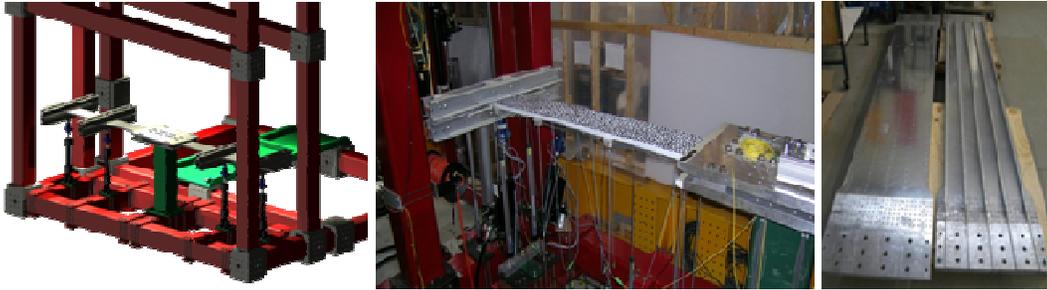
Figure 35. Simple beam and stiffened aircraft skin bending and torsion platform for evaluating load monitoring technologies

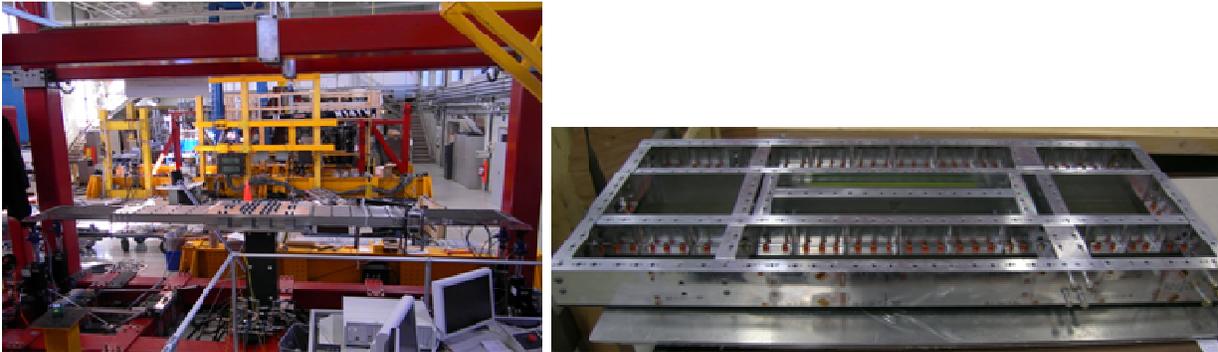
Figure 36. A simulated wing box comprised of composite upper and lower skin with aluminium spars and ribs

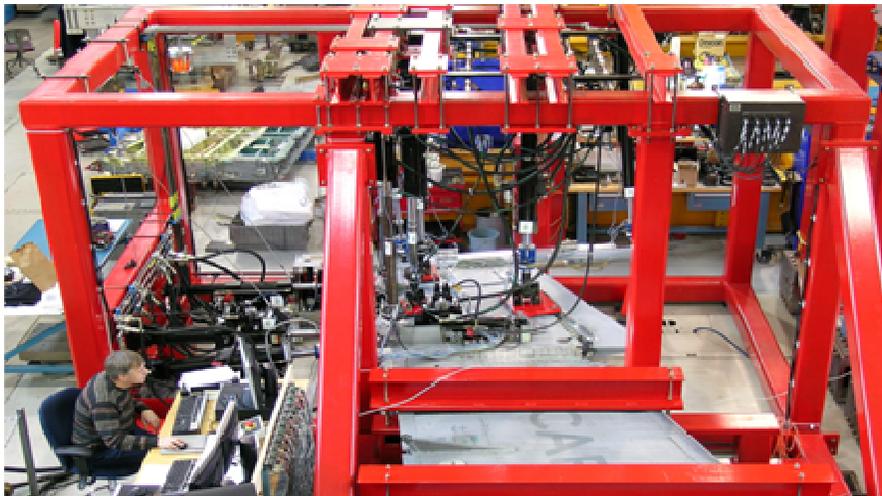
Figure 37. A large scale testing capability for F/A-18 outer wing spectrum testing

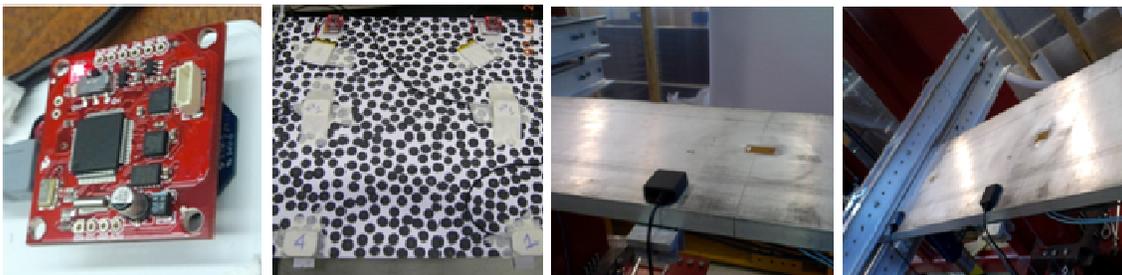
Figure 39. MEMS based load monitoring system under assessment

This MEMS based load monitoring system, Figure 39, was installed in the first SHM structural test beds and tested through the application of bending, torsion and coupled bending and torsion loading configurations. These load conditions were applied quasi-statically and at low frequencies, typical of manoeuvring loads. Constant amplitude and/or frequency, and varying amplitude and/or frequency loading spectra were applied, with the results from the developed load monitoring system under assessment being compared with the measurements obtained from the platforms' resident displacement, strain gauge and load application baseline instrumentation. These assessments were concluded with the developed sensor system results were similar to the measurements of the baseline instrumentation with a relative difference of 4% on average and with no phase shifts. These promising results have led to the installation of the system to assess its load monitoring performance on the complex F/A-18 outer wing SHM test bed at NRC.

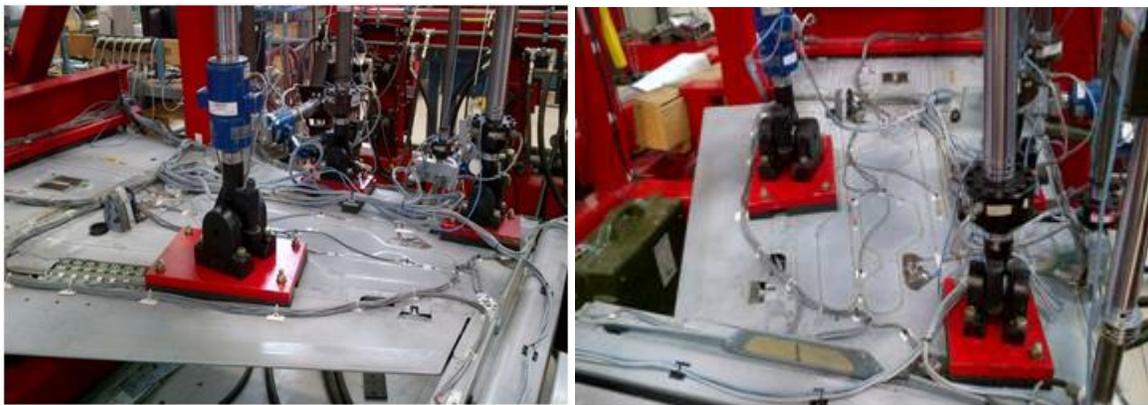
Figure 40. Optical fibre sensor for distributed sensing installed in the first SHM structural test bed

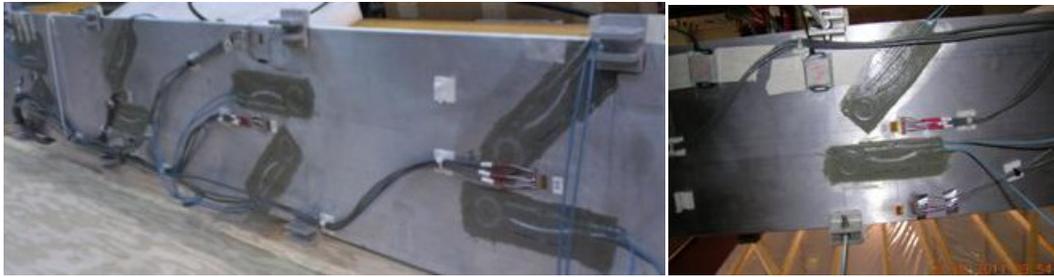
Figure 41. FBGs installed in the first SHM structural test bed, for point strain sensing

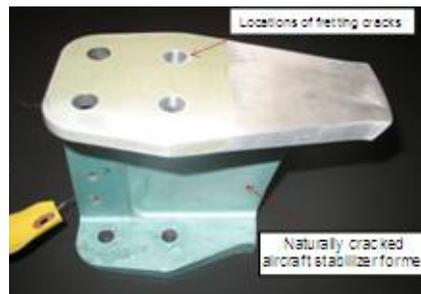
Figure 48. Naturally cracked aircraft stabilizer former (V-tail stub)

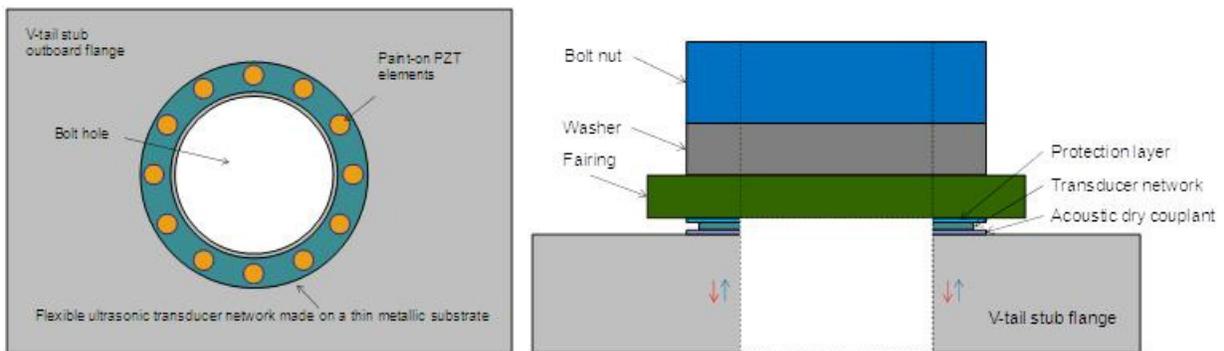
Figure 54. A proposed sensor network layout and sensing configuration for SHM of fretting cracks

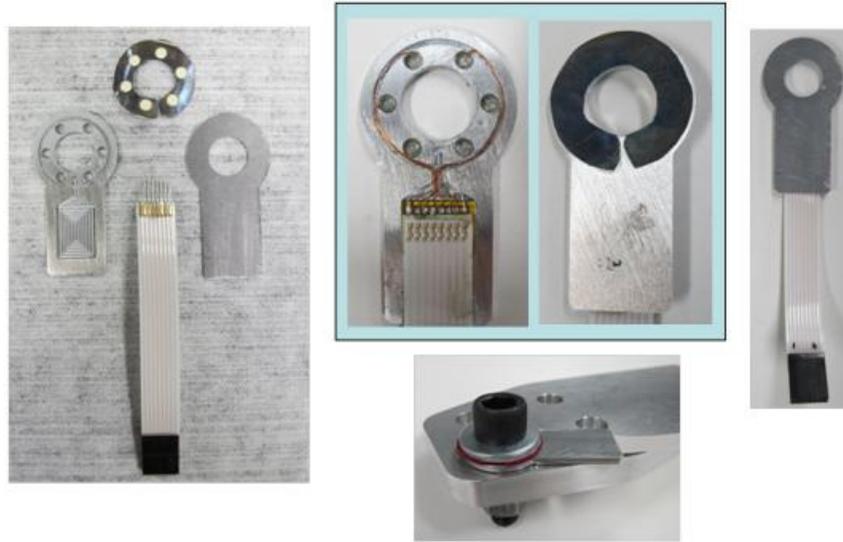
Figure 55. A trial version of the proposed sensor network (“Smart washer”) for SHM of fretting cracks
