**A REVIEW OF RESEARCH
ON
AERONAUTICAL FATIGUE IN THE UNITED STATES**

2011-2013

Compiled by
Dr. Ravinder Chona
Air Force Research Laboratory
Wright-Patterson Air Force Base, Ohio, USA

**FOR PRESENTATION AT THE MEETING
OF THE
INTERNATIONAL COMMITTEE ON AERONAUTICAL FATIGUE**

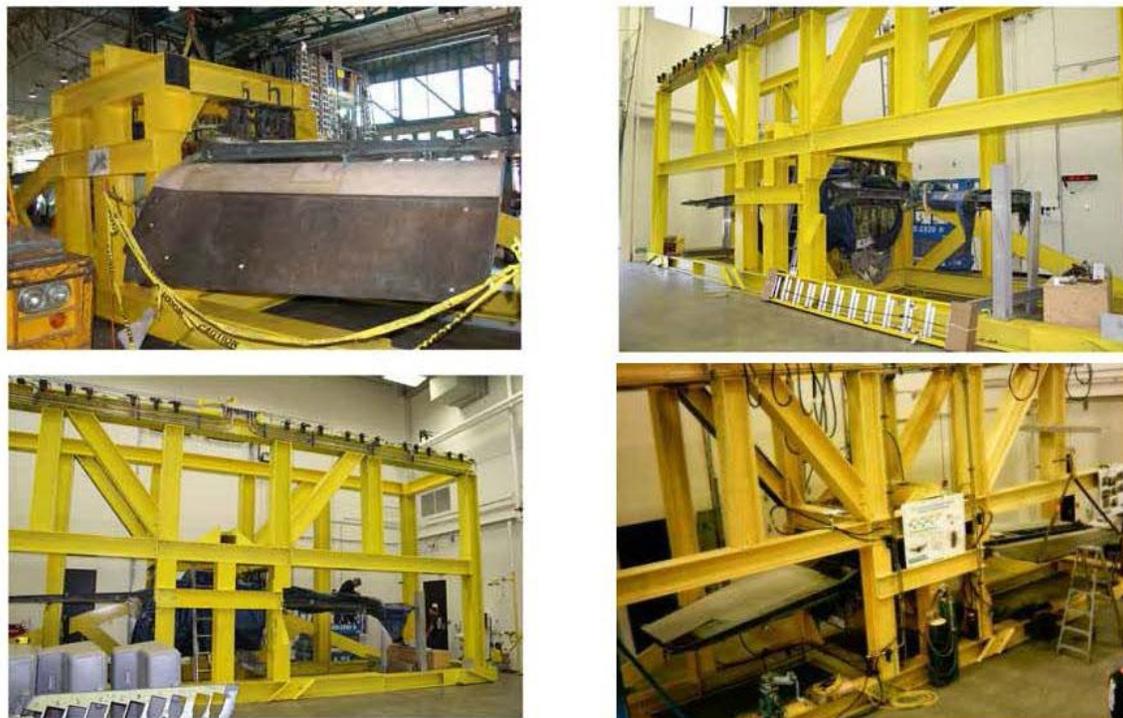
Figure 9.11-12. Full-Scale Test Fixture

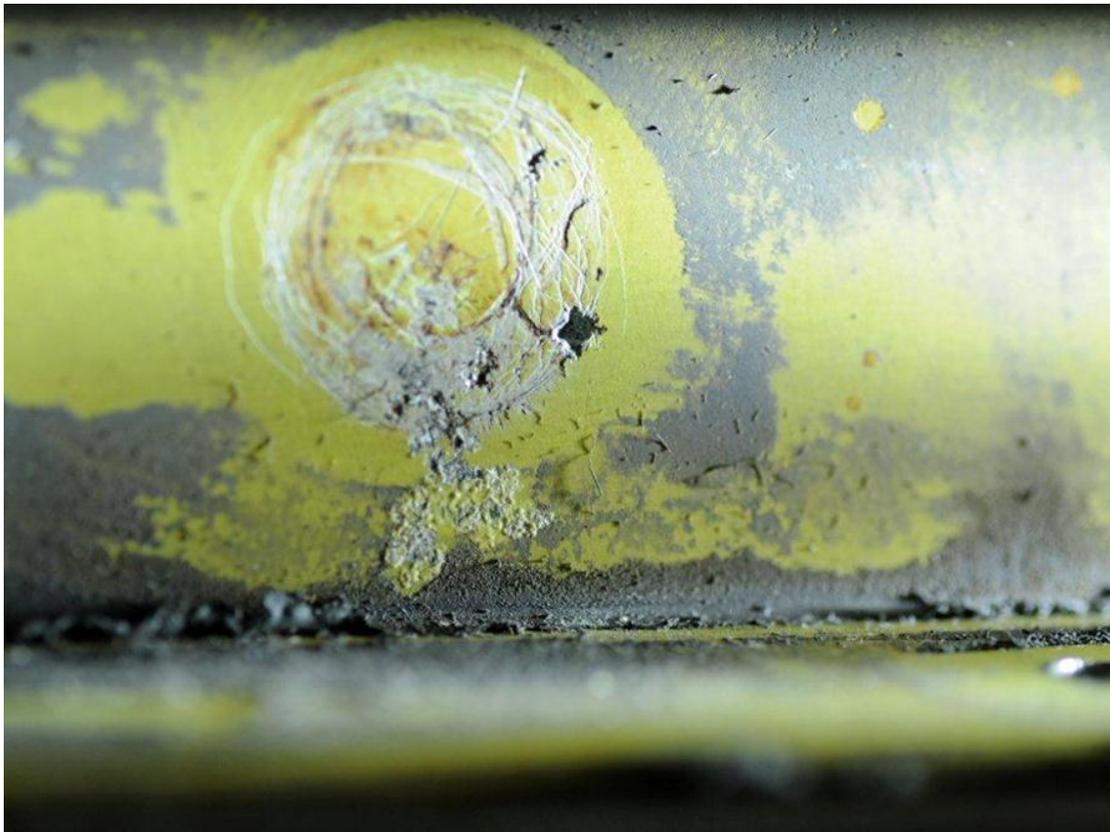
Figure 9.11-32. Wing Aft Spar Corrosion
