# Review of aeronautical fatigue and structural integrity investigations in the Netherlands during the period March 2015 - March 2017

This report is a review of the aeronautical fatigue and structural integrity activities in the Netherlands during the period March 2015 to March 2017. The review is the Netherlands National Delegate's contribution to the 35<sup>th</sup> Conference of the International Committee on Aeronautical Fatigue and Structural Integrity (ICAF) in Nagoya, Japan, on 5 and 6 June 2017.

NLR-TP-2017-137

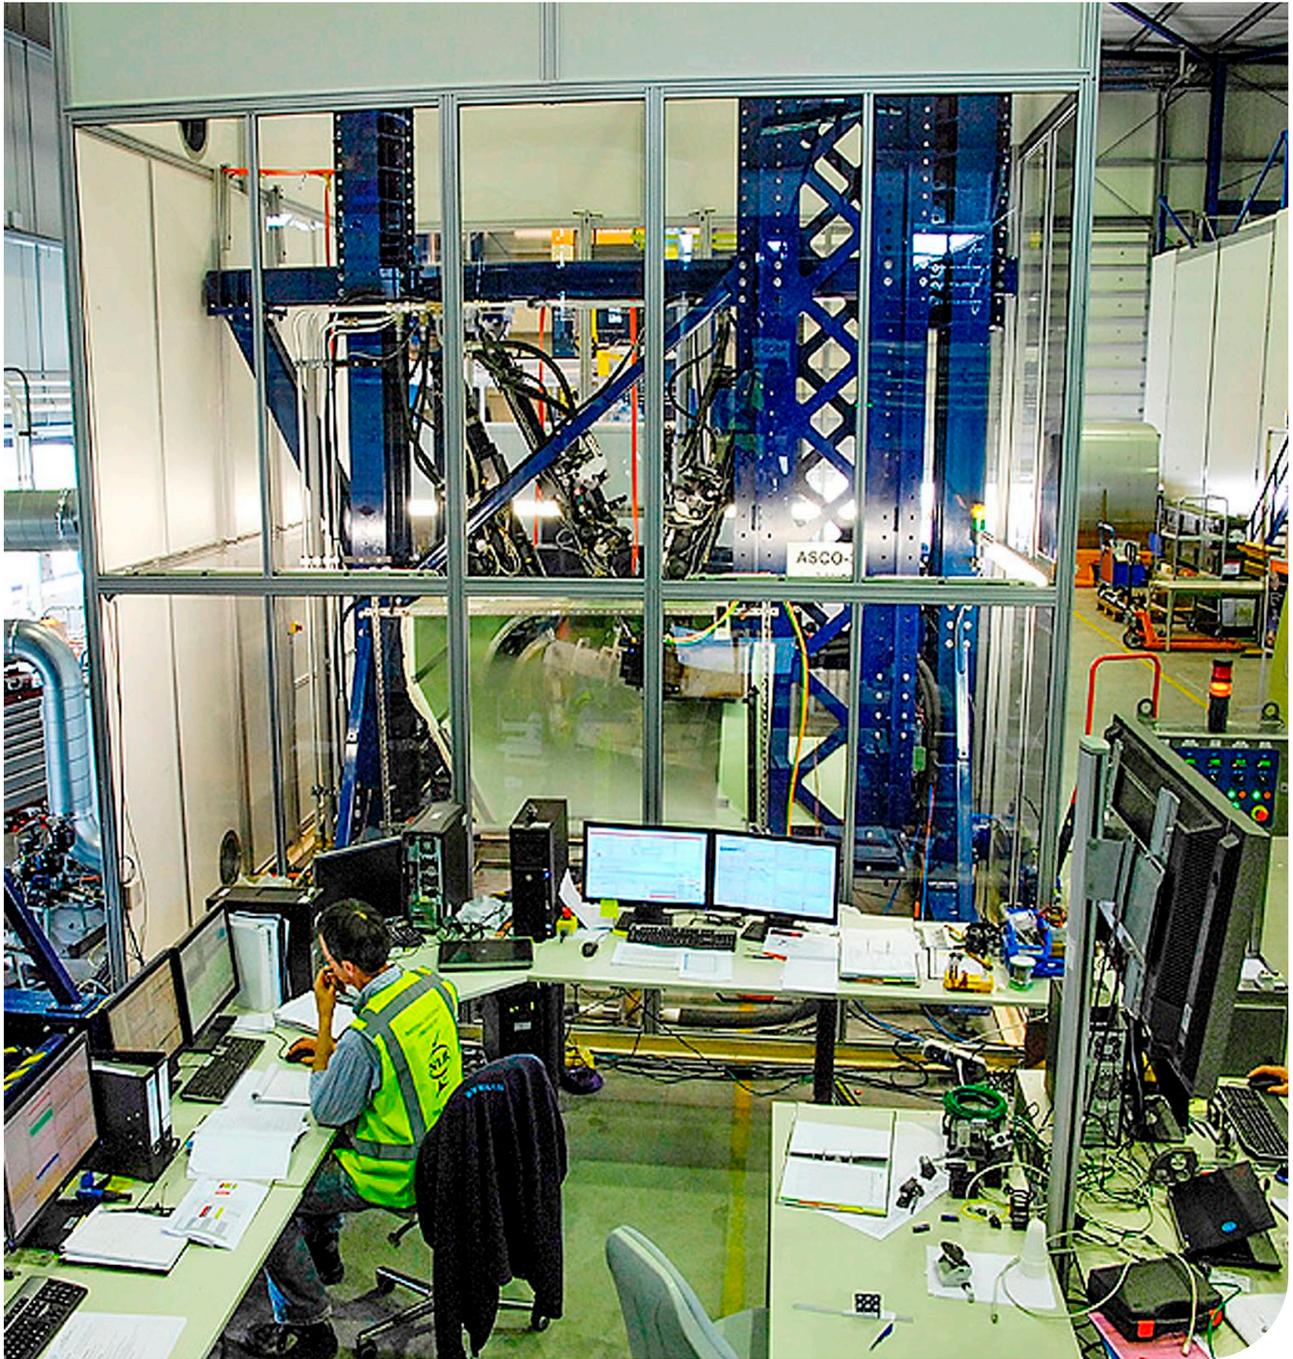
Figure 1: Full scale flap track system test at  $-55^{\circ}\text{C}$  – see section 8.2.

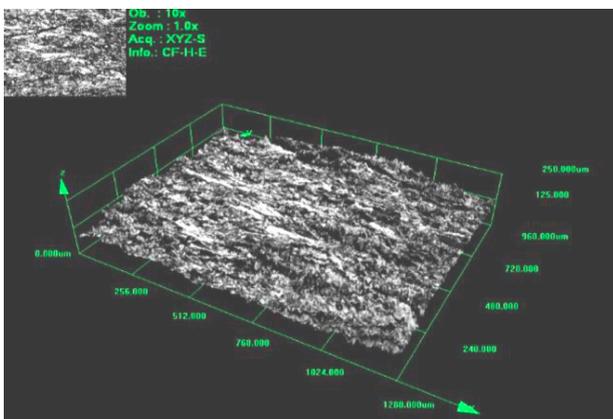
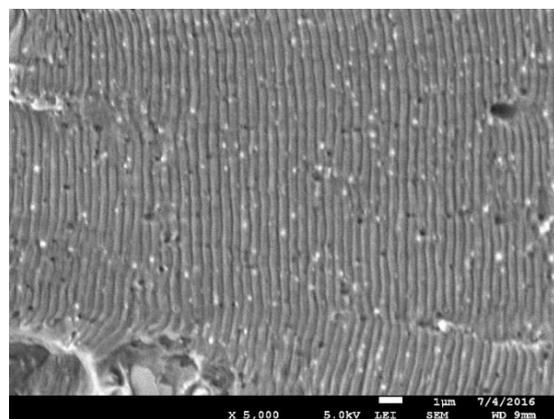
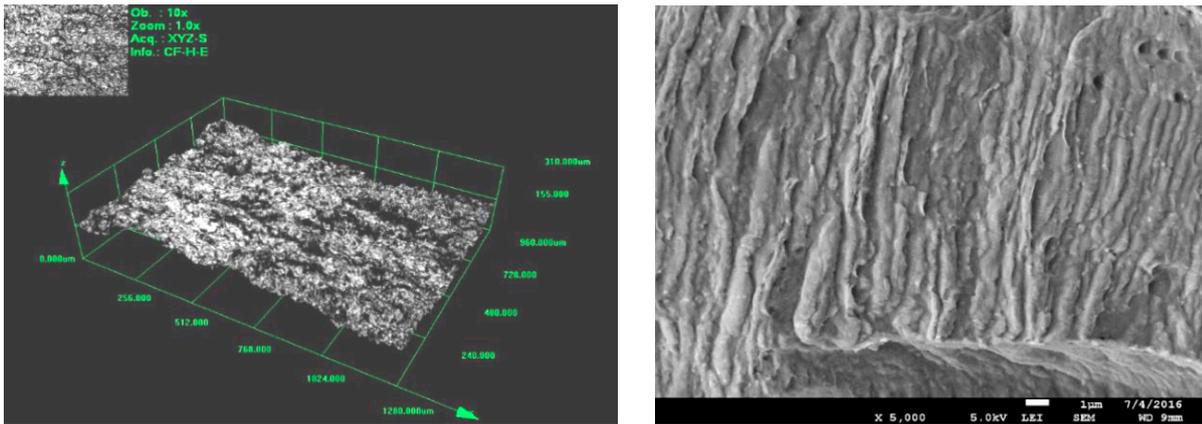
Figure 2: Differences in fracture surfaces created in lab-air (top) and vacuum (bottom) at  $a = 11$  mm, in specimens tested at  $S_{max} = 75$  MPa,  $R = 0.1$ .

- The amount of plasticity, i.e. plastic zone size, in both air and vacuum is similar.
- The transition point to non-linearity in the load versus crack opening displacement curve is only observed for low R-values; when  $S_{\text{min}}$  is above this level, the non-linearity disappears.
- The transition point is independent of environment, the stress ratio R and the crack length, but is observed to depend on  $S_{\text{max}}$ .
- The fracture surface roughness is different and develops differently for lab-air and vacuum.
- Correcting the crack surface for this roughness brings the characteristic trend of  $dU/dN = dU/dA \cdot dA/dN$  for both environments closer together.

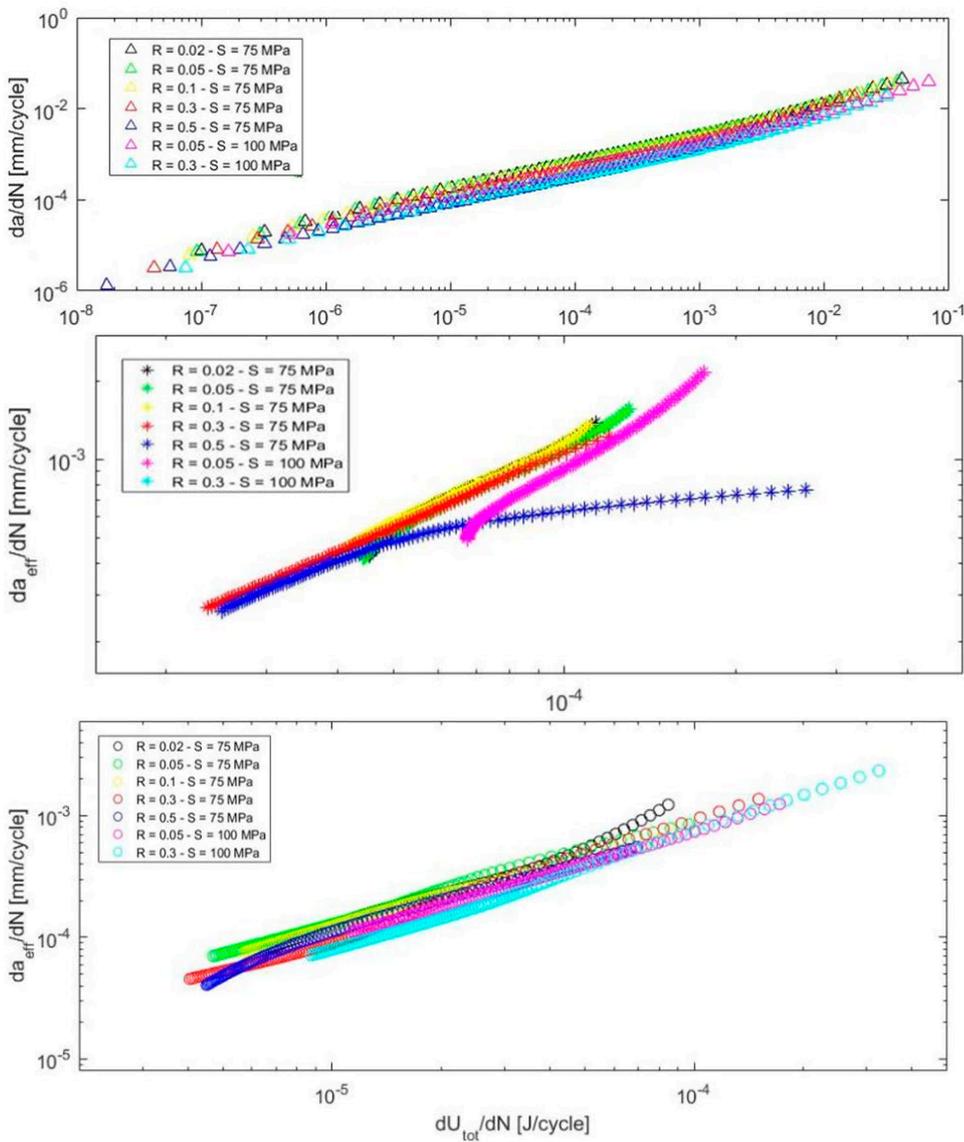
Figure 3: Striking correlation between  $dU/dN = dU/dA * dA/dN$  trends after correction of surface roughness: numerical prediction (top), lab-air (centre), and vacuum (bottom).

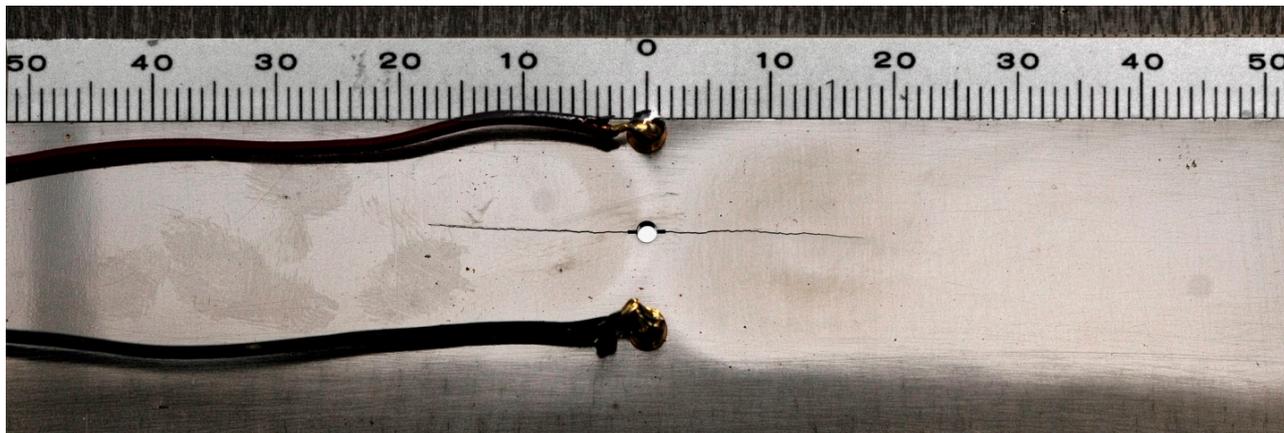
*Figure 4: Measurement of crack length in a AA 7075-T7351 M(T) specimen.*

In 2015 NLR has demonstrated that for 29 identical fatigue crack growth tests on aluminium alloy 7075-T7351 M(T) specimens the exponent of the Paris law changes between specimens and crack lengths. Fractography and crack length measurements show that the exponent is higher and varies at crack lengths where crack growth is dominated by plane strain conditions. The power law exponent decreases and is similar for all specimens after the transition to plane stress conditions at higher crack lengths. The mathematical concept of a pivot point is used to model crack growth with two different exponents using a dimensionally correct equation. It also allows to model the crack growth variation in all specimens by varying only one parameter, the power law exponent for the plane strain condition [2], which is a relevant observation for structural risk analyses.

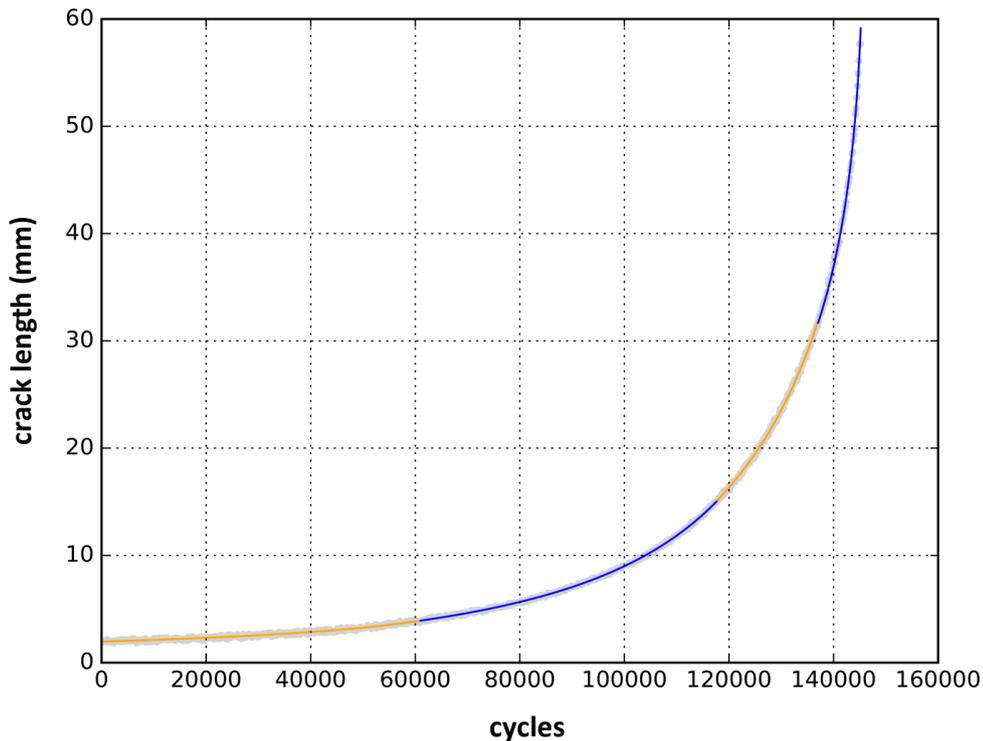
Figure 5: Crack length vs. cycles for a AA 7075-T7351 M(T) specimen. The experimental curve is exactly modelled using different power law exponents for four crack length ranges (indicated by the orange and blue lines).

PROF will extend the previous research to include the effect of stress amplitude, thickness, test conditions and variable amplitude loading on the fatigue crack growth rate. Initially the research is focussed on AA 7075-T7351. At a later stage other engineering materials will be considered as well, such as other aluminium alloys, structural and high strength steels. Specific interest is present for crack growth below the (long crack) threshold, also indicated as short crack growth. This is also applicable to ultra high cycle fatigue (UHCF), where it is unknown how many cycles are consumed in nucleation and the short crack growth phase. Quantitative fractography (QF) and marker loads will be used to determine the crack growth rate during this phase. This should lead to improved physics based knowledge on fatigue crack growth. This knowledge will ultimately allow for better alloy development, more accurate calculation of lifetime or inspection intervals and less testing in the future when, for example, the loading spectrum changes. The effect of VA loading on fatigue is modelled by a PhD-student from TU Delft. The initial CA fatigue crack growth rate test on AA 7075-T7351 M(T) specimens show that it is possible to exactly model the fatigue crack growth of each specimen from an electro discharge machining starter notch to final failure with multiple power law exponents at different crack length ranges using a dimensionally correct equation - see Figure 5.

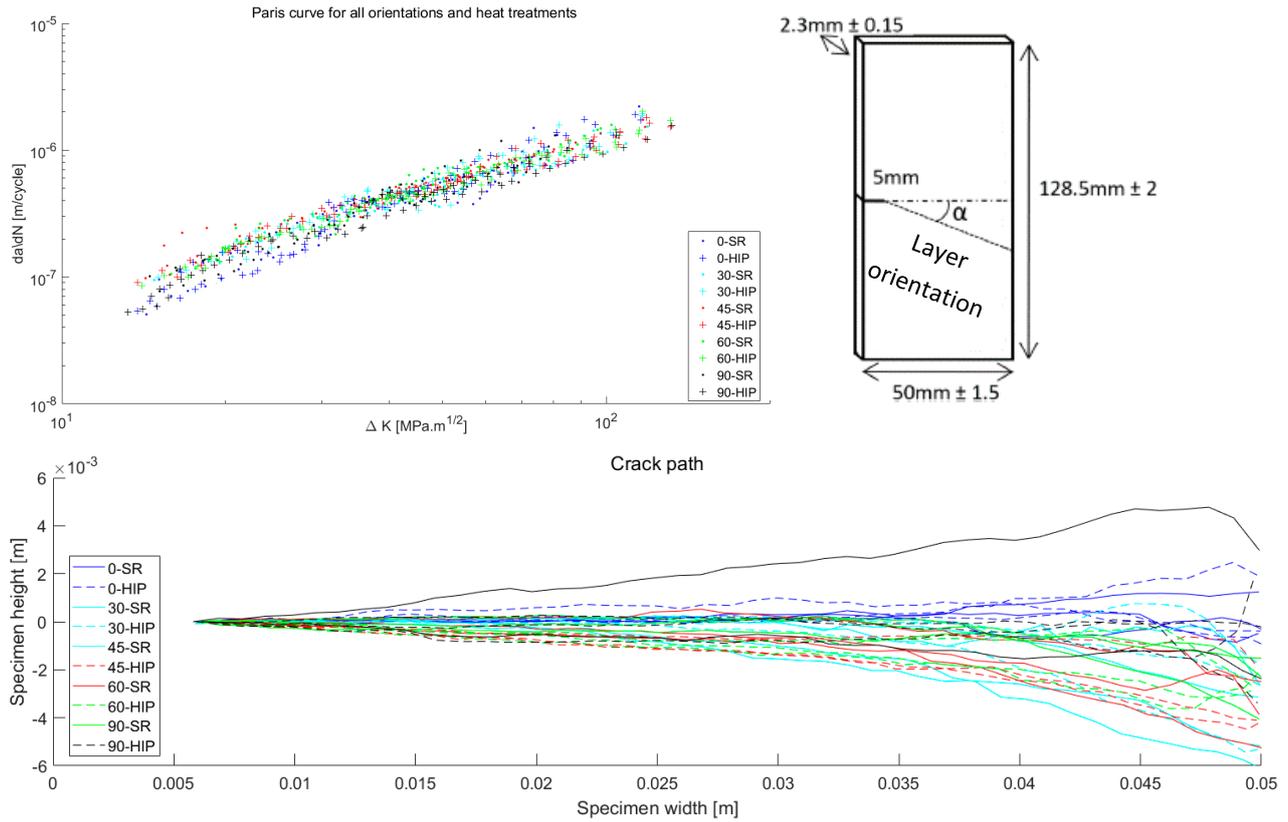
Figure 6: Paris curves for all orientations and heat treatments generated with the illustrated sample (upper), and observed crack paths (bottom).

Fatigue tests have been performed with a constant cyclic load and single edge notch specimens. Ten unique types of specimens were tested by combining five different build orientation (0°, 30°, 45°, 60° and 90°) with two different heat treatments (Stress Relieved and Hot Isostatic Pressing). In the end, similar crack propagation rates were measured for all specimens, see Figure 6. Although small differences were seen in the microstructure and DIC analysis, they did not seem to change the crack propagation rate. This observation led to the conclusion that the crack propagation rate is not influenced by a change in build orientation or a change in heat treatment.

On the other hand, the measured crack paths showed some differences. Small crack deflections were found for 30° - SR and 45° & 60° - HIP, while all other specimens had cracks propagating in a direction normal to the applied stress. As only off-axis specimens showed repetitive crack deflections, it can be concluded that the anisotropic microstructure is causing this behaviour. However, no conclusive explanation could be given based on the data gathered in this experiment. It is expected that different mechanisms caused the crack deviations as it happened in both heat treatments but for different orientations. Further research in this specific field is needed to explain the measured behaviour.

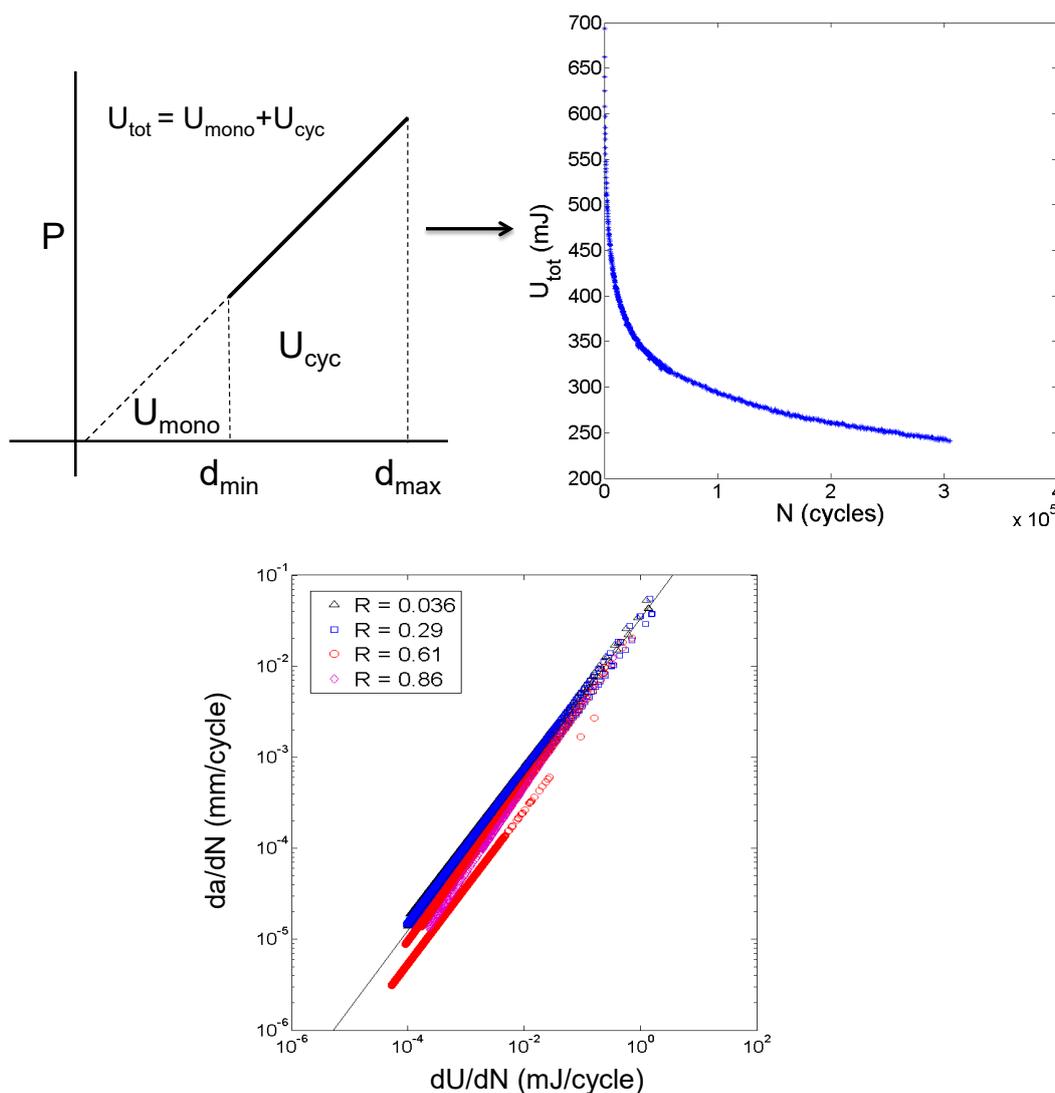
Figure 7: Illustration of the concept to characterize fatigue damage growth with  $dU/dN = dU/da * da/dN$ .

Measuring the force ( $P$ ) and displacement ( $d$ ) during a fatigue test allows the strain energy in the specimen to be determined. By measuring the strain energy repeatedly, the energy dissipation per cycle  $dU/dN$  can be found. This can then be compared to the crack growth rate  $da/dN$ .

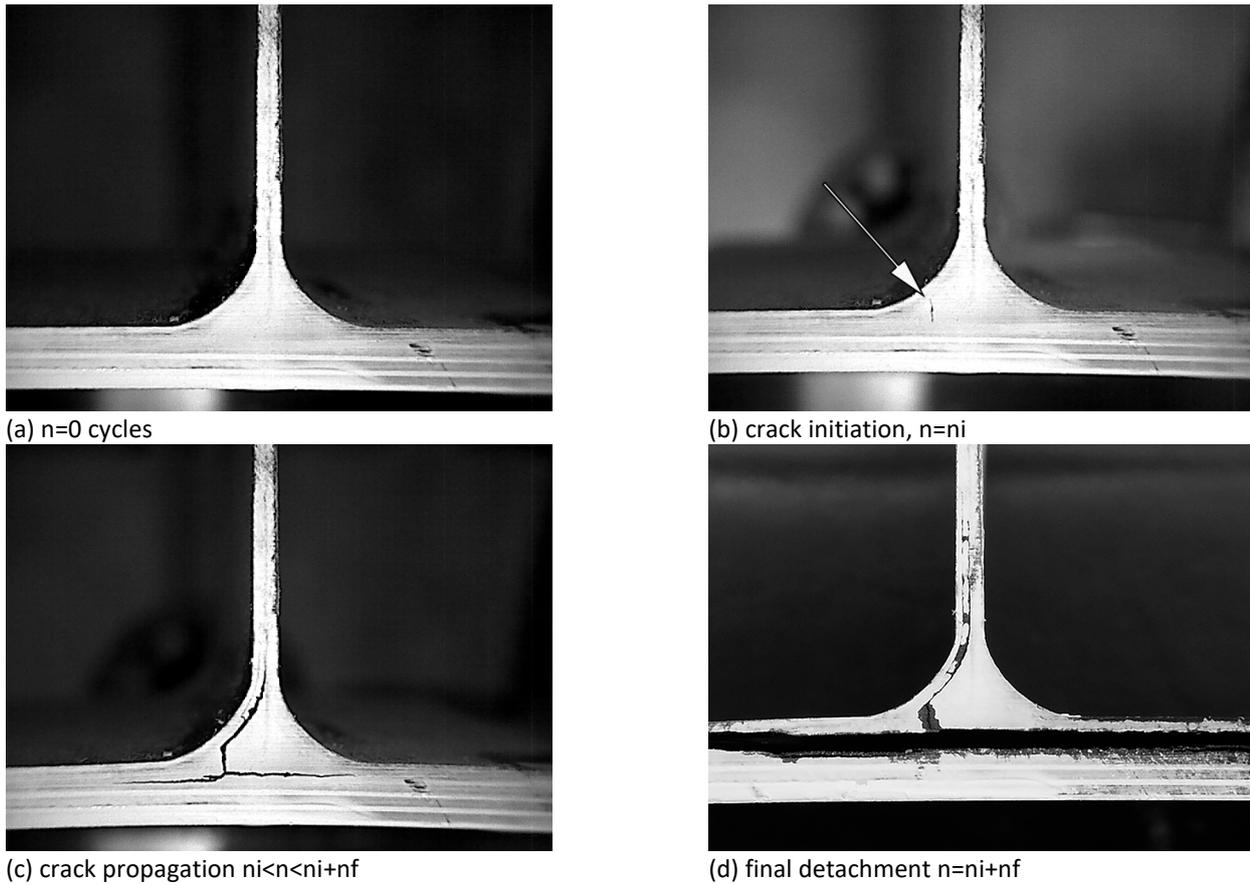
Figure 8: Typical fatigue damage events ( $n$  – number of fatigue cycles;  $n_i$  – number of cycles to crack initiation – fatigue life initiation;  $n_f$  – number of cycles from crack initiation to complete detachment – fatigue life propagation).

The damage initiation and propagation is similar under quasi-static loading and fatigue loading. The crack initiates at the CFRP stiffener noodle and propagates through the CFRP stiffener foot plies and web plies. No disbond was detected at the bond line in any of the quasi-static and fatigue tests. Figure 8 shows the typical failure sequence: (1) damage initiation at the noodle of the CFRP stiffener; (2) damage propagation by delamination from the noodle to the stiffener foot; (3) detachment of the stiffener from the skin. The fatigue life initiation of the bonded structures presents a very large scatter. The stress level at the stiffener noodle may present a significant scatter due to initial manufacturing defect yielding to a scatter in the crack initiation. Nevertheless, the fatigue life propagation presents more stable results which may allow for a good prediction and a damage tolerant design.

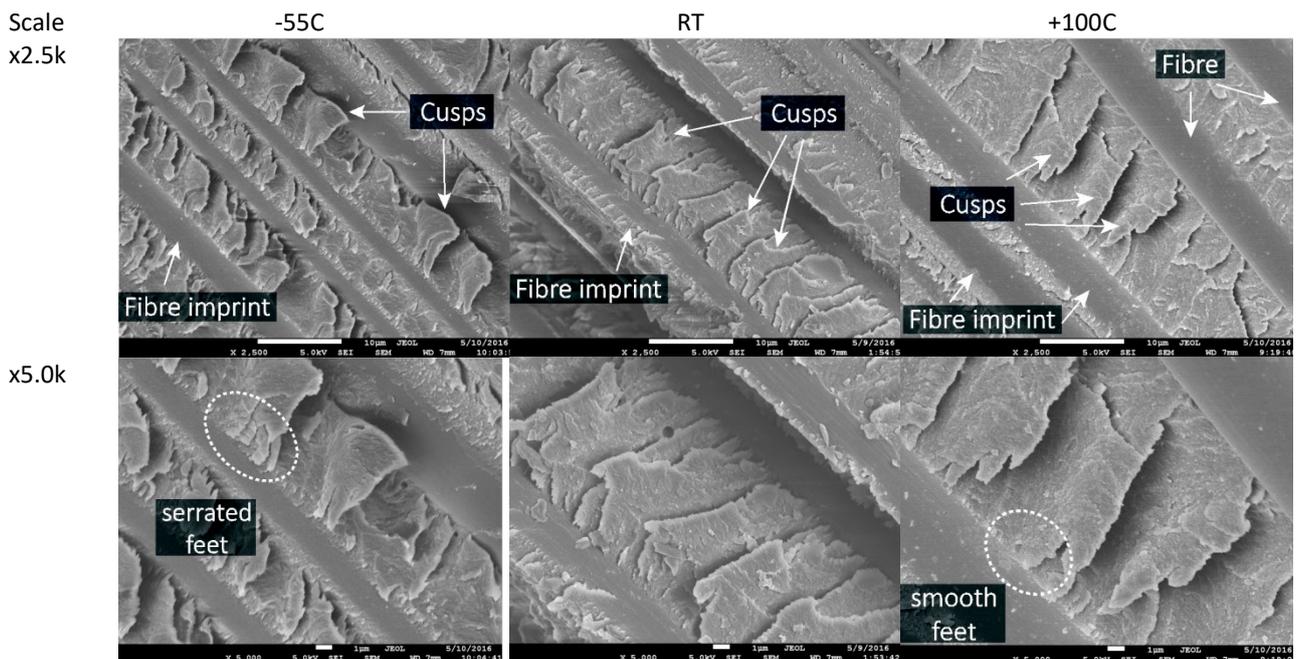
Figure 9: Typical quasi-static fracture surfaces at the area of crack propagation on the stiffener foot plies.

Figure 9 shows typical fracture surfaces under quasi-static loading. The main failure mechanism at the CFRP stiffener is mixed mode I/II delamination, both under static and fatigue loading. The fracture morphology indicates that the mechanics of crack initiation are the same under static and fatigue loading. Flake-like shear cusps are a typical feature in the fracture surface of mixed mode I/II delamination at high temperatures (above RT), opposite to cusps with serrated feet at lower temperatures. Under fatigue loading at the crack propagation area, the typical fracture morphology are rolled cusps – Figure 9.

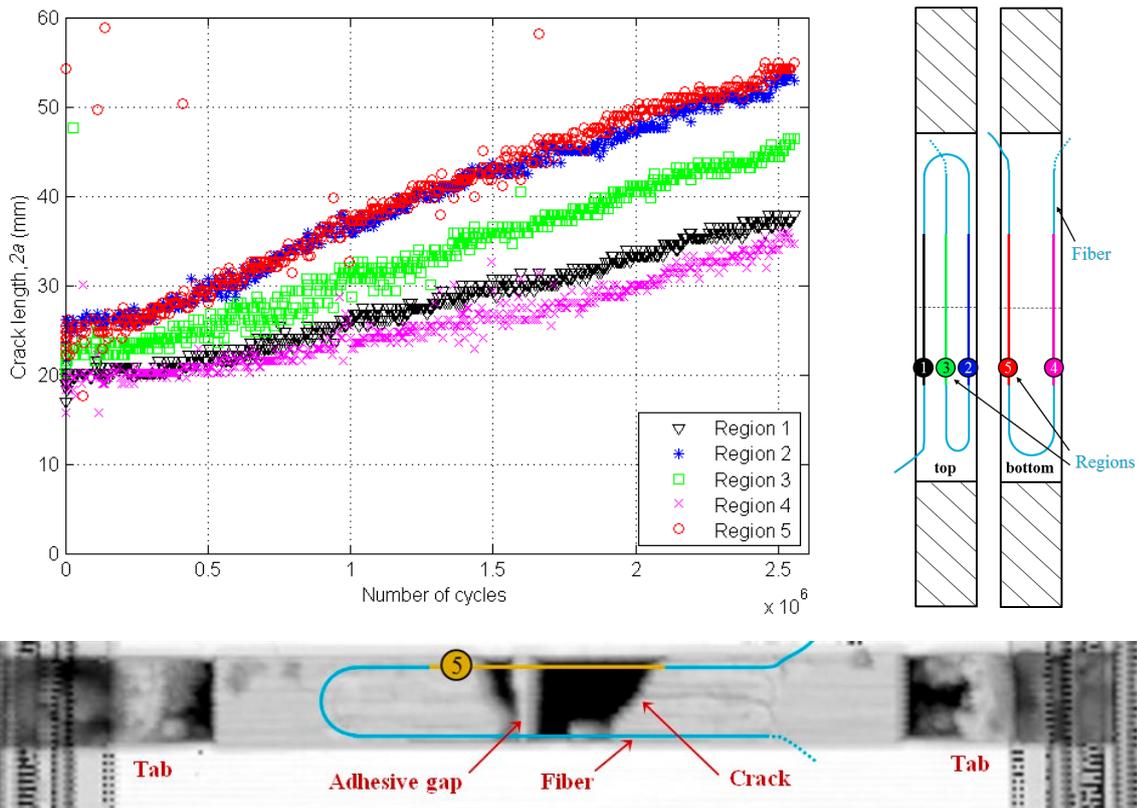
Figure 10: Crack growth behaviour observed under constant amplitude loading with a fibre optic distributed sensing system; C-scan image of disbond shown for comparison.

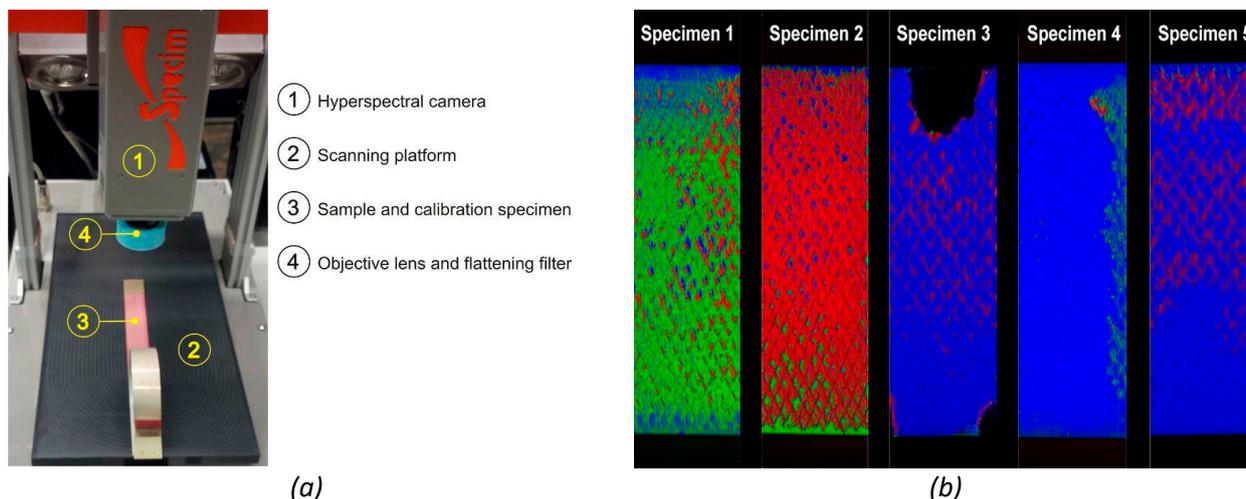
Figure 11: (a) photo of the laboratory hyperspectral imaging setup and (b) RCA resulting pseudo-color images from five peel test specimens subjected to different environmental conditions.

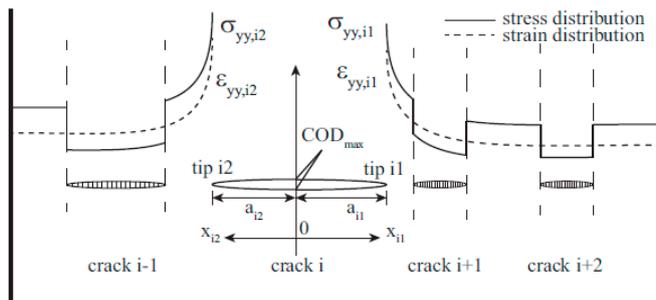
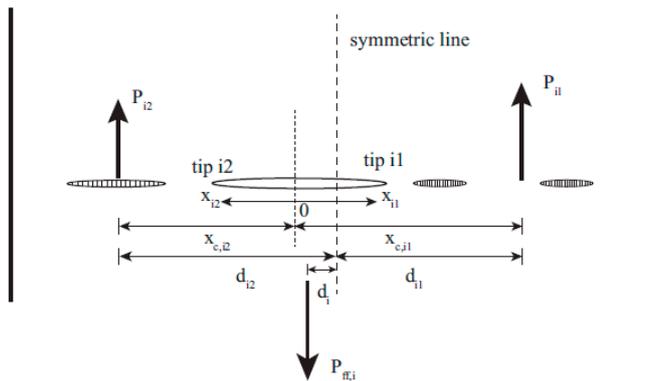
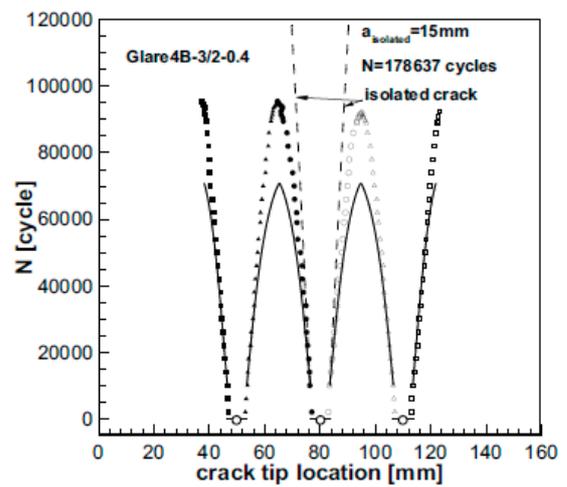
(a) Illustration of stress distributions

(b) Illustration of balanced equivalent loads

(c) Comparison of MSD test results with predictions for MSD and a single isolated crack

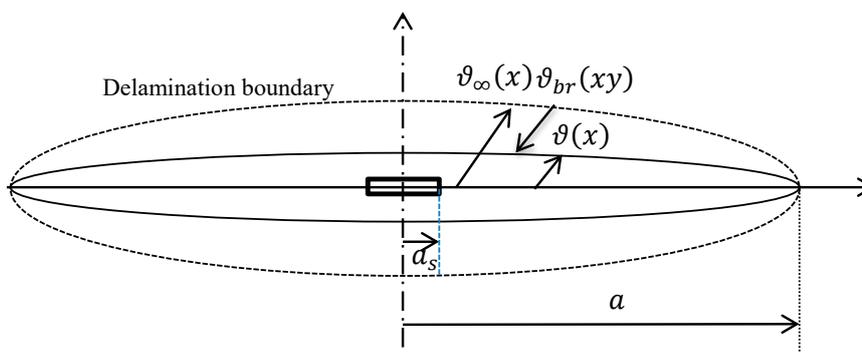
Figure 13: Illustration of the crack opening due to far field loading, and the opening restraint imposed by the off-axis bridging fibres.

The mode mix at the crack tip is governed by two aspects: the orthotropy of the laminate, which in case of unbalance with the loading axis, imposes additional shear loading while introducing axial loading to the panel, and the off-axis orientation of the fibres bridging the fatigue crack, see Figure 13. The first aspect can be determined from the laminate's angularity and directionality.

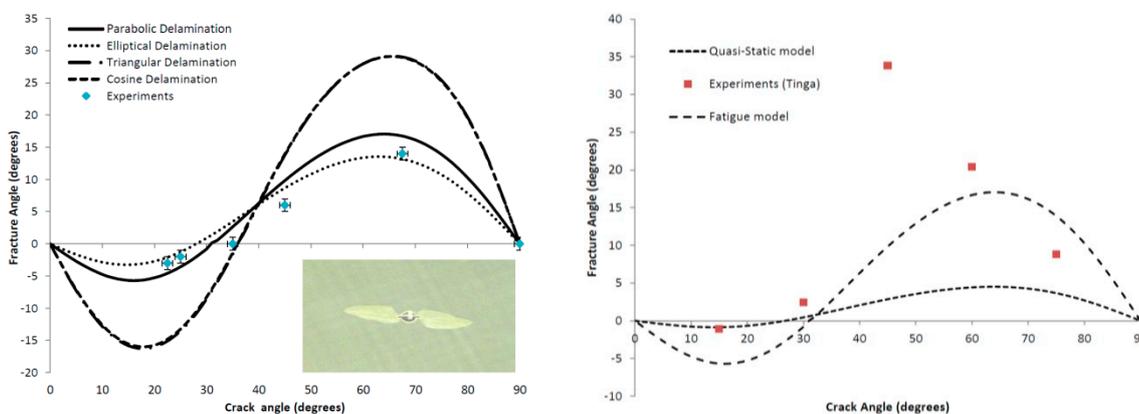
Figure 14: (a) Comparison between predicted and experimentally measured fracture angles in fatigue crack growth, and (b) similar comparison for quasi-static crack growth.

In case of quasi-static loading, representing the residual strength condition, the absence of fibre bridging does not limit the mode mix at the crack tip to be influenced by laminate orthotropy only. Development of plasticity will change the compliance of the panel and as result changes the effective orthotropy, resulting in substantially larger angles with respect to the pane transverse to loading, see Figure 14.

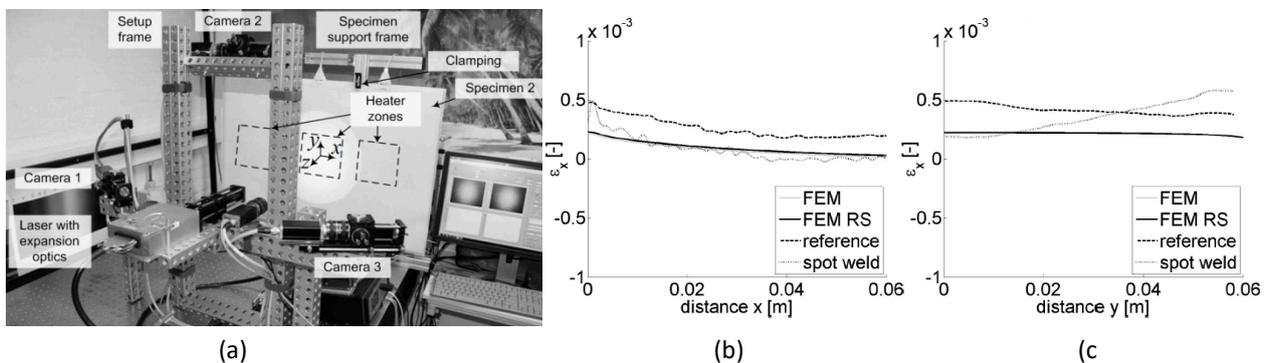
Figure 15: (a) Developed multicomponent shearography experimental setup used to measure the surface strain components, (b,c) comparison of the experimentally measured and numerically modelled values of the surface strain component  $\epsilon_x$ .

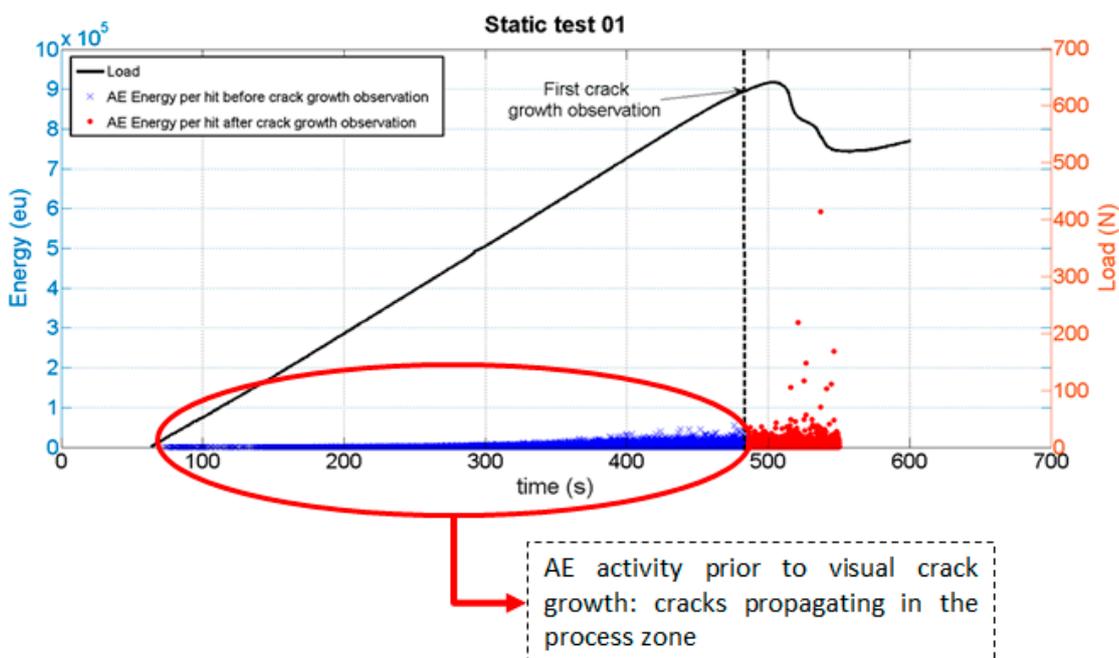
Figure 16: Static test monitored by AE.

ENF quasi-static and fatigue tests were performed and the results show that damage propagates ahead of the crack tip in a process zone. Acoustic Emission (AE) was used to verify that the process zone dissipates a significant amount of energy which should be accounted for when characterizing mode II delamination growth, as shown in Figure 16. The extent of the process zone in an ENF specimen cannot be measured by the means of visual observations made from the side of the specimen. Therefore, the definition of a crack tip is not recommended in mode II delamination studies. In fact, the concept of damage in composites under mode II loading has to be revisited.

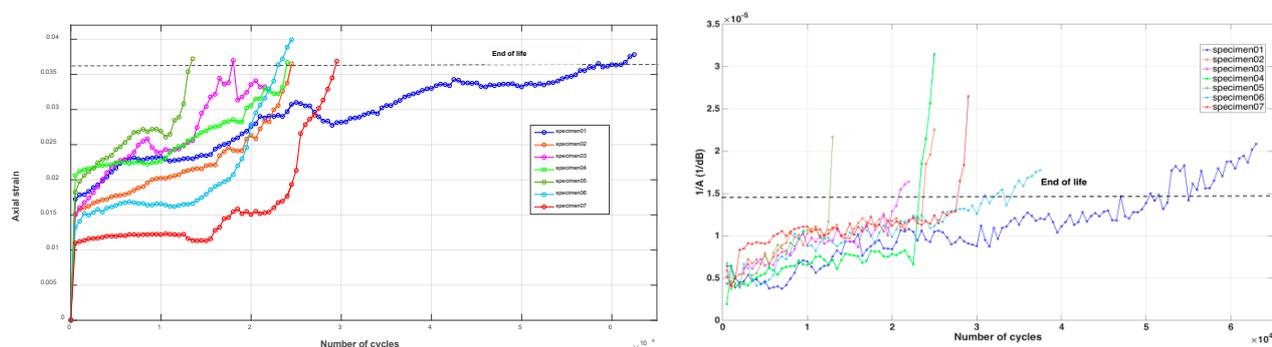
*Figure 18: Axial strain (a) and Amplitude accumulation (b) degradation histories.*

Two in-situ experimental techniques, digital image correlation (DIC) and acoustic emission (AE) were used in order to monitor the strain evolution and record the signal activity due to the fatigue damage process. The strain and AE degradation histories of the seven open-hole specimens are presented in Figure 18. AE was continuously recording the signal activity until the failure of the specimens while DIC was periodically capturing pictures.

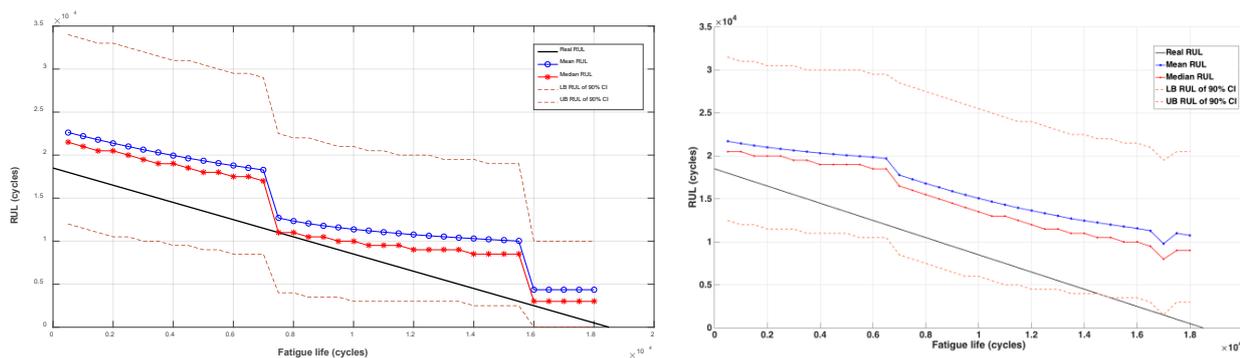
Figure 19: Mean and median estimations with 90% confidence intervals for (a) strain data and (b) AE data.

Figure 19a and Figure 19b present not only the estimations for the mean, median RUL but also provide a 90% confidence interval of RUL for specimen03 based on strain and acoustic emission data respectively. The choice of this specimen was random, similar results were obtained for the rest specimens.

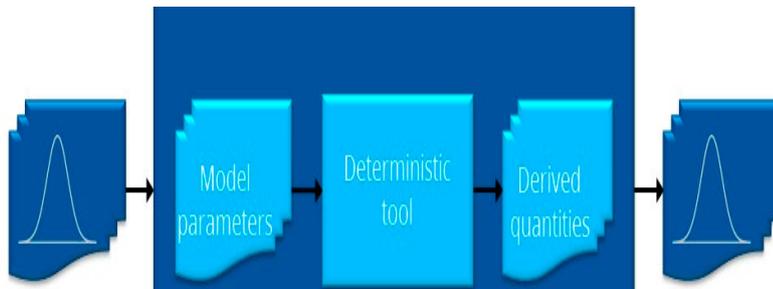
Figure 20: Schematised probabilistic analysis with RAP++.

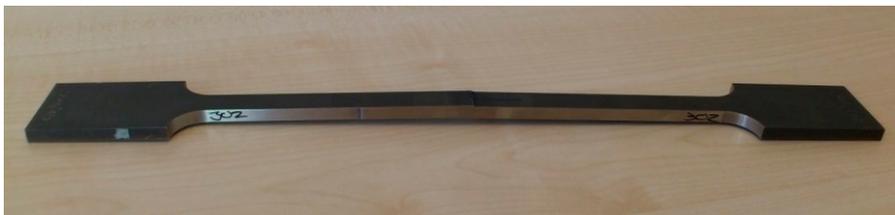
Figure 21: Dog-bone HCF specimen.

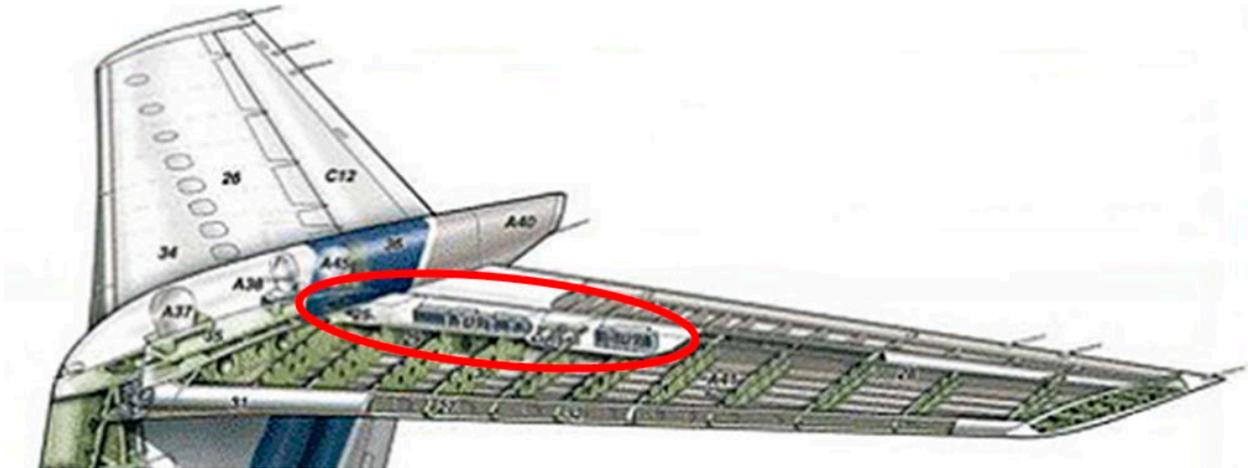
Figure 22: Location of left-hand center beam, which is joined to the pivot fitting beam at the root.

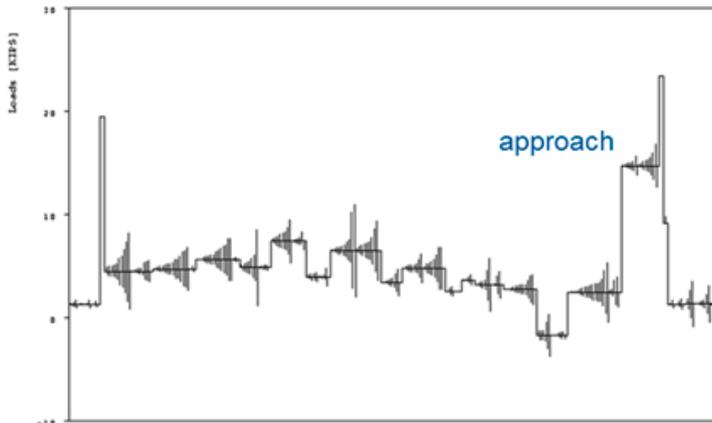
Figure 23: Typical flight spectrum with high mechanical load on pivot fitting beam upper cap in the approach segment.

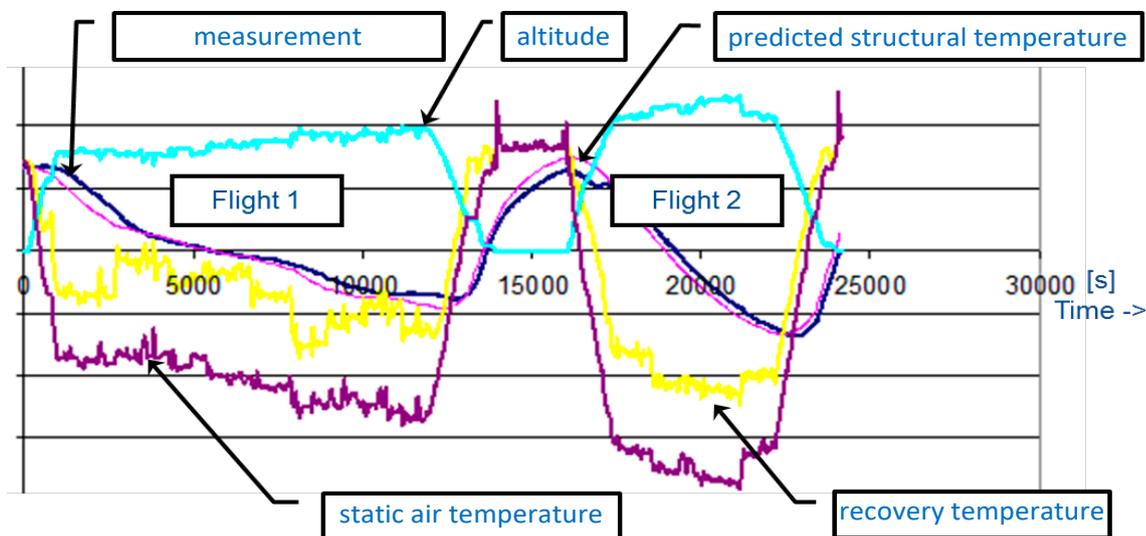
Figure 24: Excellent correlation of structural temperature predicted by OEM structural temperature model for analysis with measured temperature for the pivot fitting beam with its thermal inertia and with the local shielding from the airflow.

In the certification phase, the ground conditions of a hot day (ISA + 17°C / ISA + 31°F plus solar heating) were simulated by an array of high powered lights and structural temperatures were measured on a test aircraft. Structural temperatures were also measured on typical flights. It was confirmed that the ribs and center beam show relatively fast response to the temperature at the skin surface. Static air temperatures in flight appeared to be somewhat lower than those of the International Standard Atmosphere and were incorporated in the OEM structural temperature model. A significant temperature lag due to thermal inertia and the local shielding from the airflow by the vertical tail plane and top fairing was measured on the beam web of the pivot fitting, to which the structural temperature model was correlated. Figure 24 shows how well the OEM structural temperature model for analysis correlates also for the pivot fitting beam with its thermal inertia and with the local shielding from the airflow.

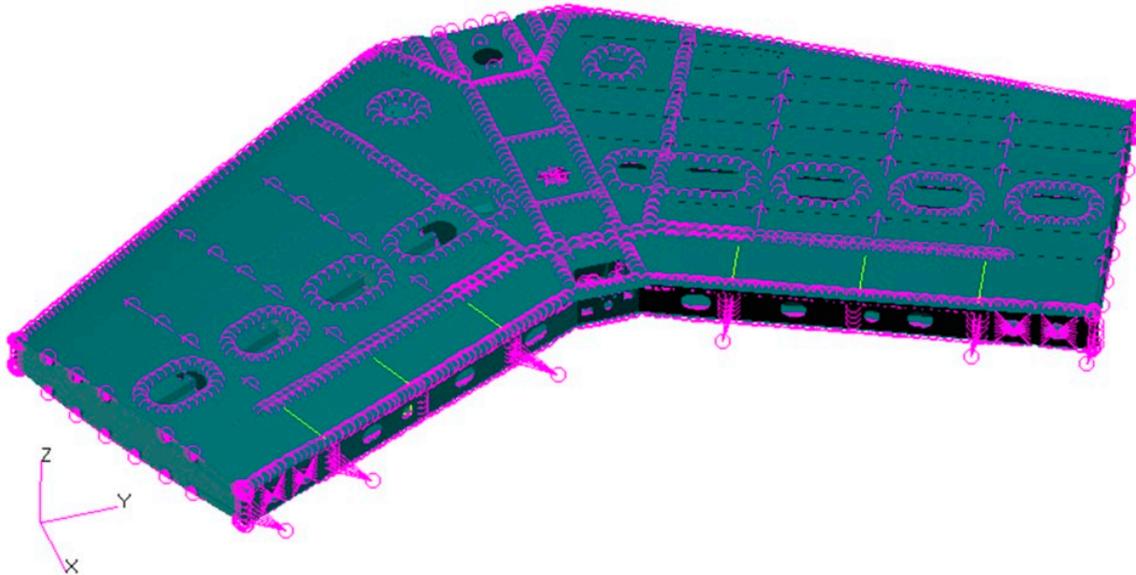
Figure 25: Fine-grid FEM model with joints modeled per bolt.

A fine-grid FEM model was used for analysis of the composite structure and mainly the FDT analysis of the metal structure. Combinations of mechanical and thermal loads were run. Joints were modelled per bolt, initially with infinite stiffness of the joining element, which is considered a conservative approach - see Figure 25. Later, a joint stiffness according to Huth [17] was incorporated into the FEM model.

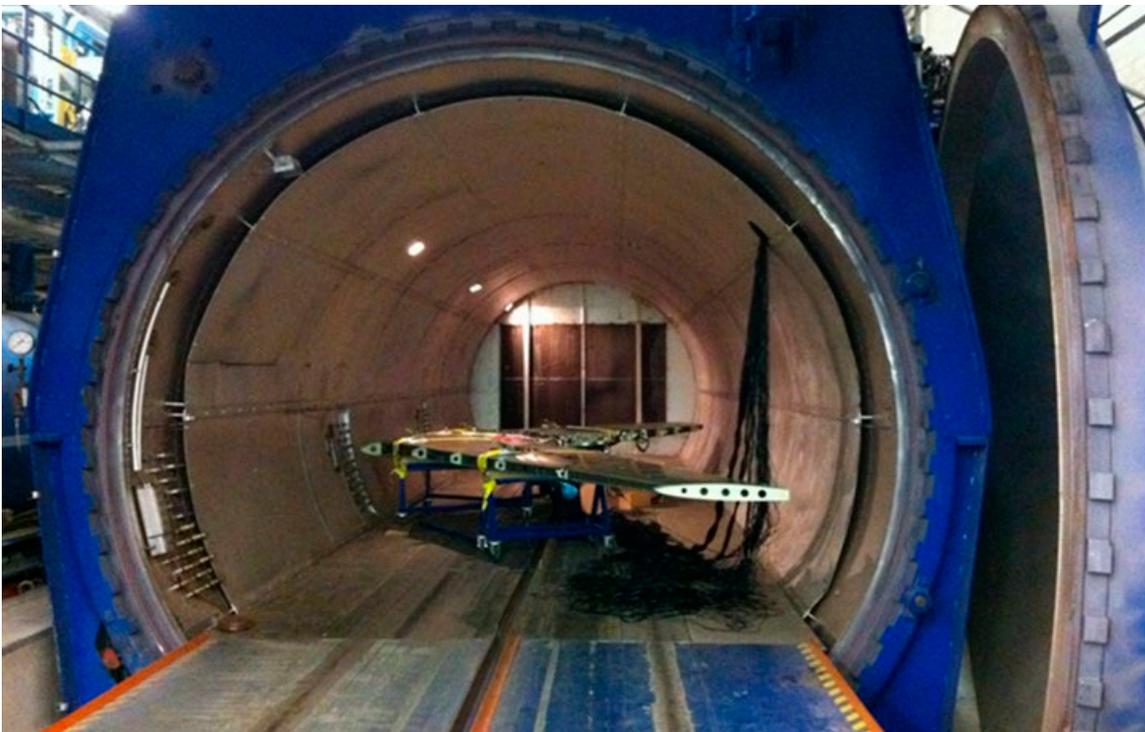
Figure 26: Thermal test on the instrumented horizontal stabilizer static and FDT component test article in an autoclave at Fokker.

These tests validated the FEM modelling of the thermal loads, especially of joints, by correlation of the strains.

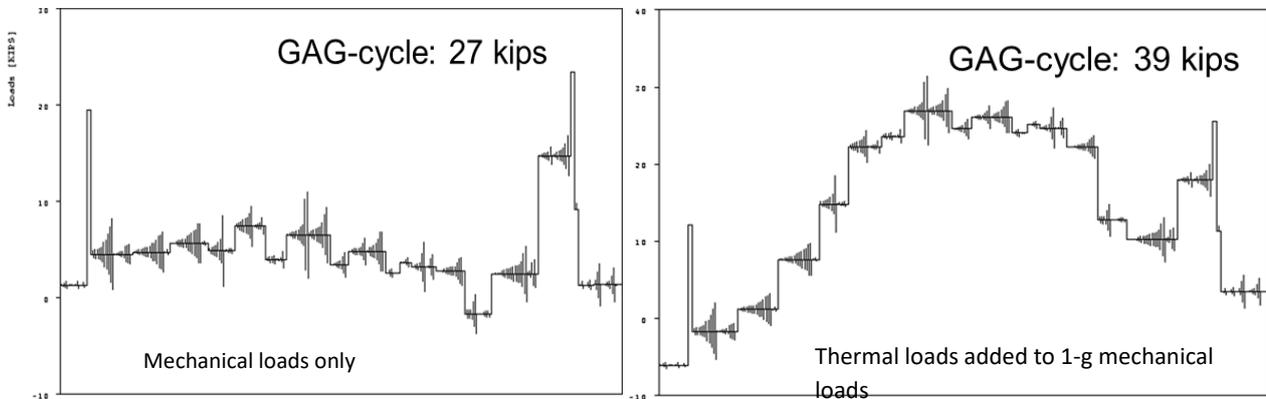
Figure 27: The loads at the aluminum center beam upper cap in a long flight (left = mechanical loads only; right = the thermal loads added to the 1-g mechanical loads).

The contribution of the thermal loads was significant for this structure. Figure 27 shows an example of the spectrum of a long flight with and without the thermal loads at the aluminum center beam upper cap.

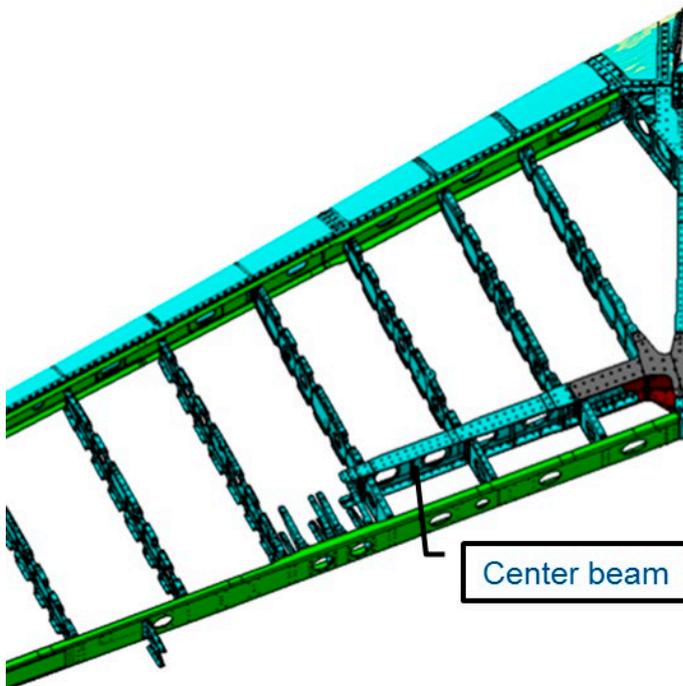
Figure 28: The long metal load path of the center beams joined to the pivot fitting beam.
