# Review of aeronautical fatigue and structural integrity investigations in the Netherlands during the period March 2015 - March 2017

This report is a review of the aeronautical fatigue and structural integrity activities in the Netherlands during the period March 2015 to March 2017. The review is the Netherlands National Delegate's contribution to the 35<sup>th</sup> Conference of the International Committee on Aeronautical Fatigue and Structural Integrity (ICAF) in Nagoya, Japan, on 5 and 6 June 2017.

NLR-TP-2017-137

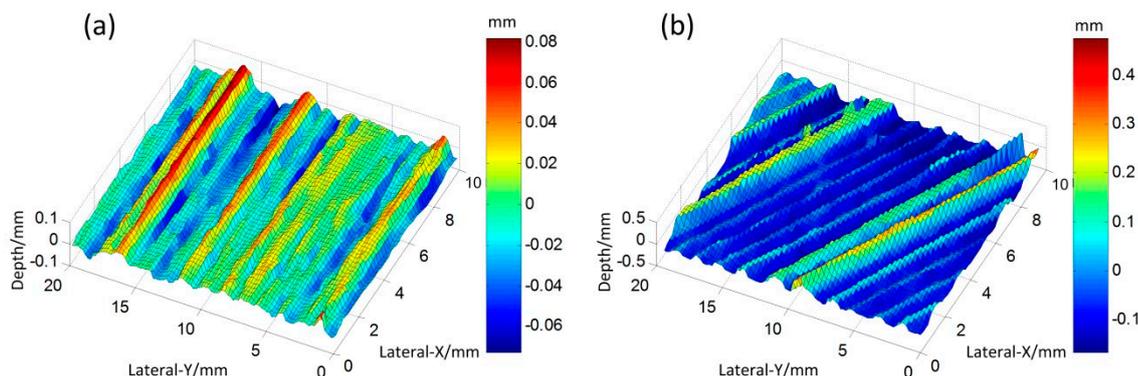
Figure 29: 3D crack profiles of carbon fibre composites. The 0 and 45° colour lines indicate the fibre orientation. The colour bars indicate the surface height.

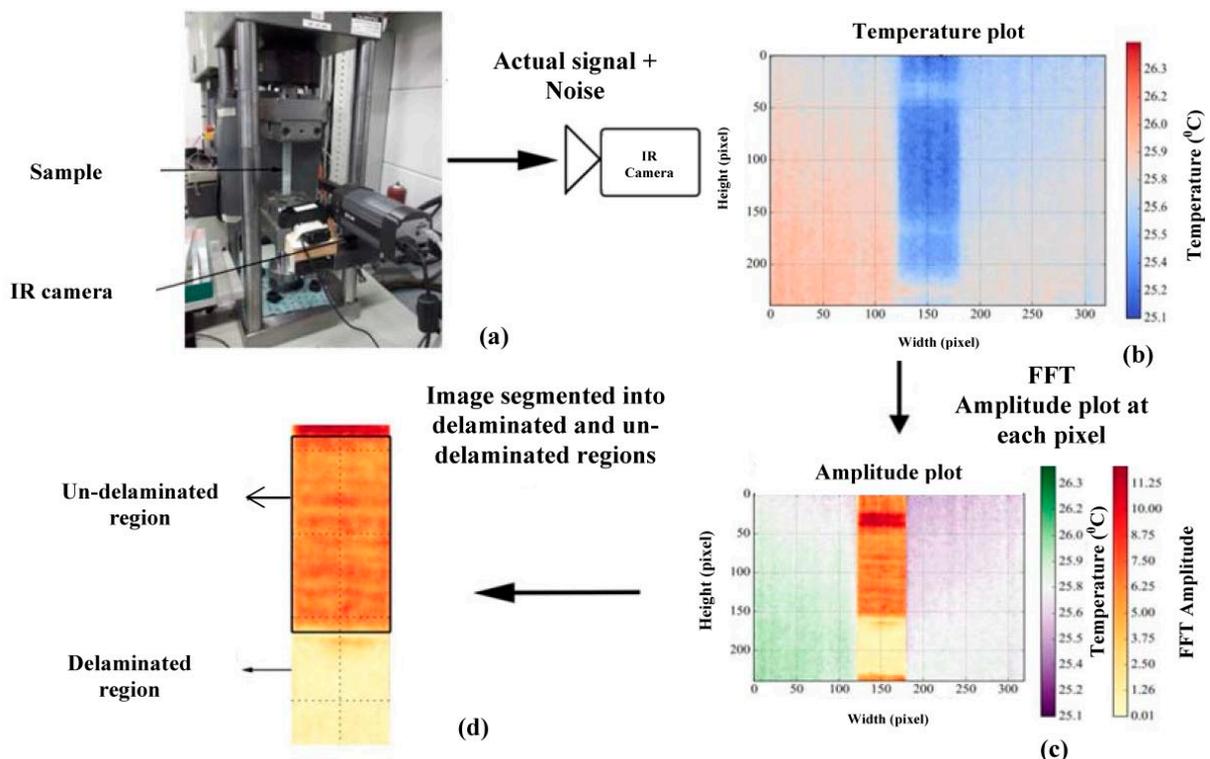
Figure 30: Block diagram of the processing algorithm: (a) the sample in the test frame, (b) temperature plots obtained from the IR camera, (c) FFT amplitude plot and (d) processed image with segmented delaminated and un-delaminated area.

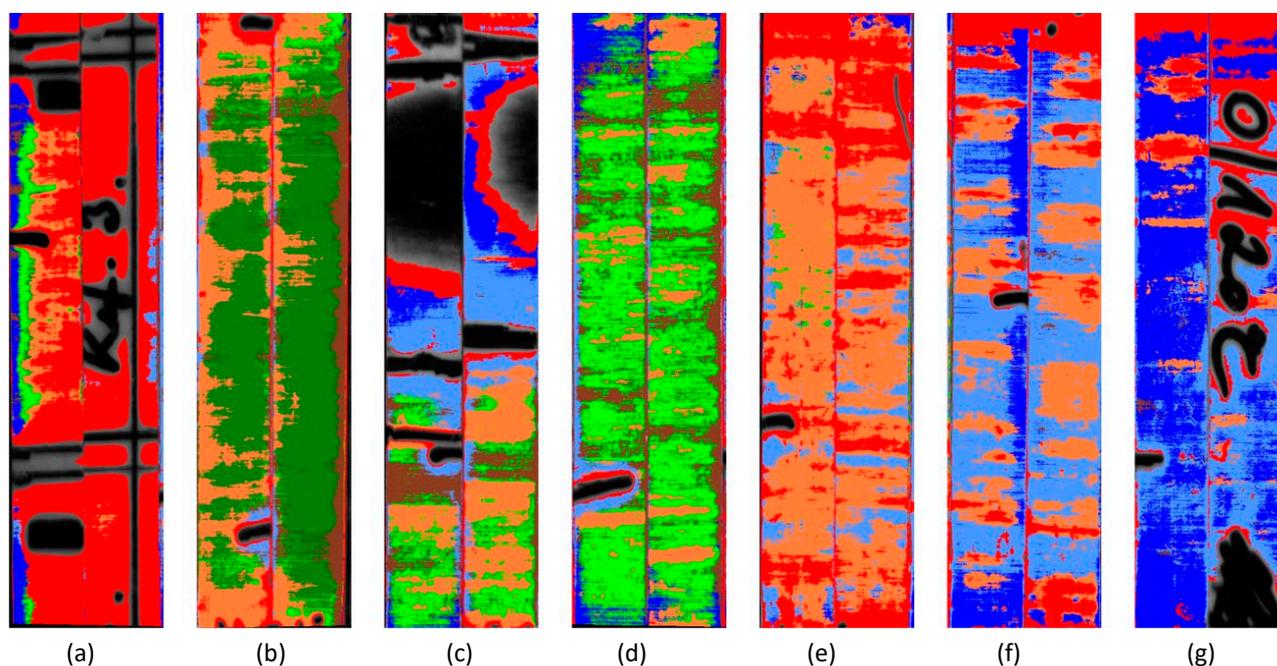
Figure 31: Hyperspectral images of the thermal cycled specimens: (a) Reference, (b) -25/+95 4000 cycles, (c) -25/+95 8000 cycles, (d) -25/+95 12000 cycles, (e) 96 h 0/+120 4000 cycles, (f) 96 h 0/+120 8000 cycles and (g) 96 h 0/+120 12000 cycles. Note that black and grey areas are not categorized with the algorithm.

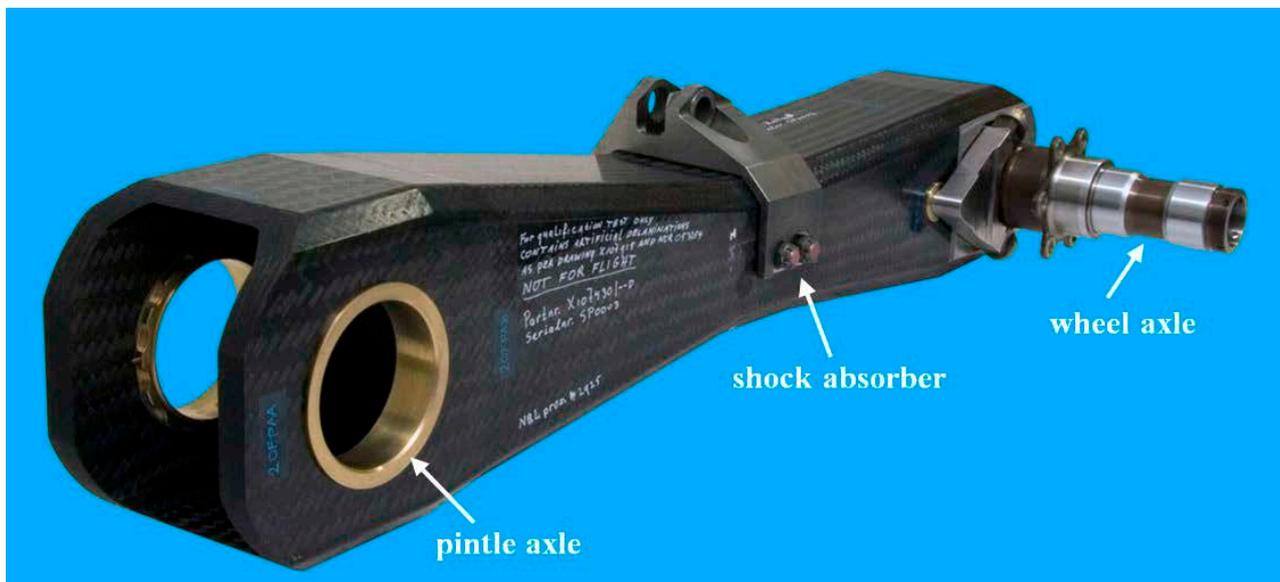
Figure 32: The RTM trailing arm of Fokker Landing Gear that was used as a calibration specimen in the investigation.

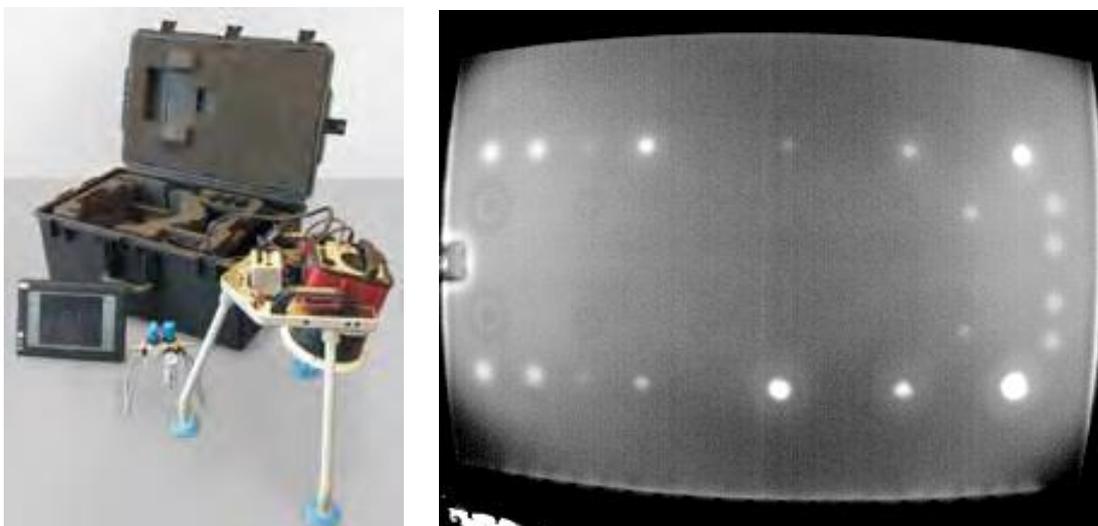
*Figure 33: Thermography inspection of a honeycomb panel with water ingress.*

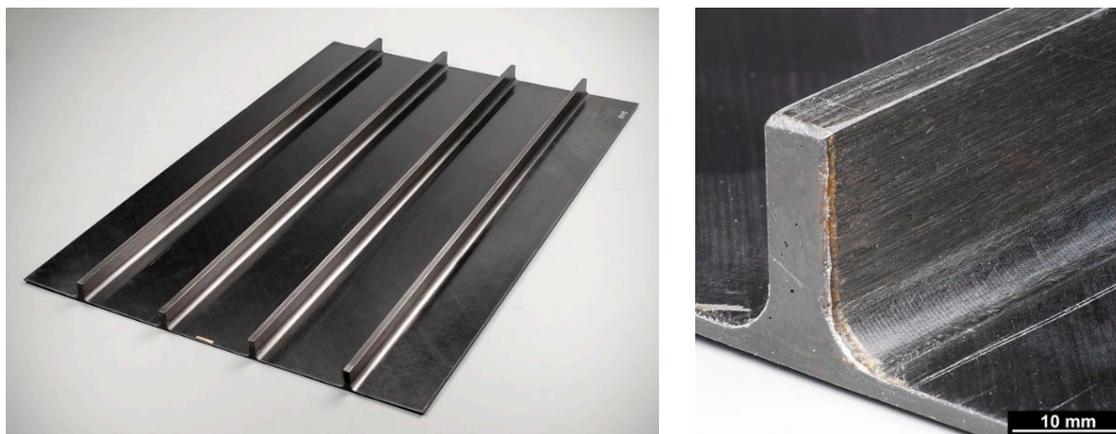
Figure 34: Rib stiffened co-cured panel (600 x 400 mm).

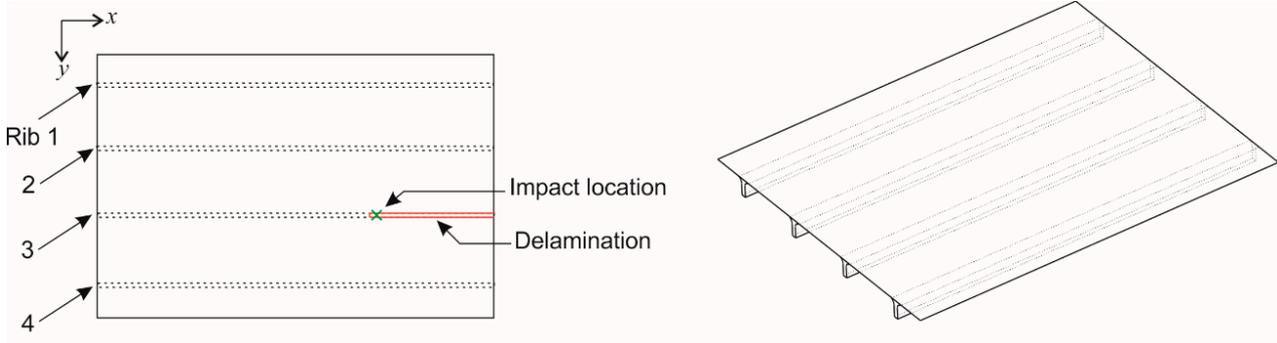
Figure 35: Schematic drawing of the rib-stiffened panel. Delamination size and location are similar to both panels.

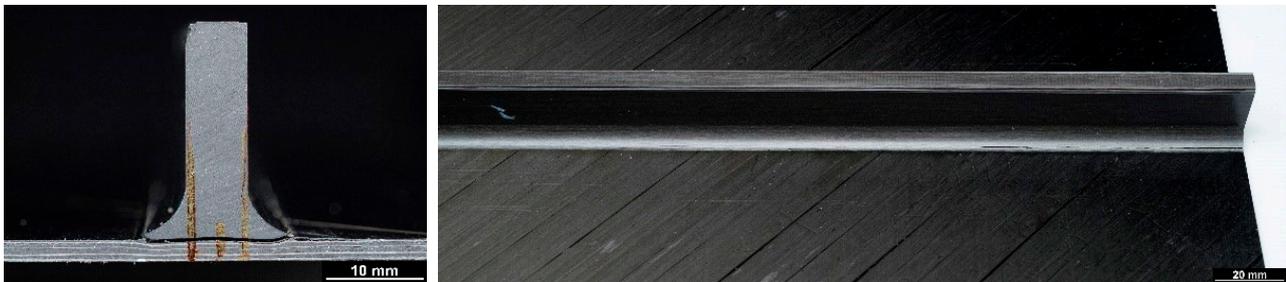
Figure 36: Close up on the damage in the first panel.

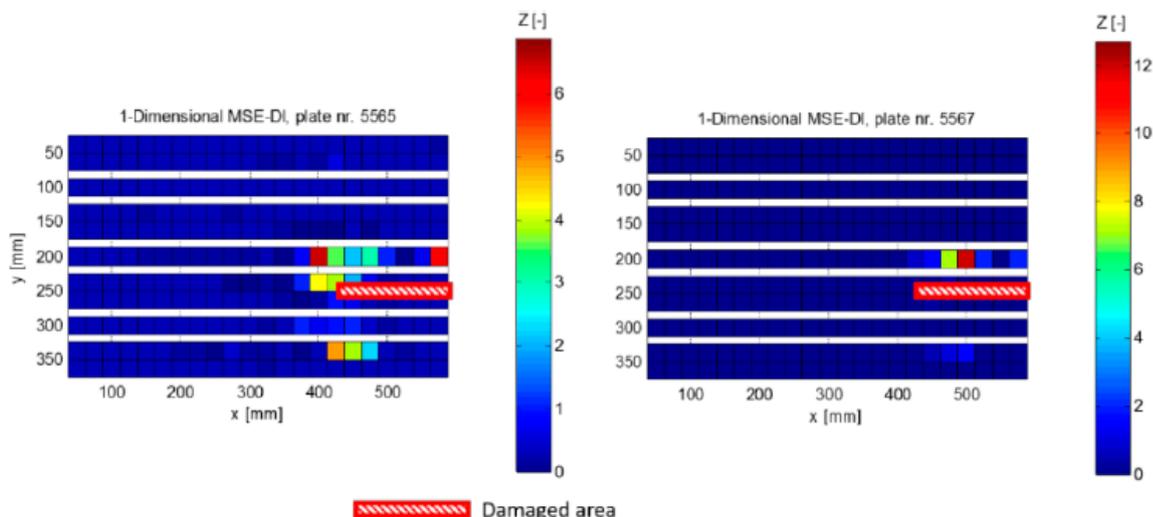
Figure 37: MSE-DI extracted from the dynamic responses of the two panels.

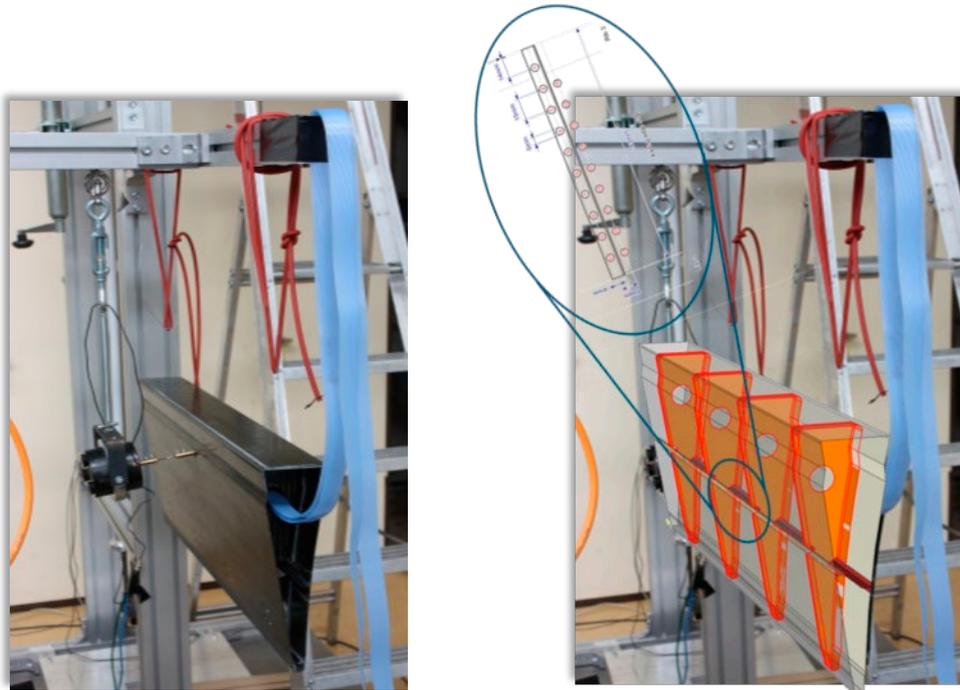
Figure 38: The freely suspended aileron with the shaker in the test rig (left) and the corresponding FE model (right).

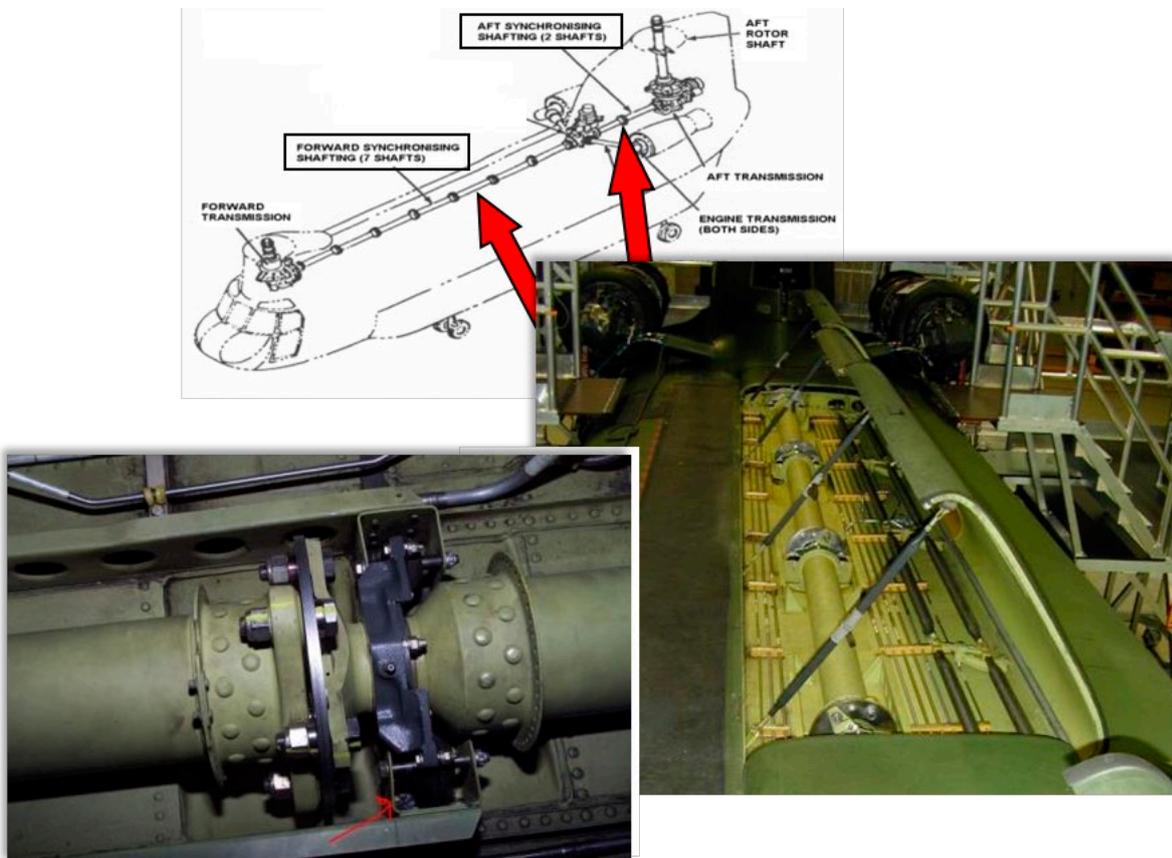
Figure 40: Chinook synchronizing shafts.

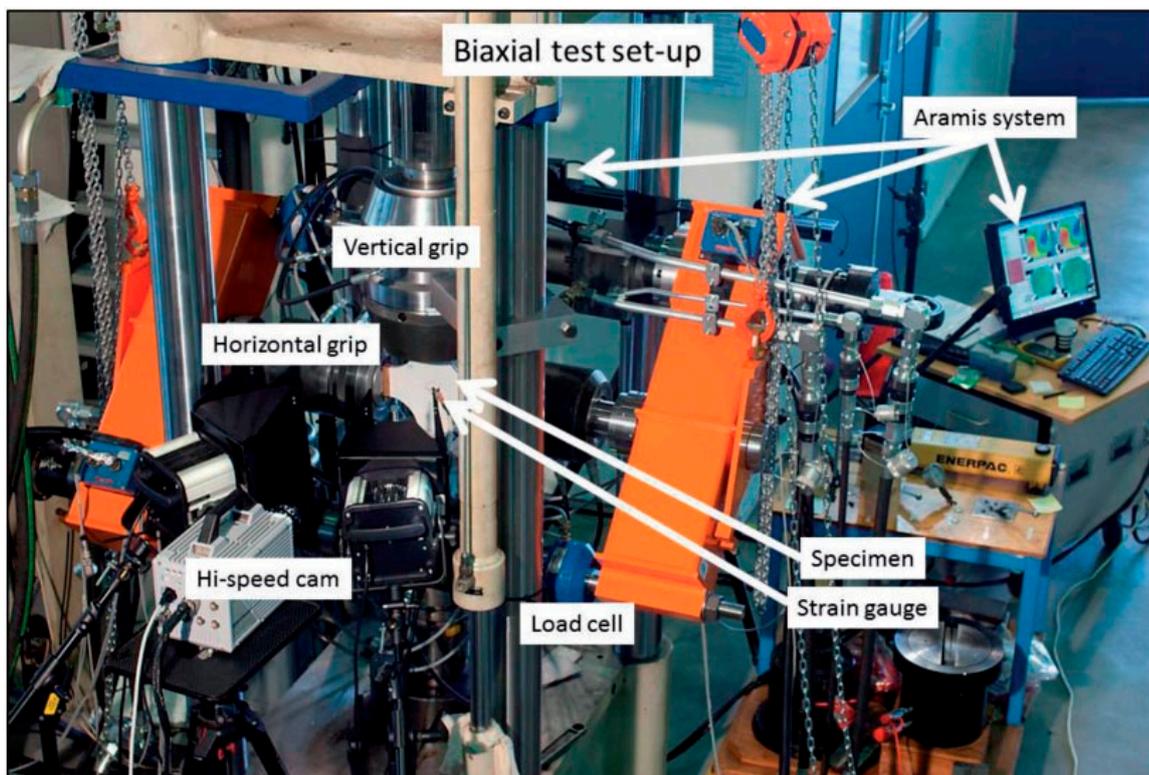
Figure 41: Biaxial test facility at NLR.

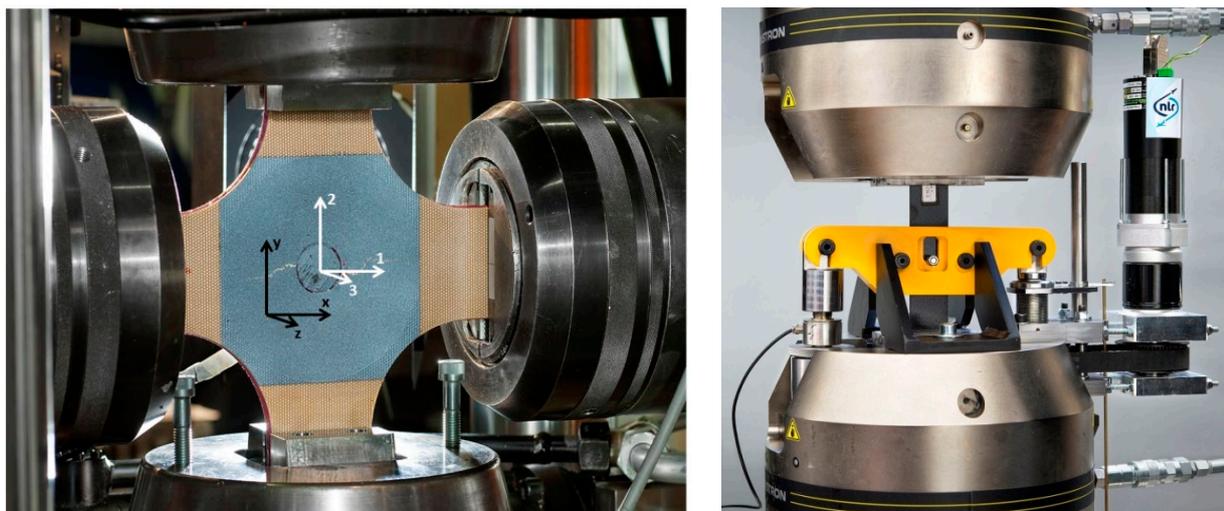
Figure 42: Multi-axial test set-ups at NLR for investigating the behaviour of thermoplastic carbon composite laminates: biaxial testing (left) and bearing-bypass testing (right).

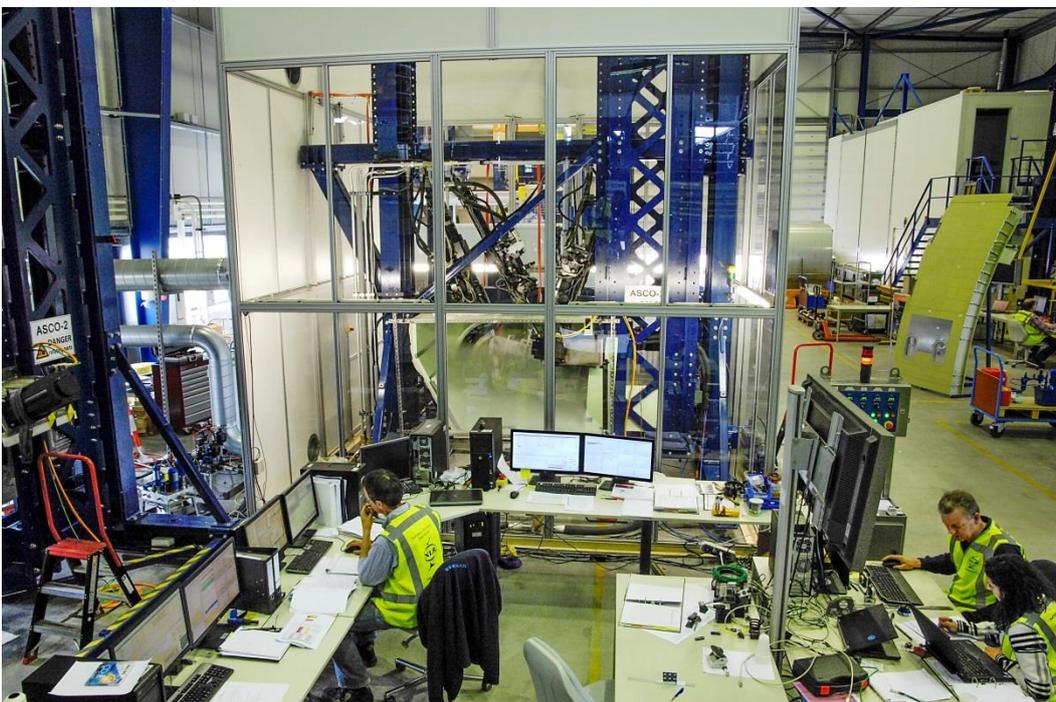
Figure 43: Overview of full scale flap track test setup at -55°C.

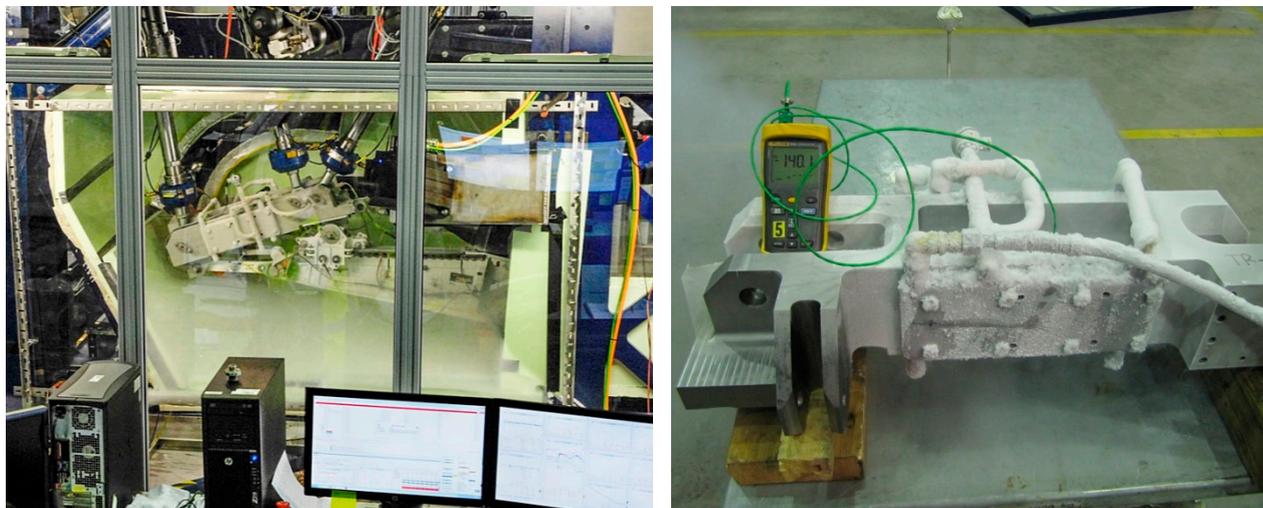
Figure 44: Full-scale endurance testing of flap tracks at  $-55^{\circ}\text{C}$  (left); thermal blocks, or heat sinks, are mounted on the LIDs to thermally insulate the test article from the test rig (right).

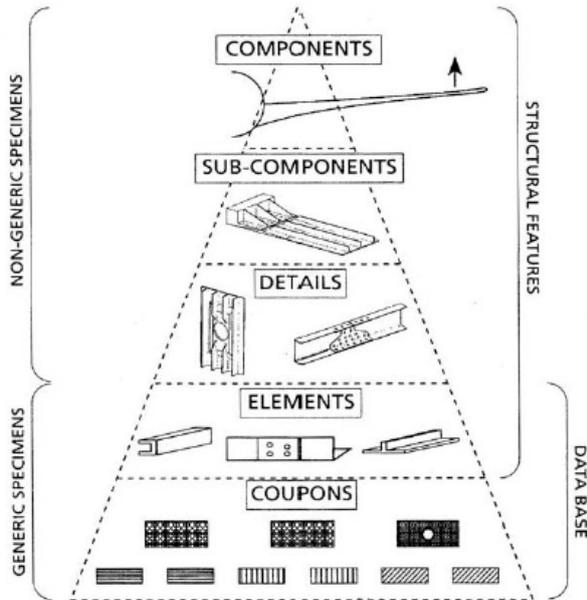
Figure 45: AC20-107B schematic diagram of building block tests.

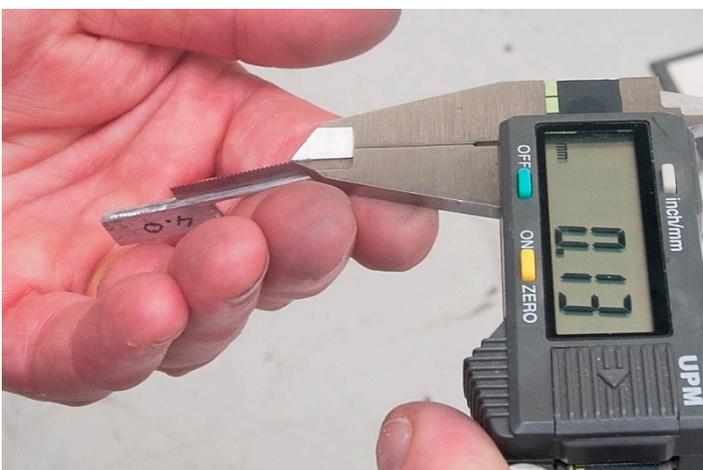
Figure 46: Sawblade thickness.

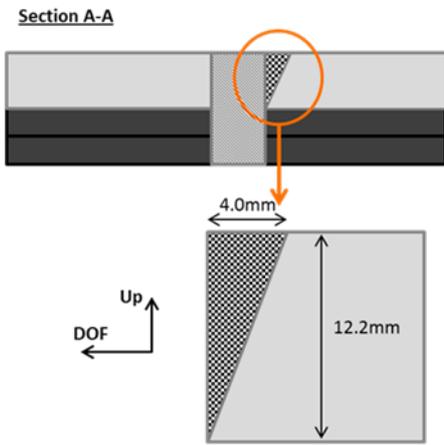
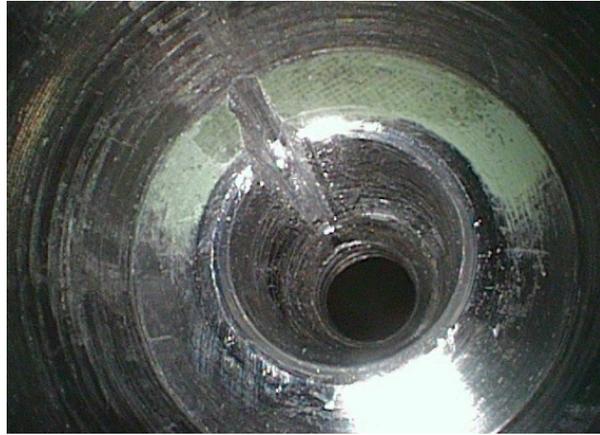
Figure 47: Non-perpendicular saw cut.

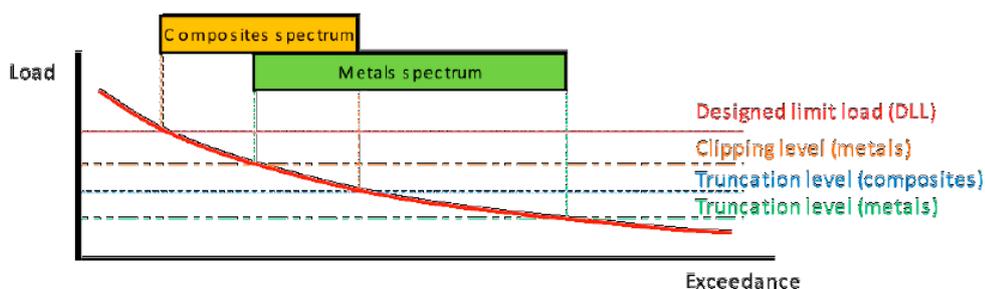
Figure 50: Difference between composite and metal load spectra.

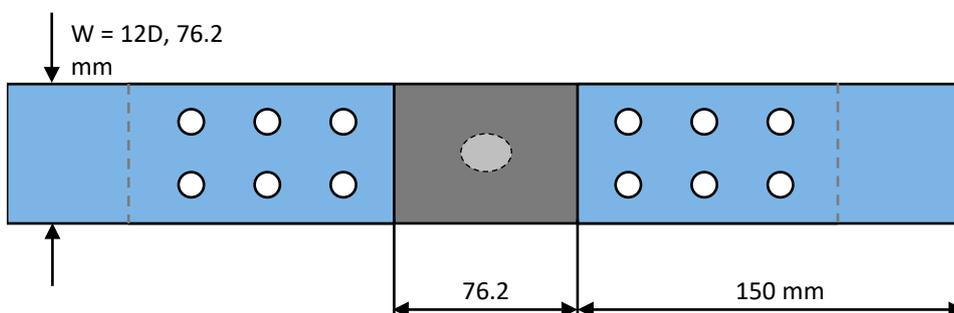
Figure 51: Schematic overview test specimen.

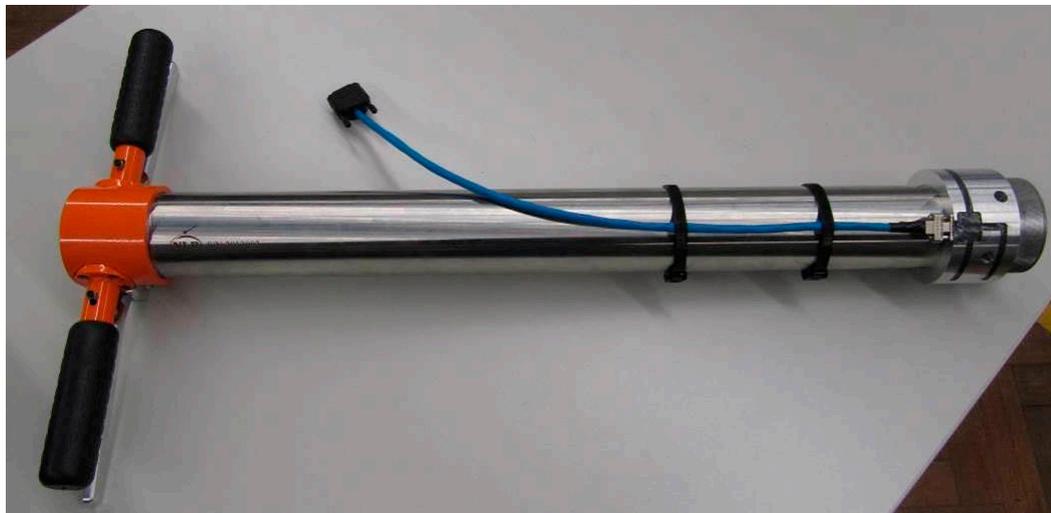
Figure 52: Portable impactor with velocity measurement device at the end of the barrel.
