REVIEW OF AERONAUTICAL FATIGUE INVESTIGATIONS IN POLAND (2015 – 2016)

Dr Antoni Niepokólczycki
Institute of Aviation, Warsaw, POLAND
(Investigations in Civil Aviation)

Dr Krzysztof Dragan
Air Force Institute of Technology, Warsaw, POLAND
(Investigations in Military Aviation)

35 Conference of the International Committee on Aeronautical Fatigue and Structural
Integrity, Nagoya, Japan, June 5-6, 2017

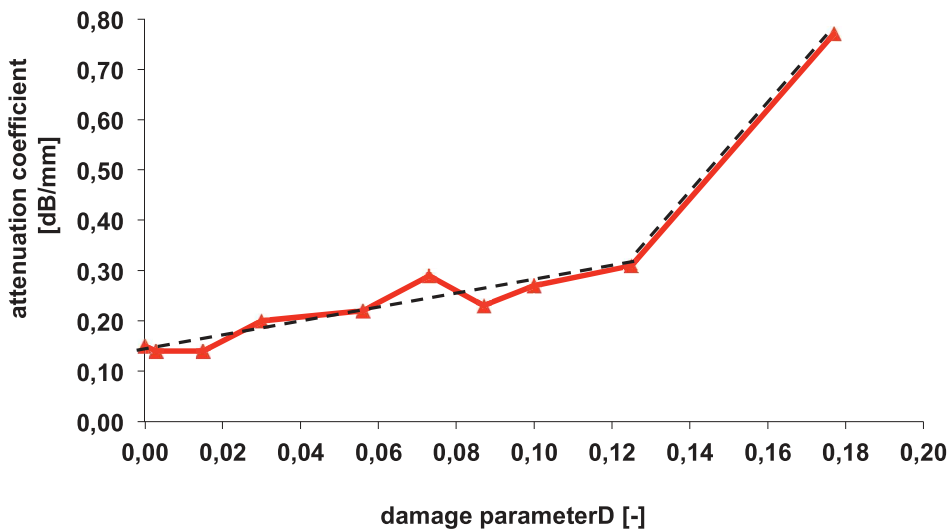
The attenuation coefficient of the material, after degradation caused by creep or tensile tests, was different than before testing. After creep testing, there was approximately a twofold increase in the value of the attenuation coefficient in the measurement part of the specimens. The damage parameter values in this area fell in the range of 0 - approx. 0.13 (Fig. 4.). However, the increase in the coefficient values in this area, despite some monotonicity, was characterized by local fluctuations. There was a large increase in the coefficient only for the damage parameter values of approx. 0.18, so in the measured area near the fracture.

Fig. 4. The values of the attenuation coefficient in the measuring part of the specimens after creep tests

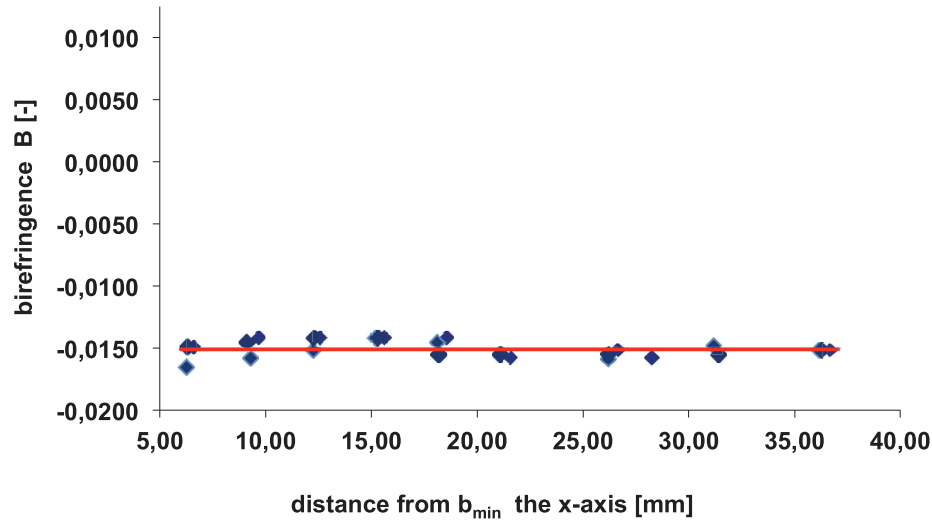
The measurements of acoustic birefringence were carried out before strength tests - static tensile tests and creep tests. The average value of birefringence in the measuring part was - 0.0151, and the difference value of birefringence for the individual areas was lesser than 0.0013. Fig. 6. shows the values of birefringence in the measuring part of specimens before strength tests.

Fig. 6. The values of birefringence in the measuring part of the specimens before testing

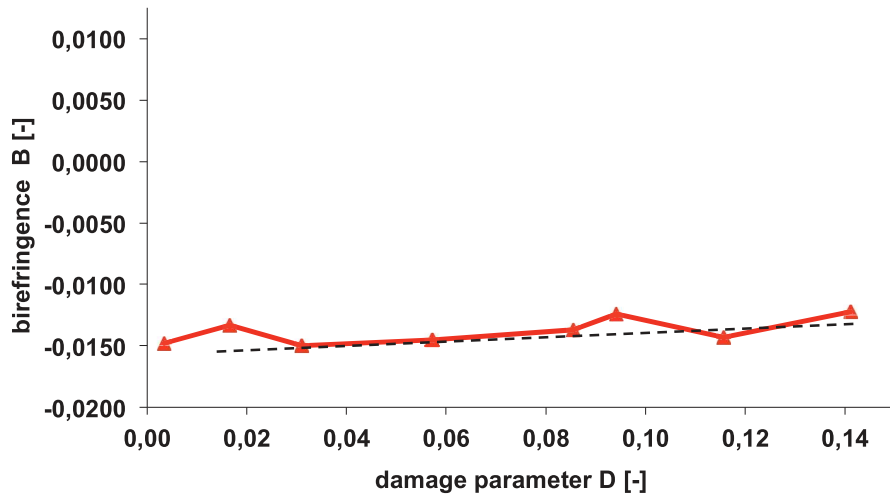
For the specimens after a creep tests, changes of acoustic birefringence fell in the range from -0.0148 to -0.0122. The value of birefringence was the lowest in the gripping part. In the measuring part there was a slight increase reaching the maximum in the highest value of the parameter of damage. In the measuring part the increase in birefringence totaled 0.0029. Fig. 8. shows the change of birefringence B as a function of damage parameter D in the measuring part of the specimen.

Fig. 8. Changes of birefringence after creep tests in the measuring part depending on the parameter of damage

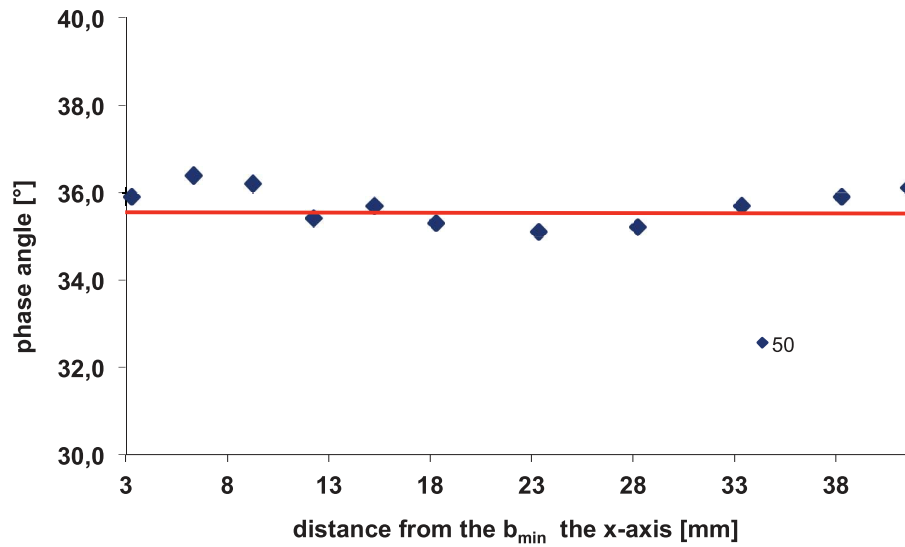
For the specimens before strength tests, the value of the phase angle was approximately constant. The differences in the measuring parts of specimens fell within the range of 1.3° (Fig. 9.).

Fig. 9. The values of the phase angle in the measuring part of the specimens before testing

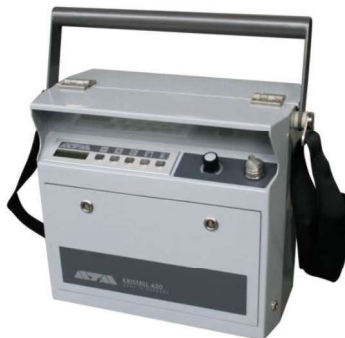
The equipment used for the experiment was the mobile polisher and etcher dedicated to the local outer layer removal, KR650 by ATM Company (Fig. 2). It allowed operators' to perform electropolishing only in the chosen area in where the stress state was known.

Fig. 2. KR650 mobile electropolisher

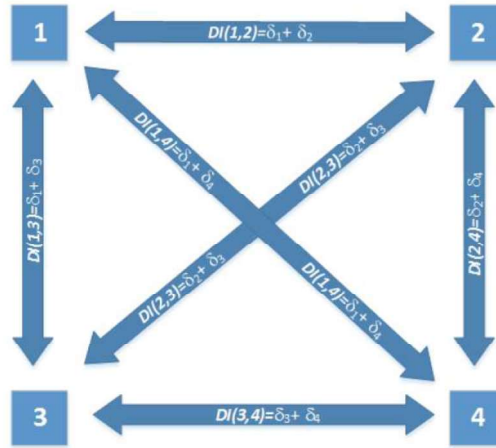
Figure 10. Damage Indices drift example for a 4-valent PZT network

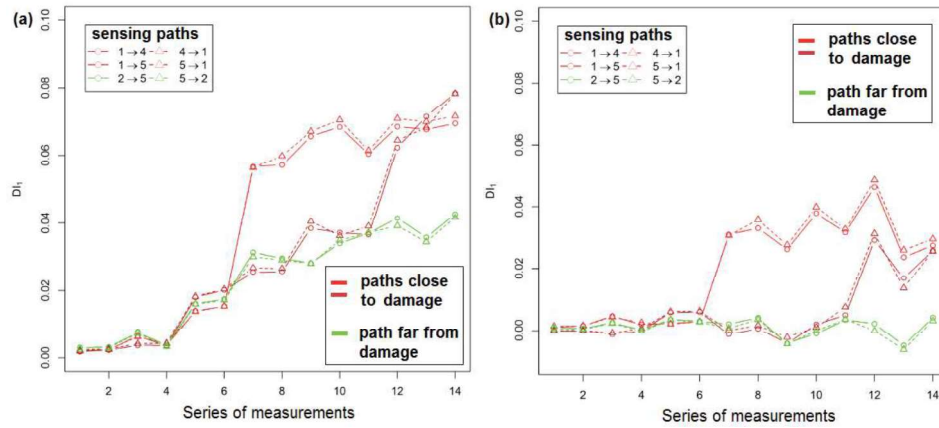
Thus the drift has been diminished. The compensation formula has been verified in laboratory studies. **Figure 11** shows example of DI_1 values obtain in an experiment

**Figure 11. Example of DI_i for sensing paths close and far from damage:
(a) before compensation and (b) after compensation**

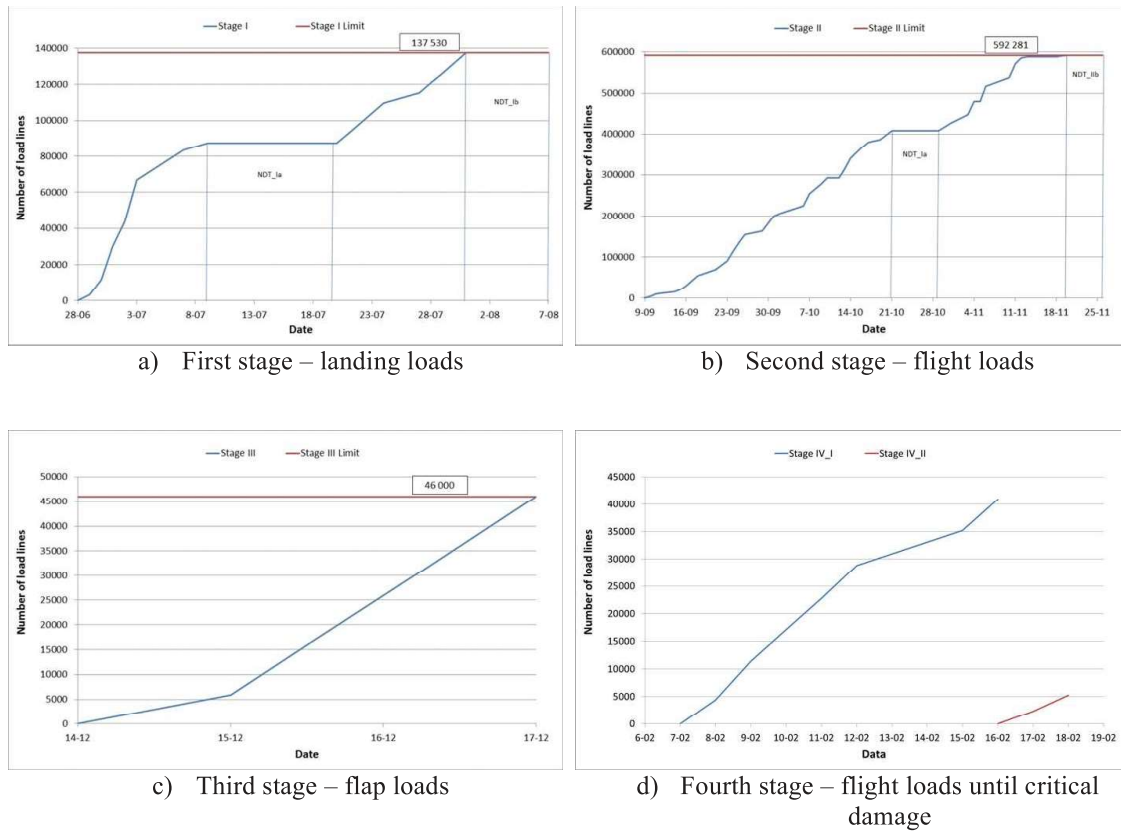
Figure 15 shows graph representation of test progress for each stage of the test. Horizontal sections in Figure 15 a) and b) represent Non Destructive Inspections (NDI) carried out during the test. During the inspections minor defects were found in the non-critical elements of the structure. An example of such damage is shown in Figure 16 a), where a crack propagating from an access hole on the wing was found at 6500 SFH. The crack initiated at the hole edge and was inhibited by a screw hole. Figure 16 b) shows the critical damage of the right wing spar which cracked during the second part of stage four.

Figure 15. Progress graphs of for the four stages of the fatigue test

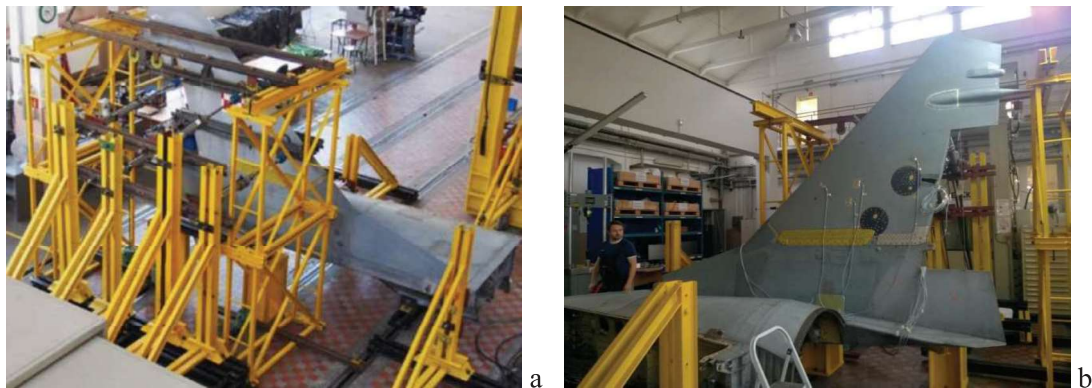
Figure 17. View of the Full Scale Durability Test Stand

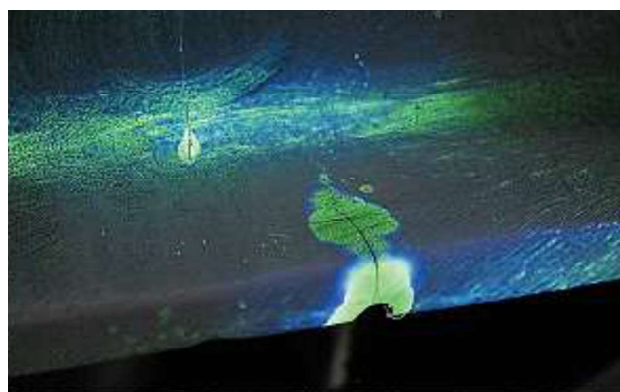
Figure 19. Fracture of sealing hose frame in the upper part of the second pilot cabin, above the seat

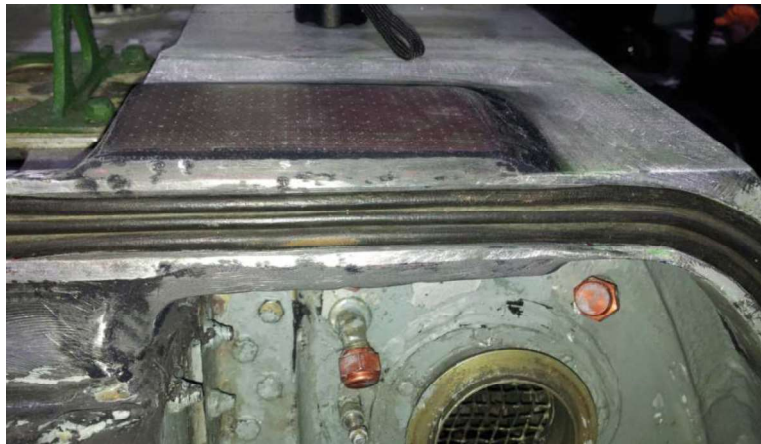
Figure 20. Structure after repair, sealing hose installed

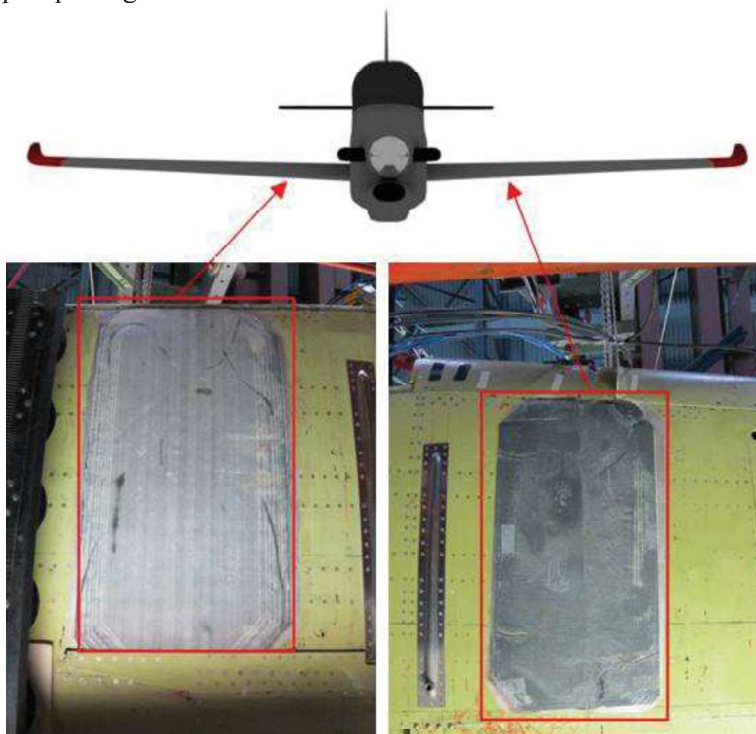
Figure 21. Location of the composite repair patches on the aircraft wing

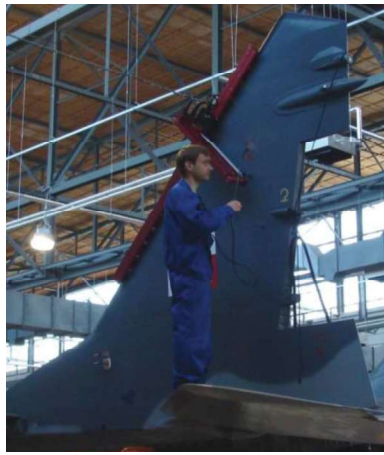
Figure 25. Composite Vertical Stabilizer Inspection
