# Review of Aeronautical Fatigue Investigations in Switzerland

May 2007 – April 2009

**KOR-TA2009-0101**

**M. Guillaume  
RUAG Aerospace AG  
CH- 6032 Emmen**

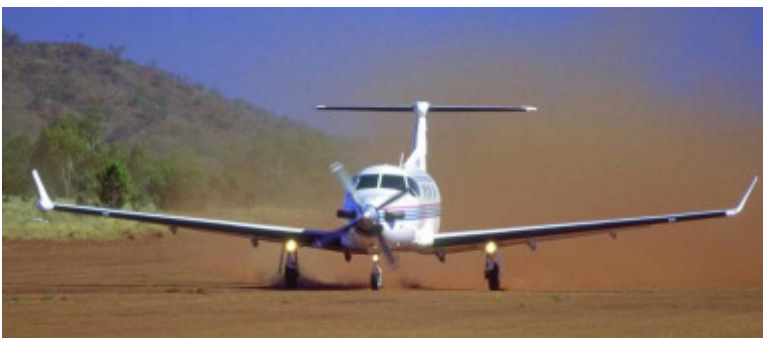
Figure 4.2.1: PC-12 during take-off (left) and FSFT article during tear down inspection (right)

The first of two stages of the LEP was completed in 2008. It comprised an extension of the safe-life limit based on the tear down inspection results of the full scale fatigue test (FSFT) article, fleet experience such as fleet usage (flown hours and flight cycles) and fleet findings (fatigue cracks, impact damage, corrosion, etc.) and based on a re-evaluation of assumptions for the flight mission and loads. This resulted in an update of the fatigue substantiation, which covered a certified life limit of 25'000 flying hours or 30'000 flight cycles. The fatigue substantiation is based on an analytical approach using crack initiation analyses in combination with the FSFT results.

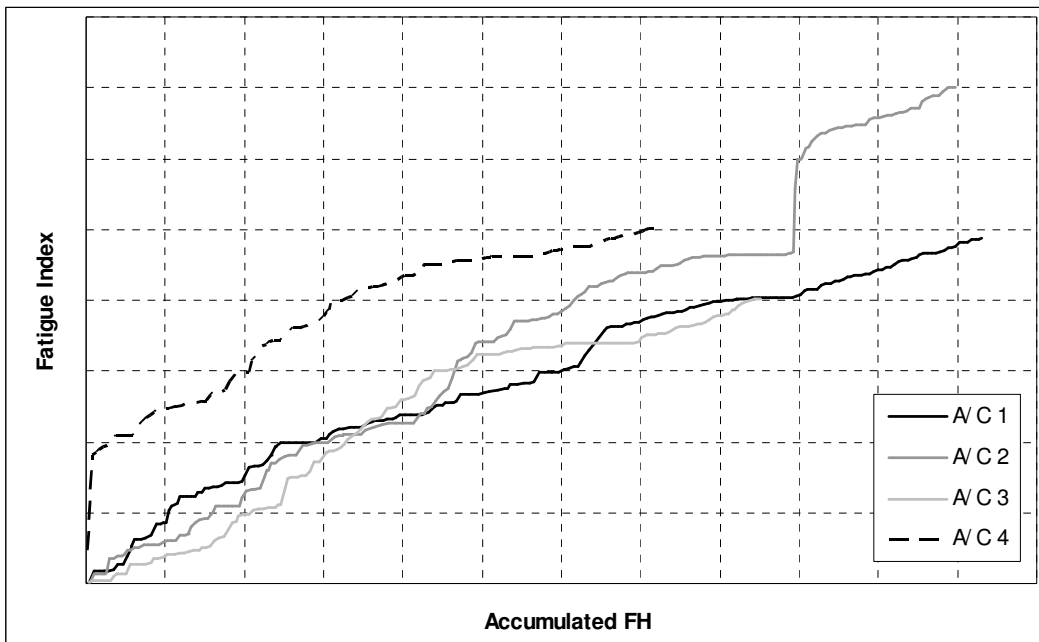
Figure 4.3.1: Typical output of the PC-21 Fatigue Monitoring System for four sample aircraft

The FMS is certified using guidance of AC 27 MG 15, because no regulations exist for such systems on FAR 23 aircraft. The fatigue usage is monitored by means of strain gauges located on major structural assemblies and expressed by so-called Fatigue Indices (FIs). Initial results of the operational fleet are promising and indicate a data capture rate in excess of 90%.

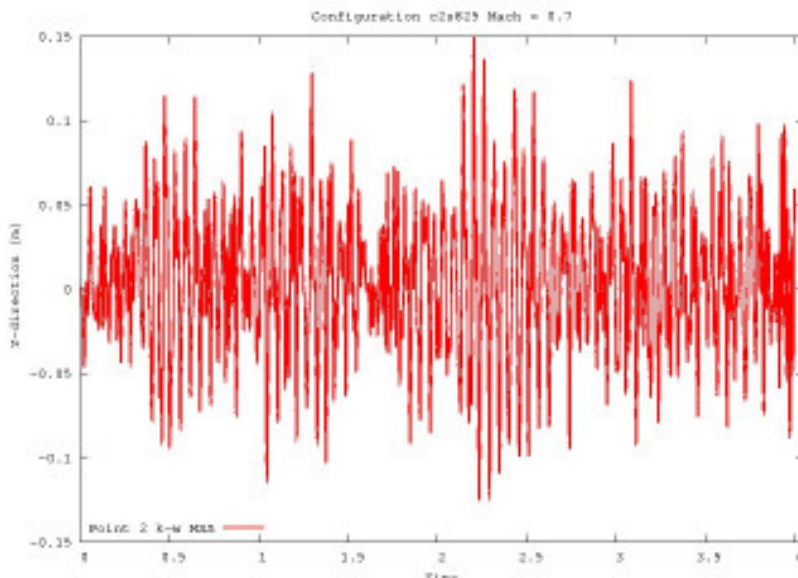
Figure 4.5.2: Movement of point 2 as function of time (4 sec), load case C2S825

As for the transonic load case 5 points were selected to show the movement of the Vertical Tail. The DES variant of the  $k-\omega$  Menter Shear Stress model was used for the calculation, and 4 seconds of real time was simulated. Figure 4.5.2 shows the movement of point 2 (located on top of the vertical tail) in the y-direction as function of time, and one can observe important movements which are not damped in time. Figure 4.5.3 shows the position of the Vertical Tail with the pressure contours on top at 2 different time instances. The bending and torsion of the vertical tail can be clearly observed.

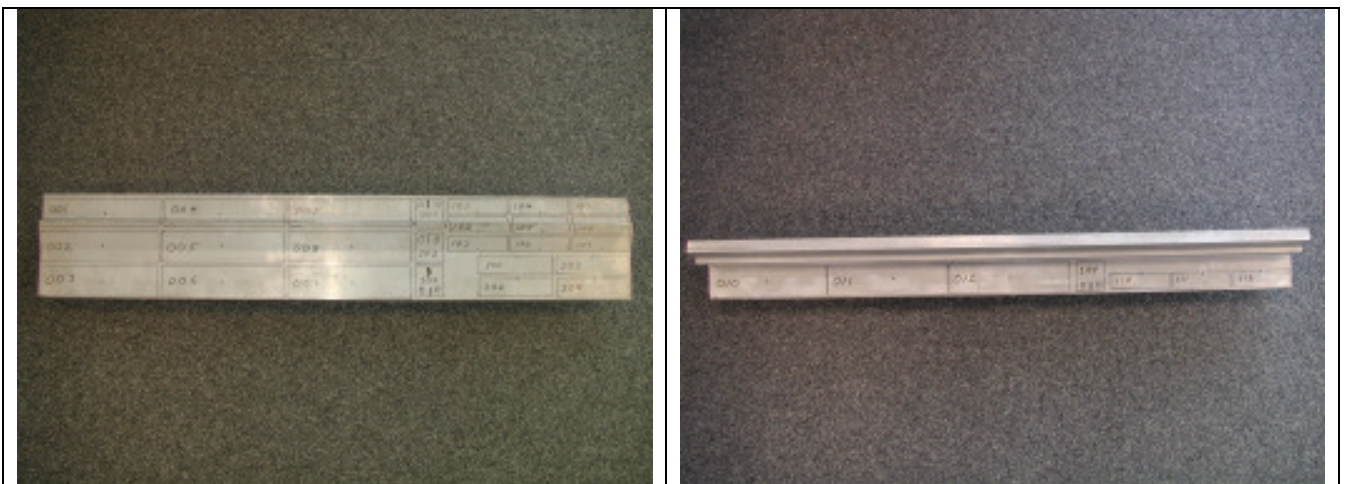
Figure 4.6.1: Layout of Test Samples

The material was selected from the longeron geometry of upper outboard longeron in the aft center section (FS498) of the F/A-18 which showed several cracks in tear down inspection. The figure 4.6.1 shows the layout of various test samples on the specimen.

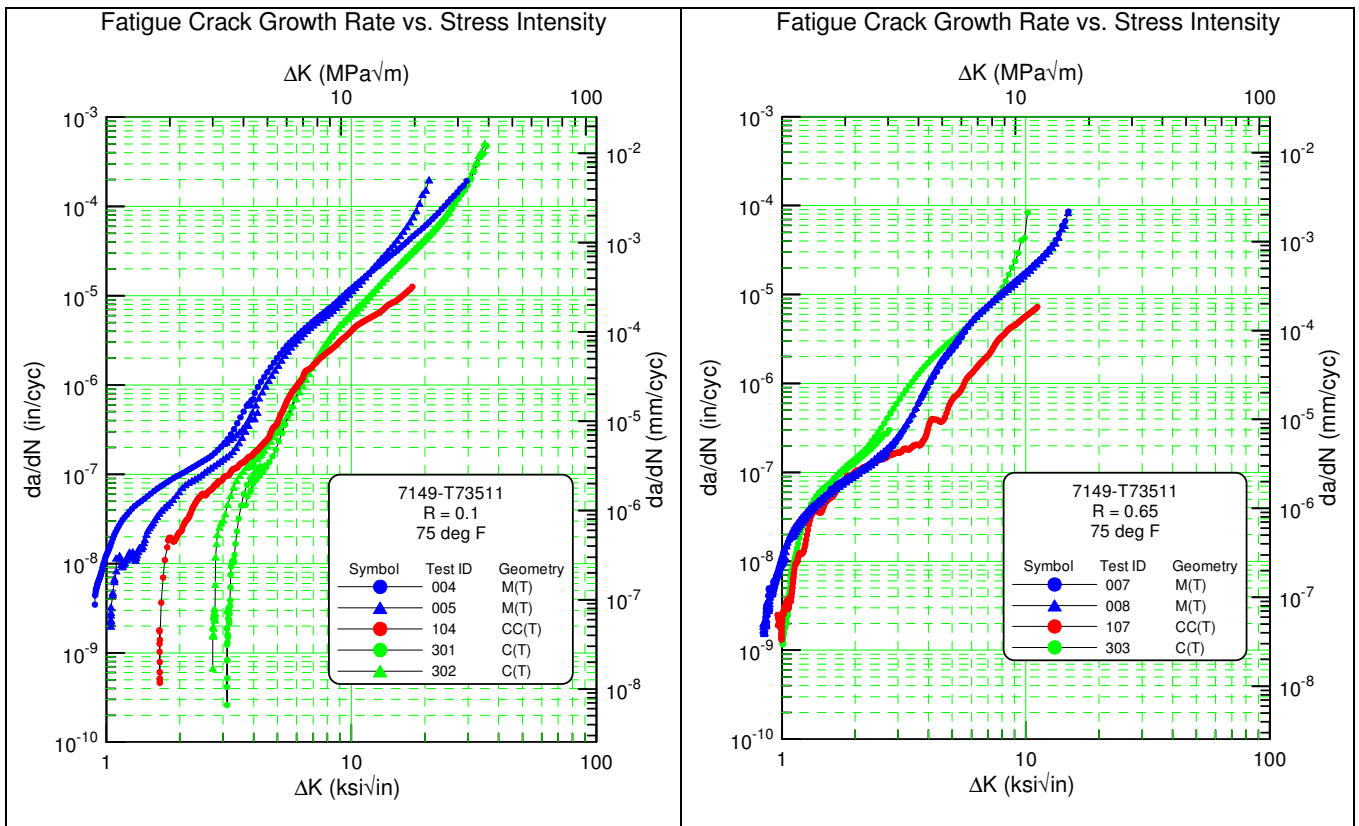
Figure 4.6.2: FCGR response for stress ratio 0.1 and 0.65 for center crack M(T), corner crack CC(T), compact tension C(T) specimen showing effect of sample type

Individual FCGR plots are showed in figure 4.6.2. These results including the linear correction factor applied to the normalized compliance or (DCPD) in order for the calculated crack length to match up with the measured crack length.

The three different sample types give almost identical results at a stress ratio of 0.65. This is largely because, at a high stress ratio, all samples are closure free, whereas at a low stress ratio, compressive residual stress will clamp the crack shut and tensile residual stress keeps the crack fully open, even at minimum load.

The high R data are unaltered for the ACR method, but the  $R = 0.1$  data have been shifted significantly to the left after correcting for crack closure.

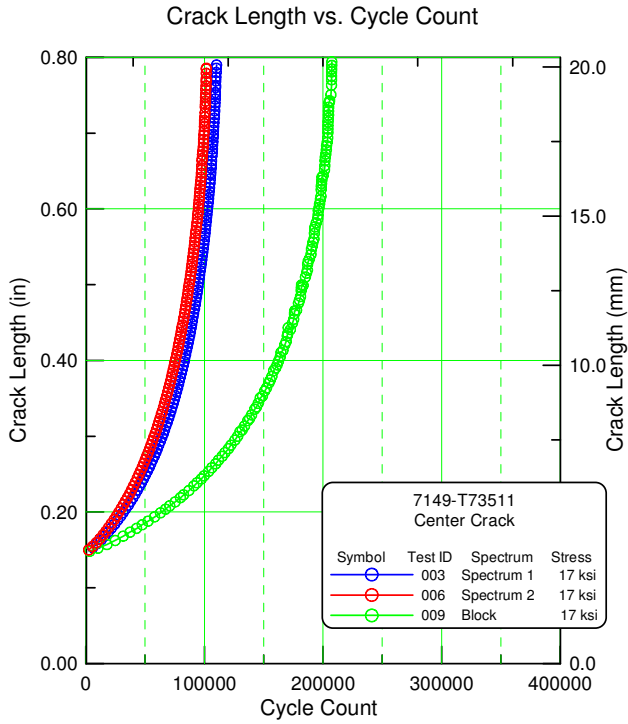
Figure 4.6.3: Crack length versus cycle count comparing spectrum types for the center crack sample

Even the AFGROW software showed for all three spectrum a CG life of 4'100 SFH the experimental results differs for each sample geometry, see table 4.6.1.

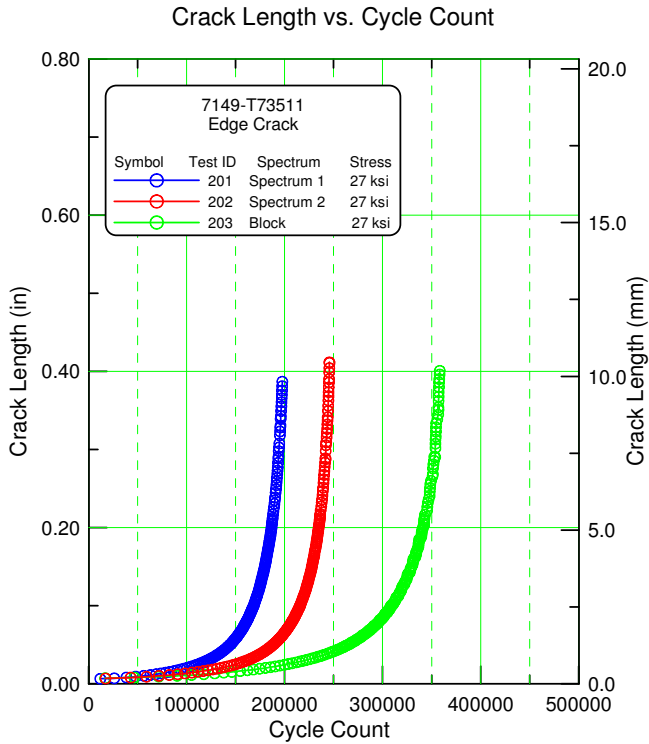
Figure 4.6.5: Crack length versus cycle count comparing spectrum types for the edge crack sample

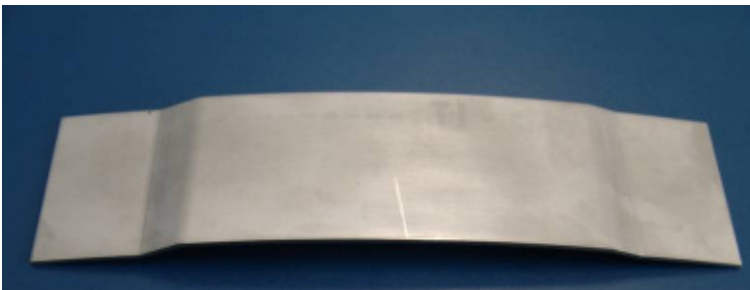
Figure 4.7.13: Feasibility of manufacturing the titanium strap for door #44

Since the strap is mounted between different components, the thickness should not change. Two solutions would have been possible for the structural refurbishment. First an aluminium strap with cold worked fastener holes or second a similar strap made from titanium. With both options the required design criteria of a crack initiation life of 10'000 flight hours can be met. As with the titanium strap the fastener holes do not need to be cold worked this solution was selected for the structural refurbishment.
