A Review of Aeronautical Fatigue Investigations in Sweden During the Period May 2009 to March 2011

Edited by HANS ANSELL
Saab AB
Sweden

ICAF Doc. No. 2426
Saab Doc. No. TDL-2011-0091

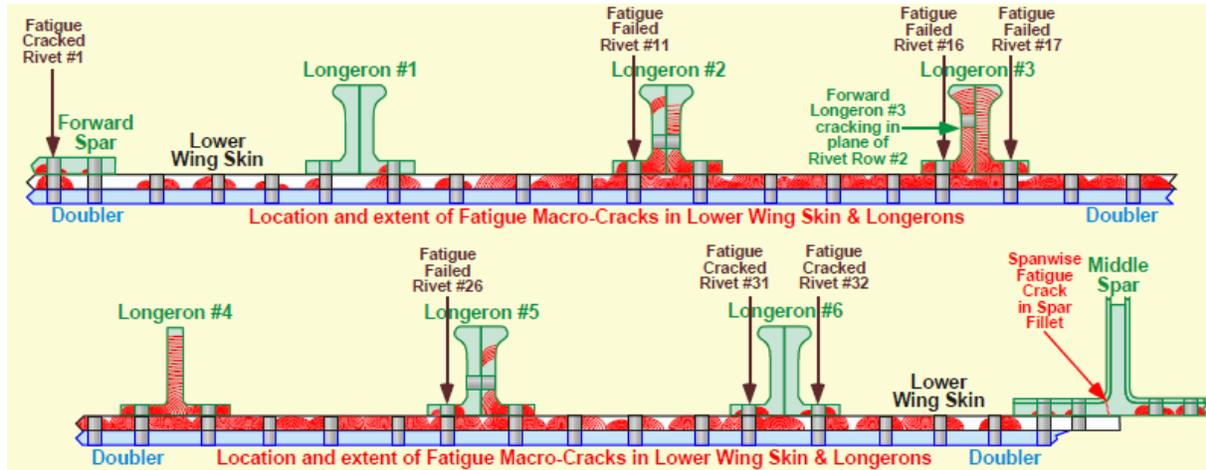
Phase V When the major fatigue crack had reach a length of about 840 mm the wing ruptured. Figure 2.

Figure 2 Schematic fatigue crack pattern in the left wing skin at STA Y=1030.

The development of the fatigue crack along rivet row # 1, that finally led to the wing fracture, can be described in five phases:

Phase I A great number (thousands) of micro-cracks, less than 50 microns deep, developed in the Alclad layer.

Phase II Some hundreds of those micro-cracks grew as fatigue cracks into macro-cracks.

Phase III A number of macro-cracks coalesced into continuous fatigue cracks that penetrated the lower wing skin.

Phase IV In a zipper opening effect the joining of the continuous crack with individual fatigue cracks created a major crack along the rivet row. Along the same row fatigue cracks of different size were developed on all the longerons.

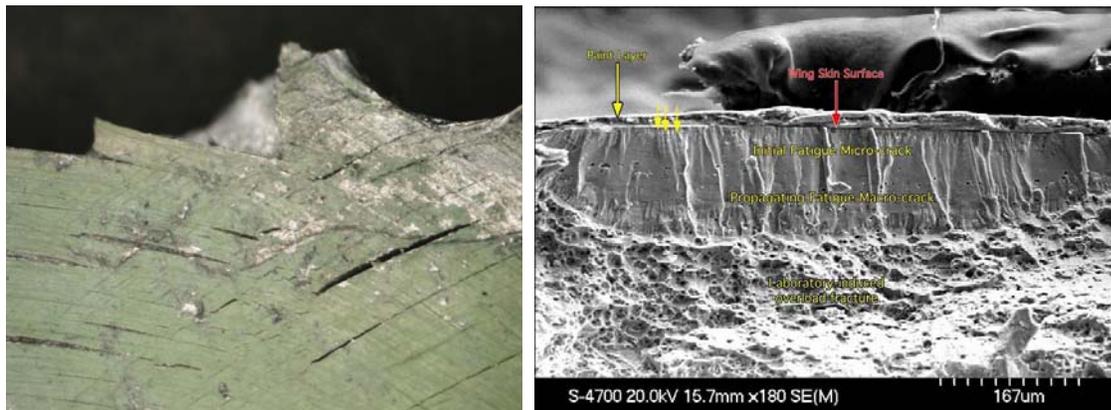
In a band that extends about 4 mm inside to 12 mm outside the centre line of the rivet row, hundreds of micro-cracks were found on the underside of the skin. Some of these were only 0.1 mm deep and 1 mm long, and could not be seen by the bare eye or with any of the usual NDT methods. Such cracks only become apparent during visual inspection with magnifying glass (x 10) or when the sheet is bent.

Figure 3. Example of micro-cracks in the finishing and SEM photo of crack surface

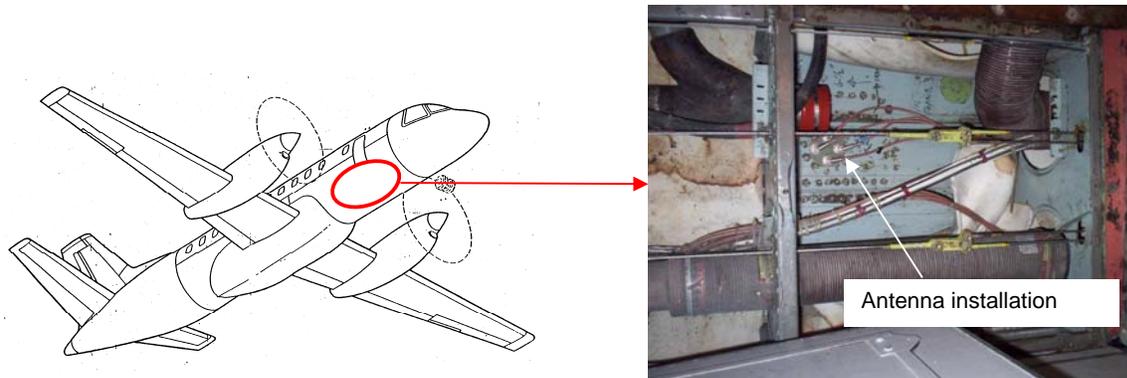
Consequently, figure 4 details the area of fuselage hull subjected to the cracking, in the bottom panel where the antenna provisions have been installed

Figure 4. Location of the area subjected to cracking

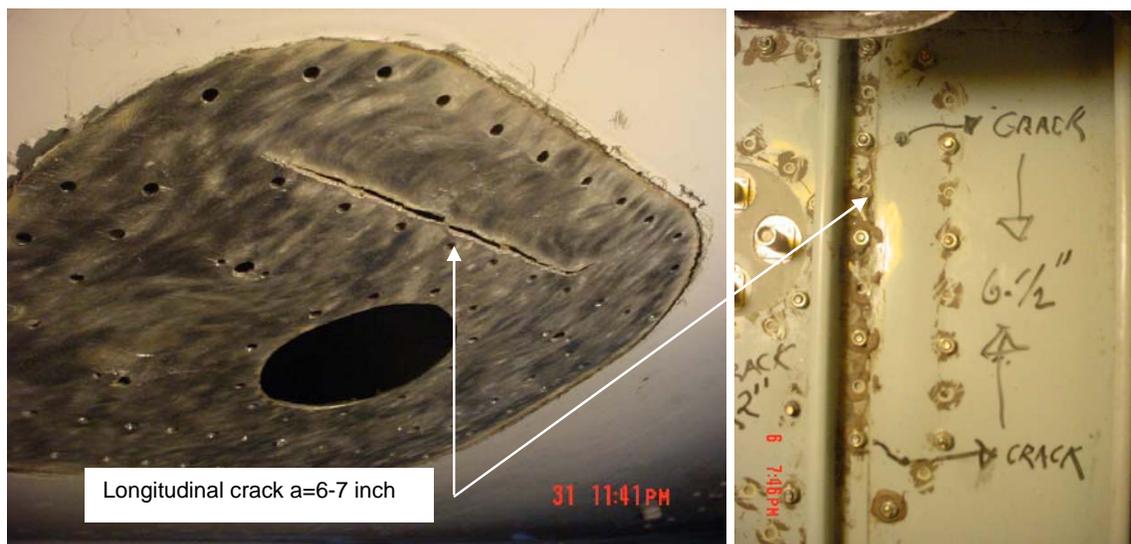
During a scheduled inspection severe longitudinal cracking was discovered in the bottom panel as outlined figure 5. Severe cracking in terms of multiple cracks and cracks measuring 6-7 inches was detected in the panels. In addition to this, environmental degradation such as corrosion was discovered in the area of the antenna installation. The skin panels and the structural provisions for the antenna were afflicted with severe corrosion.

Figure 5. Longitudinal cracking of the fuselage panel.

- Severe hardpoint (i.e large portion of load transfer) between antenna baseplate and fuselage skin
- Anchor nuts installed directly in the skin without any anchor nut plates
- Acceptance of improper edge distances
- Compromised surface protection on skin and modification items
- Improper structural reinforcement

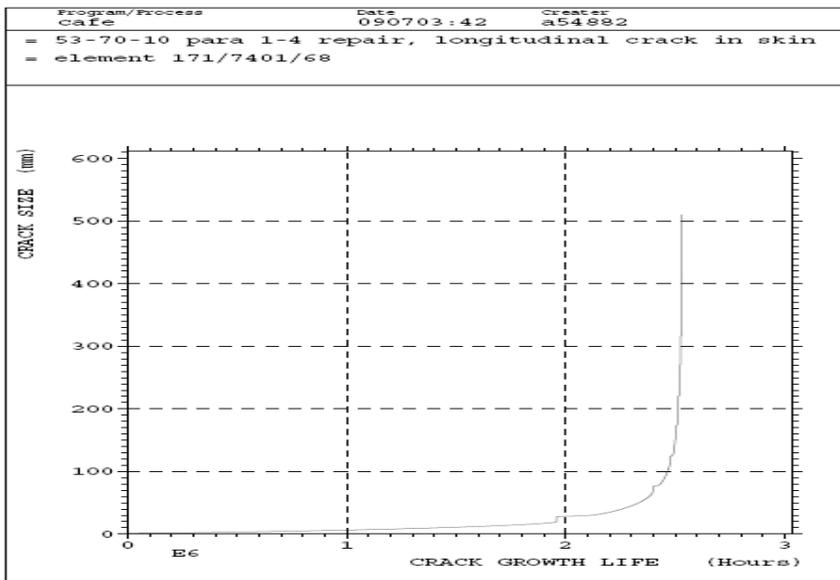
The complete crack growth curve is attached as figure 6.

Figure 6. Crack growth curve – longitudinal crack considering hard point/splices

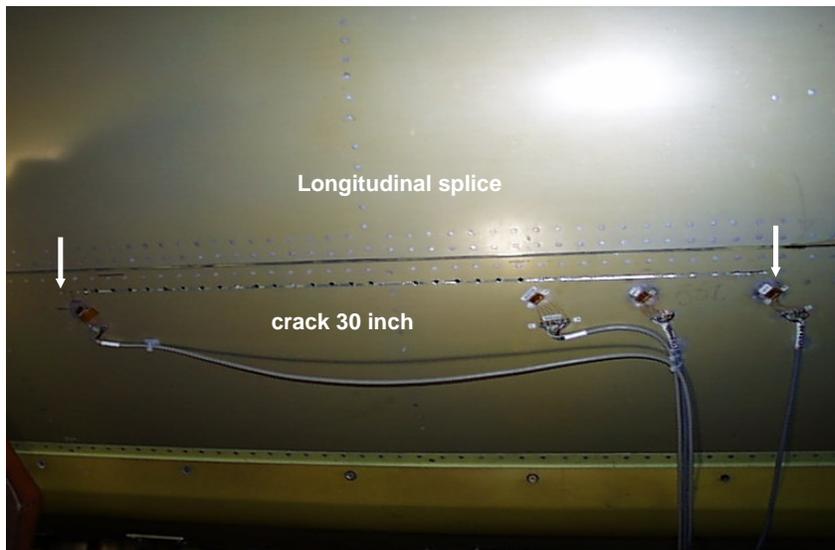
Primary structural elements such as circumferential /longitudinal fuselage splices, has subjected to full scale testing up to limit load level. Figure 7 depicts a typical and successful test of the residual strength capability considering artificial cracks.

Figure 7. Saab 340 Fuselage- Residual Strength test of longitudinal splice

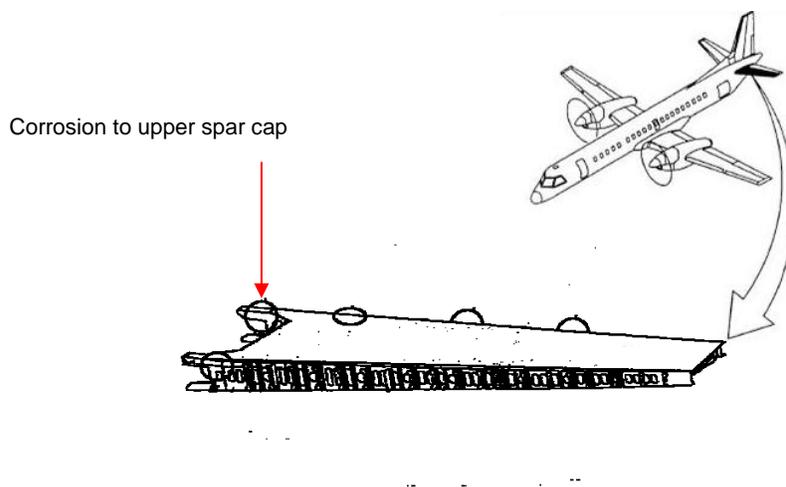
Corrosion to structural members may be regarded as crack initiation points and subsequent cracking may occur as a result of this defect. Therefore it is required inspect aircraft structure with respect to corrosion and other environmental degradation. At one occasion, it was experienced that the Saab 2000 aircraft was confined to have corrosion to the upper spar cap of the horizontal stabilizer as detailed figure 8.

Figure 8. Saab 2000 Horizontal Stabilizer-Location of corrosion to upper rear spar cap

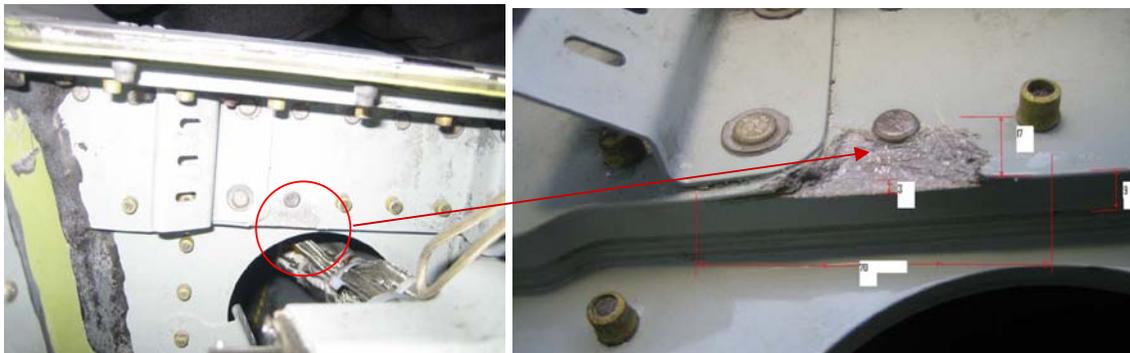
The corrosion is classified as severe exfoliation as shown in figure 9. The corrosion is caused by interference between the aluminium spar cap and electrical harness to the elevator control system. Galvanic corrosion to aluminium results in quick degradation of structural elements as shown.

Figure 9. Saab 2000 Horizontal Stabilizer-Location of corrosion to upper rear spar cap

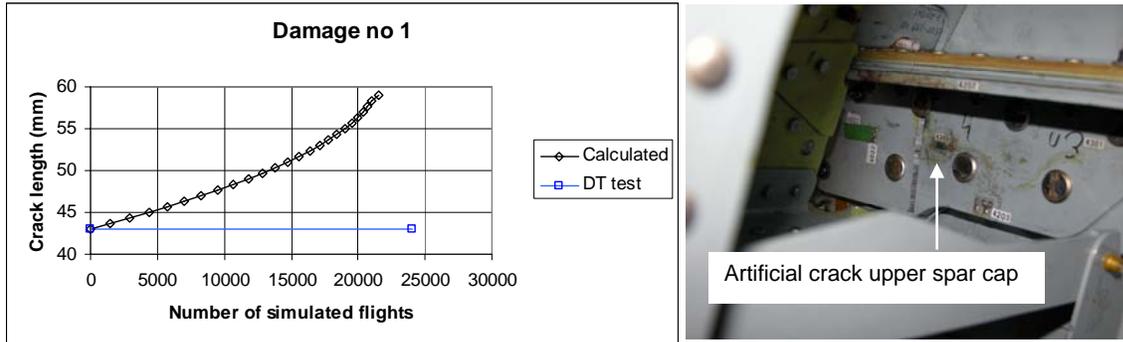
The results from analysis is given by figure 10 and 11, from the results it is concluded that the analysis is conservative compared to what was revealed during the test. Subsequently, the residual strength test with broken spar cap element sustained the criteria to withstand the most extreme limit load condition.

Figure 10. Saab 2000 Horizontal Stabilizer-Damage Tolerance analysis versus test result

The rear wing spar and the adjacent lower skin will be subjected to residual strength test where the major portion of the rear wing spar and the lower wing skin has been inflicted with saw cuts. This test is carried out in order to verify the wing structure can withstand all limit load condition considering a major damage to the primary structural elements. Figure 10 provides the prerequisites for the testing.

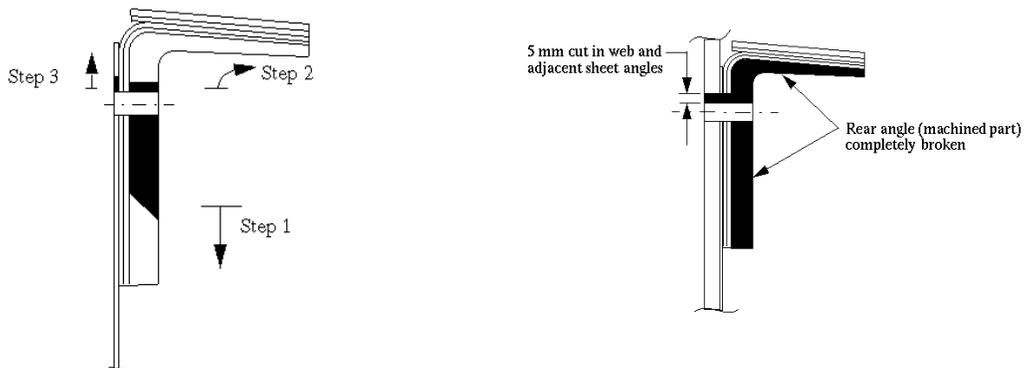
Tested In FSFT → Residual Strength Test OK 178%LL

Figure 11. Saab 2000 Horizontal Stabilizer-Damage Tolerance test

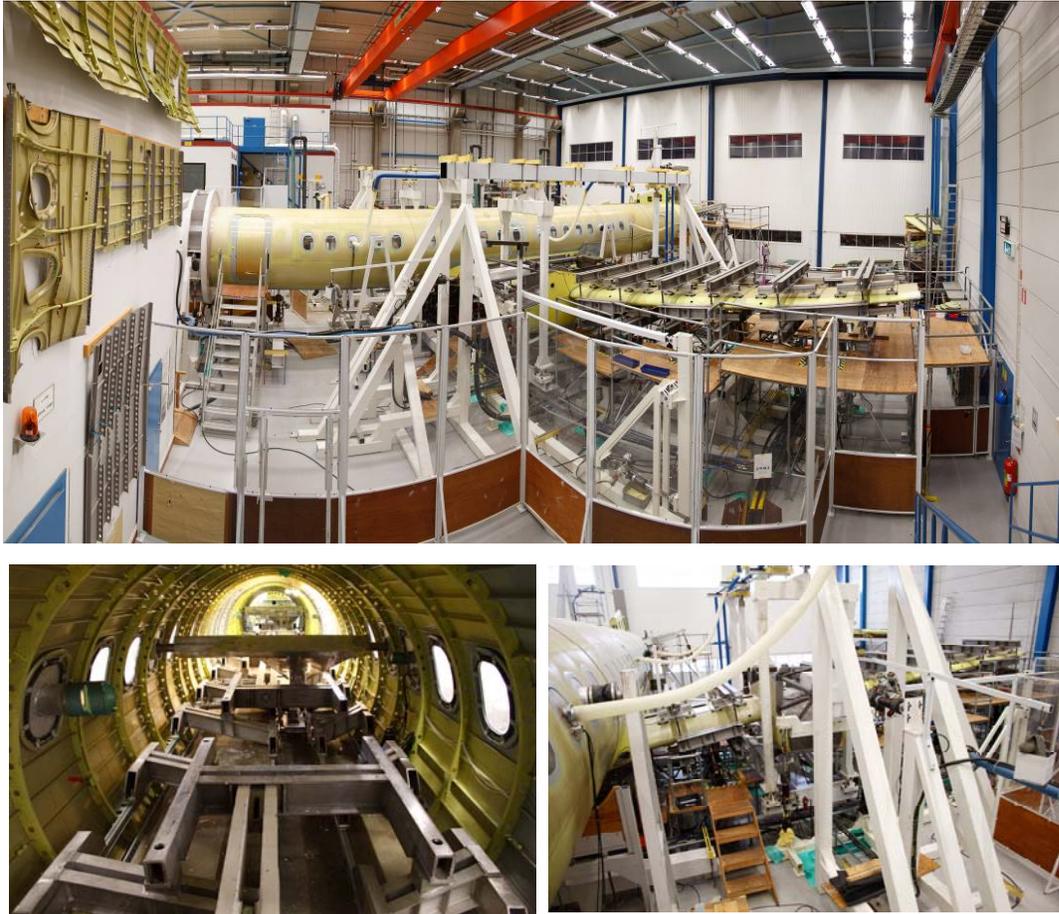
The subject test includes the centre and the rear part of the fuselage, the complete wing torque box and the rear part of the engine nacelles.

Figure 12. Saab 2000 Wing/Fuselage Fatigue and damage tolerance test

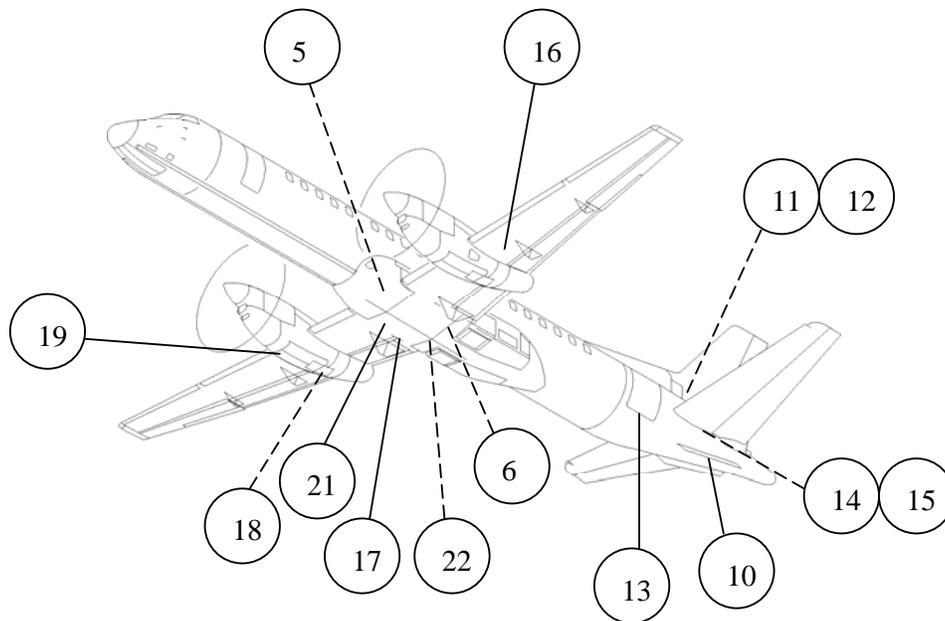
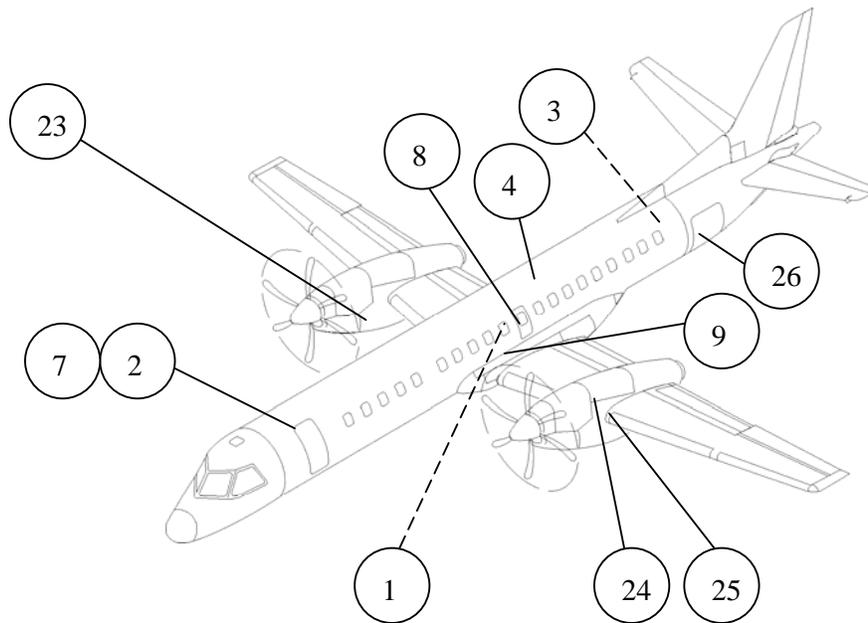
Figure 13a and b on the following pages summarizes the location the artificial cracks introduced on the Saab 2000 airframe. Figure 14 (damage 19) outlines an artificial crack in the forward lower spar cap including a similar damage to the outer wing skin. Figure 15 (damage 16) outlines an example of introduced artificial cracks on the lower wing panel, the internal located stringer is also simulated to be broken (through cutting of the entire stringer)

Figure 13a. Saab 2000 Overview of artificial cracks in test article

Figure 13b. Saab 2000 Overview of artificial cracks in test article

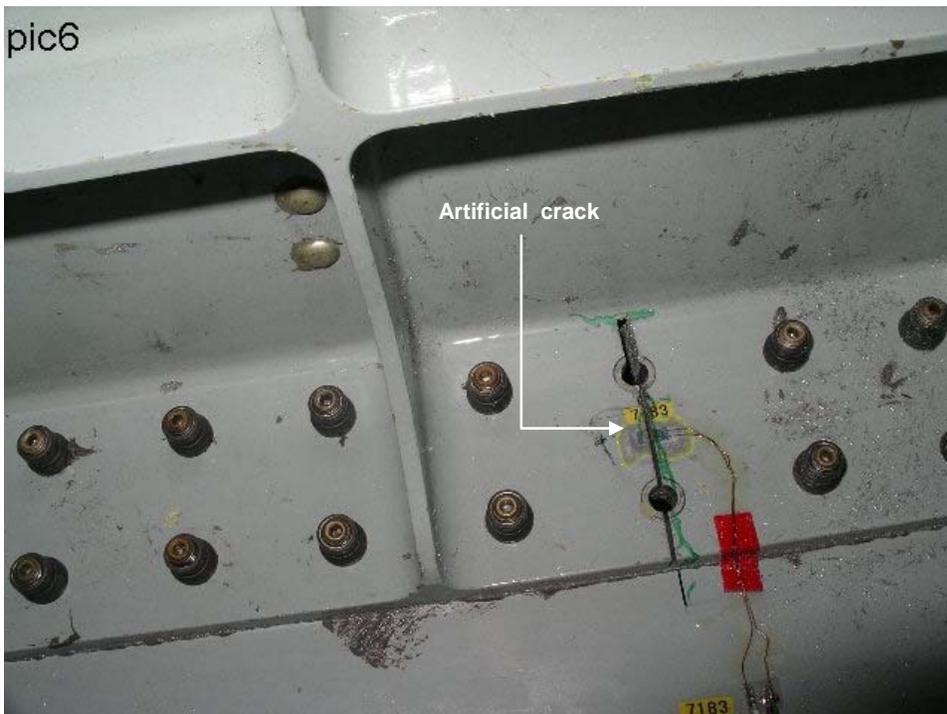
Figure 14. Saab 2000 Artificial crack in lower forward wing spar cap and in skin

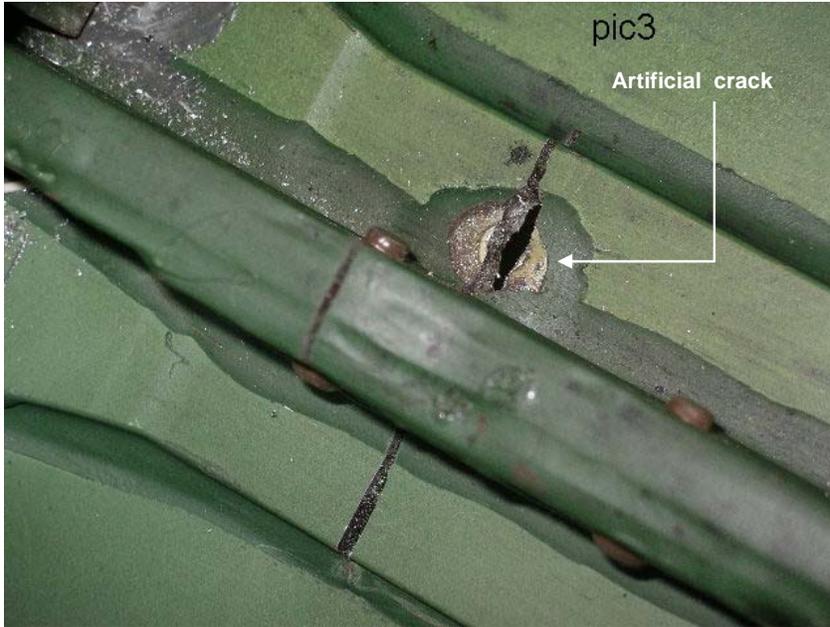
Figure 15. Saab 2000 Artificial crack in lower wing skin with an broken stringer

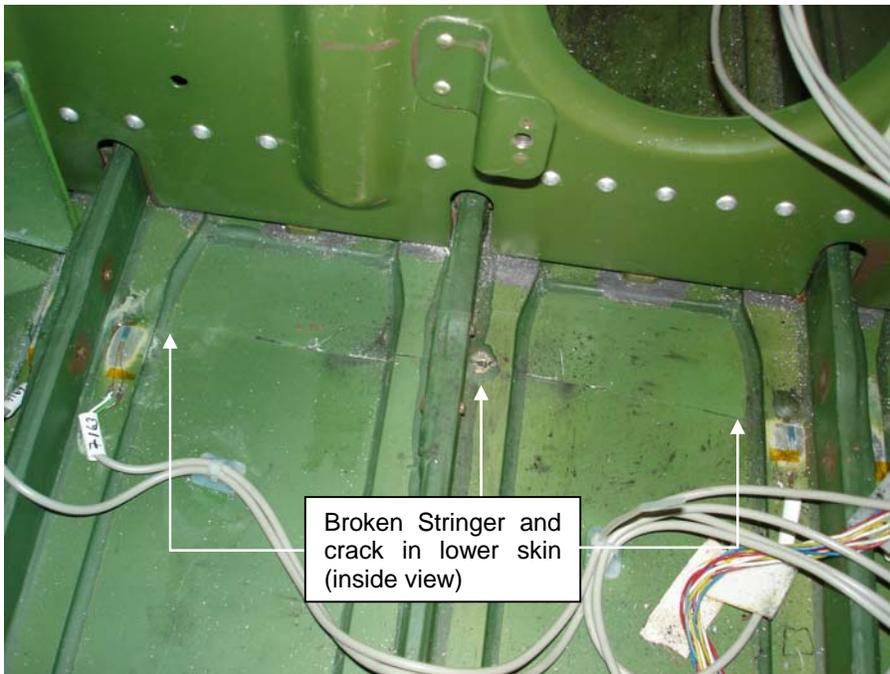
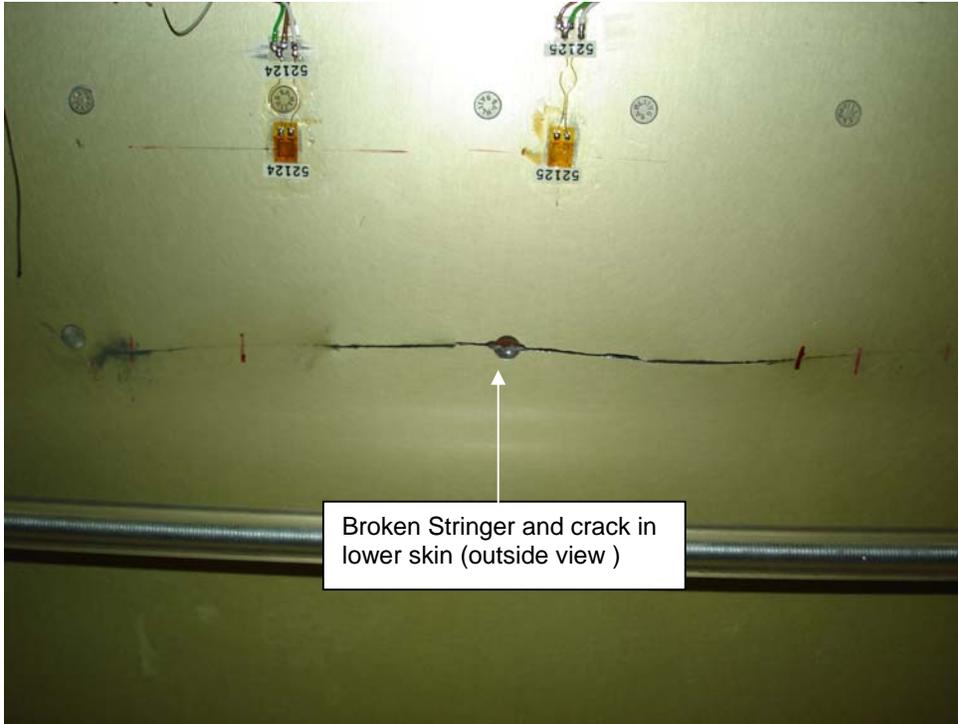
However, the artificial crack in the lower wing skin in figure 16 and 17 (damage 16) has been propagated towards the adjacent stringers and crack arrest has been noted at the bonded stringers. The initial crack was 55 mm including a broken stringer, the crack has been propagated 280 mm under 48000 flights of testing. The two-bay crack philosophy has thereby been verified for a predefined inspection interval. By comparison the results from the analysis and the test (see figure 18) it is concluded for this specific artificial damage that the crack growth rate in the theoretical analysis is slightly slower than the observed characteristics from the test article.

Figure 16. Saab 2000 Artificial crack in lower wing skin and stringer -inside view

Figure 17. Saab 2000 Artificial crack in lower wing skin and stringer -outside view

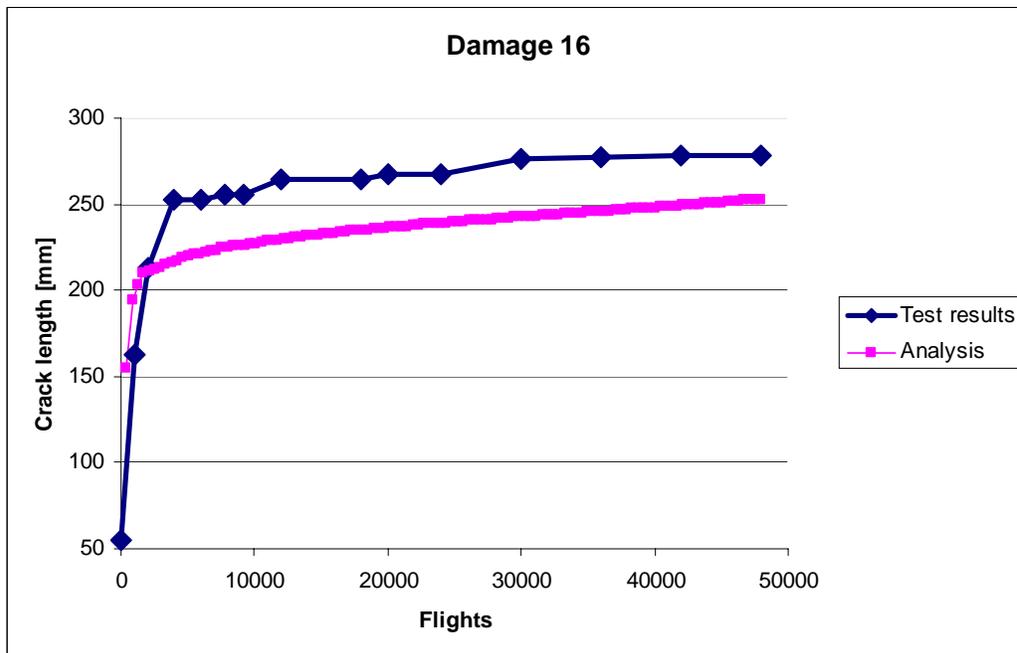
Figure 18. Saab 2000 Artificial crack in lower wing skin and stringer comparison of results

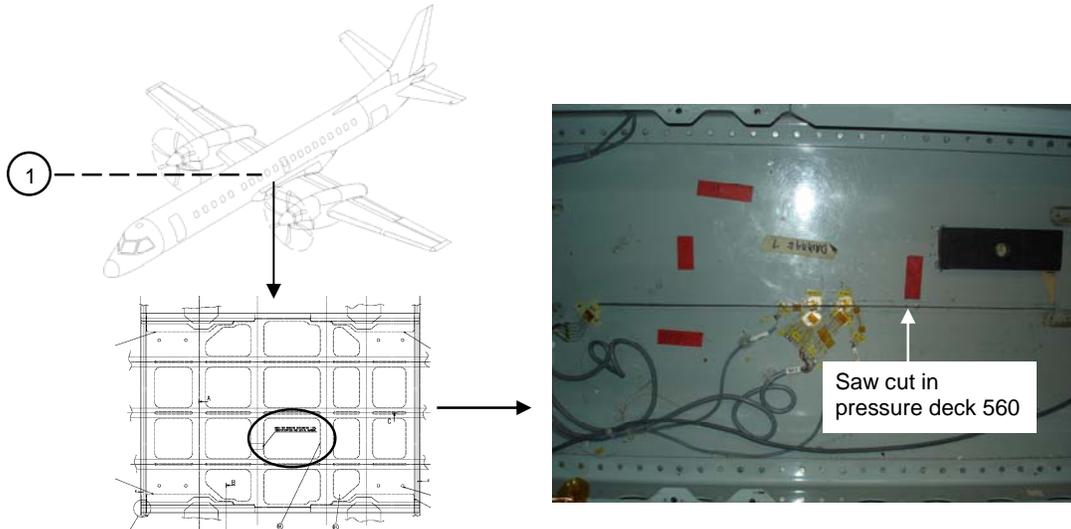
The following figure, figure 19 details the artificial crack for the residual test of the mid fuselage pressure deck, the saw cut is approximately 560 mm.

Figure 19. Saab 2000 Artificial crack (saw cut) for testing the residual strength capability in the mid pressure deck

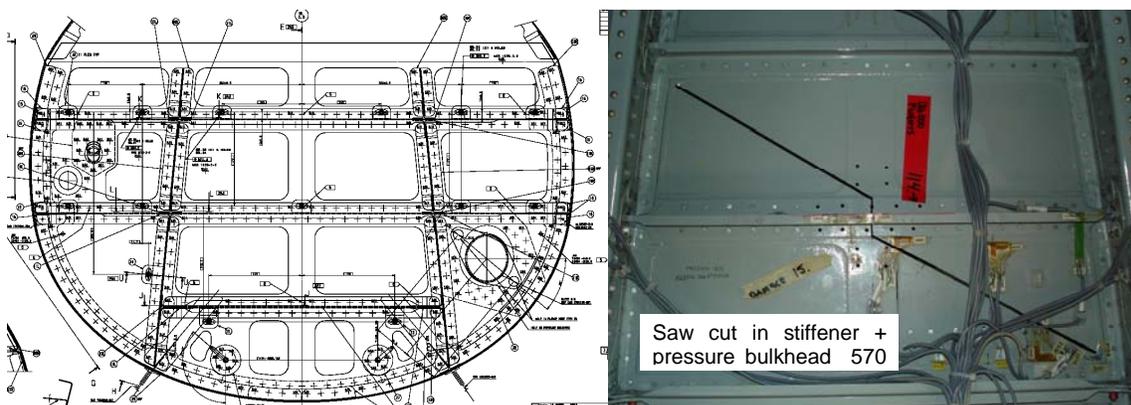
The aft pressure bulkhead will also be subjected to residual strength testing with an associated artificial crack as shown in figure 20. The stiffener including the bulkhead has been provided with artificial of 570 mm.

Figure 20. Saab 2000 Artificial crack (saw cut) for testing the residual strength capability in the aft pressure bulkhead

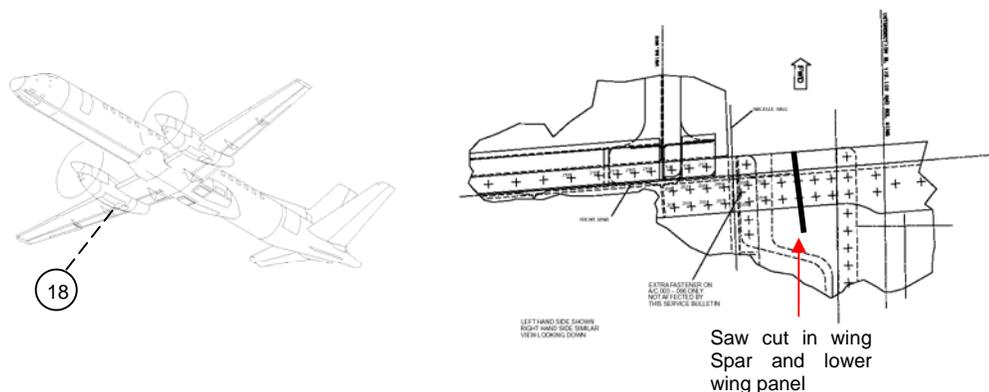
Figure 21. Saab 2000 Artificial crack (saw cut) for testing the residual strength capability of wing spar and skin structure

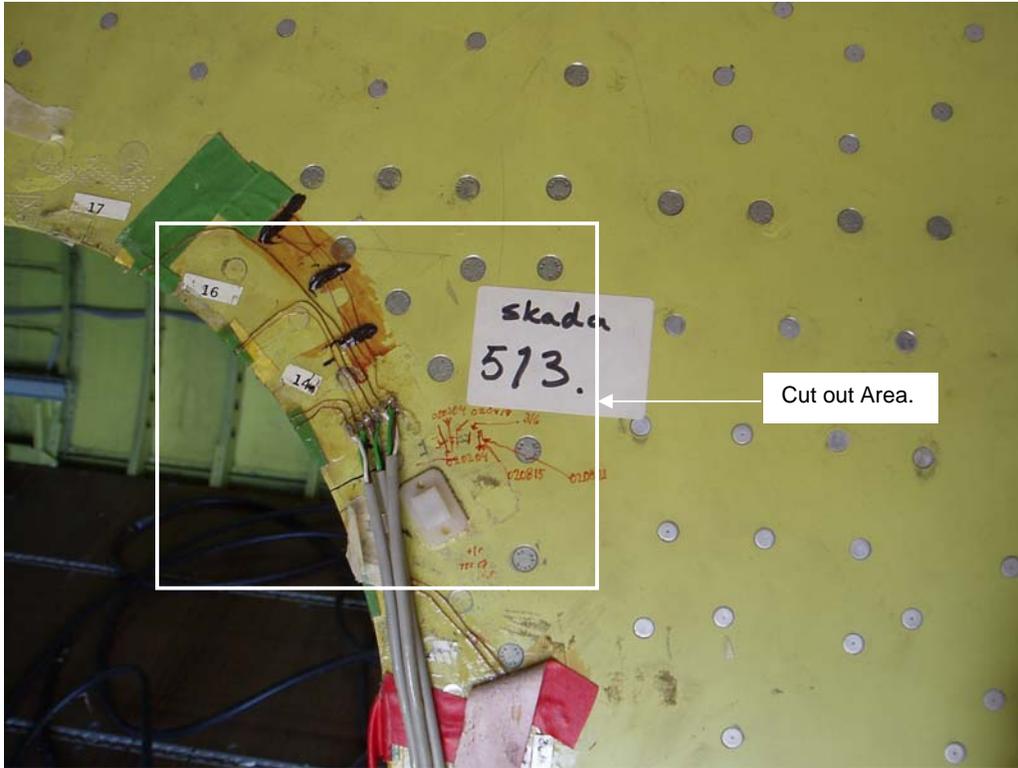
Figure 22 details the corner and a dedicated area for the tear down inspection and the following figure (figure 23a, b and c) shows the dismantled parts with some extended cracking in the embedded layers. However, they were detected on the airframe using X-ray equipment in which part was difficult to conclude. Part 1 and Part 2 were revealed to have some extended cracking due fatigue loading.

Figure 22. Cargo door cut out in fuselage skin with area subjected to tear down inspection

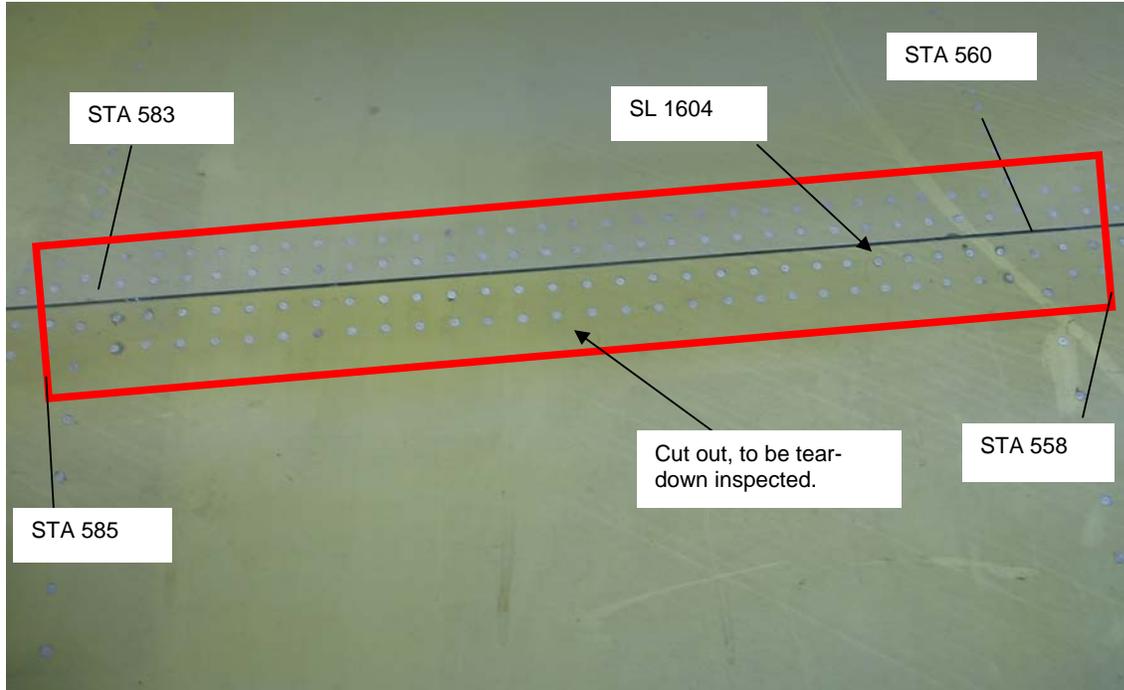
Figure 24 gives a typical longitudinal splice part subjected to tear down inspection. At some local and few places there were crack indications and subsequent measuring reported surface crack lengths between 0.1 mm to 2 mm. The residual strength test carried out in final phase was successfully and the small indications do not compromise the overall structural integrity of the splices.

Figure 24. Longitudinal Splicet between top and side panel

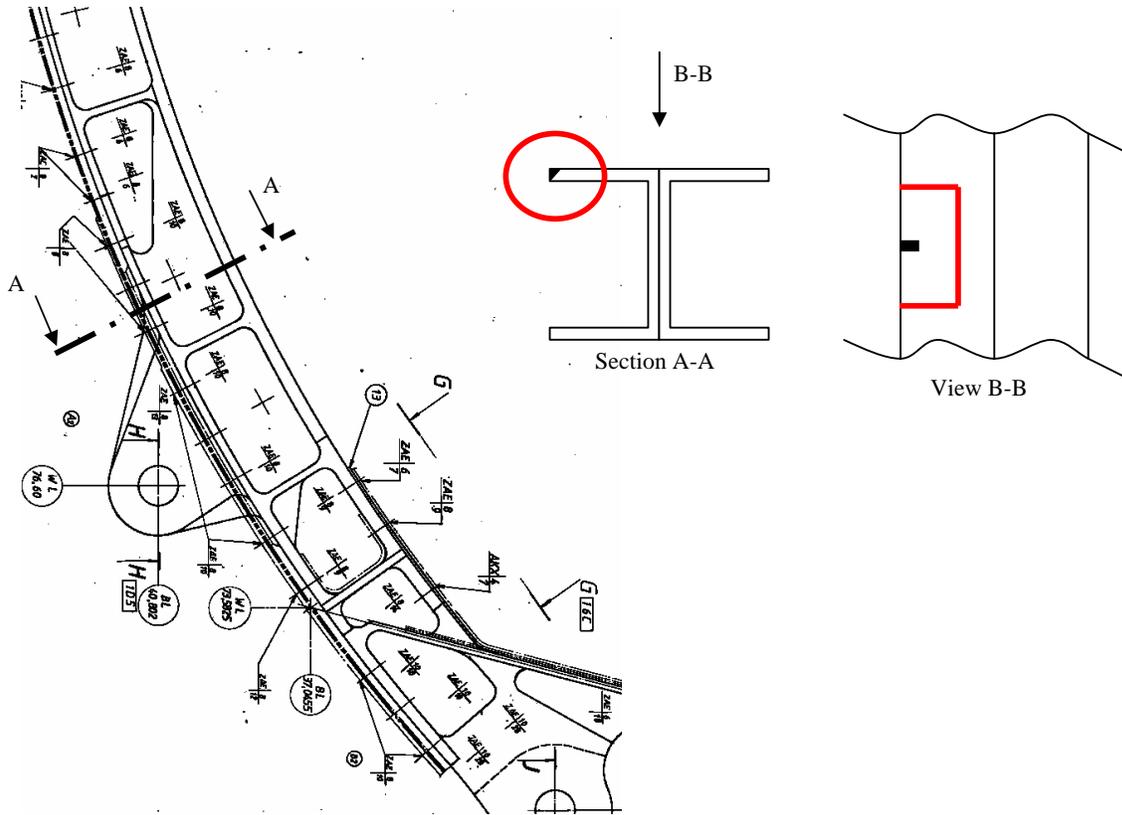
Figure 25. Wing attachment frame

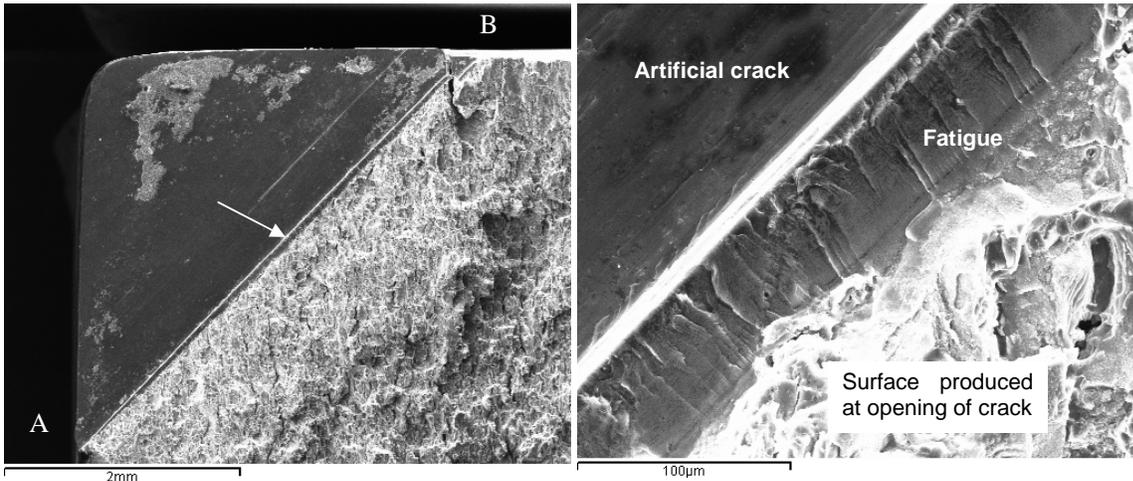
The fatigue zone was deepest, approx. 0.05-0.06 mm, in the middle between the ends of the artificial crack. Towards the ends of the artificial crack the fatigue zone faded out to almost no depth.

Figure 26. Fracture surface after opening of artificial crack. Dark marked zone is fatigue.

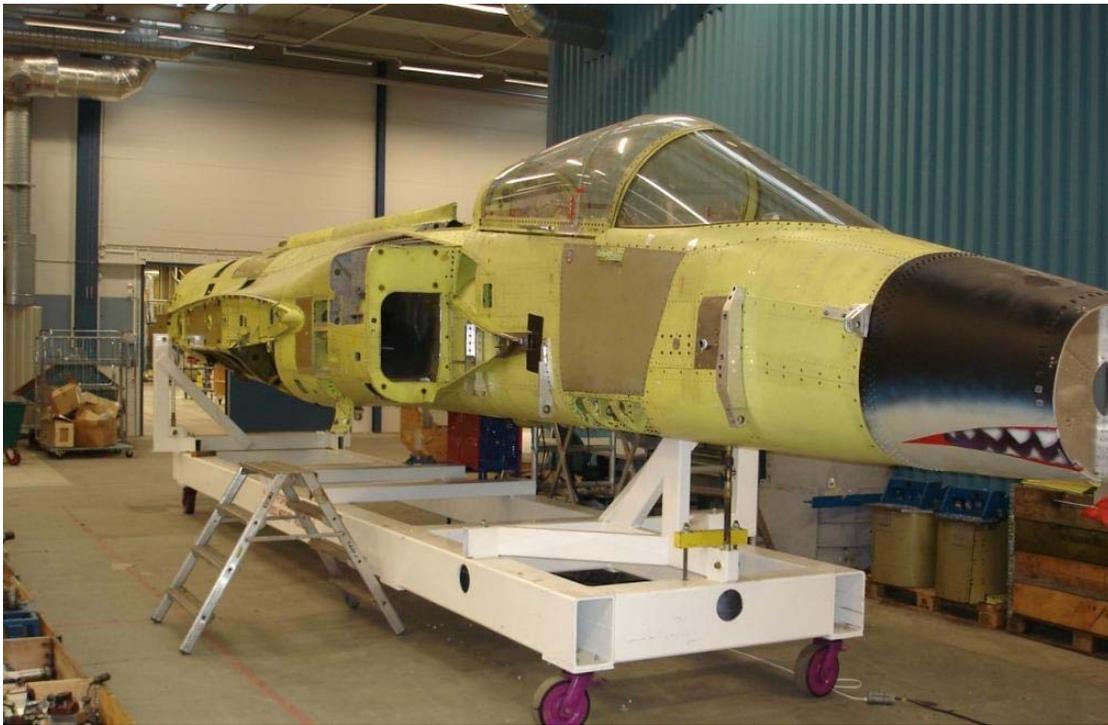
In figure 27 is the fuselage shown after removal of certain main structure such as wings and fin. The fuselage is inspected for fatigue cracks in this position before specific parts are disassembled for detail laboratory inspections.

Figure 27. The full-scale fatigue test article(A-version) after partly disassembly.

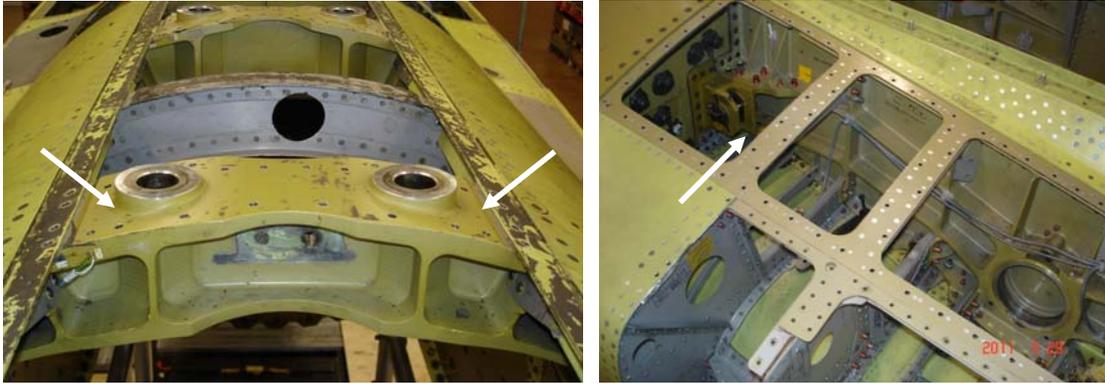
- In the fin attachment frames in an area close to where the attachment bolts are mounted.
- In the fitting attaching the servo actuator for the canard wing to the fuselage

Figure 28. Cracks in fin attachment frame Figure 29. Crack in the actuator fitting for the canard wing

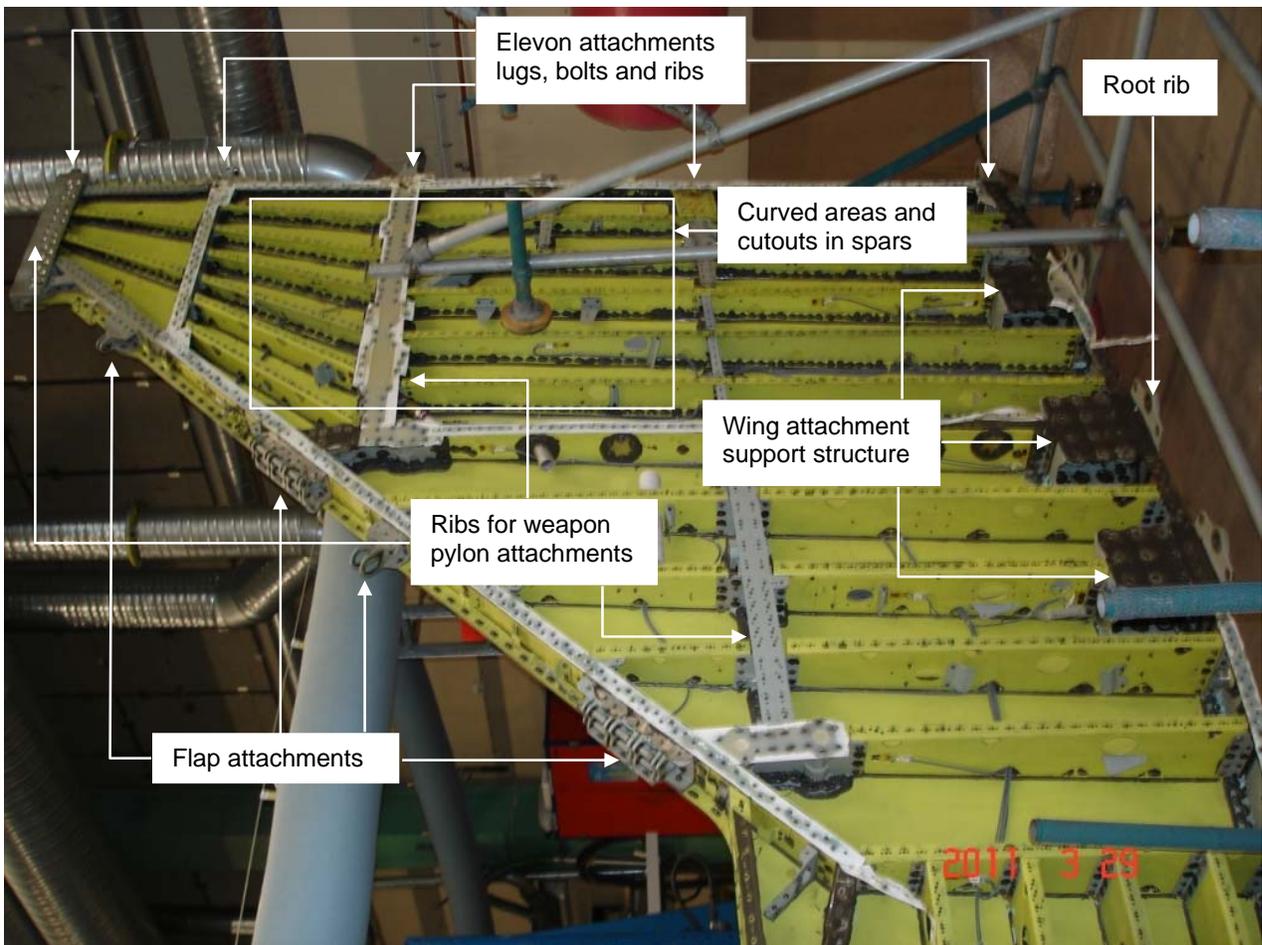
The tear down inspection will continue during 2011. The disassembled parts of the fuselage will undergo detail laboratory inspections. The wing with carbon composite skin are disassembled before a general ultra sonic inspection is done with additional inspections of local areas depending on discovered defects. After disassembly, inspections of inner structure will continue. In figure 30 is as an example the inner structure of the wing and some selected parts that will be further disambled and examined shown. Already disassembled are the wing attachment fittings and bolts which presently are under detailed examination. The fin with carbon composite skin is ultra sonic inspected completely and additionally inspected in local areas where defects are indicated.

Figure 30. Examples of parts in the wing to be inspected and examined in detail.

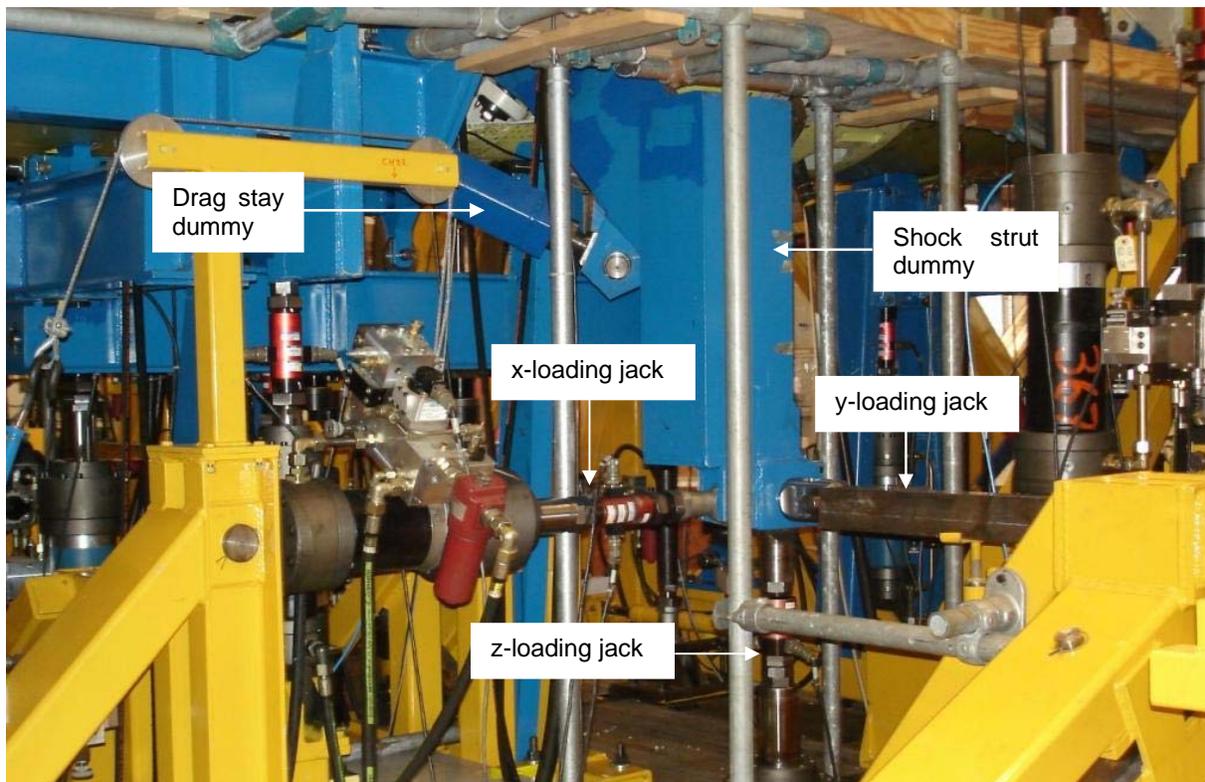
Figure 31. Photo showing hydraulic jacks and load introducing devices for the main landing gear.

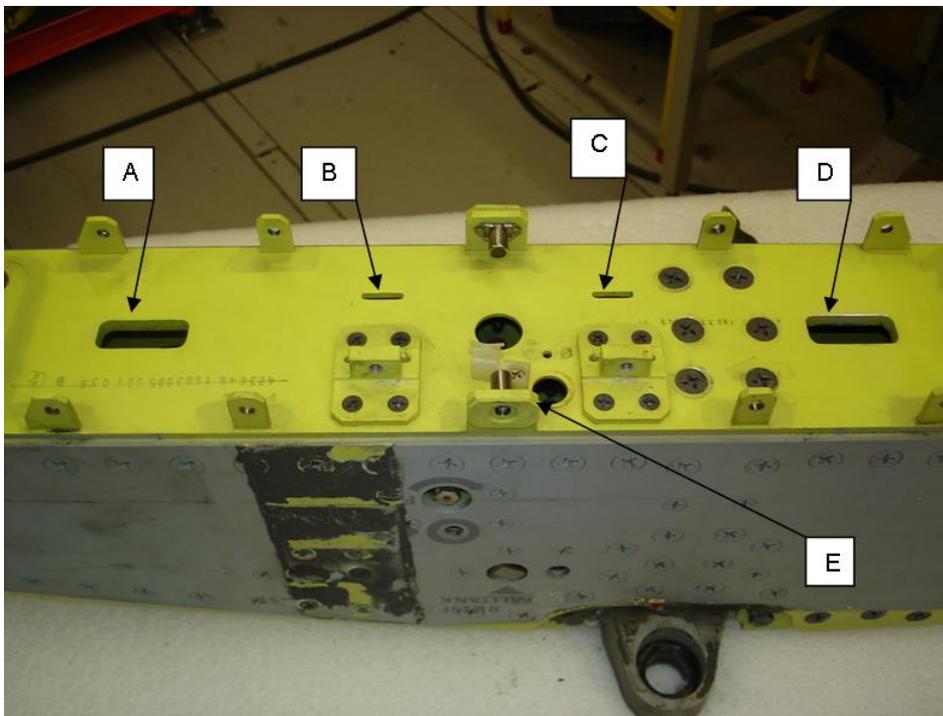
Figure 42. Test specimen #1 - Bottom spar with locations A-D where fatigue cracks have been found.

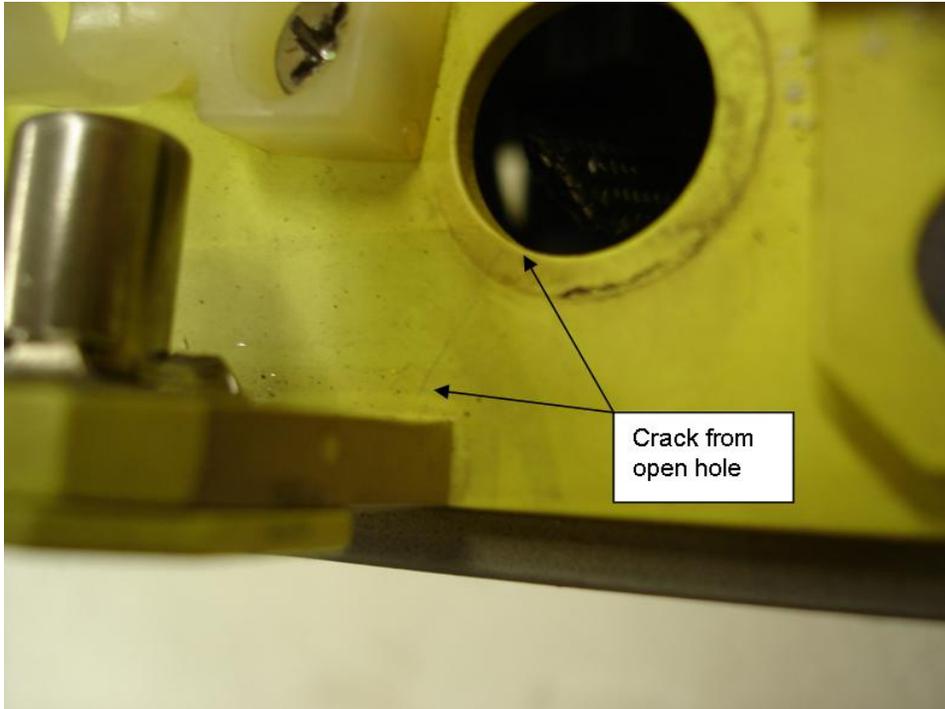
Figure 43. Test specimen #1 - Fatigue crack at hole E.

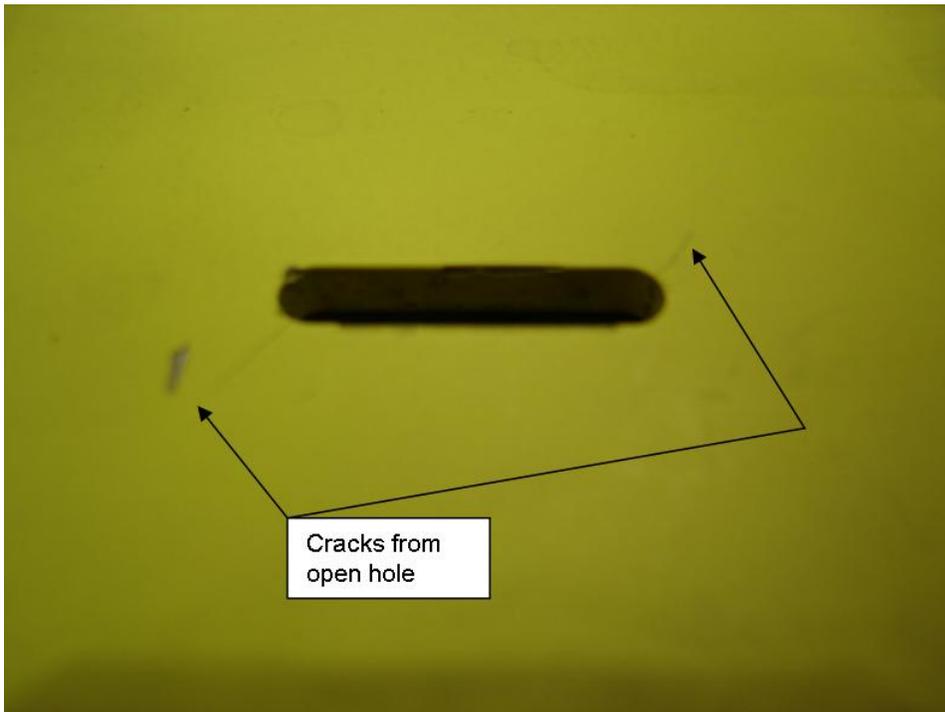
Figure 44. Test specimen #1 - Fatigue crack at hole B.
