A Review of Aeronautical Fatigue Investigations in Sweden During the Period May 2009 to March 2011

Edited by HANS ANSELL
Saab AB
Sweden

ICAF Doc. No. 2426
Saab Doc. No. TDL-2011-0091

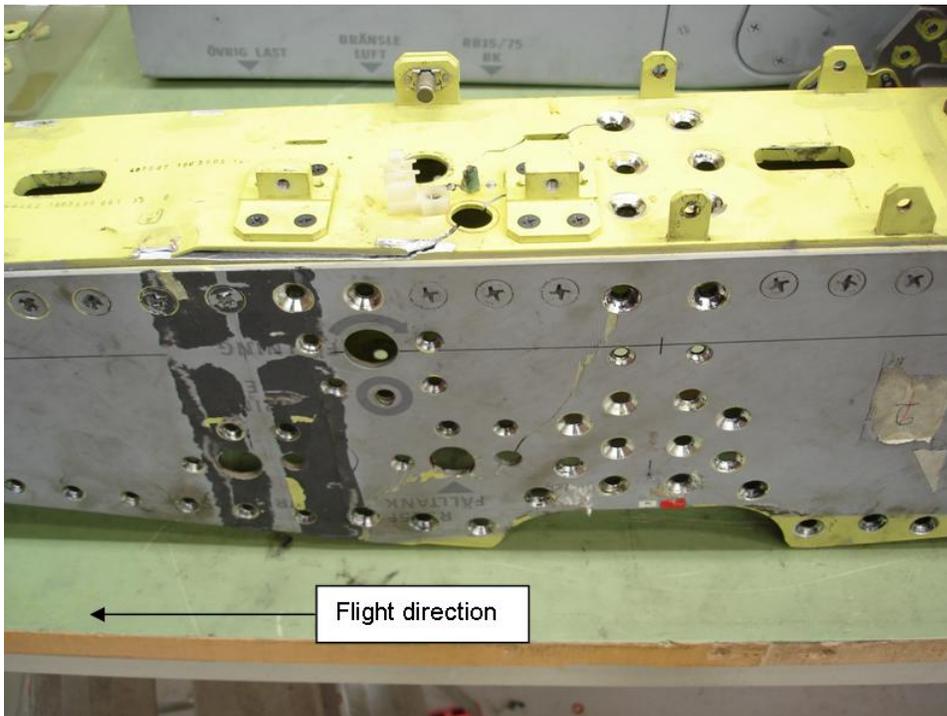
Figure 45. Test specimen #2 – Extensive cracks in bottom spar and sideplate.

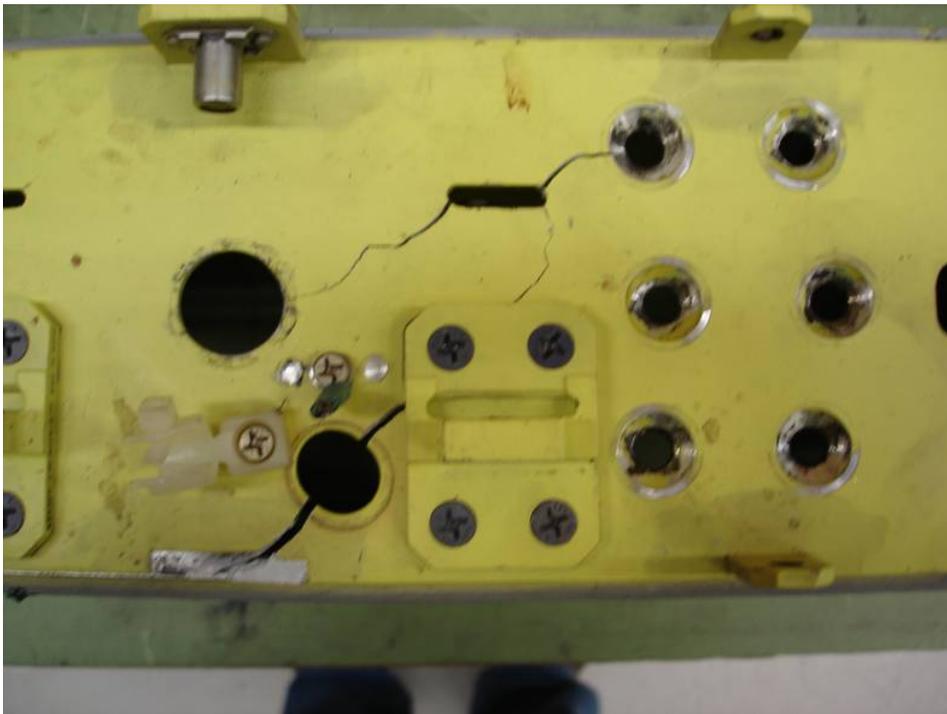
Figure 46. Test specimen #2 – Extensive cracks in bottom spar.

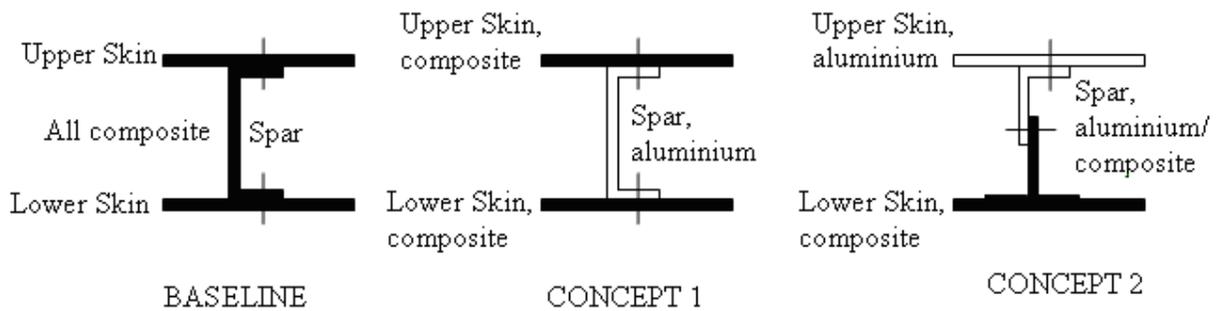
Three different concepts are studied and their cross sections showing a spar and skins are viewed in figure 48.

Figure 48. Studied box structure concepts

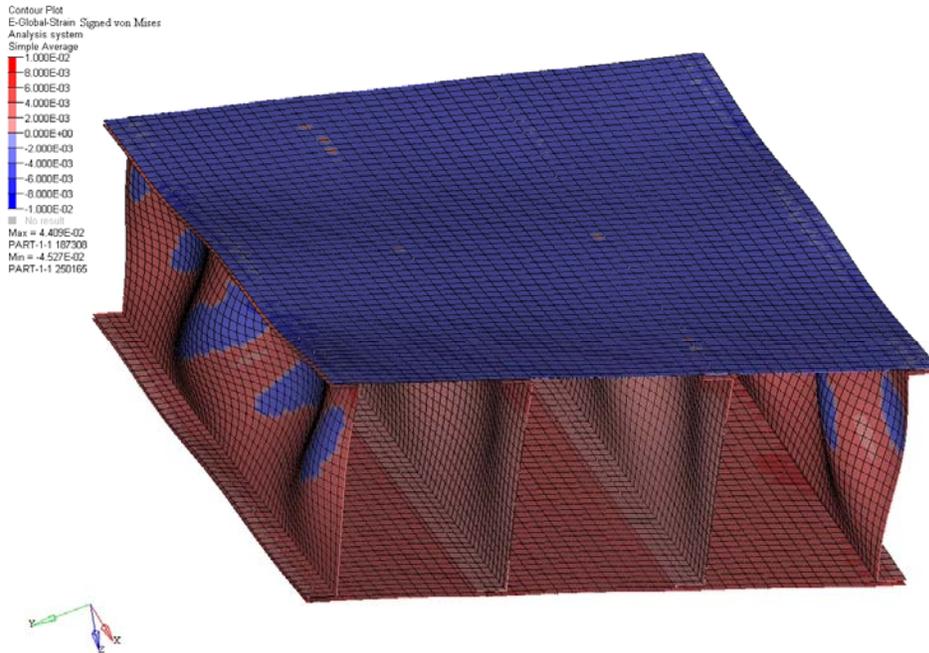
Figure 49. results from post buckling analysis of concept #1.

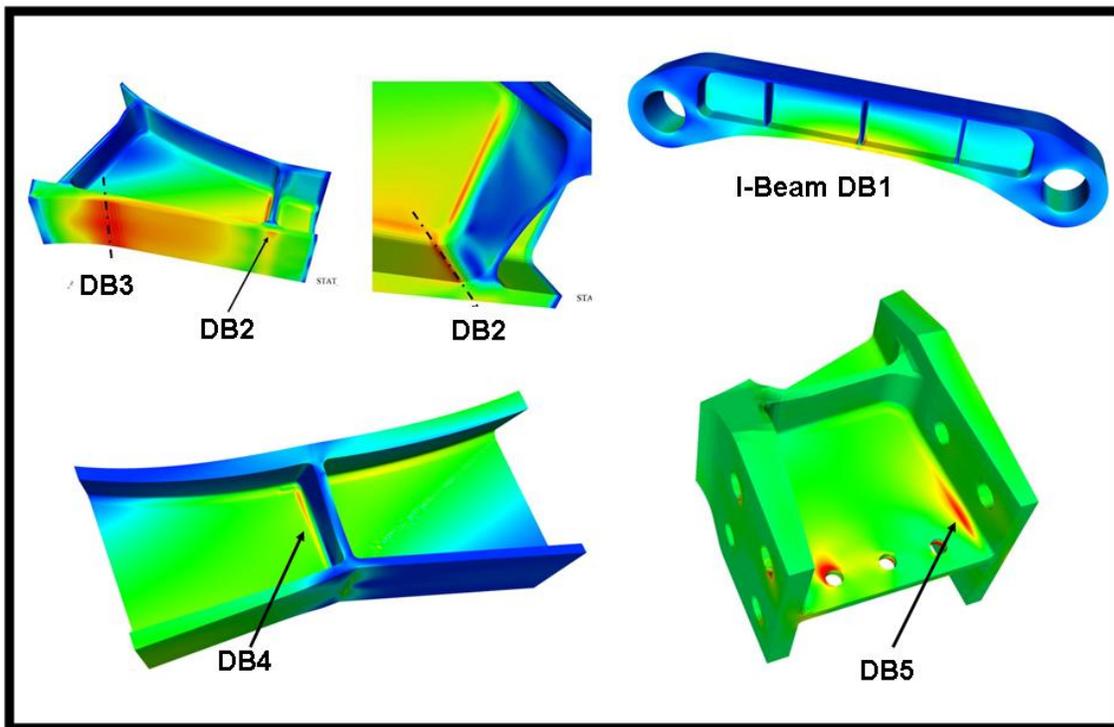
Figure 50 Five structural parts singled out for a demonstration of a new computational mechanics strategy for fast fracture-mechanics based fatigue analysis of complex components

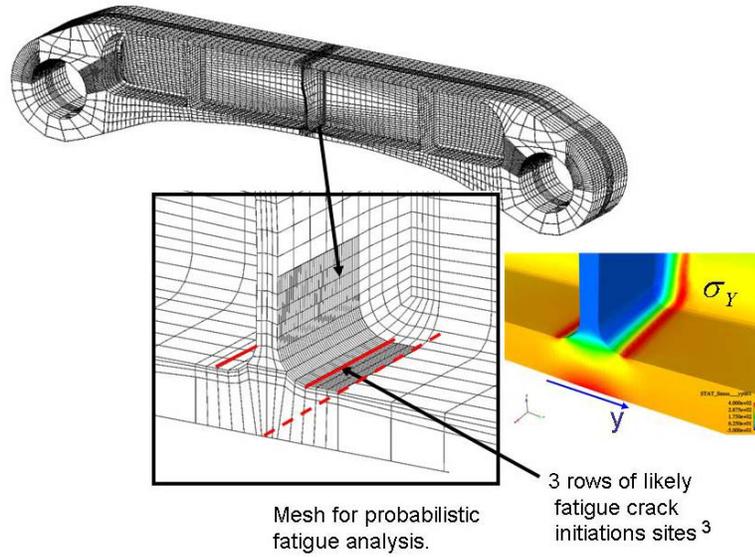
Figure 51: Three crack rows in I-beam. Data for the three crack rows are stored in a data base labeled DB1.

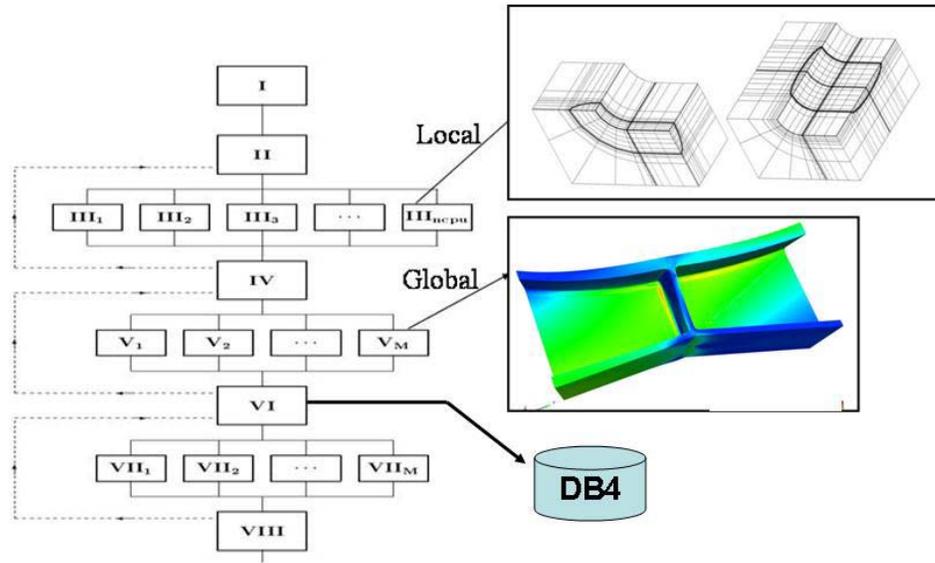
Figure 53. Schematic picture of computer implementation of splitting scheme, and an example of a large level V structure are shown.

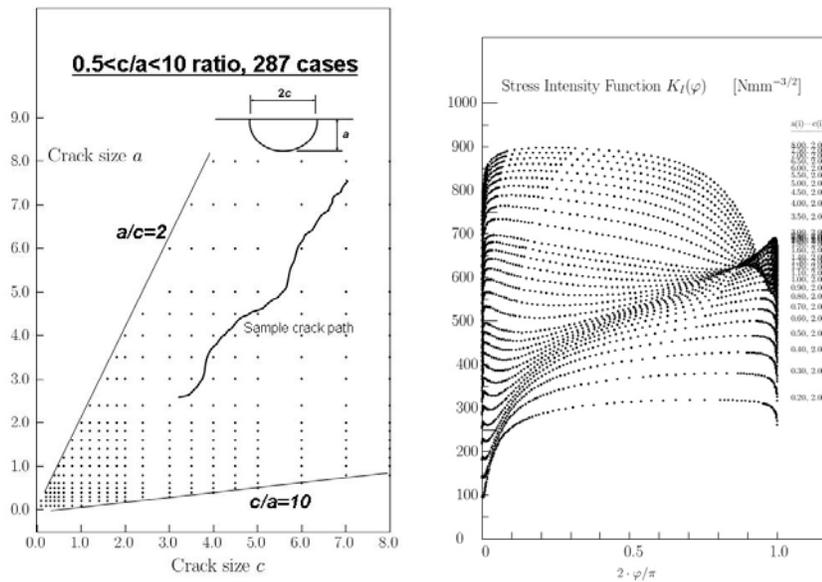
Figure 54: Graphical presentation of all (a, c) (unless global geometry prevents cracks of actual size) values contained in the five databases for all locations x .

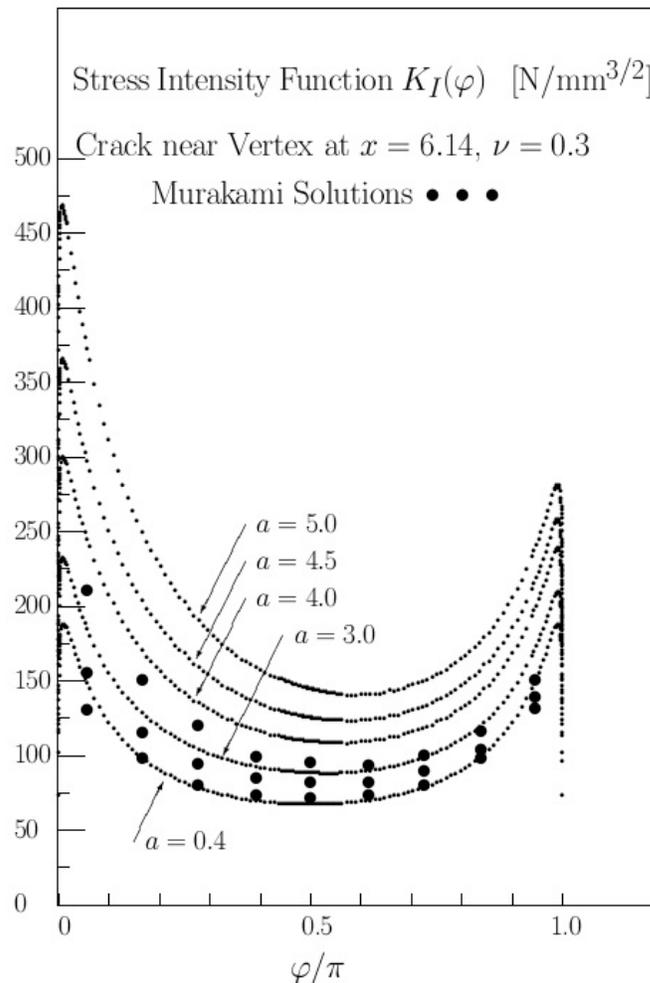
Figure 62 Stress intensity functions for cracks close to a free edge

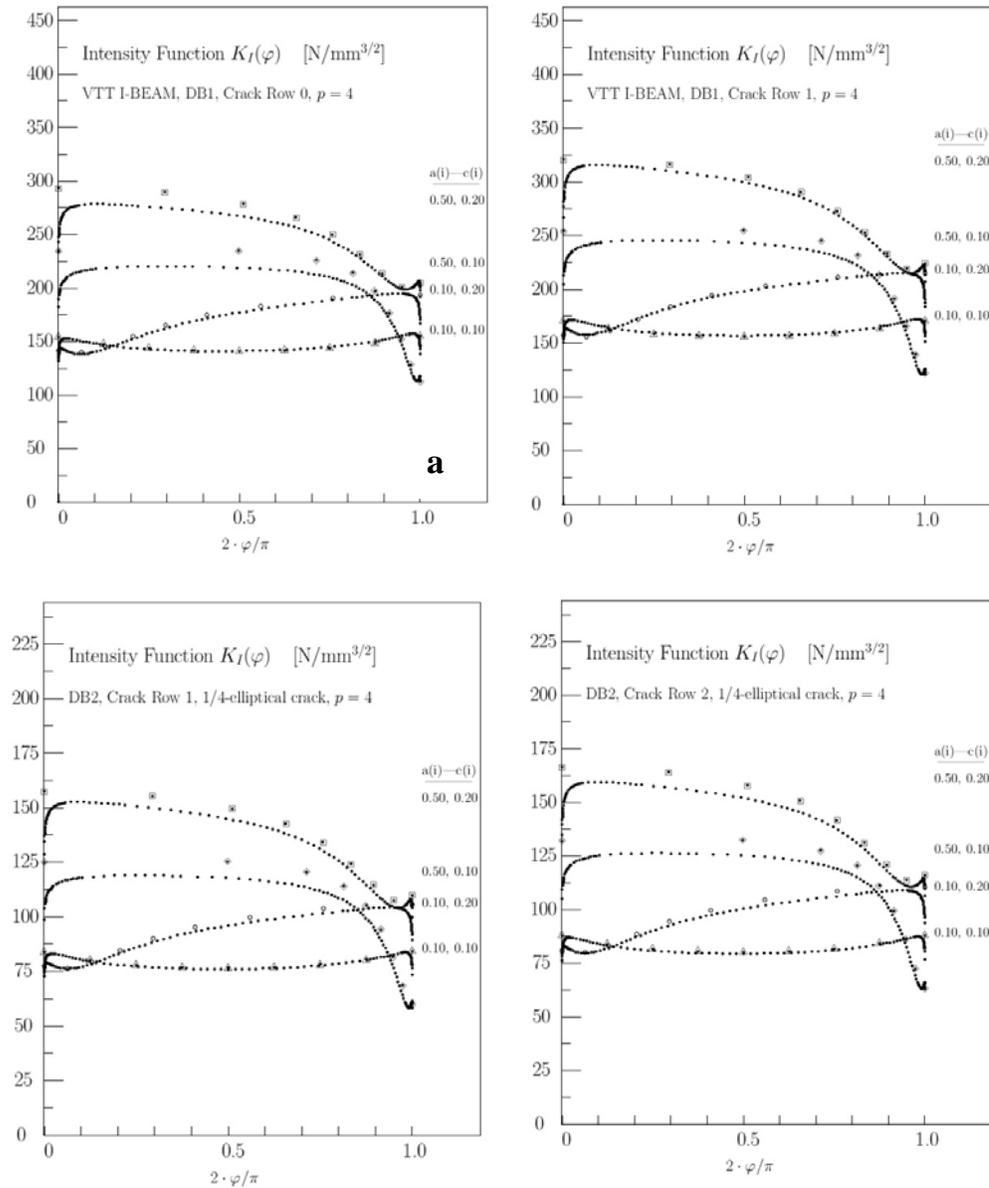
Figure 63 **a** Comparison of calculated $K_I(\varphi)$ with data in [8] for $1/4$ -crack in crack row 0 (Figure 67) in database DB1, **b** Comparison of calculated $K_I(\varphi)$ with data in [8] for $1/4$ -crack in crack row 1 (Figure 67) in database DB1, **c** Comparison of calculated $K_I(\varphi)$ with data in [8] for $1/4$ -crack in crack row 1 (the single corner crack) in database DB2, **d** Comparison of calculated $K_I(\varphi)$ with data in [8] for $1/4$ -crack in crack row 2 (containing 6 cracks) in database DB2

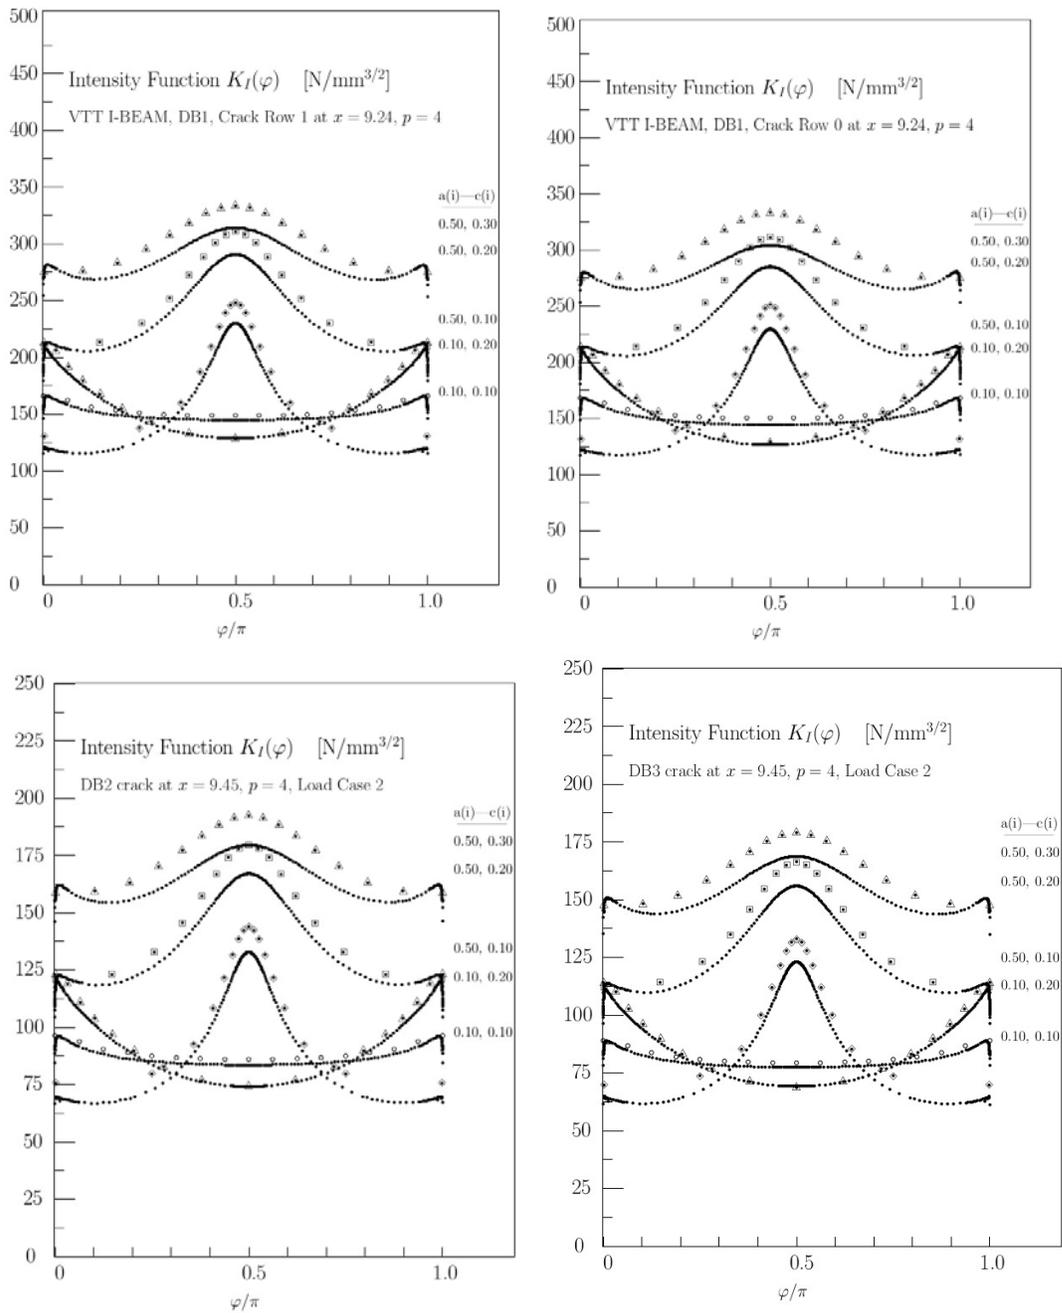
Figure 64 **a** Comparison of calculated $K_I(\varphi)$ with data in [8] for 1/2-crack in row 1 (Figure 67) in data.base DB1. **b** Comparison of calculated $K_I(\varphi)$ with data in [8] for 1/2-crack in row 0 (Figure 67) in database DB1. **c** Comparison of calculated $K_I(\varphi)$ with data in [8] for 1/2-crack in database DB2. **d** Comparison of calculated $K_I(\varphi)$ with data in [8] for 1/2-crack in database DB3

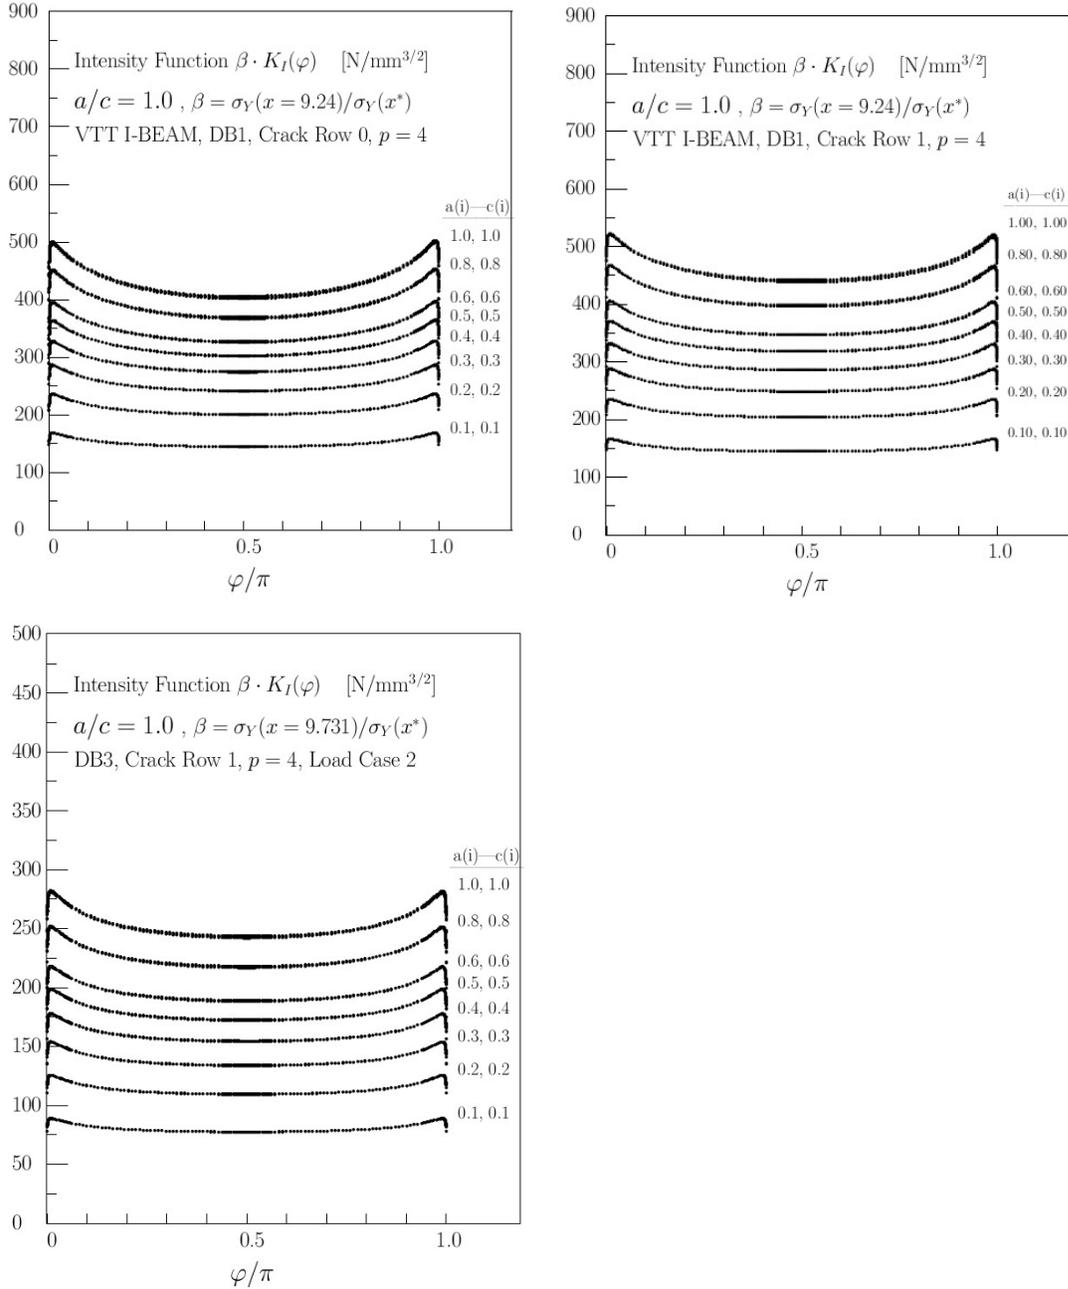
Figure 65 **a** Calculated $K_I(\varphi)$ -distributions for small cracks in row 1 scaled with factor $\sigma_Y(x = 9.24, z = 0)/\sigma_Y(x^*, z = 0)$ for $a/c = 1.0$ and for all semi-elliptical cracks in crack row 1 having $c \leq 1.0$ mm. **b** Calculated $K_I(\varphi)$ -distributions scaled with factor $\sigma_Y(x = 9.24)/\sigma_Y(x^*)$ for $a/c = 1.0$ and for all semi-elliptical cracks in crack row 0 for $c \leq 1.0$ mm. **c** Calculated $K_I(\varphi)$ -distributions scaled with factor $\sigma_Y(x = 9.731)/\sigma_Y(x^*)$ for $a/c = 1.0$ and for all semi-elliptical cracks in crack row 1 for $c \leq 1.0$ mm. Totally 40 graphs are shown in each of the three figures.

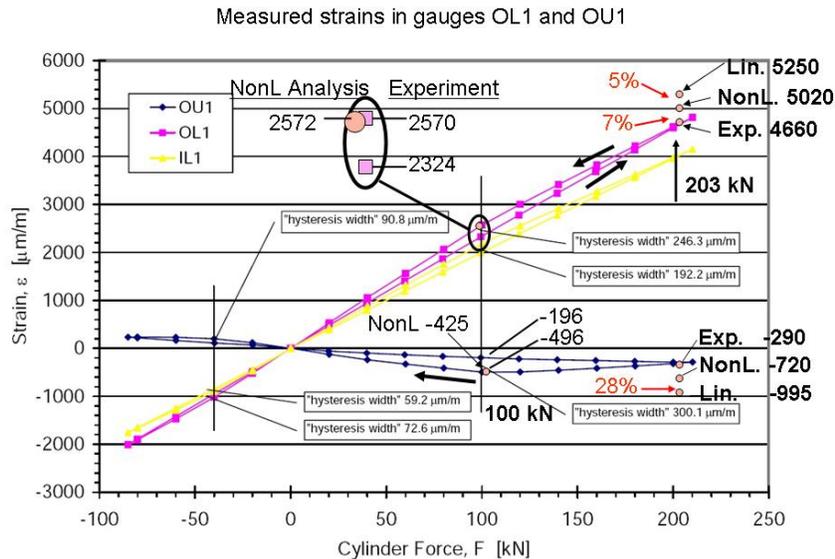
Figure 66: Comparison of strain results to the finite element result, see [4] and references therein

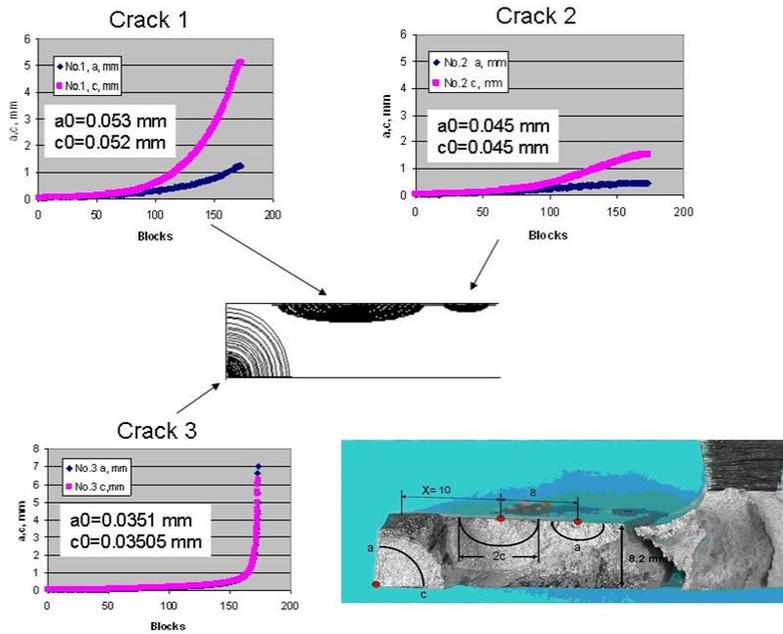
Figure 68: MSD fatigue crack growth prediction according to the present model.

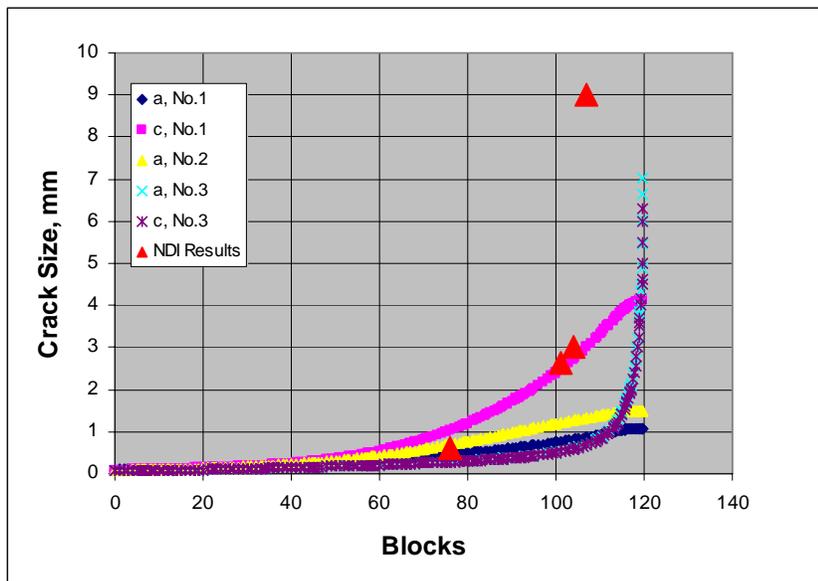
Figure 69: Predicted fatigue crack growth with increased initial crack sizes.

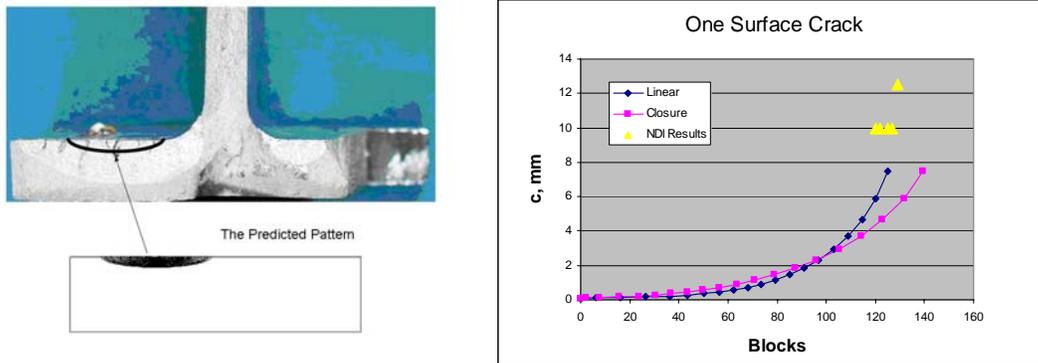
Figure 70: comparison MSD pattern and crack growth results of Test 2 (see [4] and references therein)

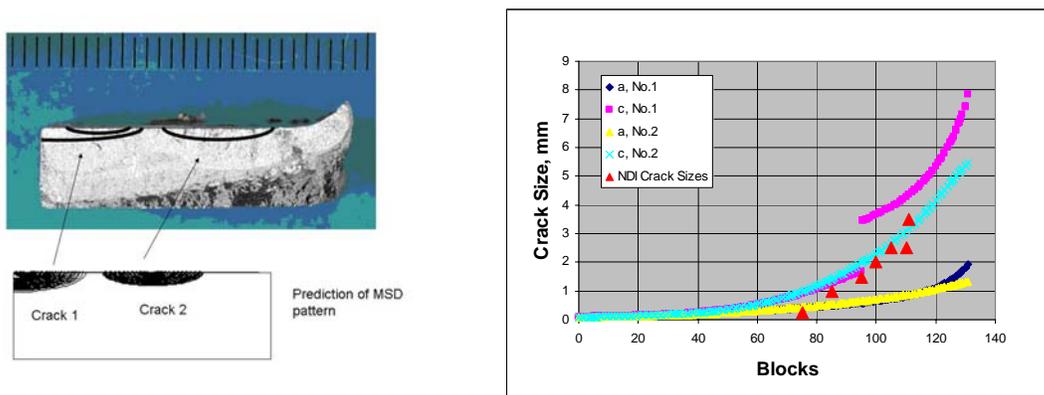
Figure 71: comparison MSD pattern and crack growth results of Test 3 (see [4] and references therein)

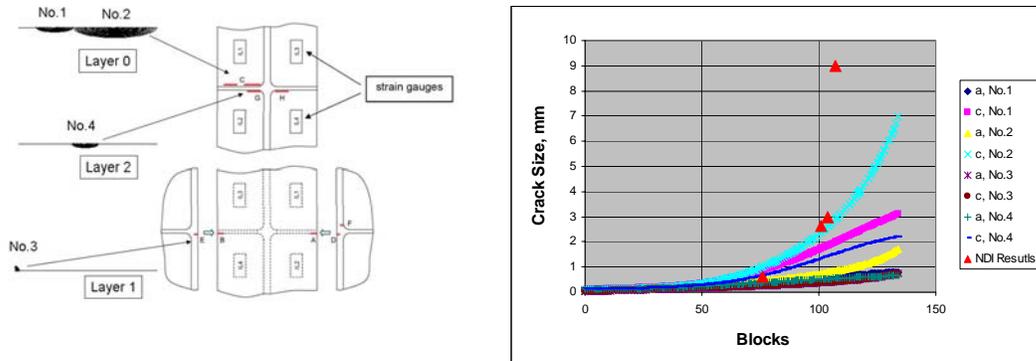
Figure 72: comparison MSD pattern and crack growth results (see [4] and results therein)

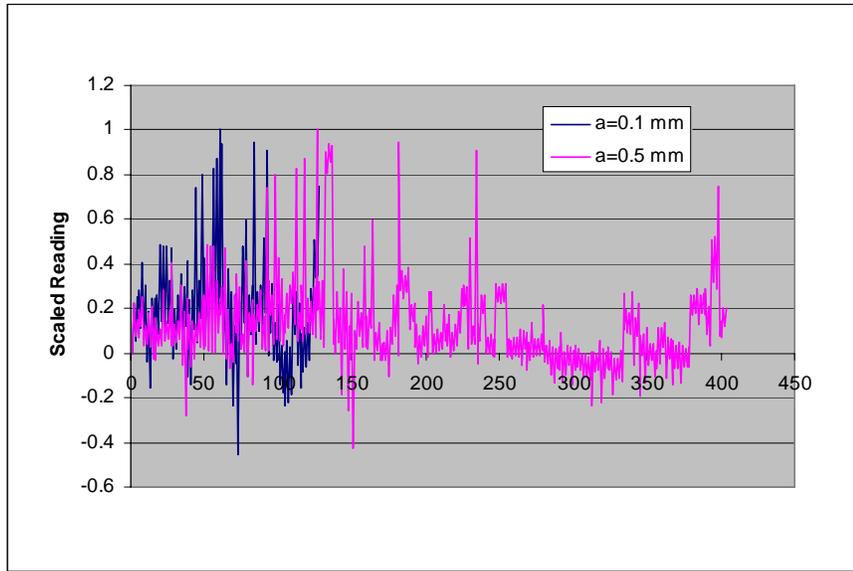
Figure 74: Comparison of filtered generic fighter load spectrum with filter being 0.1 mm maximum crack size (blue) and 0.5 mm maximum crack size (purple), respectively.

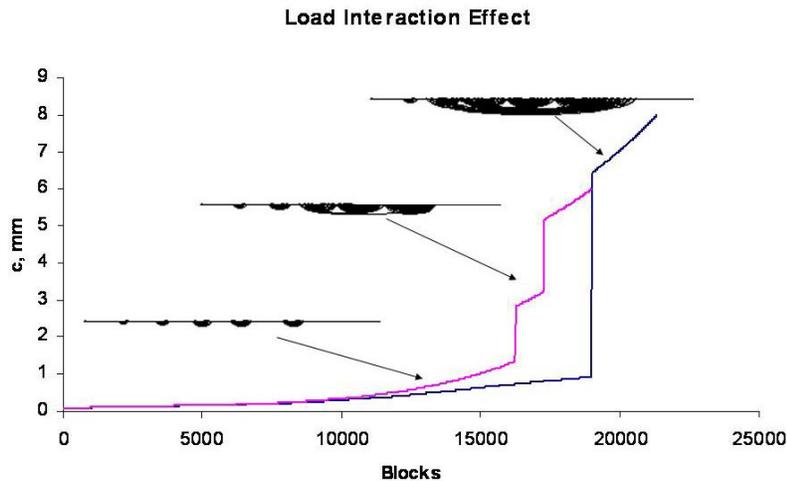
Figure 77: The prediction of MSD development under the example manoeuvre sequence. The first link-up of the crack is expected after load blocks 16000.

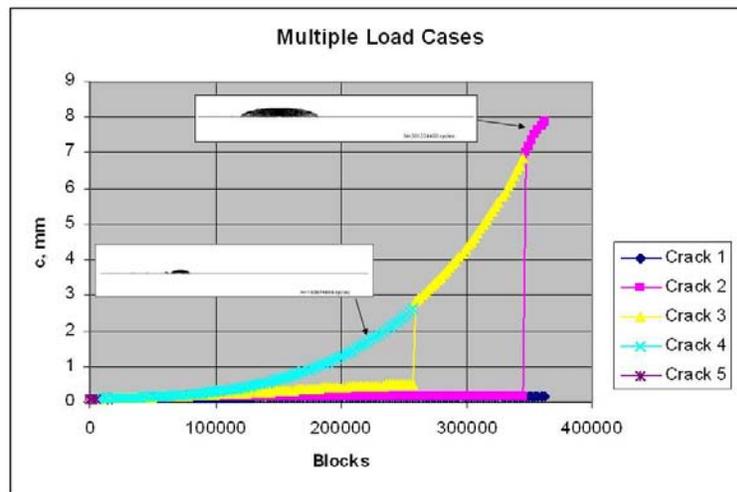
Figure 81: Predicted fatigue crack growth for DB4 the example spectrum

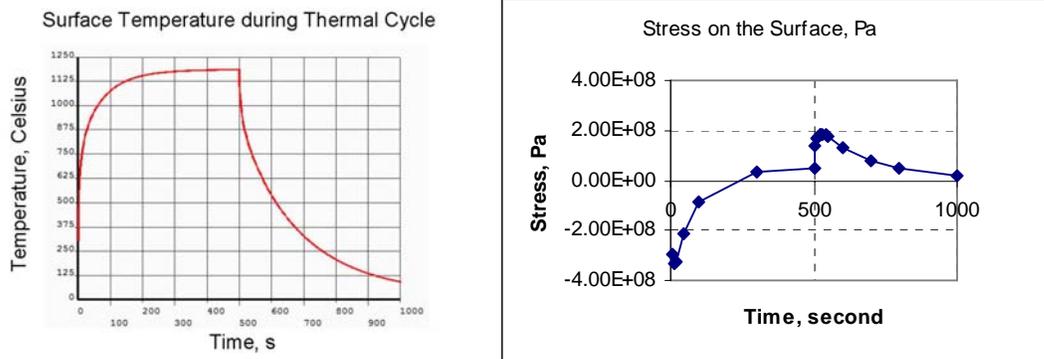
Figure 86: Temperature and stress on the heat surface as a function of time

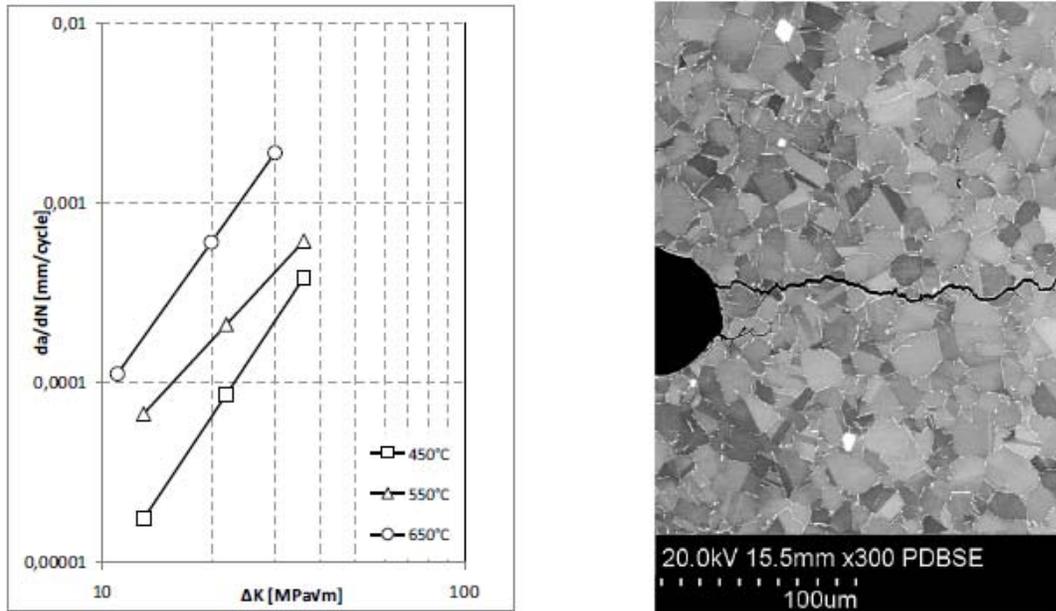
Figure 87. Baseline test results and microscope photo of the room temperature precrack

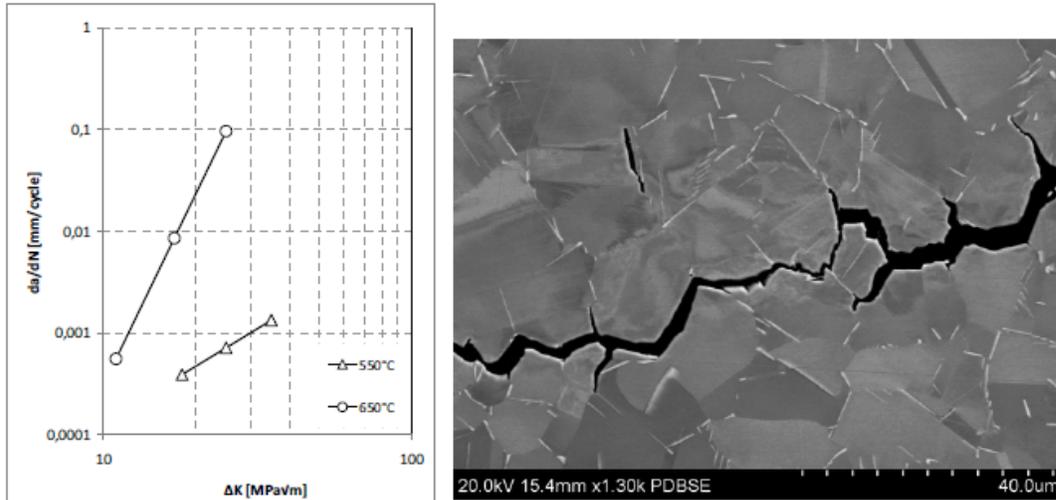
Figure 89. Crack growth rates for 90 s hold time tests and 650°C crack at 90 s hold time

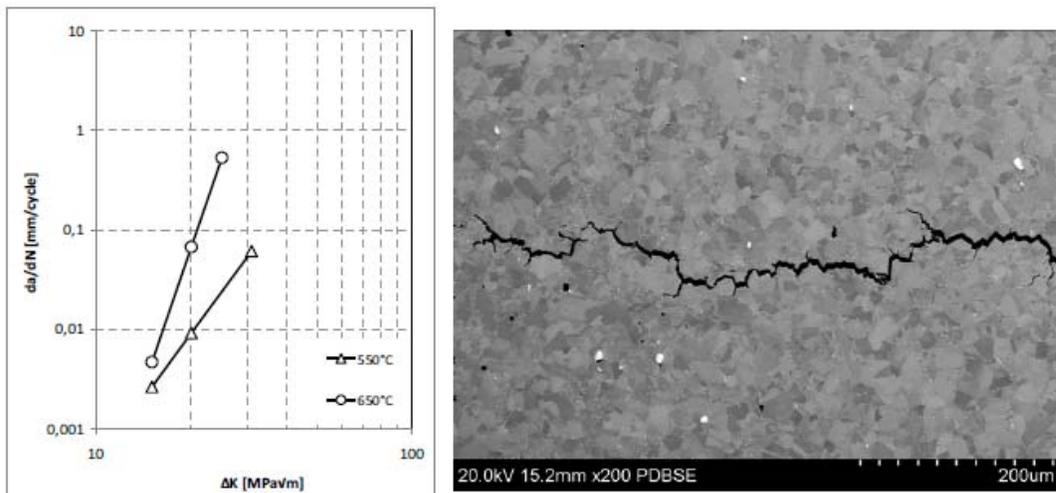
Figure 90. Crack growth rates for 2160 s hold time tests and 650°C crack at 2160 s hold time.

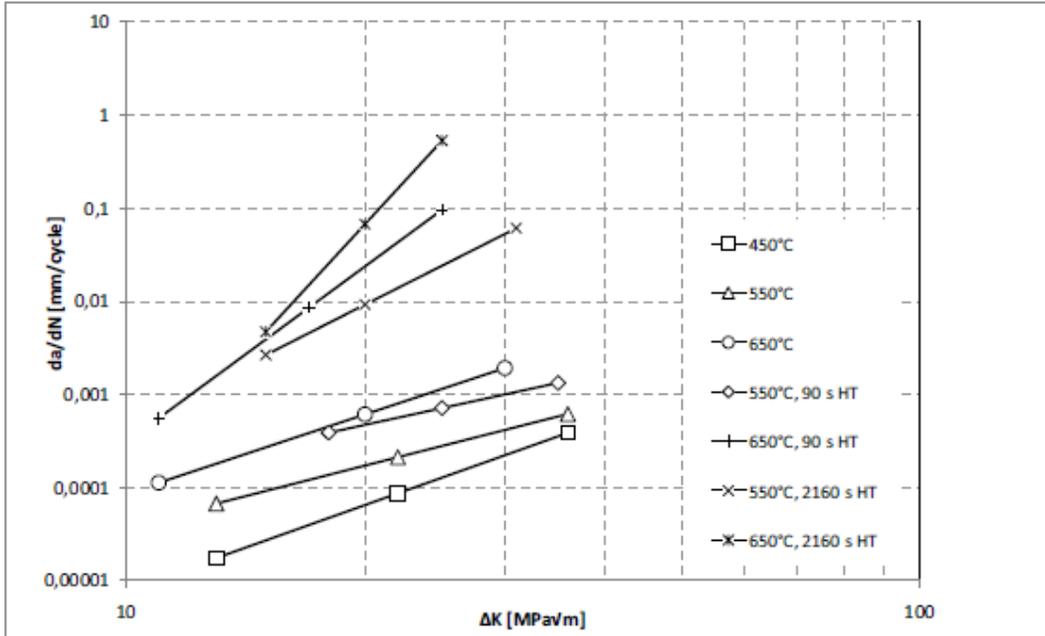
Figure 91. Crack growth rates for all tests.

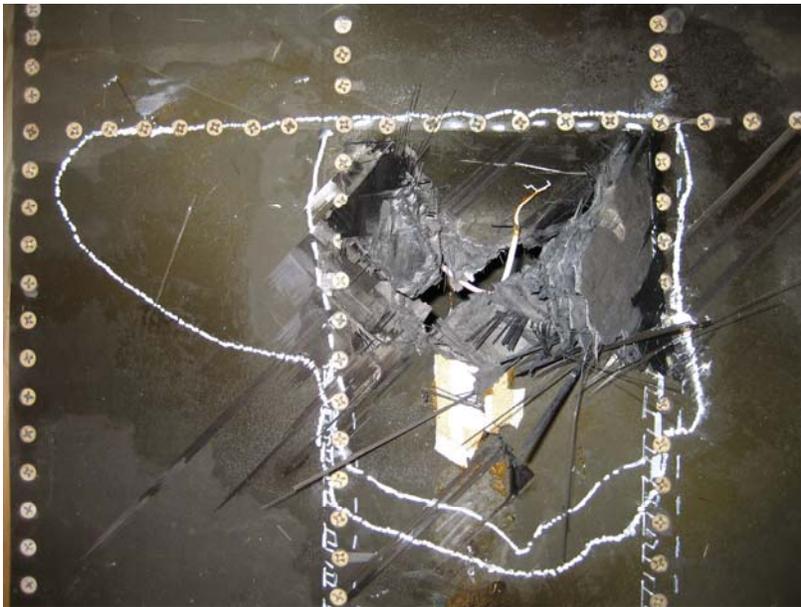
Figure 92. Damage on exit side of wing box 1 after shoot 2 with delaminations shown and damage to substructure.

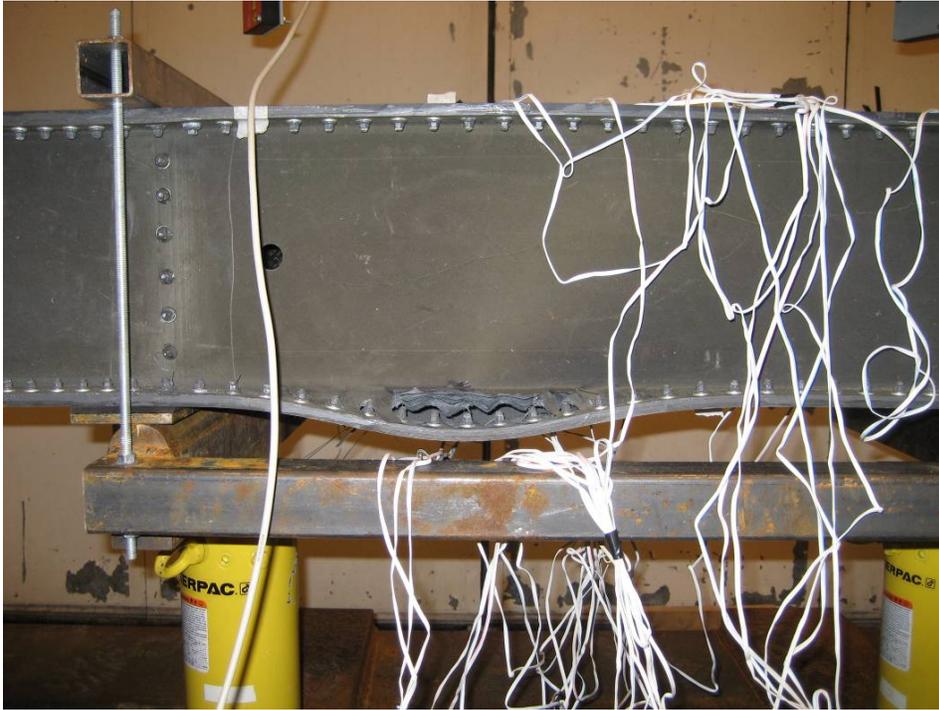
Figure 93. *Quasi-static failure of substructure of wing box 1 due to buckling of wing skin.*

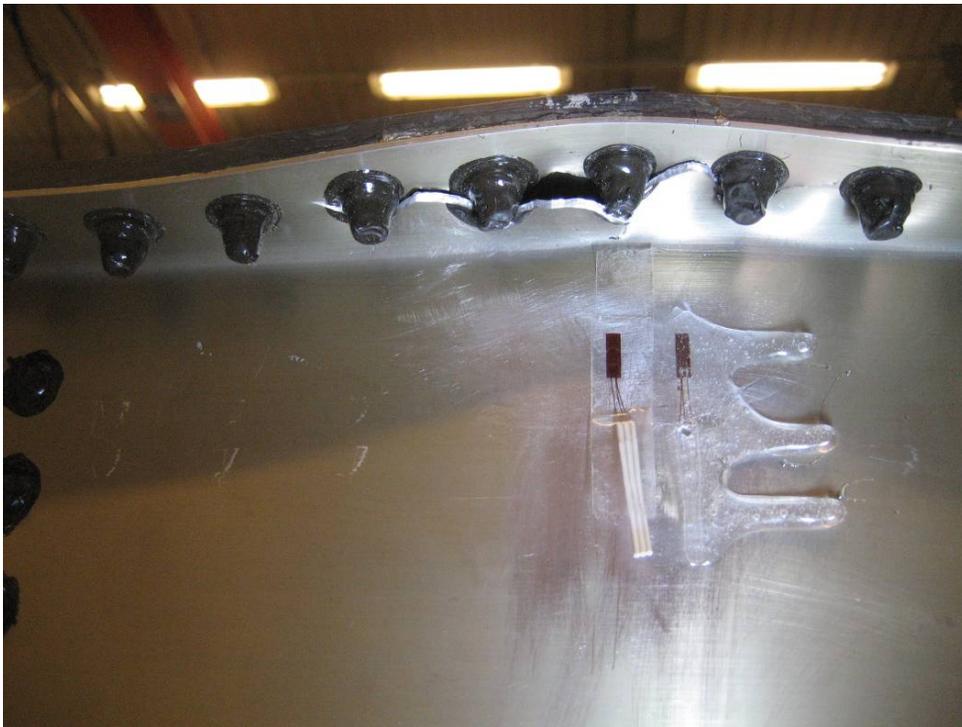
Figure 94. *Quasi-static failure of substructure of wing box 2 due to buckling of wing skin.*

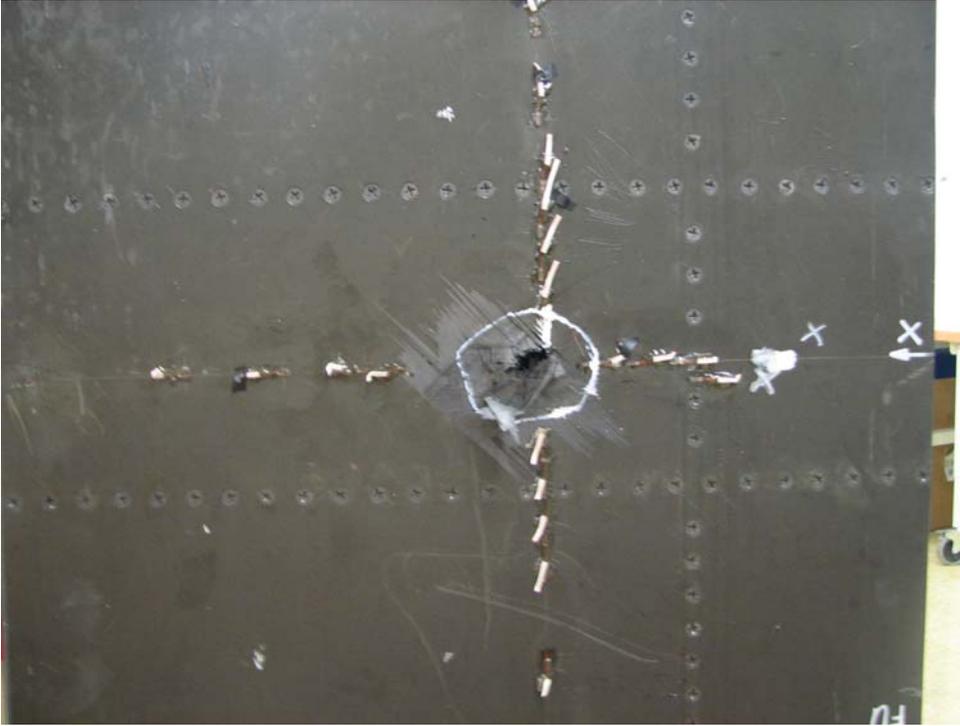
Figure 95. Damage at exit hole of unloaded wing box 2.

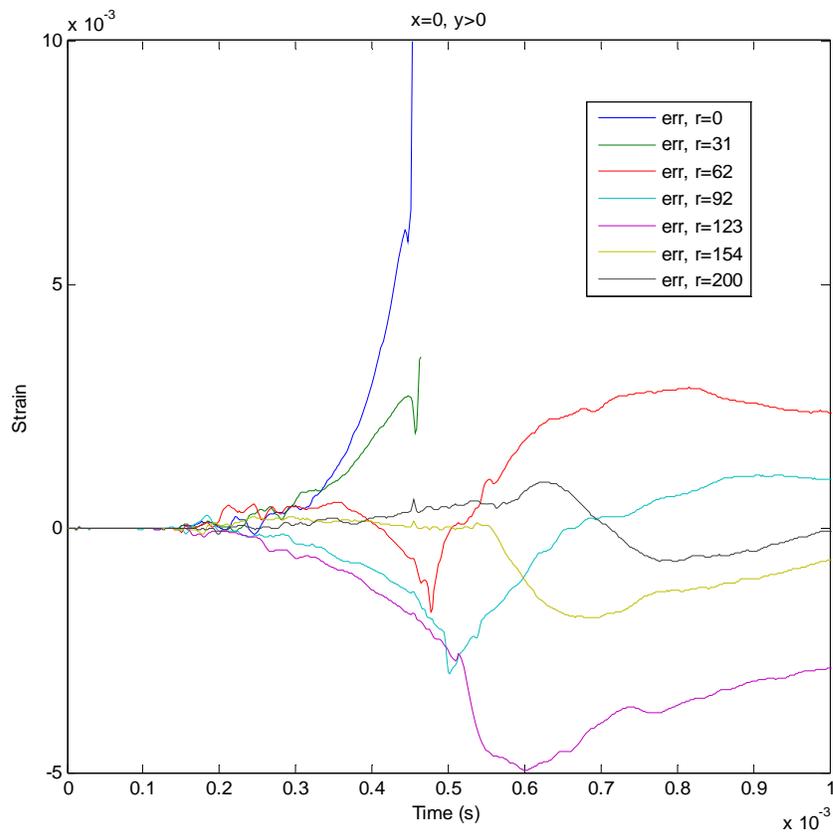
Figure 96. Dynamic strains on exit side of wing box 2 for shoot 1.

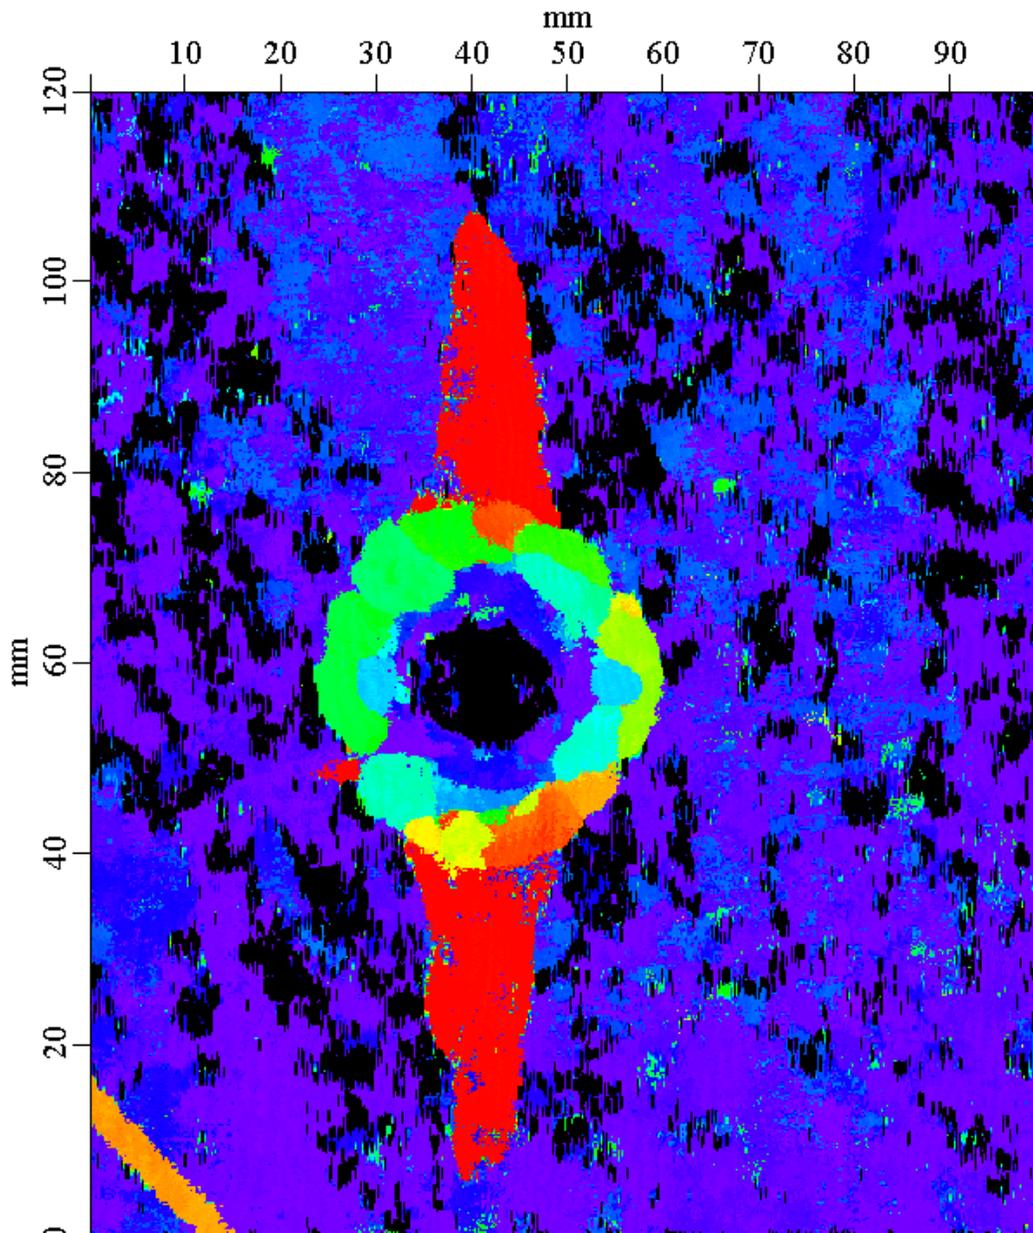
Figure 97. C-scan of specimen impacted at 35 J.

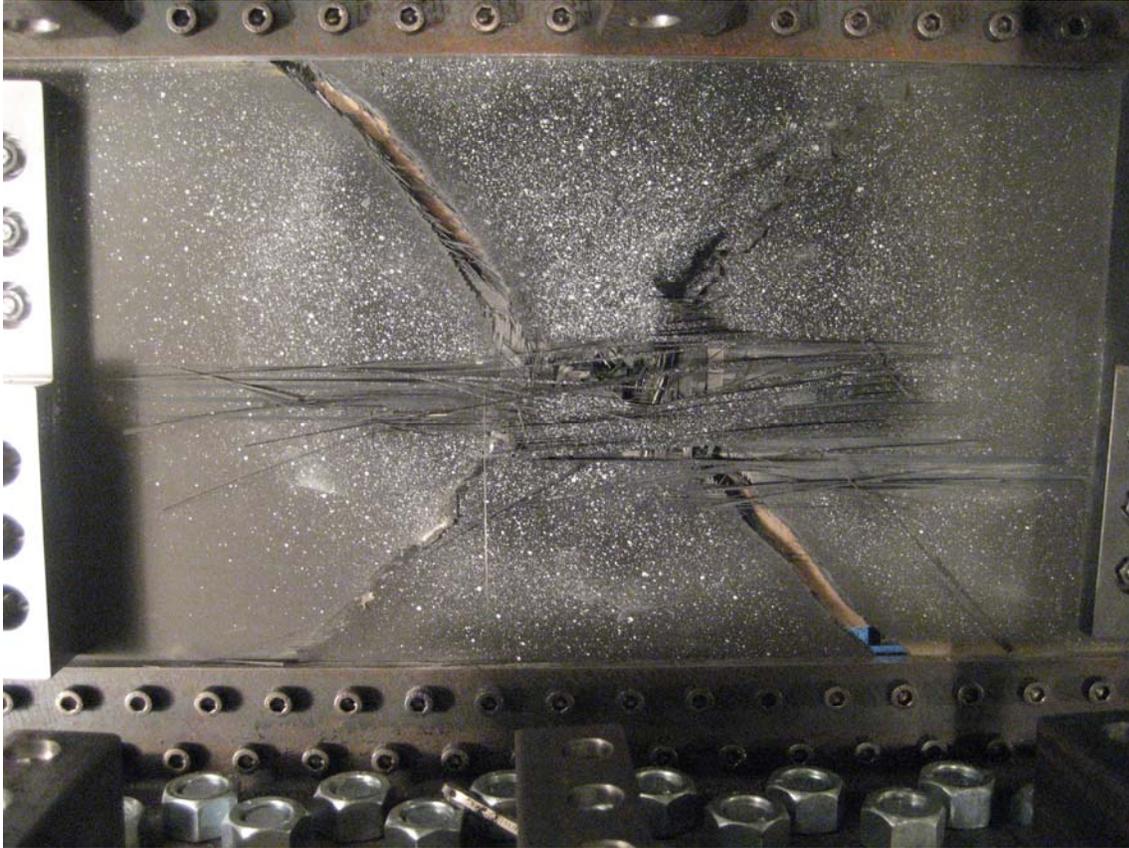
Figure 98. Shear loaded composite plate after failure.

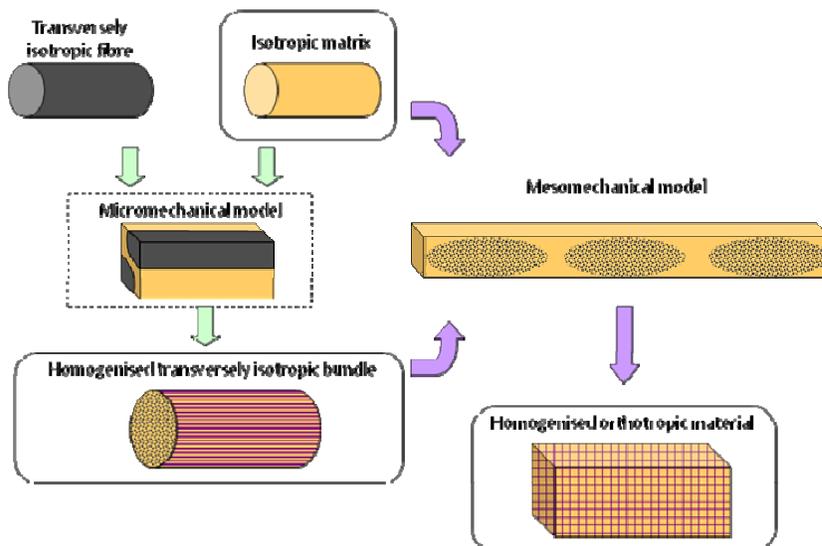
Figure 101: Hierarchic modelling approach for NCF composite material.
