A Review of Aeronautical Fatigue Investigations in Sweden During the Period May 2009 to March 2011

Edited by HANS ANSELL
Saab AB
Sweden

ICAF Doc. No. 2426
Saab Doc. No. TDL-2011-0091

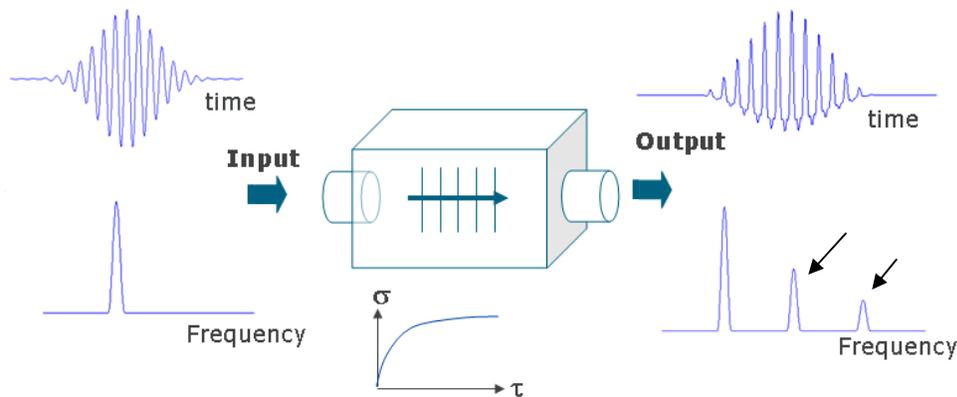
Nonlinear relationship between strain and stress

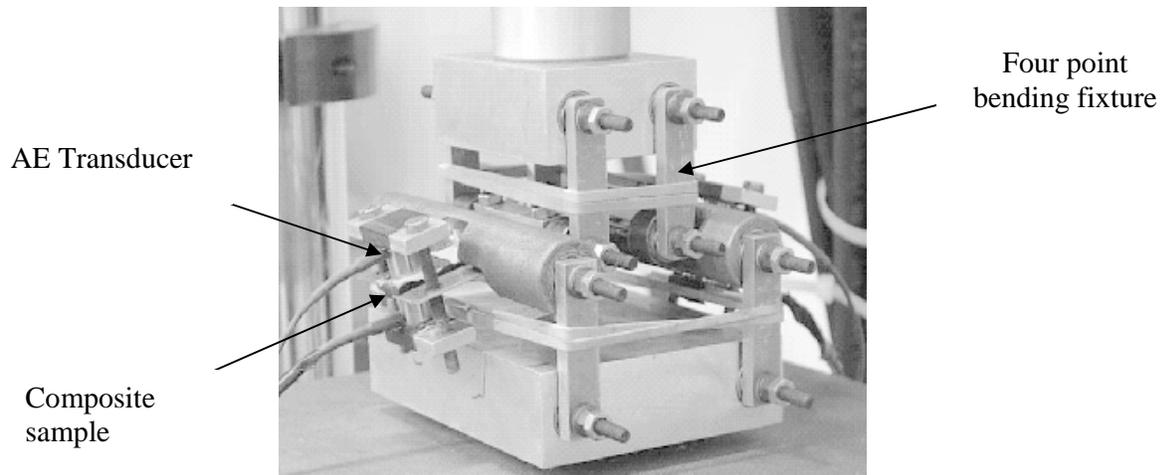
Figure 103: 4 point bending holder and AE emission sensors used cycling and monitoring of the fatigue damage

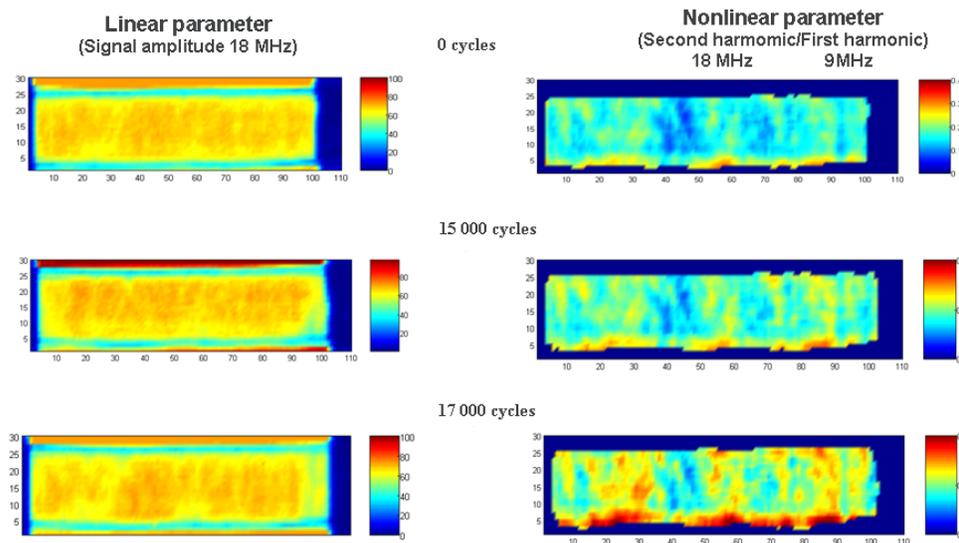
Figure 104: Conventional amplitude C-scans (on the left) and harmonic amplitude scans for a CFRP sample at different cycles of 4 point bending test

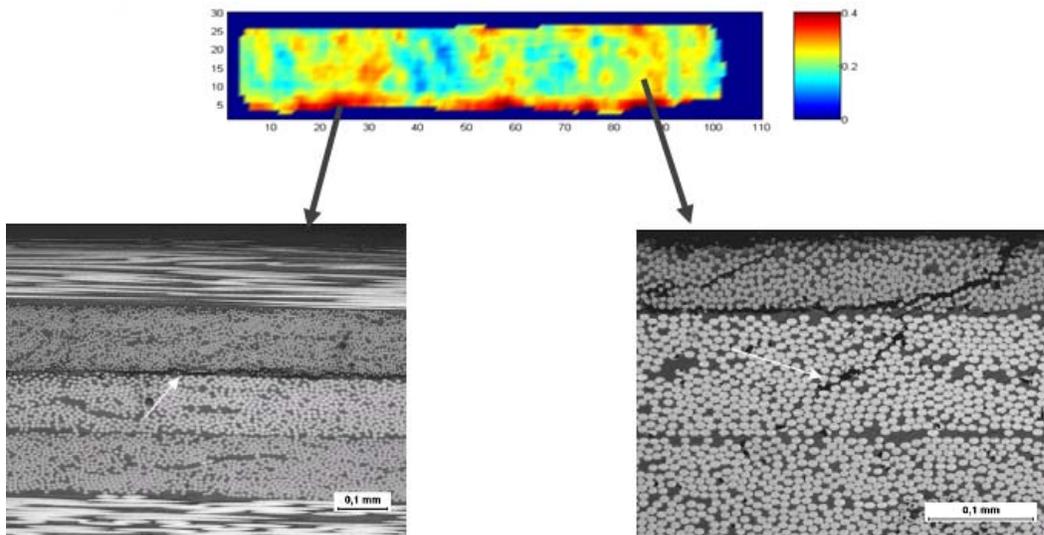
Figure 105: Micrographs of fatigue damage in CFRP laminate in areas with high nonlinear parameter
