REVIEW
OF AERONAUTICAL FATIGUE INVESTIGATIONS IN SWITZERLAND
APRIL 2013 – MARCH 2015

DR. MICHEL GUILLAUME | ZURICH UNIVERSITY OF APPLIED SCIENCES
SCHOOL OF ENGINEERING | ZAV CENTRE FOR AVIATION

ZAV DOCUMENT 2015

Prepared for the presentation at the 34th ICAF Conference

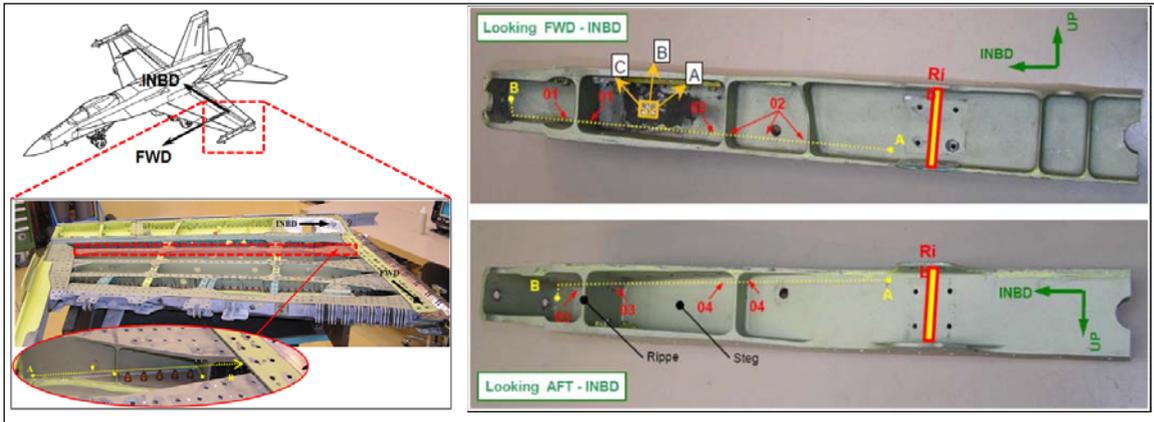
Figure 1: Crack in Outer Wing Spar 3

This analysis approach was used to perform the study on one of the cracks found during the tear down inspection at the end of the FSFT of the Swiss F/A-18 performed by RUAG. The inspection revealed a 16in long crack in the outer wing spar 3 in the spanwise direction along the web to bottom flange interface (about 1/4 of the spar was severed, see **Figure 1**).

The failed component was analysed using QF, to identify the site of crack initiation. The crack initiation location coincided with a 3D stress concentration in the model, at the lower flange to web transition corresponding to a flange thickness change. The FEM analysis using the SOLID mesh showed that the position of the highest calculated maximum principal stress was consistent with the test findings. The calculated crack initiation life at this position was 3'200 spectrum flight hours (SFH).

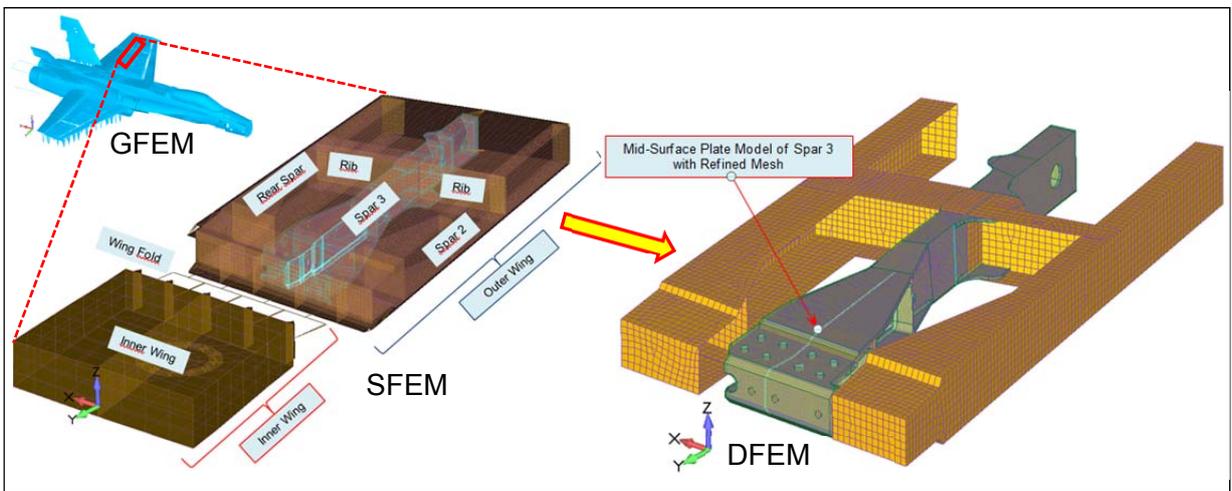
Figure 2: Finite Element Models

The background for the FEM model is the Swiss F/A-18 global FEM (GFEM), from which a sub-model (SFEM) of a portion of the inner and outer wing was derived. For the crack initiation (CI) and the thru-the-thickness CG analyses, a SOLID mesh of spar 3 was

implemented in the SFEM. For pyNASSIF and subsequent CG analyses, a detailed model (DFEM) of the spar 3 using PLATE elements was implemented in the SFEM, see Figure 2. A typical limit load case was chosen as reference load case to perform the analyses.

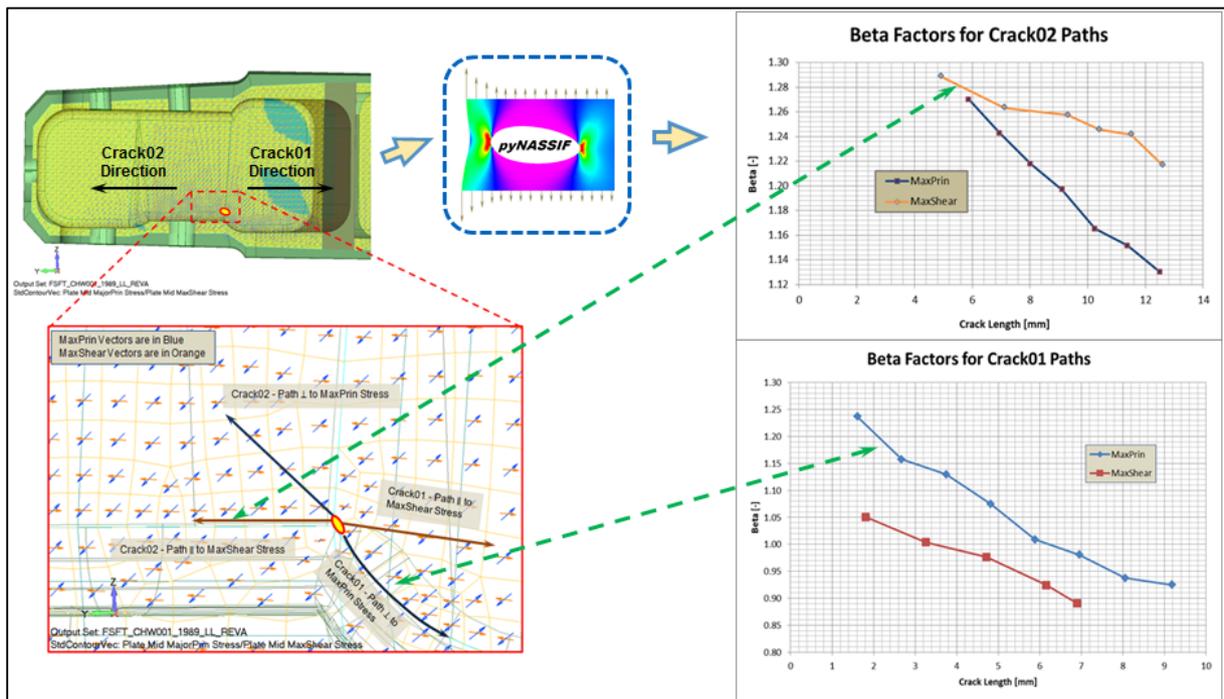
Figure 3: Crack Path Assessment

In order to perform the internal thru crack analysis, the crack path had to be defined. Depending on the crack propagation mode, the criteria for crack path definition is different. For mode I, the crack tends to grow in a plane perpendicular to the maximum principal stress. For modes II and III, the crack tends to grow in the direction of the maximum shear stress. Therefore, in the case of the F/A-18 outer wing spar 3 crack, two possible paths were analyzed on both tips and the one leading to the highest β was selected for each tip as presented in Figure 3.

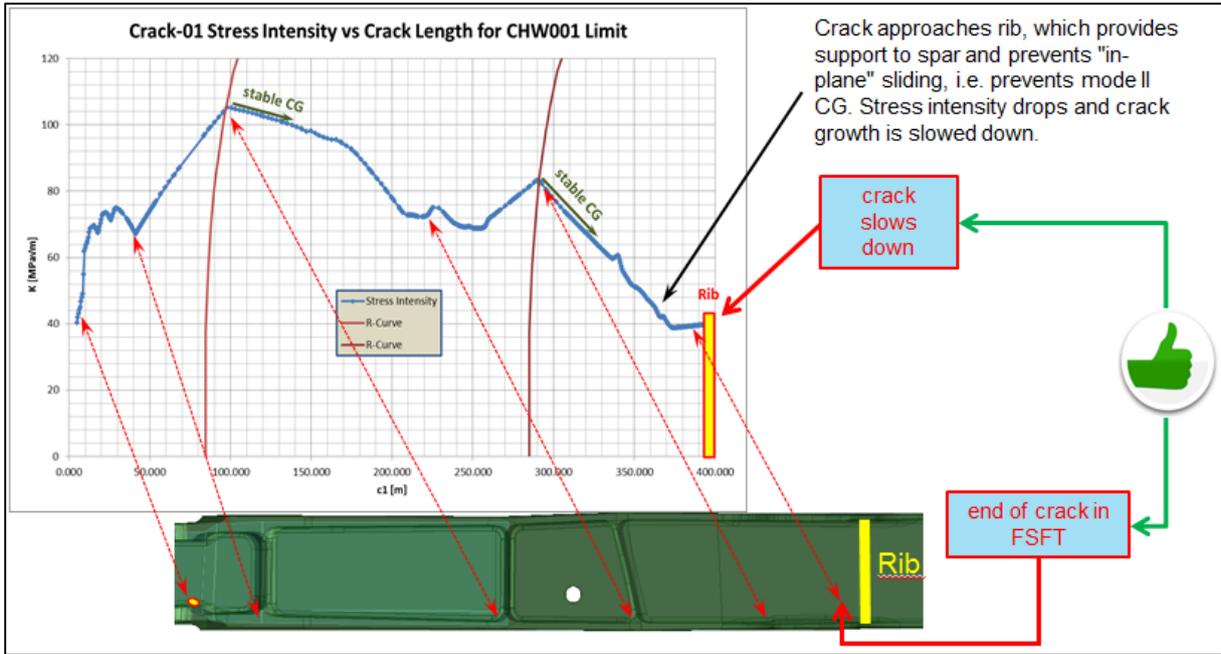
Figure 4: Stress Intensity Solution and Critical Crack Length for Tip 1

After the K solution was developed using pyNASSIF, the R-curve method was used to assess the critical crack length. On tip 1 (Figure 4), the crack was stable until it reached the first outer wing rib. At this position, the stress intensity was drastically reduced and the crack growth was almost stopped. The analysis at crack tip 1 is in agreement with the FSFT end crack position. At crack tip 2 (Figure 5), the R-curve analysis showed that the crack was instable along a portion of the end of the spar when the crack started to grow vertically along the vertical flange. Then the crack growth was stable again until it stopped when the tip reached the top flange. At this stage, the crack was mostly loaded in compression. The analysis results are in agreement with the QF findings, which showed an instable crack growth pattern along a portion of the vertical flange at the end of the spar, followed by stable crack growth. The calculated final crack length on tip 2 is also in agreement with the crack found at the end of the FSFT.

In the FSFT article, a strain gage was positioned just above the path of tip 1. During the FSFT, the SG showed a signal drop between 8'000 and 9'000 SFH, which means that the crack passed below the SG during this period, see Figure 6. According to the analysis, the crack would be expected to pass below the strain gage at about 8'000 SFH. Therefore, it was concluded that a very good agreement between calculated crack growth speed and the strain gage signals was found.

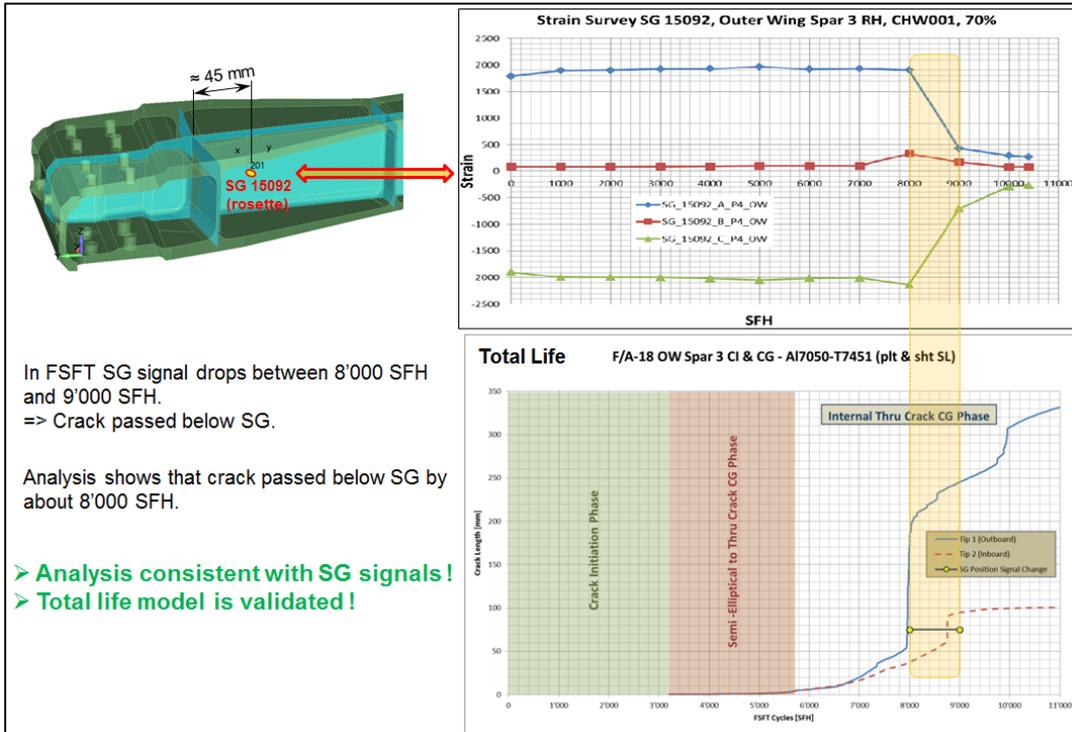
Figure 6: Total Life (CI + CG)

The total life model was then defined as the sum of the CI and CG lives as shown in Figure 6.

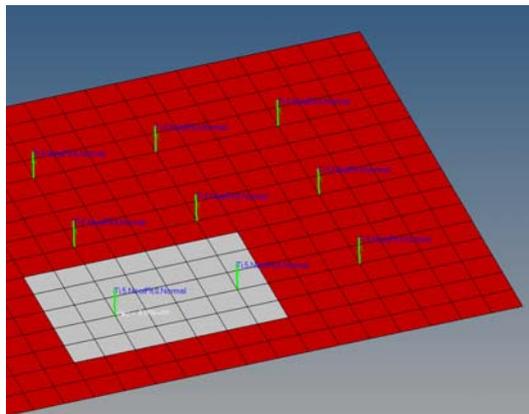
Figure 8: Example surface patch in DFEM

To circumvent this lengthy and error-prone process, RUAG Aviation has developed a modern automated tool for the analysis of fastener hole stresses. The basic idea behind this tool is to use FE-based results instead of pre-calculated literature values. The working principle of the tool is shown in Figure 7. In a first step, the user defines the areas containing fastener holes to be analyzed (represented as 2D FE-element sets, see Figure 8) and selects the subcase from which the loads have to be extracted. The tool automatically recognizes fasteners, creates a freebody of the surface and extracts all necessary information such as element geometry, sheet material and thickness, loads and fastener details. Afterwards the tool

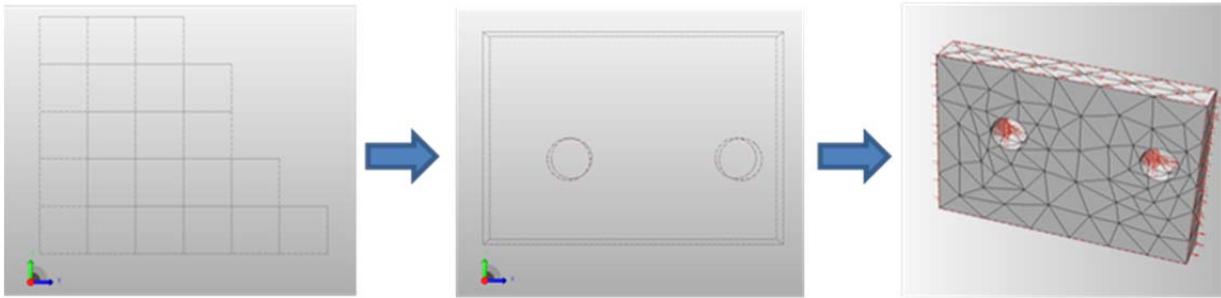
Figure 9: 3D model creation steps in StressCheck.

creates a 3D-FE model of the extracted 2D freebody. For the generation and analysis of the 3D model, a special p-type FE-Software called StressCheck is used. The advantage of this software is that quick and accurate results can be achieved due to the fact that the result quality is relatively independent of the mesh density around the fastener hole and thus the mesh can be kept coarse. The geometry of the 3D model is based on the 2D elements from the DFEM as **Figure 9** shows. Once the 2D geometry has been recreated, the sheet is extruded through the thickness and the fastener holes are subtracted. After meshing (using the software's Automesh capabilities), the loads are applied. Loads on the sheet boundaries are applied at mid-thickness on element faces closest to the original position of the extracted point load. Fastener loads are distributed on the hole interfaces according to **Figure 10**.

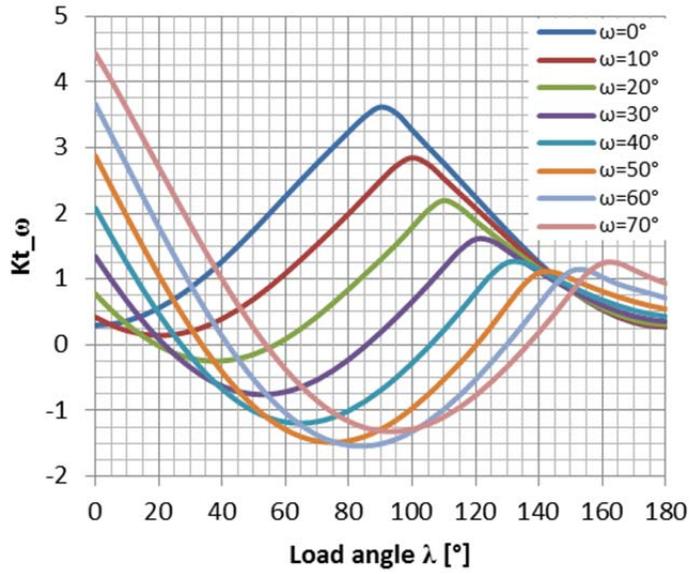
Figure 11: Max principal stress plot, lug case (λ as load angle and ω as location around hole with 0° being the orientation of a standard lug).

The tool was evaluated by calculating several model cases and checking the results against literature values. For example, FE results for a lug which is loaded at a varying angle were compared to standard curves from the literature. The Kt values at low angle match quite well, whereas significant differences at higher load angles are found. Generally peak values of the FEM are higher compared to the literature values. Interestingly, at a load angle of 180° according to the literature, Kt values are the same everywhere around the hole, which is not confirmed by the StressCheck FEM. The evaluation of the same lug model with a different mesh on a different solver confirmed the results obtained from the StressCheck model.

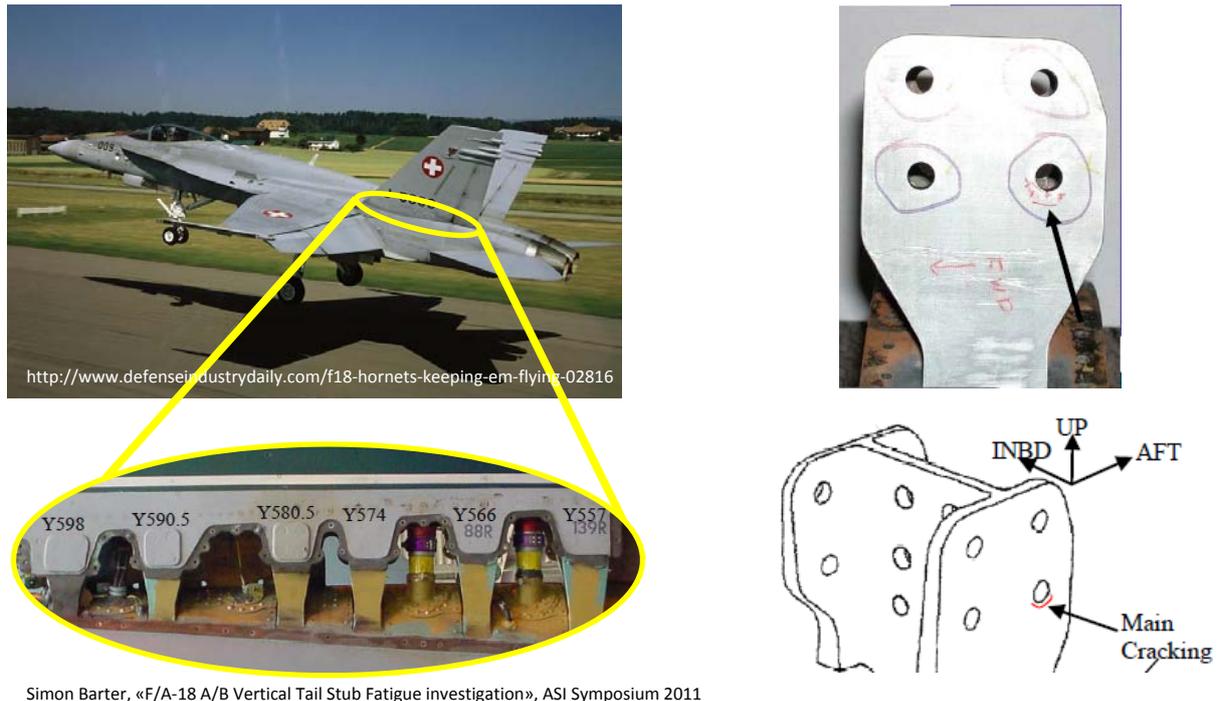
Figure 12: FA/18 vertical tail location & crack location. Ref. [1]

The F/A-18 Vertical Tail is attached to the fuselage via 6 stubs (Figure 12). During inspections, cracks were found near the fastener hole interfaces by several operators. Ref. [1] The location and direction of the cracks indicate that they are not caused by bearing loads. Several studies have already been conducted on this topic to identify the root cause for the cracks.

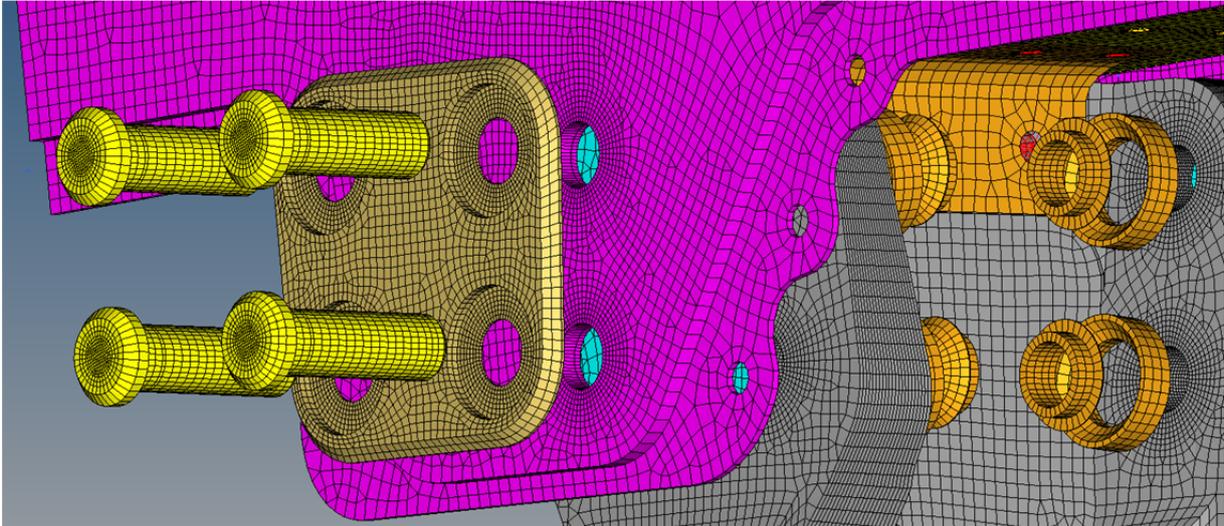
Figure 13: Vertical tail stub FE model.

Based on the idea that friction load transfer plays an important role, RUAG Aviation investigated this topic in detail. A detailed solid FE contact model of the stub-to-skin joint was created (Figure 13). The model was subjected to a simple symmetric tension load and different contact conditions (stick, slip and friction) were compared to each other.

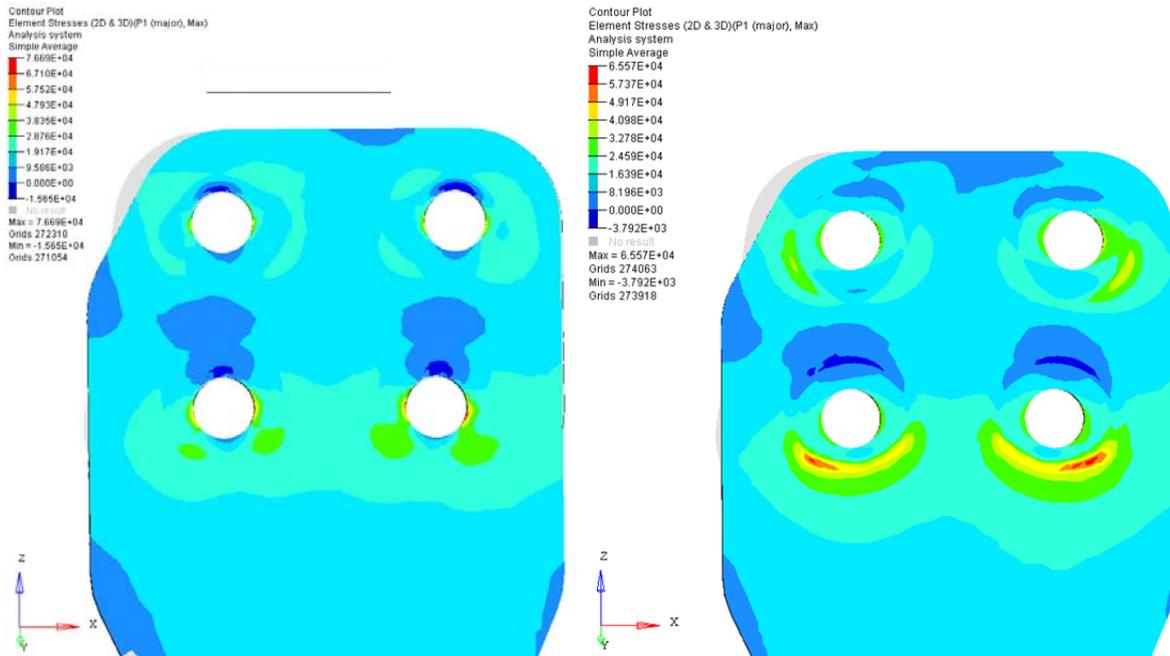
Figure 14: Max principal stress contour plots, slide configuration (left) and stick configuration (right).

In a first step, max principal stress distributions on the stub surfaces were investigated. Figure 14 shows that for the slide contact configuration, high stresses are found directly at the hole interfaces as expected, whereas for the stick contact configuration high concentrations are found at crack locations. Apparently the reported cracks could indeed be caused by sticking behavior of the contact.

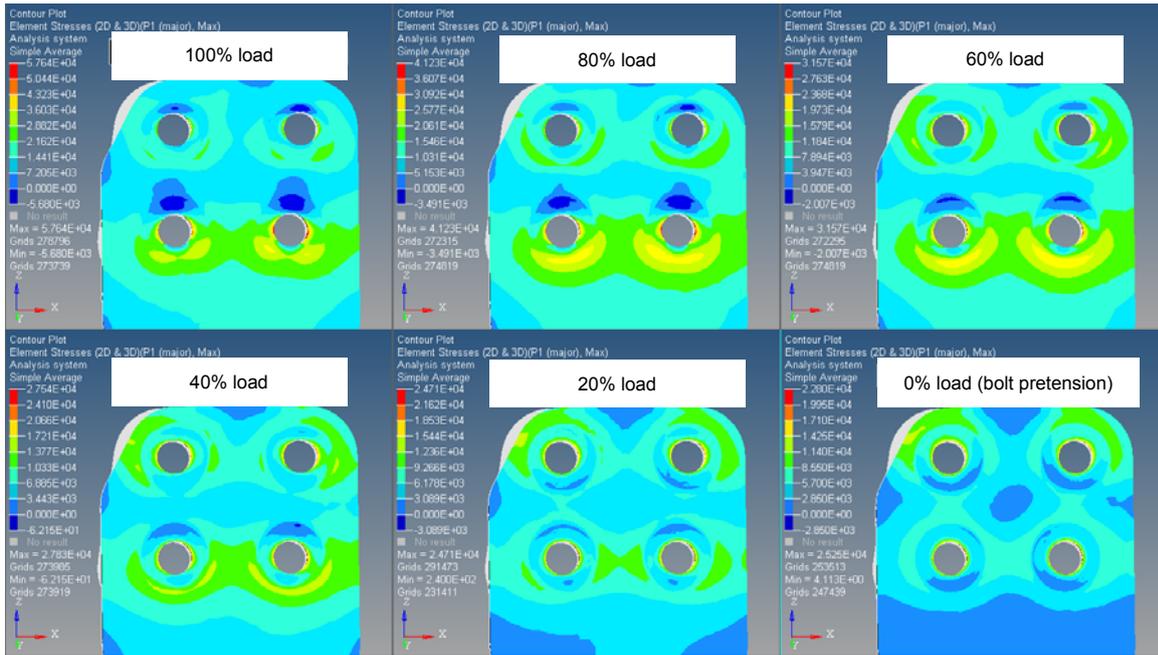
Figure 15: Max principal stress contour plots, friction configuration for different load magnitudes.

For the friction contact configuration, plots were created with different amounts of load. One can see that until 60%-80% of the final load, some stress concentrations at crack locations are visible. At 100% of the applied load however, bearing stress concentrations at hole interfaces dominate, indicating that slippage occurs between 80% and 100% of the applied load.

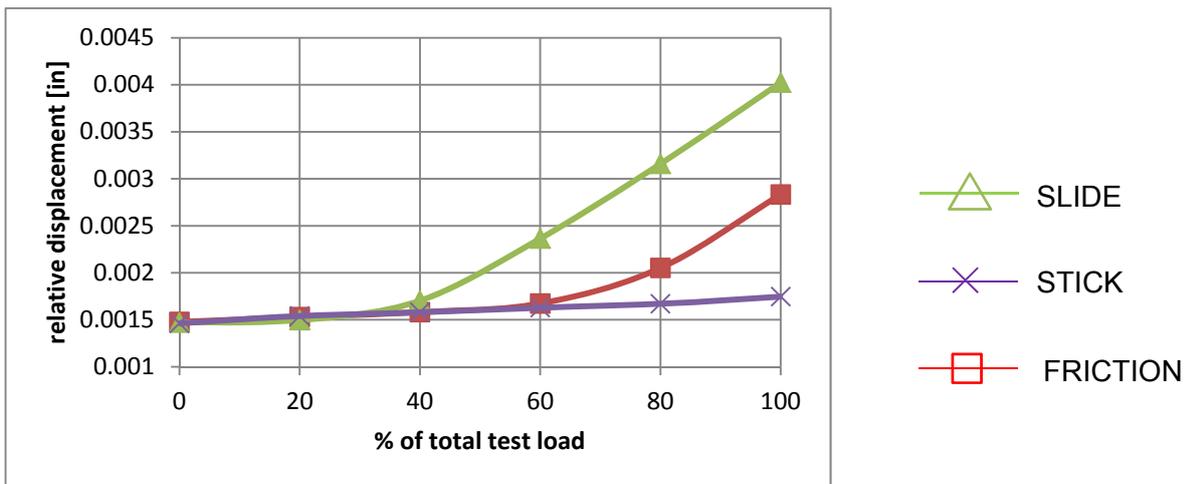
Figure 16: Hole elongation measurements for different load magnitudes.

To check the plausibility of these assumptions, the hole elongation was investigated. The idea behind this was that deformation of the holes should only occur if the surfaces would slip against each other.

Figure 16 shows an example plot of the lower left hole. The differences in stick/slip behavior of the three configurations is clearly visible. There is almost no deformation for the stick configuration as expected. Interestingly there is almost no elongation for the slide configuration until up to 40% of applied test load. This may be explained by residual stresses in the hole being present due to the interference fit fasteners which have to be compensated before elongation starts. Finally the point of slippage for the friction configuration can be identified. It appears that the surfaces tend to stick until the load exceeds 60% of the applied load. At higher load slippage starts.

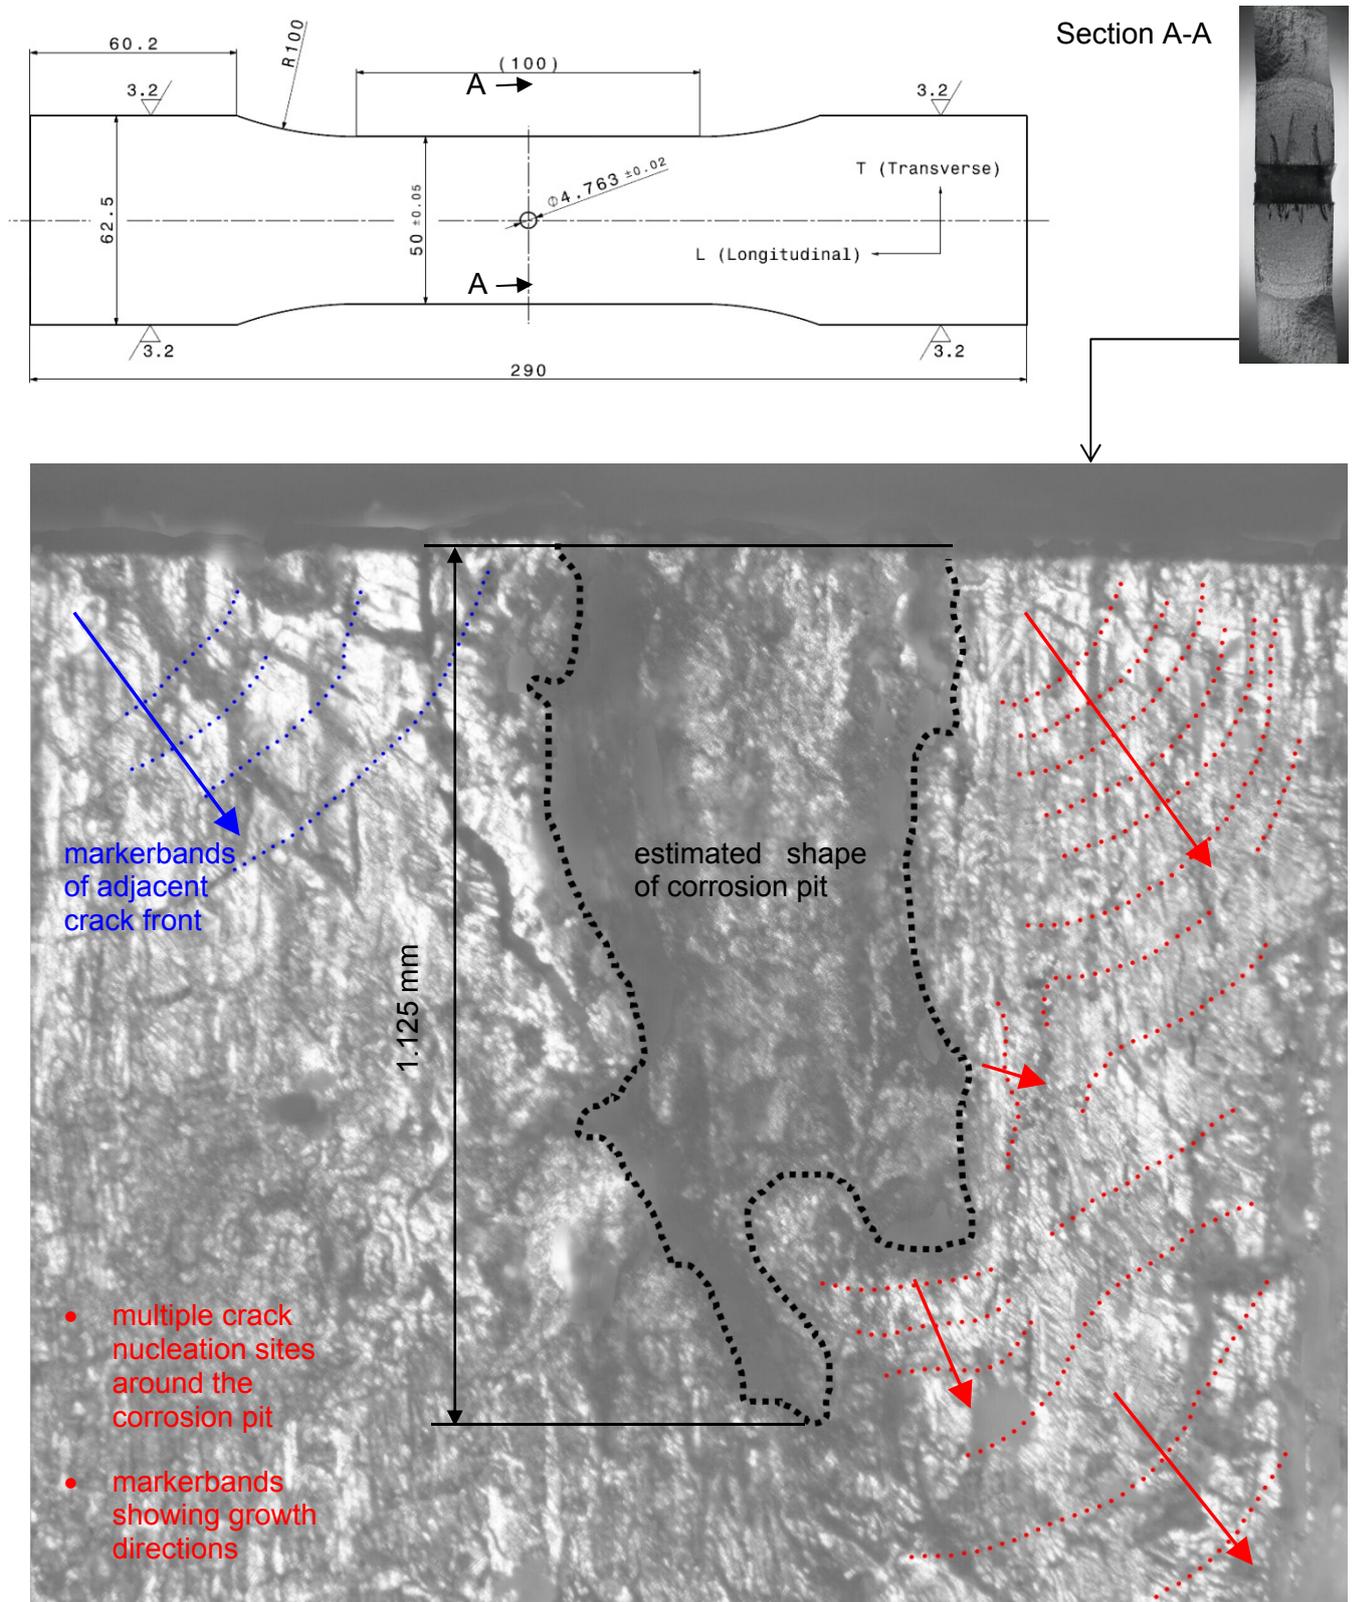
Figure 17: Severe corrosion pit with visible marker bands within centre section of straight hole test specimen

It was observed in the tested coupons that cracks nucleated within the pits, but not necessarily at their deepest points. Typically, multiple crack nucleation origins were found at each pit, see

Figure 17. Crack growth curves were recorded by quantitative fractography for each test specimen. Two different methods were then used to back-calculate equivalent initial damage sizes that can be used to characterize the pre-existing corrosion damage in a damage tolerance assessment: first the traditional back-calculated Equivalent Initial Flaw Size (EIFS) with a crack growth model that is based on fracture mechanics, and second the Equivalent Initial Pre-Crack Size (EPS) according to the Lead Crack Fatigue Lifting Framework methodology of [2], which assumes a log-linear crack growth behaviour. Both approaches showed good correlation in equivalent initial damage sizes. It was noted that the equivalent initial damage sizes correlated reasonably well with the average pit sizes. Therefore, once the existing corrosion pit sizes are known, the remaining fatigue lives can be calculated.

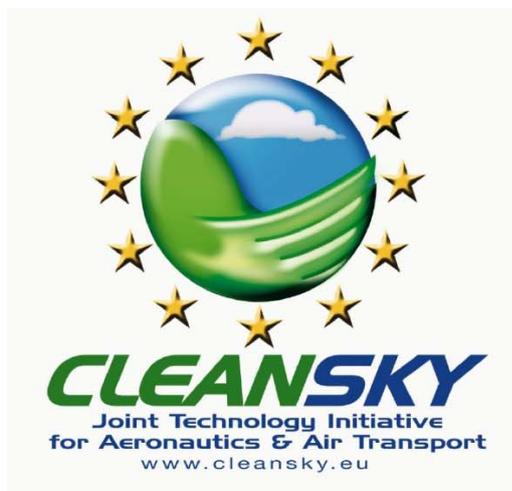
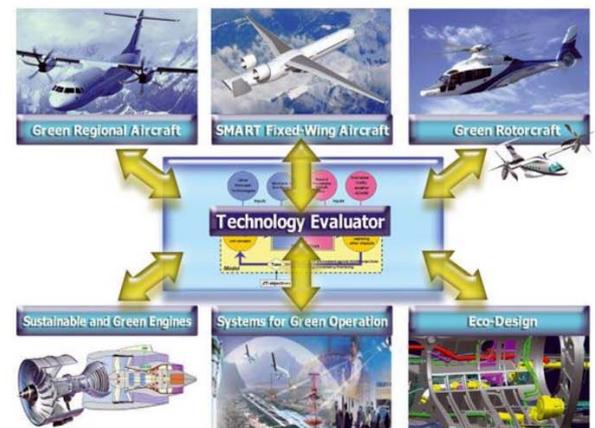
Figure 18: Clean Sky with 6 ITD's

The project is divided into 6 technology domains / ITD's (Integrated Technology Demonstrator) including Eco Design. The Technology Evaluator gathers data from each ITD and evaluates the new green conceptual aircraft based on the results of the ITD's. The Eco Design ITD focuses on green design, production and optimal use of materials, thus reducing the environmental impact.

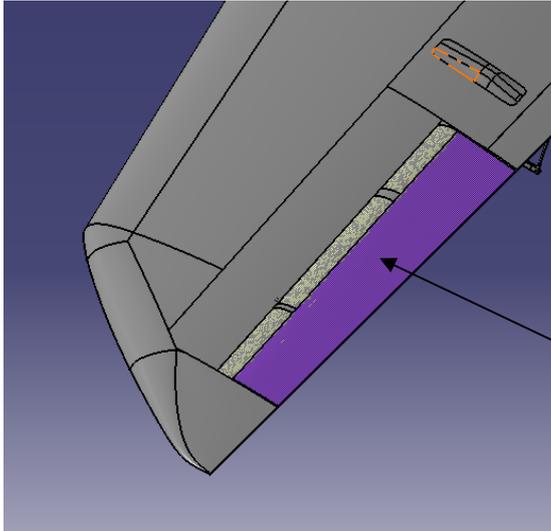
Figure 19: Outer Loft Surface Model on CATIA 5 for DO228 L/H Wing and Aileron

The A4 demonstrator is based on a DO228 aileron architecture and aims to validate a total of 7 implemented new technologies at the technology readiness level (TRL) 6 [5].

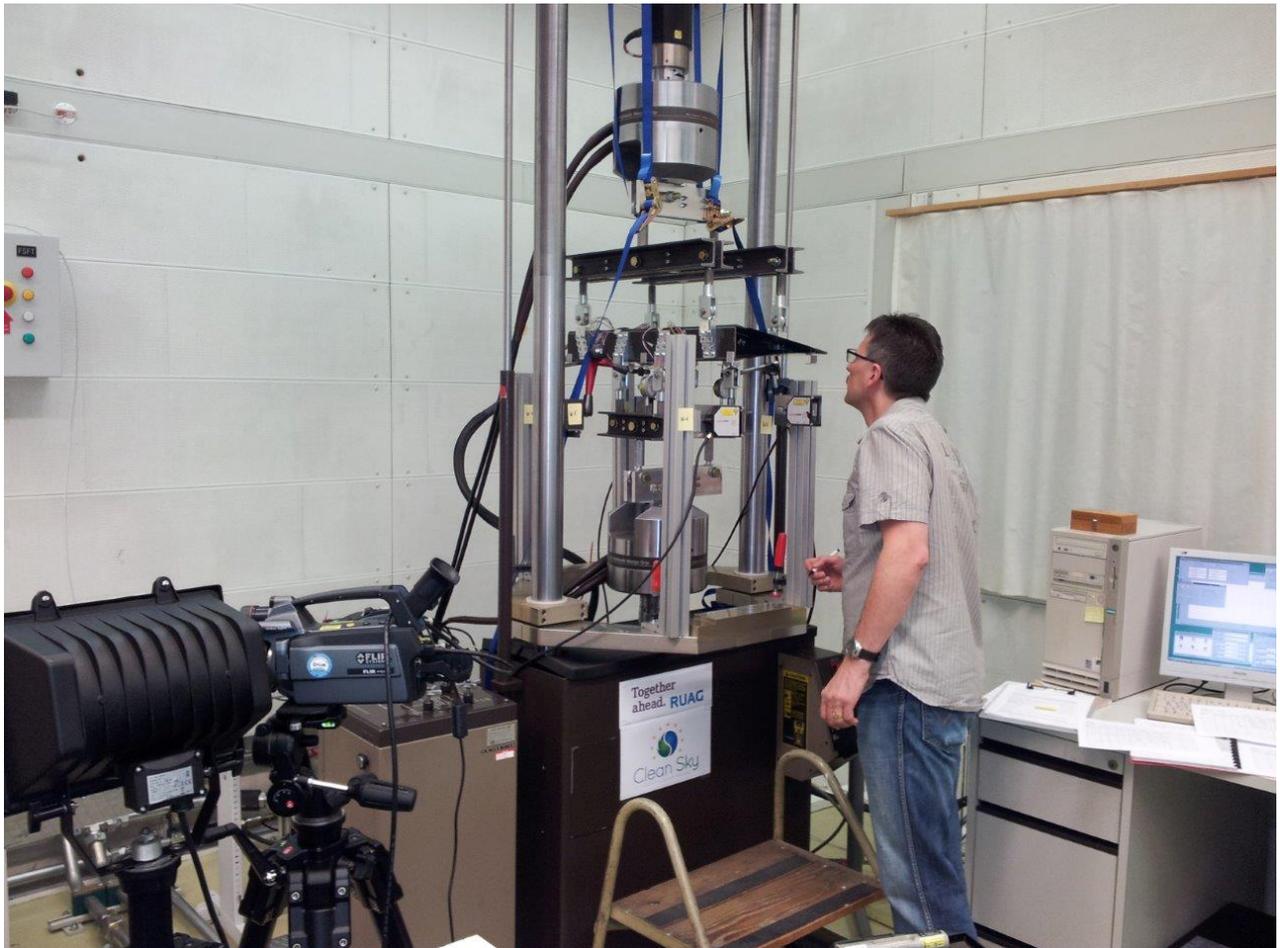
Figure 22: Test Set Up for Static, Fatigue and Rupture Testing

For the validation, three demonstrators were built. Two demonstrators were mechanically tested in a 4 point bending configuration. The performance of the demonstrator A4-1, which incorporates new technologies, was compared to the demonstrator A4-ref, which incorporates current technologies.

In June 2014, RUAG Aviation in Emmen successfully completed the mechanical testing that consisted of strain surveys, fatigue cycling and rupture. Fatigue cycling was run in a dry laboratory environment (20 °C) at approximately 2 Hz test frequency and at a load level equivalent to an 80% limit load case that included a load enhancement factor of 20%. This additional enhancement factor was required to account for environmental effects (hot/ wet and cold) that were not simulated during the tests. Only tensile loads were applied using a MTS servo-hydraulic test bench with an R-ratio of 0.1. Fatigue cycling was completed for both demonstrators without damage propagation of artificial flaws (AF) and barely visible impact damages (BVID's). Buckling of the upper skin panel was observed close to each peak load.

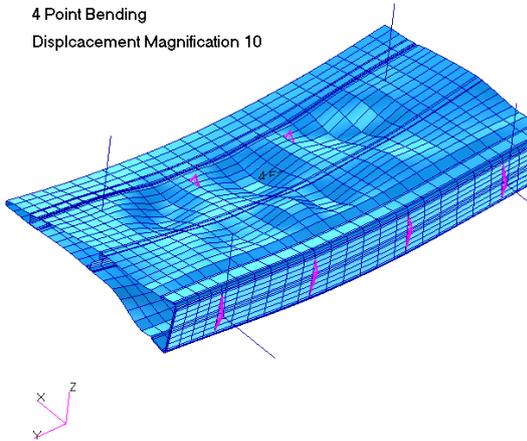
4 Point Bending

Displacement Magnification 10

Figure 23: Non Linear Analysis using **Figure 24:** Rupture of A4-1

Nastran SOL106

The test data (displacements, strains, buckling) has been checked for consistency and was subject to more detailed analysis. It was shown that in general a good correlation between test and analytical FE strains, displacements and buckling pattern was achieved. Work to correlate the rupture loads observed in the test with the analytical models (FEM) is still progressing.

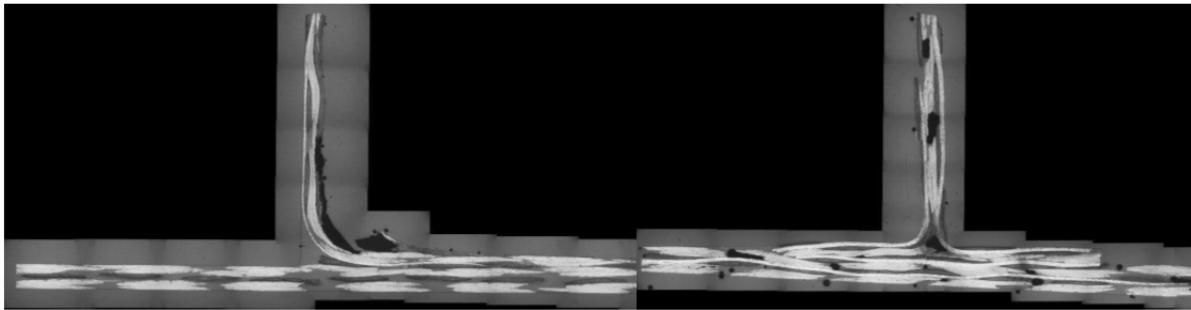
An extensive tear down was performed [6] and cross- sections were cut to assess the quality of skin-stringer connections. Two examples are shown in the next pictures.

Figure 25: L-Stringer – Skin Connection of Upper Skin

Figure 26: T-Stringer – Skin Connection of Lower Skin

In general, the parts produced with the CYTEC MTM44-1 out-of-autoclave prepreg and the LRI L-stringer showed good quality. For the bondlines, excessive porosity was observed in all cases: for the inductive cured Huntsman LME10625/10626, the oven cured LME10625/10626 and the oven cured reference paste adhesive Henkel Hysol 9394. It is assumed that the porosity is attributed to the paste adhesive mixing process that resulted in excessive air bubbles in the adhesive.

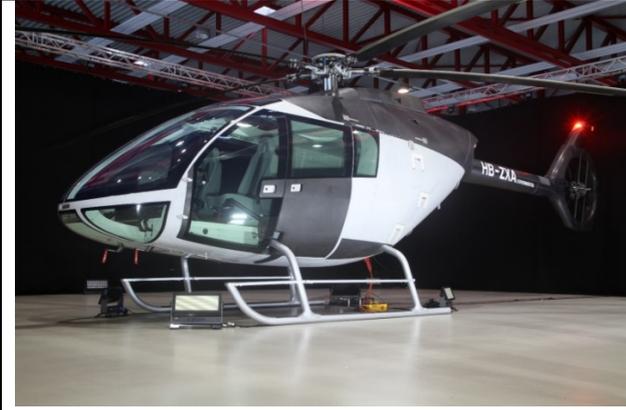
Figure 27: First prototype of SKYe SH09

The Zurich University of Applied Sciences was tasked to develop a detailed concept for the conduction of static load testing (preliminary development test) to achieve successful certification of the structure for the helicopter SKYe SH09 (see Figure 27) of the company Marengo. The new helicopter SKYe SH09 is a light single engine helicopter fully built by a composite structure. The helicopter can be used for several services, such as transport, rescue, surveillance, etc.

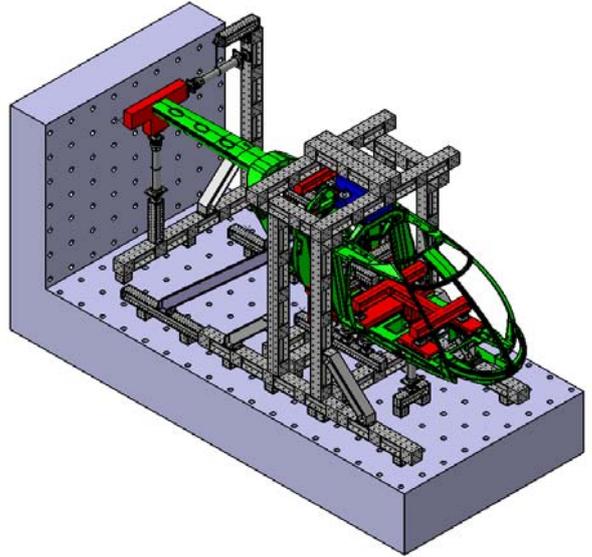
Figure 28: Preliminary concept for the static test

During the first activities, a basic test concept was proposed based on access to the helicopter structure and the structural test floor at Empa (Figure 28). Some hard points at the structure were defined in collaboration with Marengo. 5 push-pull actuators will be used for the test. The sling load case will be tested at the end of the test as well. The test article will mainly be constraint at the rotor head because it offers a lot of potential to react all the test loads. For the design of the test rig, a lot of standard steel parts from Empa can be used. To simulate the loads on the cabin, pilots, passengers, cargo, and inertia forces from heavy parts will be simulated and introduced via a specially whiffle trees. During 4 months, a complex system at the rotor head was constructed using load cells to monitor the loads and moments.

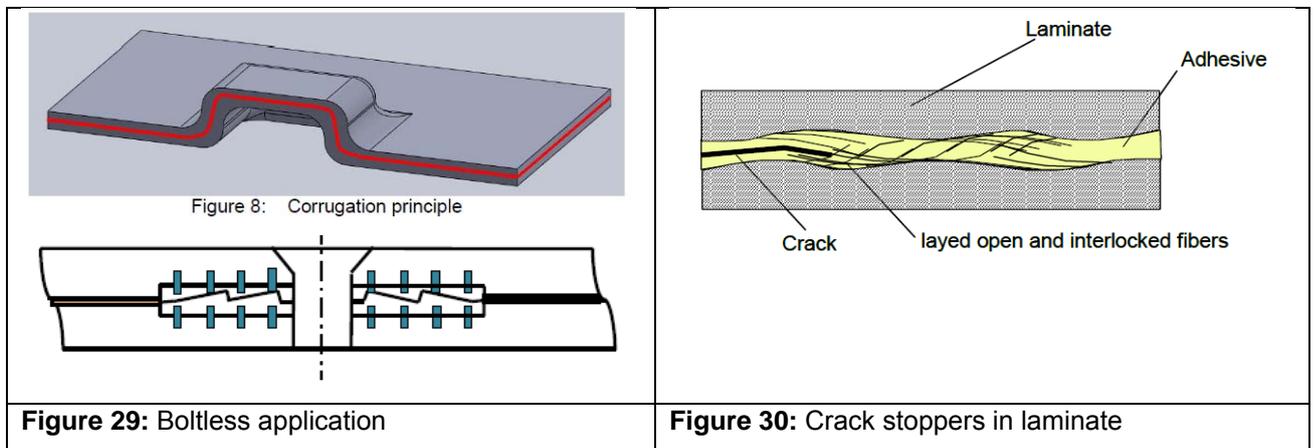
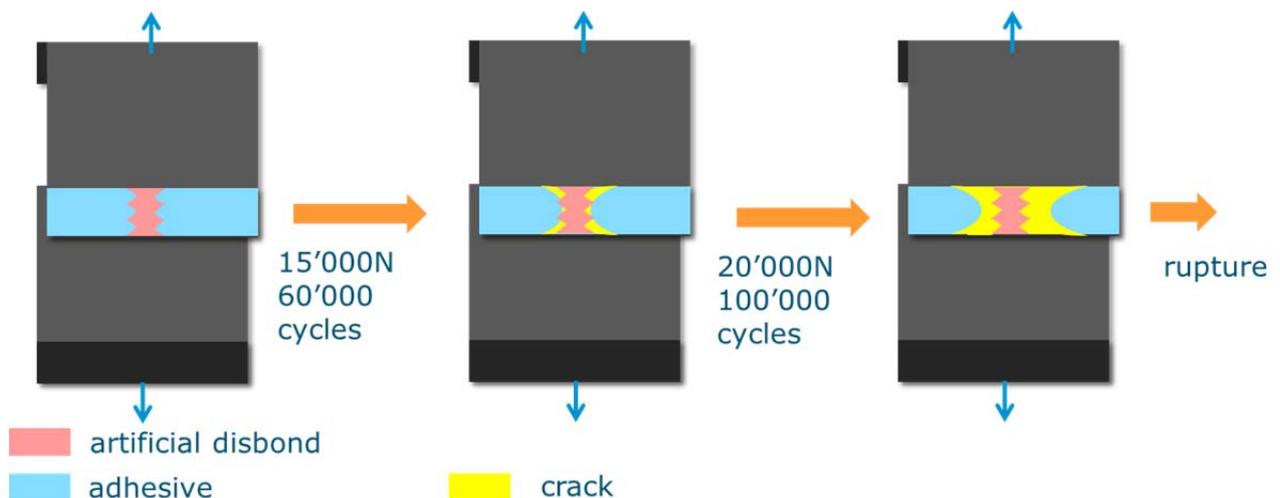
Figure 31: Dynamic test procedure of carbon epoxy specimens

Dynamics tests with strain amplitude of 300 microstrains tensile load were done at R ratio of 0.1. The carbon epoxy specimen consists of 3 mm bonded with epoxy paste adhesive.

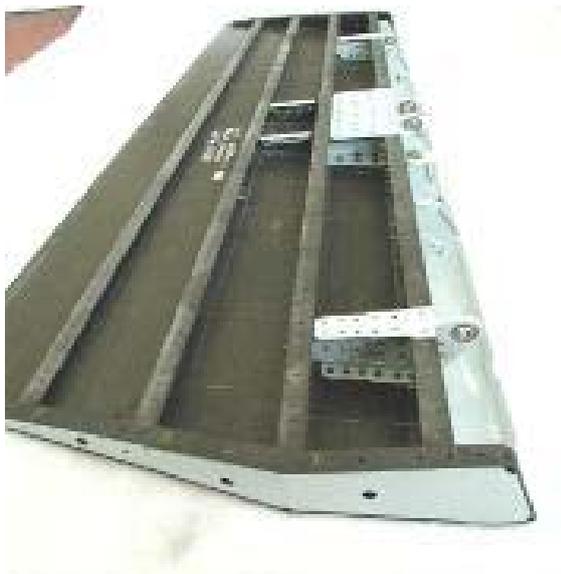
Figure 32: Application of developed technology on aileron of Bombardier CRJ700

A final application test will be made on the aileron flap of the Bombardier CRJ700 airplane.

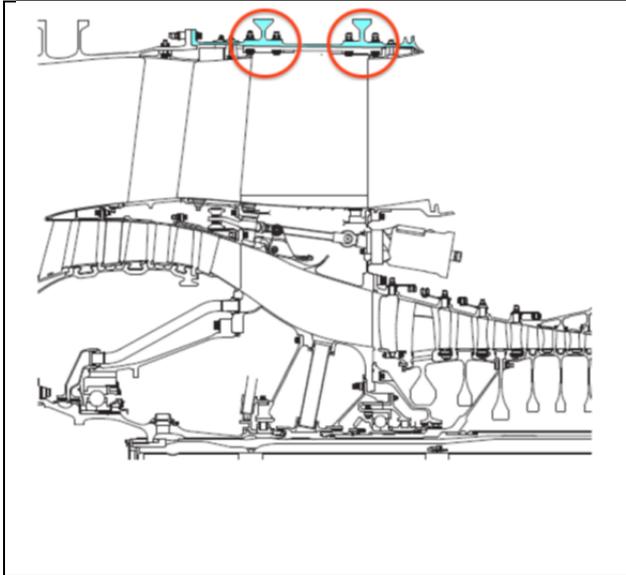
Figure 33: Fan frame shroud CFM56-7B (blue)

If the structural parts are out of tolerances or structural damages are detected during overhaul the parts will be scrapped. The costs for new parts mount up to several hundred thousand USD. Hence, SR Technics tasked the Zurich University of Applied Sciences to do an assessment for repair capabilities of the exhaust nozzle PW4000-100 (Airbus 330) and the fan frame shroud of the CFM56-7B (Figure 33, Boeing 737 NG). The CFM56-7B has some changes compared to the CFM56-5B used on the Airbus 320. The fan frame for CFM56-7B shroud consists of three parts; the outer frame is made of 2219-T6 and the strut hub is Ti-6Al-4V. For the CFM56-5B the whole is one part made of steel 17-4PH.

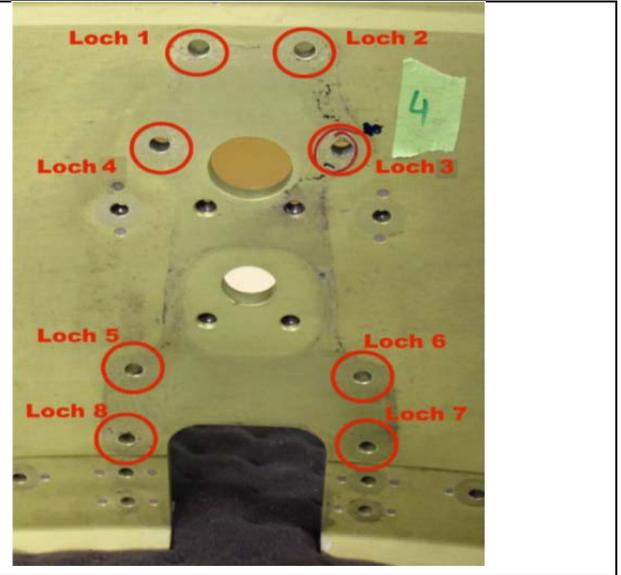
Figure 34: Holes with corrosion damages

Several inspections on multiple CFM56-7B engines showed corrosion spots on the surface (Figure 34) and in the holes on the fan frame shroud. Several factors were considered in order to figure out which kind of corrosion is damaging the structural part. Important was the analysis of the different materials involved in the assembly. The result confirmed the complex situation of fretting, pitting, and contact corrosion. The first conclusion of the OEM was that pitting corrosion is the only source of damage. Several grinding out processes depending on the depth of damage were analysed. For the holes, bushing repair solutions were studied and discussed.

In the meantime CFM adopted the results of the studies and issued a bushing repair for the particular holes.

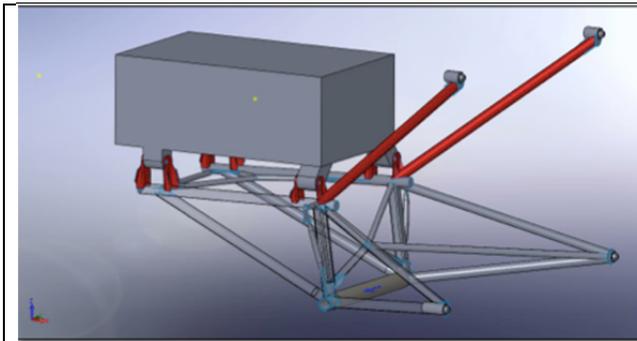
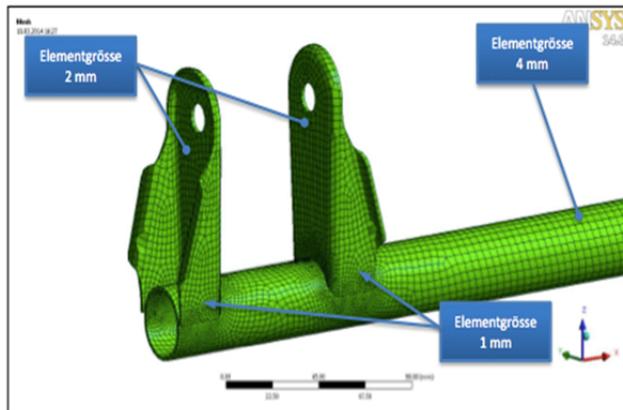
Figure 36: Engine mount structure with FE model

The engine mount is a tube structure with welded connection with steel material 4130 [1], see Figure 36 below; general simplified layout and detailed picture (aft connection to engine = Motorlasche).

In this FE model, the welds were not modeled. For the connection of the tubes ANSYS Workbench "bonded" approach was used. In the connection area the mesh size was further reduced to 1 mm.

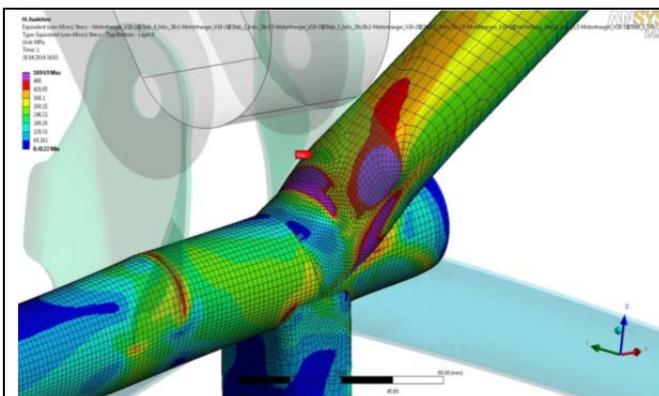
Figure 38: Critical stresses based on FE analysis,

The results of the FE model showed large deformations of 4 to 4.8 mm at left hand forward engine mount fairing. The static analysis was based on the FKM requirements. Based on the static strength analysis the ultimate load cases of steady state 6G maneuver and horizontal spin maneuver exceeded the tensile strength of steel 4130. Local plasticity was not modeled in detail which would give more accurate results.

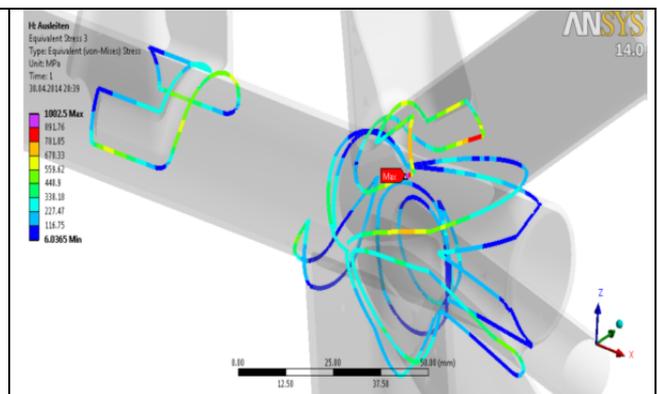
Figure 39: CAB detailed analysis for structure.

To improve the model especially at the connections and interfaces the FE model was locally refined using a submodel with volume mesh elements. The welds were simulated with a typical radius.

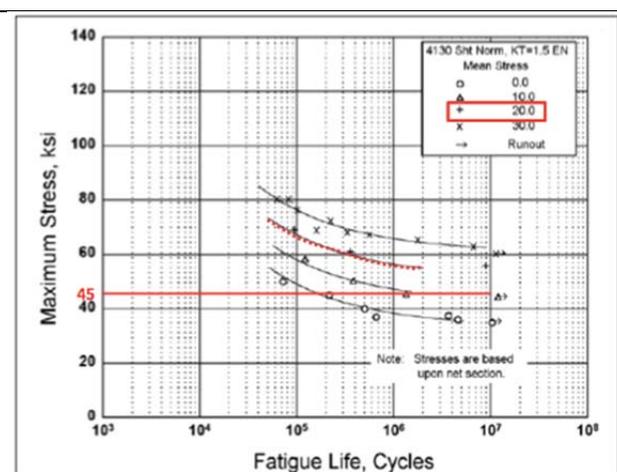
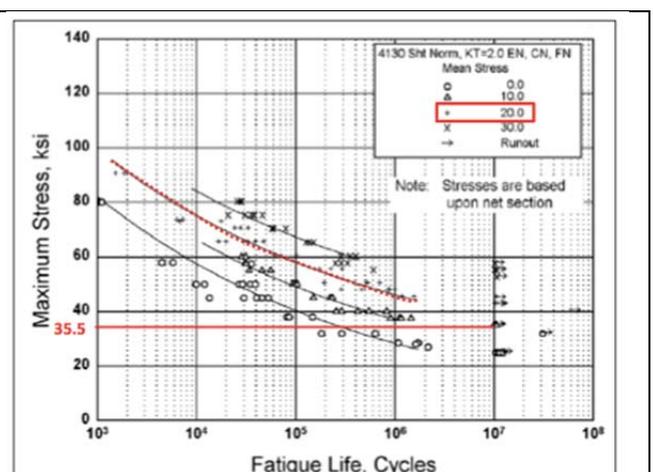
Figure 40: Stress life curves for $kt=1.5$ left side,

For fatigue investigations the flying steady maneuver loads are contributing to the fatigue damage. In the first approach MIL-HDK-5J data, see Figure 38, for steel 4130 at stress concentrations $kt = 1.5$ and of $kt = 2.0$ was used for max min stress level to see if the fatigue life is in the area of durability life. This kt values are considered because the *Motorlasche* has the kt of 1.25 and the *Anschlussbolzen* a kt of 2.0. The max stress for the *Motorlasche* was 35.5 ksi respectively 45 ksi for *Anschlussbolzen* at mean stress of 20 ksi. Both values are below the red dotted curve at 10^7 cycles, see Figure 40. This confirms that the two locations have a durability life.

To get more confidence in our analysis, we also used the local strain life approach with strain life curves. Therefore, the strains from the detailed FE models at the two critical locations (*Motorlasche* and *Anschlussbolzen*) were taken into account. Using strain life data with stress ratio of $R = -1$ we observed strain amplitudes of 0.14% (*Motorlasche*) respectively 0.23% (*Anschlussbolzen*). The strain amplitude of 0.23% showed 100'000 cycles up to failure whereas 0.14% showed infinite life. The stress ratio of the real cycle is about 0.4 which yields a higher number of cycles up to failure.

Figure 41: and $kt=2$ right side
