Review of aeronautical fatigue investigations in the Netherlands during the period March 2013 - March 2015

National Aerospace Laboratory NLR

NLR-TP-2015-123 – April 2015

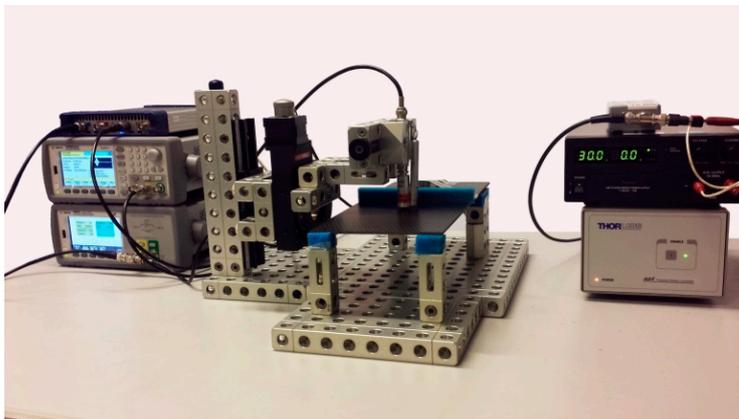
Experimental setup for air-coupled ultrasound, used for structural health monitoring.

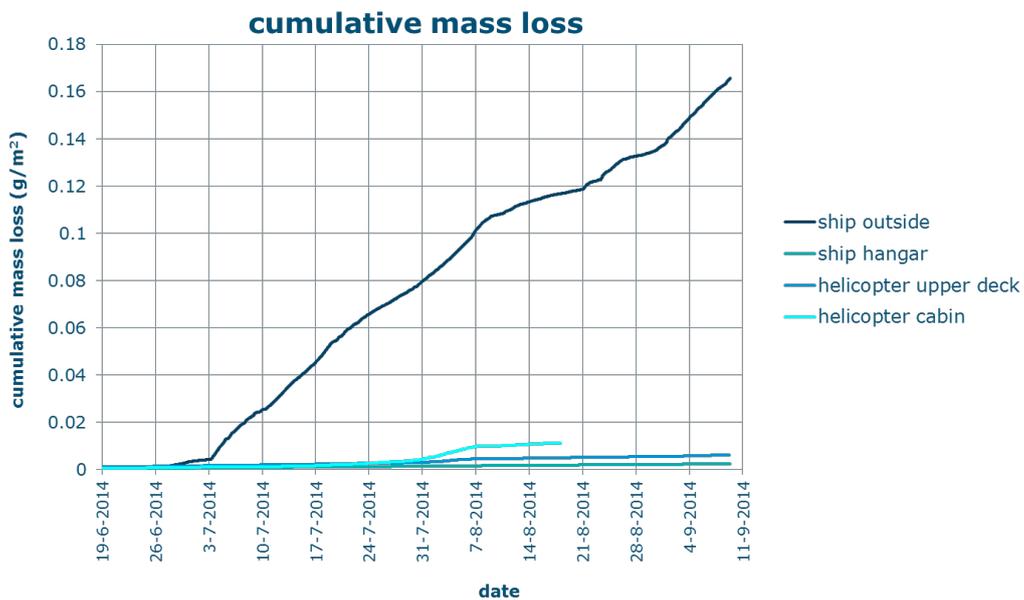
Figure 1: Cumulative mass loss results after 3 month exposure on a ship, measured with a AA7075-T6 corrosion rate probe.

The first results show that the helicopter experiences conditions that are more severe than in the hangar, but less severe than on the helicopter deck (Figure 1). The corrosion coupons indicate very severe conditions on the helicopter deck (Figure 2), which is confirmed by the sensor measurements.

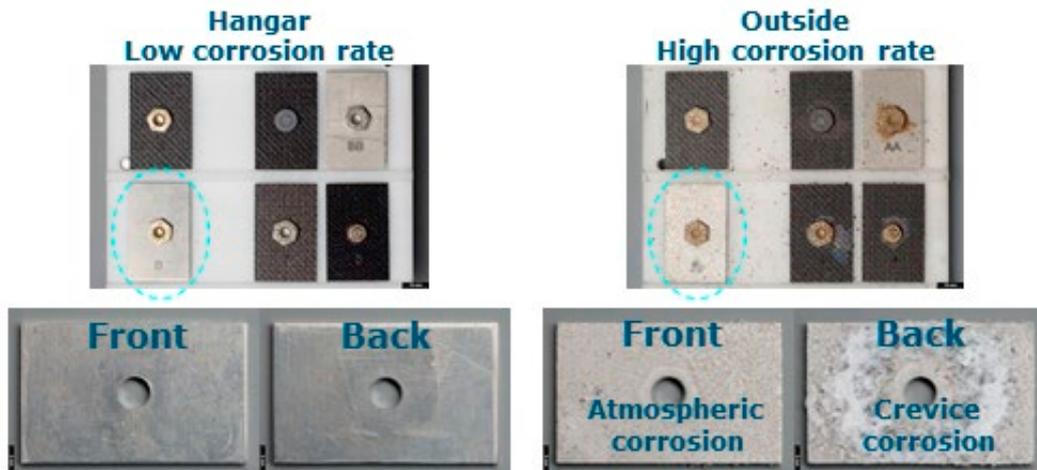
Figure 2: Corrosion coupons after 3 month exposure on a ship.

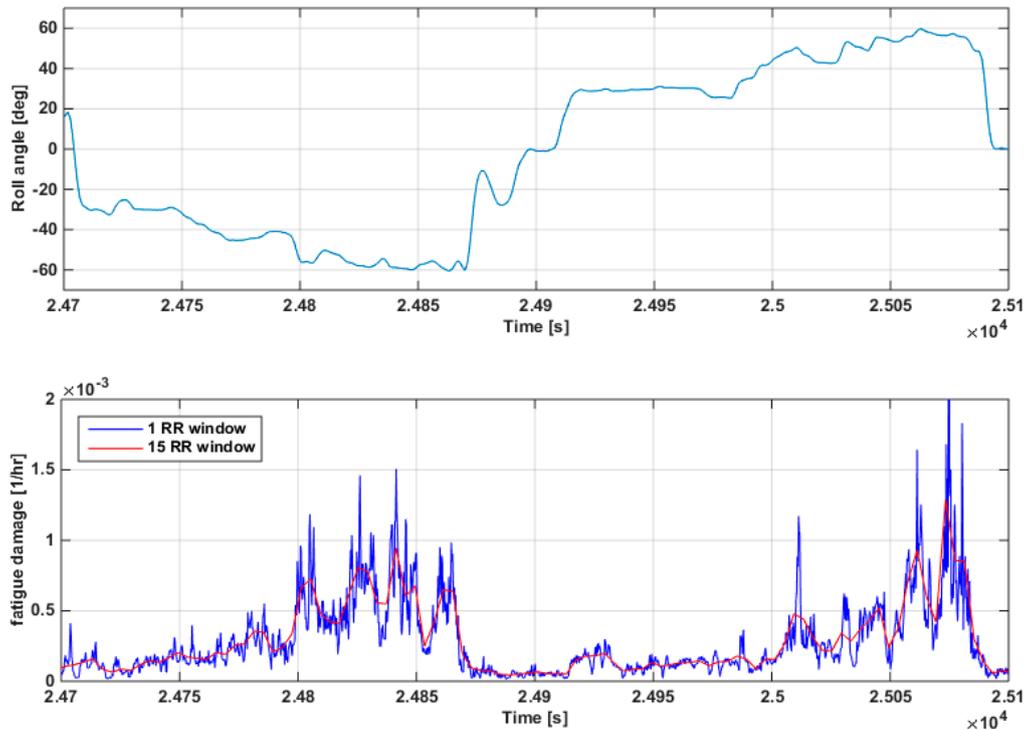
Figure 3: Severity of turning manoeuvres at different roll angles.

whole flight shows that the differences are small. Figure 3 shows the ‘window’ fatigue damage for LH and RH turning manoeuvres.

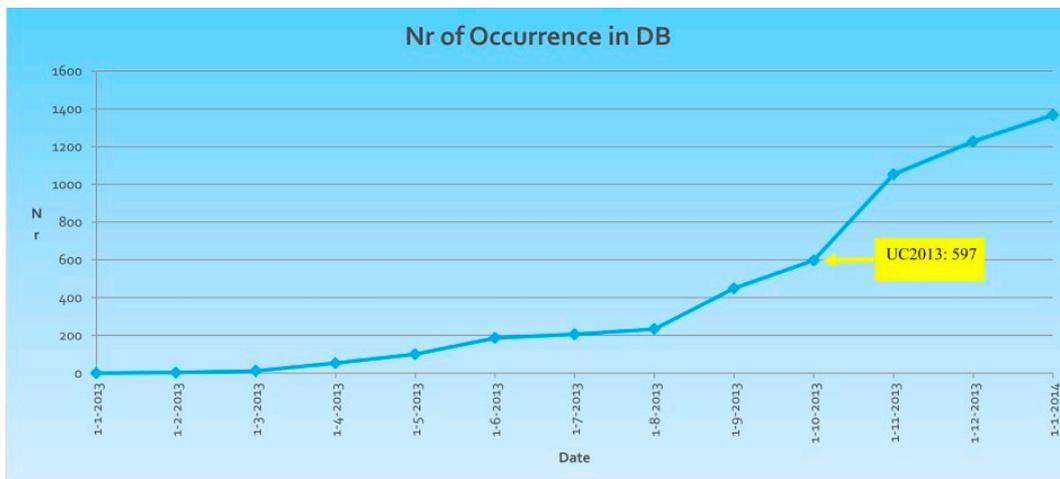
Figure 4: Number of NH90 occurrences in the database, status January 2014.

Figure 4 below illustrates the number of occurrences as of January 2014. In the meantime, this number has increased to approximately 2500 occurrences by January 2015. The sources of the respective occurrences is indicated in Figure 5, showing that most NH90 occurrences originate from issues, labeled General, Circumstances, Additional and Equipment. It has to be noted that these indications are rather premature, because most participating nations are still in the process of generating a Business-to-Business interface to achieve autonomous data upload into the SDE service at NLR in the Netherlands.

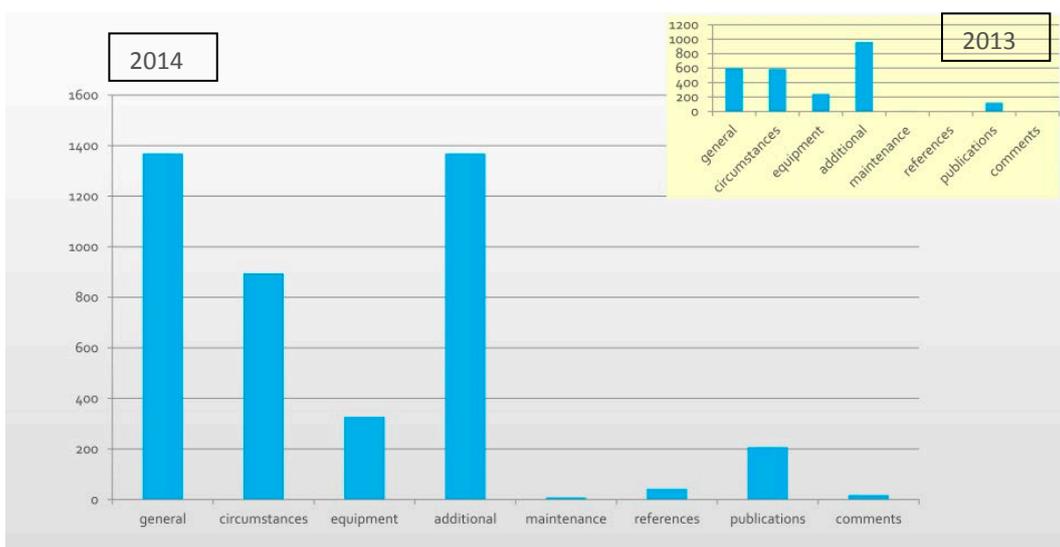
Figure 5: Sources of NH90 occurrences.

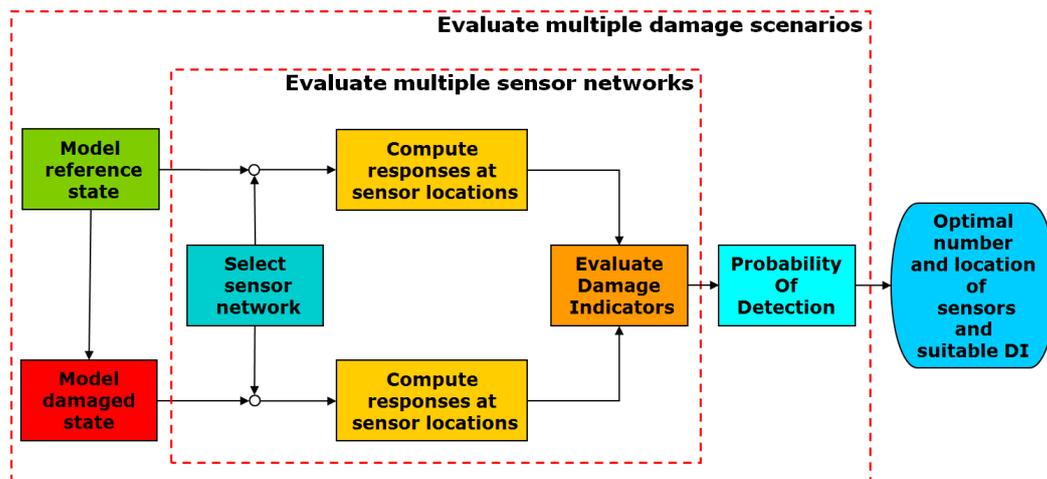
Figure 6: Flow diagram of the SHM damage detection design tool.

Within SARISTU an existing structural health monitoring (SHM) system design tool has been extended (Figure 6). The design tool is highly automated and can be applied to examine a strain sensor network (number and location) for its suitability for damage detection. Embedding or surface mounting of sensors can be easily taken into account as well.

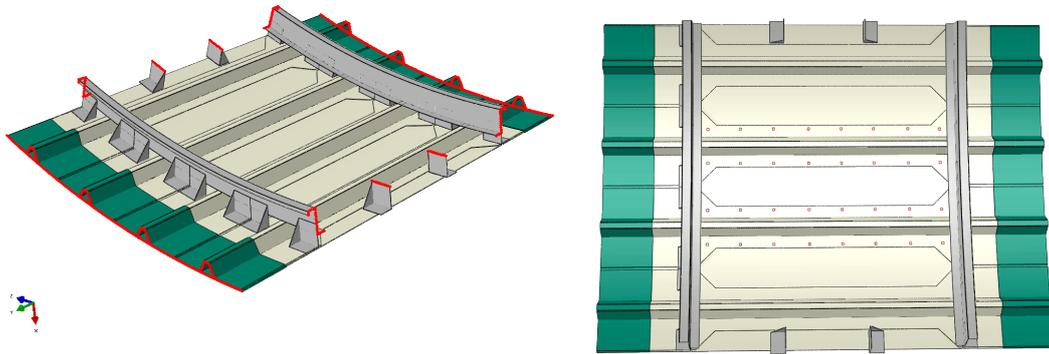
Figure 7: FBG sensor network design for a SARISTU fuselage panel.

Within SARISTU various FBG sensor networks were examined for different (flat and curved) fuselage panels. An example is presented in Figure 7 and Figure 8, which show a composite skin with hat stiffeners and aluminium clips and frames.

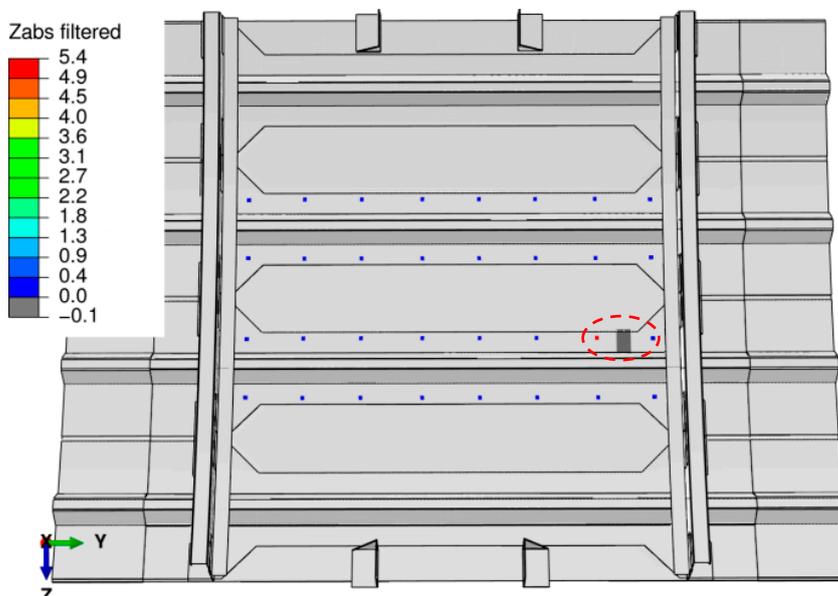
Figure 8: Damage indicator values signaling damage (in red), a simulated skin-stringer debond (in grey).

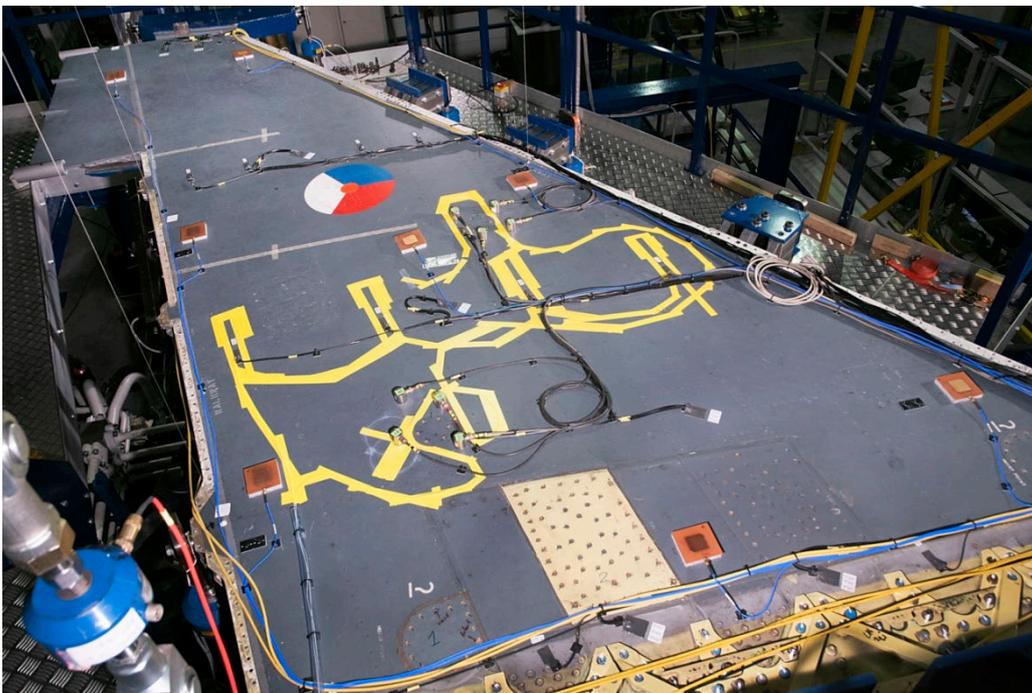
Figure 9: Monitoring of the F-16 LHS upper wing skin with AE and FBG sensors.

In addition to the instrumentation with conventional strain gauges (e.g. single gauges, full bridges and rosettes) also special load monitoring and structural health monitoring (SHM) techniques were used during the test (Figure 9 and Figure 10). For load monitoring the data of conventional resistance strain gauges were compared with the response of optical fibre Bragg gratings (FBG). A total of 19 FBG's were installed on the upper wing skin, divided over three fibres. Two FBG interrogators were used: a Deminsys system of Technobis Fibre Technologies (wave length range 830 - 870 nm) and an IFIS100 system of the Korean company Fiberpro (wave length range 1510 - 1595 nm). For SHM the acoustic emission (AE) and comparative vacuum monitoring (CVM) techniques were employed to monitor fatigue crack initiation and growth. AE continuous monitoring was done with a 16-channel SAMOS AE system (Physical Acoustics B.V.) and 16 resonant sensors (150 kHz) covering five critical locations on the upper and lower wing skin. A CVM laboratory system (Structural Monitoring Systems) with nine S0400 intercept CVM sensors was used for fatigue crack detection at the 'finger' areas of the lower wing attachment fittings under periodic monitoring.

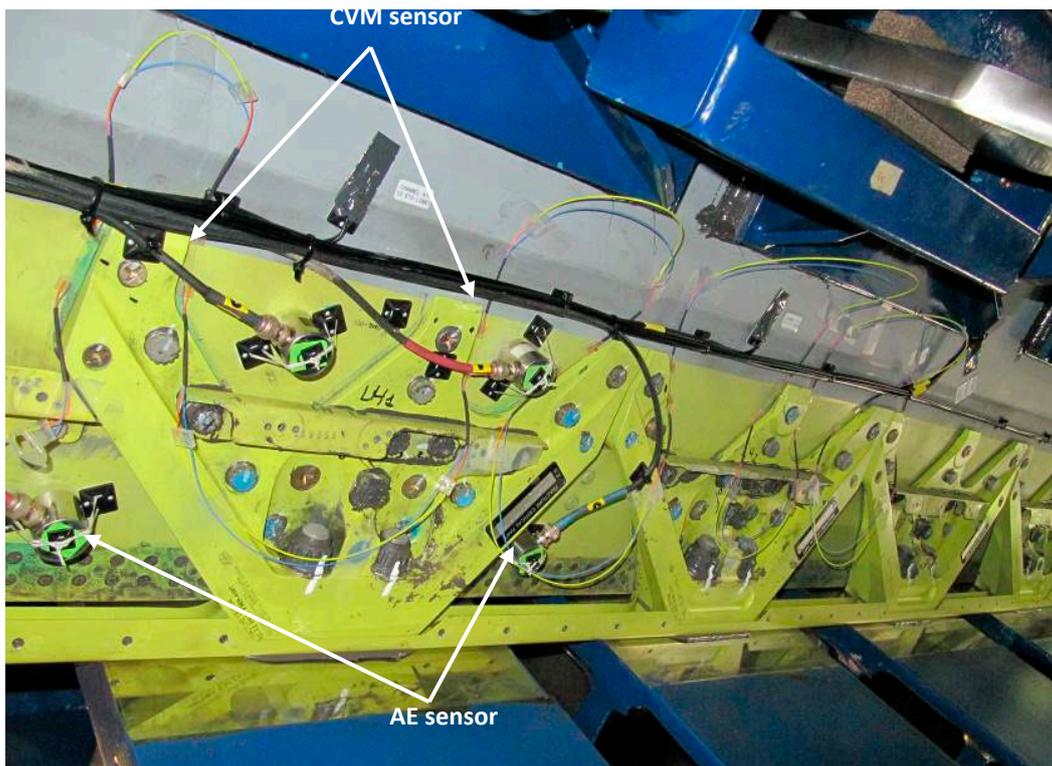
Figure 10: CVM and AE monitoring of the 'finger' areas of the WAF's on the lower wing skin.

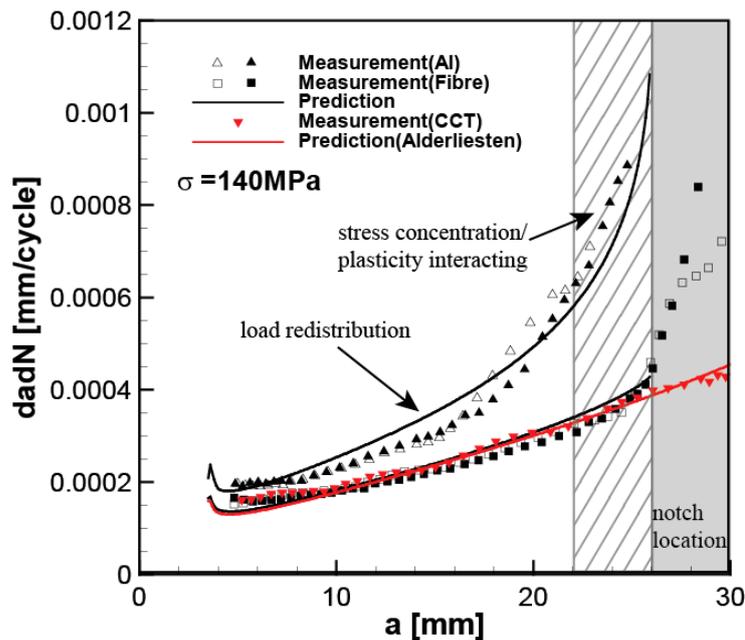
Figure 11: Comparison of effects of different stiffness reductions on the crack growth behaviour in FMLs.

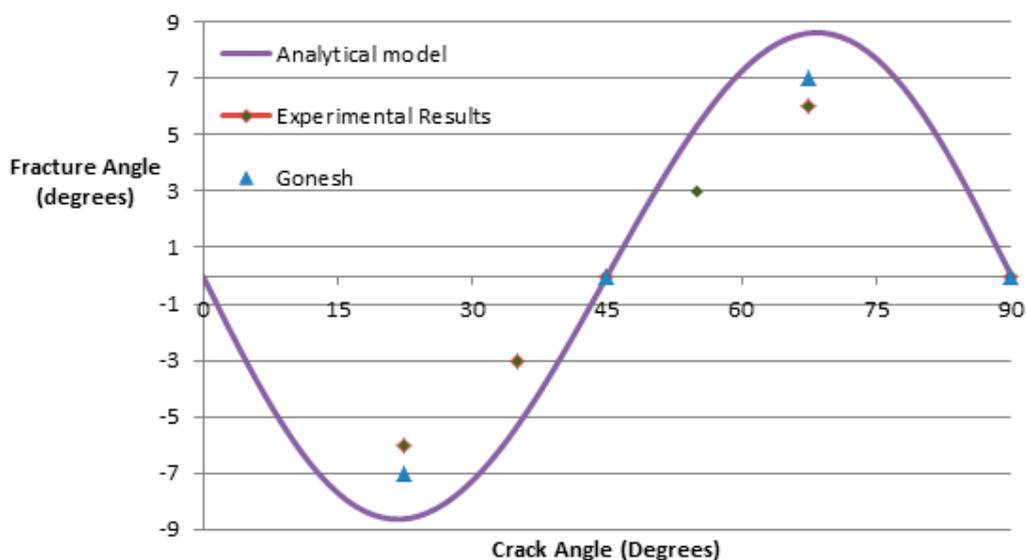
Figure 12: Comparison of experimental results (refs. [16] and [17]), and the analytical model.

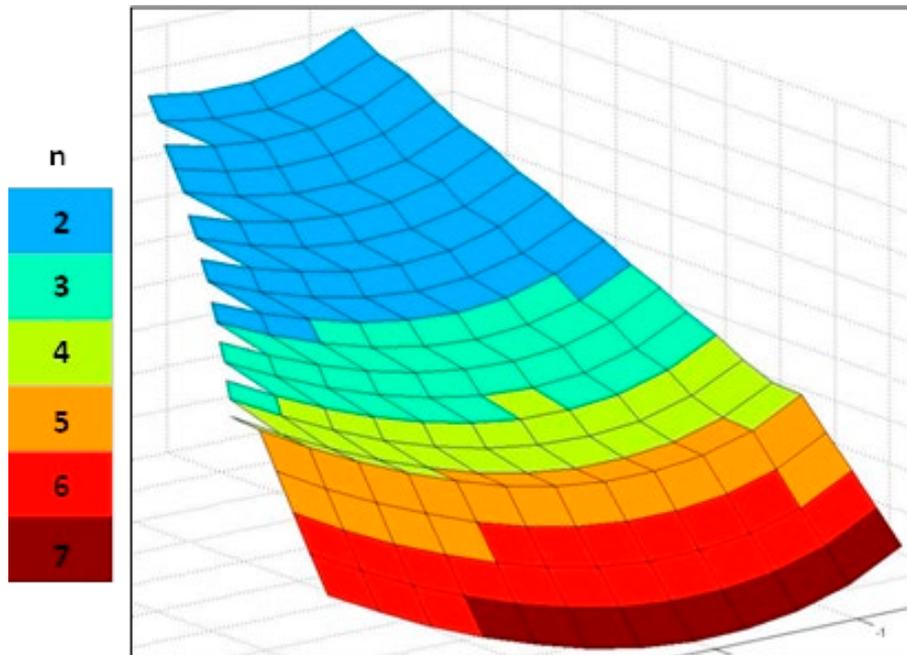
Figure 13: Wing optimisation based on $Glare2A-n/(n-1)-0.8$, n is the repetition number of a grade (number of metal layers).

Finally, the cross-section optimisation is linked to an analytical wing design model, that is now capable of dimensioning an aircraft wing structure using FML, see Figure 13 for an example output. The tool has the ability to compare and evaluate material configurations, to investigate the influence of various design criteria on the lay-up solutions and to optimise the material for the wing structure for minimised weight by considering real load cases and a parametric definition of the wing structure.

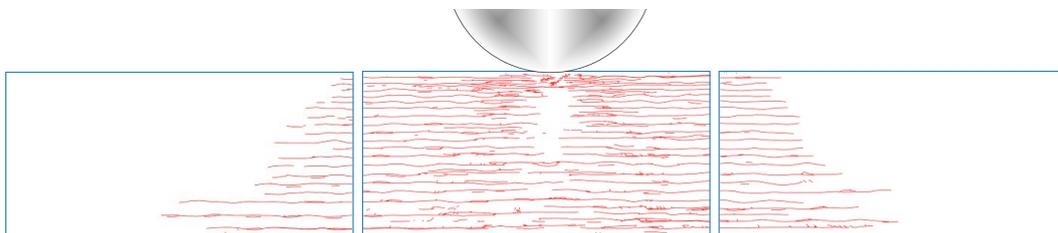
Figure 14: Slice through the centre of a specimen containing 1 inch high speed 140 J impact damage.

Thick composites (>20 mm) are sometimes thought to be fairly insensitive to impacts. However, for sufficiently high impact energy levels with blunt impactors, large damages may still occur with delaminations through the entire thickness of the laminate, see Figure 14.

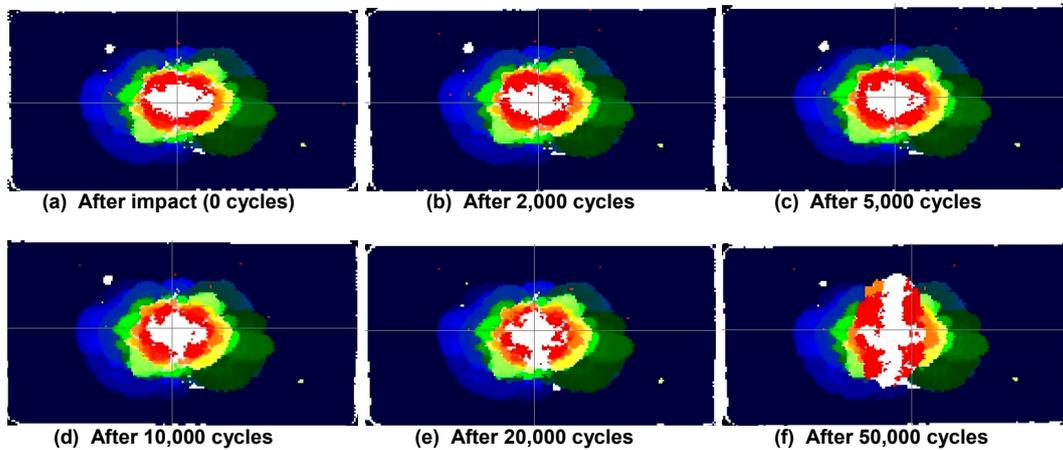
Figure 15: C-scans of impact damaged specimen (1 inch high speed 90 J) loaded in fatigue.

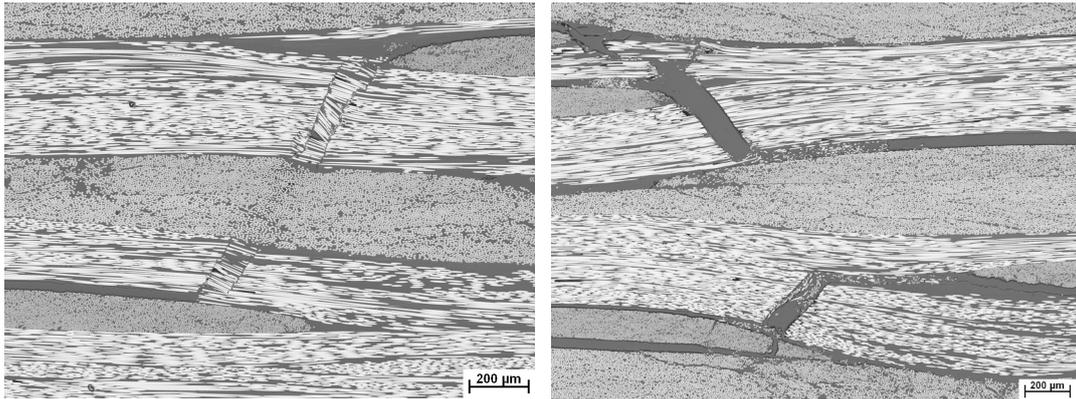
Figure 16: Left picture: kink bands at the delamination boundary. Right picture: kink bands that are pulverised under fatigue and migrate into the open delamination (deeper inside the laminate).

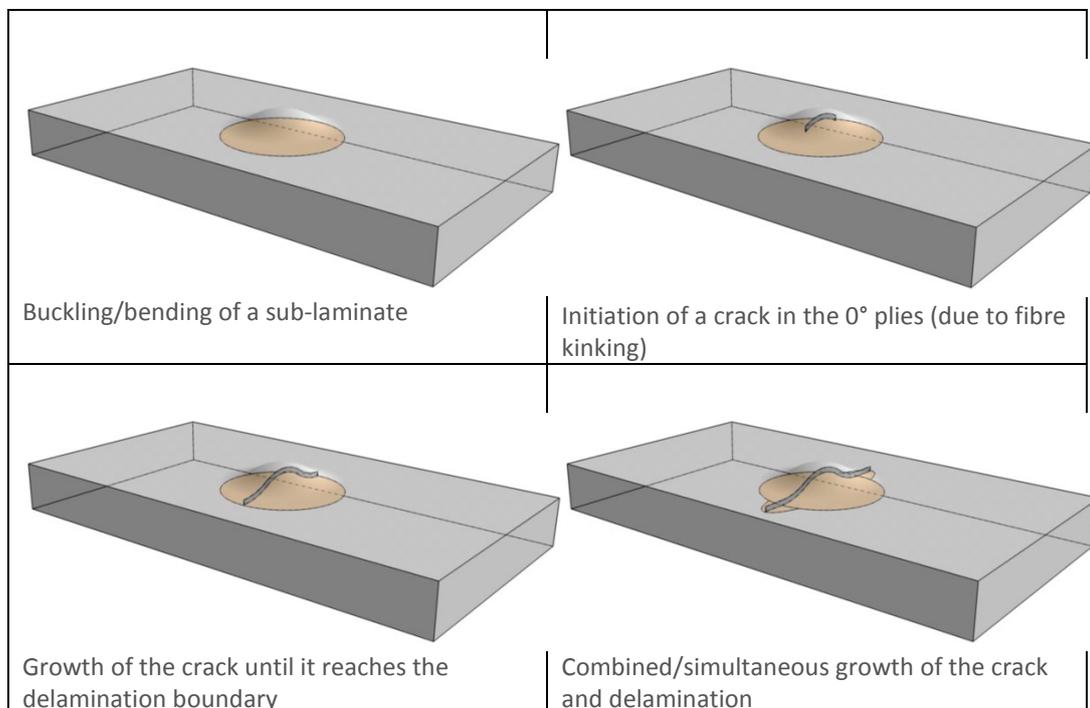
Figure 17: Schematic representation of the different stages of damage growth due to fatigue.

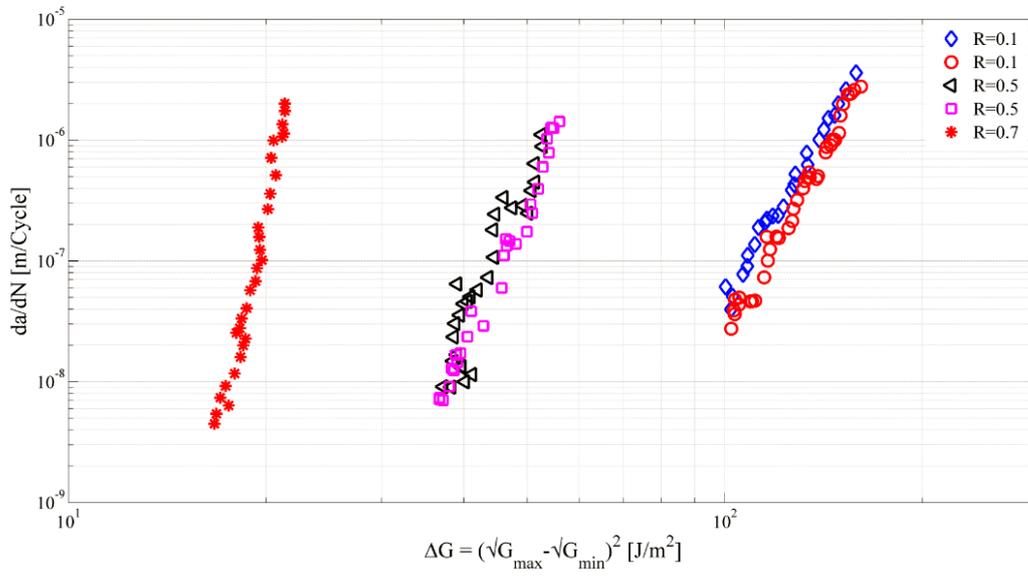
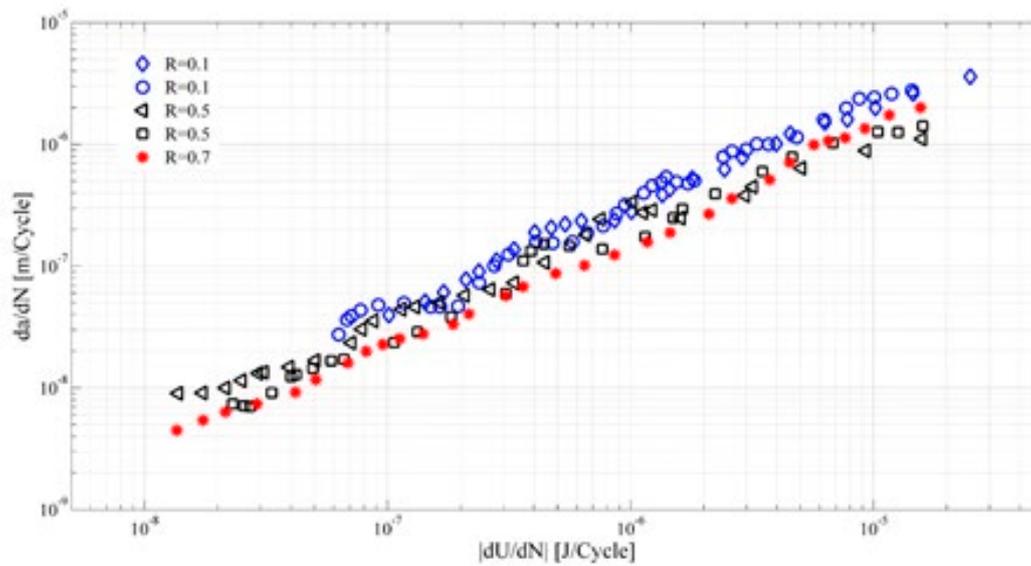
(a) Standard Paris-type correlation.

(b) da/dN against dU/dN

Figure 18: Mode I fatigue experimental results at different stress ratios.

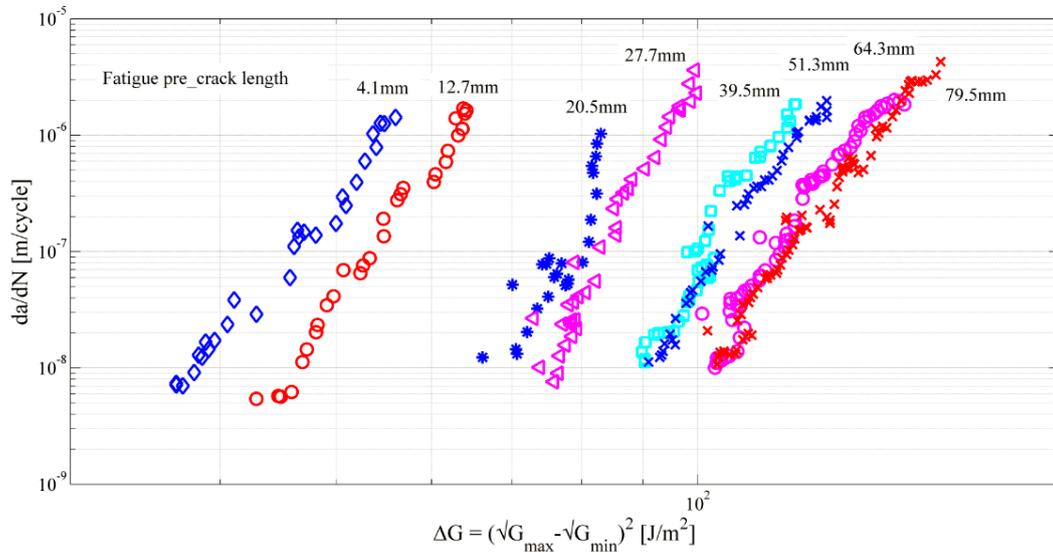
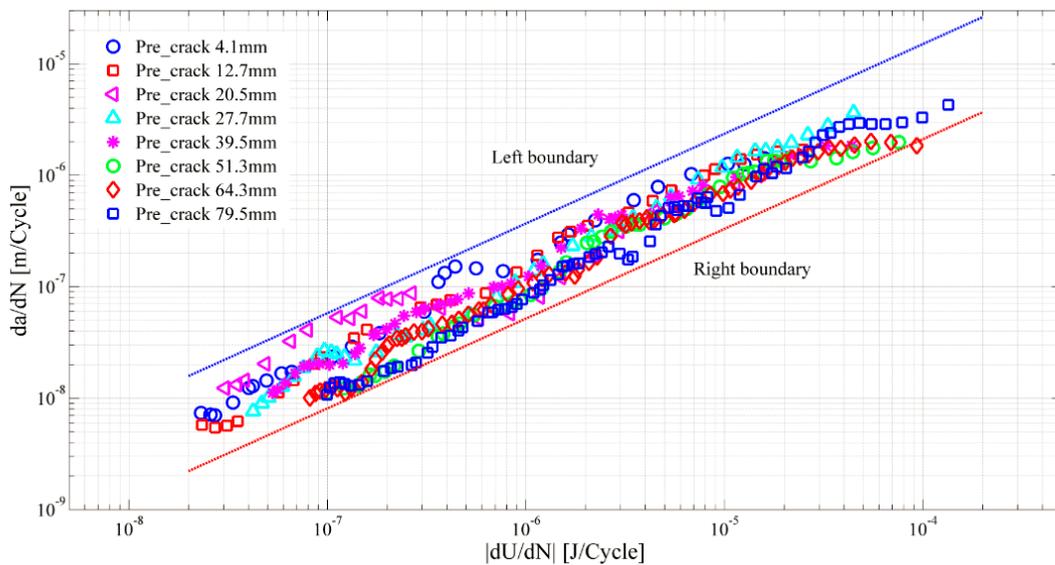
(a) Standard Paris-type correction

(b) da/dN against dU/dN

In Figure 19(a), the resistance curves shift from left to right with the increasing of crack length. In other words, the longer the pre-crack, the lower the crack growth rate at the same value of ΔG . However, if the crack growth rate is plotted against the energy dissipation per cycle, as done in Figure 18(b) all the resistance curves converge to a narrow strip. This shows that the phenomenon illustrated in Figure 19(a) is artificial and is related to the inaccurate application and calculation of SERR during fatigue delamination analysis. Bridging fibres periodically store and release strain energy in the cyclic loading. They contribute the permanent energy dissipation only when failure occurs in them. Therefore, the actual amount of energy required to grow a crack does not depend on the amount of fibre bridging, only the stress state at the crack tip (represented by ΔG) does.

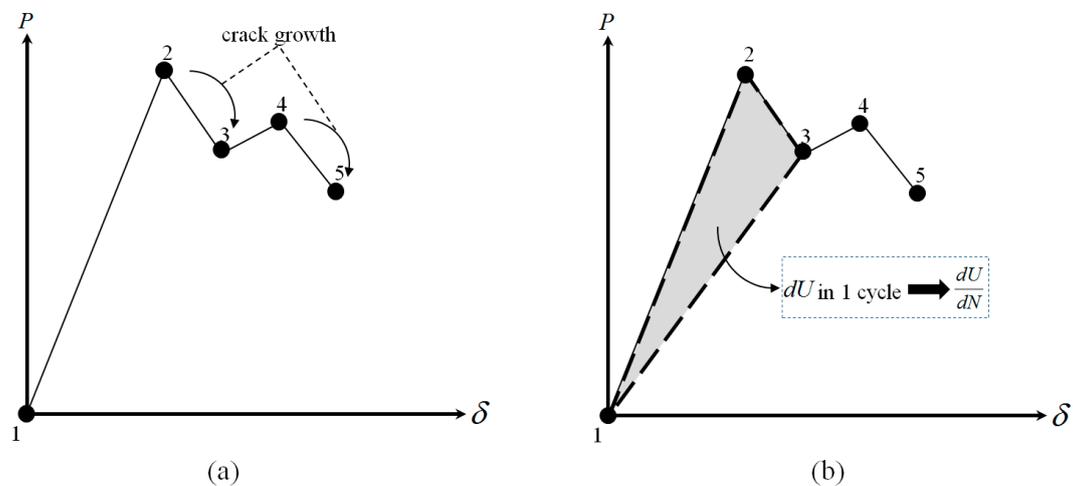
Figure 20: Illustration of the concept to discretize the quasi-static load deflection curve into low cycle fatigue cycles.

This concept is illustrated in Figure 20, Figure 21 and Figure 22.

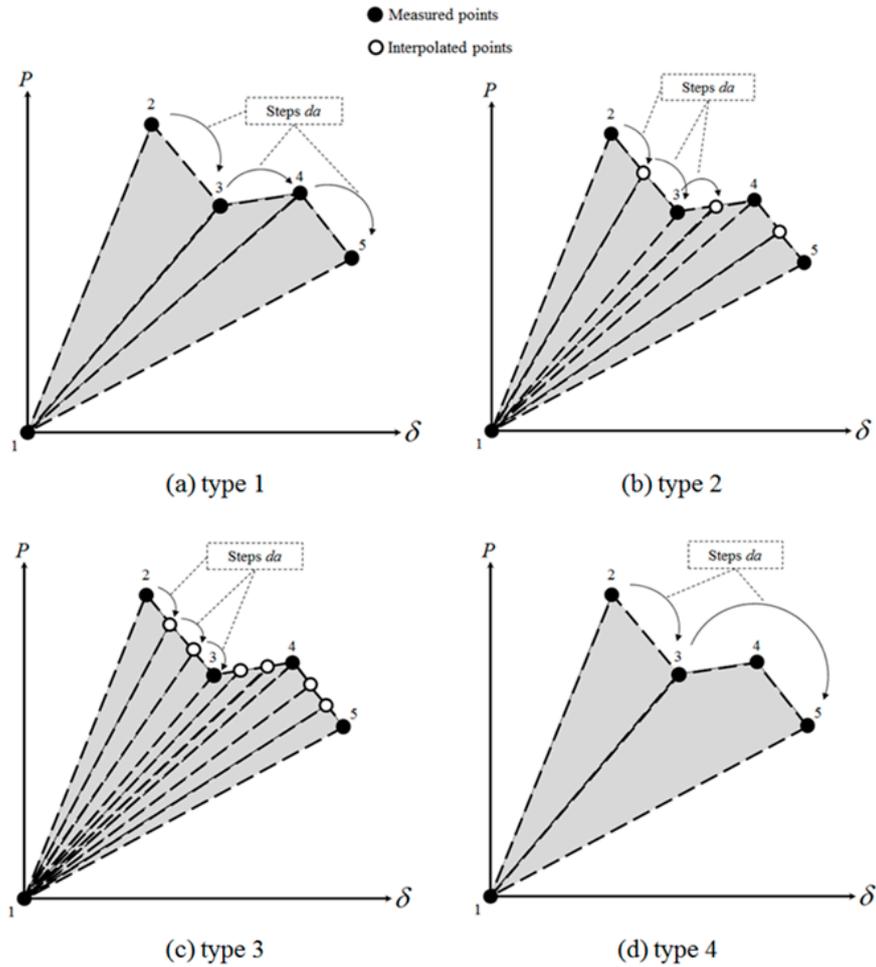
Figure 21: Illustration of the different levels of discretization of the same quasi-static data set.

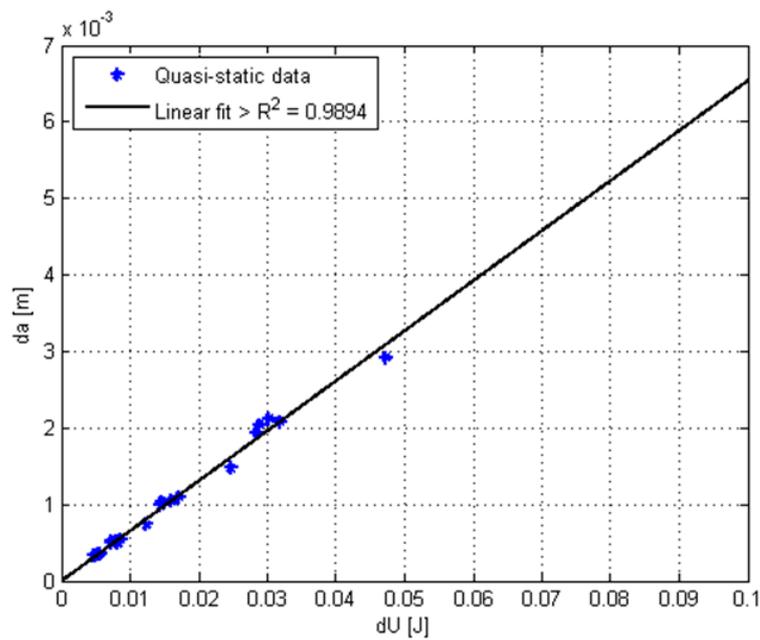
Figure 22: Average data points for different levels of discretization of the quasi-static data.

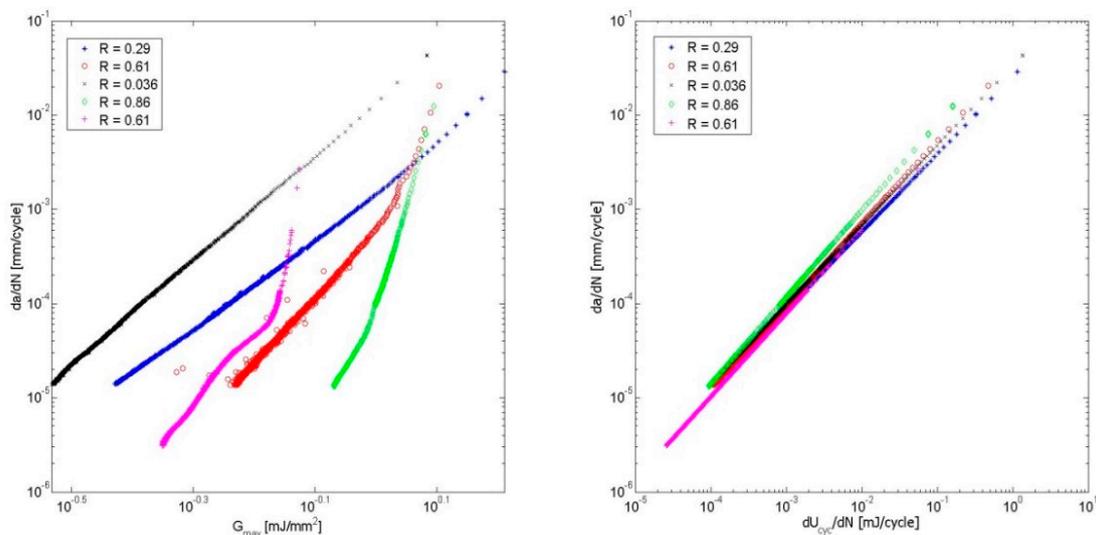
Figure 23: da/dN correlated with the maximum strain energy release rate, as is traditional (left) and with the energy dissipation per cycle (right).

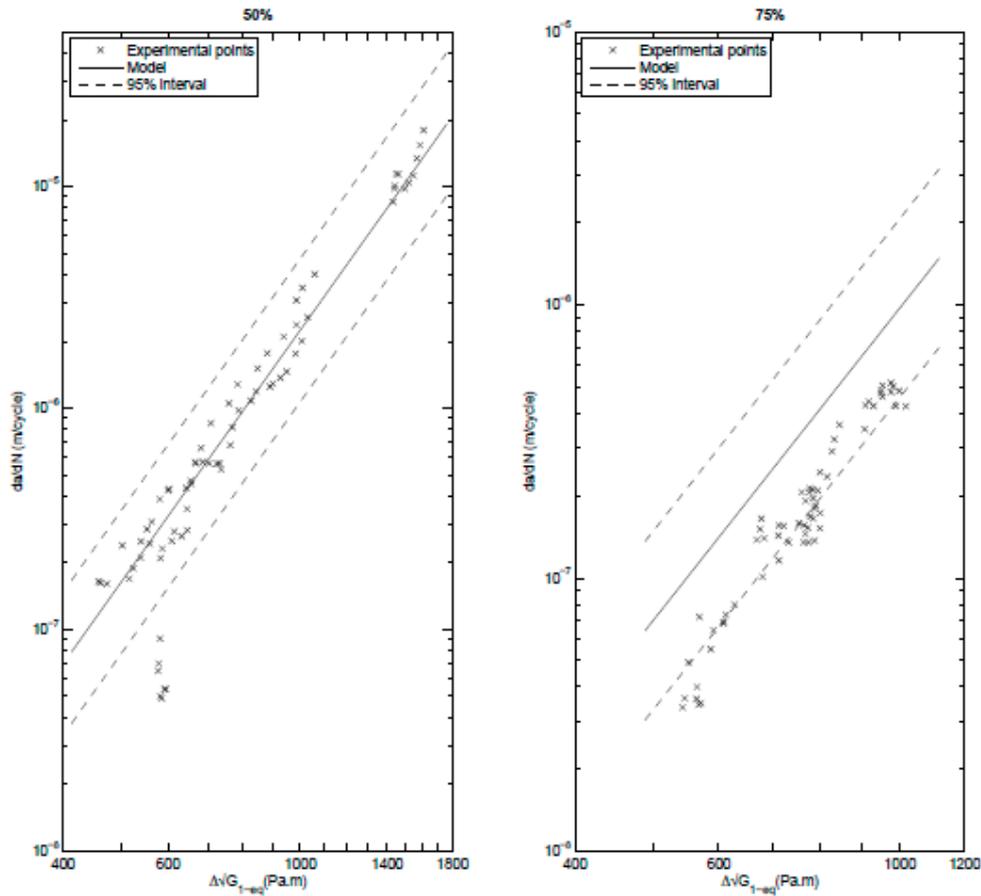
Figure 24: Model predictions for $MM = 50\%$ and 75% .

The model was evaluated in three data sets, two produced by the authors and one from the literature. The predictions have shown a good agreement with the experimental results. Moreover, the predictions tend to be conservative in the cases the agreement was not good (Figure 24).

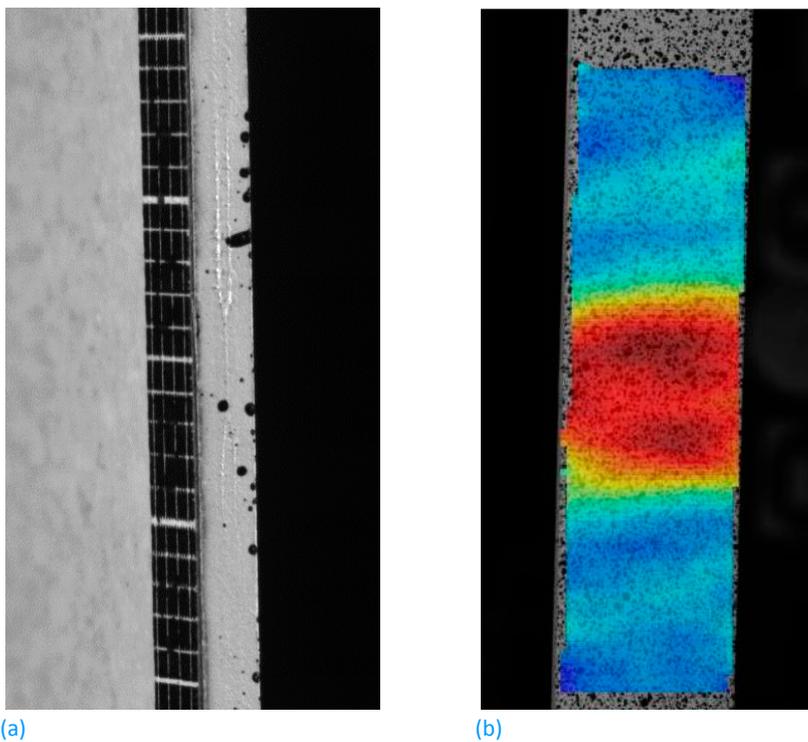
(a) (b)
Figure 25: Detail of four adhesive cracks on CCP specimen (a) and DIC measurements on the specimen's surface (b).

effects can be better observed from a reference (constant) value of crack growth. For the crack measurements, different NDE techniques are employed. Figure 25 (b) shows a Digital Image Correlation (DIC) analysis used for calculating crack growth from strain distribution over the specimen's surface.

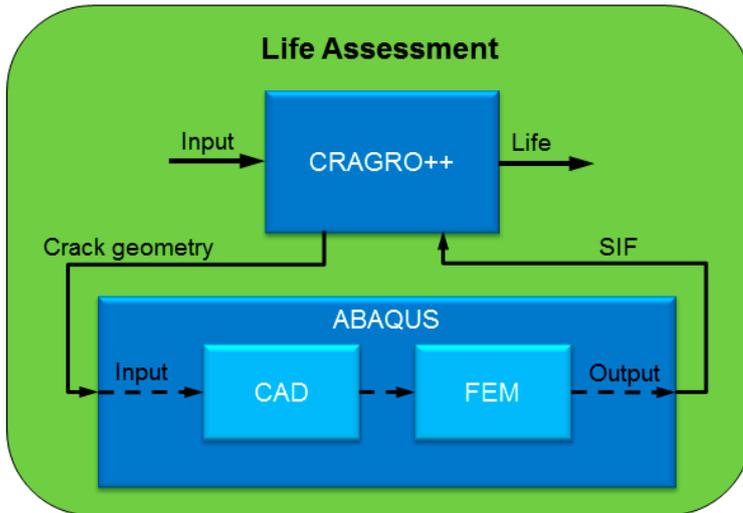
Figure 26: Life assessment framework for complex geometries and loading.

At NLR a lifing framework was developed with which a crack growth life analysis for a complex geometry and load can be performed much more efficient, automating the different steps as much as possible, especially the time consuming parts. The framework, schematised in Figure 26, provides a coupling of a CAD tool to define parameterised crack geometries, a finite element tool to compute the SIF solution and a crack growth tool to compute the life of the structure.

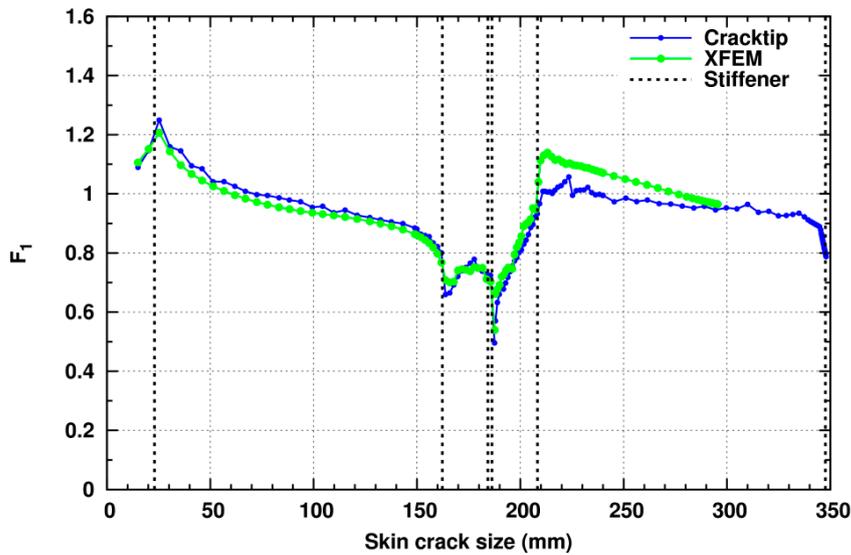
Figure 27: Obtained normalised SIF solution for the crack growth in the stiffened panel.

The framework was demonstrated on several one-dimensional and two-dimensional crack geometries, as well as for the F-16 wing test of section 8.1. For these examples the SIF solutions were automatically computed and, if possible, compared against handbook solutions. For a number of interesting examples, also more advanced crack growth life computations were demonstrated, e.g crack bifurcation in an integrally machined stiffened plate requiring on-the-fly SIF computation. Figure 27 shows the computed SIF and Figure 28 a deformation plot for one crack geometry showing a bifurcated crack with a crack growing simultaneous in the stiffener foot and in the web.

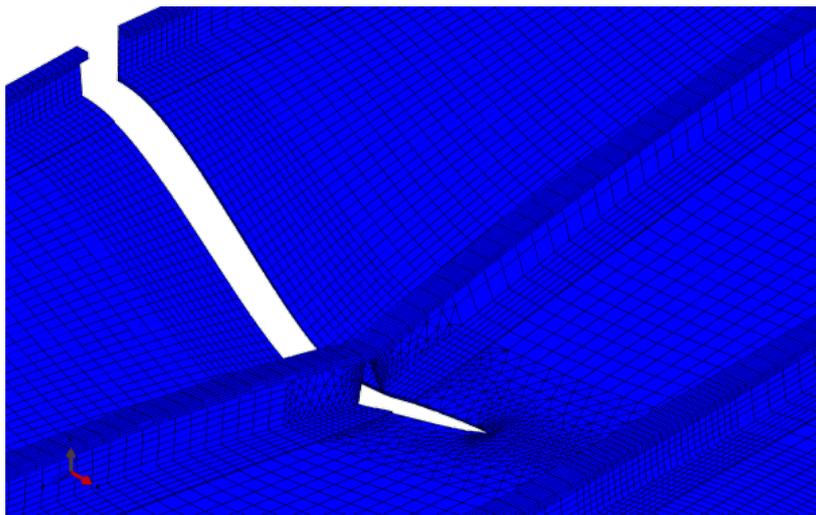
Figure 28: Deformation plot for a crack in an integrally stiffened panel.

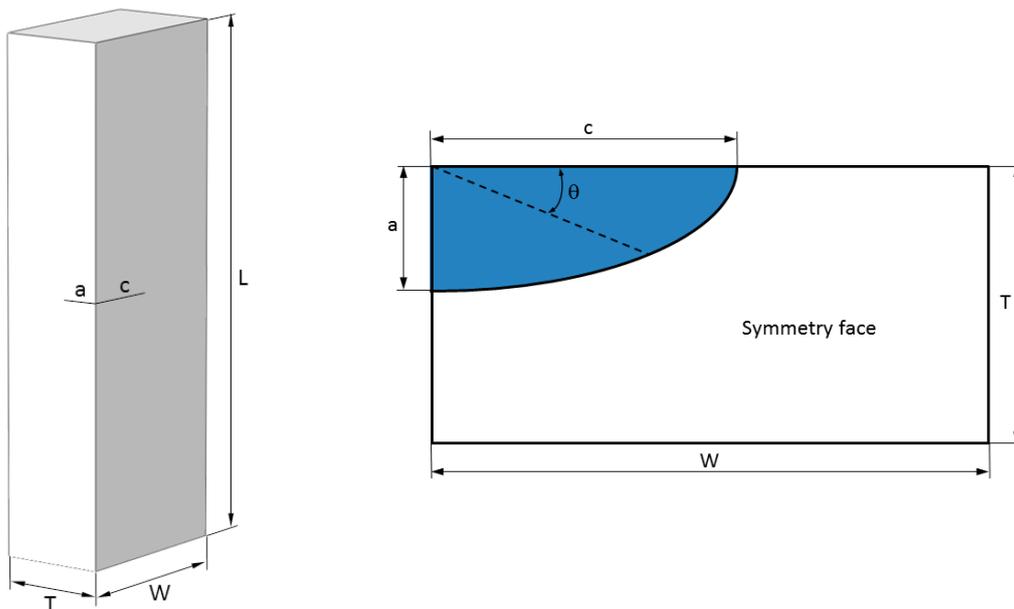
Figure 29: Schematised corner crack geometry.

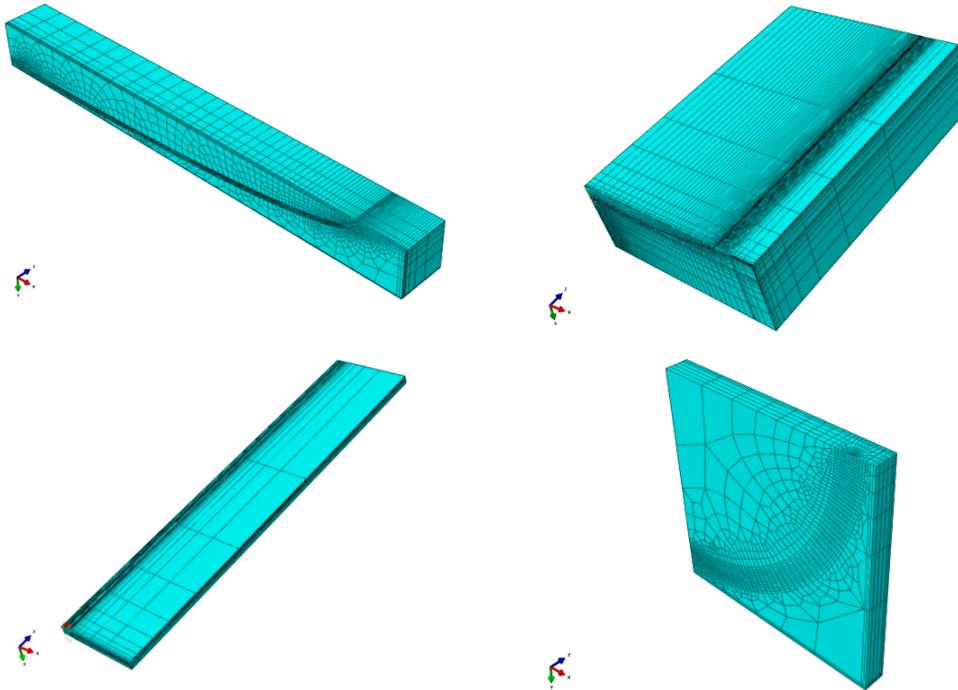
Figure 30: Examples of analysed corner crack configurations.

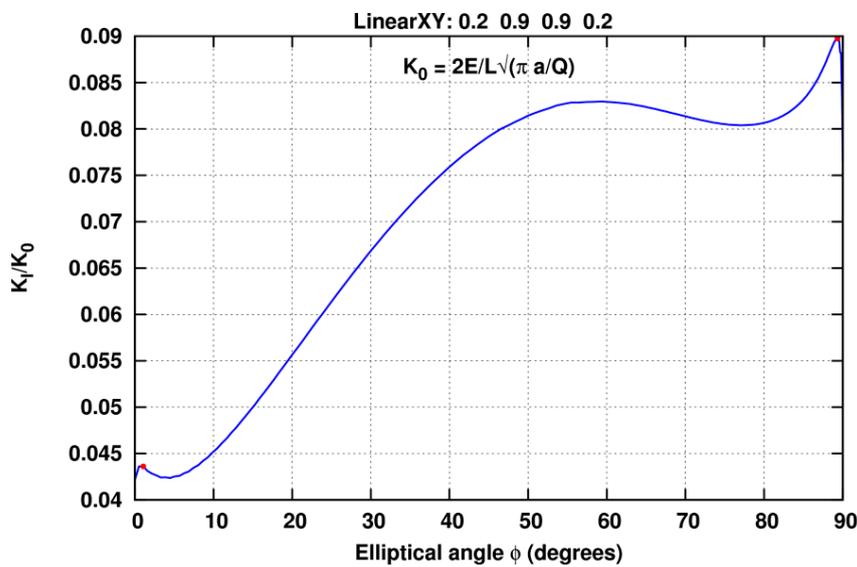
Figure 31: Example normalised SIF solution for a linear displacement field in both directions for $a/c=0.2$, $a/T=c/W=0.9$, $L/W=0.2$.

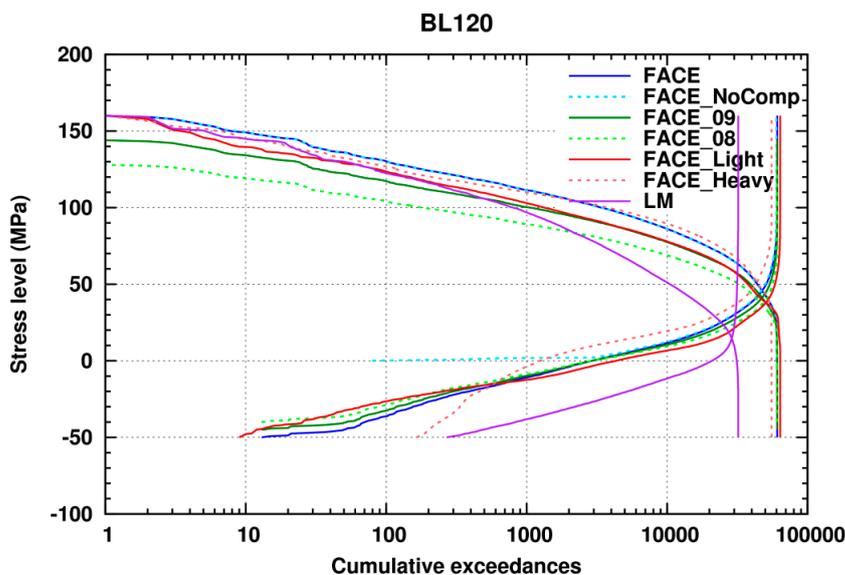
Figure 32: Stress exceedance plot of the applied BL120 test load spectra.

A second strain gauge is located near the BL120 location on the lower wing skin. The strains/stresses obtained at BL120 significantly differ from the wing root area and are thus more representative of the load severity in this part of the wing. The main objective of the work was to examine a possible extension of the CSI concept to this second strain gauge location. A second objective was to check the CSI concept for the FS325 location for the current usage which differs from the usage during the validation of the CSI concept in 1991. To this end, a series of fatigue crack growth test on representative MT coupons were performed for different load spectra, see Figure 32, and the results were applied to validate the CSI concept for both wing strain gauge locations.

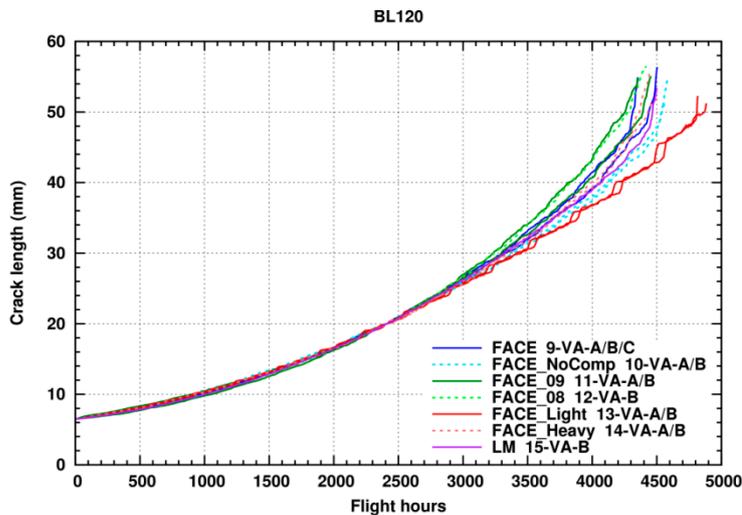
Figure 33: Scaled crack growth curves BL120 spectra.

The obtained crack growth curves indicated that the various crack growth curves can be related to one another by a constant value, depicted in Figure 33, like the CSI. This is less the case for the, for life computation less interesting, last part of the curve. An error of (much) less than 25% was obtained for the computed CSI values compared to the experimental crack growth life ratios. It therefore could be concluded that the CSI provides a reasonable accurate measure to quantify the load severity of spectrum loads measured by both the F-16 wing root (FS325) and upper wing (BL120) strain gauges. Moreover, the experimental variable amplitude crack growth curves showed exponential growth. It was demonstrated that an approximate value for the exponential growth parameter can be derived from the CSI value.
