Review of aeronautical fatigue investigations in the Netherlands during the period March 2013 - March 2015

National Aerospace Laboratory NLR

NLR-TP-2015-123 – April 2015

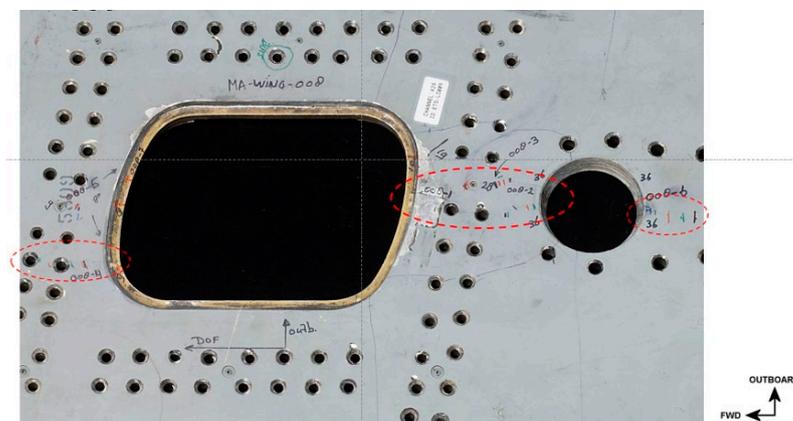
Figure 34: F-16 Block 15 Wing lower skin test lead crack configuration.

At NLR a full-scale fatigue test campaign has been performed on a left-hand-side F-16 wing of a decommissioned F-16 Block 15. This damage enhancement test aimed to grow in-service cracks of sub-detectable size to a size where they may readily be detected. The main objective of the test was to determine if the ex-service wing contained damage not accounted for in the early durability test program that was performed in the late 1970s or in the current durability and damage tolerance analysis (DADTA) of Lockheed Martin (LM). Details are provided in section 8.1. The lead crack configuration, depicted in Figure 34, that occurred in the test consisted of a crack in the lower wing skin starting at the rectangular cut-out at Butt-Line 71 growing to the spar and finally to the pylon hard point. During this period, other relevant cracks started at nearby locations in the rectangular cut-out, pylon hard point and in the underlying spar, interacting with this crack.

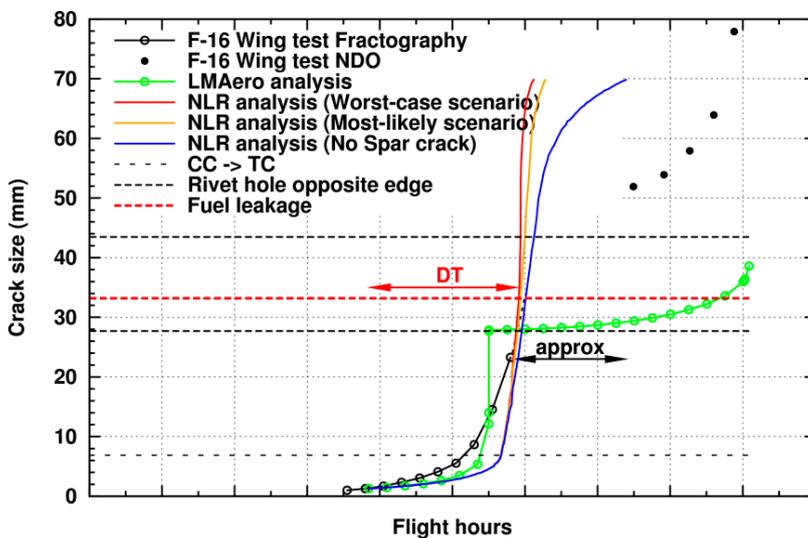
Figure 35: Crack growth life for the lower wing skin rectangular cutout lead crack.

These 23 Mode I and II SIF solutions together with the applied rainflow counted load sequence in the fatigue test for all 23 actuators was used as input for the crack growth analysis, using a special in-house developed crack growth tool, to predict the life of the F-16 Wing. The crack growth results were compared against the test results and the LM DADTA analysis results, see Figure 35. A very good correlation was obtained between the various results. This allows the model to be applied to other future crack locations in the wing, to arrive at more accurate life predictions for the Royal Netherlands Air Force usage.

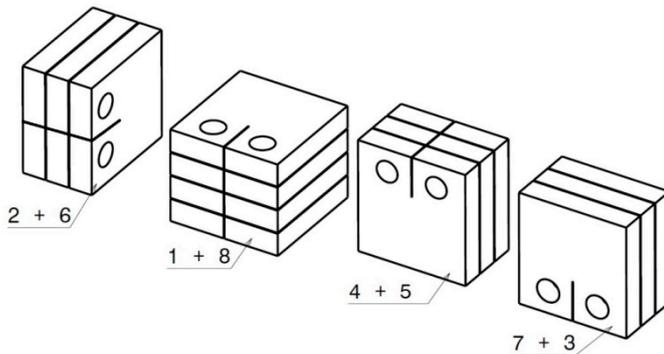
Figure 36: Building orientation of the fatigue crack growth specimens.

specimens received no additional heat treatment, the other half of the specimens received a hot isostatic pressing (HIP) treatment to reduce porosity. Figure 36 shows the orientation of the specimens and the crack plane the way they were built.

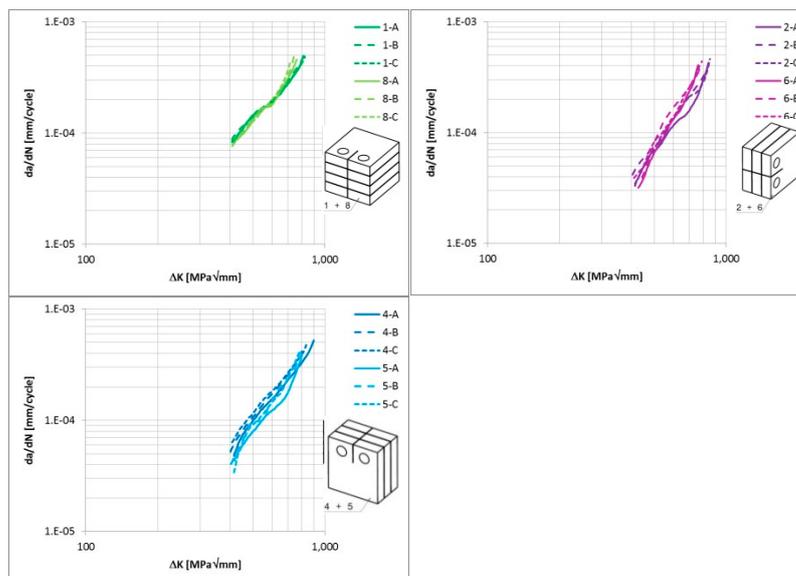
Figure 37: Fatigue crack growth rate for HIP specimens (dark lines) & stress-relieved specimens (light lines).

The fatigue crack growth rates thus determined showed negligible influence of the heat treatment (Figure 37). Some effect of the crack growth orientation was observed: the specimens that were in orientations 1 and 8 (green in Figure 38) showed faster crack growth while the specimens in orientations 2 and 6 (purple in Figure 38) showed somewhat slower crack growth. The microstructures of the specimens will be investigated in order to try to understand the observed differences in crack growth behavior for the different orientations.

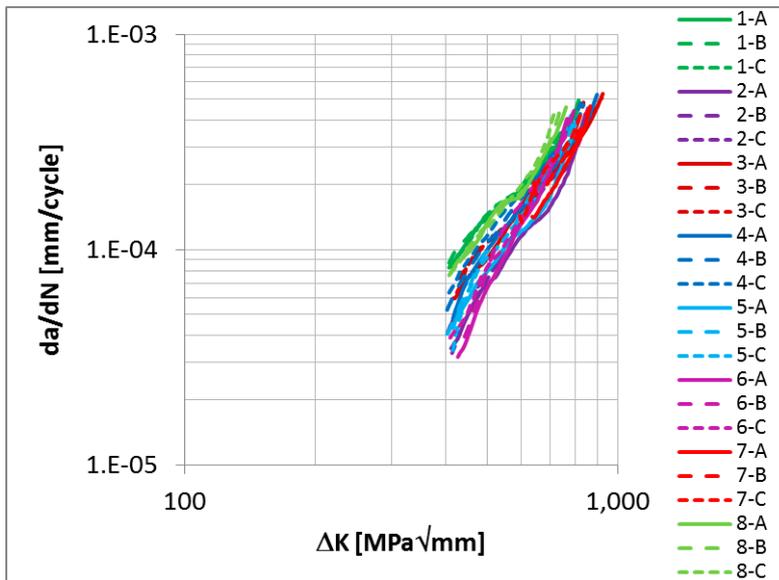
Figure 38: Fatigue crack growth rates for all specimens (specimens 1-4: HIP; specimens 5-8: stress-relieve).

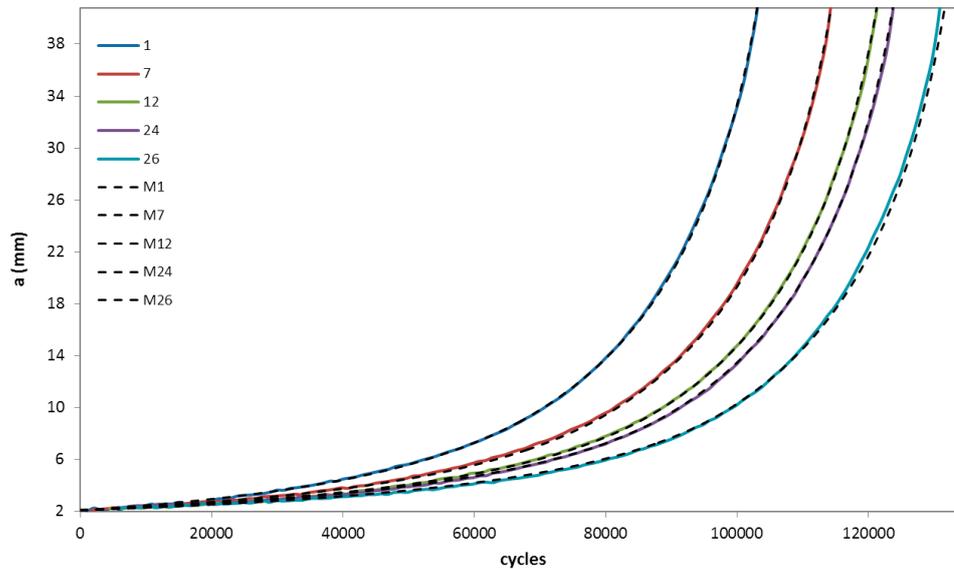
Figure 39: Crack length vs. cycles for five of the 29 specimens and the corresponding model for each specimen (dashed black lines).

Paris and Erdogan [8] were the first to show that the fatigue crack growth rate in metals shows a power law relationship with the stress intensity factor range. It is generally accepted that the exponent is material-dependent. However, it is also true that the empirical Paris equation is dimensionally correct only when the dimensions of the constant in the equation are changed with the power law exponent. In the paper submitted to International Journal of Fatigue it will be shown that for 29 identical fatigue crack growth tests on aluminium alloy 7075-T7351 the exponent not only changes between materials, but also between specimens and crack lengths. Fractography and the crack length measurements show that the exponent is higher and varies at crack lengths where crack growth is dominated by plane strain conditions. The power law exponent decreases and is similar for all specimens after the transition to plane stress conditions at higher crack lengths. The mathematical concept of a pivot point will be used to model crack growth with two different exponents using a dimensionally correct equation. It also allows modelling the crack growth variation in all specimens by varying only one parameter, the power law exponent for the plane strain condition (Figure 39).

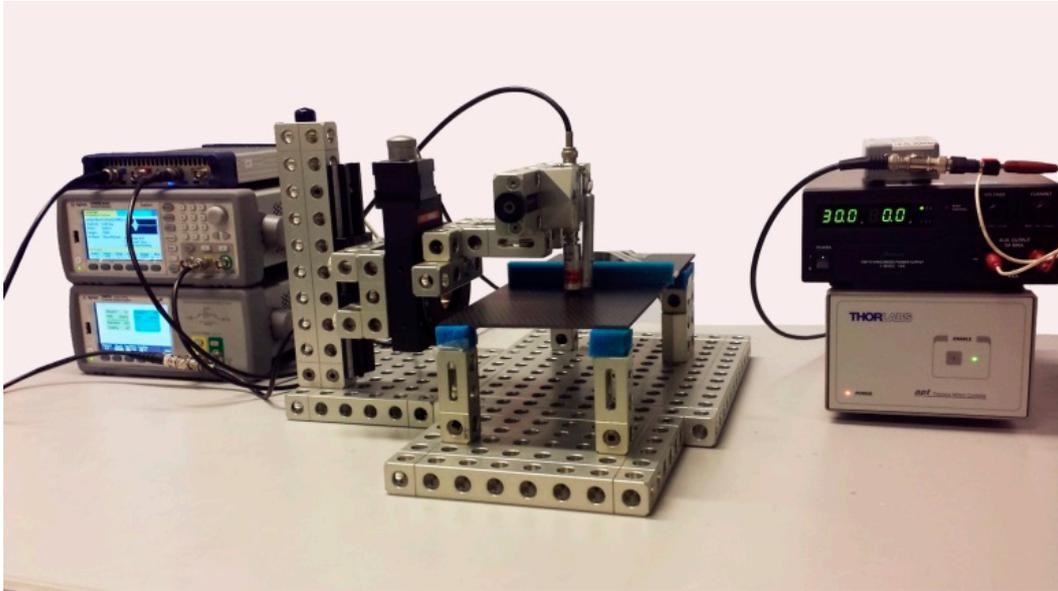
Figure 40: Experimental setup for air-coupled ultrasound.

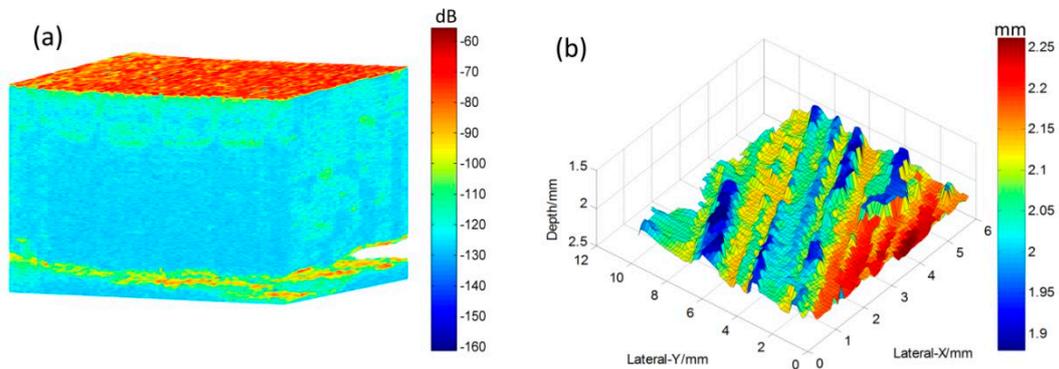
Figure 42: 3D structural image (a) of a delaminated glass fibre composite and its 3D crack surface profile (b).

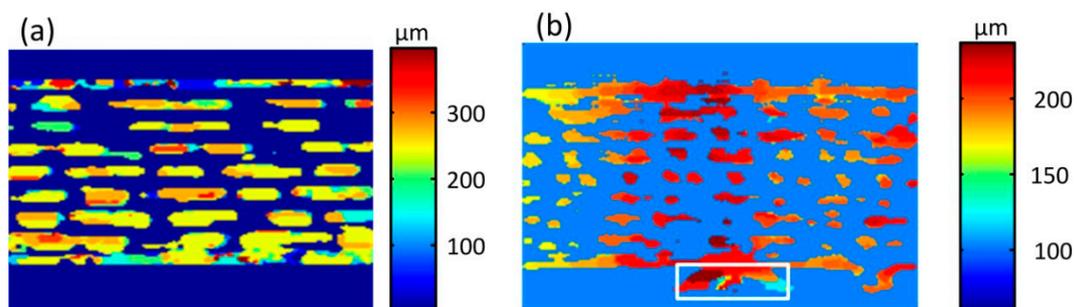
Figure 43: Internal displacement maps from a glass fibre composite under tensile loading (a) and three point bending (b).

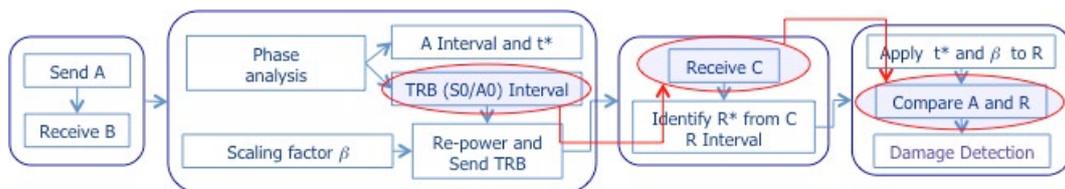
Figure 44: Time reversal process. Influence of the time reversal interval.

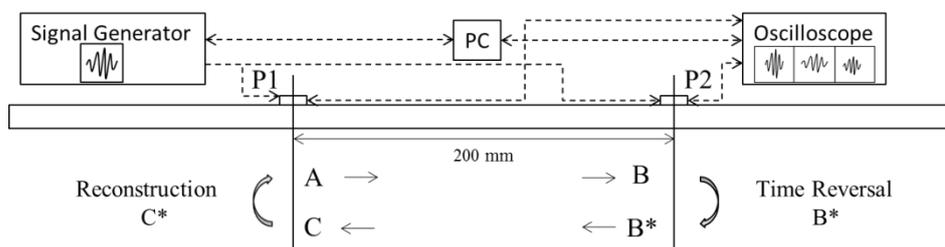
Figure 45: Experimental setup. 2 piezoelectric transducers P1 and P2 are attached to the composite laminate. A, B, B* and C are the ultrasonic signals at the transducers.

In our experiment depicted in Figure 45, the actuation signal A is propagated from P1 and received at P2 as response B. A time interval selected from B is time reversed to generate B*, back-propagated from P2 and received at P1 as C. The time interval for the reconstruction signal R is extracted from C. Note that the group velocity dispersion is automatically compensated in the time reversal process.

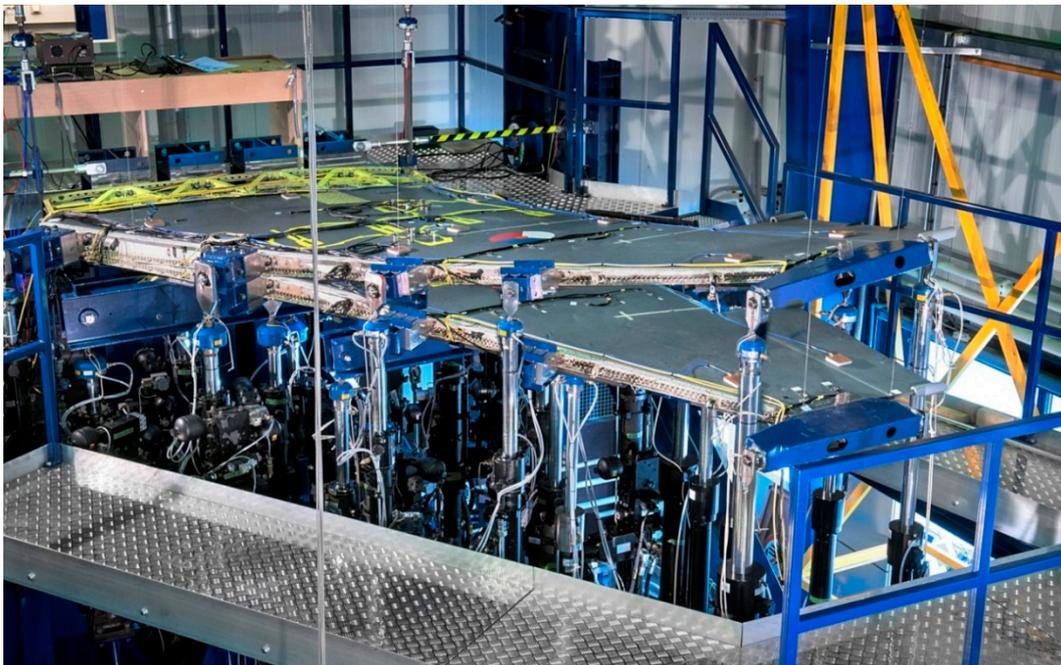
Figure 46: Composite photograph that shows the F-16 Block 15 wing deflections as encountered during the applied limit load cases that represented -3g down bending and +9g up bending.

An impression of the test setup is provided in Figure 46.

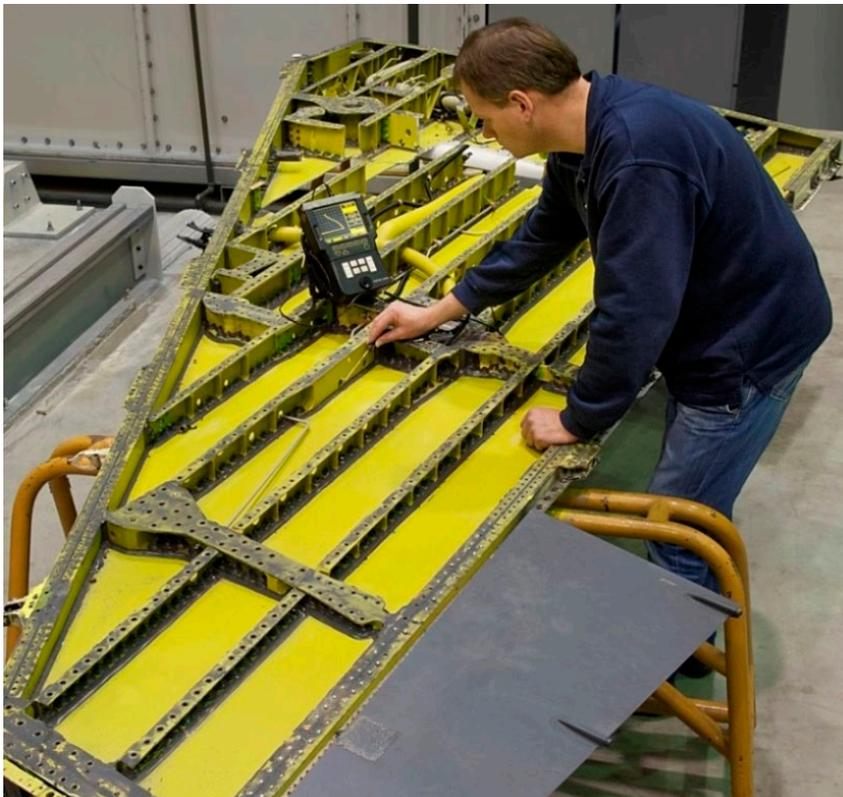
Figure 47: Eddy current inspection of the fatigue critical areas in the F-16 Block 15 left hand side wing during teardown.

In the subsequent teardown analysis of the left hand side wing – see Figure 47 – the lead cracks were investigated using optical and scanning electron microscopes. Quantitative fractography, enabled by the application of marker loads in the test spectrum – see Figure 48, yielded valuable information that was used to calibrate the available fatigue crack growth models and to update the current estimates for the service life and maintenance requirements of the F-16 Block 15 wings of the Netherlands' and Chilean air forces. The inspection and test results enabled the RNLAf and the FACH to re-assess the need for their planned modification programmes and the acquisition of new wings for subsets of their fleets to ensure the required operational availability up to the phasing-out of the last F-16 in their fleets. Based on the test results and the ensuing analyses, an example of which is given in section 6.5 of this National Review, the RNLAf has decided to cancel the plans for acquiring a set of 28 new wing sets, which led to a saving of approximately 30 MEuro.

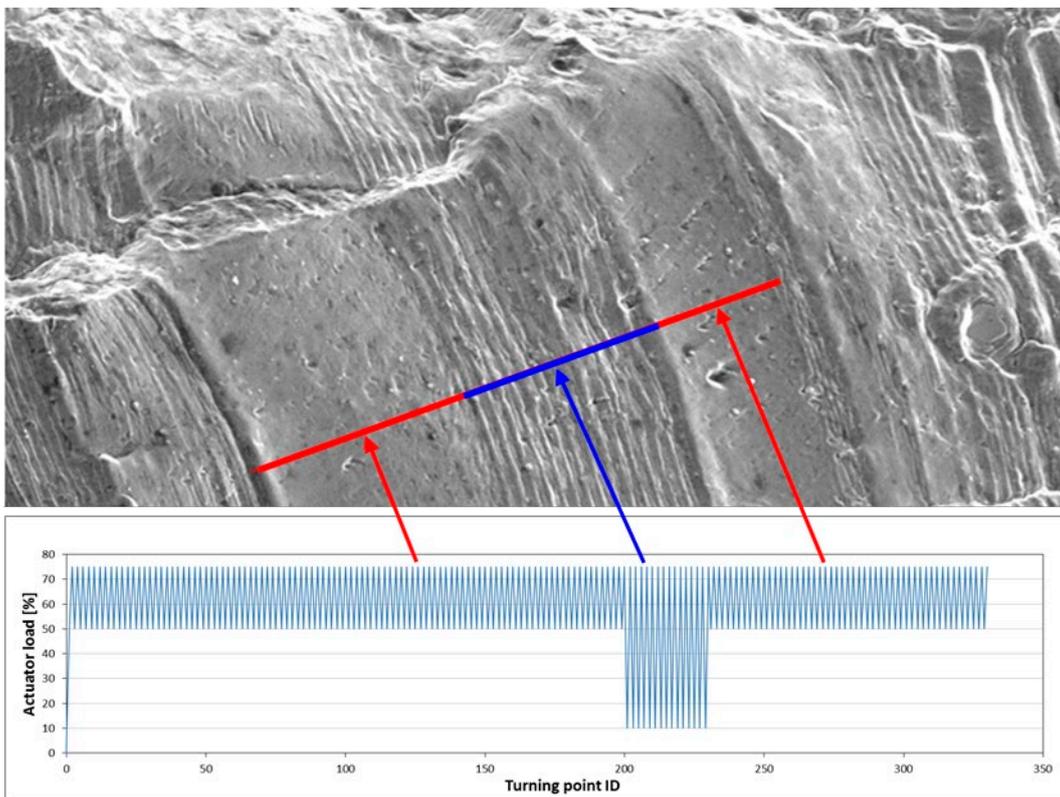
Figure 48: Fracture surface pattern for a block of marker loads.
