ASSESSMENT ON FATIGUE BEHAVIOUR OF AL7475 T7351 SUBJECTED TO NATURAL CORROSION, ACCELERATED CORROSION AND ARTIFICIAL DAMAGES

Keywords: Fatigue, Corrosion, EDM, Damage Tolerance, Al7475

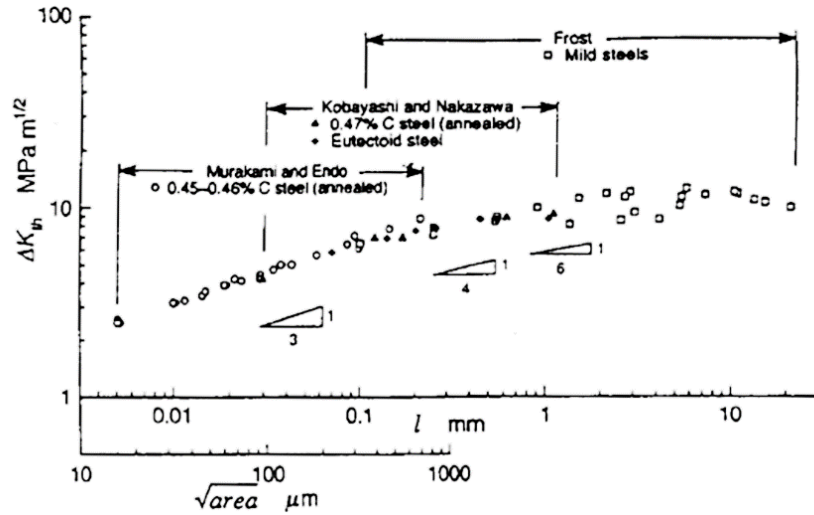
Figure 1: Dependence of ΔK_{th} on Crack or Defect Size [9]

where ΔK_{th} is the threshold of the intensity factor for crack propagation, a is the crack length, and Y a geometry factor. Considering ΔK_{th} as a material property, Eqn. 1 is represented by a horizontal straight line on a log-log plot (Figure 1); tests carried out on materials with different initial crack sizes showed that this line is valid beyond a certain crack length whose value depends on the material, while for shorter cracks $\Delta\sigma_{th}$ is over-predicted. From Eqn. 1, this means that the value of ΔK_{th} reduces with reducing crack size and for short cracks, becoming also a function of the micro structure of the material, as shown in Figure 1, from ref. [9].

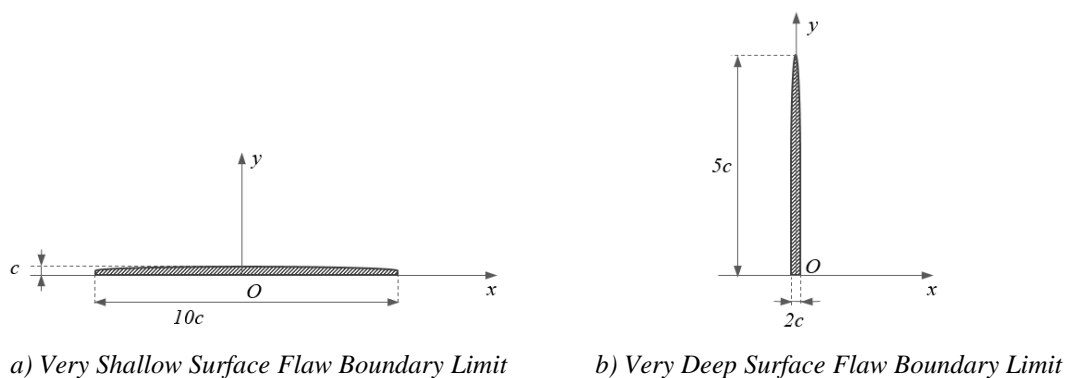
Figure 5: Very Deep and Shallow Flaws Boundary Limits

For very slender cracks, as shown in Figure 2-3, the effective $\sqrt{\text{area}}$ is evaluated by truncating the slender shape to a limiting length, since the stress intensity factor tends to a constant value as the crack length increases, even though the $\sqrt{\text{area}}$ increases without limit. The boundary limits used to estimate effective $\sqrt{\text{area}}$ for the very shallow cracks (length/depth ≥ 10) and the very deep crack (depth/length ≥ 2.5) are detailed in Figure 5.

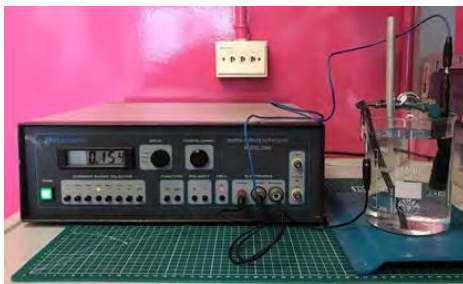
Figure 12: Setup of the Galvanostatic Test

Galvanostatic tests are performed to generate an artificial well-defined localized corrosion attack [15]. The aluminium specimen is connected to the positive pole of the DC feeder (a galvanostat AMEL Instruments 2049), and a mixed-metal oxide covered titanium mesh (MMO-Ti), used as counter-electrode, is connected to the negative pole. The setup of the test is shown in Figure 12. The aluminium specimen works as anode and its corrosion rate has been controlled by the application of an external

constant current. Specimen and counter-electrode has been immersed in a corrosion cell (1 dm³) containing distilled water and 5 g/L NaCl.

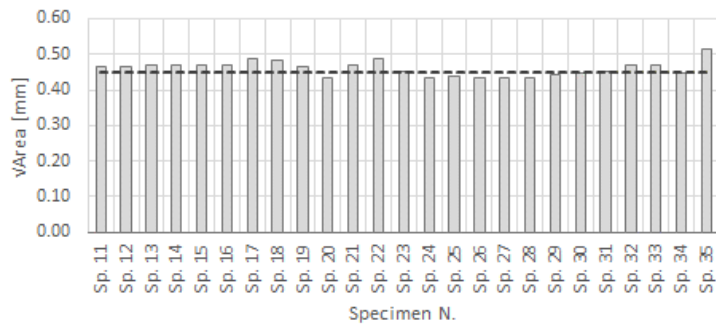
Figure 13: Galvanostatic Corrosion Damage $\sqrt{\text{area}}$ vs Target (dotted line: $\sqrt{\text{area}}=445\text{mm}$)

where Δm is the mass loss, z is the valence of the anodic reaction, F is the Faraday's constant (i.e. 96485 C), AW is the atomic weight, i is the applied current density, S is the surface and t is the time. A constant anodic current density of 100 A·m⁻² has been applied, resulting in a test duration of about 10 hours. The $\sqrt{\text{area}}$ of the pit corrosion defects is shown in Figure 13.

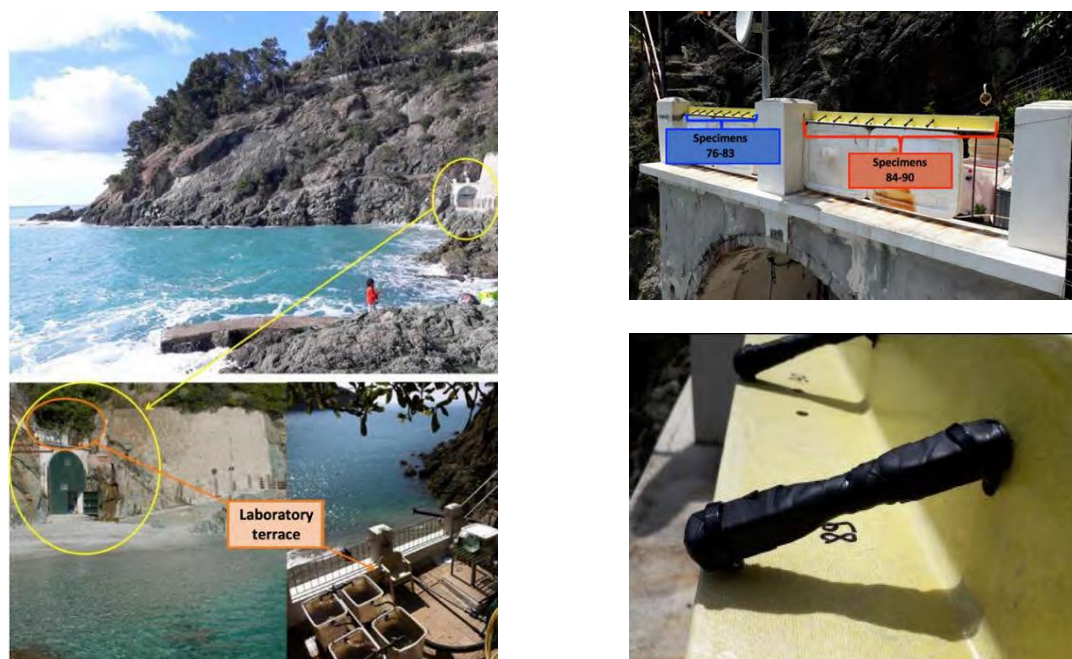
Figure 16: Exposure Rack on the Terrace of MARECO CNR-ICMATE Laboratory

All specimens have been open-air, direct exposed in the direction of the sea for 1 year to all atmospheric conditions and atmospheric contaminants. Specimens have been placed on a rack, at a distance of 20 cm from each other, and exposed with an angle between 30° and 35° from the vertical. The elevation of the exposure point above the mean sea level is 6 m, the distance between exposure point and sea is about 15 m, and the exposure orientation is E-SE, as shown in Figure 16. A macroscopic weekly observation with a monthly report has been carried out.

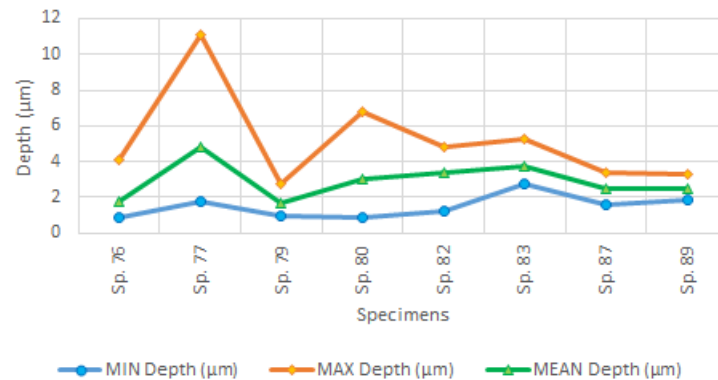
Figure 17: Natural Exposure to Marine Environment

to an unsuccessful attempt to re-open the self-amalgamating tape (that has the tendency to close on itself). The results of laser profilometry are shown in Figure 17; the minimum, maximum and average depth of the attack is reported, measured on at least 6 profiles made on each specimen.

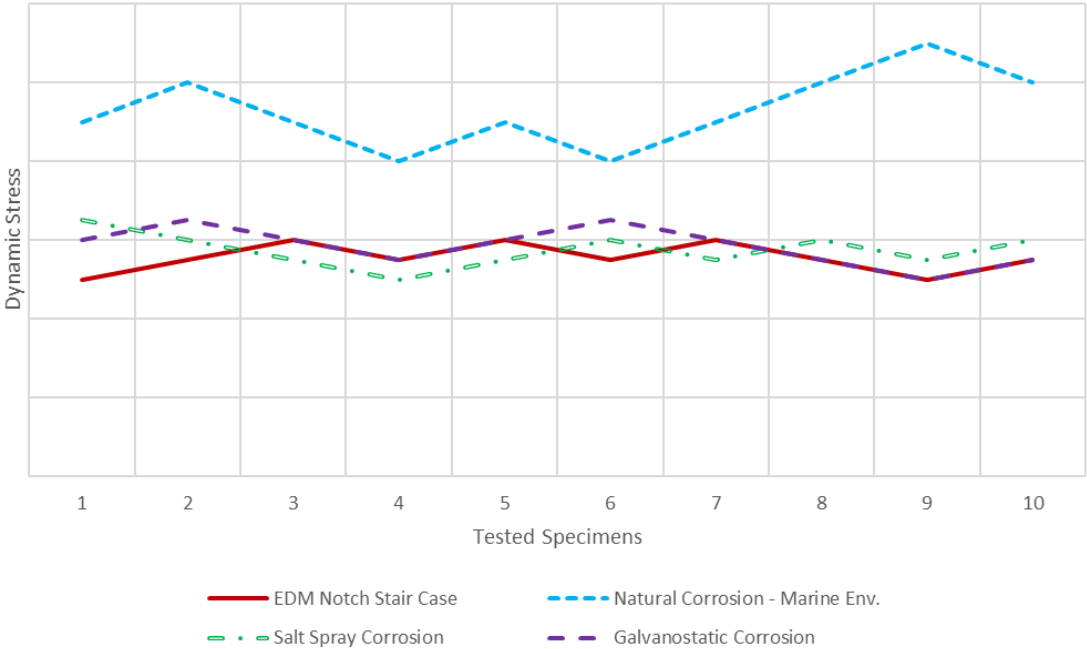
Figure 22: Comparison of Stair Case Sequences

The results of the Hodge Rosenblatt sequences for the four types of tested damage types is shown in Figure 22; artificial corrosion and EDM defects, have the same fatigue strength.
