SWISS TITANIUM RESEARCH EXPERIMENTS ON THE CLASSIC HORNET (STRETCH)

This paper presents an overview of each of these research streams encompassed within the STRETCH project with a focus on the preparation for and conduct of the DaDT phases of the titanium centre barrel FSFT.

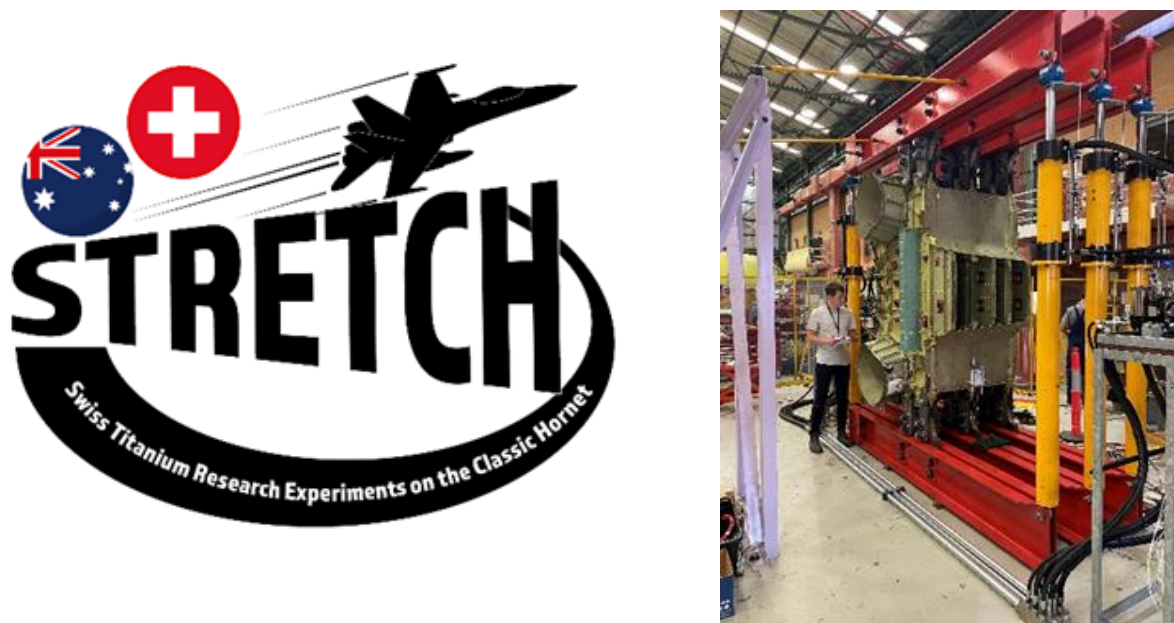
Figure 1: The STRETCH Project logo (left) and Centre Barrel FSFT rig (right).

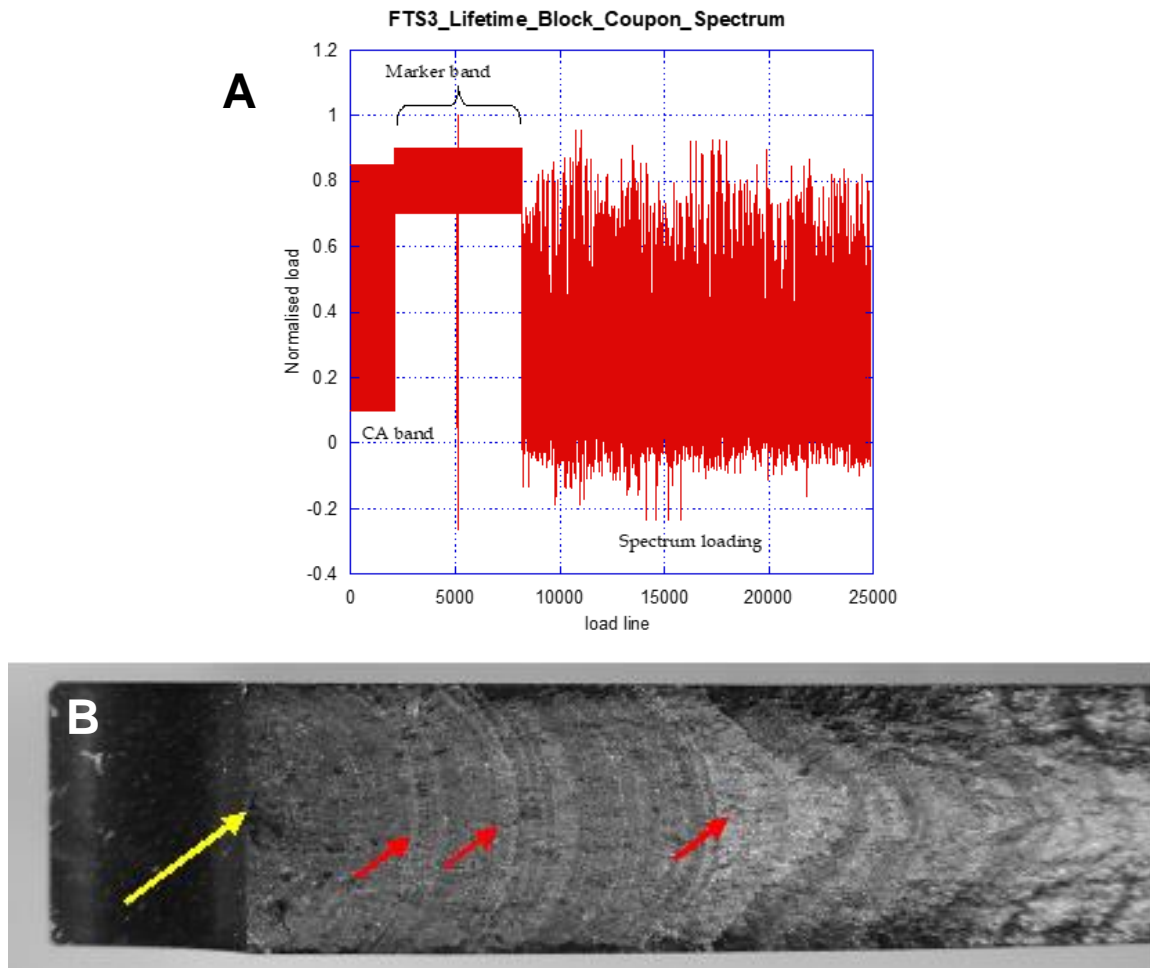
Figure 3: The FSFT sequence of CA, marker band and VA spectrum loading (Figure 3A) as applied to the article and the fracture surface of the trial specimen (Figure 3B) with the origin identified by a yellow arrow and spectrum repeats with red arrows.

(QF). The CA block was applied at the commencement of each life of the FSFT, and it was designed to produce comparable FCG to the 9% truncated variable amplitude (VA) block. This CA block produced different fracture surface topography compared to the VA blocks, thus allowing the crack depth at the start of each lifetime to be identified. The MB was applied at the end of each CA and VA block in order for regular crack front measurements to be taken using QF. This allowed FCGRs to be ascertained for each investigated fatigue crack. An example of the CA block, MB, then VA block sequence applied at the start of each testing lifetime is shown in Figure 3. Each lifetime of testing consisted of one CA block and 19 VA blocks, each followed by MB's.

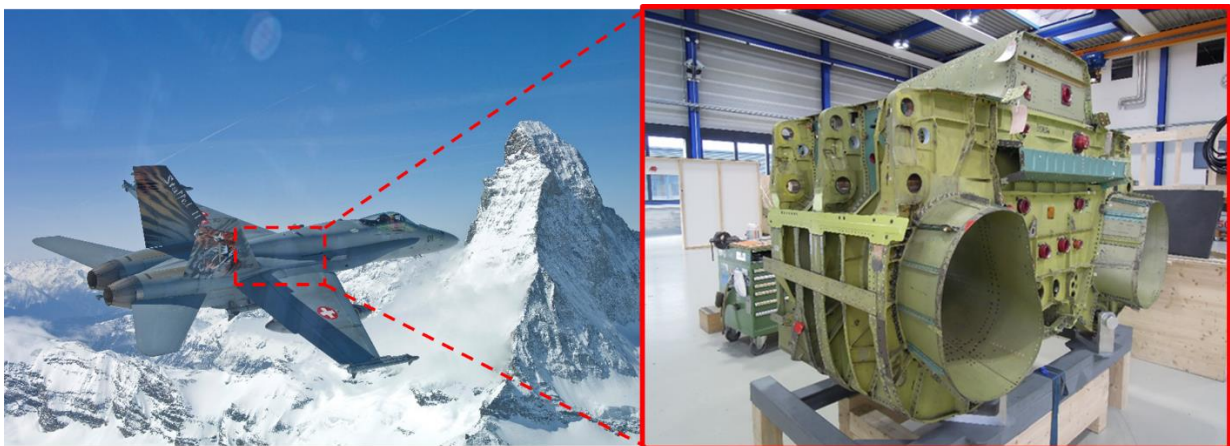
Figure 8: The FTS3 centre barrel test article comprising three Ti-6Al-4V wing carry-through bulkheads.

The centrepiece of the STRETCH project was the FSFT of a Swiss F/A-18 C/D Hornet Ti-6Al-4V centre barrel from the former Swiss F/A-18 C/D FSFT article, FTS1, which underwent 10,400 simulated flight hours (SFH) of durability testing to the Swiss design spectrum before completing a thorough NDT examination. The centre barrel test article, designated FTS3, was extracted from the test aircraft fuselage via cuts forward of the fuselage station (FS) Y453 and aft of the FS Y488 wing carry-through bulkheads.

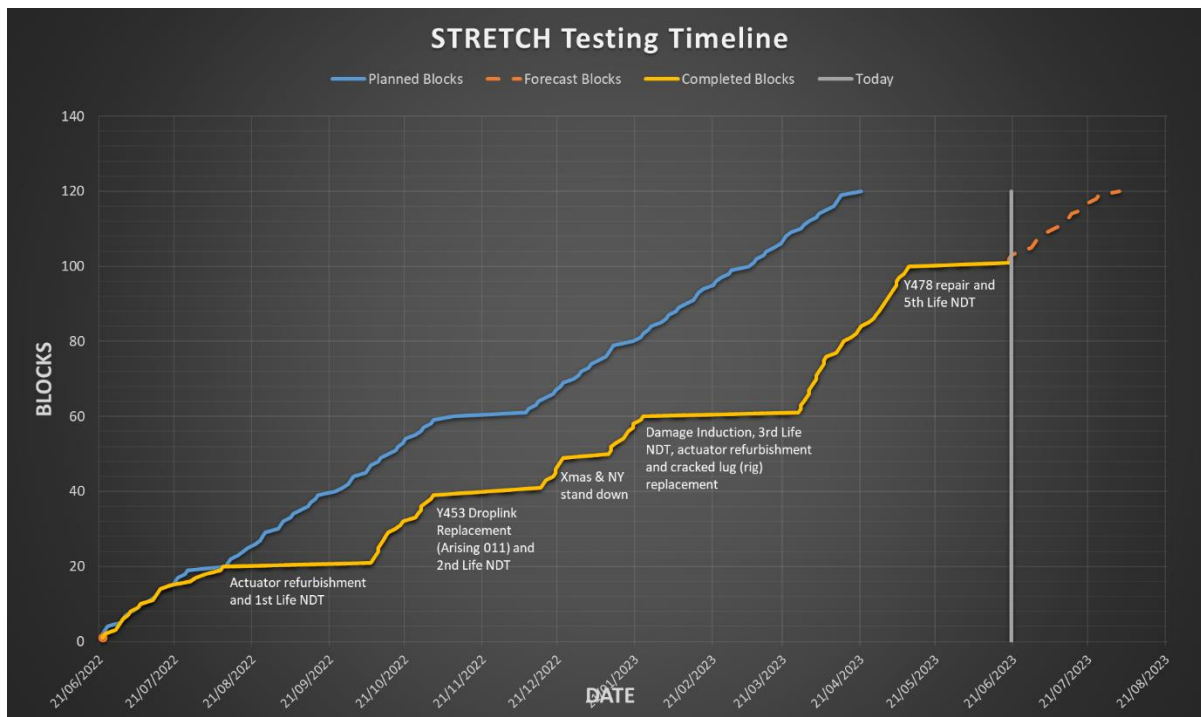
Figure 10: FTS3 'STRETCH' Centre Barrel FSFT Test Schedule.

The STRETCH project aimed to apply 3 service lifetimes of a Swiss usage spectrum, $3 \times 6,000 = 18,000$ SFH for durability test loading and a further 3 lifetimes, 18,000 SFH, for damage tolerance loading to the FTS3 article. This testing was in addition to the 10,400 SFH completed during FTS1 (deemed to be equivalent to 2 FTS3 lifetimes). Each repeated block of loading was equivalent to approximately 300 SFH. A lifetime of testing therefore included a single CA equivalent block and MB, plus a further 19 repeats of the VA + MB spectra. Daily visual inspections of the article were completed and a full NDT inspection period (typically 3 days) was completed at the end of each lifetime (6,000 SFH) using predominately visual and eddy current inspection. At the time of publication, the FTS3 test article was

still cycling during its final lifetime of damage tolerance testing. The achieved FTS3 FSFT schedule is shown in Figure 10.
