FATIGUE AND DAMAGE TOLERANCE TESTING OF GRIPEN E/F RUDDER

Abstract: A structural test of Gripen 39E/F rudder was performed to verify the safe-life and damage tolerance of the rudder structure. Two different design load sequences, one representing the operational profile of 39E-version and the other for the 39F-version, with the latter being more severe, have been considered. Preliminary analyses have shown that a test using the more severe sequence 39F would likely not be able to verify the full service life. Therefore, a strategy was adopted to test the 39E sequence with upscaled loads during a part of the test campaign and thereby verify the 39E sequence, as well as part of the service life of 39F. The test was successfully run to a number of simulated flight hours where the most critical crack had grown from an artificial defect to a predicted critical length. A subsequent static test showed that the structure had sufficient residual strength. This paper presents an analytical procedure, based on fatigue and crack growth calculations, to determine the corresponding percentage of 39F service life that is considered to be verified by the performed test. This approach shows a cost

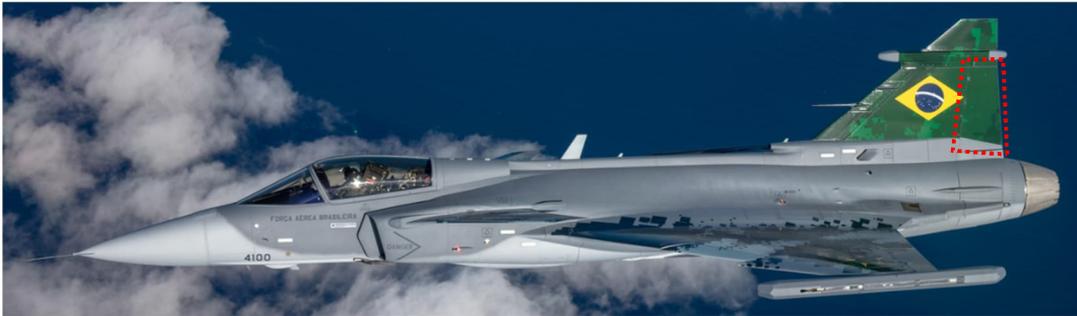
Figure 1: Gripen 39E with the rudder highlighted with a red dotted line. Copyright SAAB AB, photo Linus Svensson.

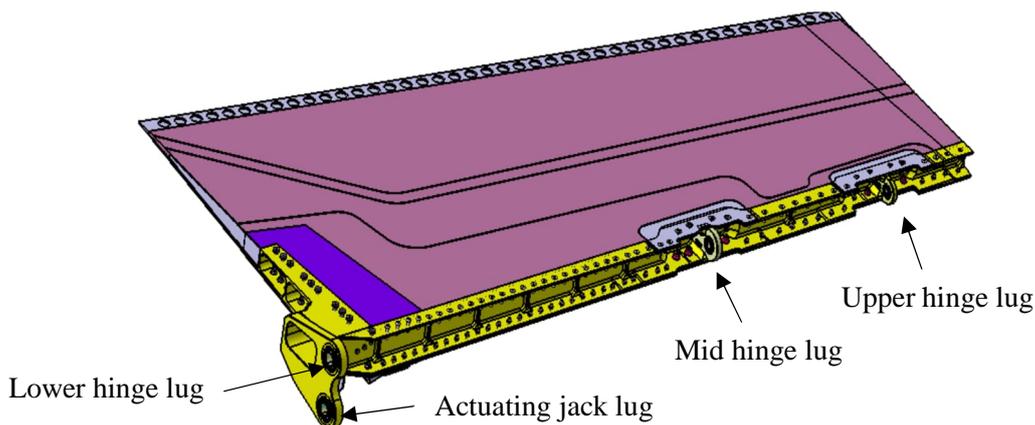
The rudder design is a sandwich honeycomb with bonded aluminium skins on each side. There are three hinge lugs and one actuating jack lug at the interface to the fin, see Figure 2. The yellow-colored parts in Figure 2 are categorized as critical parts. The verifying test program consists of a combined fatigue and DT test, where the whole rudder structure is verified for safe-life, while the critical parts are also verified for DT by introduction of artificial defects during the test campaign.

Figure 2: The overall rudder design with critical parts shown in yellow.

The test object, shown in Figure 2, was a rudder identical to a flying part. Prior to the test, initial fatigue and DT analyses of the rudder structure were performed and five points were identified as potentially fatigue critical. Those five points are the locations where the artificial defects were introduced in the test object after 2DL of testing, see Figure 3.

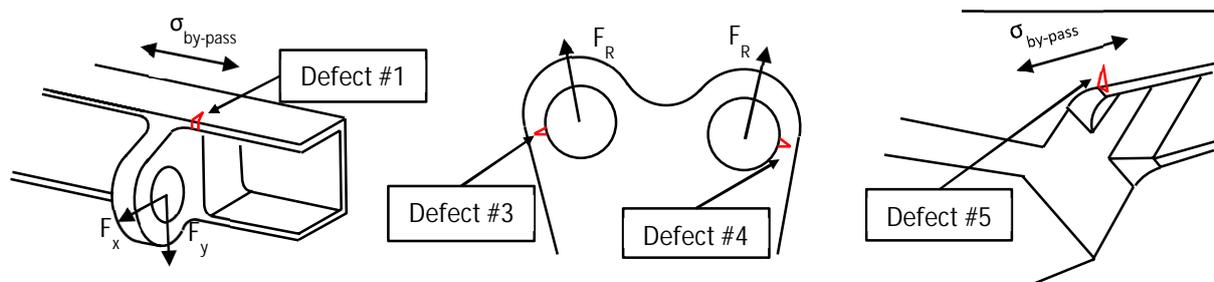
Figure 3: Left: Single edge corner defect #1 at the upper hinge. A similar defect at the mid hinge is called defect #2. Mid: Lug corner defect #3 at the actuator jack lug and defect #4 at the lower hinge lug. Right: Single edge corner defect #5 at lower fitting radius.

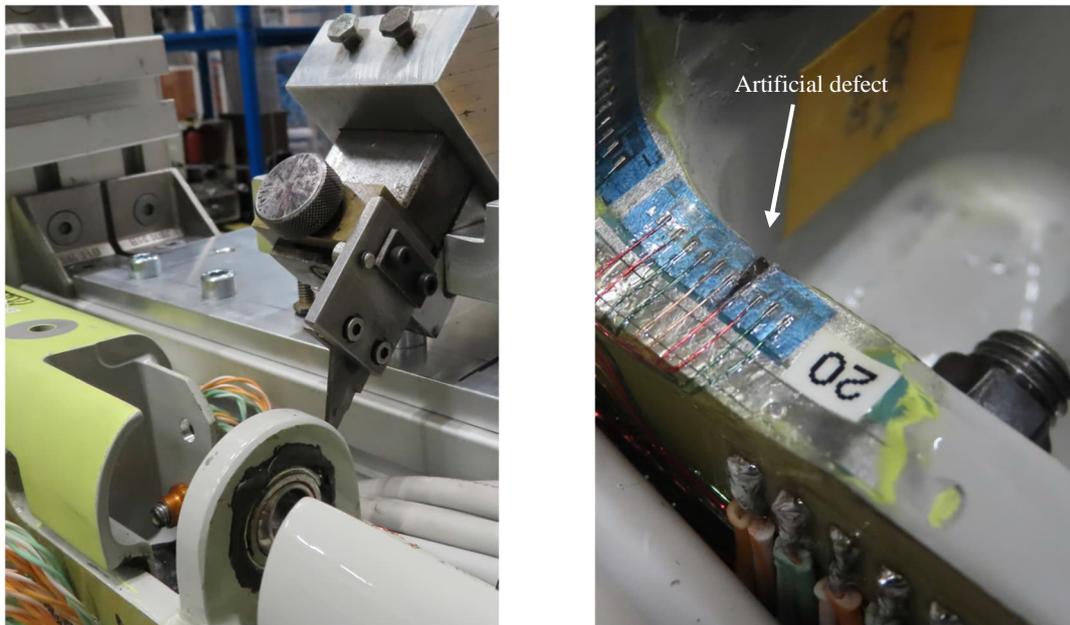
Electro-spark machining is a preferred defect manufacturing method, because it minimizes the risk of introducing plastic deformations, however it was infeasible due to the size and complexity of the test object. Instead, the defects were manufactured by saw-cutting using the tool set-up shown in Figure 4.

Figure 4: Left: Saw-cut tool set up at defect #2 at the mid hinge. Right: Detail of defect #2 interferred with a row of strain gauges.

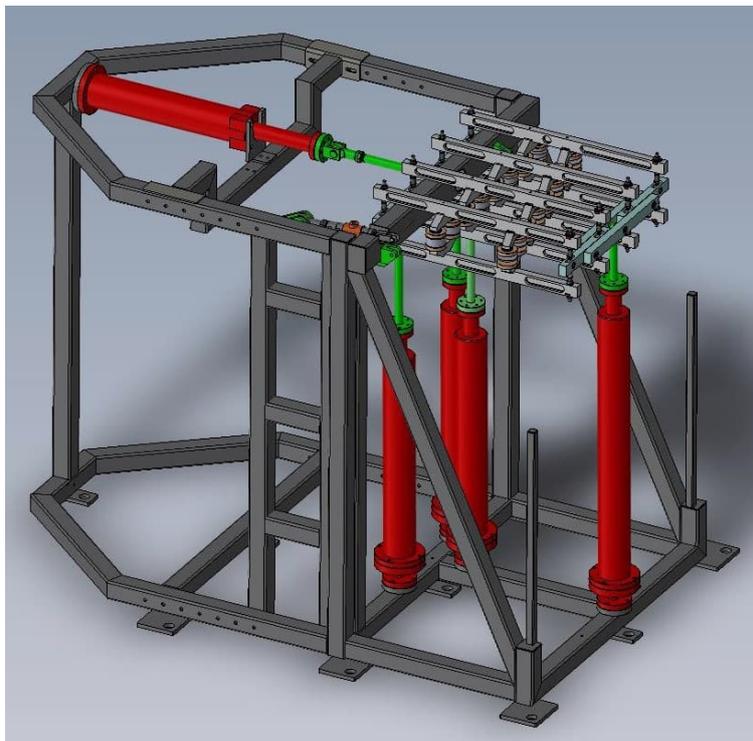
The rudder test set-up was constructed and erected to VTT's Research Hall, at the EES R-hall test floor with associated infrastructure. The tests were performed in normal laboratory conditions. The rig contained the actuators as a floating and free-standing unit and all actuators were integrated in the rig itself, see Figure 5.

Figure 5: Test set-up before rudder mounting. Figure courtesy of Arecap Ltd, A. Mattila.

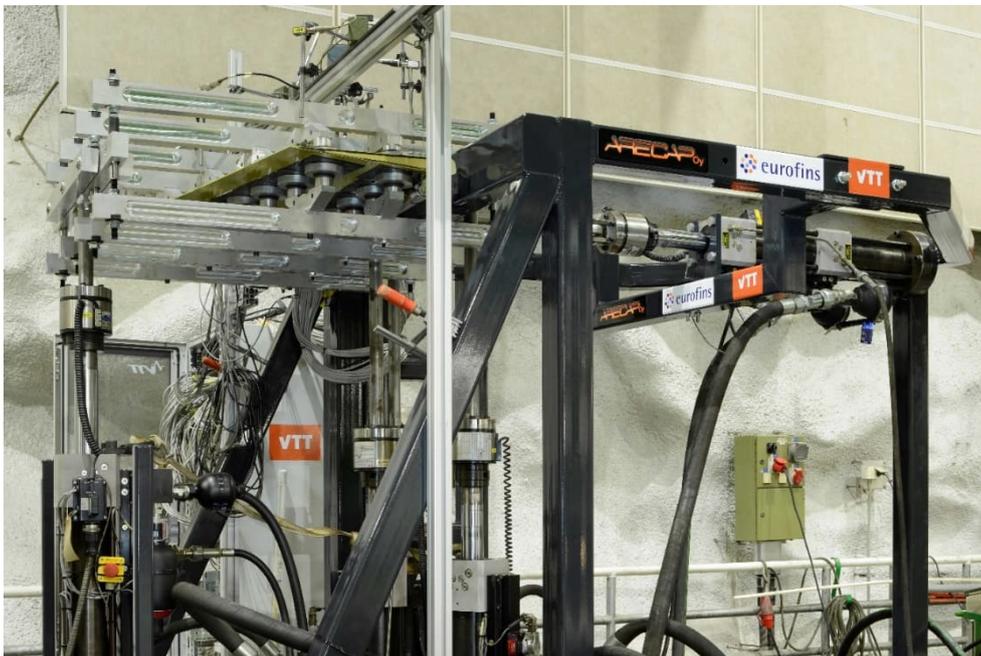
The same test set-up was used for all test stages. The design work of the test set-up structures was an iterative process, which was done in very close cooperation with Saab, VTT, EES, and Arecap Ltd. Arecap prepared the drawings and manufactured the rig with loading structures, see Figure 6.

Figure 6: Test rig and loading structures. Figure courtesy of EES, J. Juntunen.

A whiffle-tree structure with 32 pads and 5 actuators were used to introduce the load to the test object, see Figure 6. The in-flight air loads were applied with three actuators (denoted C1, C2 and C3) to the whiffle-tree, while two other actuators (C4 and C5) simulated the correct reaction loads on the middle hinge of the rudder. Upper and lower hinges of the rudder were constrained in x- and y-directions, perpendicular to the hinge line, similar to the aircraft conditions. The rudder jack operates the rudder in flight but was constrained in the test to carry the rudder moment and the reaction load was instrumented with a load cell. The tests did not represent any high-frequency buffeting in terms of high frequency loading. No master cylinders were used, thus all five actuators were managed independently. All tests were controlled by a load control mode, where the feedback transducer signal was taken from the actuator load cell. Feedback from an additional accelerometer was used to stabilize the control system. The weight of the assembly and the rudder were compensated for by a tare procedure [3].

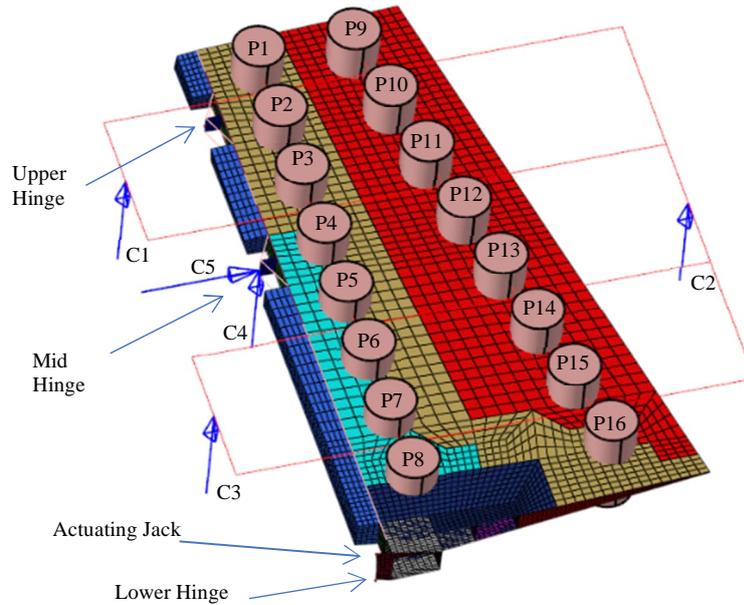
Figure 7 shows the FE-model of the test object and the load application arrangement with the whiffle-tree system, pads and actuator loads. The actuator test load sequences were determined, using the FE-model, so that the correct hinge and rudder jack loads are obtained.

Figure 7: FE-model of the rudder with pad and whiffle tree structure illustrated.

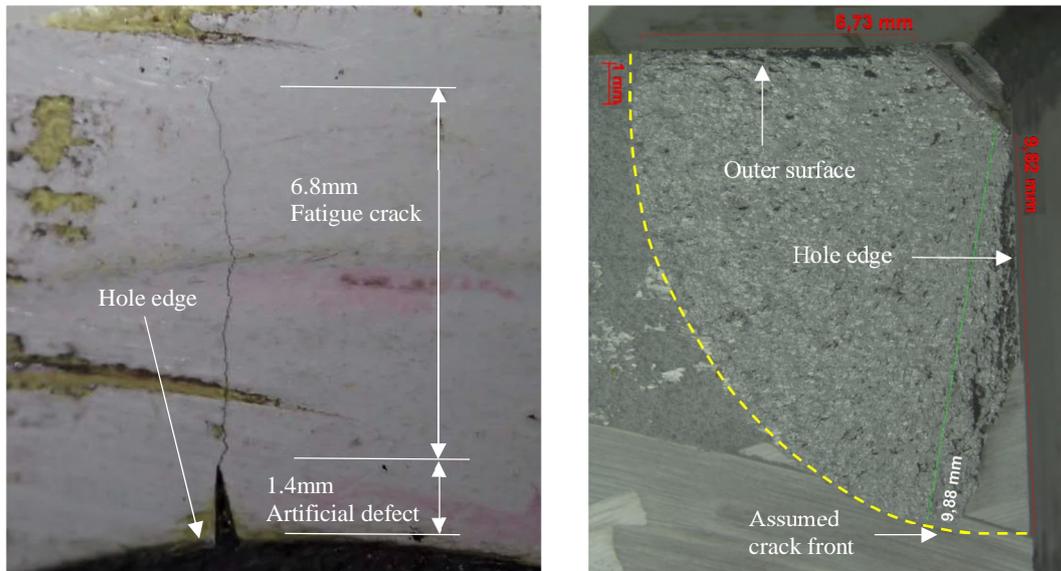
Crack growth was first observed at defect #3 during the 1.2x39E sequence load between 4.5 and 5 DL. There was also minor crack growth from other defects, but this paper will only focus on the most critical defect #3. The artificial defect introduced at 2 DL was measured to 1.4 mm. The fatigue crack that grew from defect #3 is shown, after 5.75 DL, in Figure 8. The test was stopped at 5.75 DL, when the crack length was close to the calculated critical crack length.

Figure 8: Left: Surface crack at defect #3 at jack attachment lug after 5.75 DL. Image from ref [5]. Right: Opened crack surface. Crack length at outer surface 6.73 mm agrees well with left figure. Unfortunately, the lower right part of the fatigue crack was damaged by sawing during fractography and the crack length at the hole edge is assumed 9.82 mm. Image from ref [6].

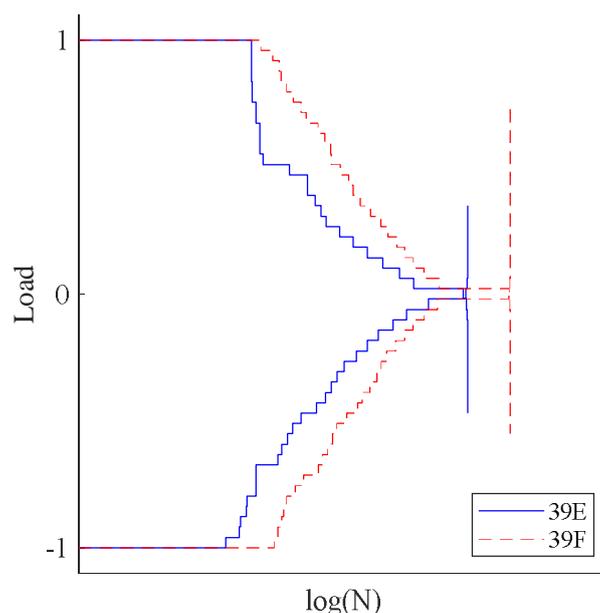
The purpose of the analysis work is to determine the number of 39F DL that the performed test verifies. The evaluation of the verified crack initiation and propagation time for the 39F sequence, based on the tested 39E sequence, is considered as a valid approach because of the similarity of the two sequences. The 39F sequence contains a larger number of load states and slightly larger amplitudes, see Figure 9, but the stress fields for the dominant load cases are similar in both sequences. This has been confirmed by local FE analyses of the stress fields. It can therefore be assumed that both sequences generate the same type of damage in the critical points but after different times. The verified life for sequence 39F is determined as the number of flight hours that gives the same calculated cumulative damage and crack growth as the tested sequence.

Figure 9: Normalized level exceedance plots of load sequences 39E and 39F.

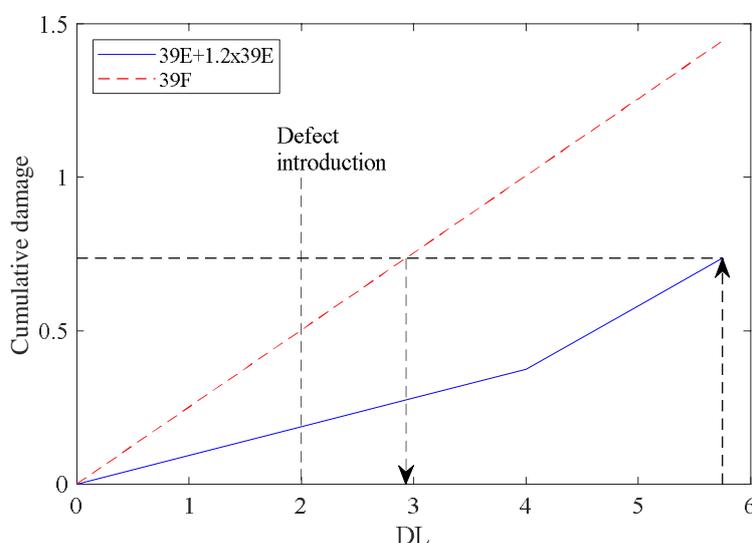
The calculation method [7] uses Haigh-diagrams based on constant amplitude tests of longitudinally loaded lugs fitted with non-interference pins which were tested to failure. The method takes into account the stress concentration, the size effect, and the fretting corrosion due to the contact between the pin and the hole edge. For obliquely loaded and tapered lugs a stress concentration correction factor is applied. For variable amplitude loading, the calculation of damage is based on the rain-flow counted cycles and linear Palmgren-Miner cumulative damage assumption. In sizing situations, scatter factors are normally applied to cover the variability associated with fatigue life. However, in the current analysis mean values are used. Figure 10 shows the calculated cumulative damage as function of DL for the 39F sequence and for the tested sequence.

Figure 10: Calculated cumulative damage for 39F sequence and for the test sequence (39E+1.2x39E) at the actuator jack lug.

At the end of the test, 5.75 DL, the calculated damage for the test sequence is 0.74. This damage corresponds to 2.9 DL for the 39F sequence, which verifies at least $2.9/4 = 72\%$ of full life, since 4 tested DL are required for verification of full life. The analyses of all other critical points showed higher percentage of verified 39F life.

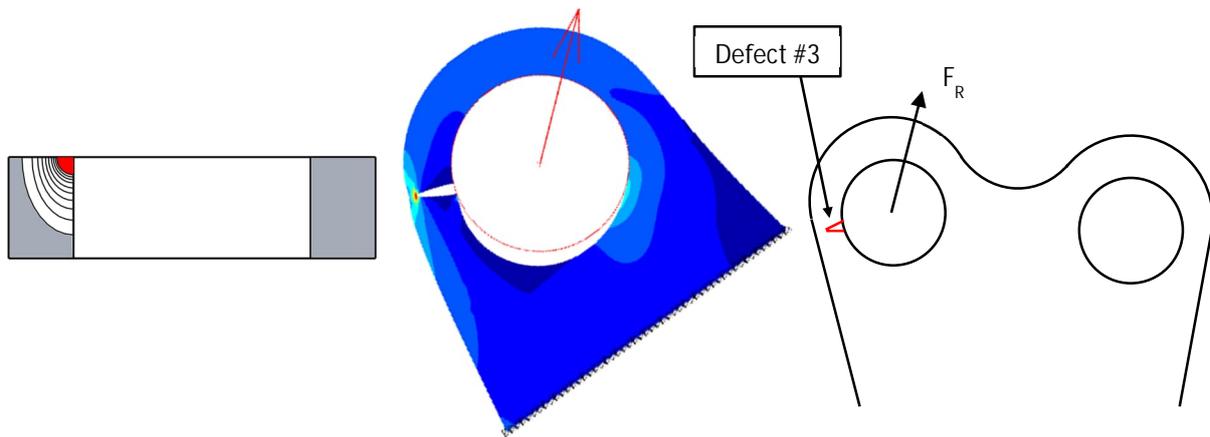
The method first uses a plane stress FE-model [9], to compute the geometry functions for a through crack in an obliquely loaded lug with a pin, see Figure 11. Two functions are computed, one for a force prescribed in a direction and one for the reversed load direction. The geometry functions are then corrected by a ratio between the solutions for a through crack and a corner crack in a longitudinally loaded lug. This compounded solution is used for integration of the crack growth rate to compute the crack length as function of the number of cycles, as described in [8]. The calculation is run to the critical crack length, i.e. when the stress intensity factor for a prescribed residual strength load equals the fracture toughness. Figure 12 and 13 show the computed surface and through crack lengths as function of tested DL after the introduction of the artificial defects for the 39F sequence and for the tested sequence. The measured surface crack lengths are also plotted in Figure 12 and 13 for comparison.

Figure 11: Left: Computed crack contours, Mid: Crack model, Right: Lug geometry.

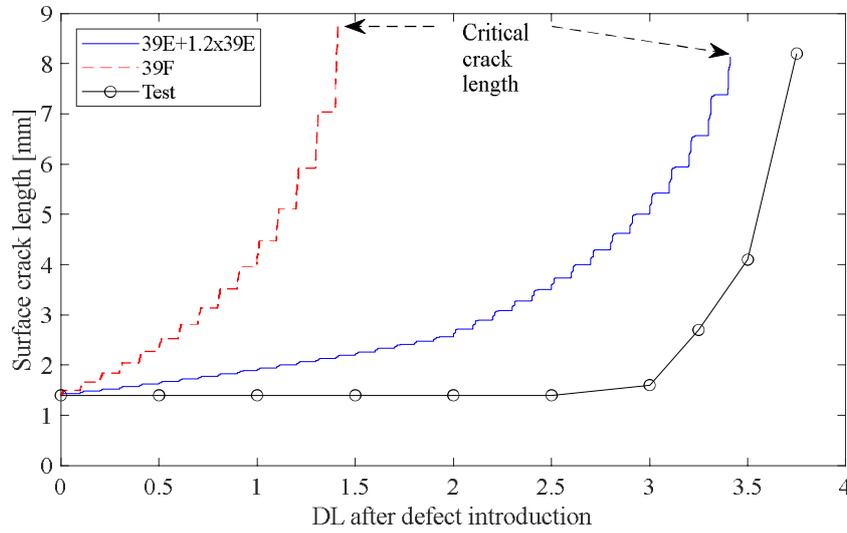
Figure 12: Calculated and measured surface crack length (including the artificial defect length) from defect #3, for the 39F sequence and for the test sequence (39E+1.2x39E).

The test was stopped at 5.75 DL, just before the measured crack reached the calculated critical surface length of 8.2 mm at 144% LL. Since the RST at 144% was performed without failure, the calculated critical length can be assumed to be somewhat conservative. The calculated critical length was slightly longer for 39F sequence at was reached at 1.41 DL of 39F sequence, which corresponds to $1.41/2 = 71\%$ of full verified life for DT.

The predicted time of crack growth to critical length was 0.34 DL shorter than shown by the test. This discrepancy is partly due to the fact that the fatigue crack in the test did not start to grow immediately after the introduction of the defect. It took around 2 DL of testing until the crack growth was first detected by inspection. However, most of the inspections and crack length measurements were performed with the test object in the rig which may have affected their accuracy. For instance, during the last inspection in the rig, the crack length was measured to be more than 1 millimeter shorter than what was measured during the tear down inspection right after. Due to that reason, it is possible that the crack had started to grow earlier and was in fact longer than measured during the in-rig inspections. In that case, the crack growth rate was lower than the test measurements indicate in Figure 12 and closer to the predicted rate.

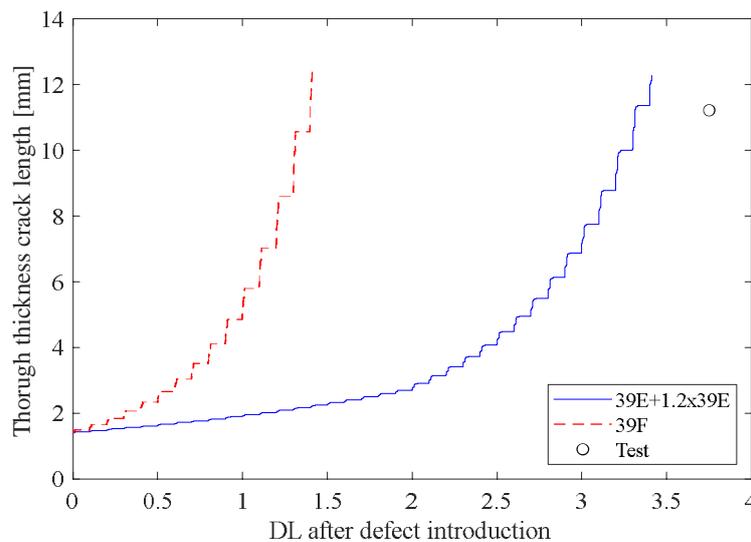
Figure 13: Calculated and measured through thickness crack length (including the artificial defect length) from defect #3, for the 39F sequence and for the test sequence (39E+1.2x39E).
