USAF Academy Center for Aircraft Structural Life Extension (CAStLE)

Utilizing Condemnations, Retirements and Mods to Improve the Structural risk Analysis of the T-38: Turning Trash into Treasure

Marcus L. Stanfield, Laura D. Hunt, and Isaac T. Grothe
Southwest Research Institute

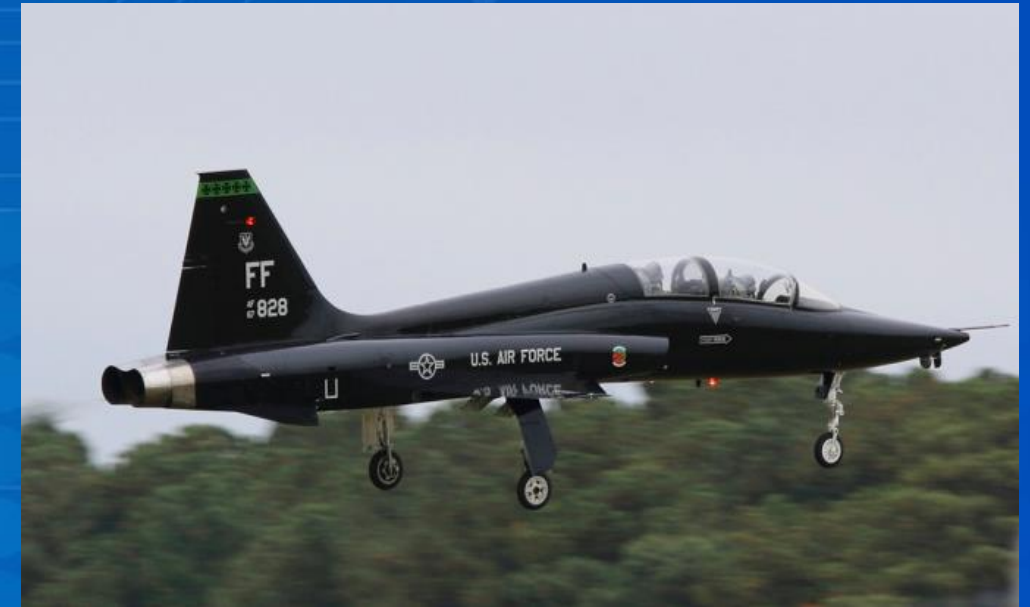
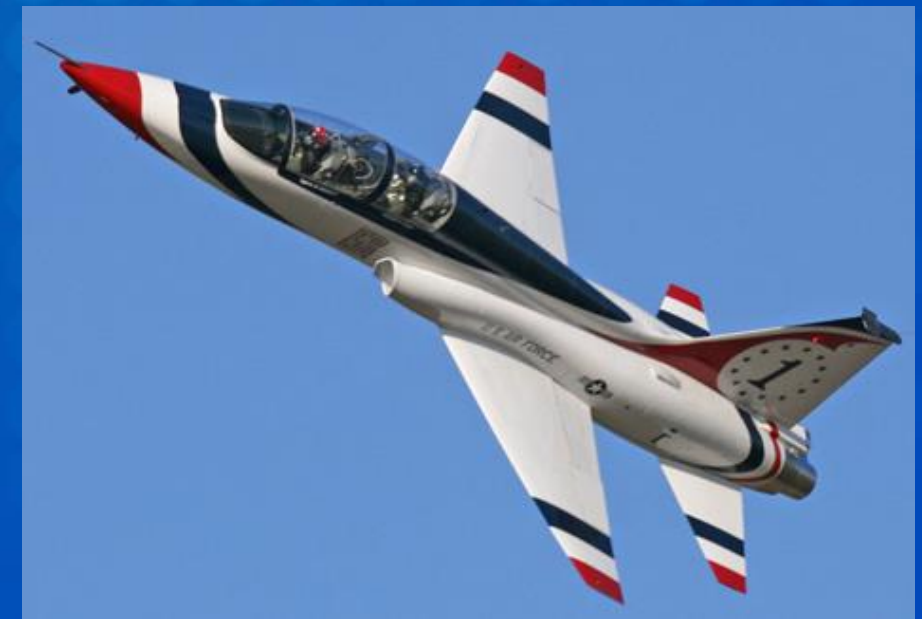
T-38 Talon

- Jet trainer introduced into service from 1961-1972, now entering its **fourth** 20 year lifetime
- Over 20 different usages and numerous modification/SLEP programs
- The purpose of this presentation is to share insight on what has made the T-38 teardown program useful for risk analysis, and by extension, fleet management

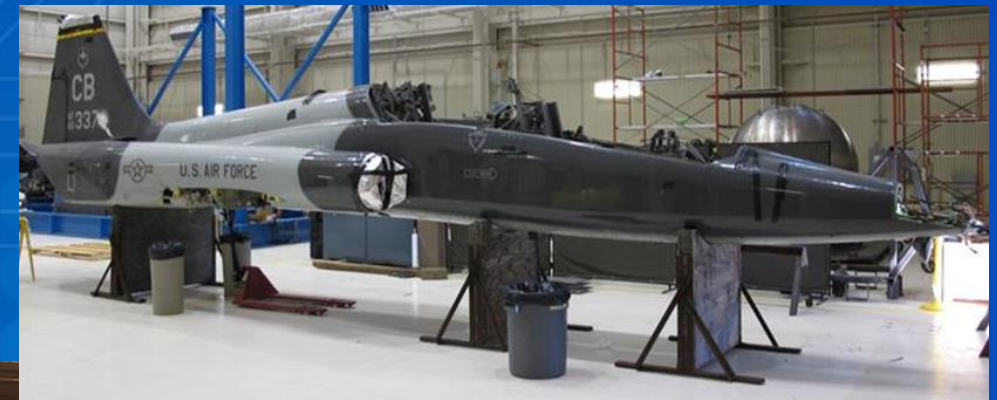
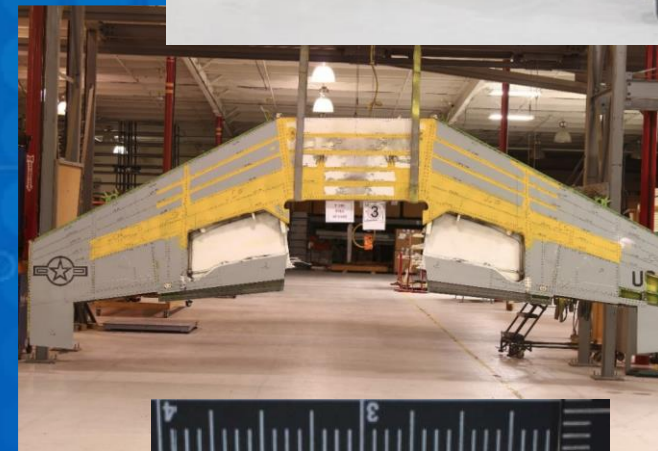
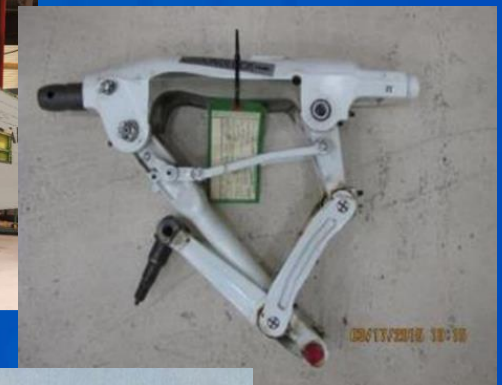
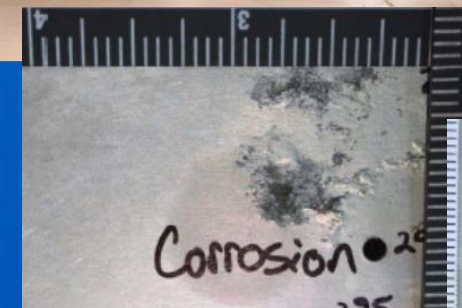
T-38 Teardowns

- Since 2010, the T-38 team has built a strong commitment to performing structural teardowns
 - 2 fuselages, 200 fatigue cracks
 - 30+ wings, 1,500 fatigue cracks
 - 22 landing gear
 - 100+ Additional condemned and modification components

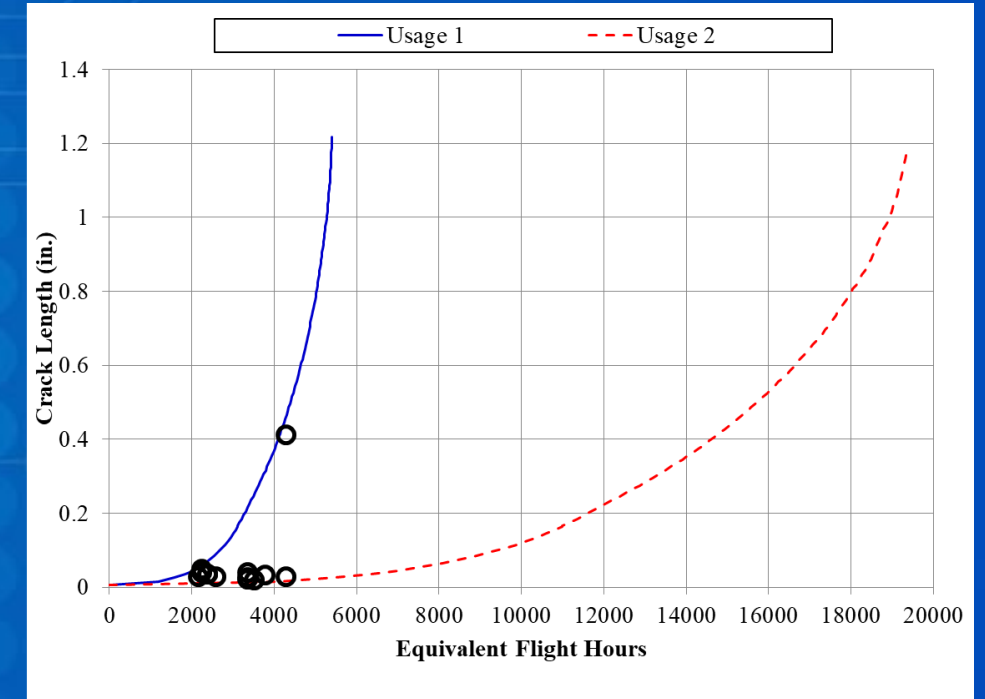
Turning Mountains into Molehills

- Group like findings at each critical location
- Calculate equivalent flight hours for each finding
 - Using the history of each wing or fuselage, determine number of hours in each usage and calculate equivalent severe usage hours
- Validation of crack growth curve

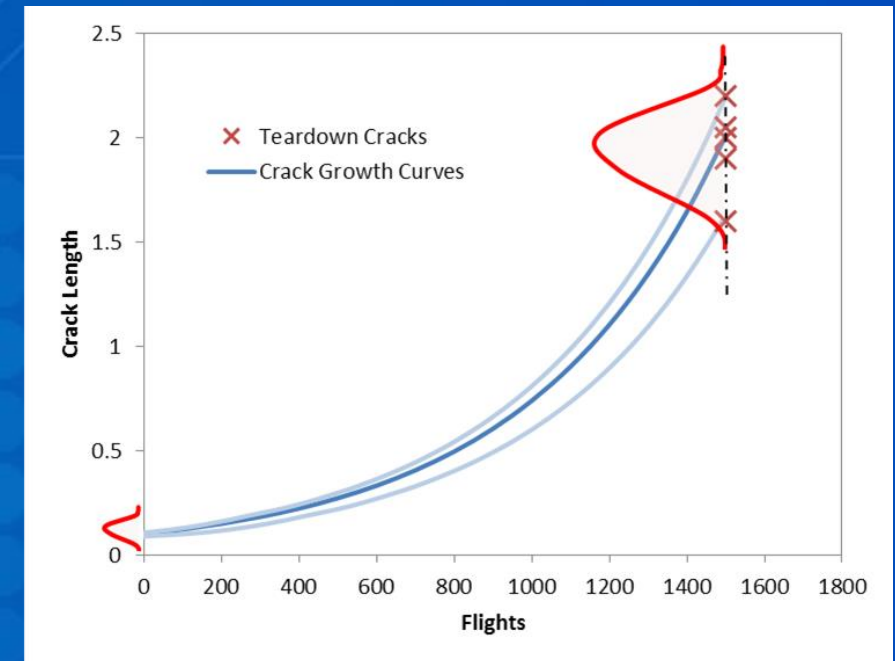
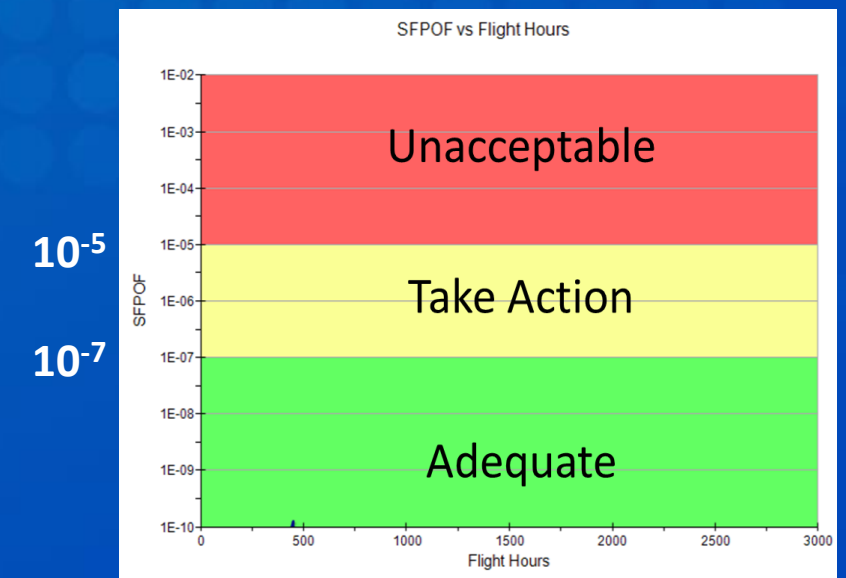
EIFS Distributions

- Equivalent Initial Flaw Size (EIFS) is a hypothetical crack that results in the equivalent life to a crack that was in the structure at time zero
 - Crack is assumed to follow the durability crack growth curve
- T-38 now has location specific EIFS distributions for the highest priority wing and fuselage locations (~10 distributions)
- MIL-STD-1530D: **Structural risk analysis** – “shall be performed using the EIFS distribution” to “determine the time beyond the design service life when required safety inspections and/or modifications would result in consequences that are judged to be unacceptable”
- Risk analysis used to determine inspection intervals, replacement/retirement, modification induction schedule

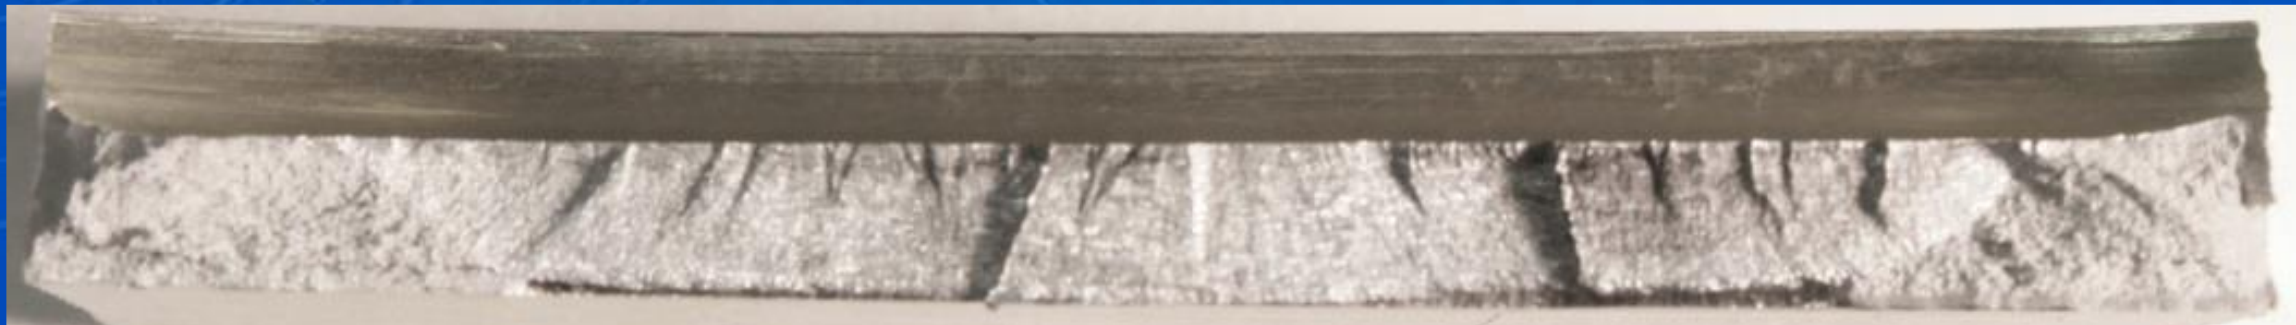
Condemnations

- Full-scale fatigue tests of two T-38 wings under different usages, presented at ICAF2017, resulted in a failure at a mechanically milled pocket in the lower wing skin.
- Updated Non-Destructive Inspection procedures resulted in numerous crack indications and condemned wings.
- Milled pocket indications were excised from the wing skin and sent for failure analysis.
- Cracks nucleated from multiple machine marks from milling process.

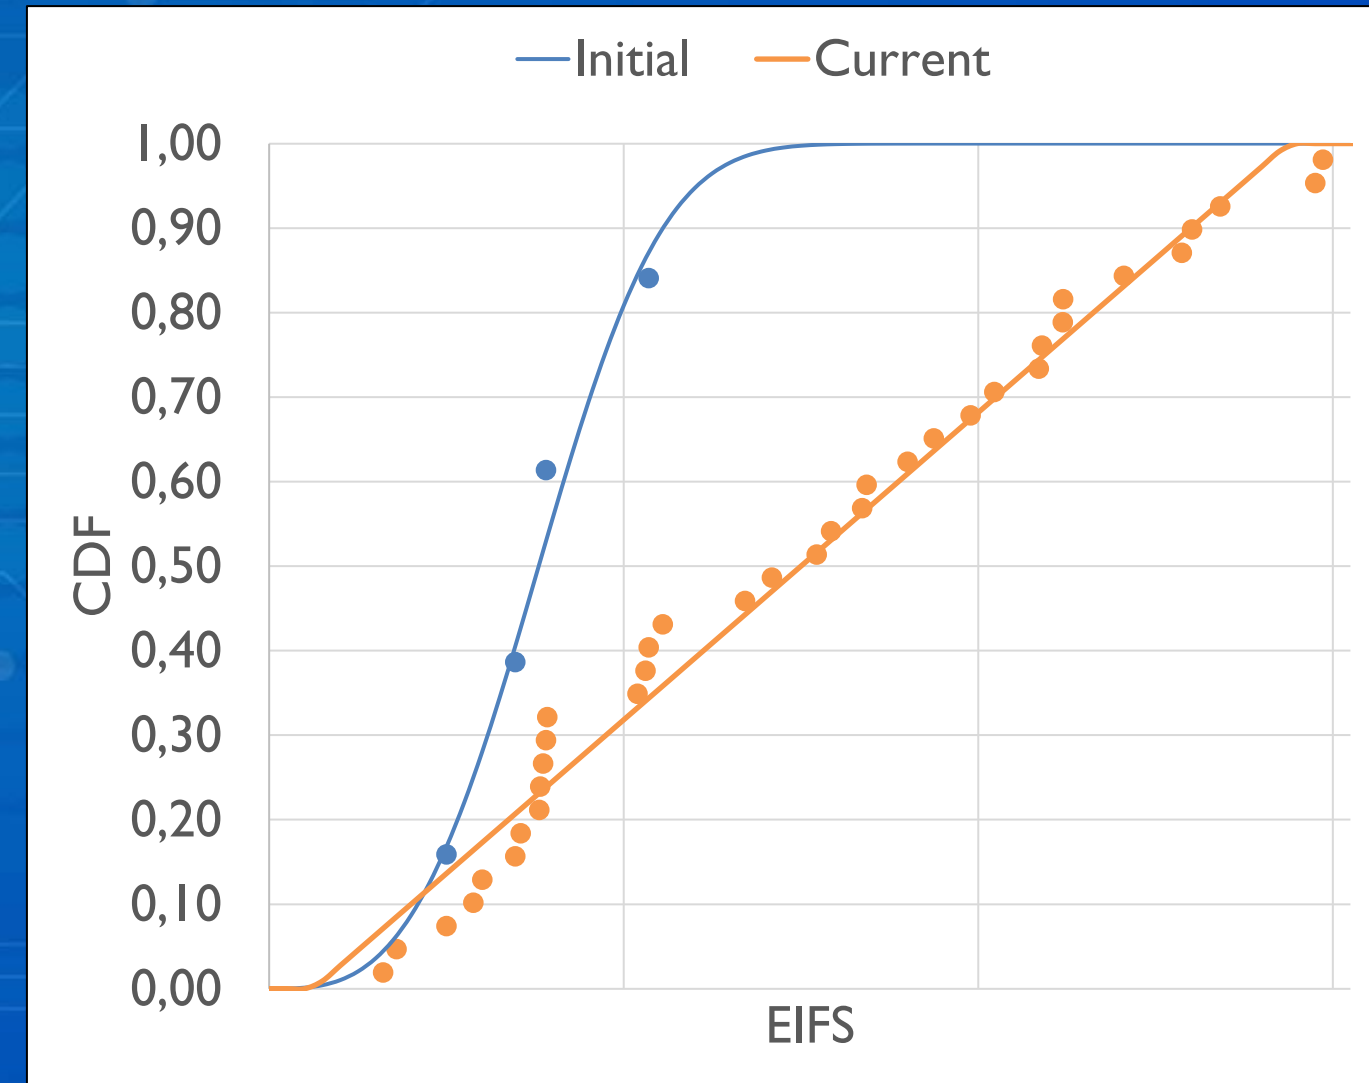
Condemnations

- 4 Initial EIFS points
- Assumed Weibull distribution
- 36 confirmed cracks from condemnations
- Uniform distribution
 - Arises in manufacturing where a mass-produced part gradually changes dimensions through **tool wear** and increased tool forces between setups

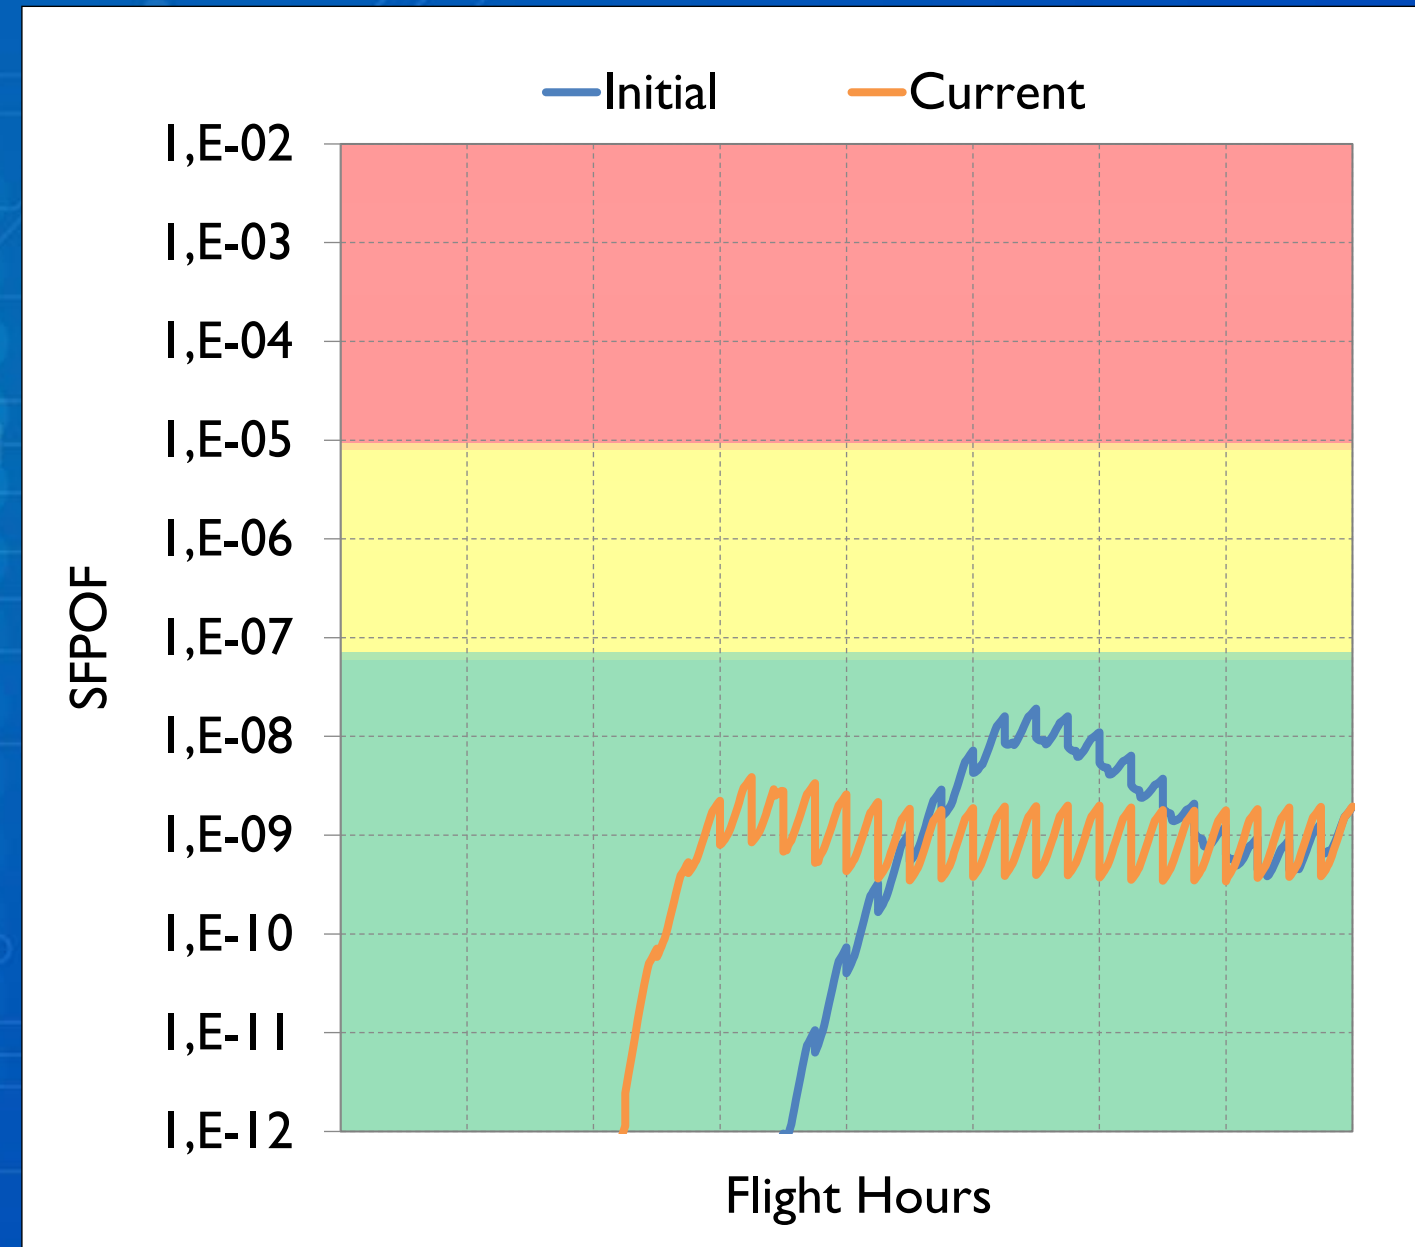
Condemnations

- Uniform EIFS shows an earlier increase in risk
- Weibull EIFS shows a 10x higher maximum for risk
- Expected crack findings match actual findings

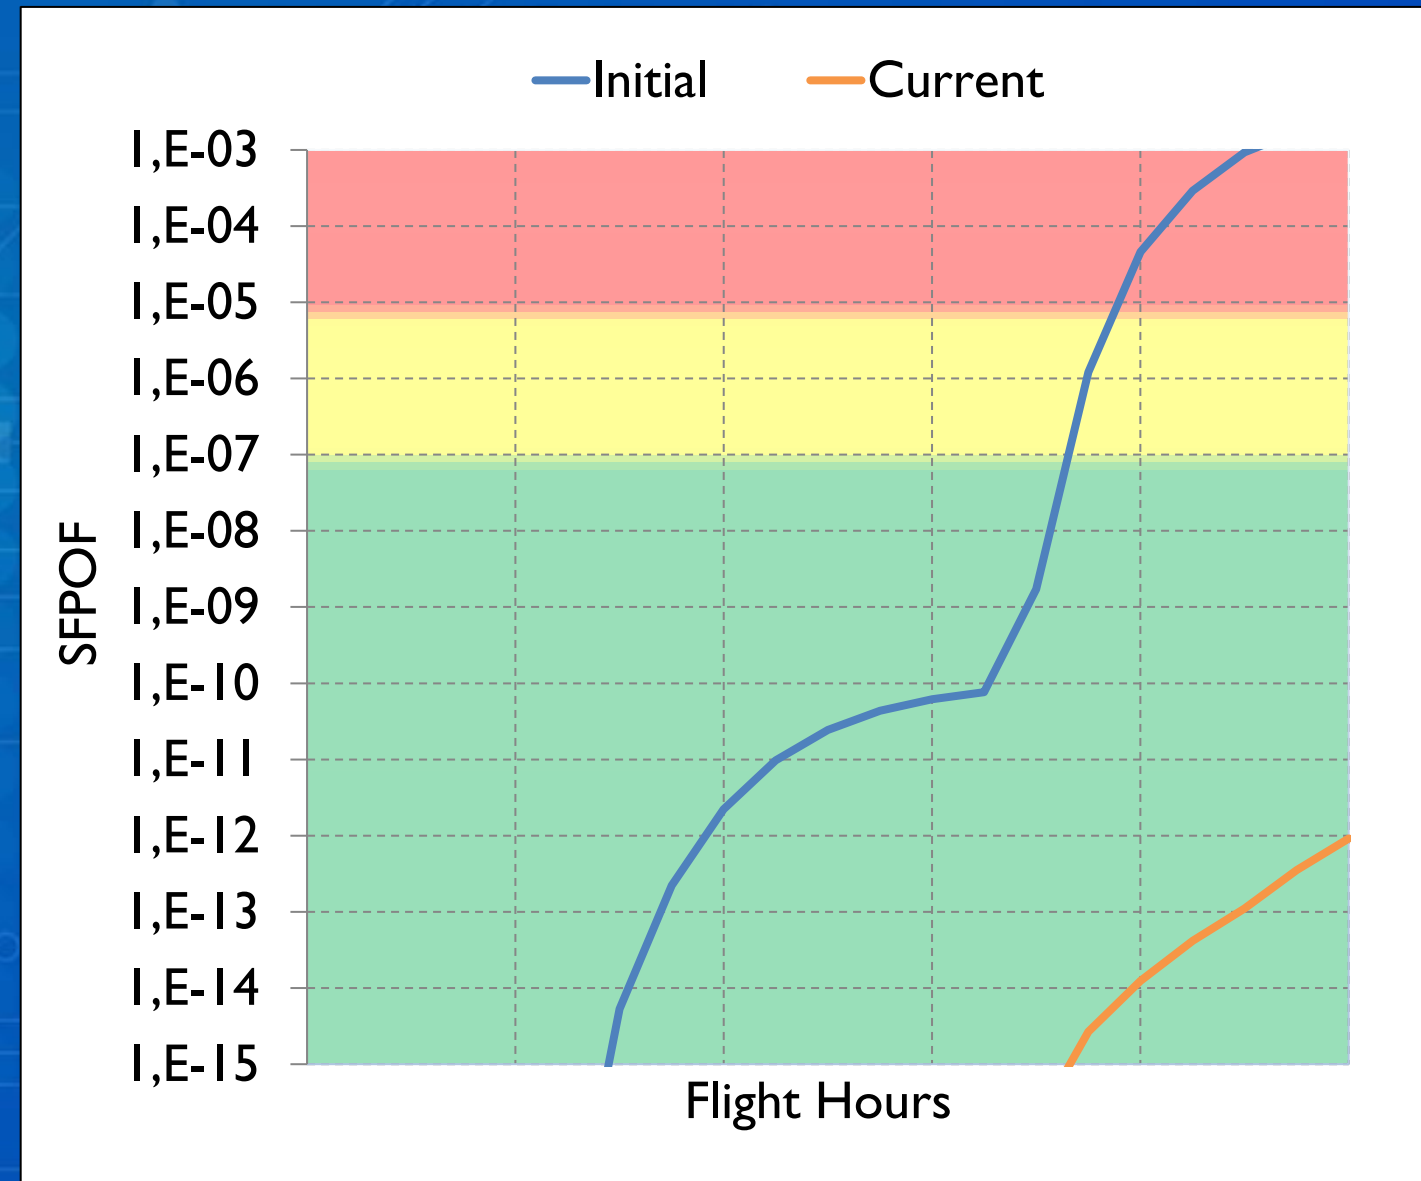
Teardowns

- Current PROF analysis shows that risk remains below 10^{-7} for the lifetime of the wing
- Why is the risk so low when there have been numerous teardown findings?
 - Largest recorded crack was 0.07 in., critical crack size is an order of magnitude larger
 - 1.2 lifetimes between largest measured crack and CCS
- **Teardowns from retired wings, identifying true cracking location, were essential for lowering risk and preventing unwarranted extra inspections**

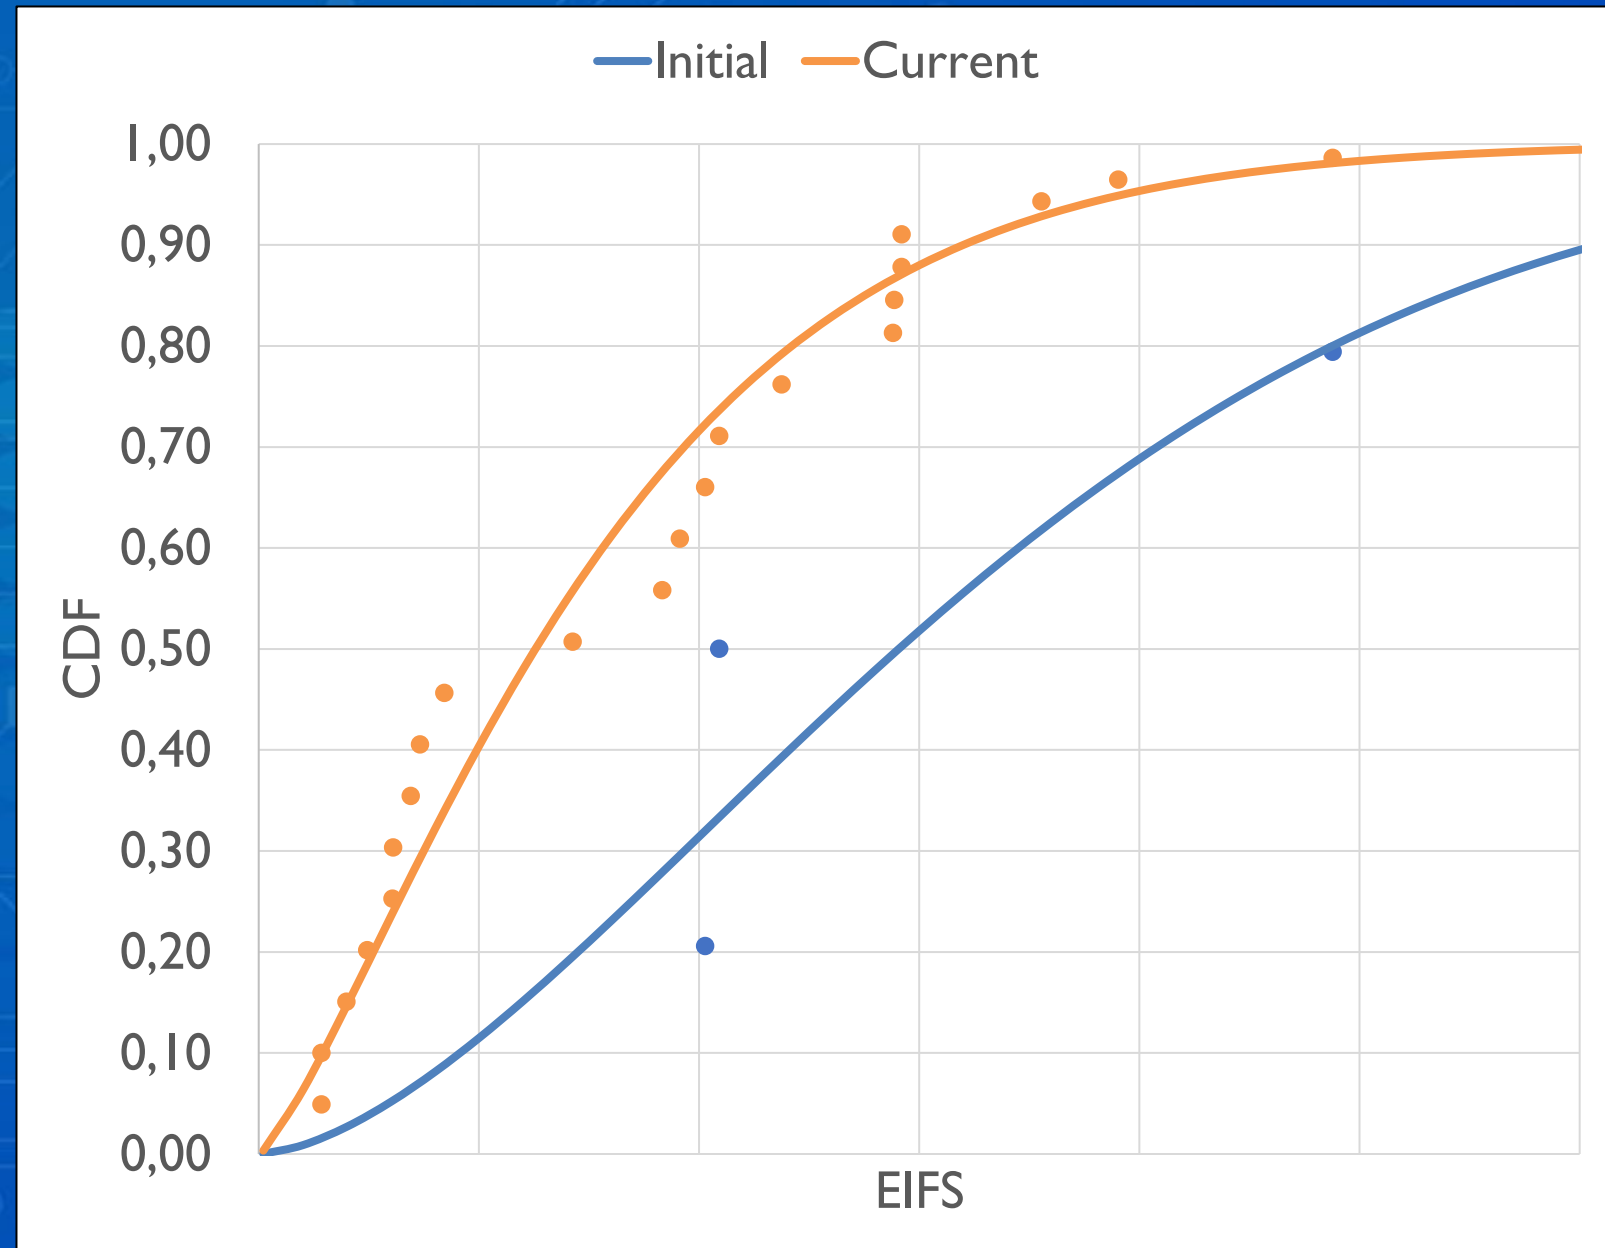
Modification Program

- Without PCIII inspections, EIFS dist. would be based on lone observed crack
- PCIII inspection of removed longerons revealed 24 confirmed cracks
 - 10 were double cracks, 14 were single cracks
- Two DTA curves were used to create EIFS distribution based on single or double crack

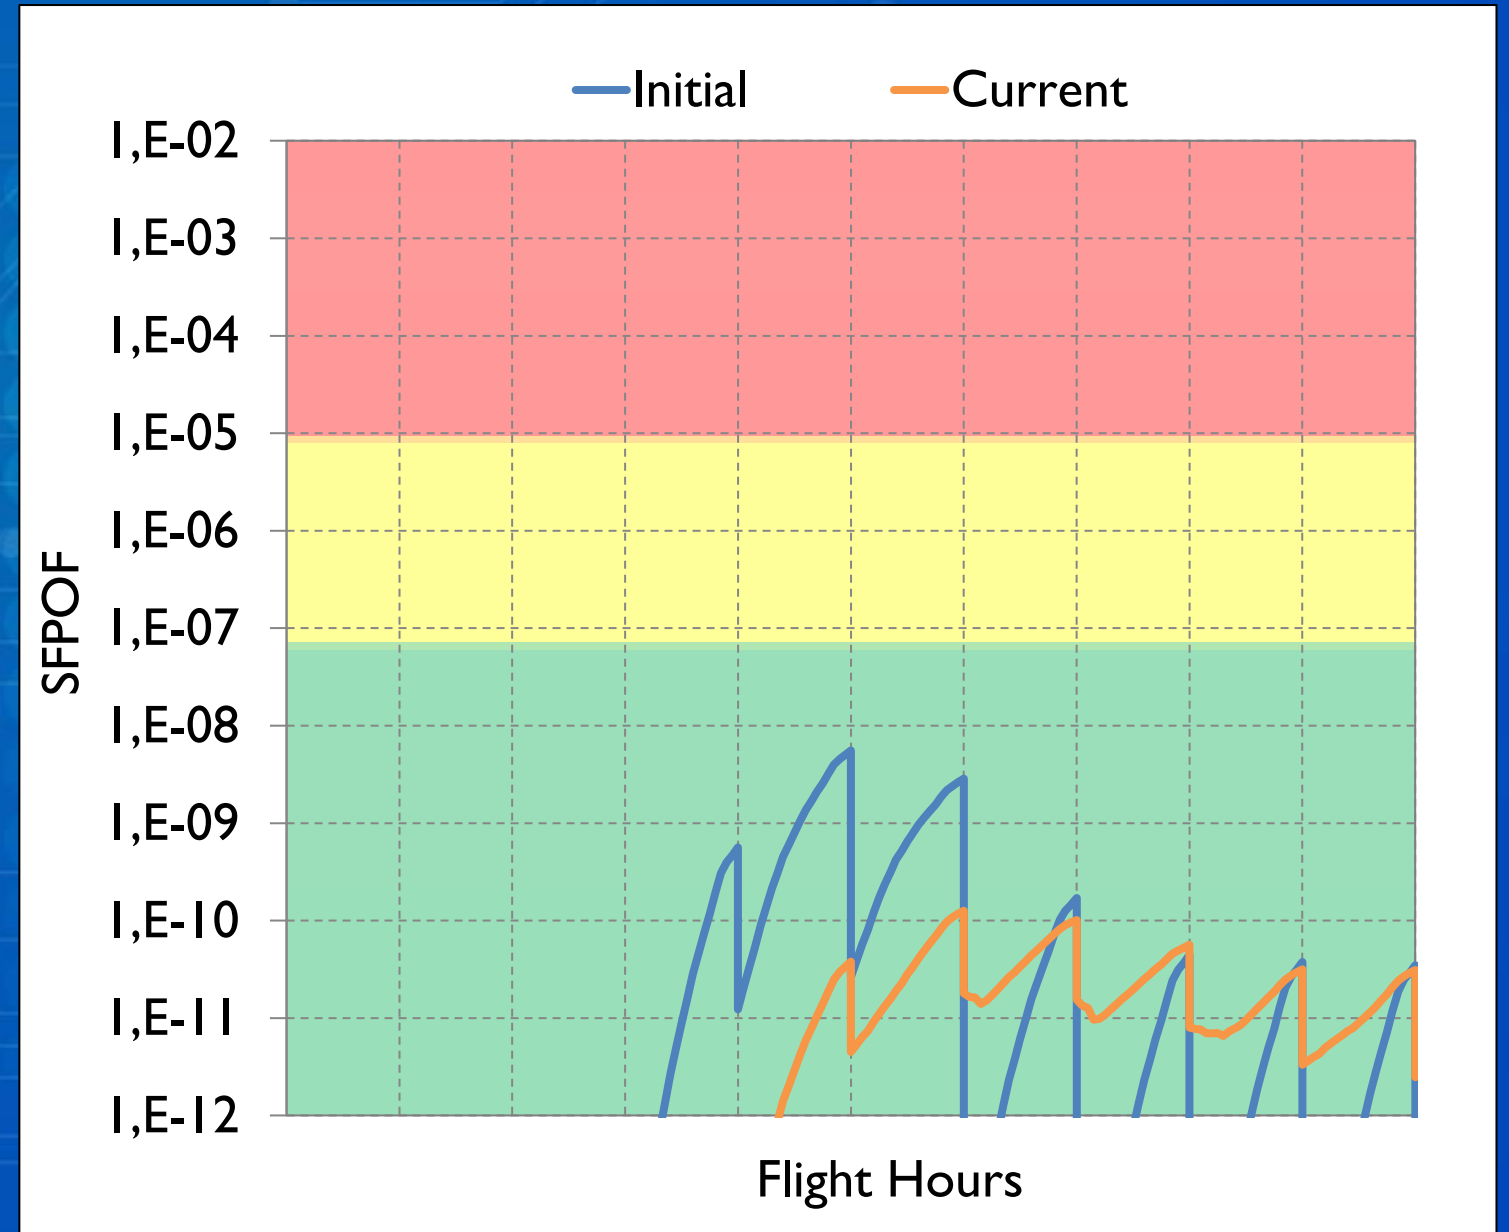
Modification Program

- Current risk shows a lower maximum and a shift to the right
- Inspections were doubled to reduce risk to acceptable levels
- Highest risk longerons have been removed and replaced in major modification program, further mitigating risk
- **Realistic risk analysis would not have been possible without data from teardowns of opportunity**
