Swiss Titanium Research Experiments on the Classic Hornet (STRETCH)

ICAF2023

Ben Main, Keith Muller, Isaac Field, Ricardo Filipe do Rosario, Mirco Figliolino, and Simon Barter

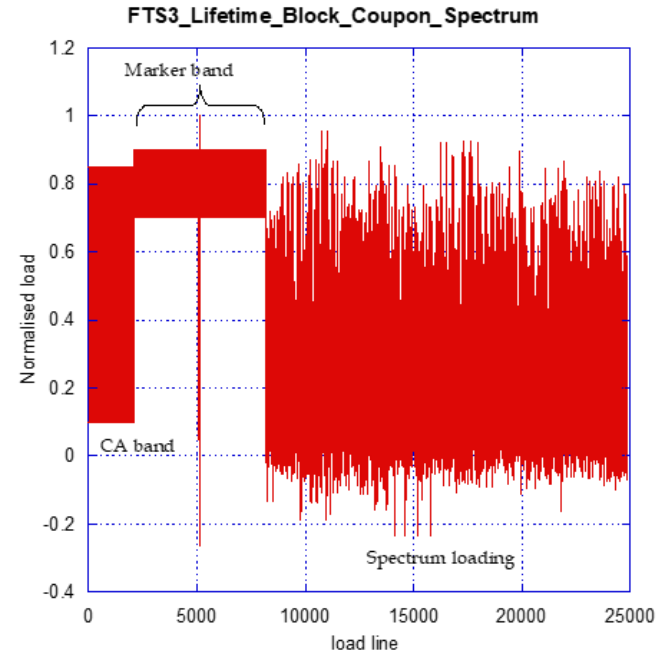
- 1 lifetime (6,000 SFH) produced by 20 blocks (300 SFH each).
- Marker band at the end of each block.
- CA¹ block at the start of each lifetime.
 - Equivalent to VA² growth.
 - Marks crack length at the start of each lifetime.
- Marker band primarily high R cycles with underloads.
 - Roughly 10% of total growth.

Name	Min. (normalised)	Max. (normalised)	Cycles
High R	0.7	0.9	1499
Low R	0.05	0.9	20
Load Line	0.02	-	0.5
Load Line	-	0.99	0.5
Load Line	-0.26	-	0.5
Load Line	-	1	0.5
High R	0.7	0.9	1499

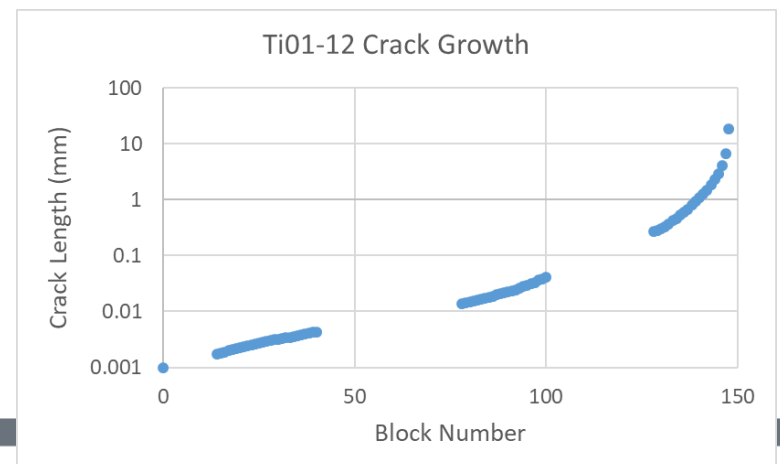
- Coupon tests validated both truncation and marker bands.
- Crack growth curves obtained from Ti-6Al-4V coupons.
 - Down to crack lengths $\approx 1 \mu\text{m}$.
 - Not all regions have visible marker bands.
 - Fastest growing crack is exponential [2].
- Compare FTS3 crack growth data to SLAP predictions.
 - Reassess service life based on improved data.

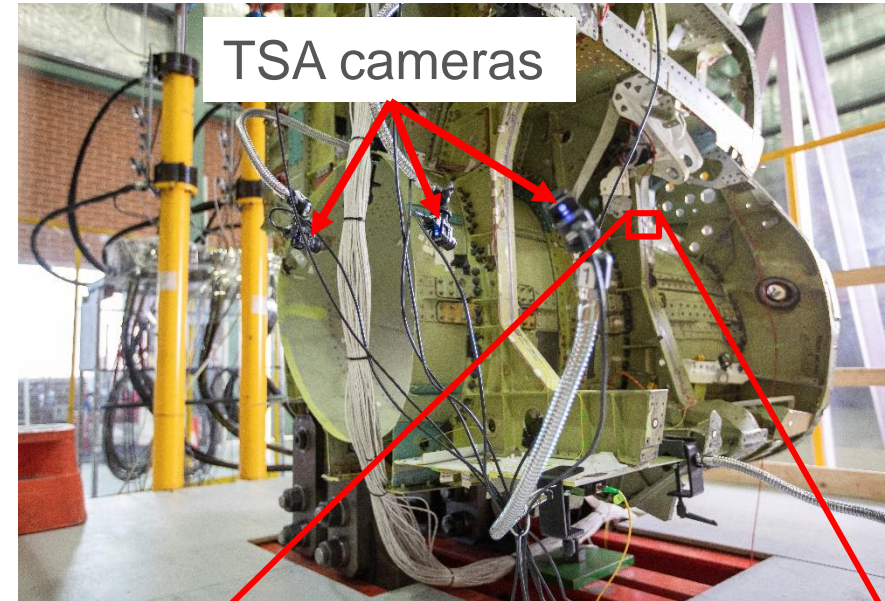
- Strain measuring instrumentation:
 - 89 × foil strain gauges.
 - 8 × Fibre Optic Sensor (FOS) lines.
 - 8 × Thermoelastic Stress Analysis (TSA) cameras.
- Other instrumentation:
 - 6 × Linear Variable Displacement Transducers (LVDT).
 - 6 × load cells.

- FOS and TSA is less widely utilised for strain measurements compared to foil gauges.
- FOS generally in close agreement to foil gauges.
 - Provides detailed 2D strain distributions.
- TSA able to provide large coverage strain data.
 - Easily identifies strain hotspots.

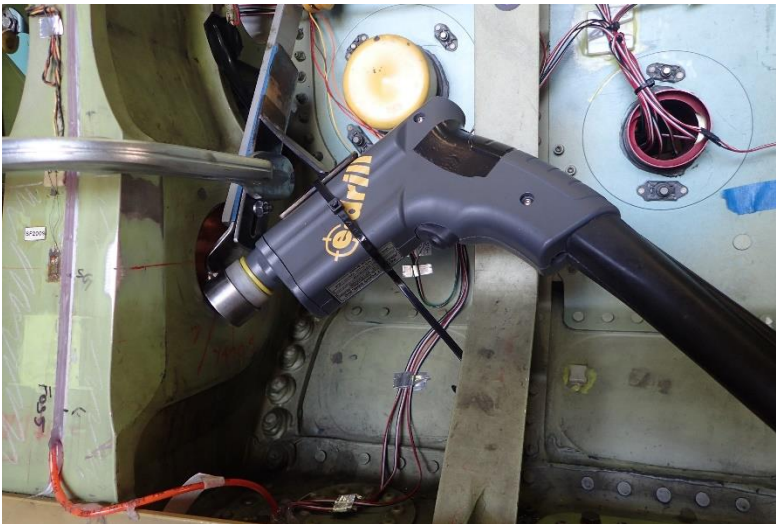
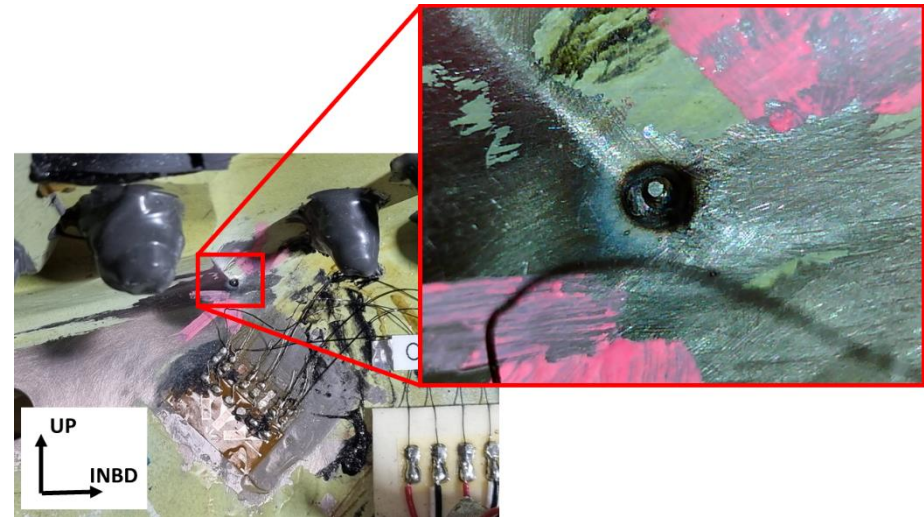
- 17 fatigue hotspots damaged.
- Two unique damage methods used:
 - Plasma arc spot melting.
 - E-Drill modified as EDM.
- Plasma arc ideal for roughly 0.01” damage.
- E-Drill ideal for roughly 0.05” damage.
