FATIGUE AND DAMAGE TOLERANCE TESTING OF GRIPEN 39E/F RUDDER

31st ICAF Symposium – Delft, 26-29 June 2023

Jan Erik Lindbäck

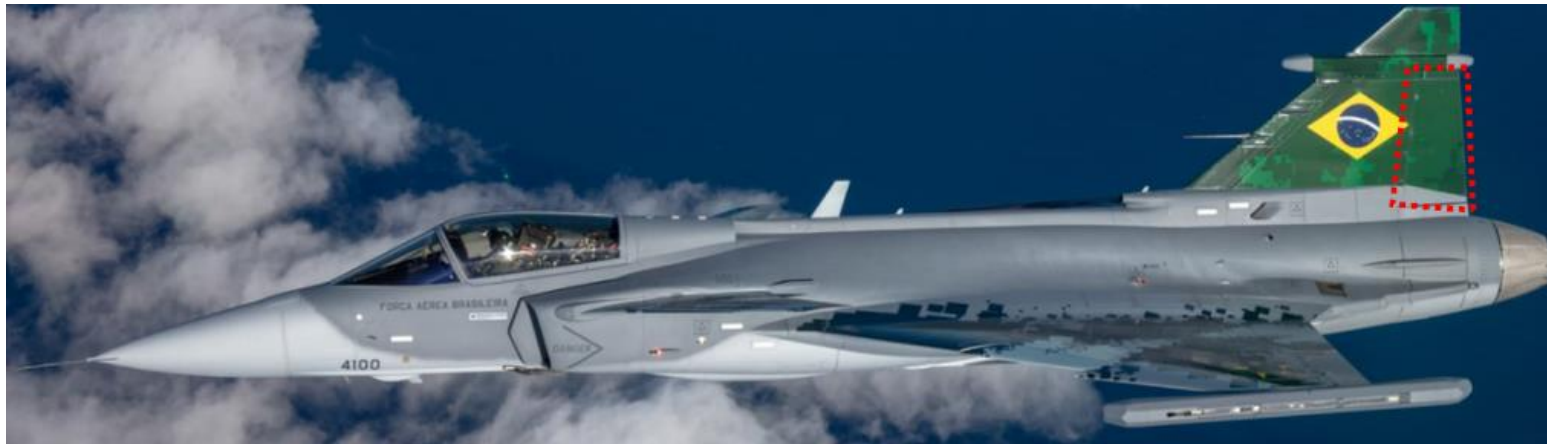
39E Single-seater Aircraft

- Gripen 39E is the single seater (many A/C)
- Gripen 39F is the 2-seater (fewer A/C)
- The same Rudder for 39E and 39F, but different load sequences
- From Fatigue and DT-analysis of the Rudder: 39E show full life but not 39F

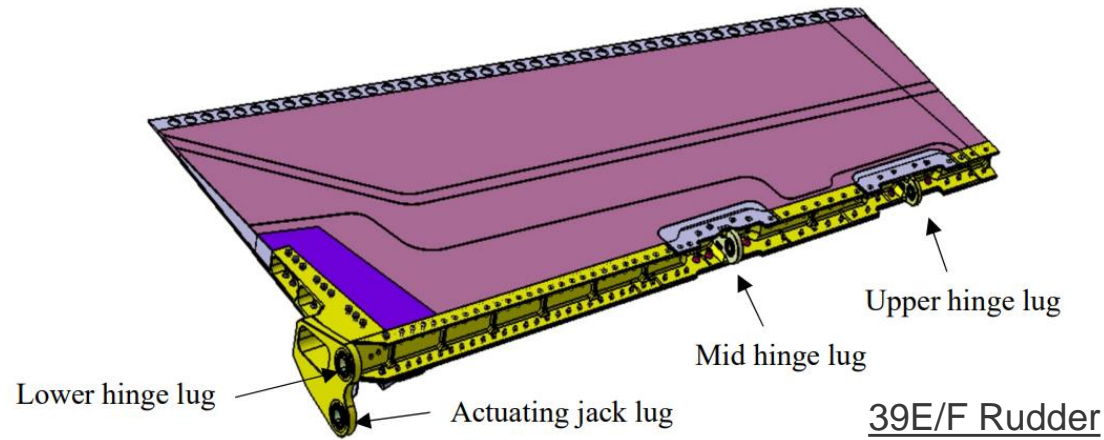
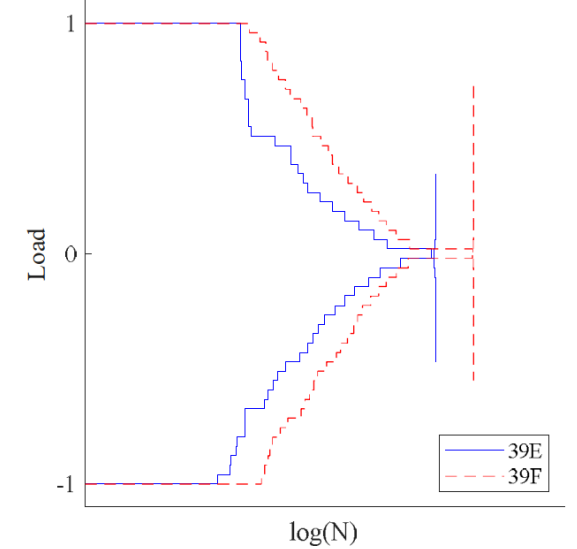
The Rudder and four options

39E/F Jack Load Spectrum

1. Run the more severe 39F-sequence that will cover also 39E
2. Run two separate tests for 39E and 39F
3. Run the 39E-sequence first and continue with the 39F-sequence
4. Run the 39E-sequence first, then continue the 39E-sequence scaled with a factor 1.2

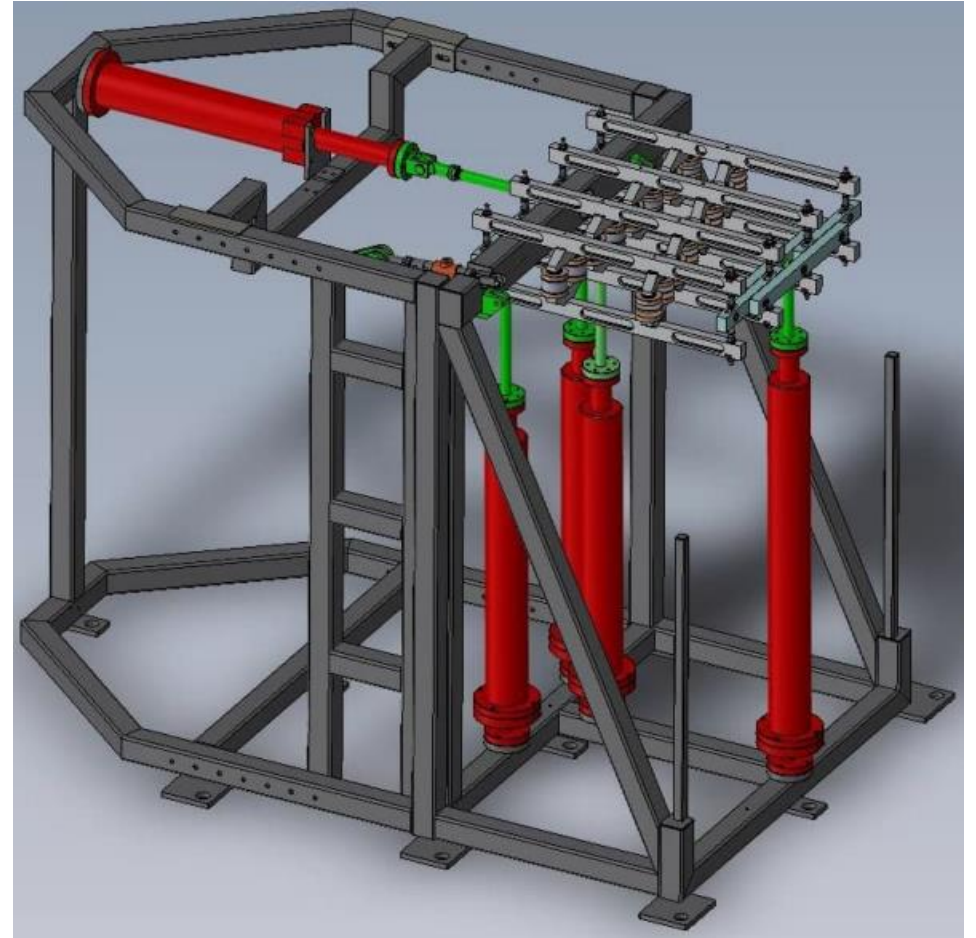
- The Rudder test was performed by VTT in Espoo, Finland
- Three actuators to apply air-loads via a whiffle tree and 16 pads on each side of the Rudder
- Two actuators to simulate the mid hinge reactions
- A load cell to monitor the reacting Jack load
- Displacement transducers and strain gauges
- Approximate 75 hours to run one design life

Test set-up before rudder mounting.
Figure courtesy of Arecap Ltd, A. Mattila

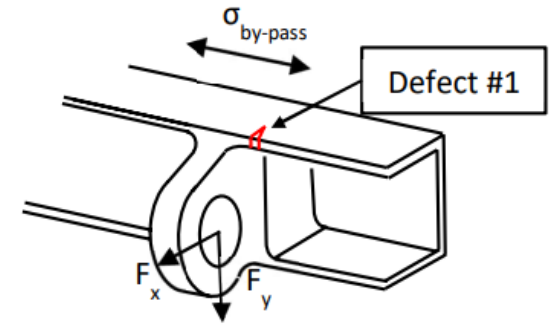
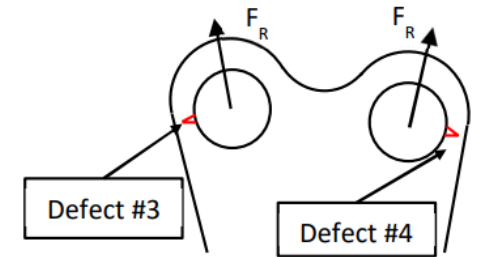
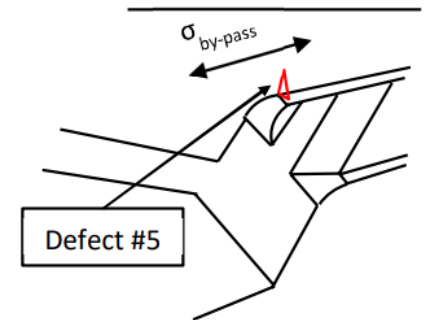
- Test Procedure, part 1 to verify 39E
 1. Run up to 2 Design Life with 39E-loads
 2. Introduce artificial defects
 3. Run up to 4 Design Life with 39E-loads
 4. Perform Residual Strength to 120%LL
- Test Procedure, part 2 to verify 39F
 5. Run up to 5.75 Design Life with 39E-loads scaled with a factor of 1.2
 6. Perform Residual Strength Test to 144%LL (1.2*120%)

Five defect positions of which #3 at the Jack actuator was most critical

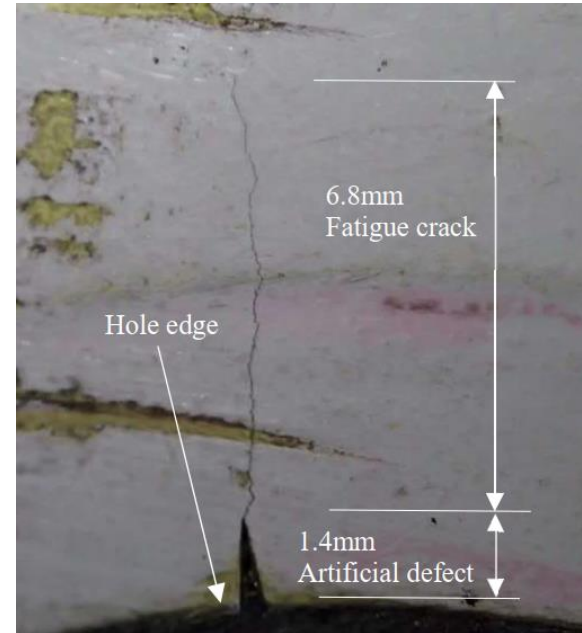
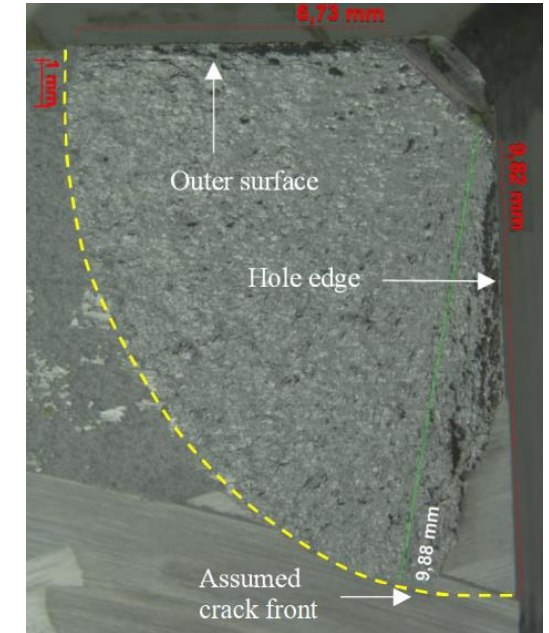
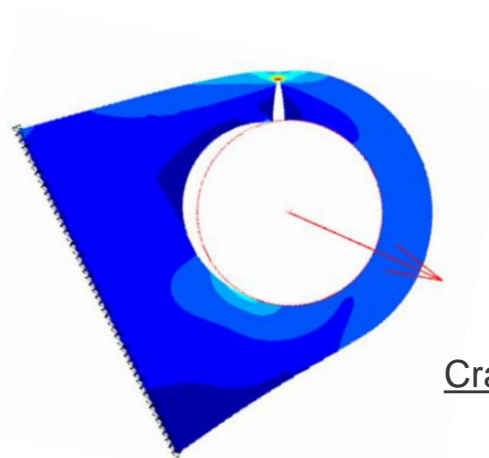
Test Results, defect #3, Jack Lug

- Ended the test after 5.75 Design Life
- Defect #3 was then 6.8mm
- Close to critical crack length
- Inspections with Eddy Current and Penetrant to detect crack growth

Crack #3 at Jack hinge lug

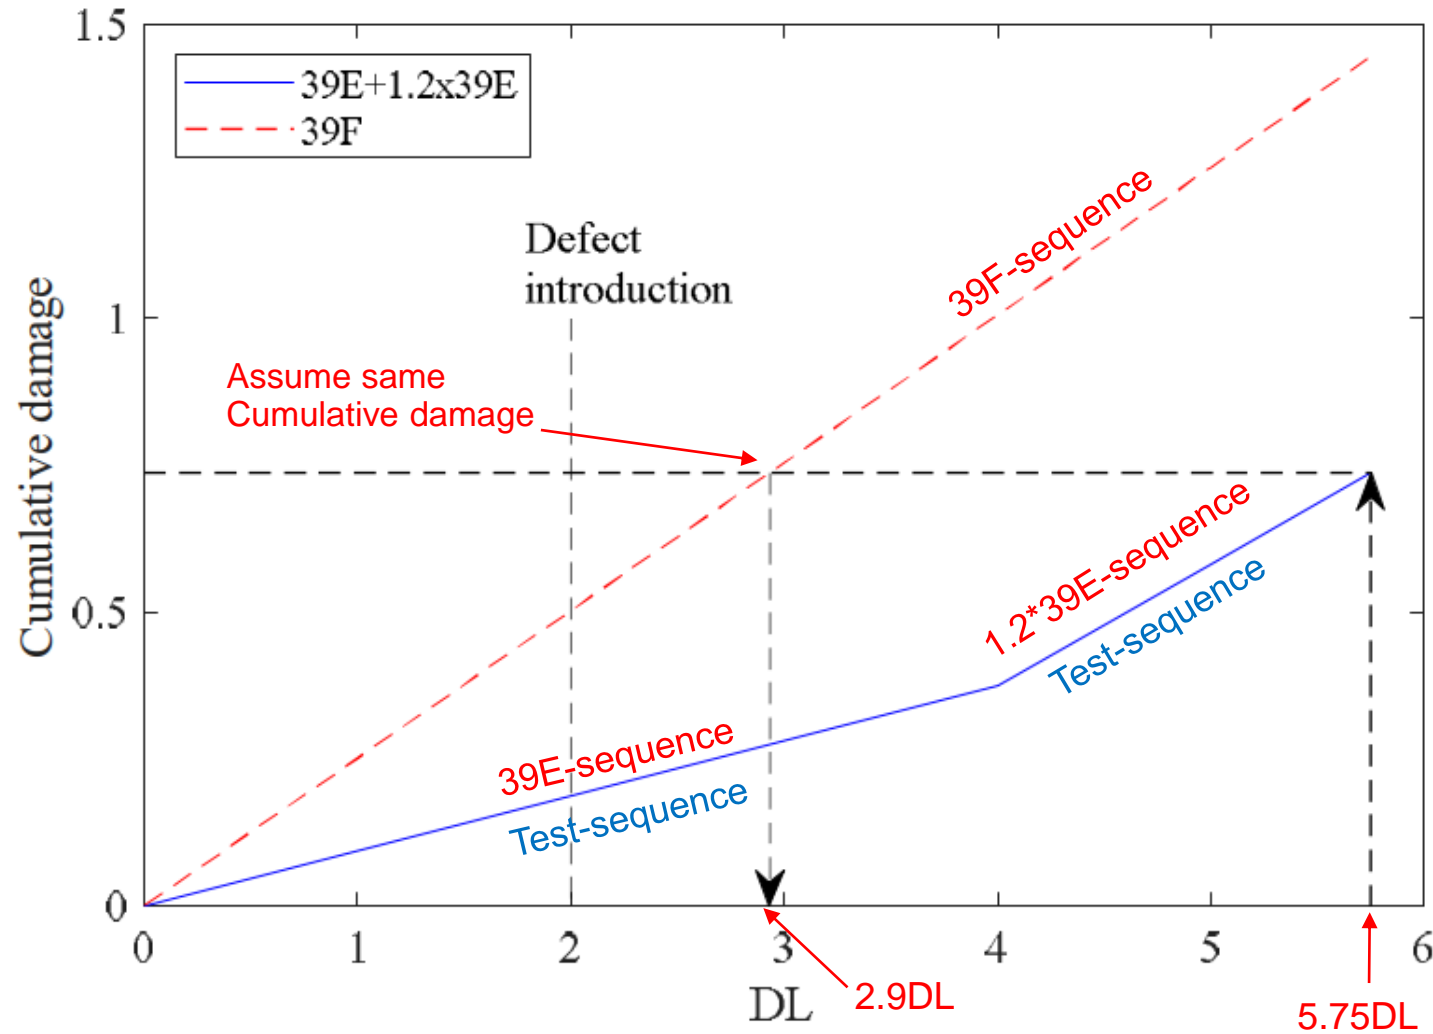
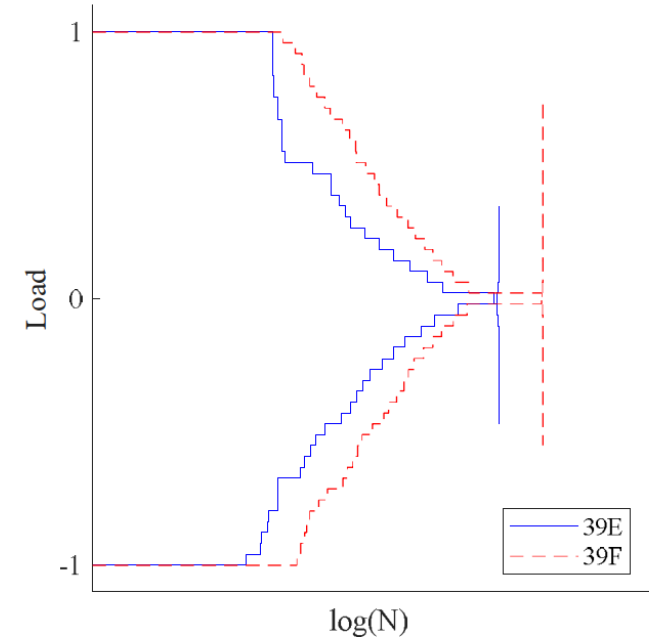
Fatigue damage analysis

39F Fatigue life analyzed to:
 $2.9/4=72\%$ of full life

- The current test and analysis approach has verified full life for 39E sequence and at least 70% of full life with 39F sequence.
- Judging by the predicted cumulative damage, and predicted and measured crack growth rate, it is doubtful that 4 DL of safe-life and 2 DL of DT testing could have been reached either with 39F sequence or with continued testing with the 1.2x39E sequence.
- However, 70% of full life is substantial and is considered as an appropriate time to first in-service inspection.

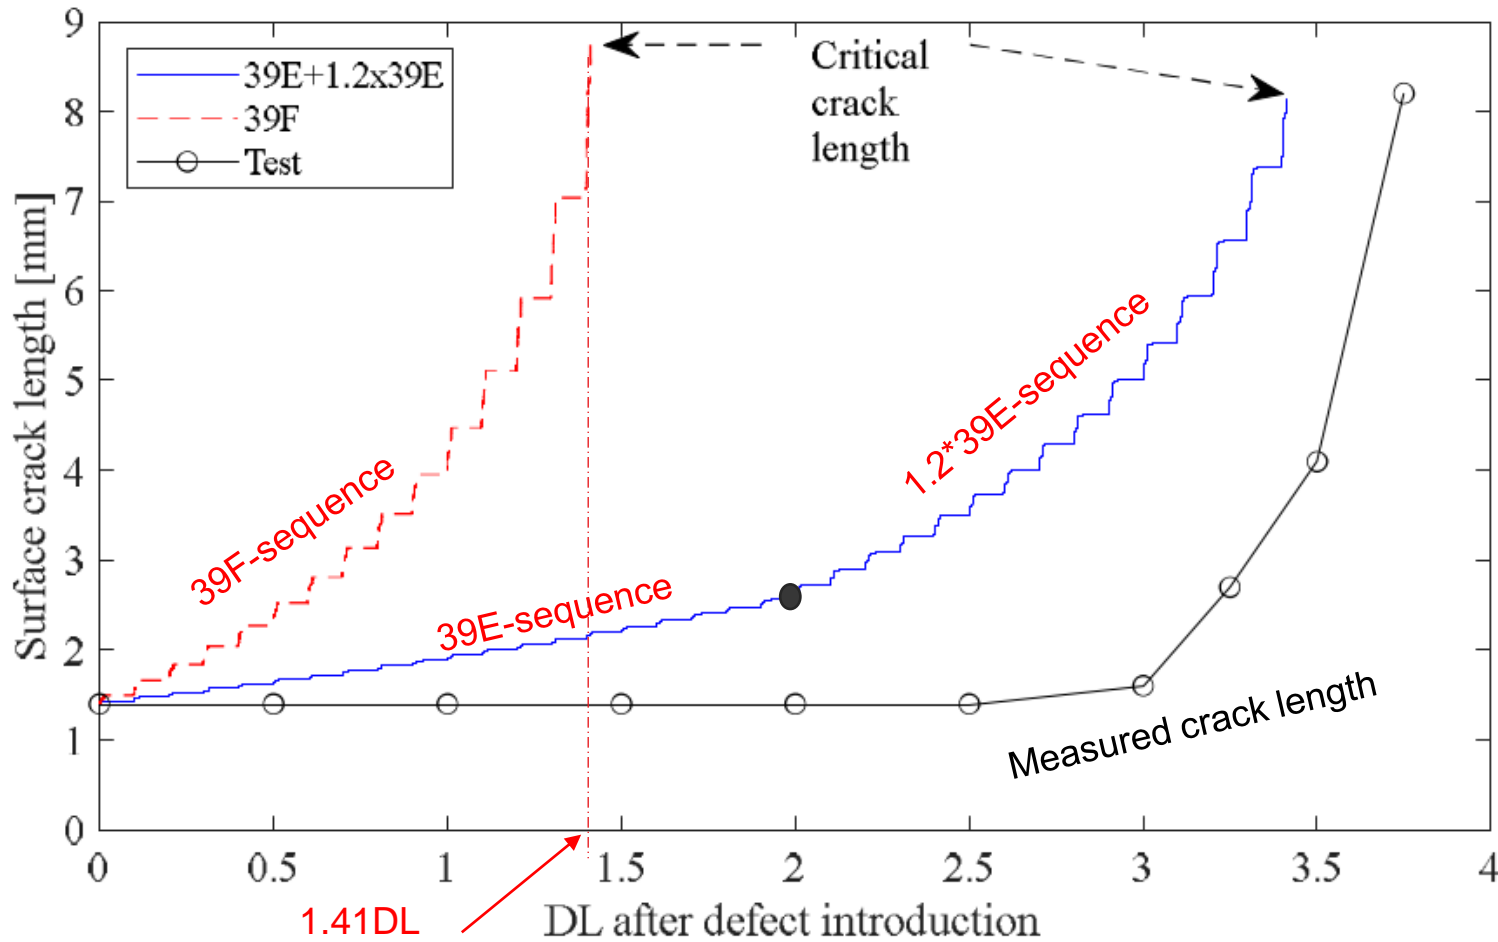
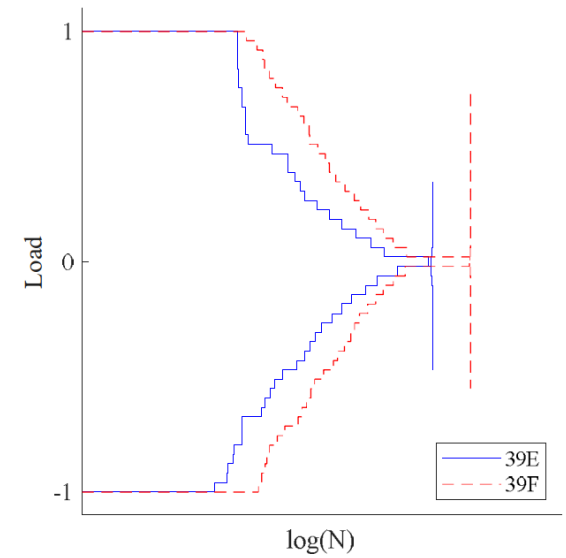
Crack growth analysis

39F DT life analyzed to:
 $1.41/2 = 71\%$ of full life
