EXPERIMENTAL STRENGTH AND FATIGUE ASSESSMENT OF A DISBONDED F/A-18 A/B/C/D INNER WING STEP LAP JOINT

F/A-18
A/B/C/D
Inner Wing
Step Lap Joint
(IWSLJ)

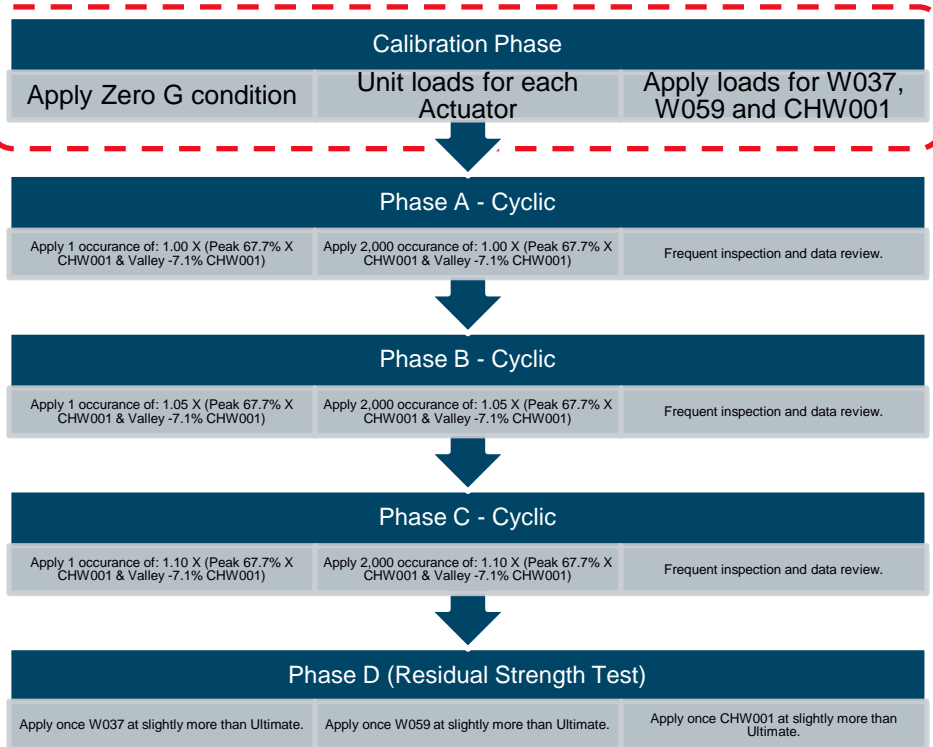
Test Sequence & Spectrum

Swiss Wing Root Bending Moment (WRBM) exceedance plot was used to determine cyclic loads.

- Swiss spectrum captures other fleets.
- Reference peak and valley WRBM corresponds values that occur once per hour.
- A total of 6,000 peaks and valley will be applied.

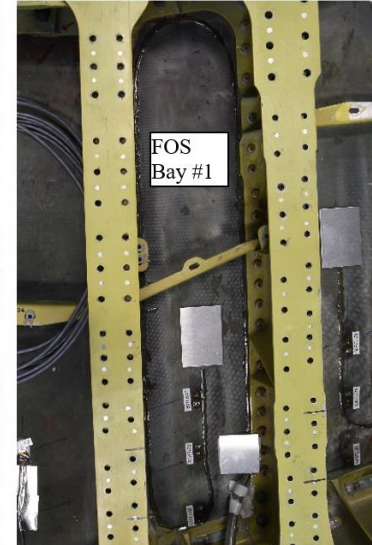
Instrumentation (3/3)

Optical strain measurements using fiber optic sensors

- Inside wing box near spars.

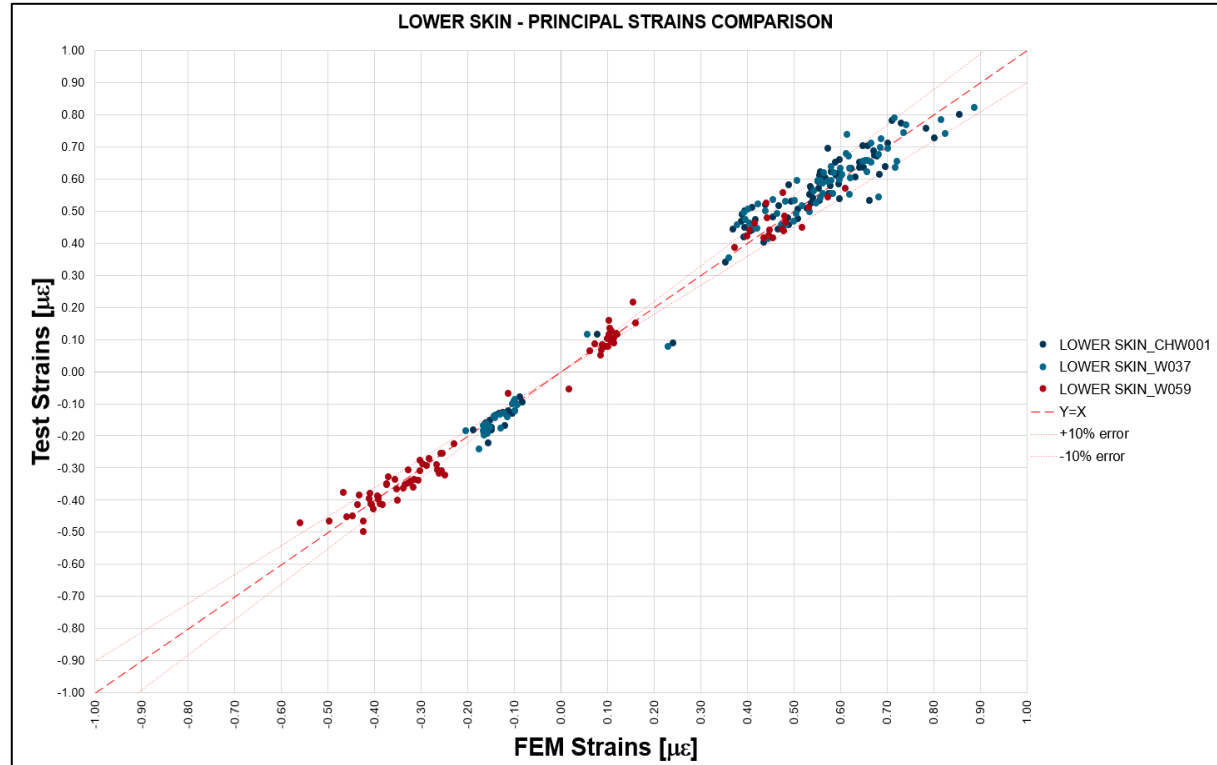
Overall good strain correlation between FEM and test.

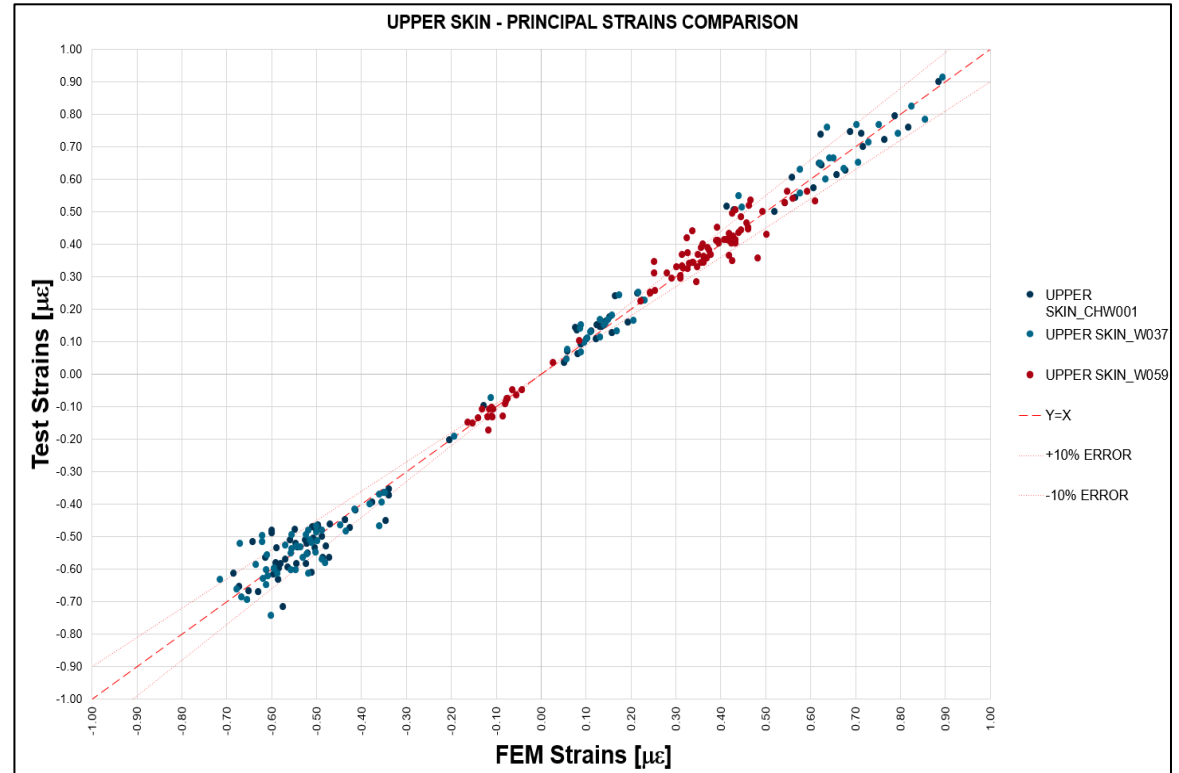
Overall good strain correlation between FEM and test.

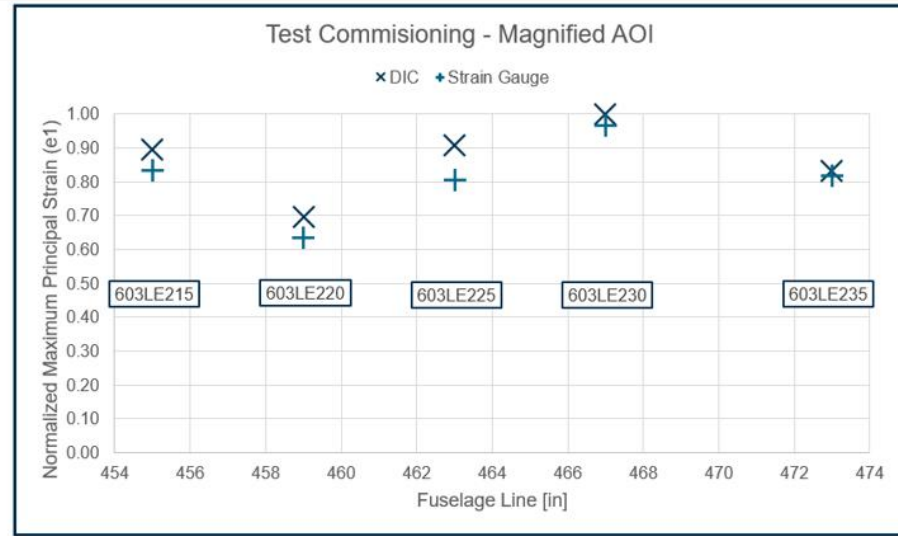
Overall reasonable agreement was achieved with the high magnification DIC
