FATIGUE IN NEW AND AGEING AIRCRAFT

AGING AIRCRAFT - USAF EXPERIENCE AND ACTIONS

John W. Lincoln*

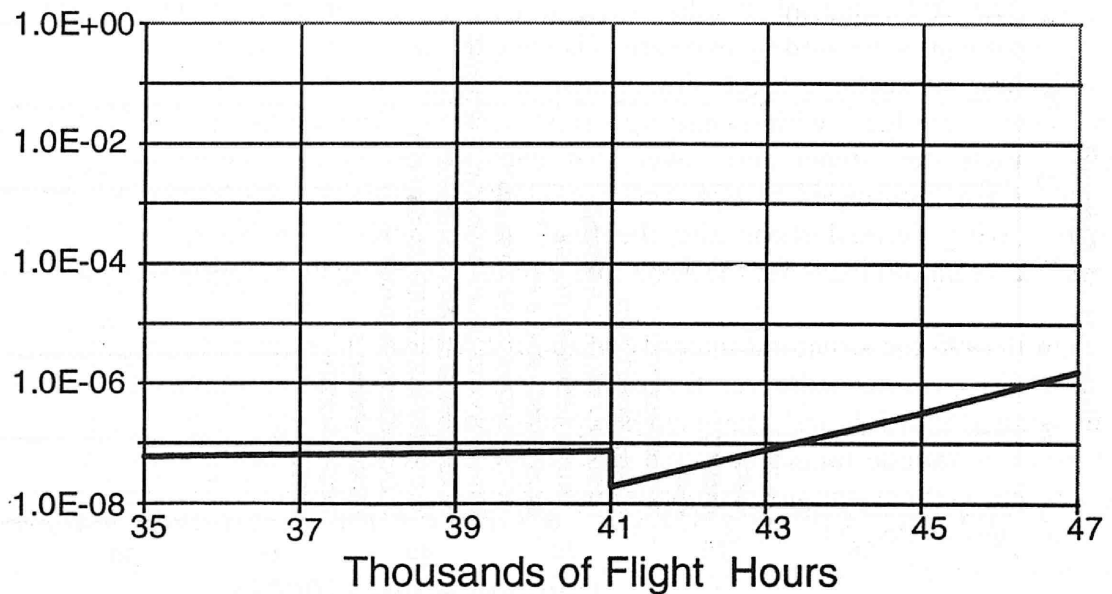
Figure 24 Risk of failure from spanwise splice cracking

At the initial meeting of the ad hoc team, they concluded the current program of inspecting with eddy current should be adequate to protect the safety of the wing. Figure (24) shows the calculated risk of failure from spanwise splice cracking. However, the team emphasized the success of the management philosophy using "slow crack growth" is totally dependent on the performance and accuracy of the NDI mandated by the C-141 program manager. The ad hoc team recommended the performance of the inspectors be examined by a team of experts. These experts would conduct an on-site audit of the inspectors and conduct proficiency tests. This would determine if inspections on the C-141 wing are being effectively performed as required by the technical orders.

These disturbing results precipitated two action plans. The USAF aimed the first plan at improving the ongoing inspection with high frequency eddy current. This plan included the continued testing of C-141 inspectors and the elimination of those that did not appear to be proficient. This activity was somewhat subjective since the USAF had not correlated the test demonstrated proficiency with the degradation of the detection probability for cracks. For inspections that are so dependent on human factors such as this, the USAF needs to establish quantitatively the influence of the inspector on the reliability of the inspection.

Second, they planned to replace existing labor intensive eddy current with an automated NDI system that uses ultrasonic technology. Ultrasonic inspection would be a significant advantage for this structure since it can inspect both layers of the spanwise splice joint for cracks as small as two to three millimeters. This is possible since the joint has a sealant that will act a coupling and transmit the ultrasonic energy. The technology used in this inspection is not new. The mechanization of the technology will relieve the uncertainty associated with the human factor aspect of the inspection. Another advantage of this approach is that
