Review of Aeronautical Fatigue Investigations in Switzerland

May 2005 – April 2007

KOR-TA2007-0165

M. Guillaume RUAG Aerospace CH- 6032 Emmen

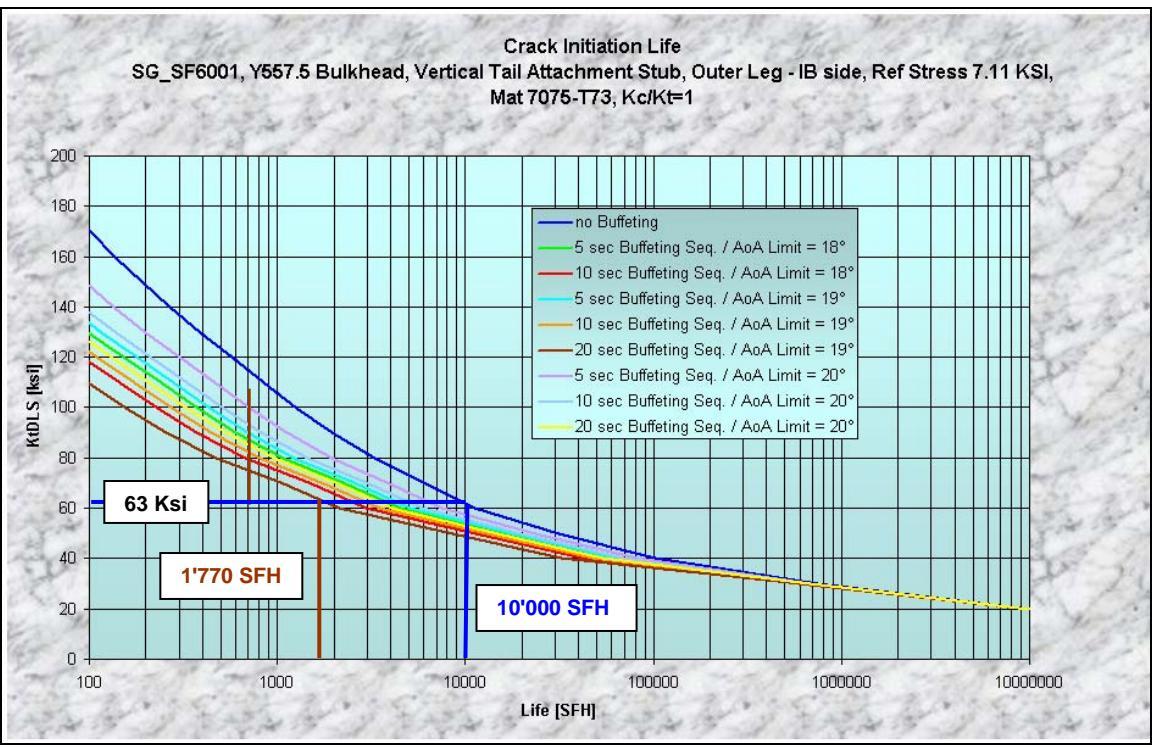
Figure 4.4.3: Crack initiation life curves for the variation of AoA and buffeting time

Using the crack initiation software CI89 from Boeing the crack initiation life was decreased from 10'000 SFH (63 Ksi = design goal) to 1770 SFH, see figure 4.4.3. Due to buffet the durability life could be decreased by factor up to approximately 5. For critical buffeting locations higher safety factors should be considered. Detailed unsteady aeroelastic coupling together with flight test data will deliver more information for the assessment of the structural integrity on the F/A-18 vertical tail due to the Swiss usage.

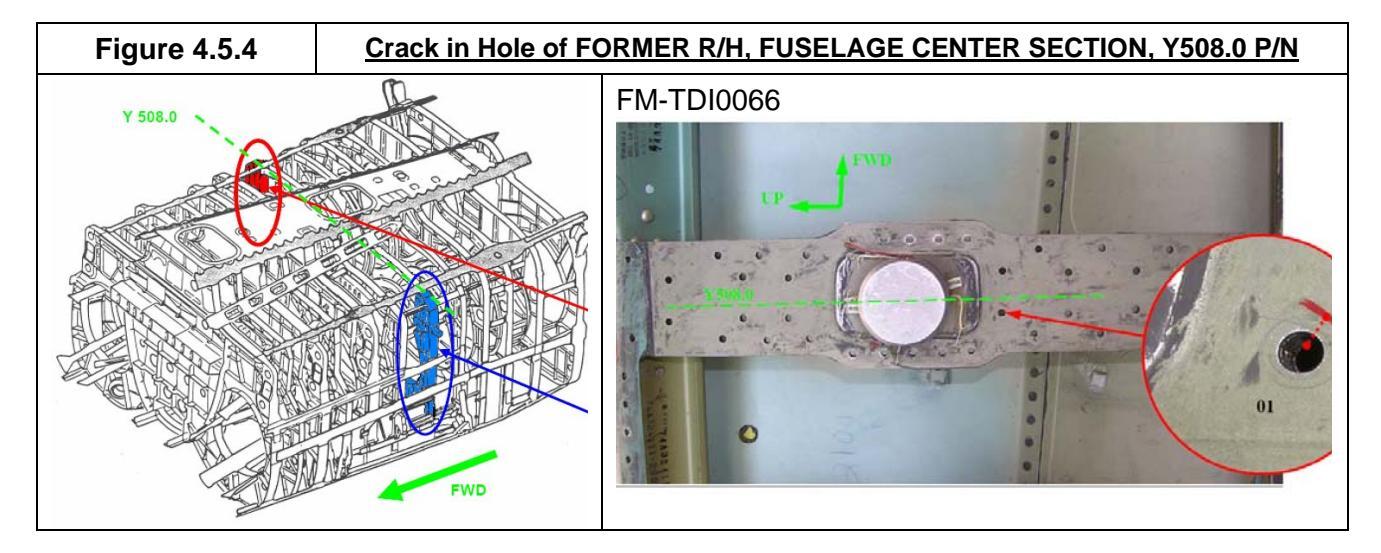
The critical locations based on the Swiss FSFT were evaluated in detail. Total 37 parts of the center fuselage showed cracks after 10'400 SFH. For 18 parts of 37 parts the cracks were observed during the tear down inspection. The only fracture critical (FC) part was the former center section at FS508, see figure 4.5.4. Only a small crack at the hole was found at LH side during the tear down inspection.

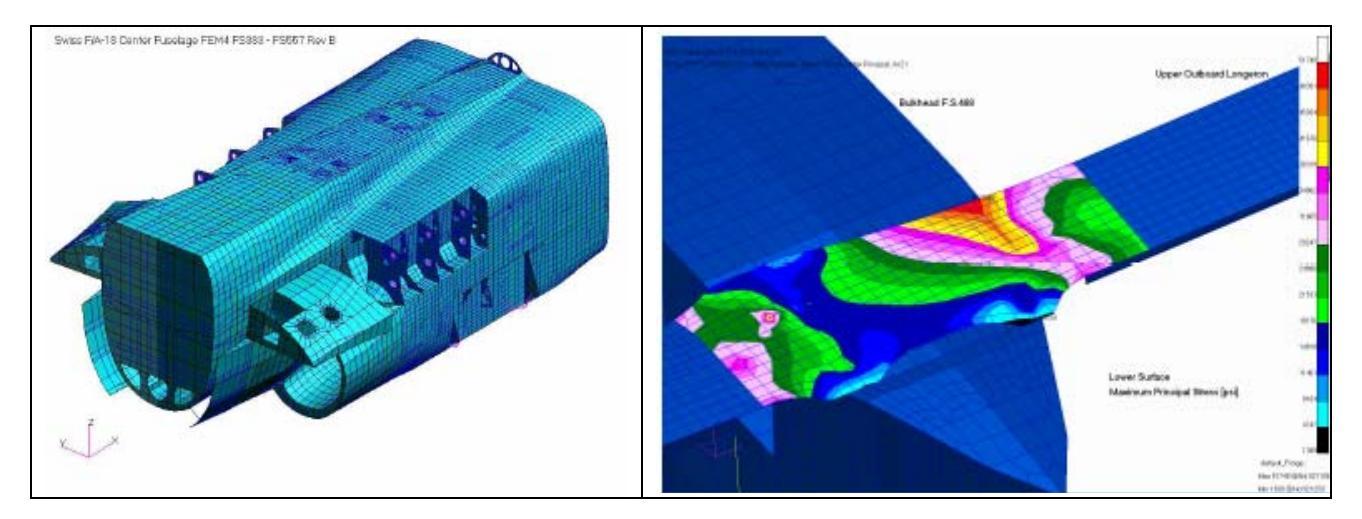
Figure 4.5.9: Detailed Swiss FE model used for analysis with details in the upper outboard longeron at FS489

A detailed FEM analysis on the outboard longeron showed a high stress at the edge of FS489. During tear down inspection a crack was found there but the Fraktographie (figure 4.5.3) showed that the crack initiation occurred not at the predicted highest stress area by finite element analysis, see figure 4.5.9. The material (7149-

To study the stresses and strains at the critical locations in the center fuselage the already existing Finite Element Model (FEM) was refined and checked in detailed with Swiss drawing set, see figure 4.5.9. The measured strains in the test were also used and compared with strains from the FE model.

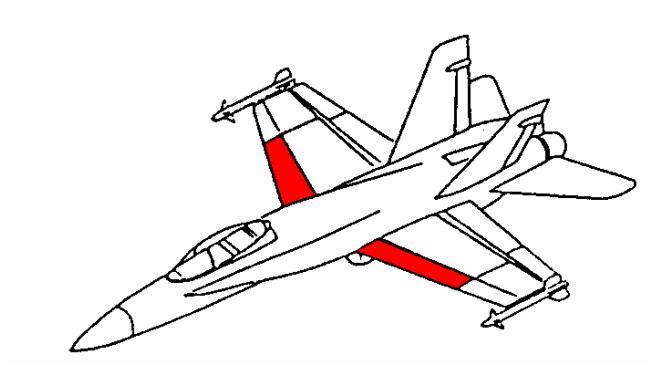
Figure 4.6.1: Inboard ledading edge flap (ILEF)

During the Swiss F/A-18 Full Scale Fatigue Test (FSFT), cracks of considerable size have been detected in both the left and right ILEF after only 3000 Design Spectrum flight hours. Such early cracking was not expected, as this location was improved by Swiss-specific modifications. Although the ILEF was primarily used as a load introduction component for the Inner Wing during the FSFT, and the loads were not intended to fully represent expected usage loads, the FSFT results are representative enough to consider the damages as fleet relevant. In addition, similar ILEF damages have been found in other fatigue tests (i.e. FT01/ST16/FT93), as well as in fleet aircraft of other users. Based on these findings, the cracks in the ILEF spar were rated as a Major Structural Issue for the Swiss F/A-18 fleet.

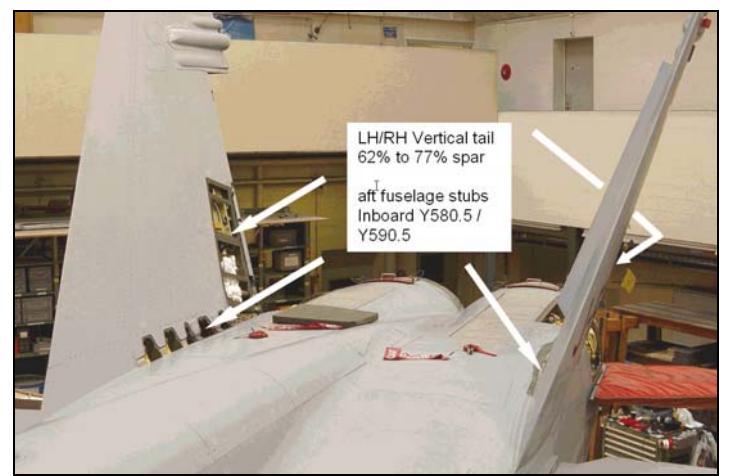
Figure 4.7.1: F/A-18 Buffeting NDT-Inspection

Based on a review of relevant F/A-18 buffeting reports, potential critical locations have been defined on the vertical tail and aft fuselage stubs. The most critical locations are the structural parts of the 62% and 77% spar of the vertical tail, as well as the last two aluminum aft fuselage stubs Y580 and Y590.

These components have been NDT-inspected in the Swiss fleet leader (based on an AoA> 10° criterion). No cracks were found. Investigations are also underway to investigate Swiss F/A-18 buffeting from measured in-flight data.
