REVIEW OF CANADIAN AERONAUTICAL FATIGUE WORK 2003-2005

Jerzy P. Komorowski, William Wallace
INSTITUTE FOR AEROSPACE RESEARCH
NATIONAL RESEARCH COUNCIL OF CANADA

This paper provides a review of Canadian work associated with fatigue of aeronautical materials and structures during the period 2003 - 2005. All aspects of structural technology are covered including full-scale tests, loads monitoring, fracture mechanics, composite materials and non-destructive inspection.

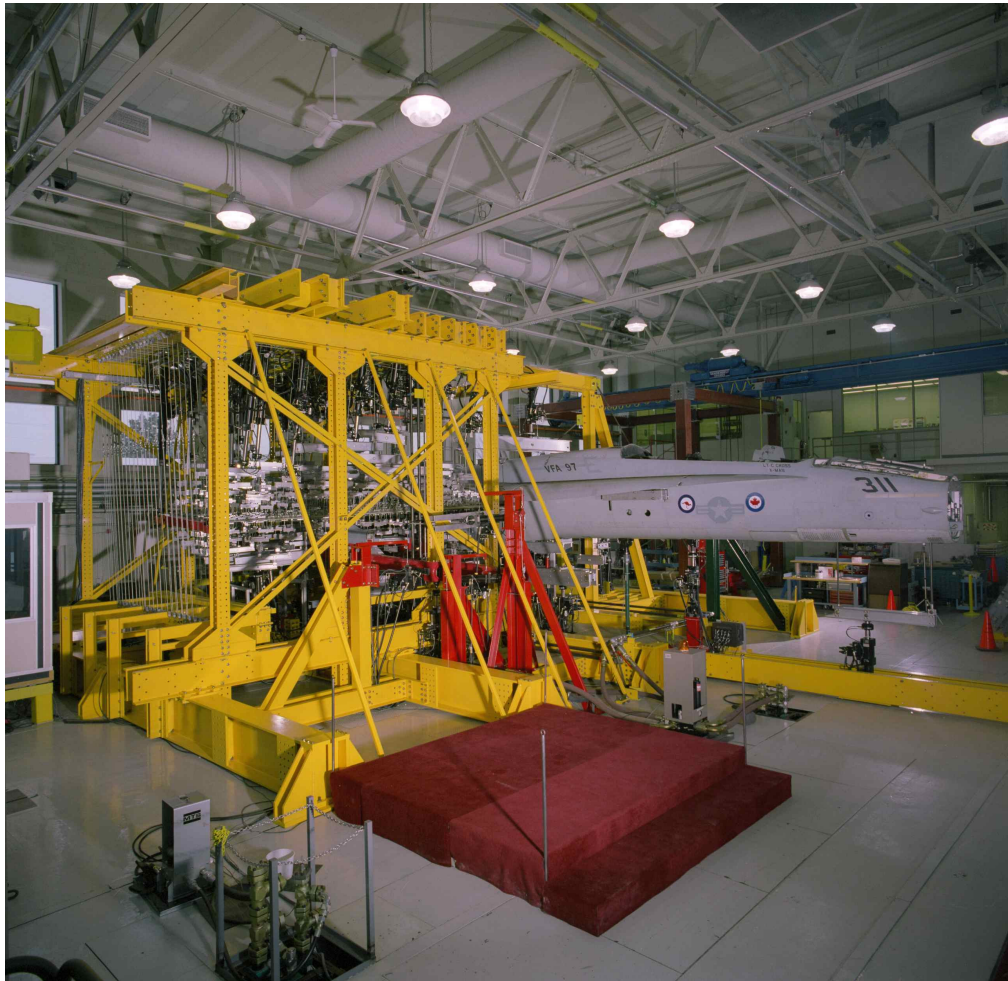
Figure 1. FT-245 Wing Fatigue Test

The fatigue cycling to three life times applied quasi-static loads in a sequential block. Each block represents 326 hours of CF aircraft flight. These loads were extracted from in-service aircraft measured data that represent average usage in a severe squadron. The spectrum accounts for manoeuvre, inertia, and some dynamic loads. The base data used to derive the spectrum had approximately 25 million end-point conditions and the final spectrum was truncated to about 155,000 with about 50,000 being unique load conditions. The lower level dynamic loads were truncated severely to obtain manageable test time. The objective is to determine the economic life of the F/A-18 IFOSTP aircraft wing structure and where possible obtain crack growth data to support management on a safety by inspection basis, validate repairs and modifications and obtain engineering data. This test is being conducted to demonstrate that the F/A-18 wing structure has a life equal to or greater than 6000 operational hours free of catastrophic failure. It is also required to verify the period decided upon for fleet structural inspections and to yield data on maintenance schedules, component replacements such as aileron and trailing edge flap fittings and repairs or modifications where applicable.

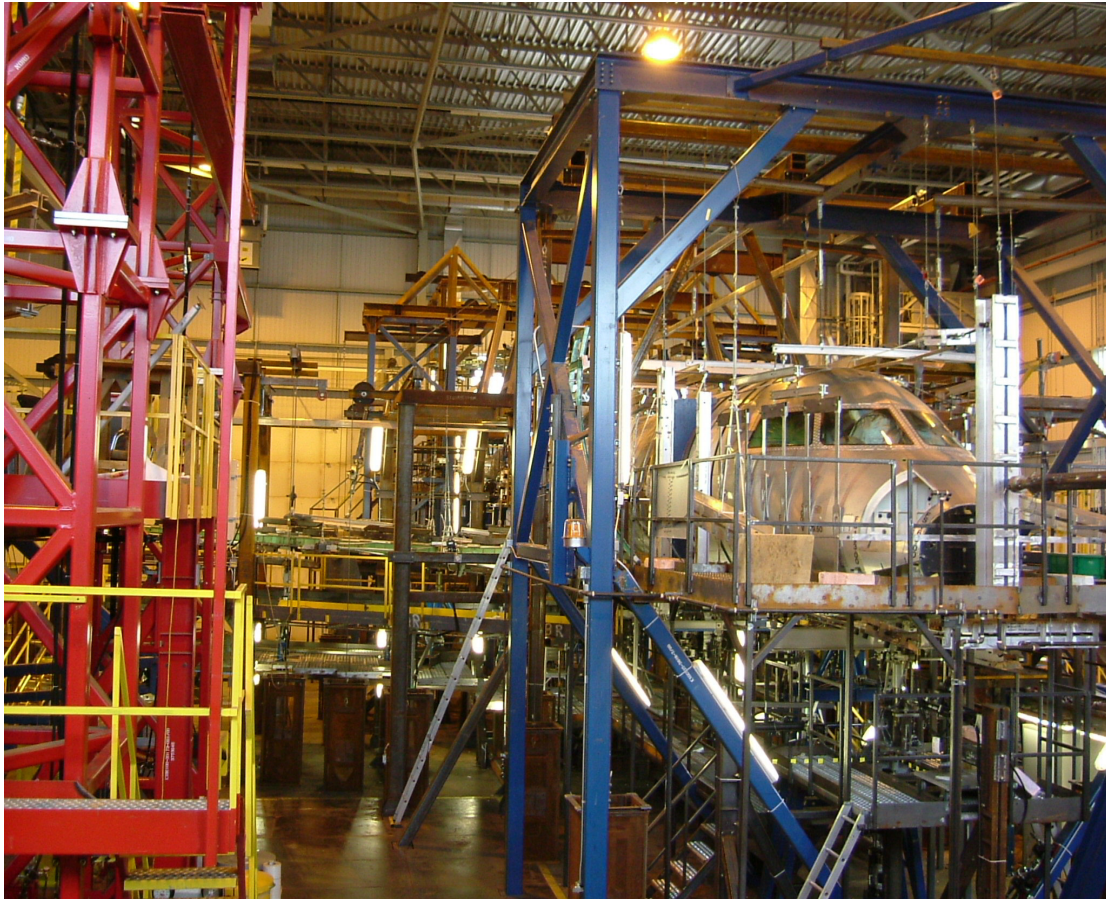
Test started in August 2003 and by December 2004 completed 80,000 flight cycles (in-service cycles + test cycles). Test setup is shown in Figure 6.

Figure 6. CRJ200 Fleet Leader CAFT.

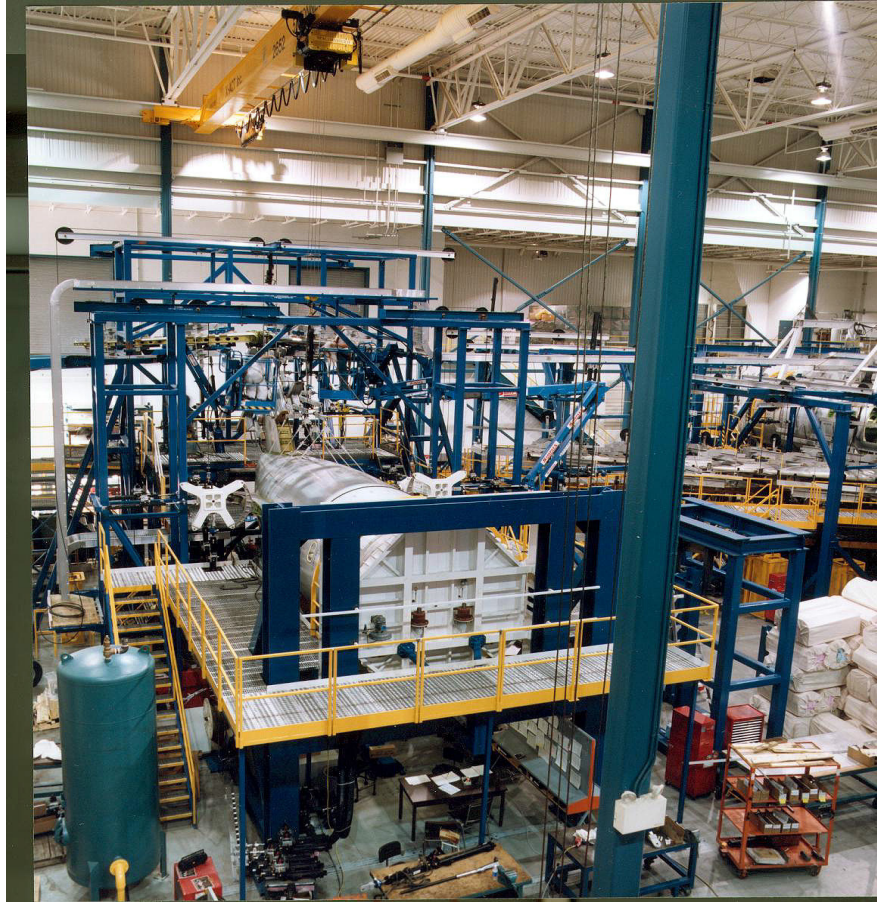
Figure 7. CRJ700 DaDT aft fuselage/empennage test.

As was reported in the previous Canadian Review [1] the CRJ700/900 DaDT full scale test is being done in 4 sections: CRJ700 forward fuselage, center fuselage/wing, aft fuselage/empennage test (Figure 7), and CRJ900 center fuselage/wing.

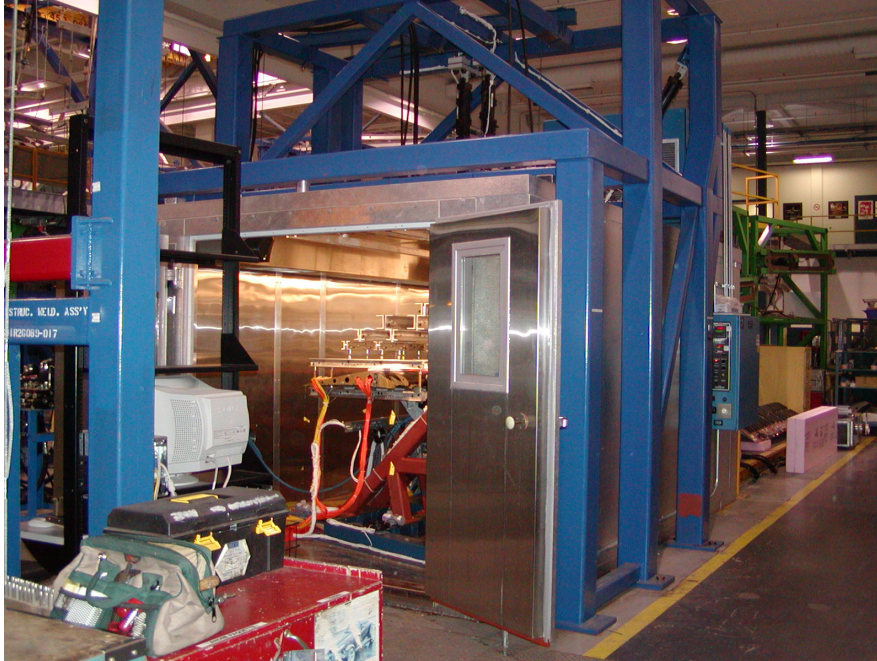
Four flap full scale test articles have undergone testing: birdstrike, metallic flap static and DaDT, composite flap static and DaDT, and flight testing. The composite ground tests required environmental enclosure around the specimen (Figure 9).

Figure 9. CRJ200/700/900 RTM outboard flap undergoing DaDT testing.

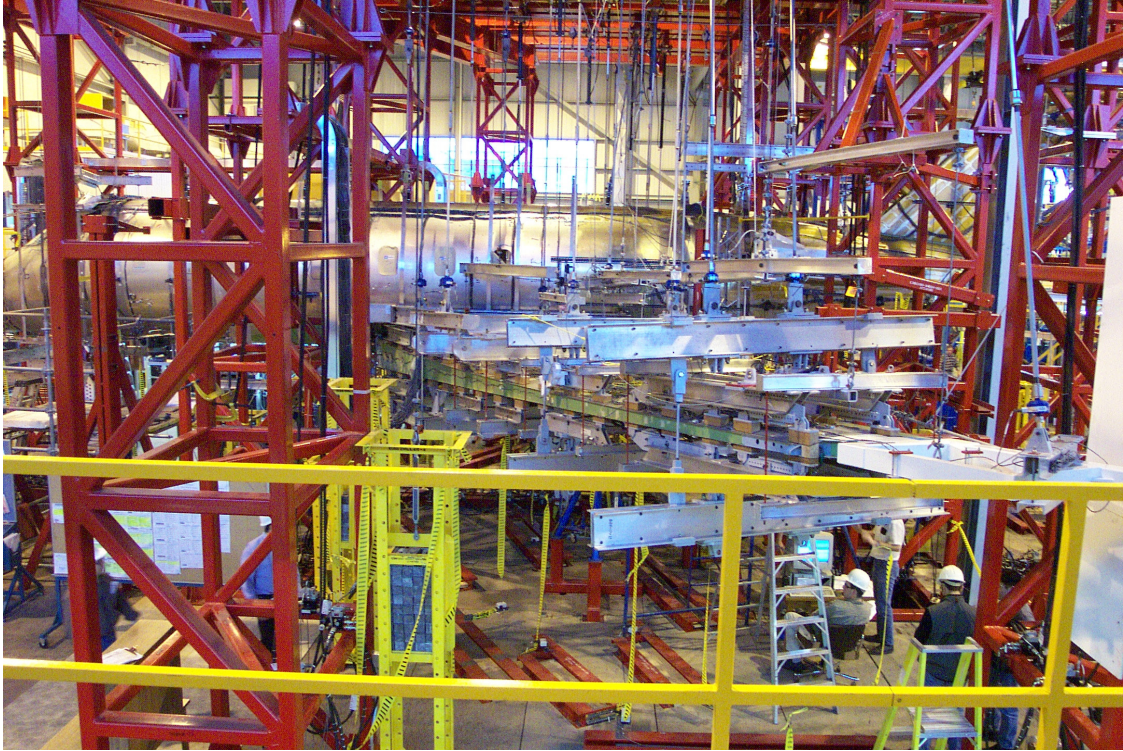
Figure 10. Challenger 300 CAST.

Complete airframe static test (CAST) – consisted of 19 limit load and 22 ultimate load test cases. The test article was instrumented with 2234 strain gauges: 1759 axial (E), 371 shear (S), 104 rosettes (R), 14 load cells, 101 displacement transducers (LVDT). The CAST is shown in Figure 10.

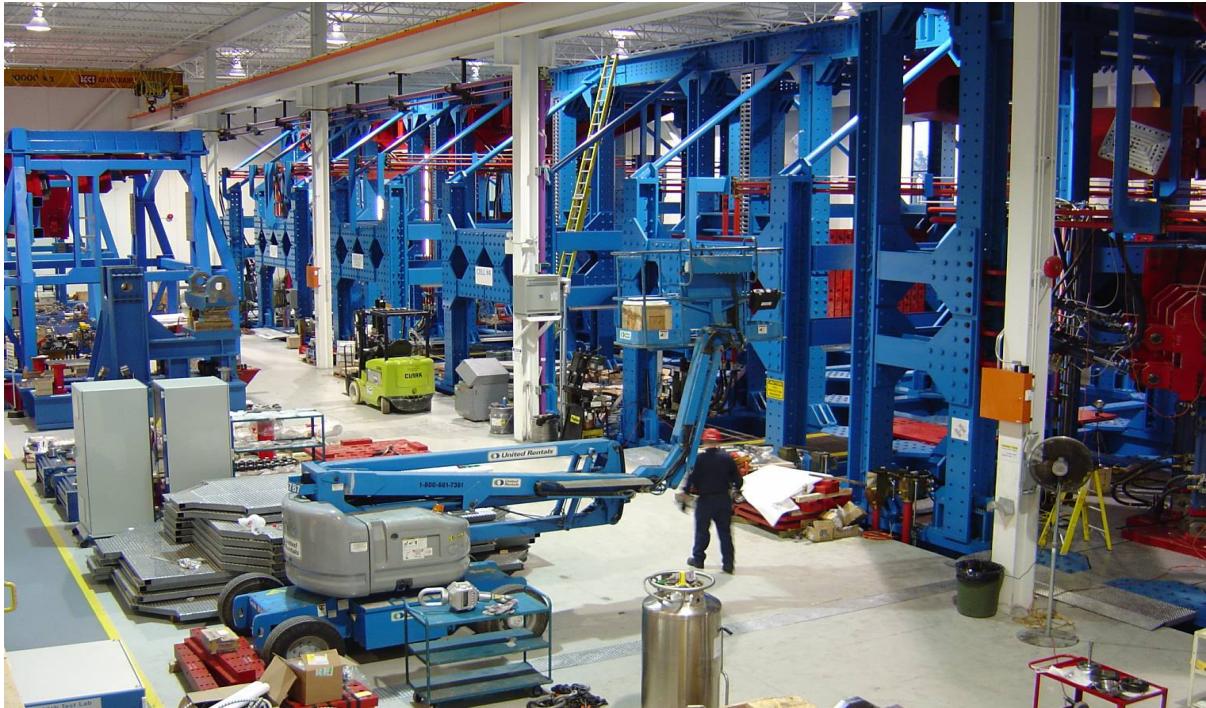
Figure 14. The A380 super structural test rig

Goodrich Landing Gear has been responsible for the design, manufacture and testing of the wing and main body landing gear of the Airbus A380-800 aircraft. The qualification test program ensures that these gears meet stringent requirements for aircraft safety and structural integrity. The tests include a series of landing simulations (drop tests) to demonstrate and quantify the energy absorption characteristics and behaviour of the gears during landing. Strength testing ensures that the envelopes of extreme load conditions expected in service are safely within the structural capability of the gears. Fatigue testing ensures that the complex spectrum of daily service loading does not result in fatigue failures in future service. Endurance testing ensures that the retraction equipment of the gears will perform as designed throughout the life of the aircraft. These landing gear tests required over two years of careful preparation –including the construction of a new lab and enormous rigs, Figure 14, to support the test equipment, and new developments in test application technology.

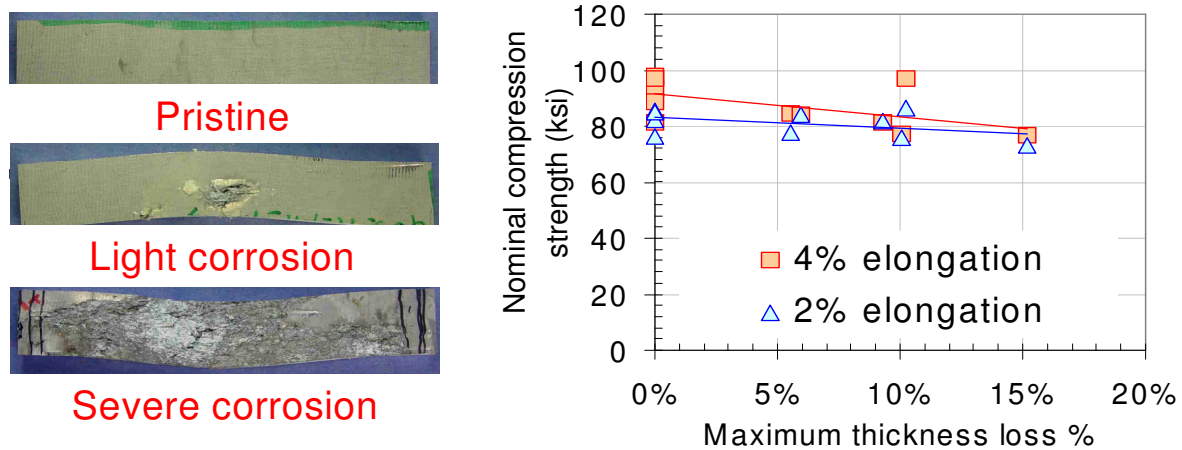
Figure 18. Typical static test: compression strength test and results.

- Exfoliation may NOT necessarily have a detrimental effect on the residual strength in the elastic and near plastic regimes, such as compressive yield (Figure 18) and bearing strength, but may have an effect in the plastic region, such as ultimate compression strength. In addition, exfoliation may have a greater effect on buckling.
- Effects of exfoliation on local strain/stress concentration are more significant than those on residual strength.
- The ‘soft inclusion’ based FE modeling was calibrated and verified using the experimental results, and was capable of quantifying the effect of exfoliation on residual strength (Figure 19).
- The developed engineering fatigue model could give a good estimation on the range of the remaining fatigue life, based on conventional NDI inputs (Figure 20).

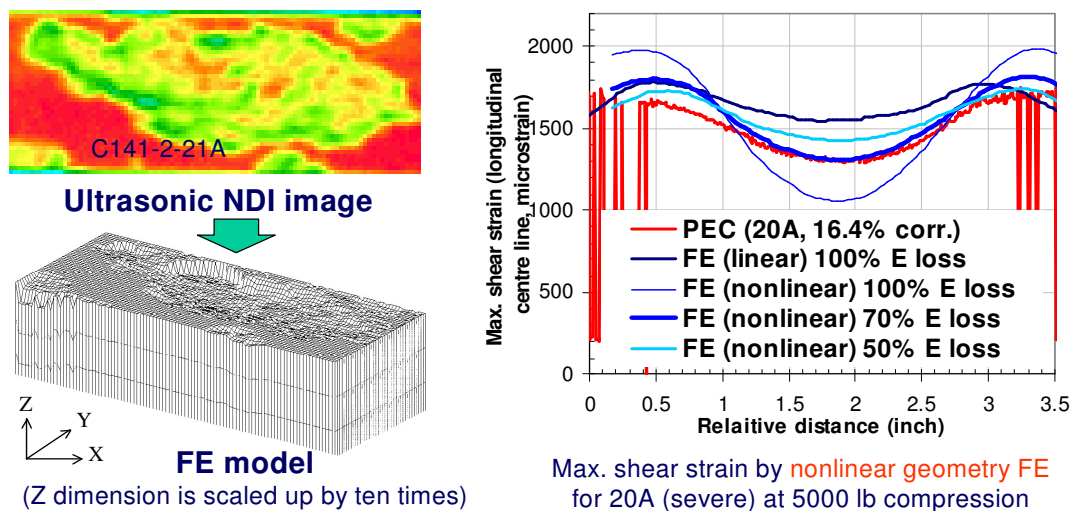
Figure 19. FE modeling process using NDI inputs and modeling results (Young's modulus E loss was calibrated in between 50-70% by non-linear FE analyses).

The objective of this project was to develop an analytical framework/tool to evaluate the effects of exfoliation on residual strength and remaining fatigue life of aircraft structures, and provide appropriate guidance for the repair action. Extensive test programs have been carried out using pristine and corroded specimens manufactured from naturally exfoliated 7075-T6511 wing panels. These included static tension and compression tests, compression strength tests Figure 18, bearing strength tests, and fatigue tests. Both thermographic (from the damaged side) and ultrasonic (from the undamaged side) non-destructive inspections (NDI) were performed to determine the maximum depth and three-dimensional (3D) profiles of the exfoliation damage. In the static tests, the strain/stress changes due to exfoliation were measured using strain gauges, photo-elasticity, and digital image correlation techniques. In the fatigue tests, crack origins were determined with the aid of a scanning electron microscope and the mechanisms of fatigue cracking in exfoliation regions were summarized. Progressive polishing and optical observations were carried out on failed specimens to quantify the depth of intergranular corrosion. In parallel, an analytical model was developed based on a 'soft inclusion' technique and 3D finite element (FE) modeling. The 3D FE model was first verified using the test results from the pristine specimens. For the corroded specimens, a technique to automatically generate the 3D geometry of the 'soft inclusion' (damage zone) from the NDI input was developed using the PATRAN Command Language (Figure 19). Non-linear FE analysis was also performed to

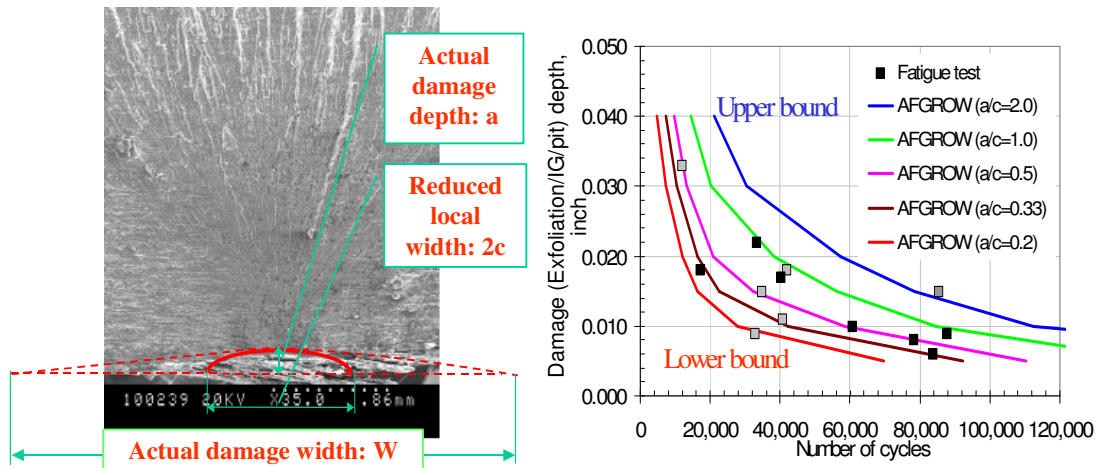
Figure 20. Fatigue cracking model in IG/exfoliation and remaining life estimation

analyze the non-linear bending effect due to exfoliation. Once calibrated, the ‘soft inclusion’ based FE model was used to quantify the effects of the exfoliation on the residual strength (yielding strength and buckling). Based on engineering considerations, a simplified fatigue model was also developed for estimating the remaining fatigue life of the exfoliated specimens. The fatigue model used a semi-elliptical surface crack model based on the damage depth determined from NDI and the local aspect ratio of the damage (Figure 20).

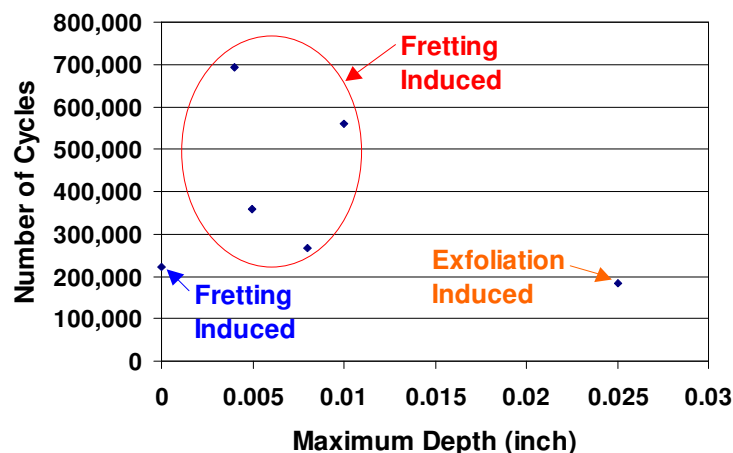
Figure 21. Results from fatigue tests carried out on coupons containing various levels of exfoliation.

All the tests were carried out under constant amplitude compression dominated cyclic loading, with a maximum gross section stress of 82.7 MPa (12 ksi) and a minimum gross section stress of 137.9 MPa (20 ksi). The specimens were tested to failure in laboratory air at a frequency of 10 Hz and the results are presented in (Figure 21). The maximum depth of the exfoliation was measured using ultrasonic inspection carried out after failure from the back face of the specimen. Figure 21 shows the majority of the specimens failed by fretting fatigue. A black residue was present on most of the fracture faces suggesting that fretting fatigue took place.

The results presented in Figure 21 were obtained from tests carried out using compression dominated constant amplitude loading. Since this type of loading was not representative of the load applied to an upper wing skin, it was decided to carry out a test using a truncated upper wing skin spectrum. The specimen chosen was inspected to determine that the depth of the exfoliation was 29%. Since it was anticipated that this specimen could be subjected to a significant number of load cycles, tabs were bonded to the ends of the specimen to prevent premature failure, Figure 26.

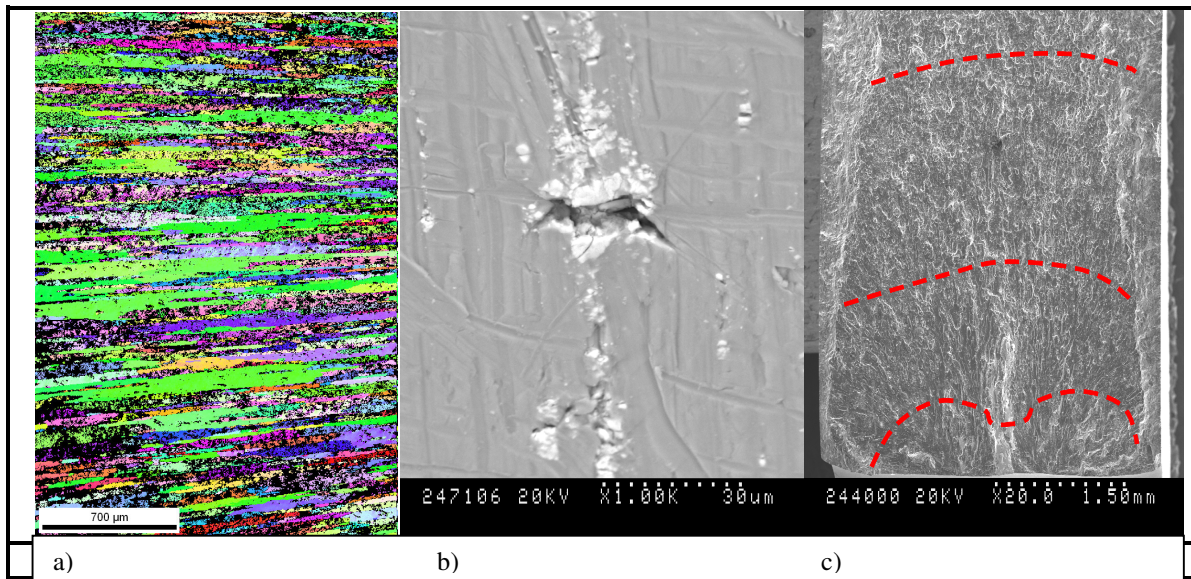
Figure 28. Microstructural features such as constituent particles, grains size and orientation play key roles in nucleation and propagation of short cracks in AA2024-T3, a) grain orientation using OIM, b) particles acting as the main fracture origin, c) marker bands were used to characterize the growth pattern.

As shown in Figure 28, it was observed that almost all the fatigue failures originated at constituent particles and microstructural features such as grain boundaries and grain orientation influence the early crack growth patterns. A novel hypothesis for the short crack mechanism has been developed.

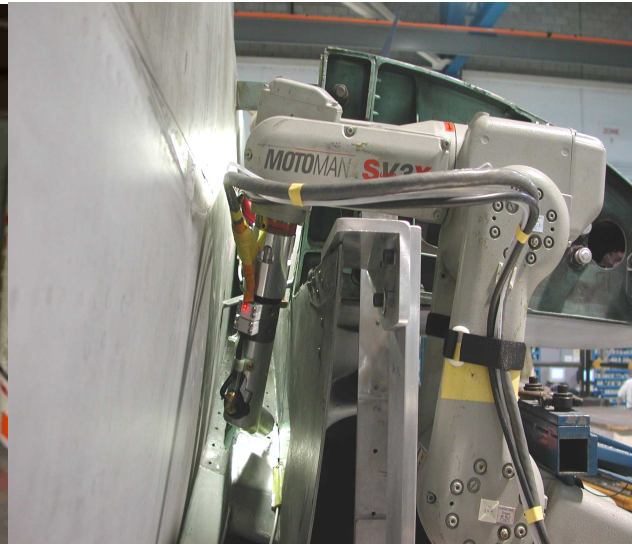
Figure 43. Robotic Material Removal Modification on the CF-18

The new robotic material removal capability has been successfully used in the development of a new CF-18 modification. For this modification, the material removal area is very difficult to access as illustrated in Figure 43. The robotic application has allowed material removal following an optimum profile that reduces the stress and ensures a longer period before crack re-initiation. Because of accessibility, a technician cannot do this modification. The alternative is to remove and replace the complete frame. This option is much more expensive than the development of a robotic material removal modification.

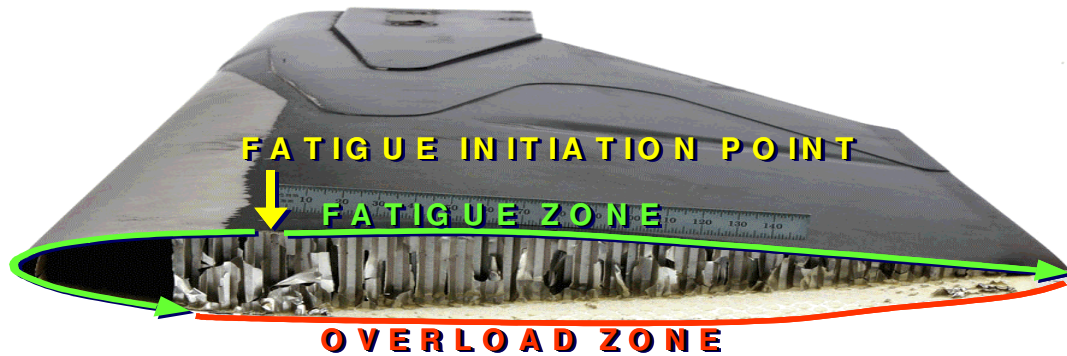
Figure 53. Root portion of the failed tail rotor blade viewed from the tip end. The ruler is situated on the inboard side of the blade. The yellow arrow indicates the origin of the initial fatigue crack at a 0.008-inch deep nick. The green line indicates the fatigue portion and the red line the final overload zone.

The main tail rotor section was found 280 meters up track from the crash site with one complete tail rotor blade attached but the other blade was missing the outboard 18.5 inches. The 18.5-inch section had fragmented into one large piece and two smaller pieces that were found a further 100 meters up track. Examination and analysis of the tail rotor pieces by QETE identified the tail rotor blade had failed due to fatigue cracking (Figure 53 and Figure 54). The initiation site for the fatigue failure was a 0.008-inch deep nick, Figure 55. Analysis of debris on the surface of the nick indicated material consistent with stone.

Examination of the blade fracture surface showed that the fatigue zone extended to about 65 percent of the cross section of the blade structure. Based on a striation count, it was estimated that the fatigue crack grew from initiation to catastrophic failure in 50 to 70 flying hours.

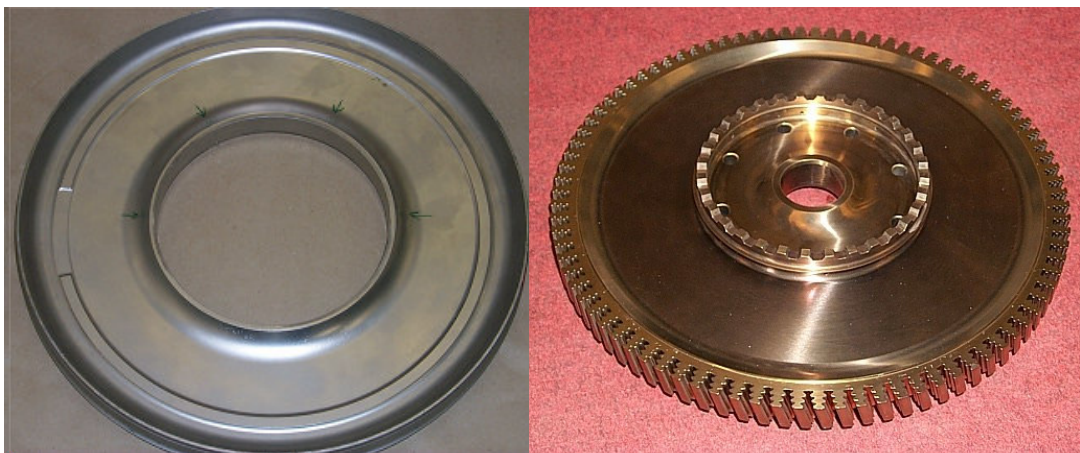
Figure 87. Spacer 1-2 and 2nd stage wheel from the T56 Series III engine.

of the IAR to the project was to design and perform testing of two turbine spacers and two discs in the IAR's spin rig facility. The spin test results were applied to verify the crack initiation and crack propagation lives for these two components.
