**Review of Aeronautical Fatigue**  
**Investigations in Switzerland**

*Swiss National Review*  
*of the International Committee on Aeronautical Fatigue and*  
*Structural Integrity*

## Document: ZAV-KOR2021-001

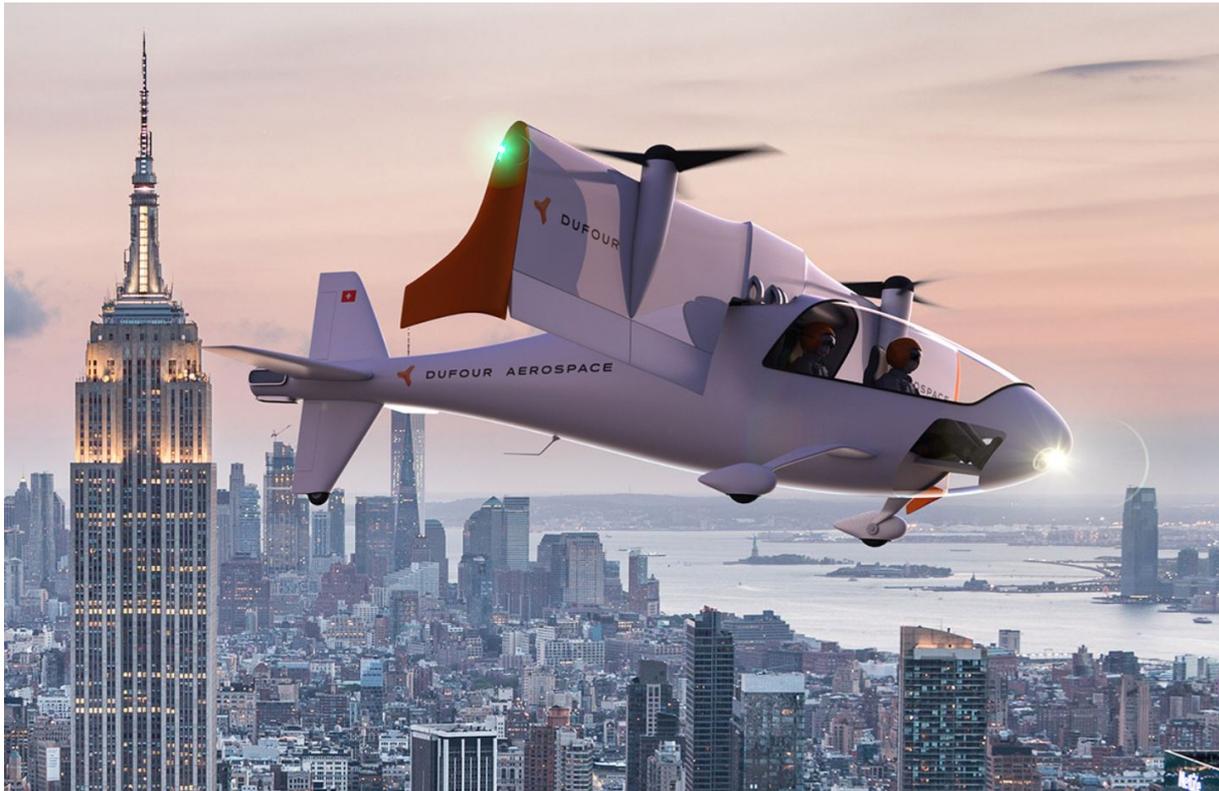
Switzerland is well known as the Home of Autonomous Systems. There are a lot of start ups developing drones for various applications with sophisticated sensor integrations. Also urban air mobility concepts are in an early detailed design phase. The most popular is the concept of Dufour Aerospace, for which wind tunnel tests and simulations are underway to define the first prototype, see Figure 4. 4. The hybrid propulsion integration, with all the performance, reliability and maintainability aspects, is challenging in this EVTOL concept.

Figure 4. 4: Early concept of Dufour Aerospace EVTOL concept

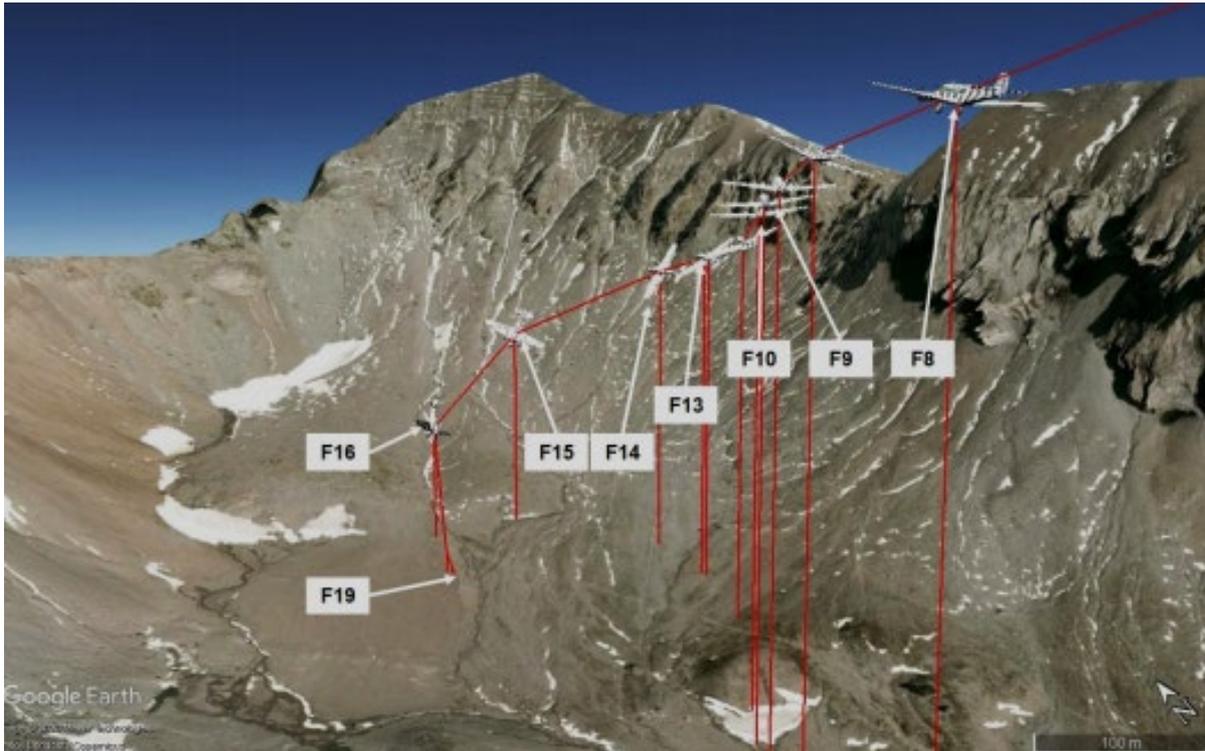
The final report of the crash of the Junkers Ju-52 in August 2017 was released by SUST, the Swiss transport safety investigation board. All three crew members and 17 passengers were killed. The direct cause of the accident was attributed to the fact that, after losing control of the aircraft, there was insufficient space to regain control of the aircraft, which then crashed into the ground, see Figure 4. 5. The investigation identified the following contributing factors:

Figure 4. 5: Reconstruction of the final flight path of Ju-52 into the ground

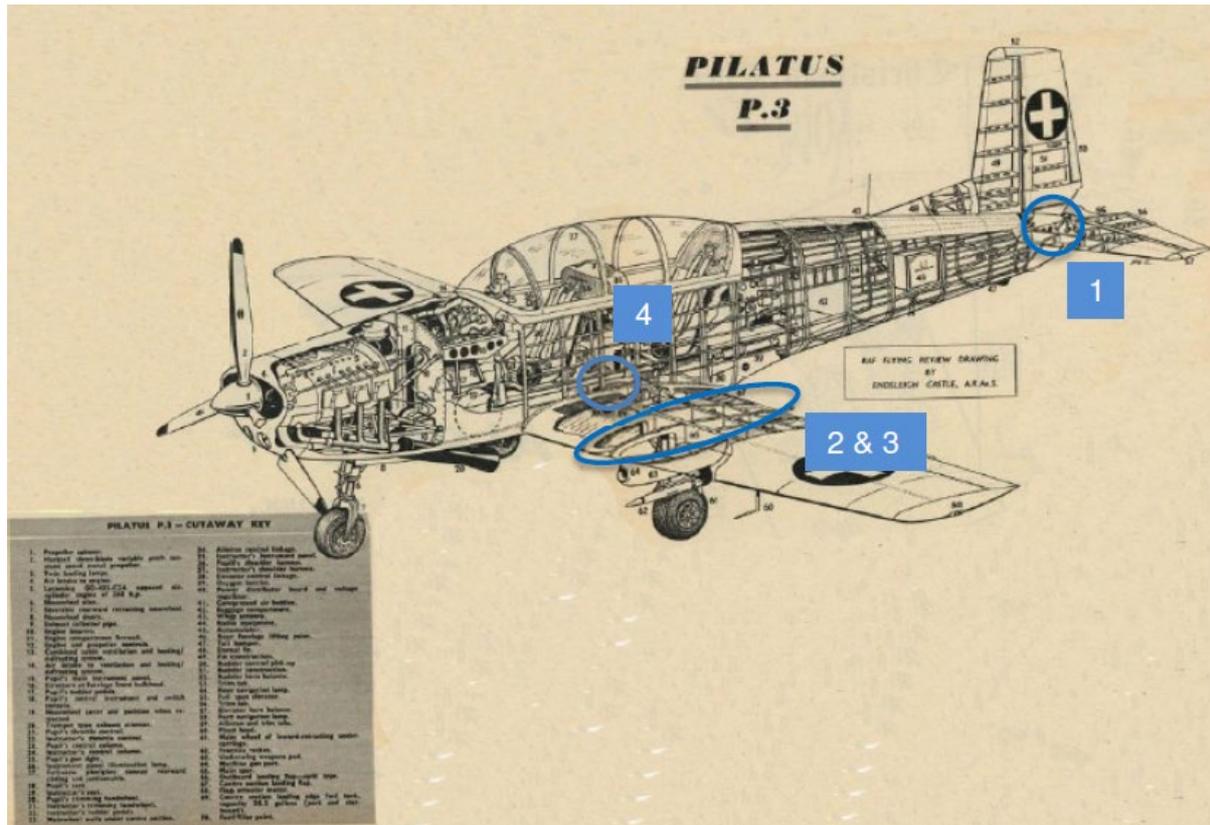
Following 4 locations (see Figure 4. 6) have been identified as the most critical parts from the point of view of the structure integrity. These parts are called Fracture and Fatigue Critical Structures (FFCS): HTL-Fitting (1); External Wing Splice at rib 12 (2); Internal Wing Splice at rib 12 (3); Upper fuselage attachment (4). Detailed Crack Initiation (CI-) and Crack Growth (CG-) analyses have been performed for these parts.

Figure 4. 6: Fracture and Fatigue Critical Structures (FFCS)

Since these parts may be affected by the same problem as the HTL fitting (location 1 in Figure 4. 6) a comparison of each FCS part with the HTL fitting was made from the point of view of lug stress and geometry. It appears that each FCS part is less critical than the reference location; i.e. the HTL fitting. The SSID contains also information about Corrosion Inspections. The basis for these inspections is the result from the fleet leader corrosion inspections carried out in 2015. Since almost no corrosion damages were discovered on this aircraft the defined corrosion inspections in the standard Aircraft Maintenance Program remain valid. Thus no specific additional corrosion inspection was considered to be addressed in the P3 SSID.

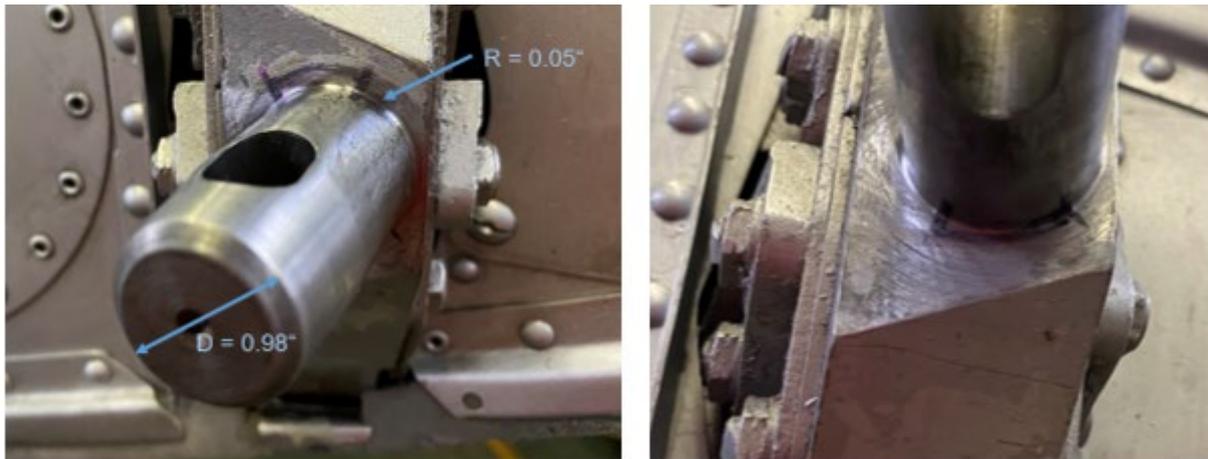
As part of the Civil Aviation Maintenance Program of the Hunter Mk58/68 a NDI check has been performed on the front wing to fuselage attachment fitting. In this process cracks has been discovered on the upper and the lower side of the fitting radius (see Figure 4. 7). It is to mention that this kind of cracks have already been discovered in the past on the Hunter Mk58/68 aircraft.

Figure 4. 7: Cracks in the radius on the upper (LH) and lower (RH) side of the front attachment fitting

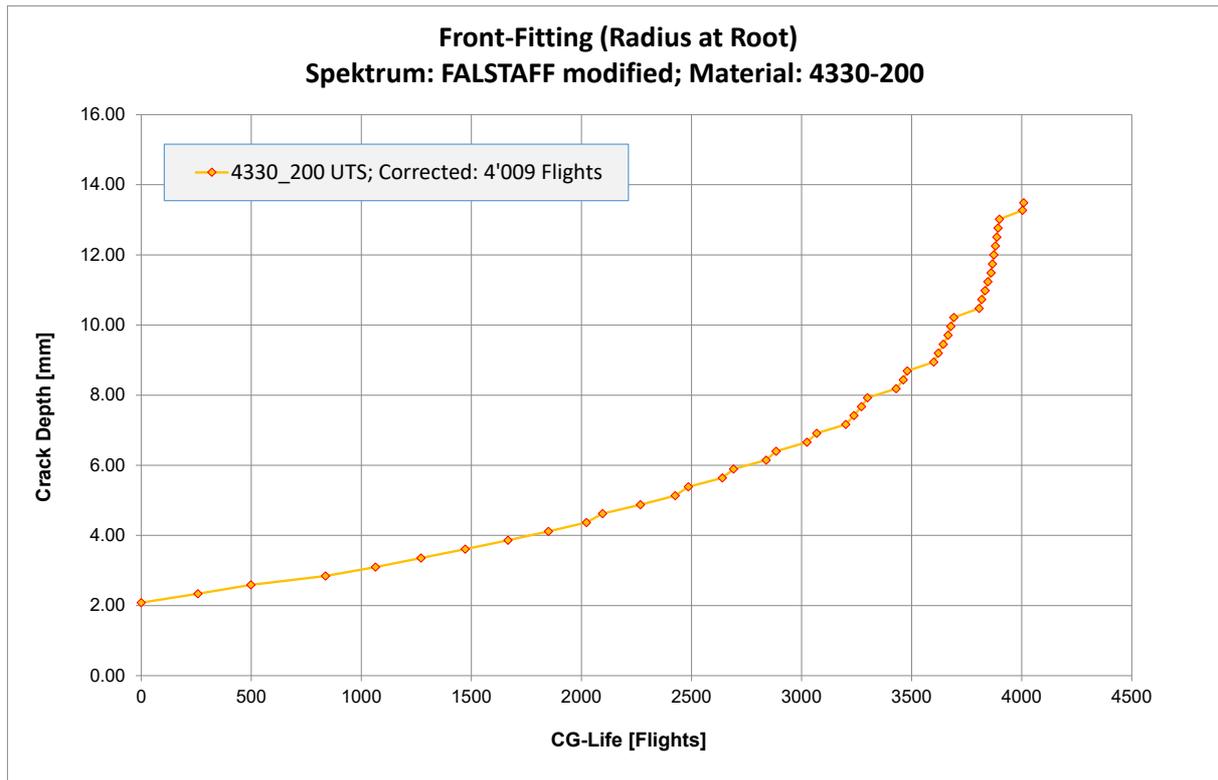
The CG analysis was carried out with the same stress and spectrum assumptions . The initial crack size was the detected crack size at the inspection, i.e. 0.403" (10.3mm ) length and 0.082" (2.1mm) depth. The crack growth curve is shown in Figure 4. 8. The crack growth life is 4000 flights. This is by far longer than the 25 flights, which is authorized by the Swiss Federal Office of Civil Aviation.

Figure 4. 8: Crack growth life of front attachment fitting

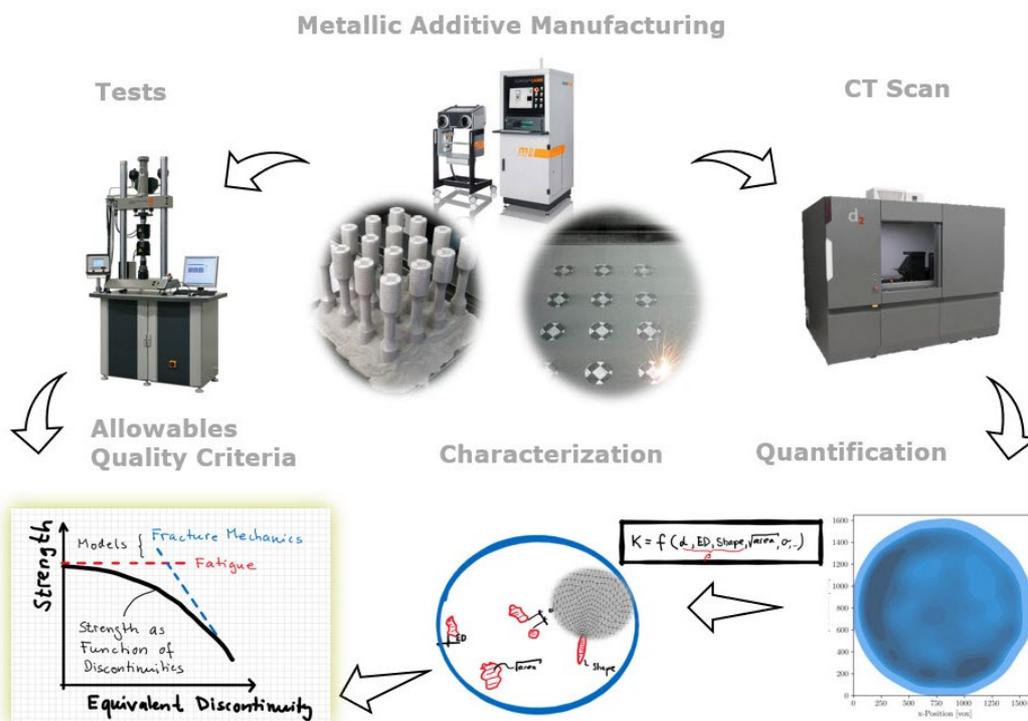
A research tool-box has been built to test the feasibility of the proposed structural integrity concept: Fabrication of specimens from the metallic 3D printer, determination of fatigue strength, application of X-ray imaging using computed tomography (CT) to identify discontinuities, models and software for quantification and characterization, fabrication of flaws to study crack propagation behavior, etc. Intrinsic flaws were successfully identified, visualized, and processed using the CT scanner. The fatigue behavior of specimens, which were made from titanium powder, shall be correlated with the distribution and nature of the discontinuities. This will allow statements on strength based on CT scans only and thus merge design and quality criteria.

Figure 4. 9: Design Allowables and Quality Acceptance Criteria Concept for Additive Manufacturing

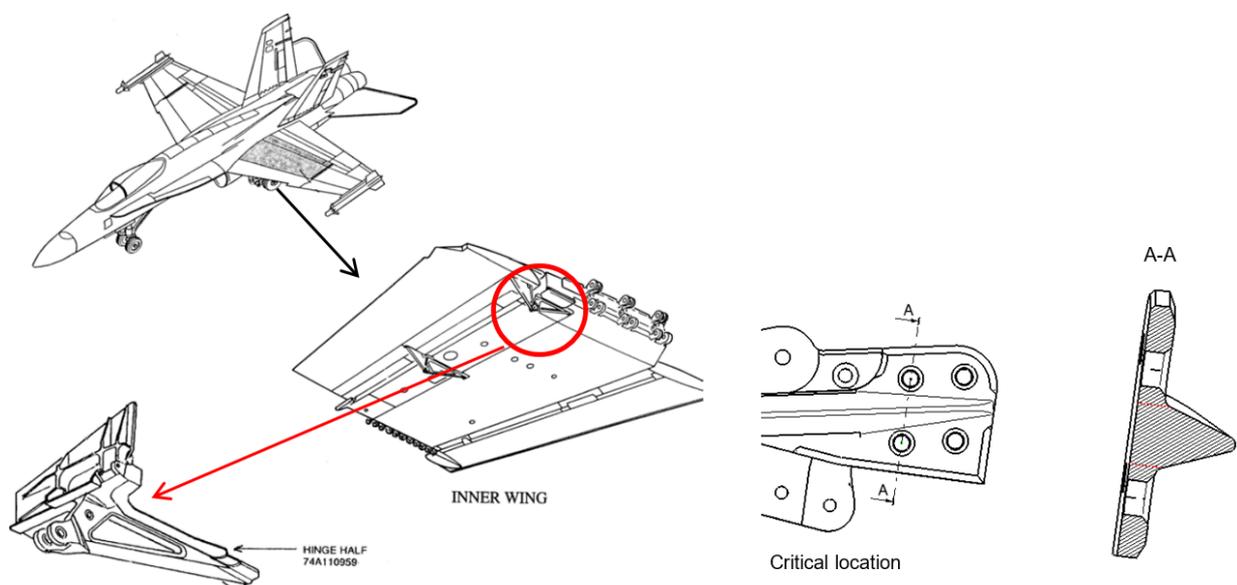
The F/A-18 Inner Wing (IW) Trailing Edge Flap (TEF) Inboard Hinge is one of the two attachment points of the TEF. The forward flange attachment holes, connecting the TEF hinge to the lower surface of the wing, are known critical locations. Fatigue cracks have been reported by many F/A-18 operators. Conducted studies identified the root cause for the cracking as a combination of bearing loads and local bending effects induced by the high fastener tension loads.

Figure 4. 10: Position of IW TEF TEF hinge (left) and critical holes (right)

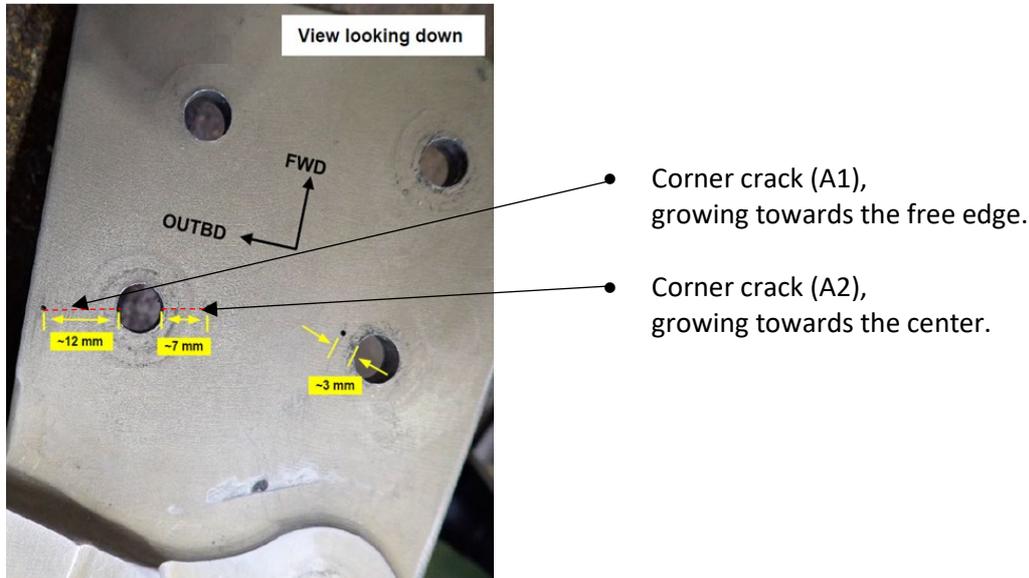
During inspections, a cracked TEF hinge has been detected. The cracked TEF hinge has been replaced and the cracked area has been made available for quantitative fractography (QF1) investigations. RUAG AG used the QF data of the cracked holes (Figure 4. 11) to develop and validate a crack growth (CG) model of the TEF hinge cracking.

Figure 4. 11: Position of Crack used for QF investigations

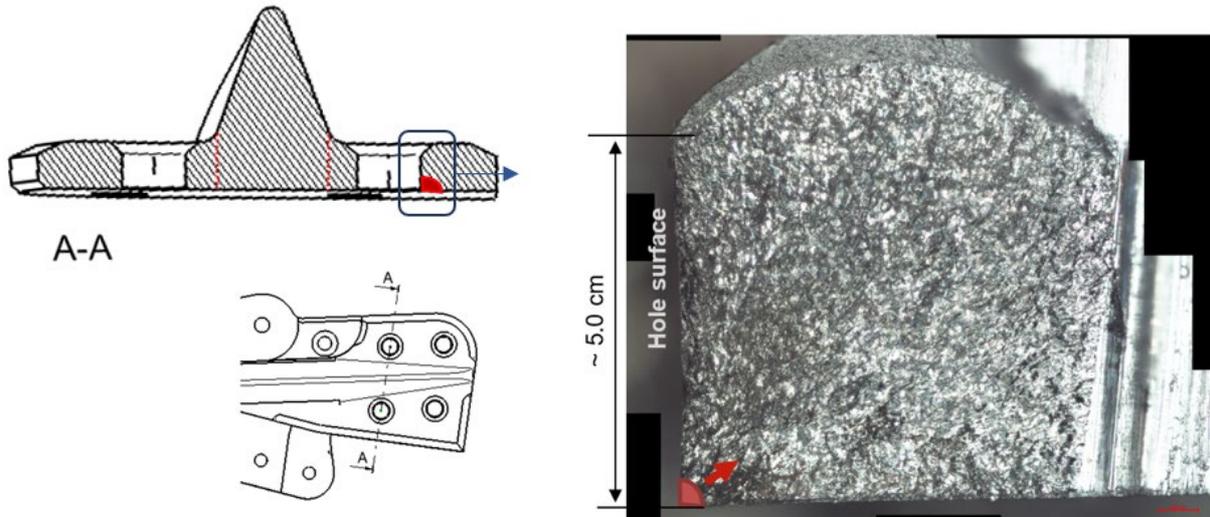
QF evaluation of the cracked hole propagating towards the free edge was able to identify a 0.00165" (0.042 mm) indentation as probable crack origin. The image of the crack is presented in Figure 4. 12. Along the hore surface (a-length), the crack has grown about 1.0 mm beyond the edge of the countersunk. Along the surface (c-length) the length is about 12.0 mm.

Figure 4. 12: Corner crack (A1), growing towards the free edge

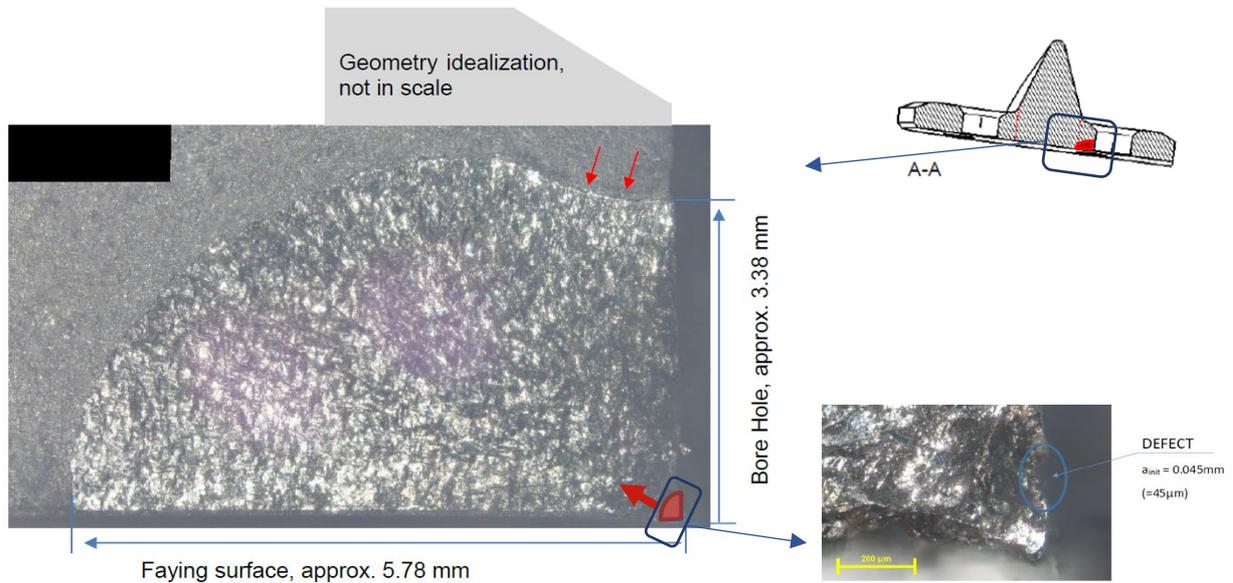
The analysis of the fracture surface of the crack growing towards the hinge centerline identified a damage, probably caused by the drill during manufacturing. Furthermore, a 0.00177" (0.045 mm) defect was also observed at the edge of the hole. Both could have acted as Equivalent Pre-Crack Size (EPS). The length along the faying surface (C-length) is about 0.227" (5.78 mm), the one along the bore hole (A-length) 0.133" (3.38 mm), see Figure 4. 13.

Figure 4. 13: Corner crack (A2) growing towards the center

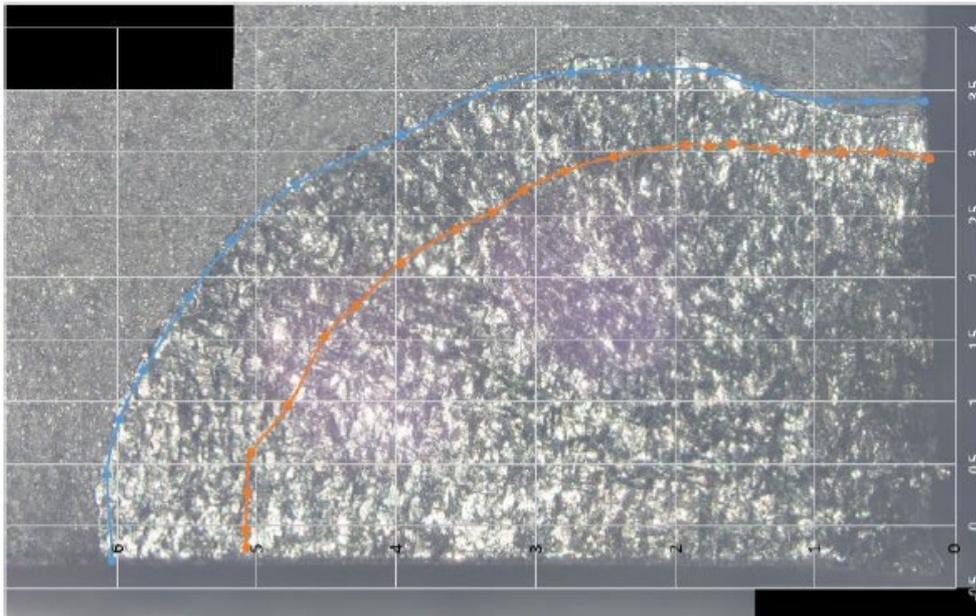
The crack growth is affected by local effects below the countersunk head of the fastener. Along the bore hole, in the upper region (marked by the red arrows), the crack has slowed down. This can also be observed by the change in the CG curve slope presented later on.

Figure 4. 14: Crack front (A2) towards hinge center, different lengths along bore hole

As the crack growth rate is not constant along both directions, the crack shape can be approximated by an ellipse with an aspect ratio of about 1.0 to 1.7.

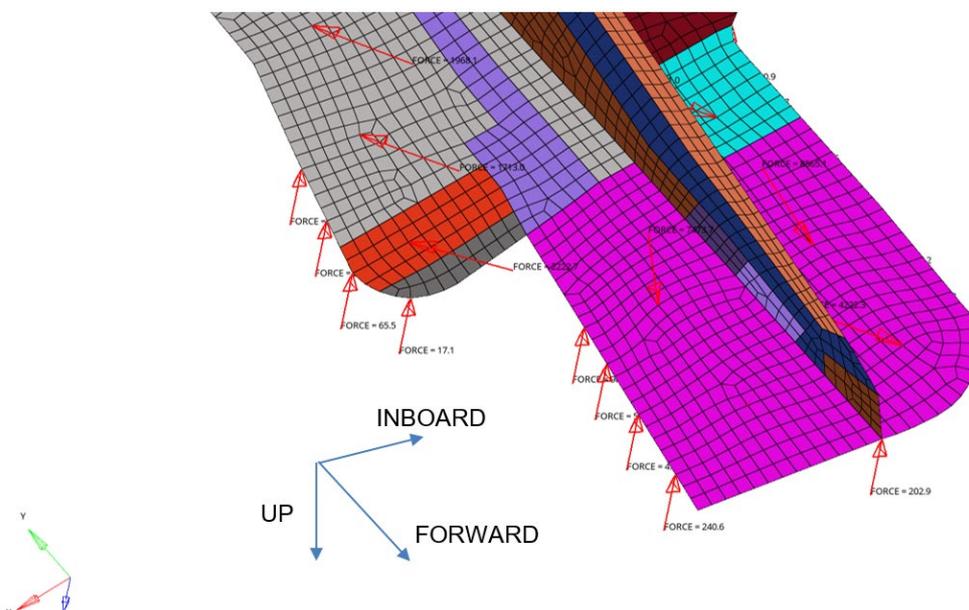
Loads for the crack growth analysis are extracted from a detailed FEM of the IW area around the hinge. An existing Nastran FE model, reproducing the inner portion of the inner wing of the F/A-18, has been refined and modified by introducing linear gaps around the periphery of the horizontal flange of the TEF hinge to account for the heeling and toeing effect between the TEF hinge and the surrounding structure.

Figure 4. 15: Detail of FEM mesh at TEF hinge forward flange

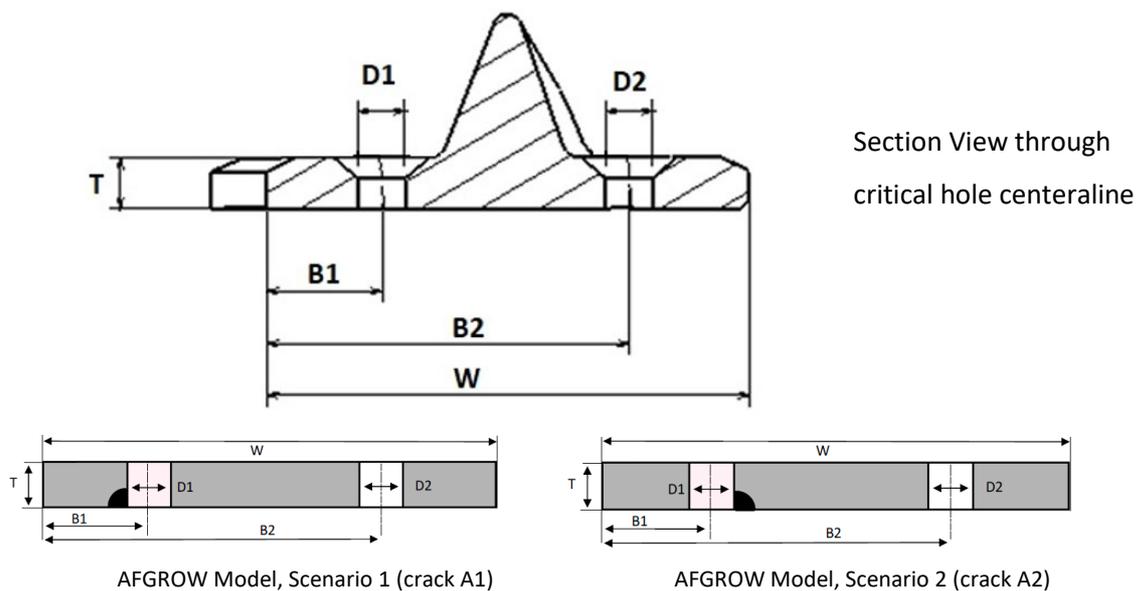
The setup of the crack growth models in AFGROW is presented in Figure 4. 15. The geometry of the TEF hinge flange required to be idealised by neglecting the triangular section and by neglecting the fastener countersunk.

Figure 4. 16: AFGROW crack growth models

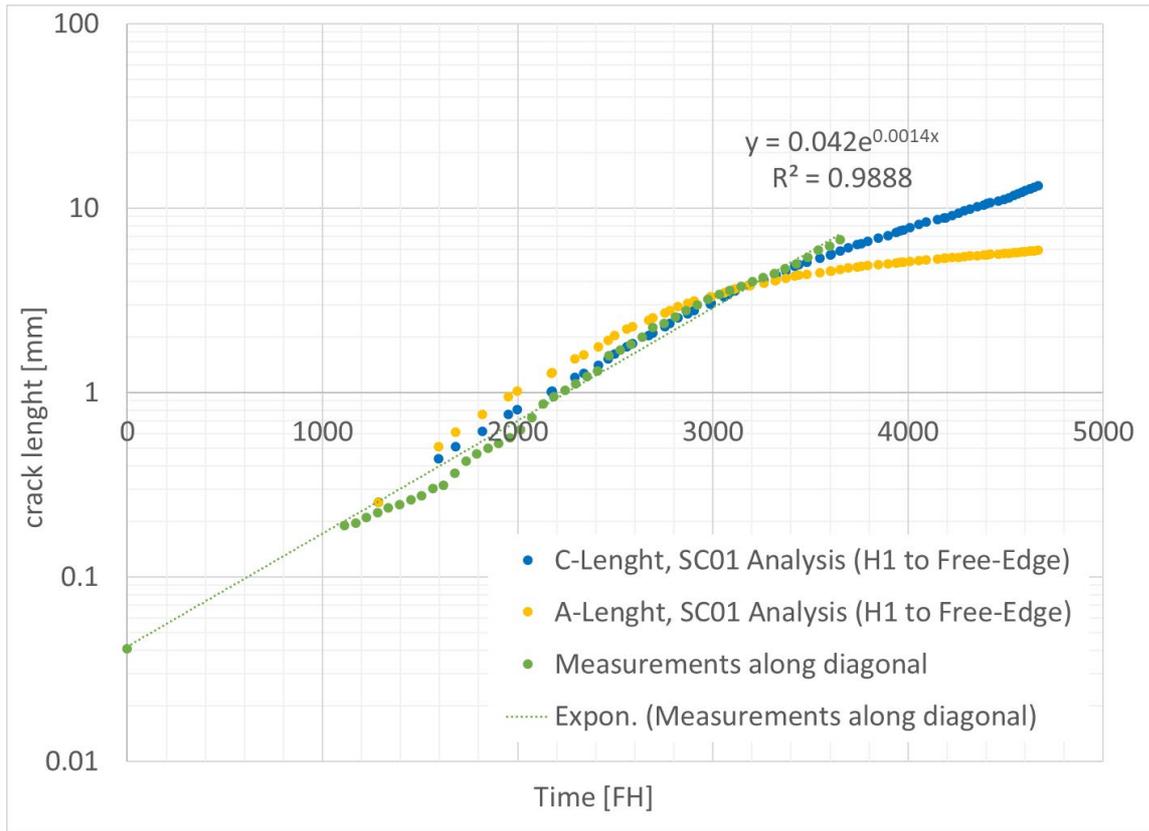
QF data of the cracked hinge is used to validate the CG models. A good match between observations and AFGROW model predictions is observed for both CG scenarios.

Figure 4. 17: AFGROW predictions vs. measurements, crack hole (A1) towards free edge

For both scenarios, the prediction seems to be fairly accurate along the surface and slightly conservative along the bore.

For the scenario where a crack is growing towards the free edge of the TEF hinge, based on CG model results, it's expected that the crack will not break through the thickness until it becomes critical.

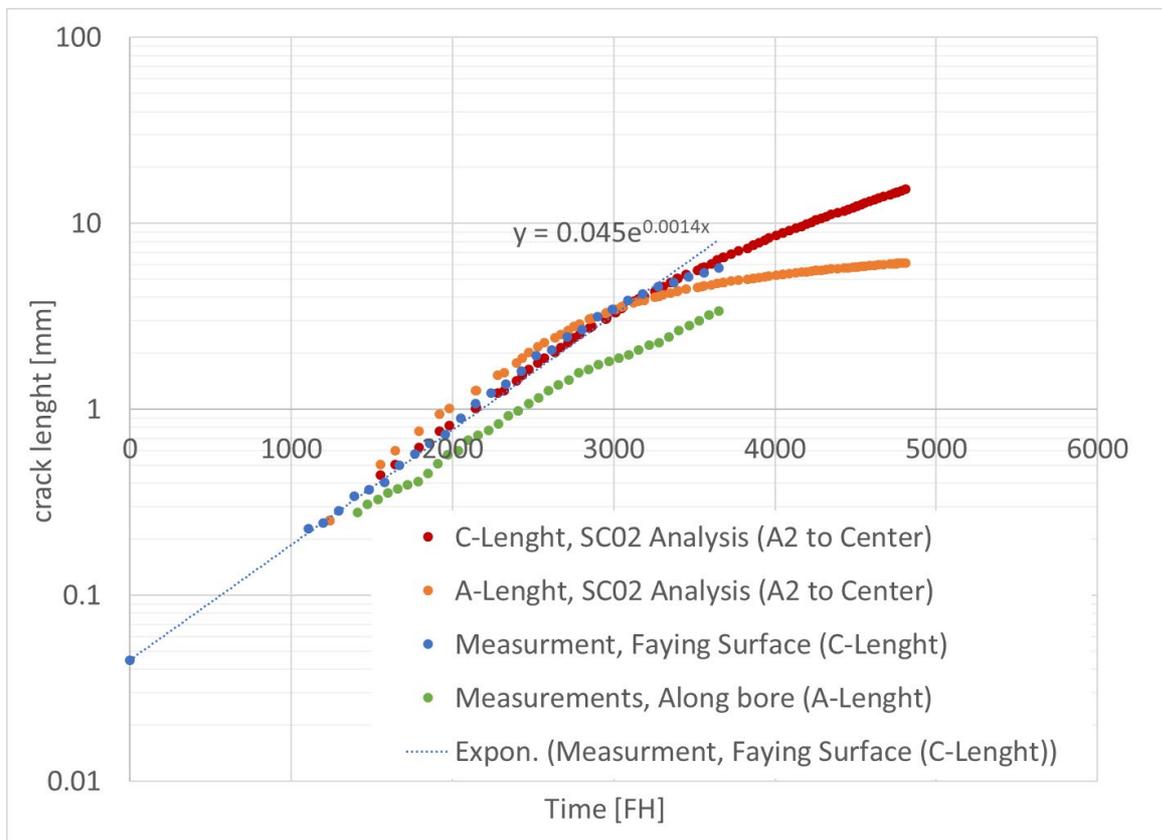
Figure 4. 18: AFGROW predictions vs. measurements, crack hole (A2) towards free center

For the scenario where a crack is growing towards the hinge centerline, a similar behavior as the ones growing towards the free edge is obtained. The accuracy of the model is anyhow limited to small cracks. Once the crack has grown further away from the countersunk head, it could eventually start to accelerate again in the direction of the vertical flange that has not been accounted for in the CG model. That would require further assessment and additional QF data for calibration.

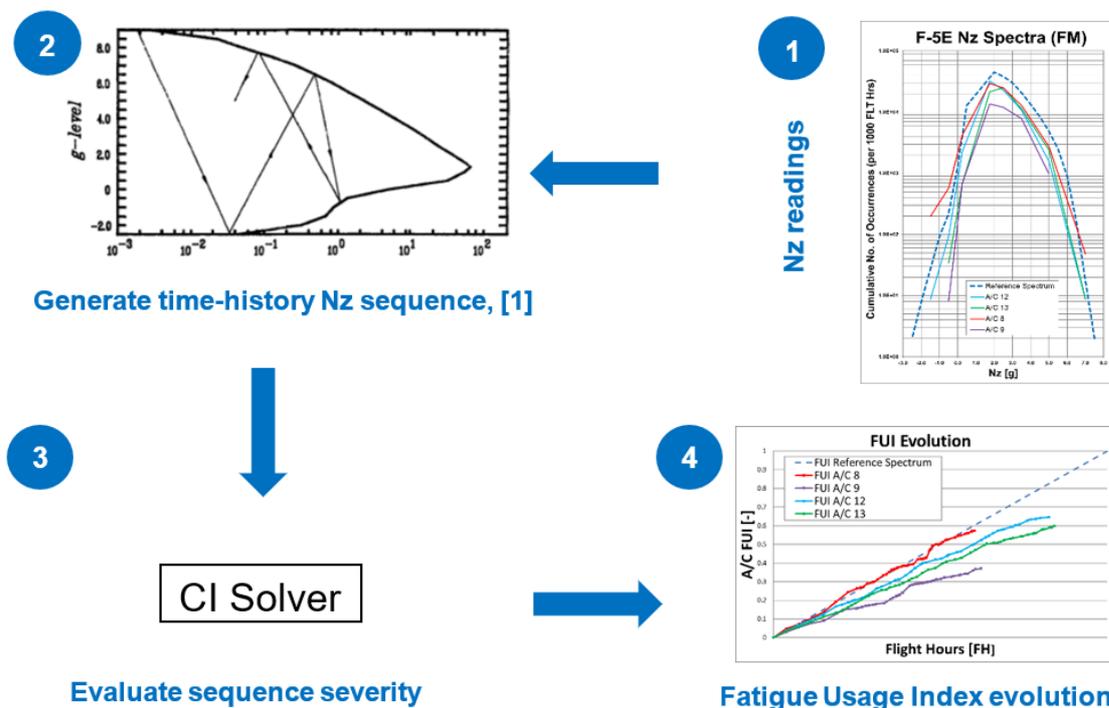
The chosen approach takes the cumulative Nz exceedance data and reconstructs a pseudo-random time-history Nz sequence that is read into a crack initiation (CI) solver. By referencing the resulting CI live to the CI life of a reference spectrum, a Fatigue Usage Index (FUI) is calculated.

Figure 4. 19: Process of Fatigue Usage Index (FUI) calculation

To evaluate the algorithms, cumulative exceedance spectra are processed from known Nz time-history sequences. These spectra are re-transformed into time-history sequences using the different algorithms. FUI values are calculated for each of these sequences and are compared to the FUI value of the reference time-history sequence. The upper to lower curve excursion algorithm revealed the best (robust, reproducible) results.

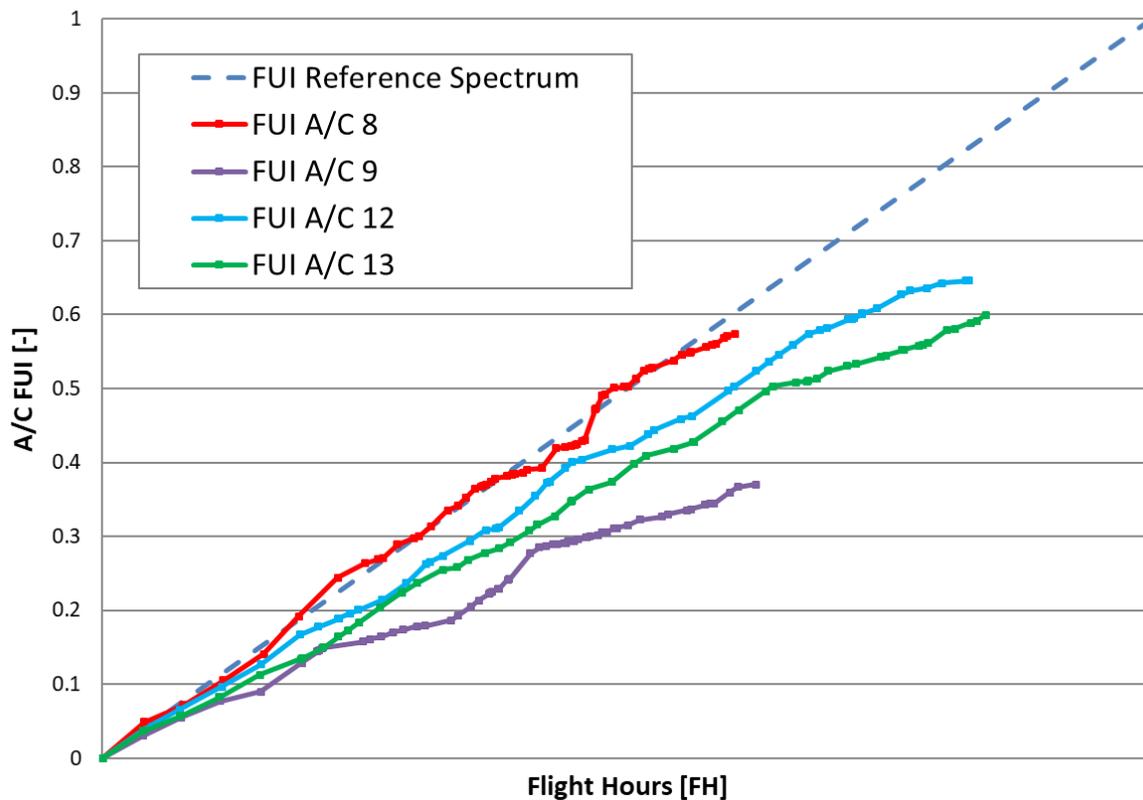
Figure 4. 20: FUI evolution of individual aircraft

It was shown that an effective individual aircraft tracking and fatigue monitoring could be set up, even with simple cumulative accelerometer exceedance data of existing legacy monitoring systems. The evaluation of the resulting FUI and FUI rate over the last years provides valuable inputs for fleet fatigue evaluation and control.

It was decided that the value FUI=1.0 is reached with the F-5E reference Nz spectrum after the certified service life, although other referencing concepts may be applied as well. Therefore, the reference stress used for the CI calculation is defined by the stress that results in the CI life = certified service life when run with the reference spectrum. For CI calculation the material values for the most common material used for the F-5E/F structure, i.e. aluminum alloy 7075-T73, is used.

F-5E Nz exceedance data is available since almost the very beginning of service in the Swiss Air Force. Missing data is substituted by reference spectra data.

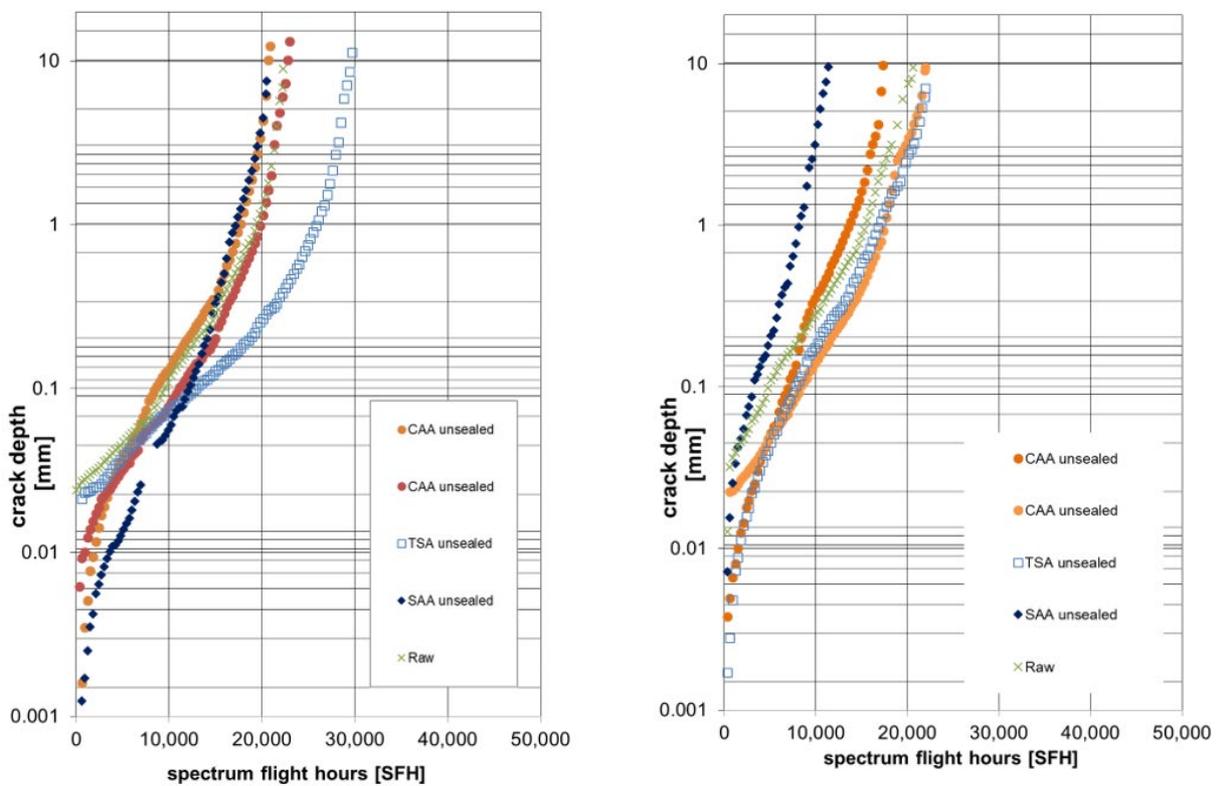
Figure 4. 26: QF curves for unsealed AA7050 (left) and AA7075 (right) for the low load level, collapsed such that all curves begin at zero flight hours to compare the crack growth rates (slopes).

The crack growth rates (slopes) are similar for the different surface treatments and the raw coupons in each material. The crack growth rates appear to be slightly higher in the AA7050 samples than in the AA7075 at this low load level. The samples shown were randomly selected for each surface treatment type and do not represent a general comparison of the fatigue lives.
