**Review of Aeronautical Fatigue Investigations
in Switzerland**

Document: ZAV-KOR2017-012

**Prof. Dr. Michel Guillaume
Zurich University of Applied Sciences
ZHAW / School of Engineering
Centre for Aviation**

Prepared for the presentation at the 35th ICAF Conference

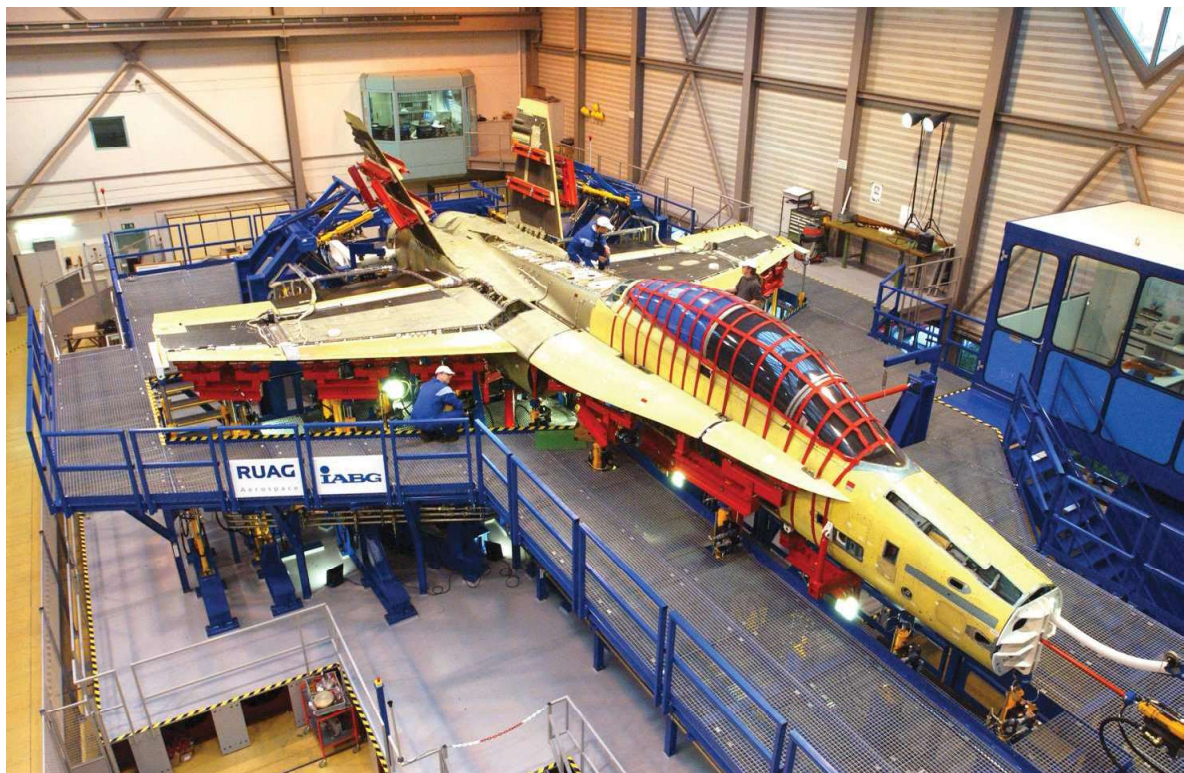
Figure 1 A total of 10'400 flight hours were simulated in a full scale fatigue test running from 1998 until 2004.

It has been more than 20 years since the Swiss Air Force procured 34 F/A-18 Hornets. An additional F/A-18D airframe was acquired and, on behalf of armasuisse, an Swiss Air Force F/A-18 design flight spectrum was tested on the full scale fatigue test.

The Swiss Air Force flight spectrum required for the F/A-18 is more severe than that of other air forces. Therefore, to fulfil the structural requirements, armasuisse commissioned Boeing to install structural modifications and reinforcements during the production of the aircraft. A fatigue test was then required to validate the improvements. The full scale fatigue test was set up to demonstrate twice the foreseen life cycle of 5'000 flight hours. Upon completion of the tests in 2004, the test airframe was thoroughly dismantled and examined for damage.

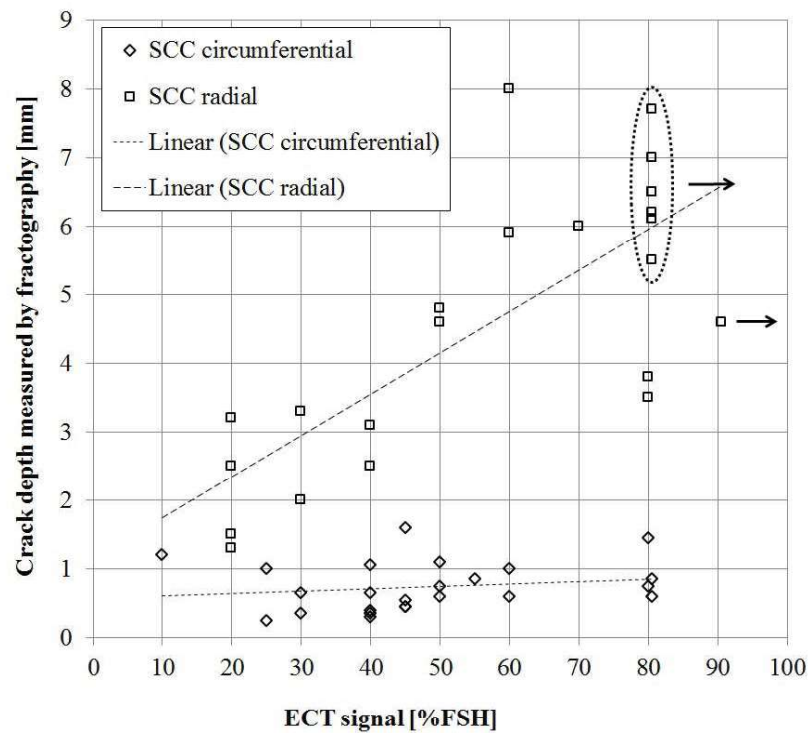
Figure 9 Eddy current signal strength in % FSH (Full Screen Height) for SCC.

ECT signal strength was recorded every 2mm along the crack path on the surface for each of the 15 investigated stress corrosion cracks. The stress corrosion cracks were subsequently broken open and the actual crack depth was measured at the positions where the eddy current signal strength was recorded previously.

It was revealed that the ECT signal strength does not show an one-to-one relation to the stress corrosion crack depth. A differentiation of the eddy current signal strength between circumferential and radial cracks could be made. The circumferential cracks seem to give ECT signals partly comparable to fatigue cracks, whereas the radial cracks give much smaller indications compared to their depth. The radial cracks show a significantly lower eddy current signal strength than the reference standard EDM notches. The depth of radial cracks would be significantly underestimated if it was compared to the signal of an EDM notched reference standard.

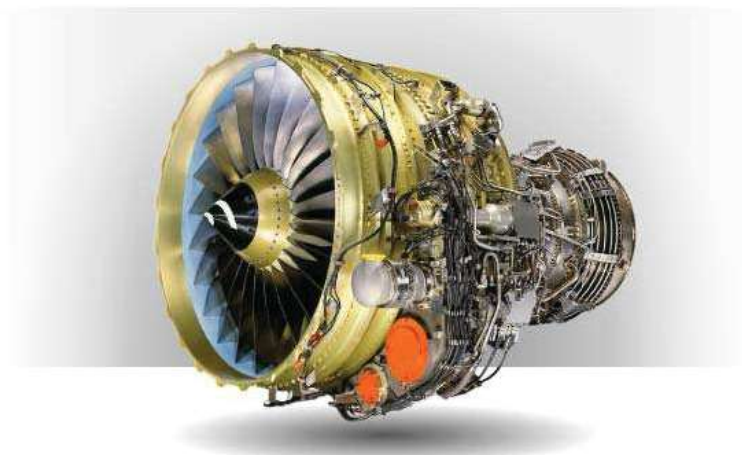
Figure 11 The fan frame shroud of the CFM56-7B engine

If the structural parts are out of tolerances, or structural damages are detected during overhaul, the parts will be scrapped. The costs for new parts mount up to several hundred thousand USD. Hence, SR Technics tasked the Zurich University of Applied Sciences to do an assessment for repair capabilities of fan frame shroud of the CFM56-7B (Boeing 737 NG, see Figure 11 below). The CFM56-7B has some changes compared to the CFM56-5B used on the Airbus 320. The fan frame shroud for CFM56-7B consists of three parts; the outer frame is made of 2219-T6 and the strut hub is Ti-6Al-4V. For the CFM56-5B the whole component is made of one part made of steel 17-4PH.

Several inspections on multiple CFM56-7B engines showed corrosion spots on the surface and in the holes on the fan frame shroud. Several factors were considered in order to figure out which kind of corrosion is damaging the structural part. Important was the analysis of the different materials involved in the assembly. The result confirmed the complex situation of fretting, pitting, and contact corrosion. The first conclusion of the OEM was that pitting corrosion is the only source of damage. Several grinding out processes depending on the depth of damage were analysed. For the holes, bushing repair solutions were studied and approved by detail stress and fatigue analysis. This repair (skin blending, with several options depending on the severity of the damage) can now be directly applied by the SR Technics engine shop.

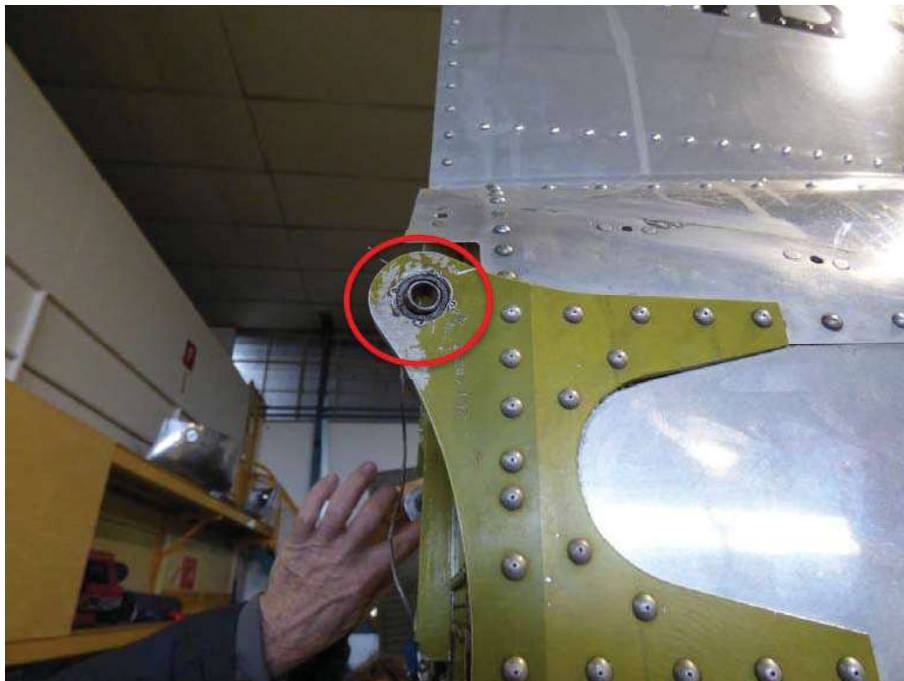
Figure 15 Figure of bearing for horizontal tail fairing on the fuselage

Another concern, was the installation of the bearings in the lugs. Especially the lug of the horizontal tail fairing in the aft fuselage showed special stress concentration, see Figure 15 on the next page.

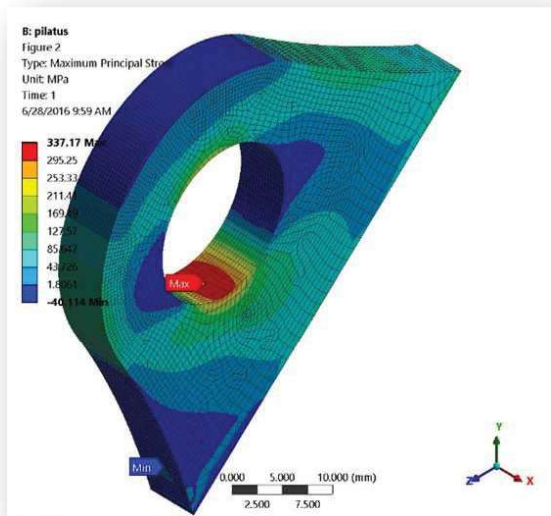
Figure 16 FEM model for the horizontal tail fairing to determine the principal stress for fatigue analysis

For this area, a structural analysis (see FEM model below) was done, followed by crack initiation and crack growth analysis. The line-by-line sequence of the P3 full-scale fatigue test program from 1960 was no more available. During the usage of the Swiss Air Force, only two aircraft were monitored by nz fatigue meters from Zambra & Negretti. Only exceedance plots from 1960 till 1990 were available. For the fatigue calculations, the FALSTAFF spectrum was adopted to min nz of 3 g and max nz of 6 g. Based on special study, the spectrum was modified for the horizontal tail. The crack initiation life was much larger as the crack growth life; the total life showed a factor of more than seven times the service life of the original service life.
