# A REVIEW OF AERONAUTICAL FATIGUE INVESTIGATIONS IN FINLAND MARCH 2013 – FEBRUARY 2015

Presented at the 34<sup>th</sup> Conference of the  
International Committee on Aeronautical Fatigue and  
Structural Integrity (ICAF),  
Helsinki, Finland, 1-2 June 2015

Compiled by Aslak Siljander, Piritta Varis

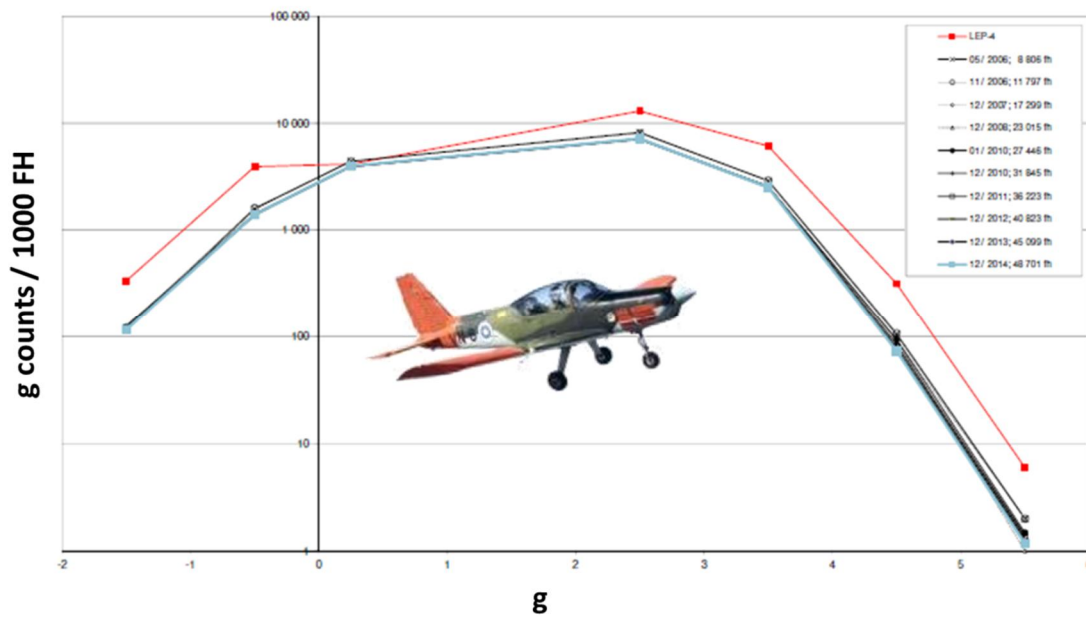
**Figure 3:** *The g counts per 1000 FH of the Valmet Vinka. From top to bottom: The spectrum representing the LEP design assumptions (LEP-4); the post LEP g counter spectrum as of May 2006; as of November 2006; as of December 2007; as of December 2008; as of January 2010; as of December 2010; as of December 2011; as of December 2012; and the updates from the previous review: as of December 2013; as of December 2014. All curves (excluding the red LEP-4) represent the fleet average from all Vinkas, as ranked according to the a/c center of gravity normal acceleration. Picture by courtesy of Patria Aviation.*

Based on the g counter information, the primary trainers are in good structural condition with regard to the flight hours. The severity of usage in view of the g counter status is more benign than that on the basis of LEP assumptions, see **Fig. 3**. It is possible to operate with Vinka until 2020 under its current type certificate. According to the FINAF's current plans the Vinkas planned withdrawal date is 2018. If there is a need to operate beyond 2020, the Vinka fleet will require another LEP.

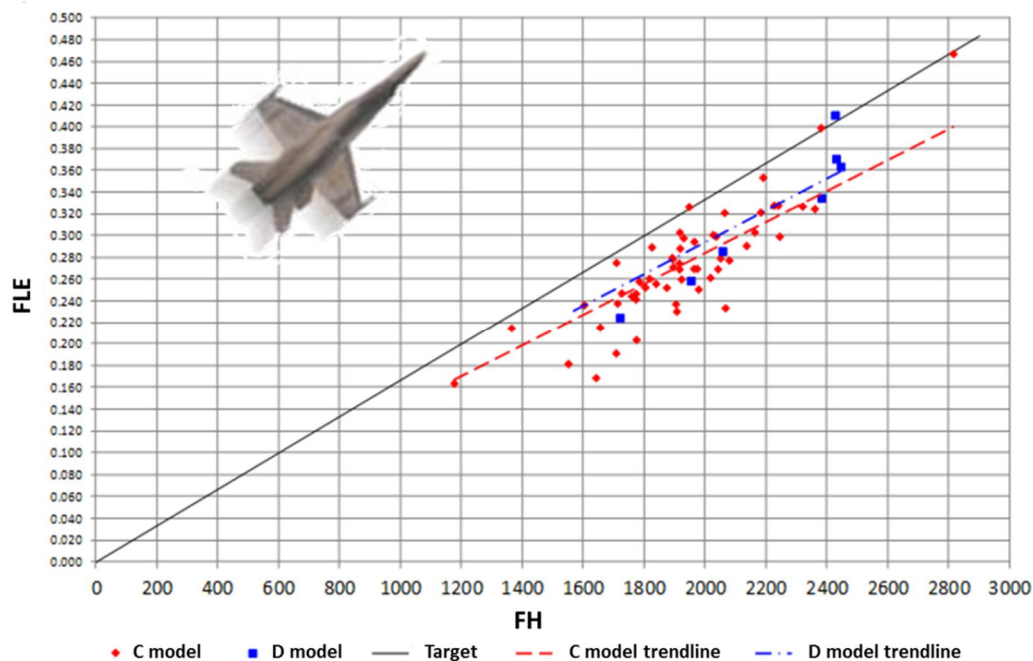
**Figure 4:** Summary of the wing root fatigue life expended (FLE) of the FINAF F-18C/D fleet at the August 2014. The data is from all 62 aircraft included. The target is 4500 FH and simultaneously 0.75 FLE. Picture by courtesy of the Joint Systems Centre.

The current structural life consumption of the FINAF F-18 fleet is shown in **Fig. 4**. As presented in the figure, the aircraft usage seems less severe than the design target. However, when compared to other F-18 operators the usage is more severe. The current target for the FINAF F-18 aircraft is 4500 FH and 0.75 FLE (simultaneously). To achieve this goal, the FINAF F-18 fleet needs a series of structural modifications and inspections. The first set of structural modifications (SRP1 – Structural Refurbishment Program 1) are designed and performed by Patria. Over half of the fleet is currently in the SRP1 configuration. Additional modifications were implemented to the SRP1 and the entire fleet will be on this SRP1+ configuration by the end of 2017. There is still more modifications and inspections needed after SRP1+ to achieve the 4500 FH goal. FINAF is also investigating the possibilities to extend the life of F-18s for 5 years, which equals approximately to 5000 FH.

It is worth noting that the structural life consumption (**Fig. 4**) is mainly decided based on a single detail of structure. The data collected from the said detail is processed by a piece of software provided by the aircraft manufacturer. As a result the structural life consumption for each aircraft in fleet is given.

The severity of the Finnish usage in view of structural fatigue with the two jets of noteworthy maneuvering capability can be seen in **Fig. 4** (Hornet). Fig. 4 clearly demonstrates the need to maintain, further develop and apply concrete and systematic efforts to cope with the structural deterioration effects of these two aircraft types.

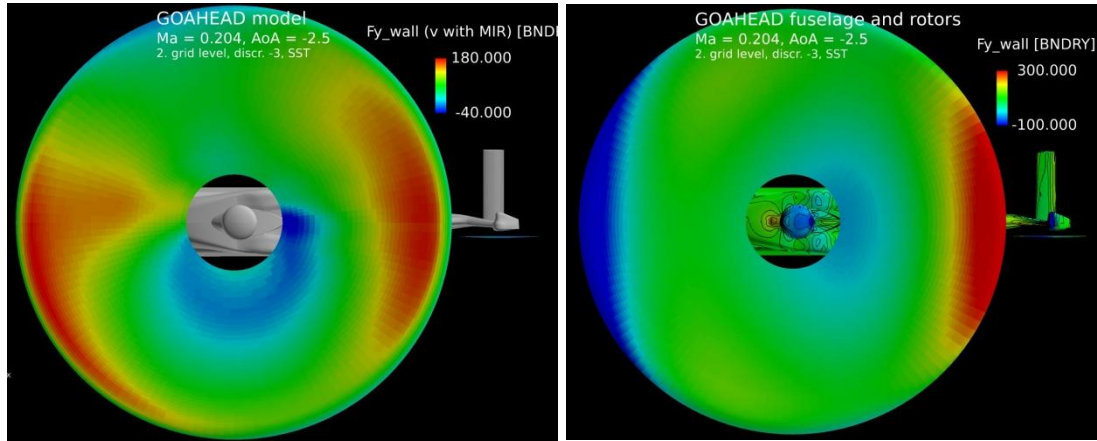
**Figure 5:** Main rotor thrust distributions in the GOAHEAD test case at fast cruise computed with FINFLO using the new (left) and old (right) actuator disk models. Picture by courtesy of Patria Aviation.

In subsequent repeat simulations [3] of the GOAHEAD test case with rotors, the FINFLO results were dramatically improved. The flow and force distributions on the main rotor became significantly more realistic, as illustrated in **Fig. 5** containing the thrust loadings obtained with the new and old actuator disk model.

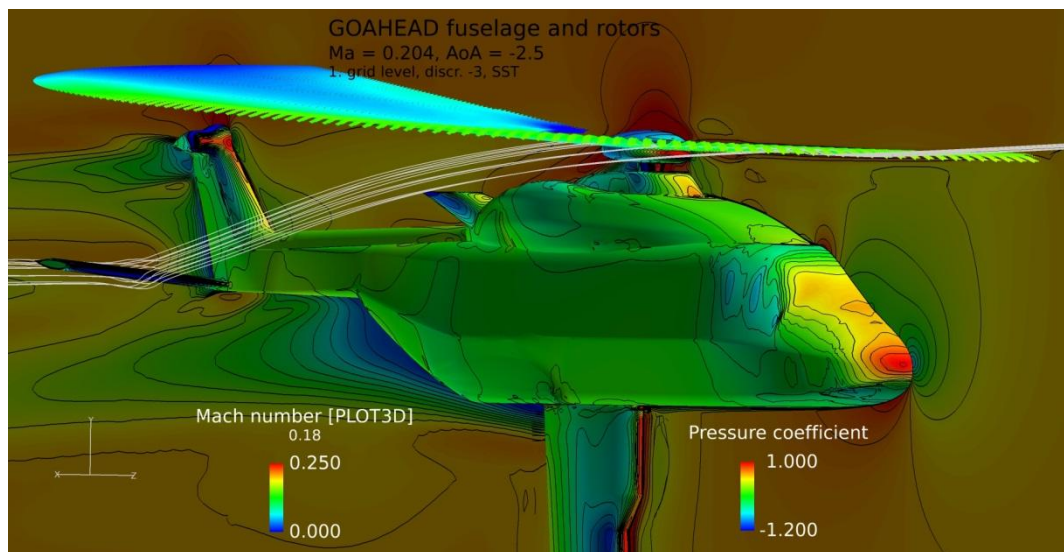
**Figure 6:** Computed flowfield around the GOAHEAD model and streamlines of main rotor wake surrounding the horizontal stabilizer. Picture by courtesy of Patria Aviation.

With the new actuator disks, the time-averaged rotor effects on the fuselage and tail surface became much better predicted. For example, **Fig. 6** shows how the main rotor wake emanating from its front sector hits the horizontal stabilizer, which increases the tail loads markedly. With the old actuator disk model, this effect was entirely missed.

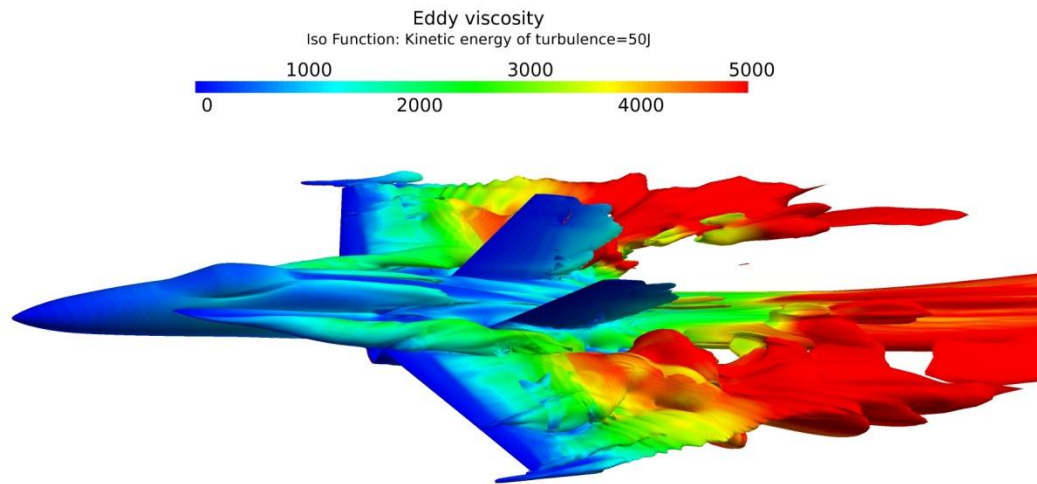
**Figure 7:** An iso-surface of the kinetic energy of turbulence colored by the eddy viscosity in a pull-up case. Flight parameters are  $Ma = 0.75$ ,  $AoA = 9.4^\circ$  and  $n_z = 5.1$ . Picture by courtesy of Finflo Ltd.

As a part of the FINAF Hornet Mid Life Upgrade 2 (MLU2) Program, unsteady flow cases have been simulated using different approaches: URANS and Delayed Detached Eddy Simulation (DDES). The time-averaged loads predicted by these methods do not differ significantly from each other, but the DDES prediction contains higher frequencies. As compared to the steady-state RANS prediction there are significant differences in the time-accurate results. At a high angle of attack the simulated flow field remains often oscillatory even in the RANS simulation, but these oscillations are unphysical. An example of the simulated flow fields is a pull-up case at  $Ma = 0.75$ ,  $AoA = 9.4^\circ$  and  $n_z = 5.1$  (*Fig. 7*).

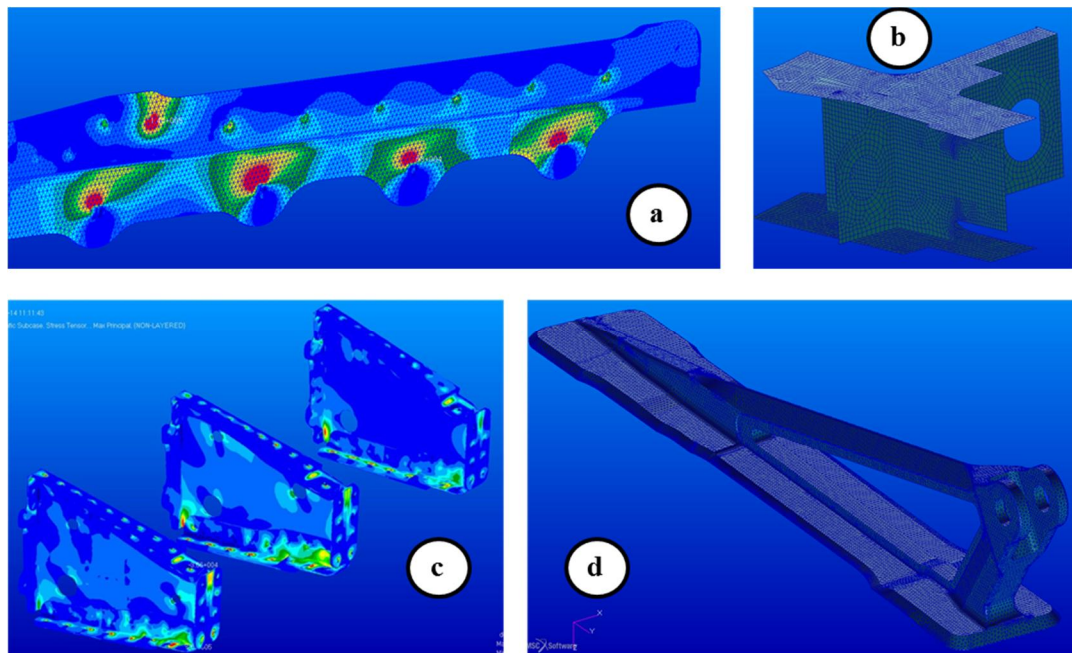
**Figure 8:** Detailed FE models: **a)** aft fuselage lower outboard longeron, **b)** vertical tail lower rib, **c)** wing root intercostals Y453, Y470.5 and Y488, and **d)** inner wing outboard trailing edge flap hinge. Pictures by courtesy of Patria Aviation.

Previous development phases of the global and detailed finite element (FE) modeling of the FINAF F-18C Hornet have been outlined in [1] Chapter 13.2.1.3. Since then some new detailed FE models have been prepared: aft fuselage lower outboard longeron [7], vertical tail lower rib [8], wing root intercostals Y453, Y470.5 and Y488 [9], and inner wing outboard trailing edge flap hinge [10], **Fig. 8**. According to these analyses, the aft fuselage lower outboard longeron is Full Life in the FINAF usage, but the other parts have some fatigue issues and require pre-emptive repair actions. New analyses with previously prepared detailed FE models of vertical tail stub Y590.5 and bulkhead Y508 wing root shear tie were performed [11] to define transfer functions for life estimation based on strain gauges installed in HOLM instrumentation modification, see reference [1] Chapter 13.2.2.1.2 and this report's Chapter 13.2.2.1.1.

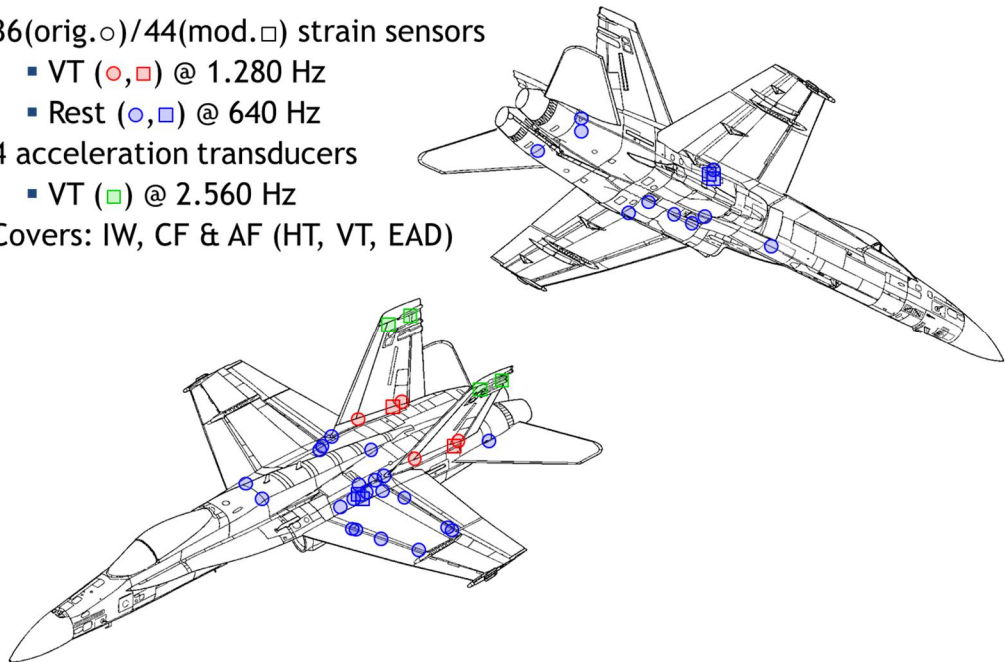
- 36(orig.○)/44(mod.□) strain sensors
  - VT (○,□) @ 1.280 Hz
  - Rest (○,□) @ 640 Hz
- 4 acceleration transducers
  - VT (□) @ 2.560 Hz
- Covers: IW, CF & AF (HT, VT, EAD)

**Figure 9:** An overview of the onboard HOLM system (the HOLM measurands) after the HOLM modification. Rectangular symbols denote the new strain gauge locations and the colors indicate sampling rates. Picture by courtesy of VTT.

As a step to cope with the on-going structural issues the FINAF started modification process in which the existing HOLM instrumentation was extended to support the national aircraft structural integrity management plan, **Fig. 9**. The modification helps assessing the structural impact of new training missions. In addition to the HOLM system modifications, some of the current strain sensors were relocated into a more acute (i.e. fatigue critical) structural locations.

buffet-induced dynamic stressing of the FY508 and the vertical tail regions. The existing data acquisition system was upgraded and a total of 12 new channels (8 strains + 4 accelerations) and associated LRU, system cable harnesses and other needed accessories were added and the systems were calibrated mechanically and electrically to these two HOLM jets, **Fig. 9**. [25] [26] [27] [28] [29] [30]. The two HOLM jets are slightly different in their instrumentation suite.

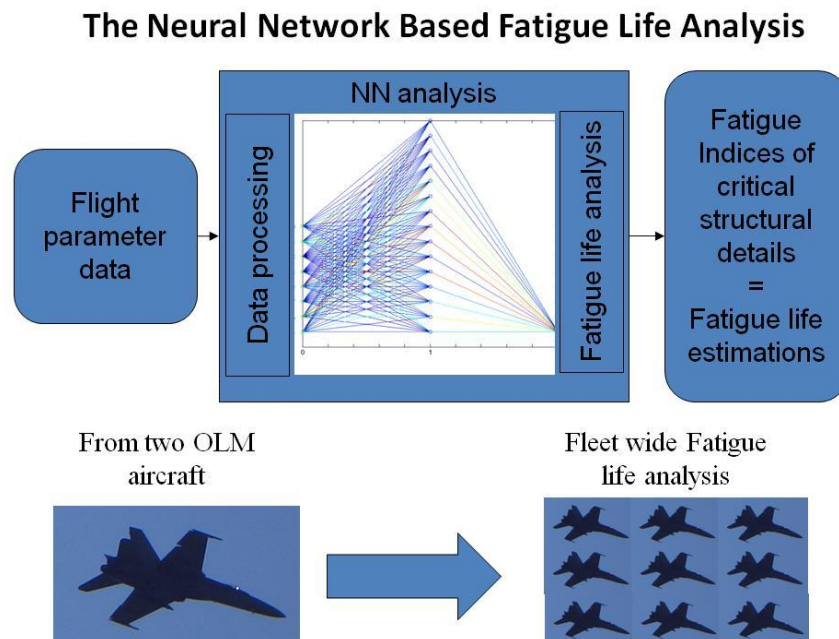
**Figure 10:** Data flow of the applied monitoring method. Picture by courtesy of Patria Aviation.

Previous development phases of the parameter based fatigue life analysis system have been presented in [1] Chapter 13.2.2.3. The parameter based fatigue life analysis is an individual aircraft fatigue life monitoring system developed for the FINAF F-18 Hornet fleet by Patria Aviation, **Fig. 10**. The parameter based fatigue life analysis utilizes flight parameter data, stored by standard aircraft systems, and artificial neural networks (ANN) to produce flight-specific fatigue damage estimates. The fatigue damage (Safe-life) estimates are calculated for 17 structural locations; each consisting of 1-3 features (e.g. 3 fastener holes in the same structure).

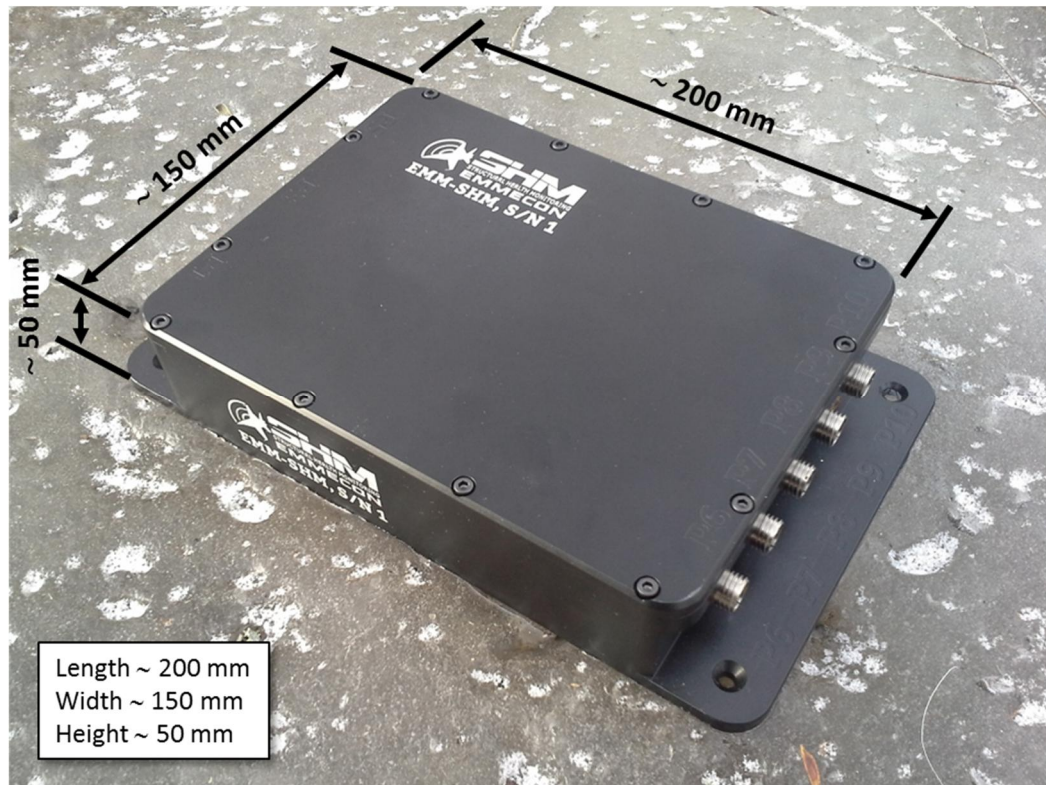
**Figure 11:** An overview of Emmecon's SHM system. Picture by courtesy of Emmecon Ltd.

Emmecon's SHM system (strain measurement and analysis) has further been developed since the previous review, **Fig. 11**. One FINAF Mk66 jet trainer was equipped with Emmecon's onboard SHM prototype system during the jet's normal squadron service. During the three-month normal squadron service period (63 flights total) the SHM system collected in-flight data from two structural locations (vertical fin and tailplane).

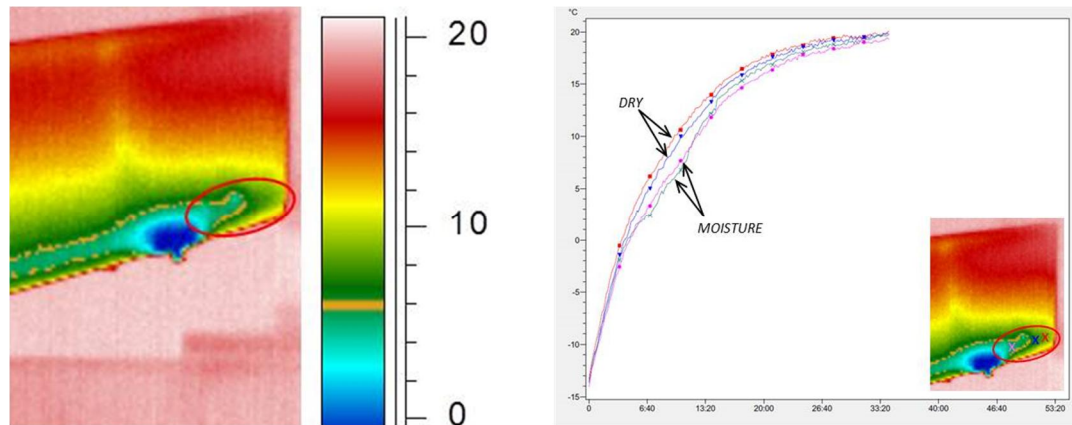
**Figure 13:** An example of the thermographic inspection based on the phase transition of water. Abnormal warming is observed within the circled area (left). The measurement locations are displayed with symbols "X" (right); each warm-up curve's color is related to the same color "X" (lower right within the circled area). Moisture ingress/penetrated water can be observed from the curves denoted with "MOISTURE". Picture by courtesy of VTT.

Thermographic inspection based on the phase transition of water exploits the phase transition energy that is needed for the ingressed water to be defrosted (melted). Water ingress indication is observed in a specific phase transition temperature and the indication insures the presence of water. Another advantage of this method is that no additional excitation source is needed for the tests. Method based on the phase transition can be especially exploited during the long period of arctic weather conditions in Finland and other cold areas. Composite structures can be left outside in freezing conditions overnight and inspected when they have been brought in to warm conditions. The non-contact thermographic inspections are conducted during the warm-up period in the hangar, **Fig. 13**.

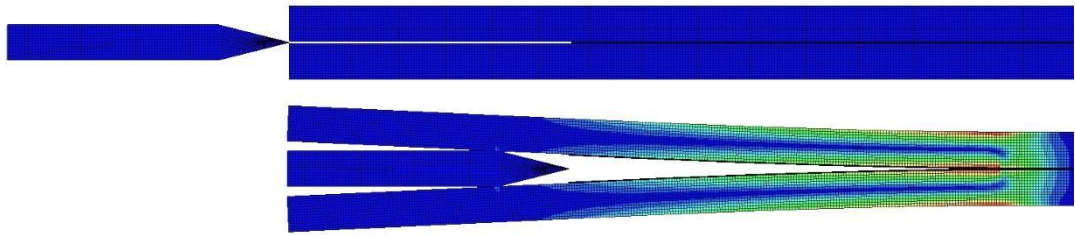
**Figure 14:** Simulation of the wedge test specimen). Picture by courtesy of Aalto University.

Based on the work performed on VCCT analysis two publications are prepared. The previously reported work on analysis of the FINAF F-18 trailing edge flap delaminations is published as a poster presentation in ICAF 2015 [36]. The second paper with the title ‘Applicability of VCCT in Model I Loading of Yielding Adhesive Bonded Joint – a Case Study’ is submitted for publication in International Journal of Adhesion and Adhesives [37]. The paper is under peer review process. In addition, a paper including simulations performed on wedge test specimens is under preparation. The simulation of wedge test is illustrated in *Fig. 14*.

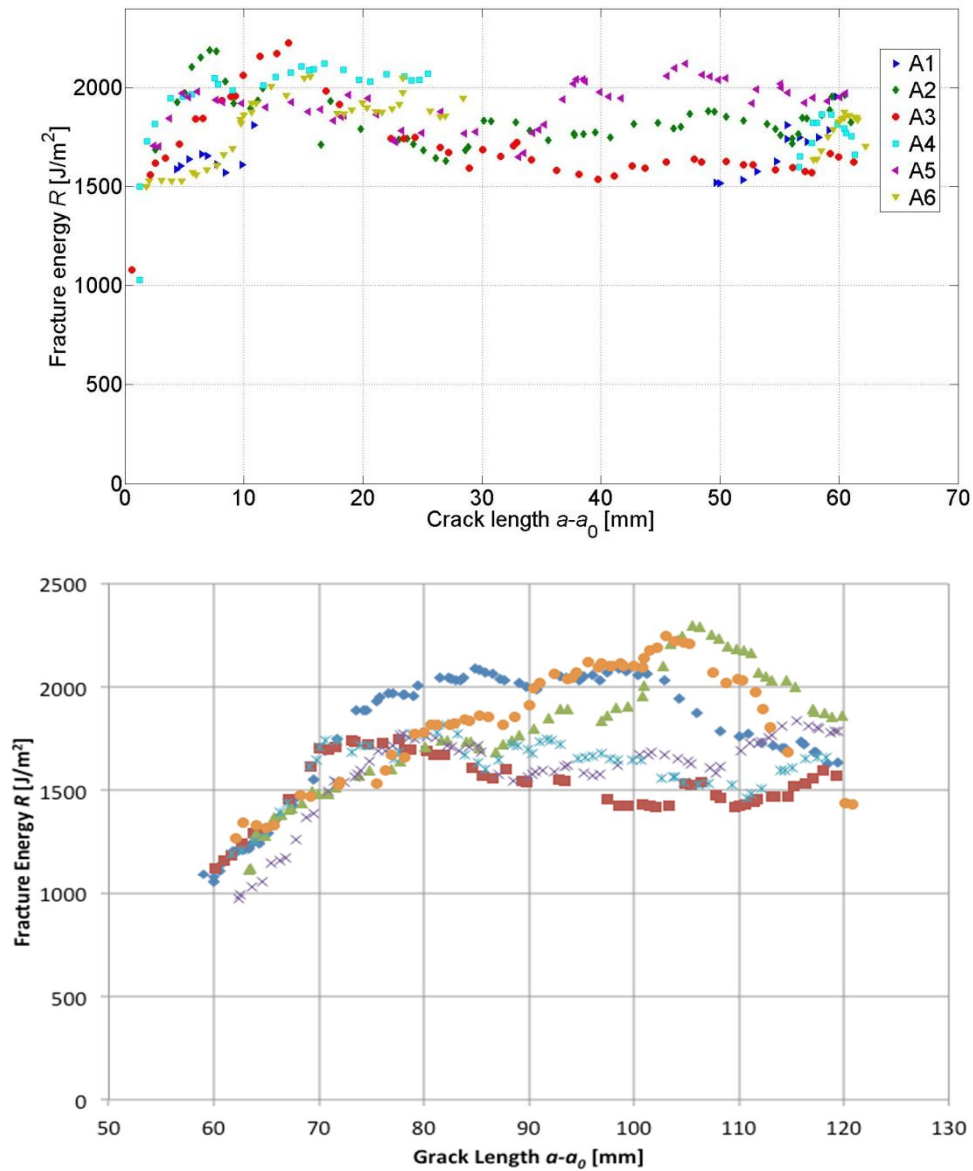
**Figure 15:** Fracture energy of DCB specimens with two (above) or one (below) adhesive layers. Picture by courtesy of Aalto University.

The experimental work in mode I loading was continued. The double cantilevered beam (DCB) with aluminum adherends and FM 300-2 adhesive film was used. The tests are performed on specimens with either two or one adhesive film layer. On the average the propagation  $G_I$  values are similar for both cases but in case of one adhesive film the bridging effect of the carrier is more significant. In addition the behavior of the crack in the beginning is different as illustrated in *Fig. 15*.

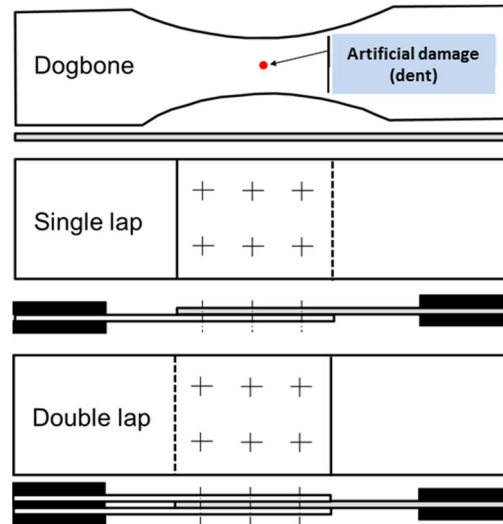
**Figure 16:** An overview of the three coupon types. Picture by courtesy of Patria Aviation Oy and VTT.

[40] [41] [42] [43] of the FINAF F-18 repair methods. The coupon fatigue tests were performed by VTT. Three different coupon types were utilised: a basic dogbone coupon (7050-T7451), a lap joint coupon (7075-T76) and a double-lap coupon (7075-T76), **Fig. 16**. A total of 52 + 24 + 25 coupons were tested (basic dogbone, lap joint and double-lap, respectively).

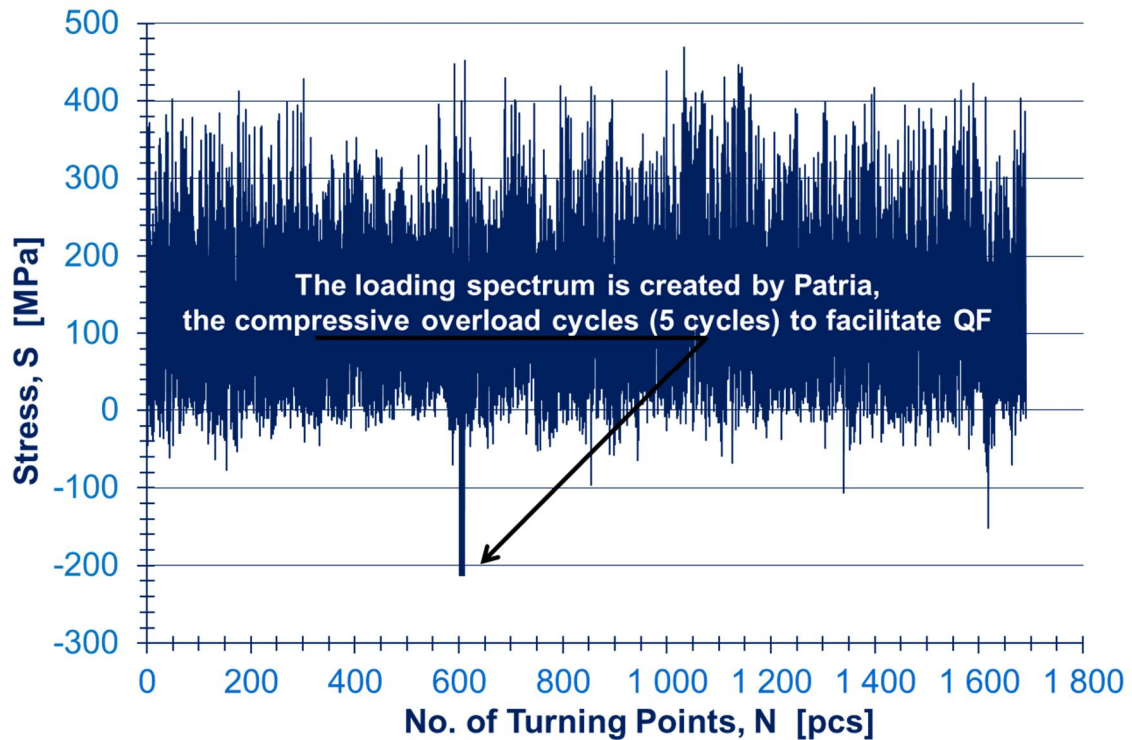
**Figure 17:** An overview of the variable amplitude loading spectrum for the dogbone coupons: HOLM S47 (Y488 BLKHD). Picture by courtesy of Patria Aviation Oy.

The specimens were subjected to either constant amplitude or variable amplitude loading, **Fig. 17**.

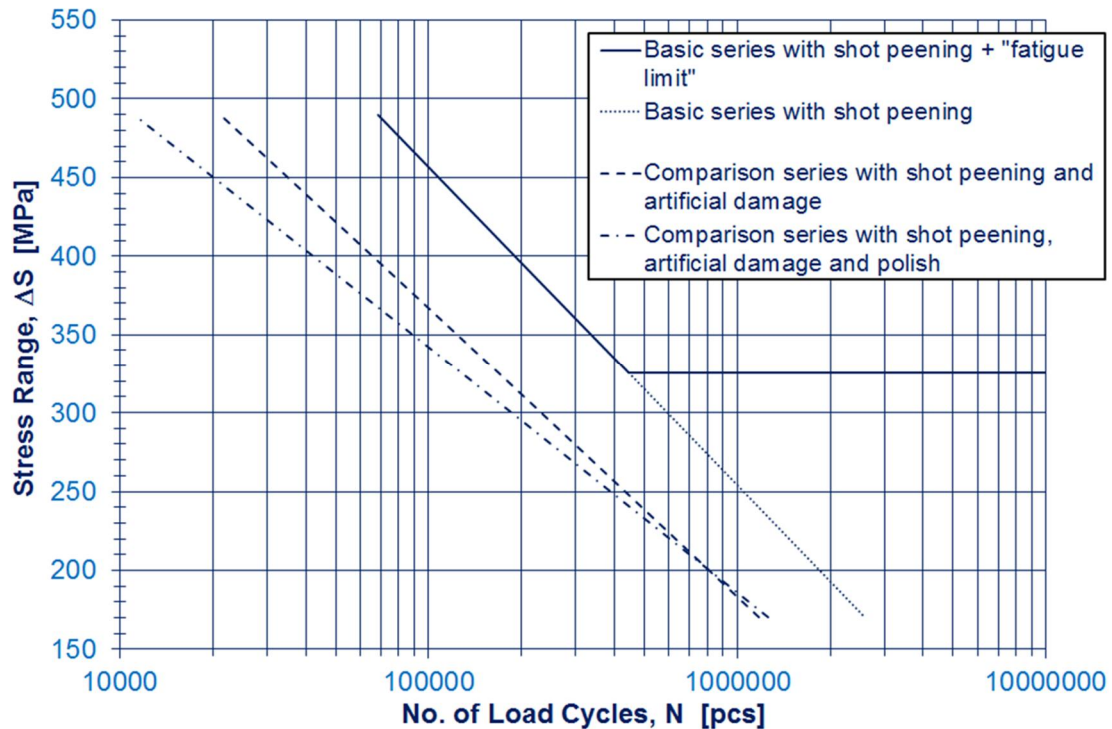
**Figure 18:** Summary of the dogbone coupons' results (constant amplitude loading), natural logarithm fitting in the test results. Picture by courtesy of Patria Aviation Oy.

For the dogbone coupons the following observations could be made (**Fig. 18**):

- The fatigue life of the dogbone coupons with shot peening and sharp dents was surprisingly good in that the dents appear to affect less than the  $K_t$  theory. In fact, the fatigue life was better than basic material Al 7050-T7451 without shot peening (MIL-HDBK-5H values).
- The achieved shot peening LIF (life improvement factor) was 4 ... 10 depending on the stress level. Sharp edge removal from the coupons prior to the tests was noticed to be important.
- Blending and polishing inside the shot peened area is a bad solution (fatigue life was lower than without dent removal). Repair shot peening is required.
- During the dent removal process, the Confidence Cut is mandatory

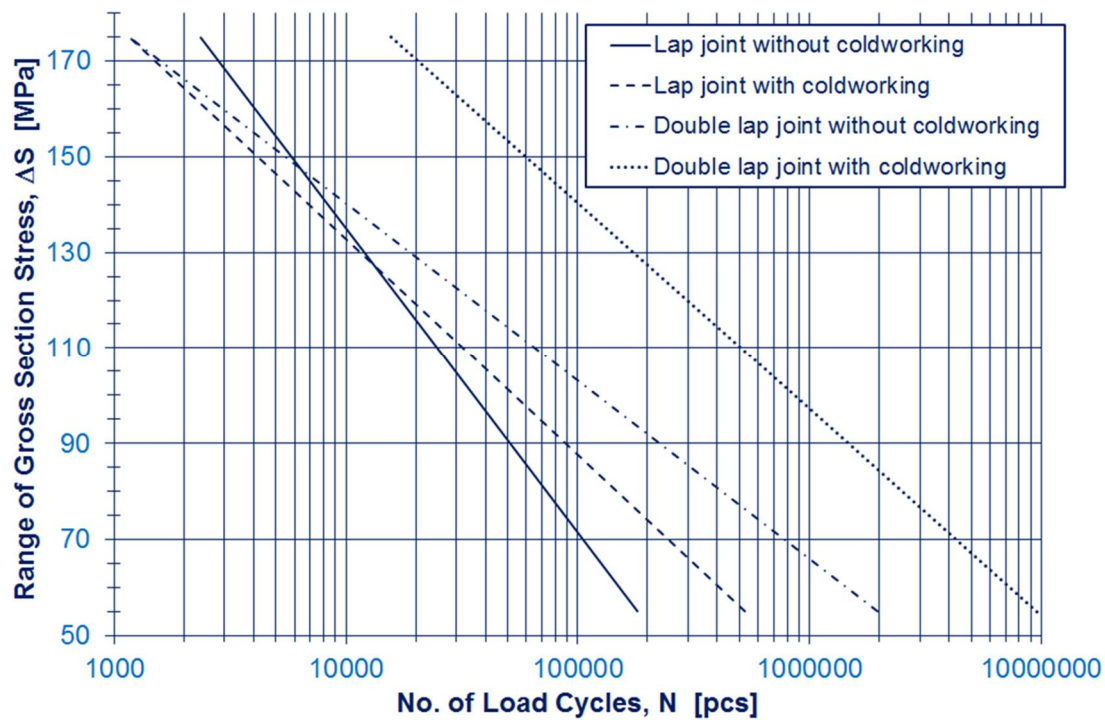
**Figure 19:** Summary of the lap coupon and double-lap coupon results (constant amplitude loading), natural logarithm fitting in the test results. Picture by courtesy of Patria Aviation Oy.

For the Jo-Bolt tests (lap and double-lap coupons) the following observations could be made (**Fig. 19**):

- CW (cold worked) Jo-Bolt joint seems to be as good as the I/F (interference) fit Hi-Lok (tested earlier). Confirmation for the Inner Wing Front Spar modification, it can be done twice: the first oversize before 0.4 FLE and the second oversize at 0.8 FLE (for exceeding latter limit)
- The cold worked LIF (life improvement factor) for the Jo-Bolt joint is approx. 1.3 (single lap joint) and approx. 2 (double lap joint).
- In the single lap joint coupons the secondary bending effect is dominant. The fatigue life of the Jo-Bolt joint is barely as good as the Hi-Lok joint (single lap joint, Class 2 holes).
- The HSB 63511-02 blind rivet "LIF" of 0.1 ... 0.25 can be neglected for Jo-Bolt joints. The HSB "LIF" is valid for CherryMax-type blind rivets.

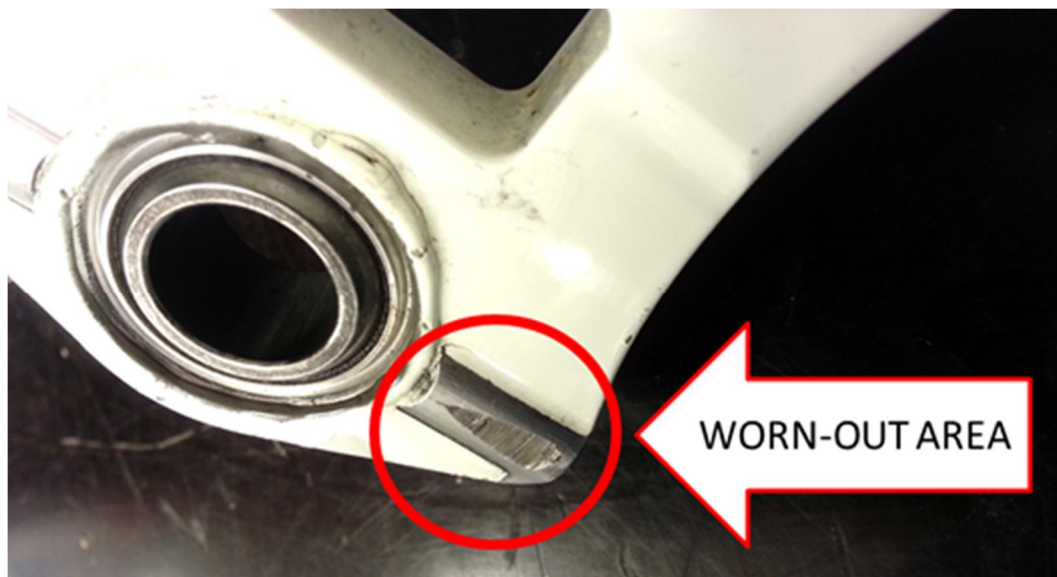
**Figure 20:** An overview of the Aileron's hydraulic cylinder's worn flange. Picture by courtesy of the FINAF.

As there are several on-aircraft parts and subsystem components (e.g. hydraulics, flight controls etc.) that wear out during normal service, the FINAF initiated a study with VTT to investigate possibilities to develop in-country capabilities related to restoring the structural integrity of the worn parts thus supporting maintenance, repair and overhaul (MRO) activities and improving the management and sustainment of spares and component life cycle. One such subsystem component wearing out in normal service is the FINAF F-18 Aileron's hydraulic cylinder's flange, *Fig. 20*.
