## EVALUATION OF COLD SPRAY FOR AIRCRAFT REPAIR

**Abstract:** Cold spray (CS) is being used in both civil aviation and military aircraft fleets as a method for repairing obsolete or damaged parts. There is also ongoing research funded by the United States Navy examining the ability to use CS repairs on aluminium alloys for structural applications on aircraft. Using blend out geometries relevant to aircraft damage mitigation, recent fatigue testing has shown that a CS repair of AA7050-T7451 fatigue sample geometry with a 15% to 30% blend out depths were able to improve fatigue life to near that of an undamaged fatigue sample at two stress ratios. Additional mechanical and material property testing of CS repaired coupons have shown results far exceeding those of a blend out repair, a typical aircraft repair technique. Properties such as ultimate tensile and yield strength show values similar to those of wrought. These results suggest that CS can be used for aircraft structural repair.

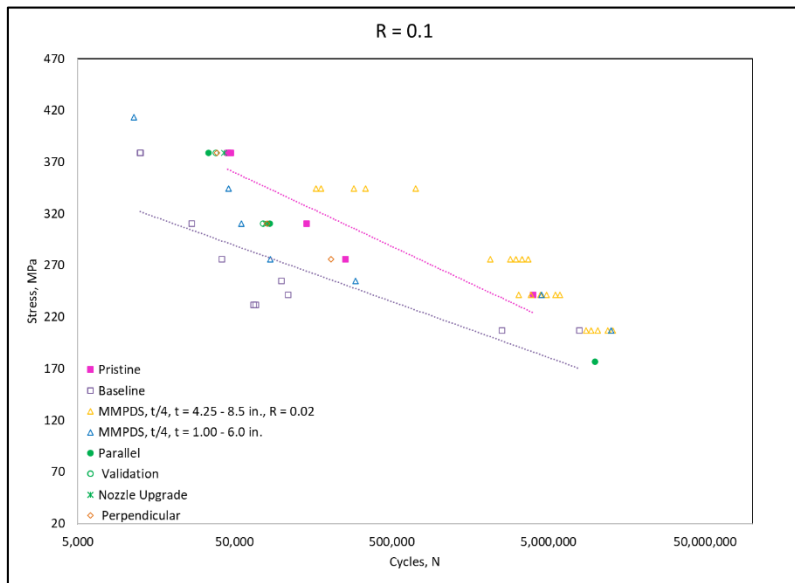
Fatigue testing was performed on 15% blend coupons. Spray validation was also performed to show that the CS repair process could be locked and repeated giving the same mechanical property results. Parallel and Validation were linear-parallel coupons sprayed months apart using the same process. Perpendicular was a linear-perpendicular raster pattern using the same machine parameters as the other sprays. A Nozzle Upgrade also occurred during the research program and was included in the validation testing on the repeatability of the CS process. The perpendicular sprays performed slightly better than the parallel as shown in Figure 7 and Figure 8. The R=0.1 shows a greater improvement with the perpendicular raster than the fully reversed loading.

Figure 7: 15% Blend S/N Curve, R=0.1

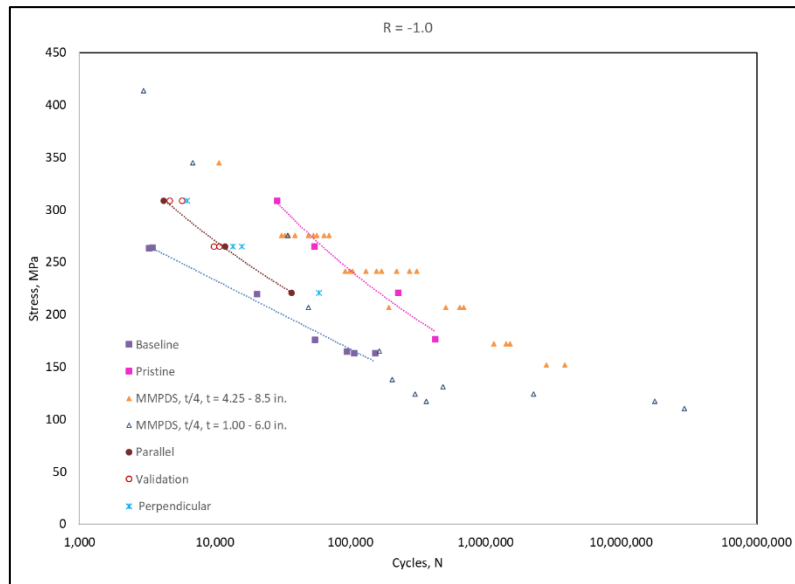
Figure 8: 15% Blend S/N Curve, R=-1

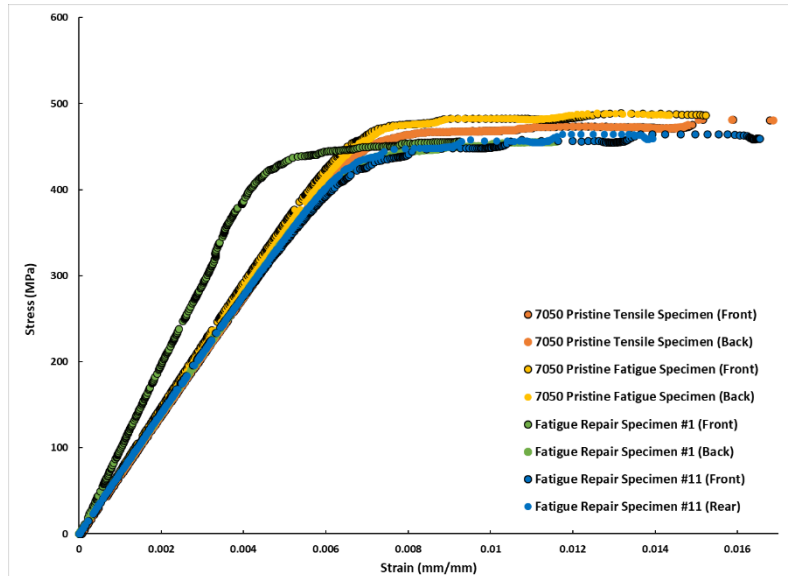
The 15% CS repaired coupons had a UTS and YS that was 95% of wrought at 490 MPa (71ksi) and 448 MPa (65ksi). The stress-strain curve of both wrought and CS repaired coupons can be seen in Figure 10. Figure 11 and Figure 12 show the comparison of the yield and ultimate tensile strength of the repaired coupons to the pristine coupons.

Figure 10: Stress vs. Strain of Pristine and CS repair coupons.

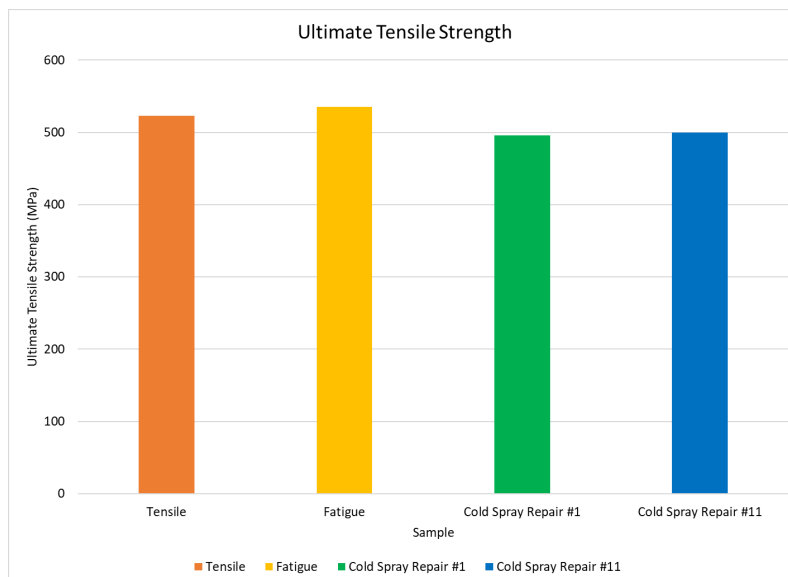
Figure 11: Ultimate Tensile Strength of pristine tensile (Tensile) and fatigue (Fatigue) coupons and 15% CS repair blend coupons (Cold Spray Repair #1 and #11)

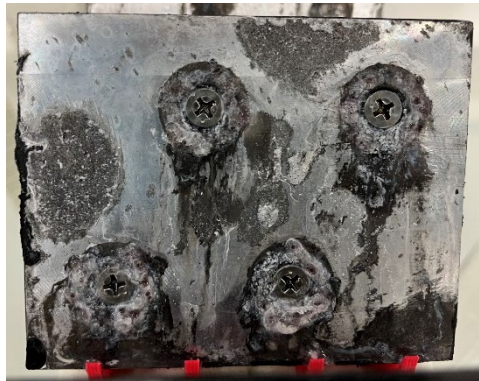
Both Process A and Process B saw corrosion damage develop quickly. Figure 14 shows damage after 168 hours (1 week) of salt fog exposure. Corrosion attack is present in both the wrought aluminium and CS repair. At the four areas of CS repair, darkening and pitting are present in both processes. During testing, an area of large gelatinous corrosion product formed on the CS. This is a likely indicator of deep pits forming [19,20]. Figure 15 shows the sample after 1000 hours. The heavy corrosion product was removed from the surface by a clean water rinse. Deep pits in the CS repair area were visible after the corrosion product was removed.

Figure 14: Repaired coupon after 168 hours of exposure.

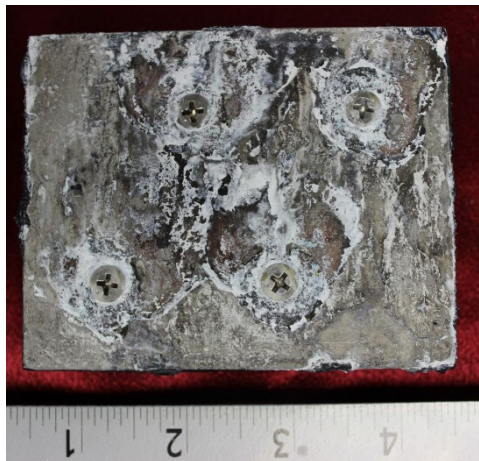
Figure 15: Repaired coupon after 1000 hours of exposure and clean water rinse.
