COMPRESSION AFTER IMPACT FATIGUE DAMAGE GROWTH IN CFRP – WHAT DOES NO-GROWTH REALLY MEAN?

Abstract: Impacts on carbon fiber reinforced composites (CFRP) can produce a complex internal damage comprising multiple delaminations, which is hard to detect from visual inspection. This situation is known as barely visible impact damage (BVID). Considering that every airplane faces several impacts during its operational life, and that the majority of exposed surfaces in new generation aircraft is made of CFRP, there is a high chance that some aircraft will be flying with unnoticed impact damage. For this reason, BVID damage tolerance must be taken into account in design. The FAA and EASA dictate a no-growth design philosophy for BVID. Although multiple delaminations are present, BVID fatigue growth is usually assessed by measuring only the projected delaminated area with ultrasound inspections. This is done to simplify the damage description and because of the limitations in ultrasound inspection methodologies. In the present work, we show two cases of delamination propagation that are neglected following this procedure. Our experimental monitoring of delamination propagation with differen

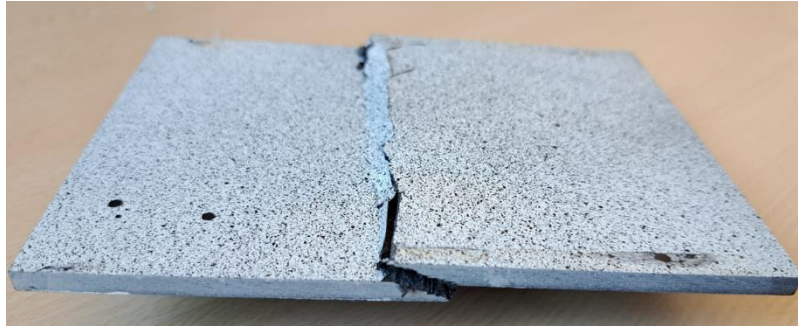
Figure 4: Failed specimen after CAI fatigue test.

In all specimens final failure was characterized by unstable delamination propagation in multiple interfaces and fiber kinking. The fractured specimen appears very similar to static CAI tests previously conducted by the authors [13], showing a final fracture that runs in the centre of the specimen, perpendicular to the loading direction (Fig.4).

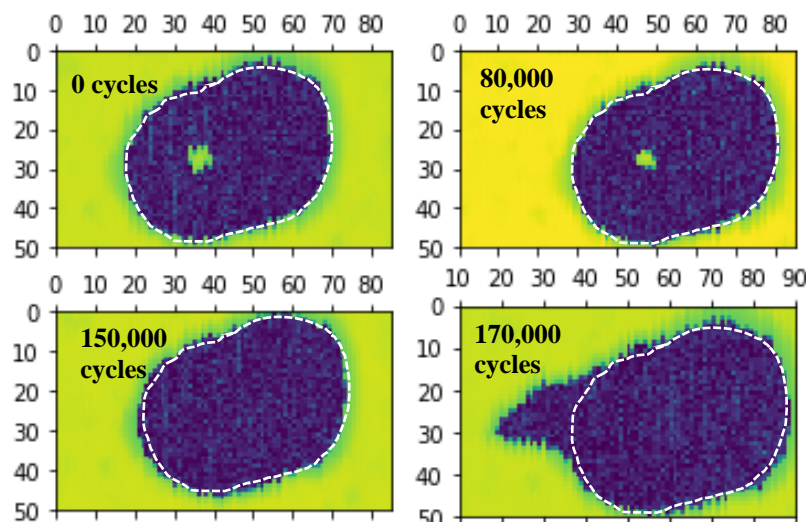
Figure 5: Delamination monitoring in fatigue using through thickness attenuation [12]

Some common trends were observed in the fatigue damage propagation and failure of the four specimens. In *series 1 – specimen 1*, no growth was captured with the through thickness scan. This because failure happened after 2,600 cycles and only three inspections were performed at 10, 100 and 1,000 cycles. In all the remaining specimens, a macroscopic and relatively fast delamination growth happened in the perpendicular to loading direction, proceeding from impact damage towards the lateral edges of the specimen (Fig.5 and Fig.6). This observation is consistent with several tests in literature [17] [18].

The first observation presented is the growth monitored in specimen 1 of series 1. In this case we used through thickness attenuation scan to evaluate growth below the impact contact point. As explained in previous sections, there is an area below the impact point, where little or no delamination is present. Because of the impact dent curvature reflection, it was difficult to evaluate this area using the echo-pulse system. For that reason we adopted through thickness transmission scan. The results clearly show how the delamination propagation firstly happened in the central area, and only after that, a single delamination started growing towards the lateral edges (Fig.5). If only the outer projected external area is taken into account, this growth in the central area is *not* considered.

At the starting point of Fig.5, if a central non delaminated area is present, the laminate is forced to deform locally in two half buckle shapes. Delamination growth in the central area may join two half delaminations into a single larger one. This would result into a single buckle, a sudden increase in the strain energy release rates at the external edges of delaminations and a reduction of the buckling load.
