Enhanced technology repair for corrosion and fatigue damage in hybrid aerostructure

Abstract: The cold expansion method has been successfully used in aerospace structures to repair and prevent fatigue damage for more than 50 years. In 2022, PartWorks completed the first part of an innovative program for the United States Air Force using a new process incorporating cold expansion to repair corroded fastener holes (U.S. Patent 11,255,371) on aerostructures. This paper summarizes the experimental and analytical results of that development and demonstration program. In addition to addressing the corrosion issue, another critical goal of this program is to find ways for OEMS and operators to take credit for the compressive Engineering Residual Stress (ERS) imparted during the process. A part of getting life credit from ERS requires documenting that each fastener hole is processed correctly and ensuring the correct holes were processed. A data record with process data that shows this should be captured and included in the digital thread of that aircraft.

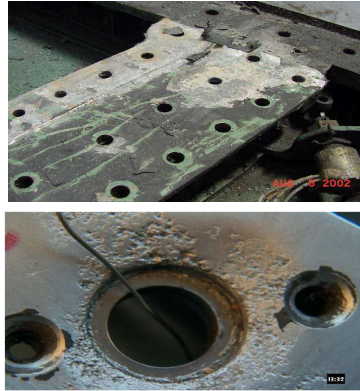
Modern aircraft use thousands of fasteners, which makes the detection and repair of corroded fastener holes a costly and time consuming effort. See Figure 1 for an example of the galvanic corrosion found at fastener holes in aluminum alloy substructures after the carbon fiber skins are removed.

Figure 1. Fastener Hole Corrosion

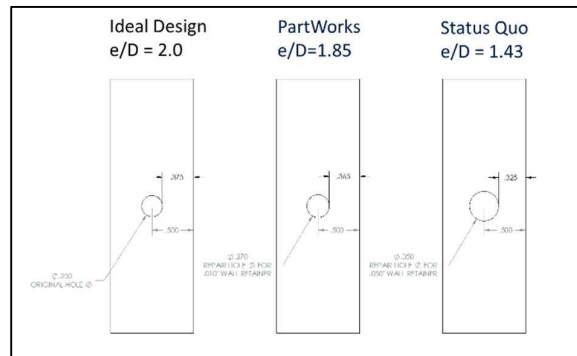
Figure 2. Demonstrating e/D distance for a typical repair

One of the disadvantages of the current repair process to the parent structure is that the reaming process may significantly decrease the hole edge distance (e/D), where e is the distance from the center of the fastener hole to the edge of the part and D is the hole diameter (

Figure 2). In most cases decreasing e/D reduces the fatigue life of the aircraft structure. Typical aircraft design guidelines recommend that the hole edge distance be 2.0 or greater for new structures and at least 1.5 for repaired structures. Shrink fit bushing repairs can reduce the edge distance below 1.5 (a e/D below 1.5 is referred to as a short e/D condition) and hence reduce the fatigue life of the aluminum alloy substructure, especially for smaller holes. For example, if you have 1/4" hole with $e/D=2$, and ream to 0.375" for a standard NAS75 (1/16" wall), the e/D goes from 2.0 to 1.33.

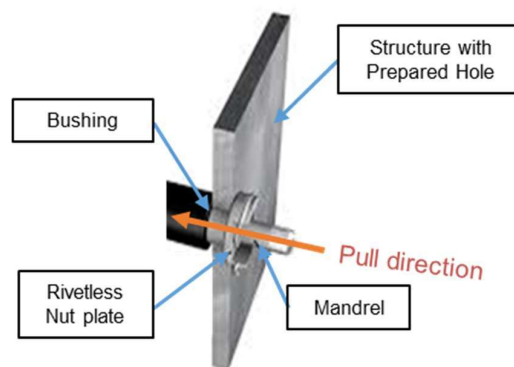
PartWorks has spent the last several years developing a fast, low cost and standardized process for repairing fastener holes as shown in Figure 3. The steps for repairing the fastener hole with the PartWorks process are:

- (1) Ream out a small portion of the inner surface of the fastener hole to remove some of the pitting that results from galvanic corrosion and begin with a standard hole size
- (2) Insert a thin-walled bushing into the fastener hole that will restore the inner diameter to the desired size
- (3) Insert a mandrel through the bushing and fastener hole
- (4) Cold expand the bushing into the inner surface of the fastener hole with the mandrel, introducing a high interference fit and inducing plastic strain around the hole.

As the mandrel is removed, the hole and bushing contract elastically which puts the volume around the fastener hole under compressive residual stress.

Figure 3. Repair of a corroded fastener hole

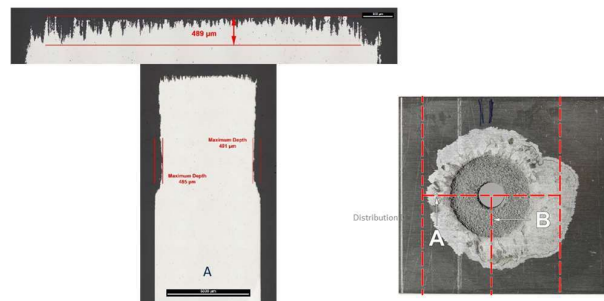
A critical part of this program was the development of a corrosion protocol that allowed fatigue specimens to be corroded to match the most severe level of damage identified in the fleet in a practical time frame. This protocol was developed by the University of Dayton Research Institute (UDRI) based on the prior work by Kelly & Burns at the University of Virginia. The severe corrosion that resulted is shown in Figure 4.

Figure 4. Corroded specimen

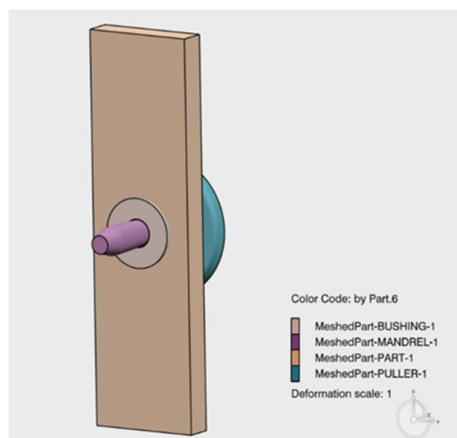
Finite Element Analysis (FEA) simulations of the nutplate were performed to predict the residual strain and stress generated during the cold-work process. The model consisted of the bushing, specimen, noscap from the puller unit and mandrel as shown in Figure 5. A closeup of the finite element discretization is shown in Figure 6. The model was run in Abaqus® FEA software using the explicit method.

Figure 5. FEA Model

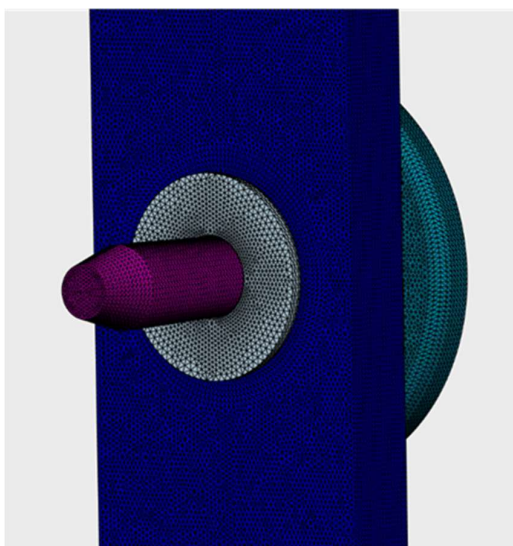
Figure 6. FEA Model Closeup

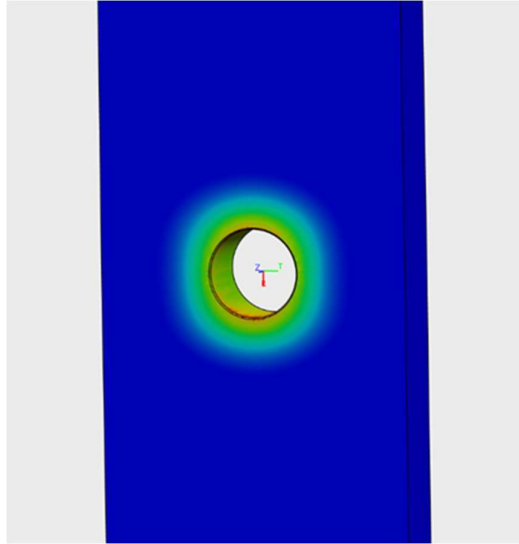
Contour plots of the residual hoop plastic strain and stress after the mandrel pull through are shown in Figure 7 and 8. The residual hoop plastic strain was tension as expected from the expansion due to the expansion of the mandrel. The associated residual hoop stress was in compression near the hole and transitioned to tension away from the hole which is consistent with general understanding of the cold expansion process.

Figure 7. FEA Residual Hoop Strain

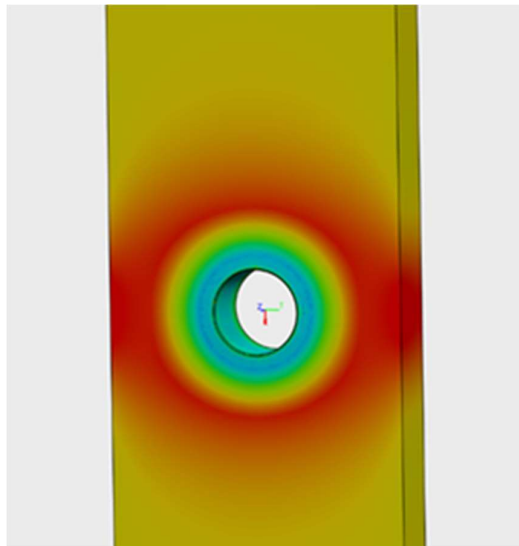
Figure 8. FEA Model Residual Hoop Stress

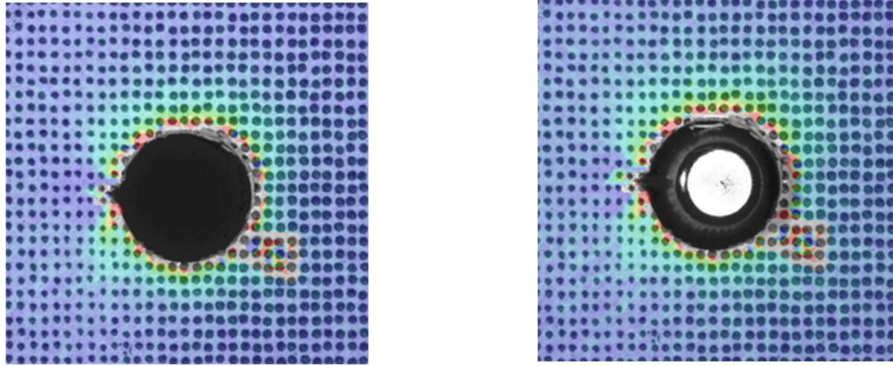
Digital Image Correlation (DIC) was used to capture the residual strain imparted during the cold expansion process. The DIC process is in widespread use in experimental mechanics where high sensitivity and non-contact are required. As a result it does not affect testing or influence the cold expansion processing. Results of the DIC method showing the measurements of the residual hoop strain during and after installation are shown in Figure 9 and 10.

Figure 9. DIC Showing Strain During Expansion (left) and Residual Strain After Processing (right)

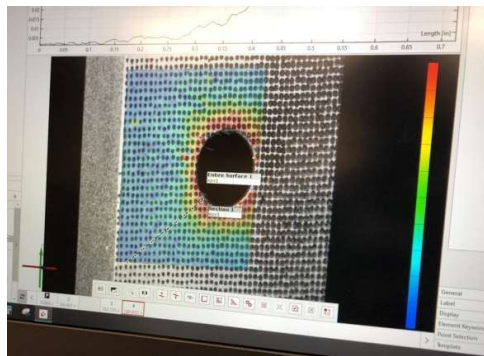
Figure 10. Residual strain visualization using DIC

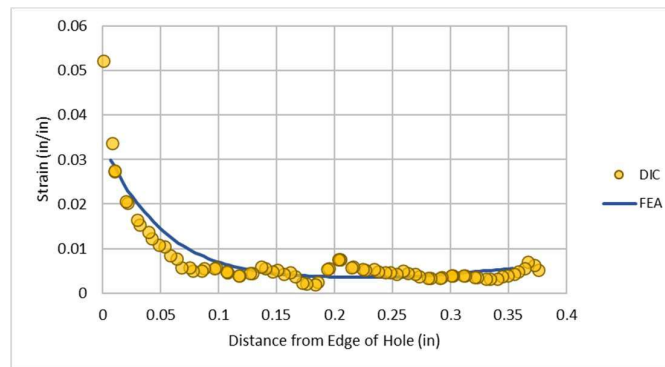
DIC measurements and FEA results along radial lines from the center of the hole were compared to validate the model as shown in Figure 11 and 12. The measured and predicted strain values showed good agreement. As expected, the residual hoop strain was highest at the edge of the hole and decreased quickly with radial distance. In the short edge margin direction, as shown in Figure 11, both the FEA and the DIC measured strains showed a fall off to a level of residual strain that was consistent all the way to the free edge indicating that the ligament was permanently stretched. The results in Figure 12 along the very large edge margin do not show this since there is more surrounding material to resist a permanent stretching of the ligament.

Figure 11. DIC Comparison with FEA Hoop Strain on Short Edge Margin

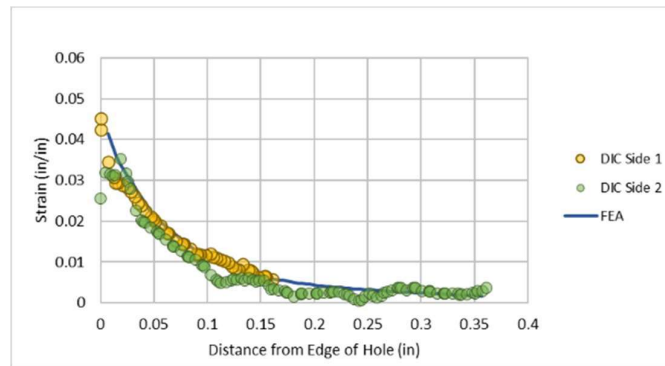
Figure 12. DIC Comparison with FEA Hoop Strain on Vertical

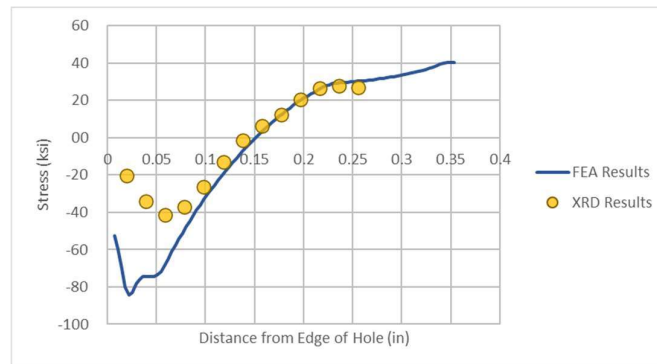
X-Ray Diffraction (XRD) was used to measure the residual hoop stress in the specimen after installation and compared with the FEA results to validate the model as shown in Figure 14. A good correlation was found away from the hole. The correlation closer to the hole was less consistent and indicate the possibility of the need for a more accurate material behavior model and study of other features that affect the residual stress at the surface in the model.

Figure 13. XRD Measurement Comparison with FEA Hoop Stress

The comparisons of the experimentally determined strain and stress showed good correlation with the FEA simulation but additional work is needed for correlating the surface stress measurements.

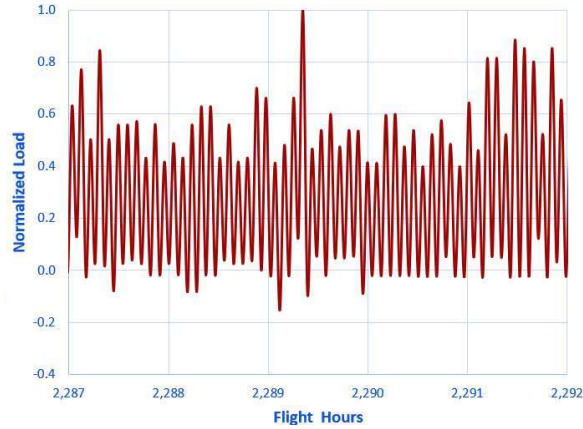
To quantify the level of fatigue life improvement of PartWorks standardized repairs, test specimens were fabricated that replicate the material and fastener configurations for USAF aircraft of interest. Test specimens were purposefully corroded to mimic the types and ranges of corrosion per the protocol identified earlier. Specimens were fatigue tested with both constant amplitude loading and fighter spectrum loading (Figure 15) to obtain the fatigue life of the configurations in Table 1 previously shown.

Figure 14. Typical fatigue test spectrum for fighter aircraft

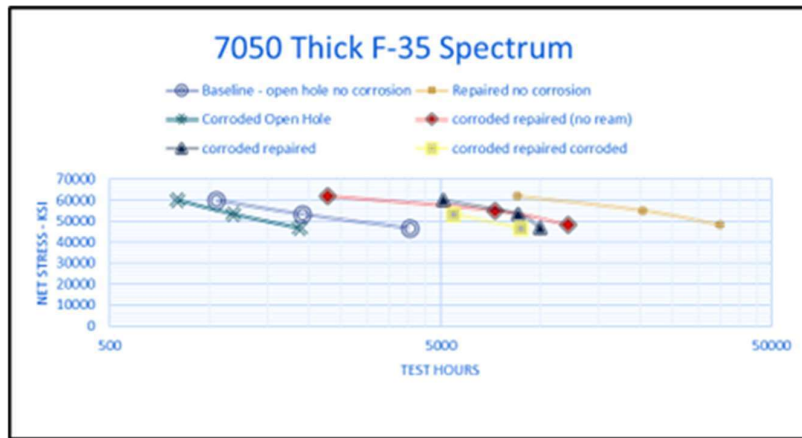
Figure 15 shows fatigue data generated by PartWorks as part of this program. This figure compares the specimens outlined in Table 1 previously.

Figure 15. Fatigue Test Results for Repaired specimens – Corroded and Baseline

The PartWorks process increased the fatigue life for all specimens, regardless of whether it was corroded or how whether a ream of the corroded hole was performed. To better compare the fatigue life benefit across all specimen configurations, the open hole test specimen was chosen as a baseline to compare to as shown in Figure 16. As expected, an open hole subjected to corrosion showed a significant drop in fatigue life. The hole with a nut plate without corrosion represents both a repaired hole without corrosion and a hole with an expanded nut plate during production. This demonstrated a very high life improvement over the open hole. All repairs with corrosion demonstrated very good life improvements, even if corrosion took place after the repair took place.

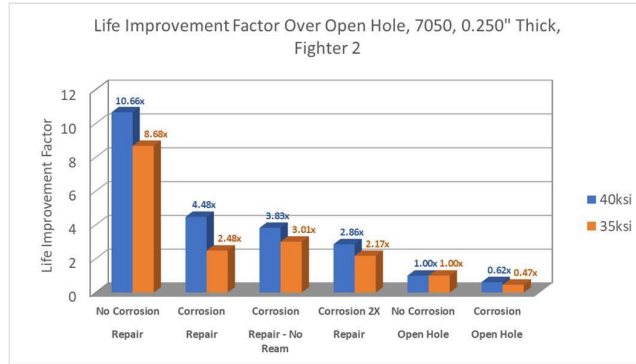
Figure 16. Fatigue Test Results for Repaired specimens – corroded and baseline

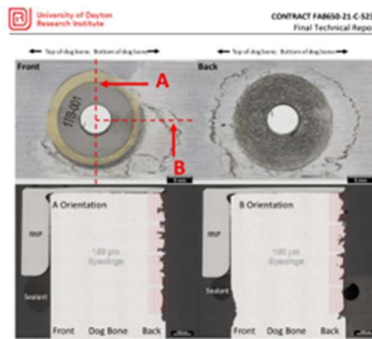
A test was performed to evaluate the ability of the adhesive/sealant to prevent moisture ingress post repair in-service. This phase of the program involved incorporating the PartWorks repair in a new part including adhesive/sealant on the OD of the repair bushing. The part was then fatigue cycled for 10,000 flights to explore the durability of the repair and bond. Then the part was put subjected to the severe corrosion protocol to evaluate if moisture or corrosion by-products would be exhibited down the bore of the hole or if the adhesive would act as a sealant. To check, the part was sectioned to look at the cross section of the bore afterwards. As seen in Figure 17, the unprotected portions of the part were severely corroded. However, even though the corrosion protocol affected the exposed surfaces of the part, the surfaces with adhesive under the flange and the bore of the hole were protected from corrosion.

Figure 17. Results of severe corrosion tests on the bore of a fastener hole.

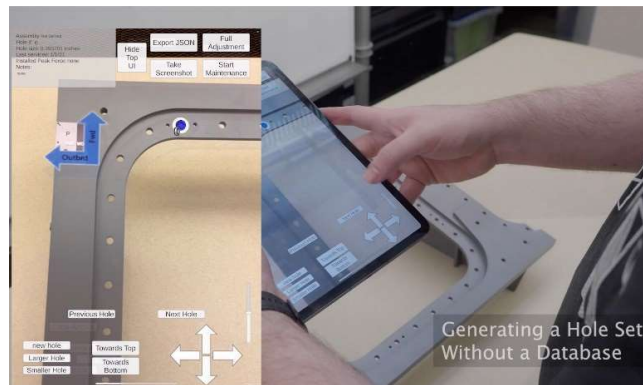
Partworks and Georgia Tech (GTRC) developed the first phase of a maintenance aid AR system. For the first mode of selecting holes to be repaired, a manual operation can be conducted that allows an operator to prescribe which holes are to be repaired on screen, see **Error! Reference source not found**.¹⁸ Once the holes are selected, the operator or mechanic can proceed to install parts and the subsequent actions will be tracked and recorded by the tool.

Figure 18. Manually Selecting the Holes to be Processed using AR

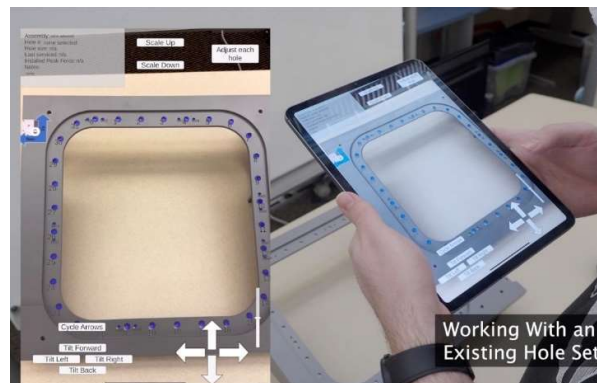
For the a second, more automated mode of operation, as seen in Figure 19 below, the system can read a data file or CAD model and pre-populatd the hole locations to be processed on the screen. The operator has an opportunity to correct any hole locations that may not have matched the database. The operator or mechanic can then continue with the repairs with the system tracking the processing of each hole and providing feedback for pass/fail to the operator.

Figure 19. Auotmatic Selection of Holes to be Processed using AR

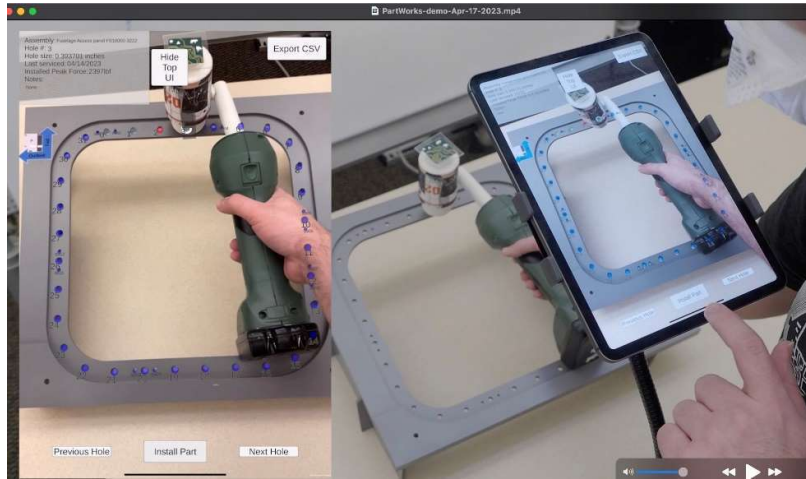
Figure 20 below shows the feedback to the operator from the AR system that a hole had an issue with the installation as indicated by the red dot on the screen. The operator can then review discrepancies, open the datasheet on the table and comment regarding the hole flagged with the error indicator.

Figure 20. Error Notice of an Issue during Hole Processing
