Evaluation of Cold Spray for Aircraft Repair

Sarah Galyon Dorman-SAFE Inc
Justin Rausch-SAFE Inc
Moriah Ausherman-SAFE Inc
Gregory Shoales-CASTLE Director

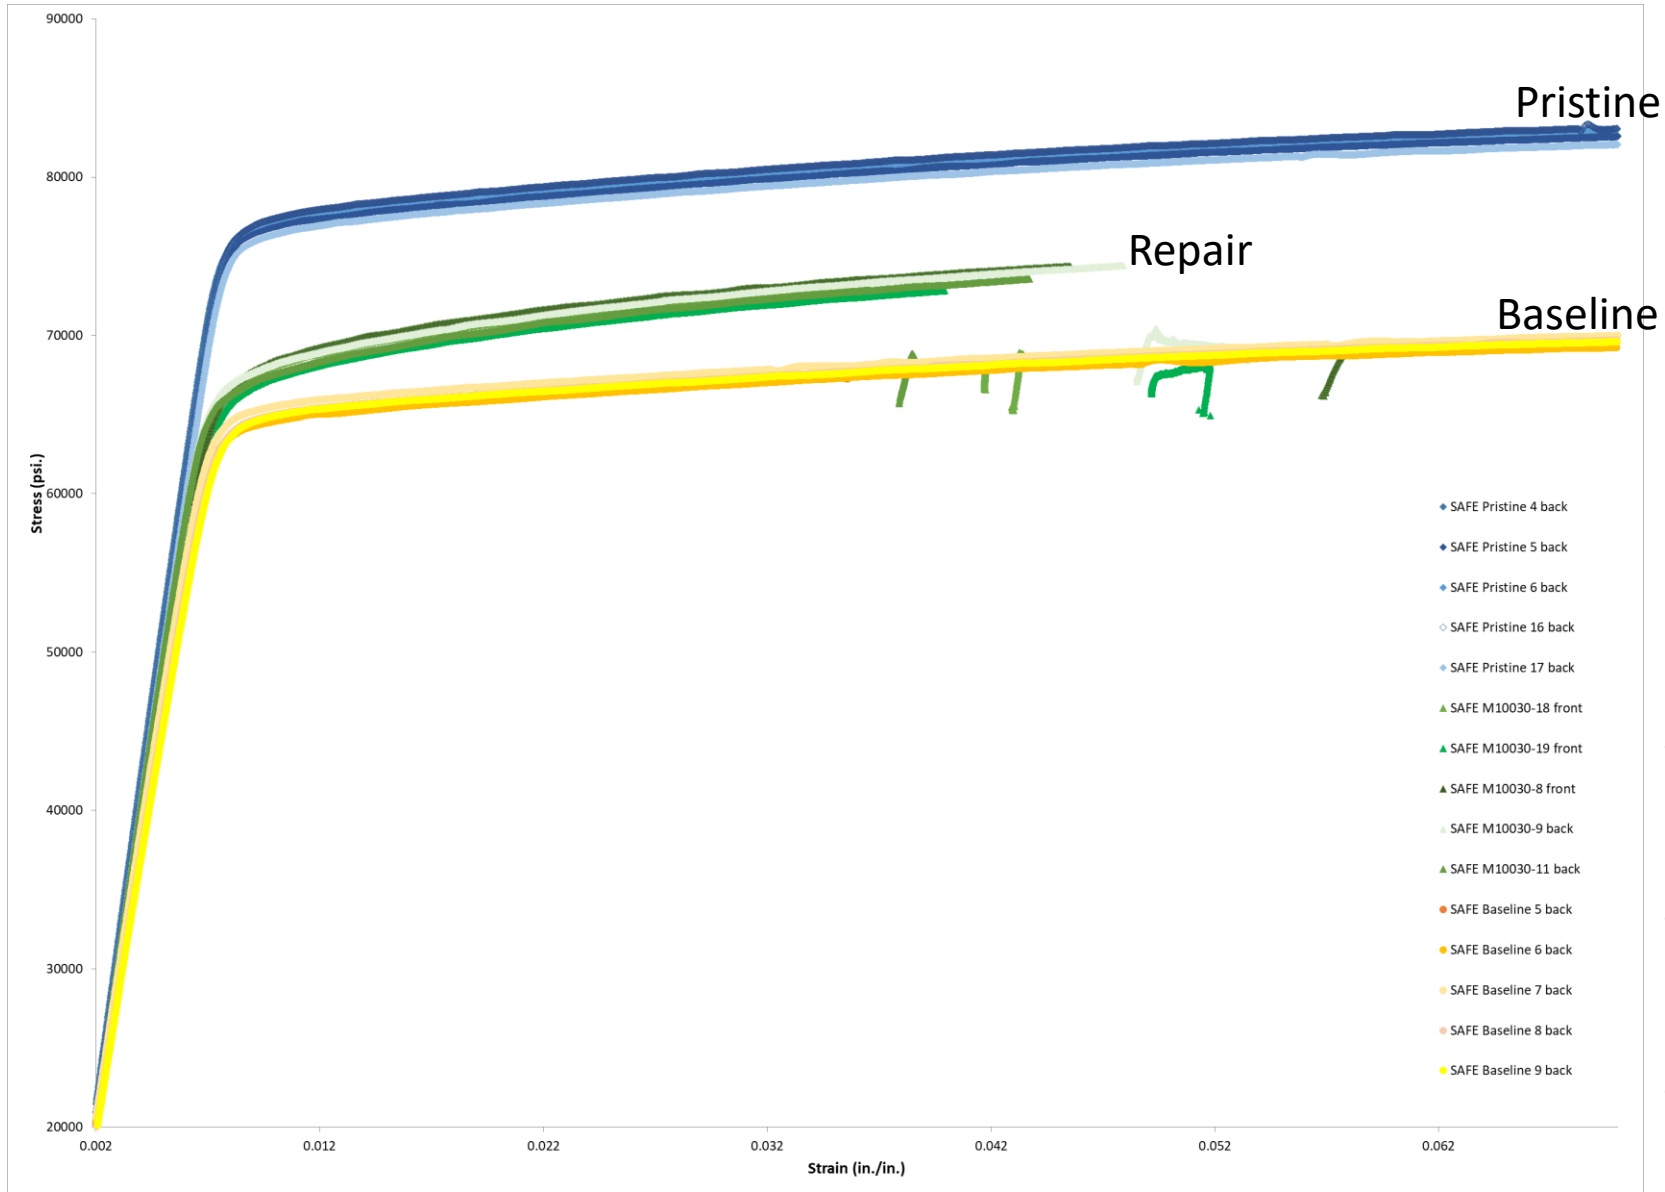
This geometry is repaired and then machined to the dimensions of the Pristine geometry.

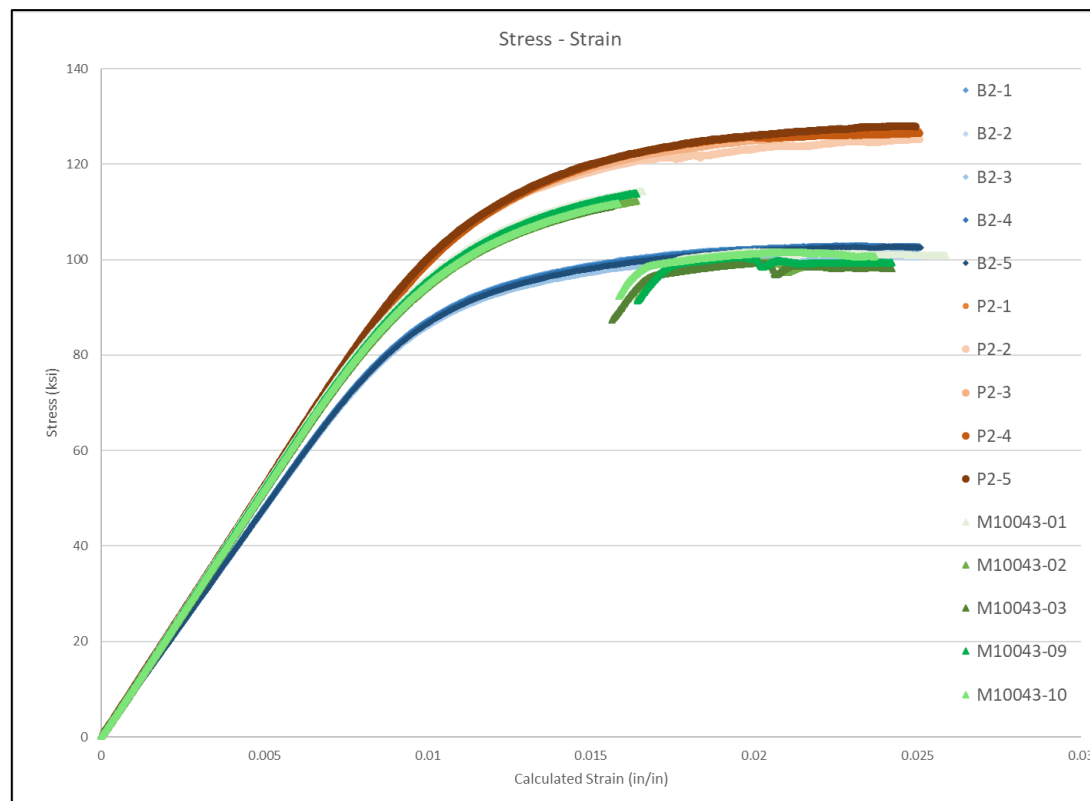
Bending Final Data

All repaired samples passed with no disbondment noted.

Cracking of the cold spray was noted in all samples.

Stress strain curves were used to show the comparison of the sample performance.

Red Data-Pristine
Blue-Baseline
Green-Repair

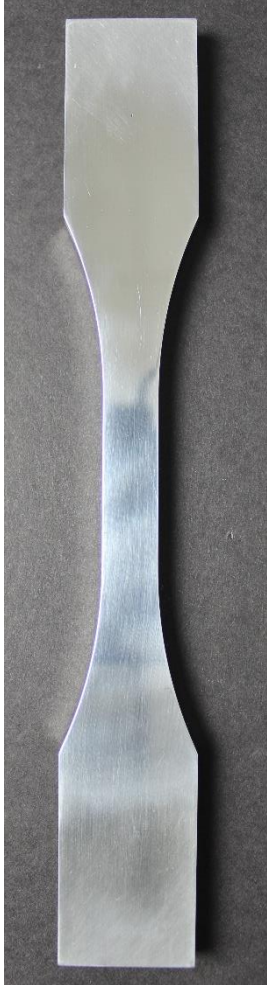
Pristine

15% Blend Geometry

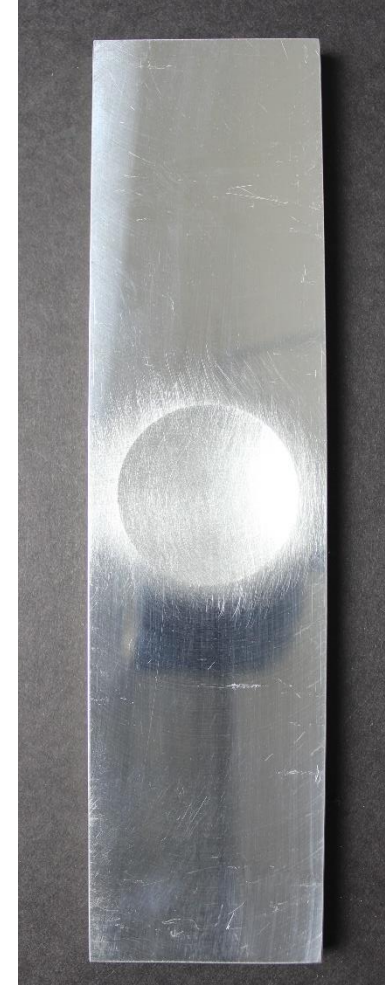
Baseline

30% Blend Geometry

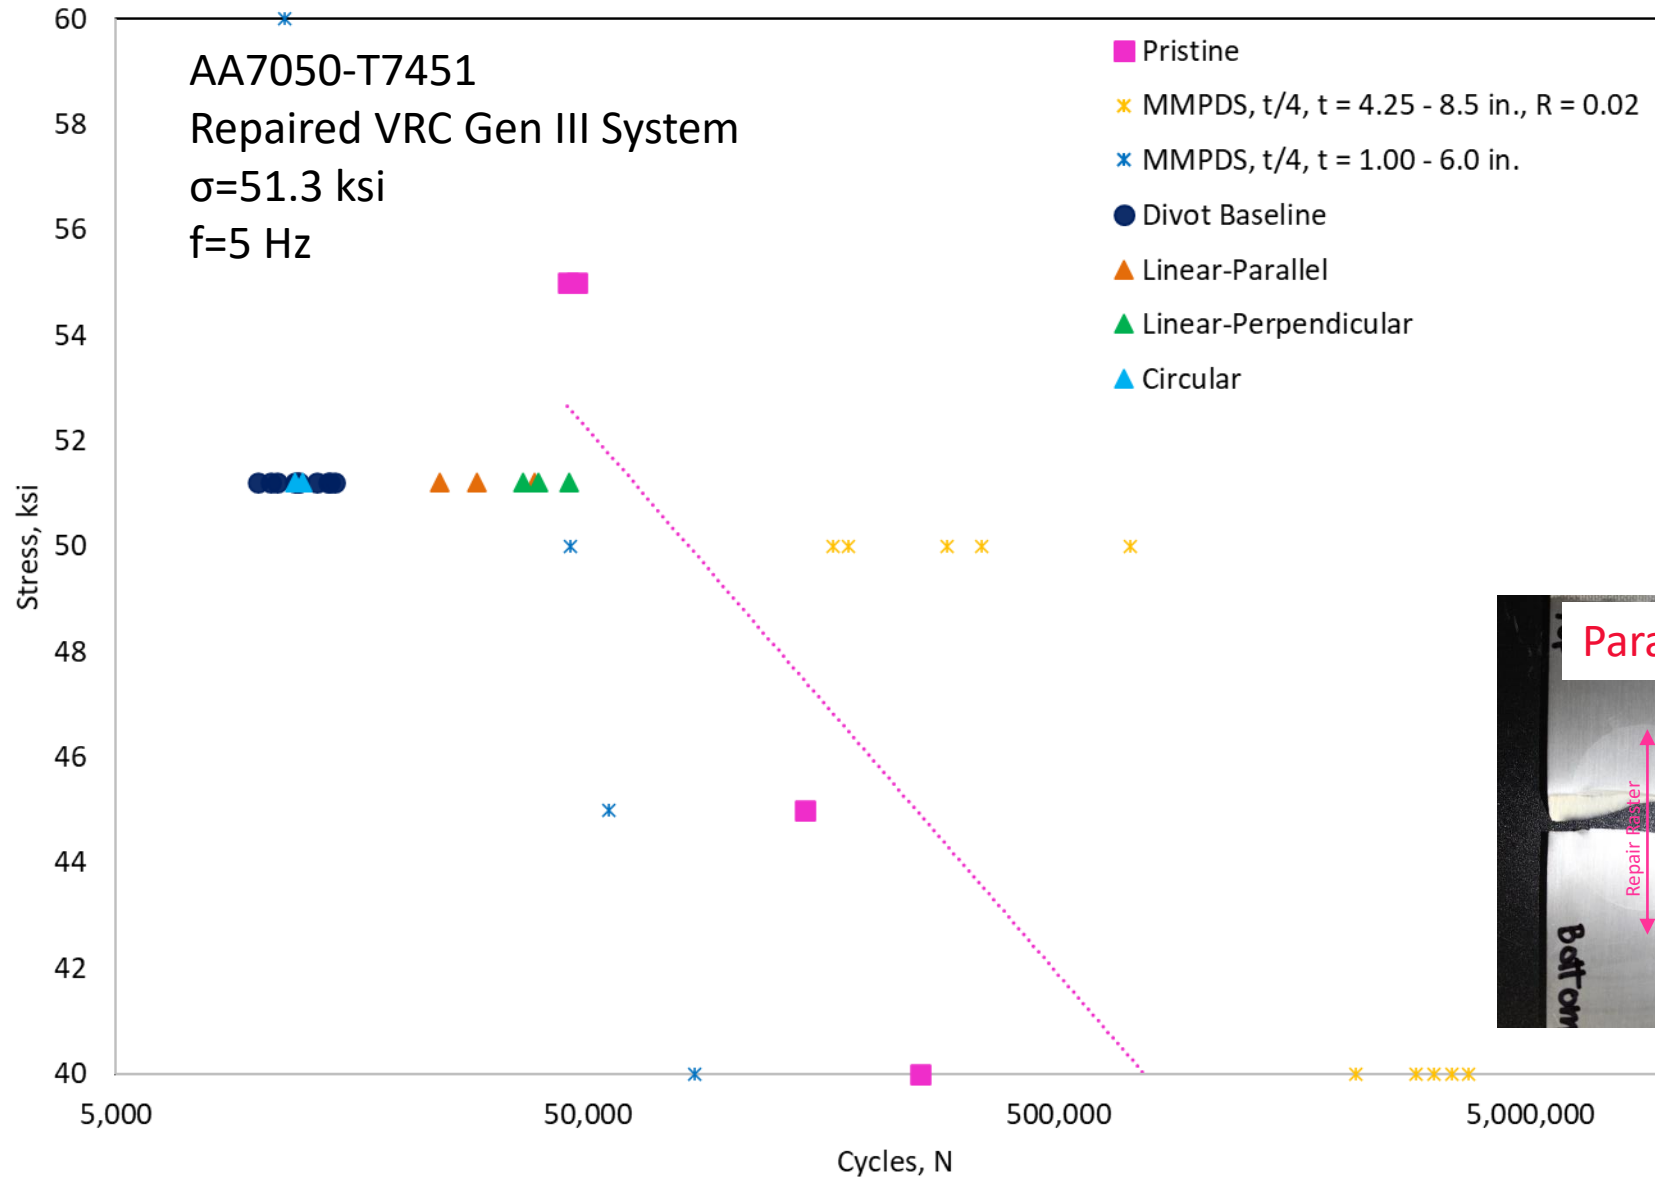
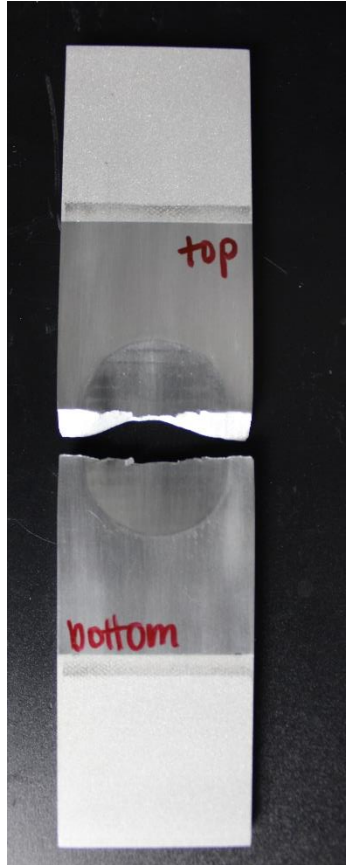
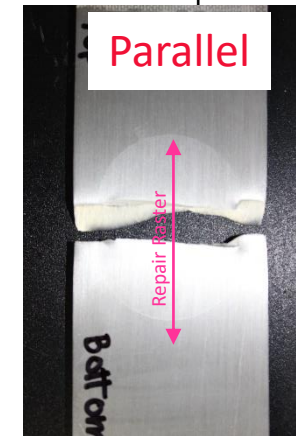
30% Divot Geometry

R = 0.1

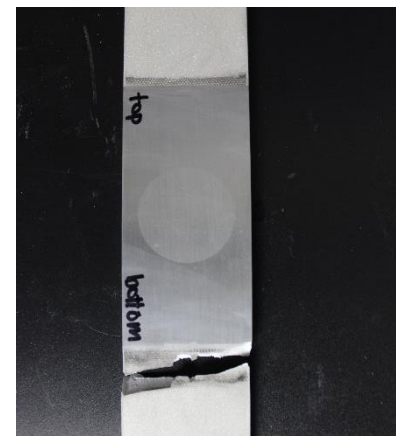
Grip Failure
R= 0.1
N= 38,524 cycles

- In most of the linear-parallel samples, sprayed parallel to the length of the coupon, fracture initiated within the cold spray. No obvious signs of consistent porosity within the cold spray were noted in center cold spray. The correlates with the increased cycles to failure over the baseline.

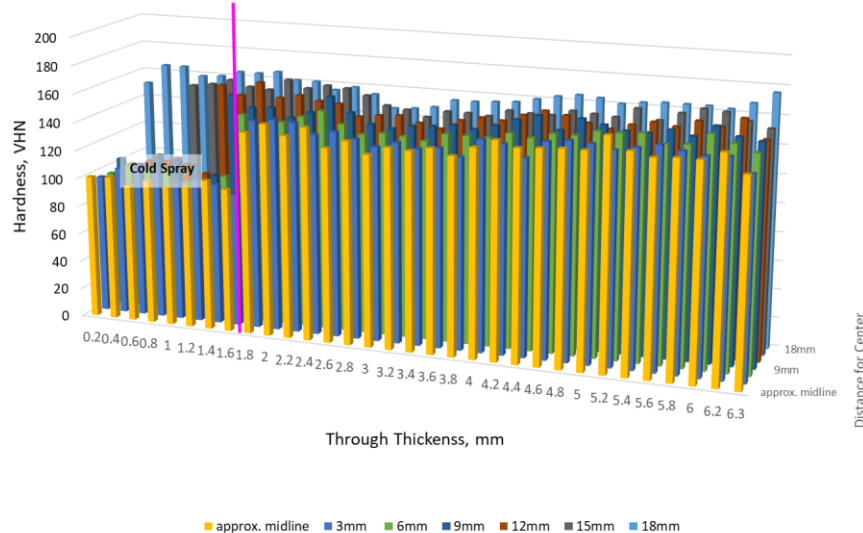
Microhardness Through Depth and From Mid Point on Linear CS Repair

Hardness Average at 2mm Depth (just over deepest CS repair)

Distance from Center	Midline	3mm	6mm	9mm	12mm	15mm	18mm	21mm
Linear	156	156	157	157	159	158	159	160
Circular	146	144	149	152	153	156	160	
Perpendicular	159	157	157	157	161	158	159	160

Measurement Made Through Sample Thickness from CS Centerline

Cold Spray Hardness	
Linear	104.3
Circular	99.9
Perpendicular	110.3

The linear sprays showed limited to no change in hardness: suggesting heat input is acceptable

- The majority of the fatigue crack initiated within the cold spray and propagated across the interface into the wrought material
- No heat effect was noted in the samples from microhardness measurements suggesting the heat input is well controlled

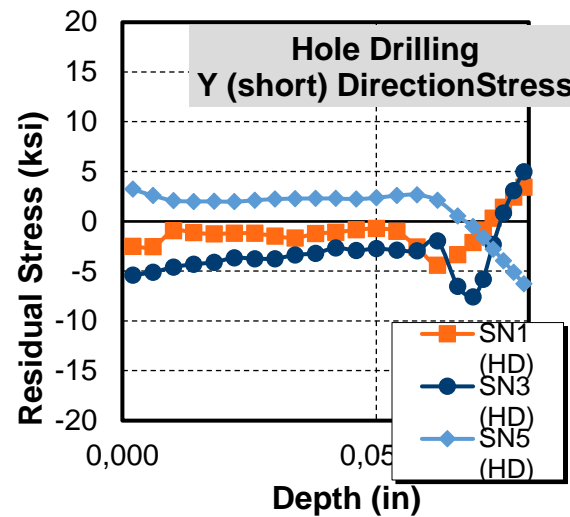
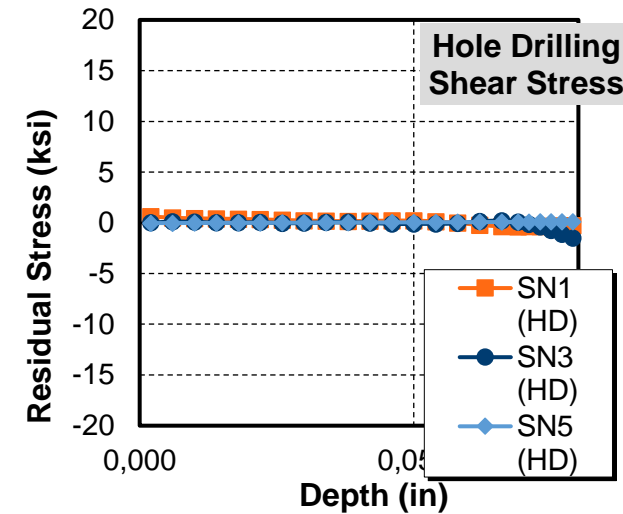
The coupons with a circular raster pattern had tensile residual stress up to the transition from cold spray to wrought (SN5). The parallel (SN3) and perpendicular (SN1) coupons each showed compressive residual stress with increased compressive residual stresses occurring in sprays nominal to the stress direction, (ie. Y direction (perpendicular) sprays and X direction stress.)
