Authors:  
Dr. Matthew Kokaly  
Jude Restis

Enhanced Technology Repair for Corrosion and Fatigue Damage in Hybrid  
Aerostructure

ICAF 2023  
Presented by Jude Restis  
June 2023

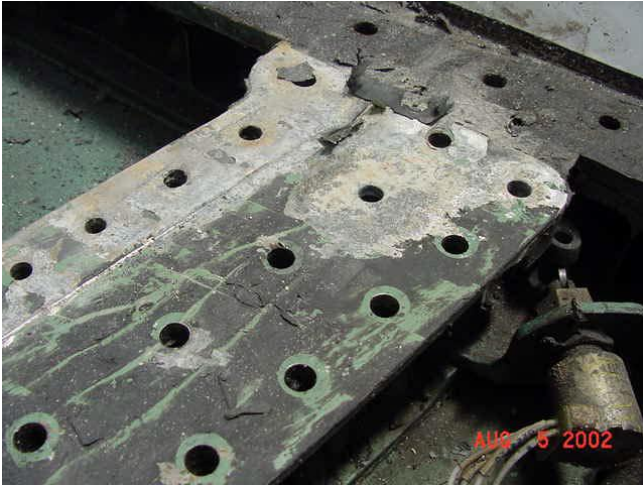
Widespread galvanic corrosion damage experienced on multiple programs with composite over aluminum in the presence of moisture

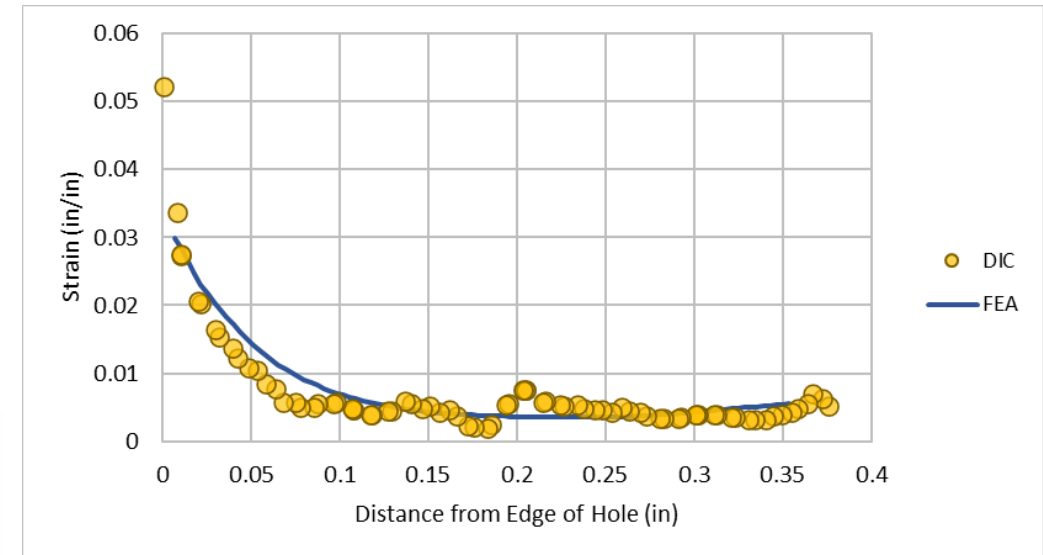
## Residual Strain Visualization with DIC

- Image Capture: Before, during and after repair
  - On-tool image capture
- DIC used to correlate residual strain with FEA
- Will also be correlated to X-Ray diffraction

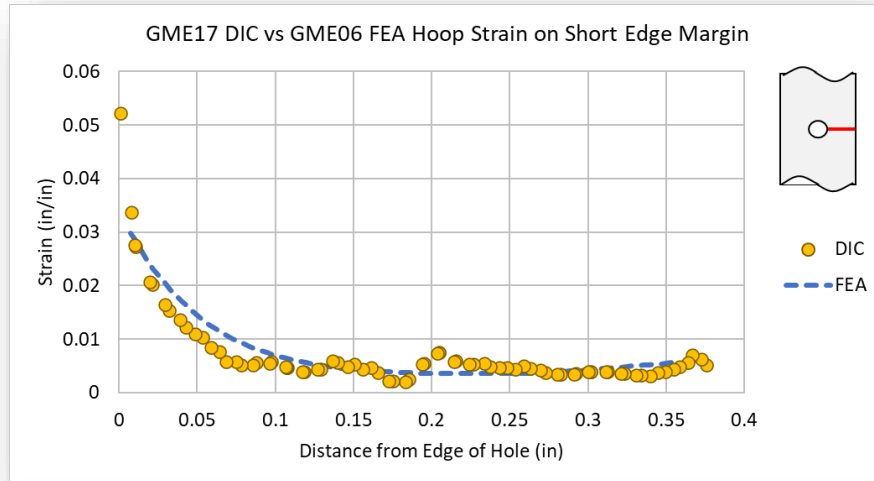
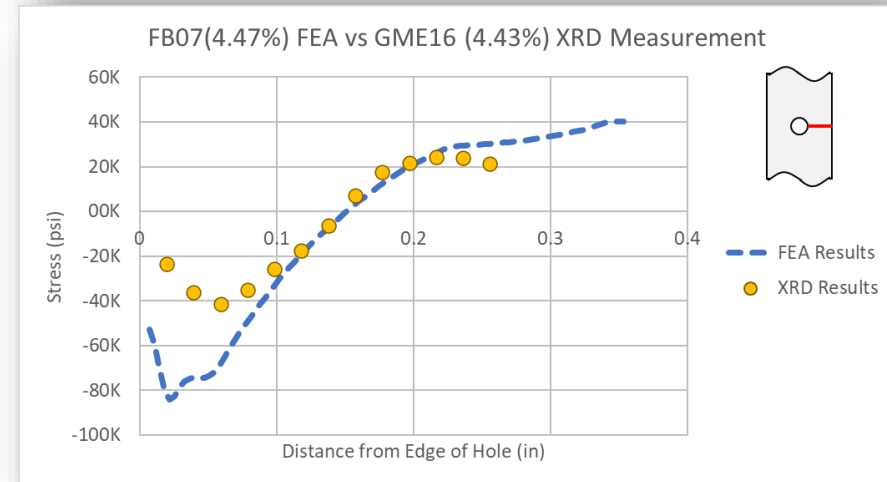
- Correlation – FEA, Digital Image and X-Ray Diffraction

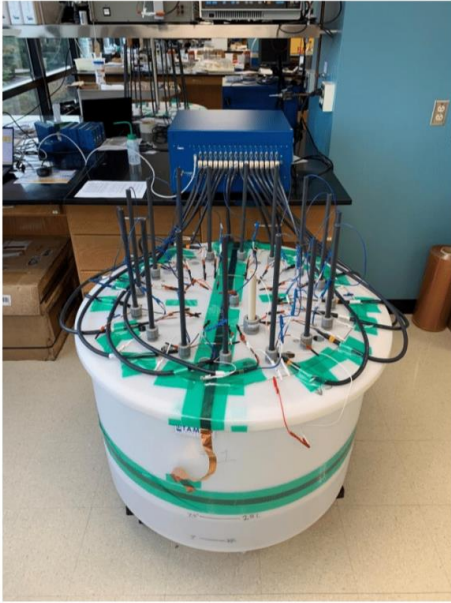
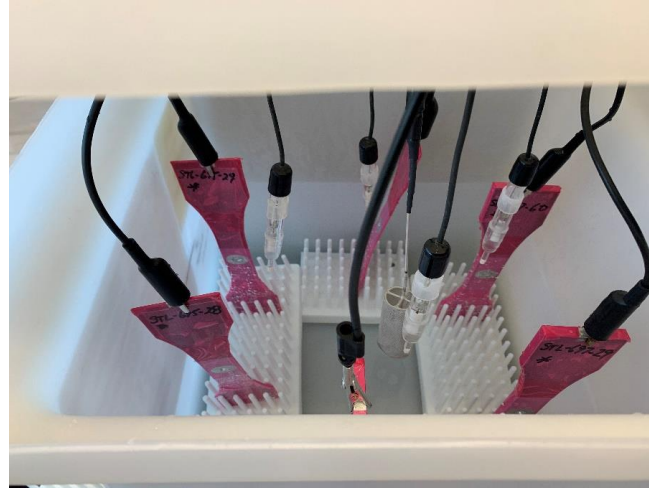
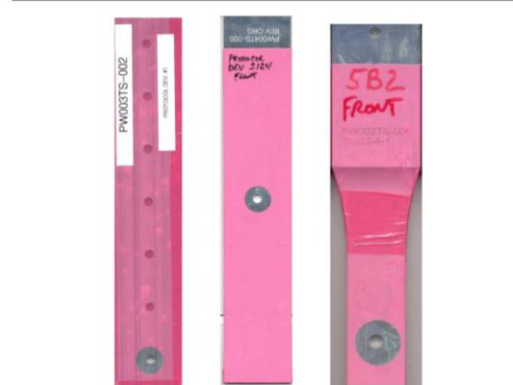
# Corrosion Protocol Development

- NaCl and NaAlO<sub>2</sub> solution
- Dogbones masked with electroplaters tape
- 0.25 in dia. hole, 0.75 inch dia. surface exposure each side of dogbone

Figure 6 (L) Representative image of a multihole protocol development specimen taped off to expose one bore hole for corrosion testing; (C) Representative image of a single hole protocol development specimen taped off to expose one bore hole for corrosion testing; (R) Representative image of a dog bone fatigue test specimen taped off to expose the bore hole for corrosion testing (note: only top 2/3 of dog bone visible in scan image, although entire dog bone was taped).

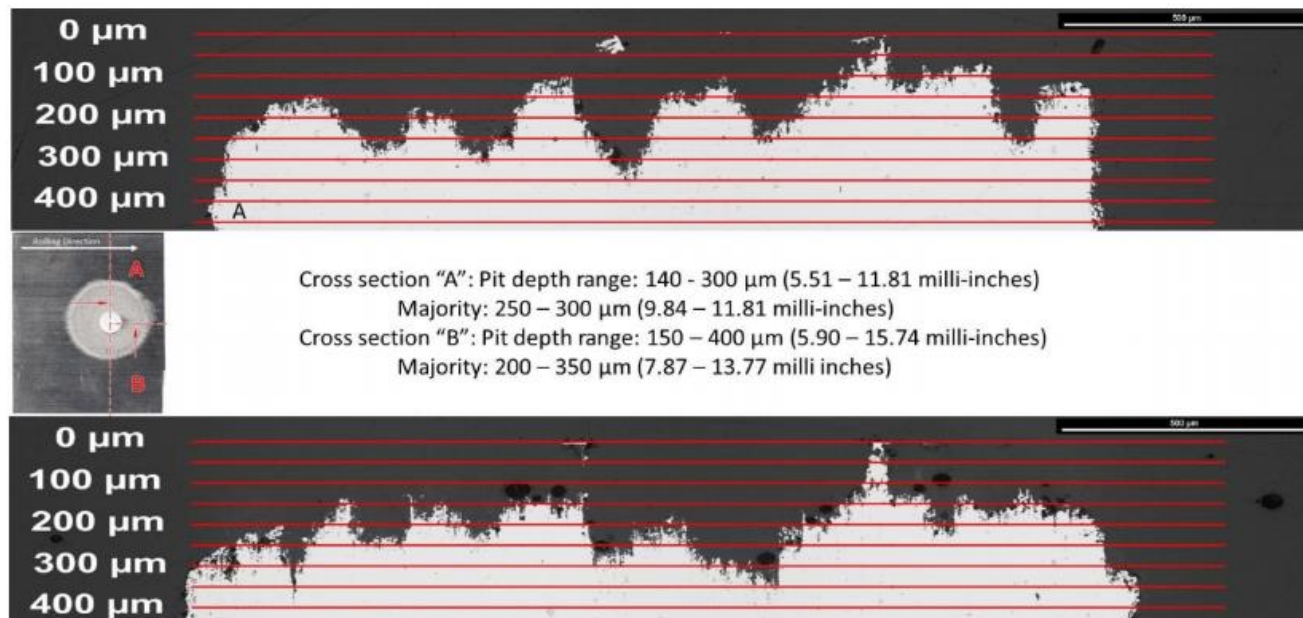
**Figure 14.** Metallographic images of cross-sections of 0.06" thick AA7050-T7541 protocol development specimens along the bore hole wall at "A" orientation (Top) and "B" orientation (Bottom) after 120 hours of corrosion testing.

0.06 thick 7050 – 120 hour corrosion protocol

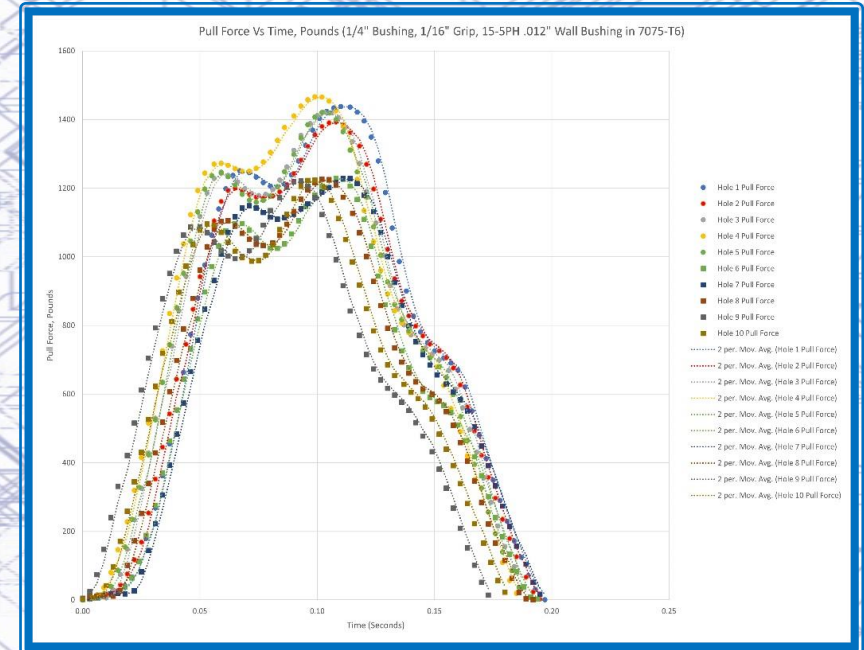
# Process Verification - In Tool Measurement and Feedback

- Cold Expansion process parameters and pull-force documented in tool
- Pull-force data correlated to:
  - DIC
  - Test data
  - Material properties and geometries
- Good / Bad feedback provided to operator

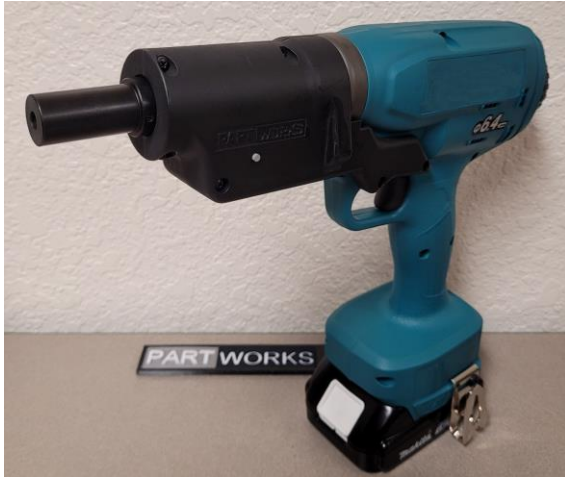
Handheld Puller with Process Control Electronics Incorporated

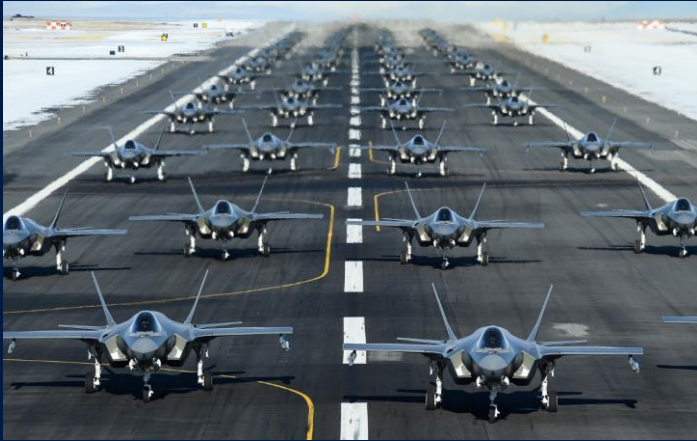
# Considerations for New Production

USN F-18 program spends \$690M / year on corrosion (30% of total maintenance budget)

Hybrid structure of some of the newest aircraft have similar corrosion problems

PartWorks solution incorporated in new production can mitigate corrosion in fastener holes
