A Review of Australian and New Zealand Investigations on Aeronautical Fatigue During the Period April 2007 to March 2009

DSTO-TN-0885

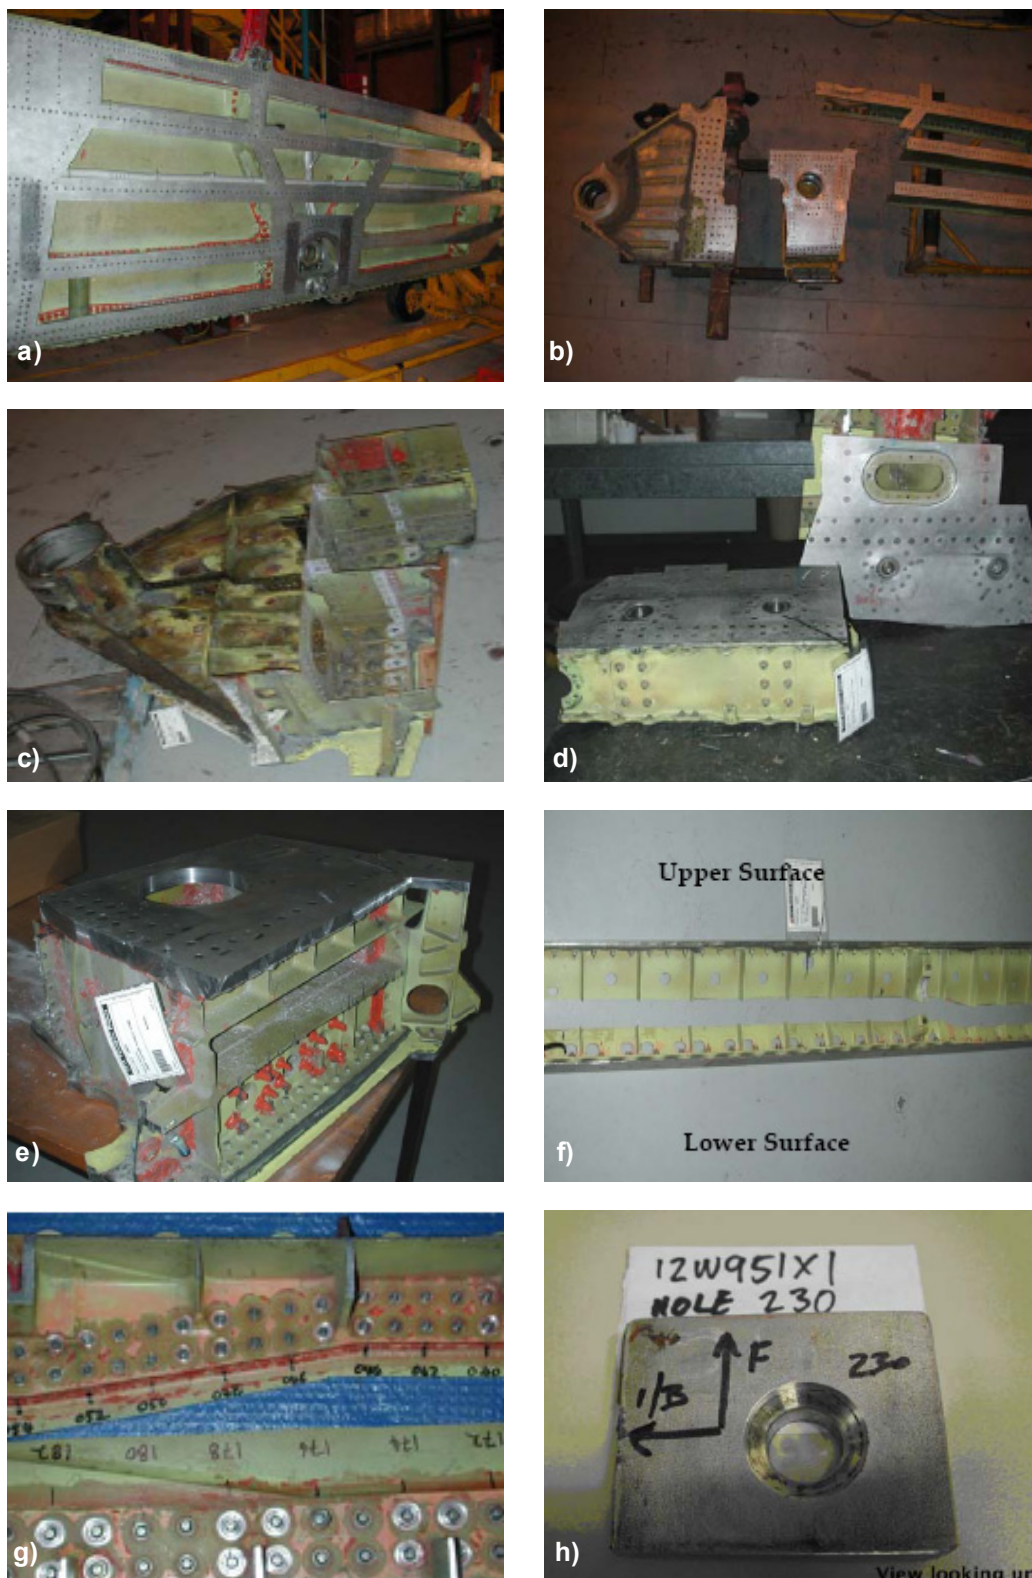
Figure 4 a) Upper Wing Skin removal; b) Separation of the Wing Pivot Fitting (WPF) and Inboard Pivot Pylon (IPP); c) WPF Lower Plate; d) Lower Wing Skin (LWS) Hardpoints; e) IPP Housing; f) Spar fragment; g) Example of water picked fragments; h) Fragment prior to being broken open for fractographic analysis.

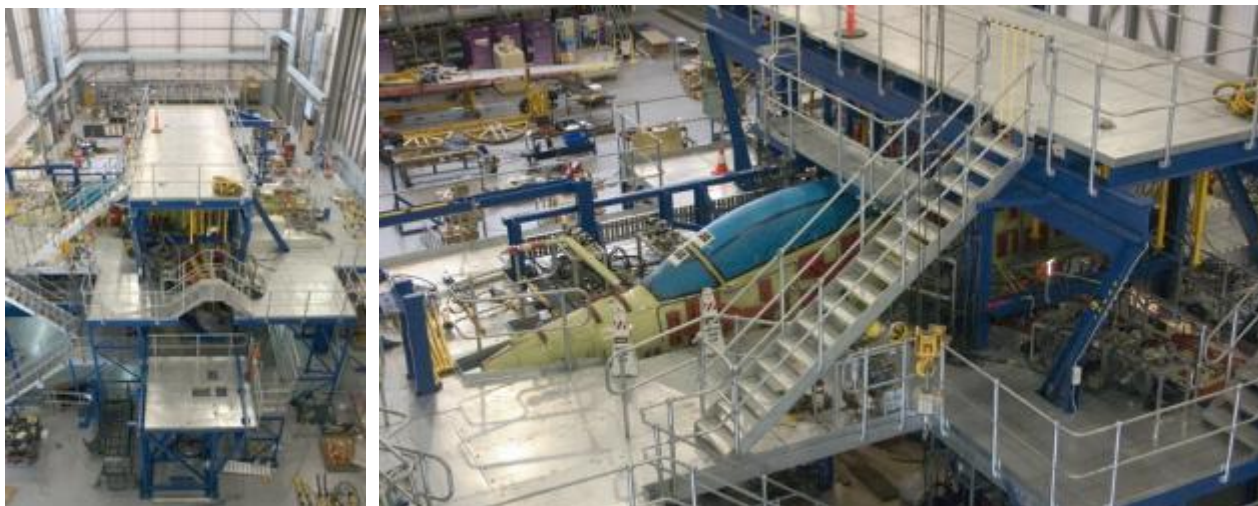
Figure 18 LIF Test Rig (left) under construction, and (right) with aircraft installed.

Design, construction and commissioning of the test rig was completed in December of 2005. The fatigue test commenced in December 2005 with the application of a simulated Production Flight Acceptance Test (PFAT) load block. Continuous testing commenced in February of 2006 and is expected to continue until 2012, eight years before the fleet's proposed withdrawal date. The fatigue test will be followed by DSTO carrying out a residual strength test and a full teardown inspection. Overall the project will be completed by 2014.

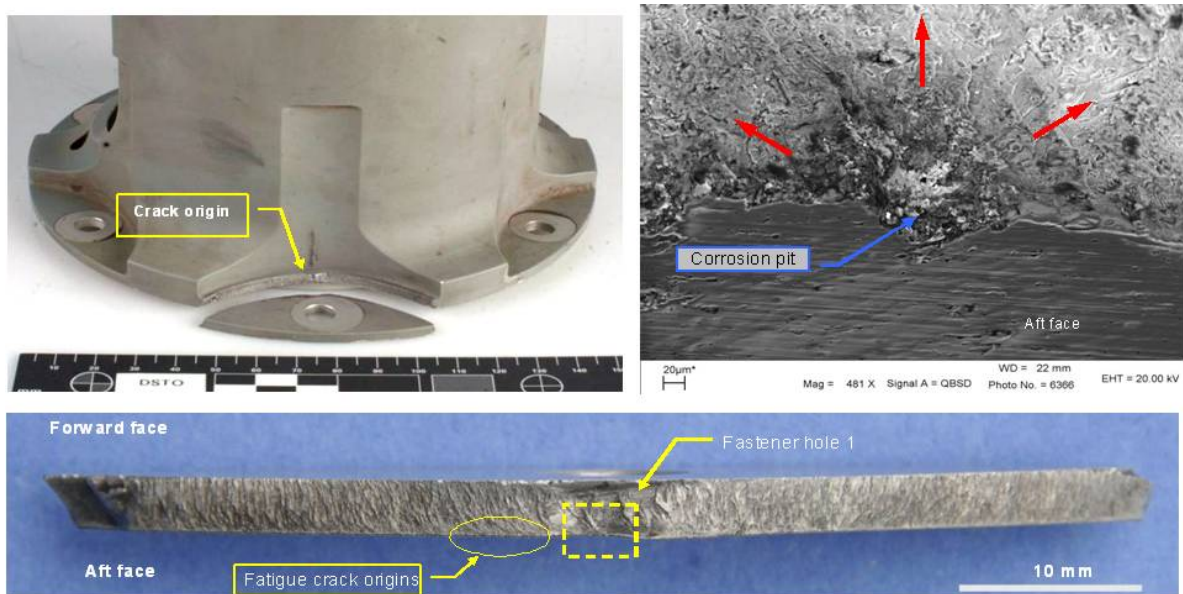
Figure 22 Black hawk high speed shaft tube cracking.

It was likely that the combined effects of the service stresses, the point loading (and flexing) and the presence of surface damage and corrosion pits caused the fatigue crack initiation, Figure 22.

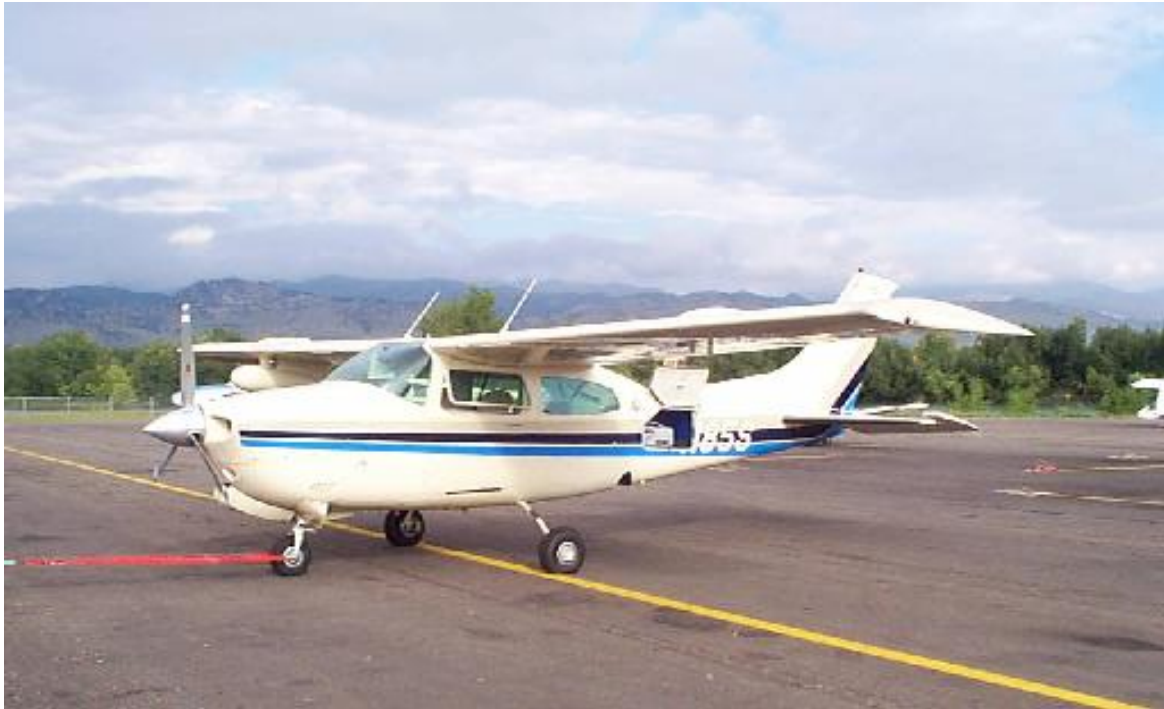
Figure 25 The Cessna 210 has a wing carry-through forging that is prone to corrosion as well as fatigue

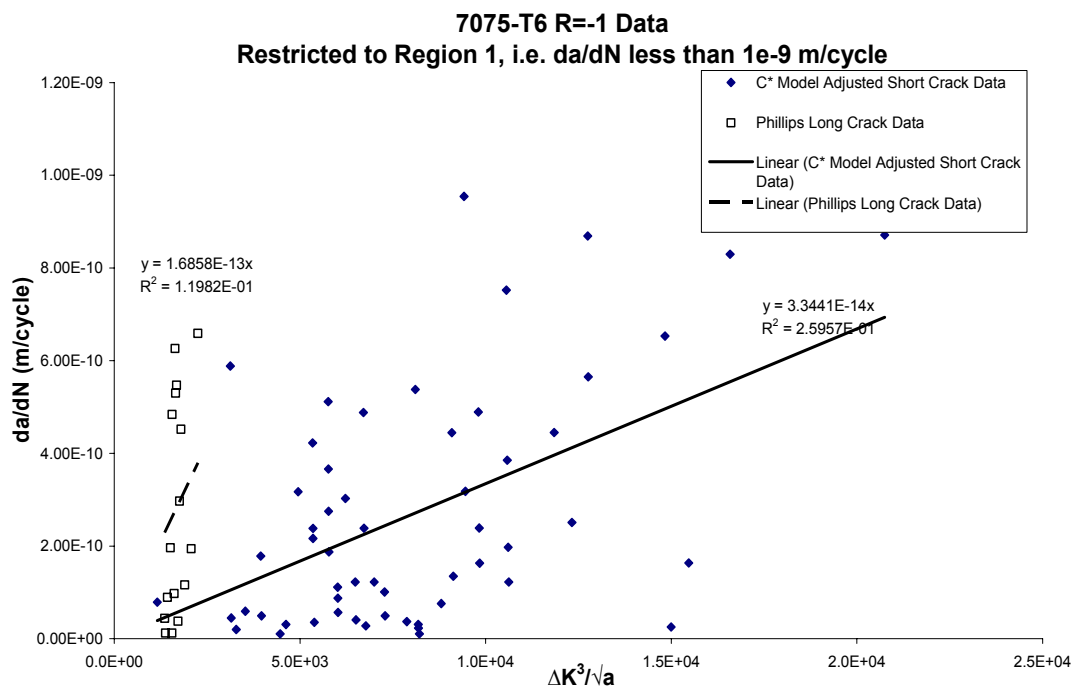
Figure 30 Crack growth rate plotted against the C^* parameter. Note the difference between the long and the short crack data points.

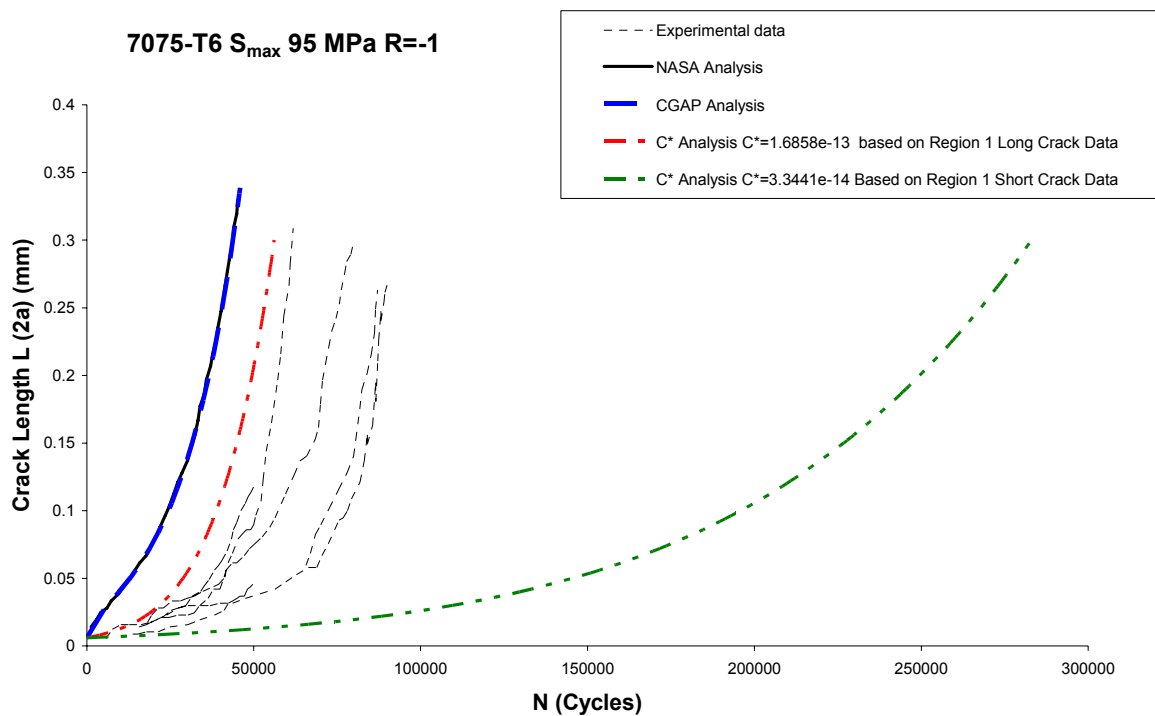
Figure 31 C^* based crack growth analysis results using long and short crack data restricted to Region I compared with the experimental crack growth data.

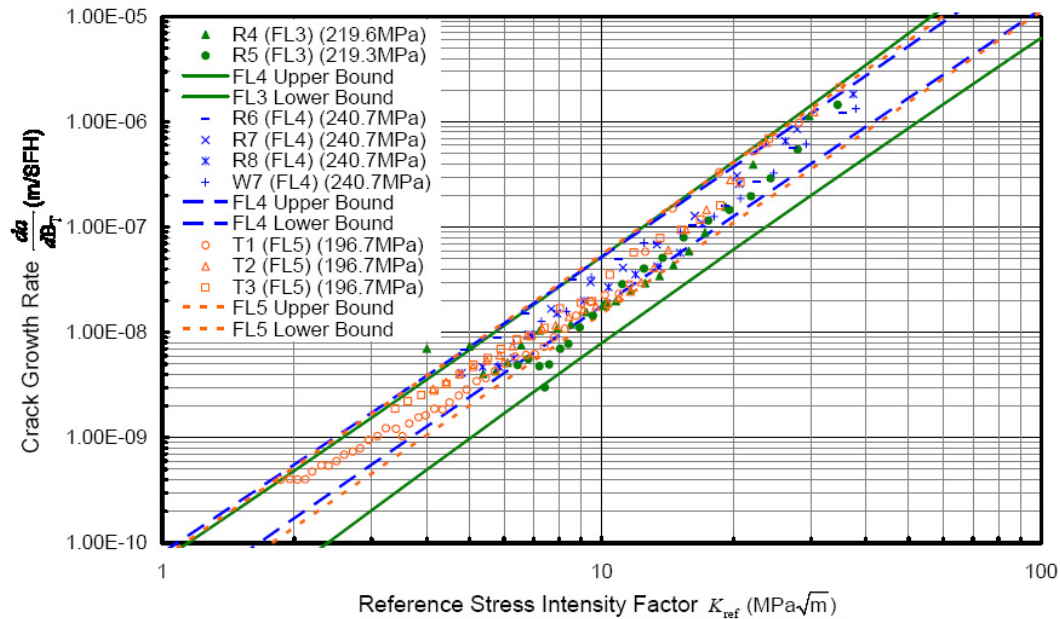
Figure 34 Prediction intervals (upper and lower limits) for FL3, FL4 and FL5 crack growth rate data sets.
